Architect's Field Report

21 April 2021

15094 Community Bank Headquarters

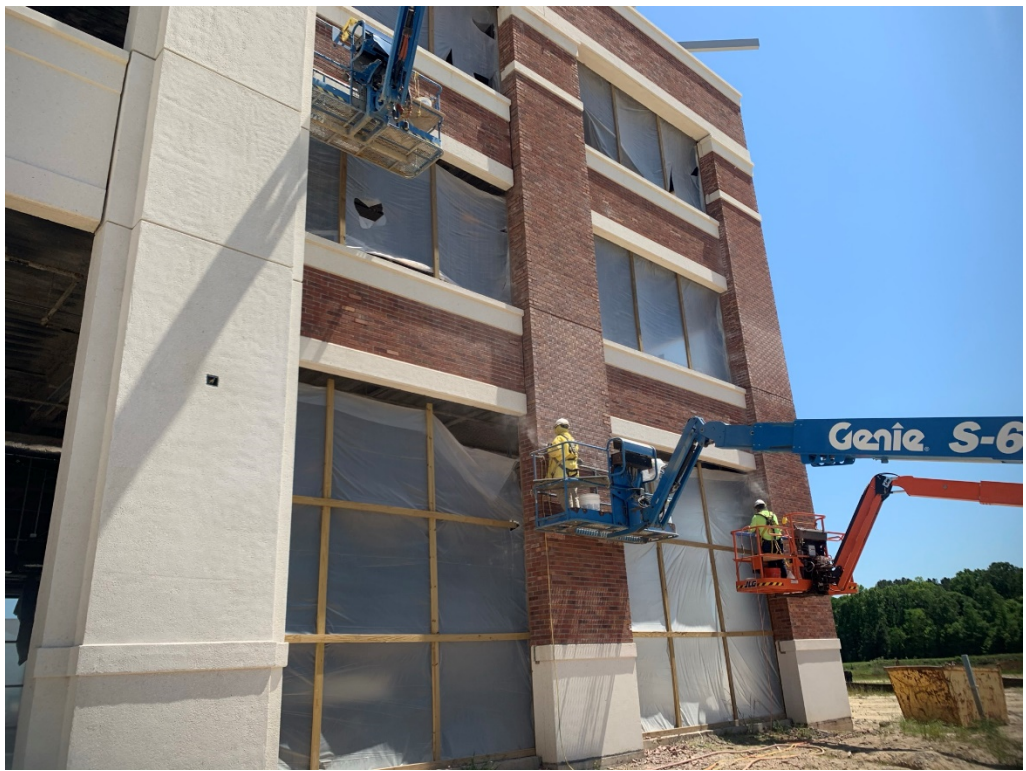
Observations On site, masons are busy repairing brick panels by grinding out joints.  
Work has moved from the North around to the West side of the building.

Figure 1 – Masons Reworking Brick

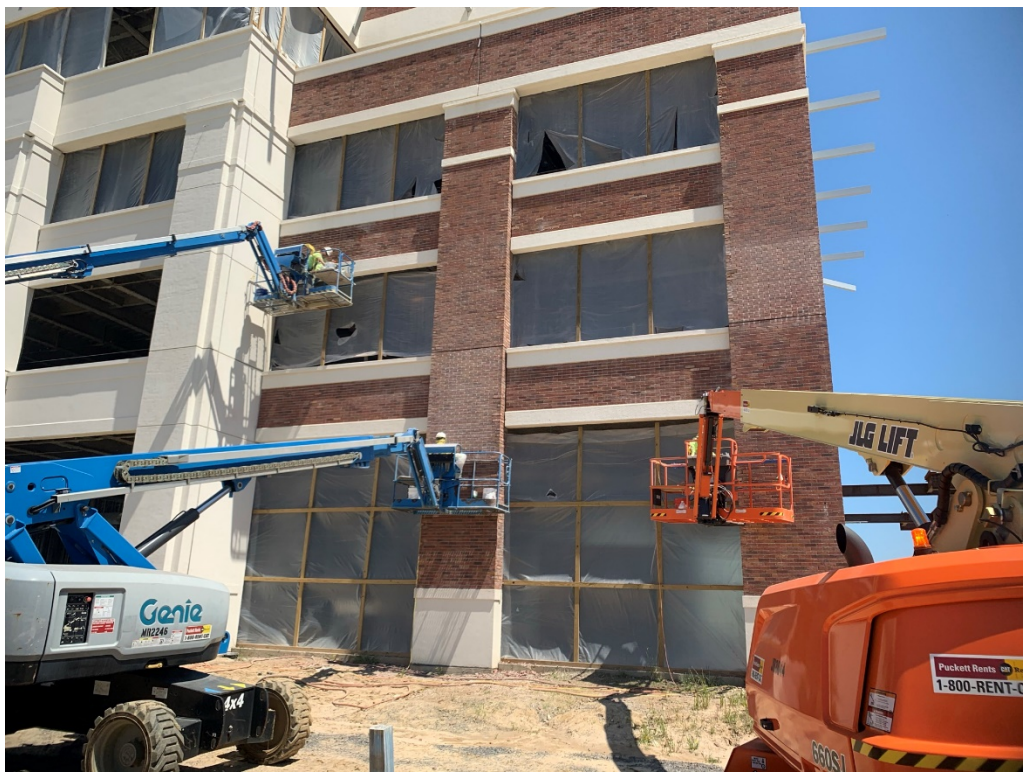
Figure 2 – Masons Reworking Brick

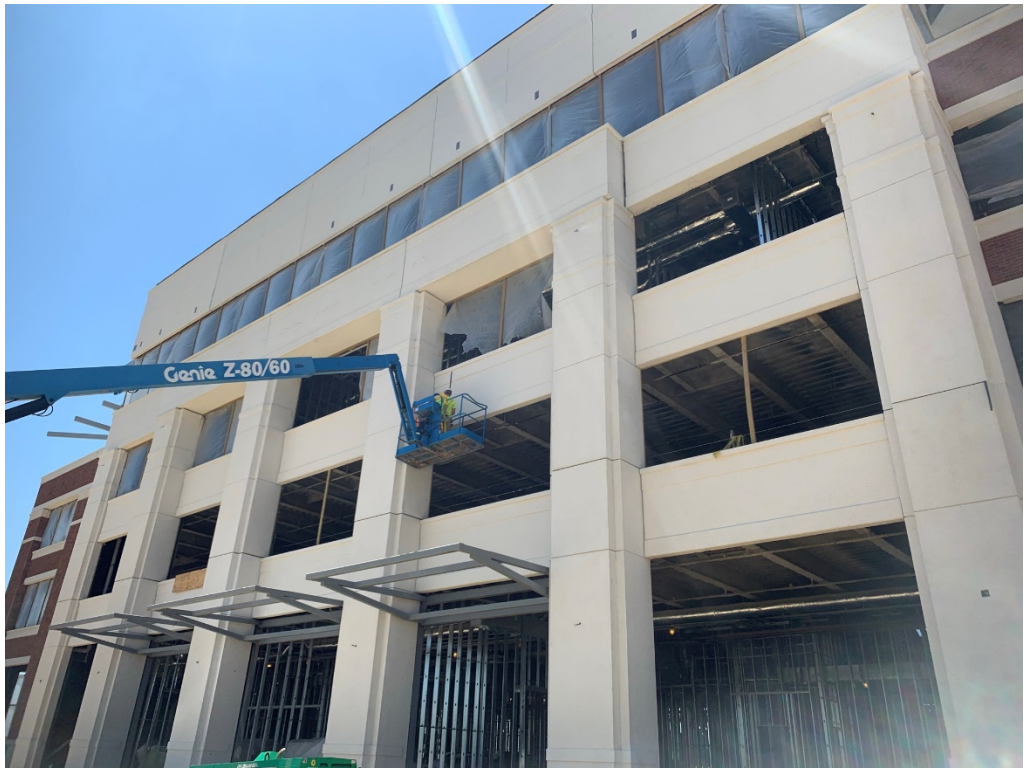
At the east side, workers on a lift were working with the solid panels.  
Also, electrical workers were working out their trench for underground  
conduit at the southeast side.

Figure 3 – Panel Adjusters

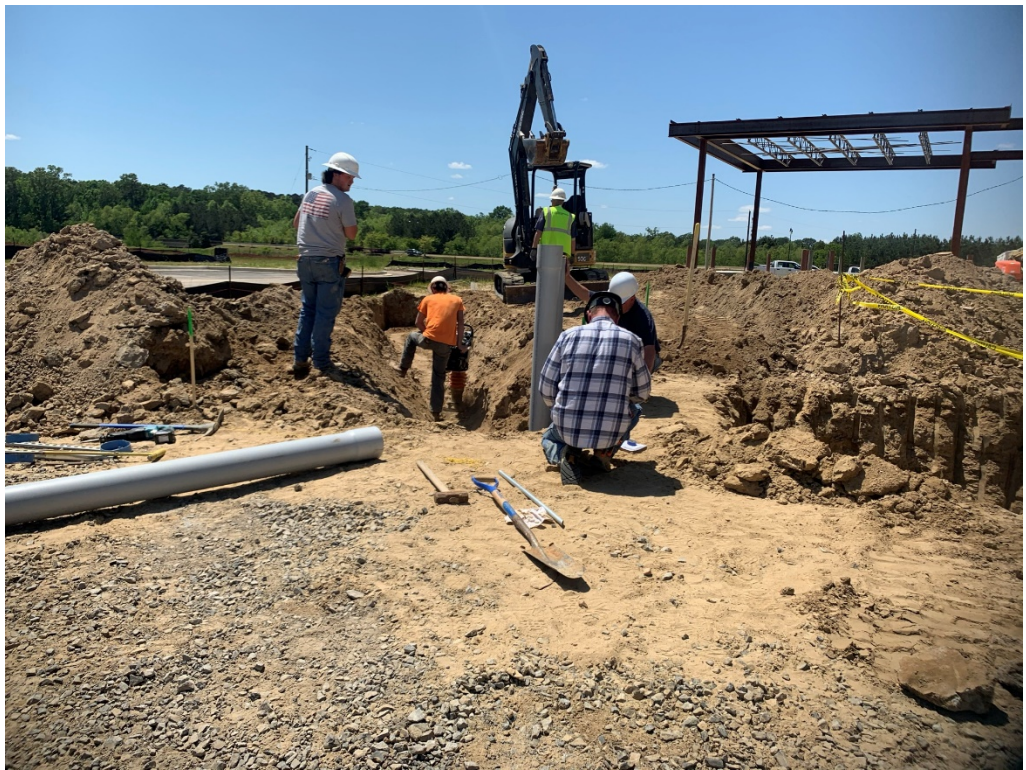
Figure 4 – Underground Electrical Work

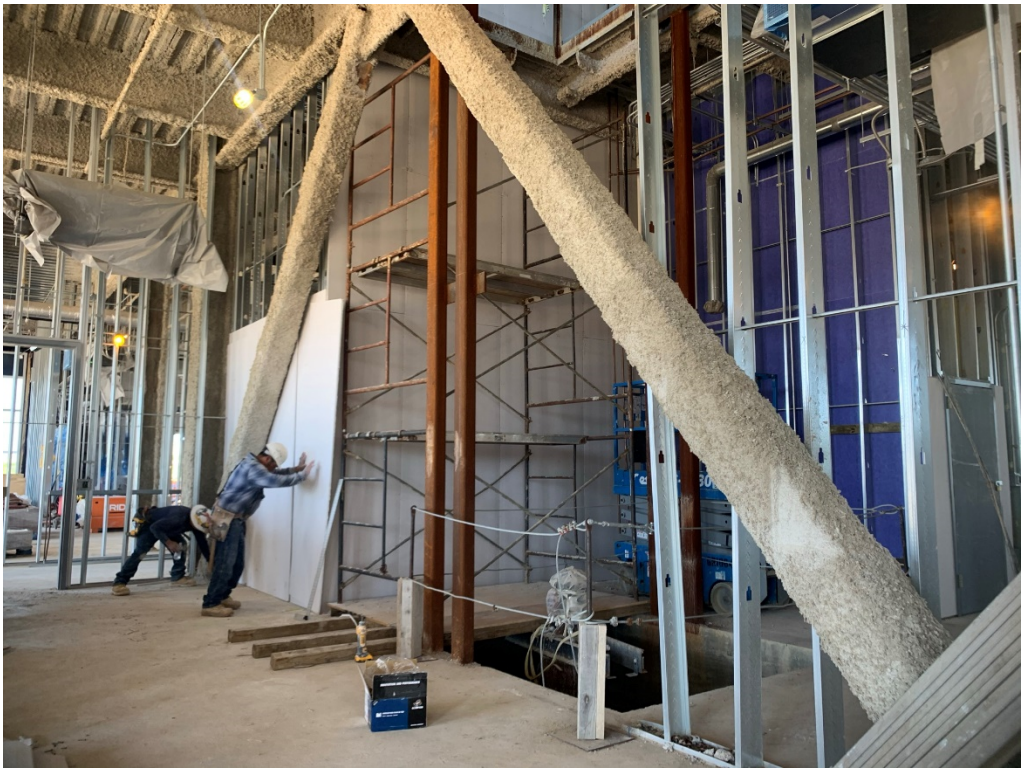
At the interior, drywall workers were installing sheets at elevator 3.  
There did appear to be new fireproofing sprayed at the steel in this area  
indicating that the previously uncovered steel at this shaft has been  
covered.

Figure 5 – First Floor Drywall Install at Elevator Shaft

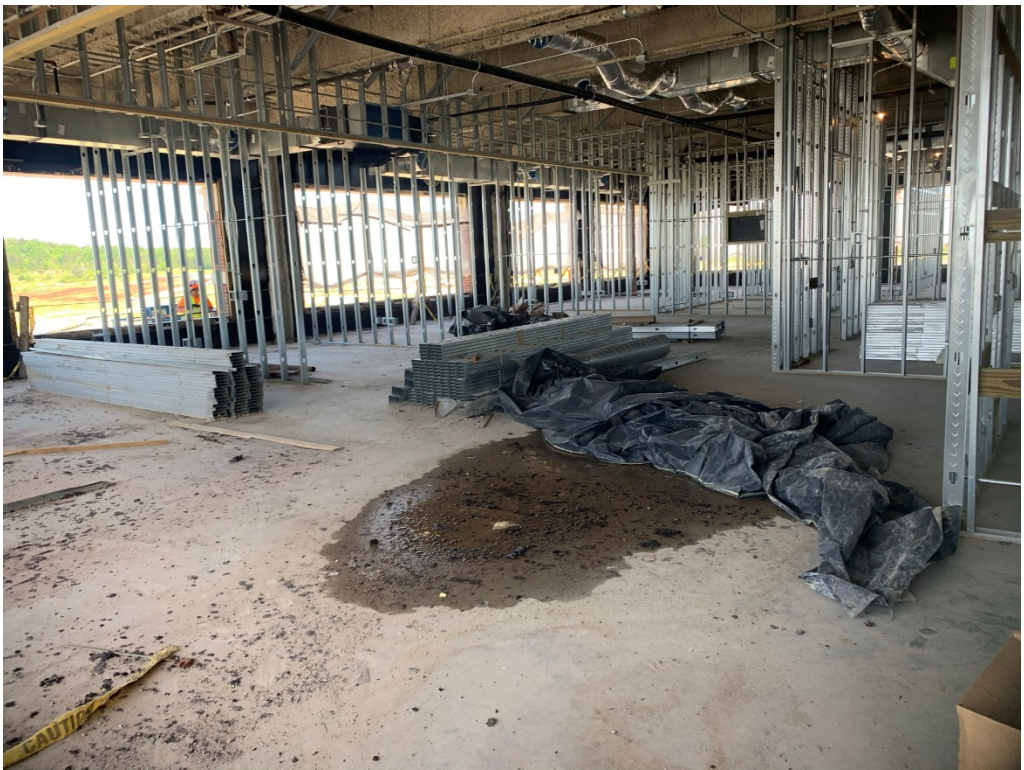
Figure 6 – 3<sup>rd</sup> Floor Progress
