Architect's Field Report

29 April 2021

15094 Community Bank Headquarters

Date / Time 28 April 2021 / 1:30 PM

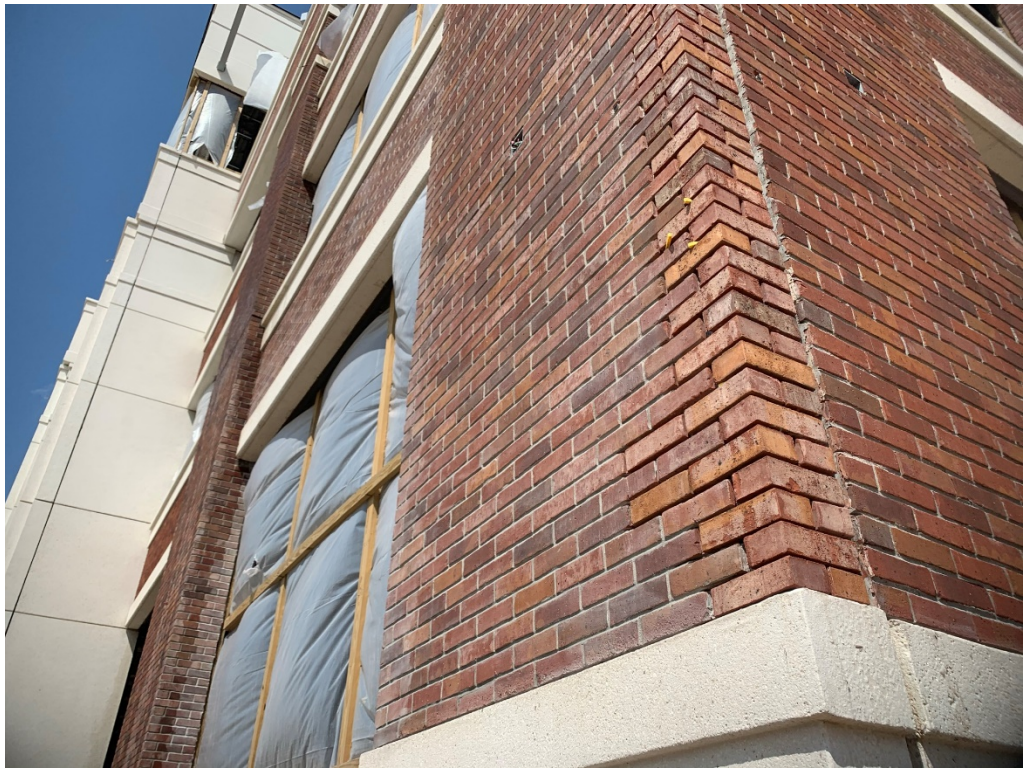
Observations Arriving on site, I walked the exterior. Brick work is ongoing at the southwest corner. Bricks are set but still need mortar between.

Figure 1 – SW Corner Brick Progress

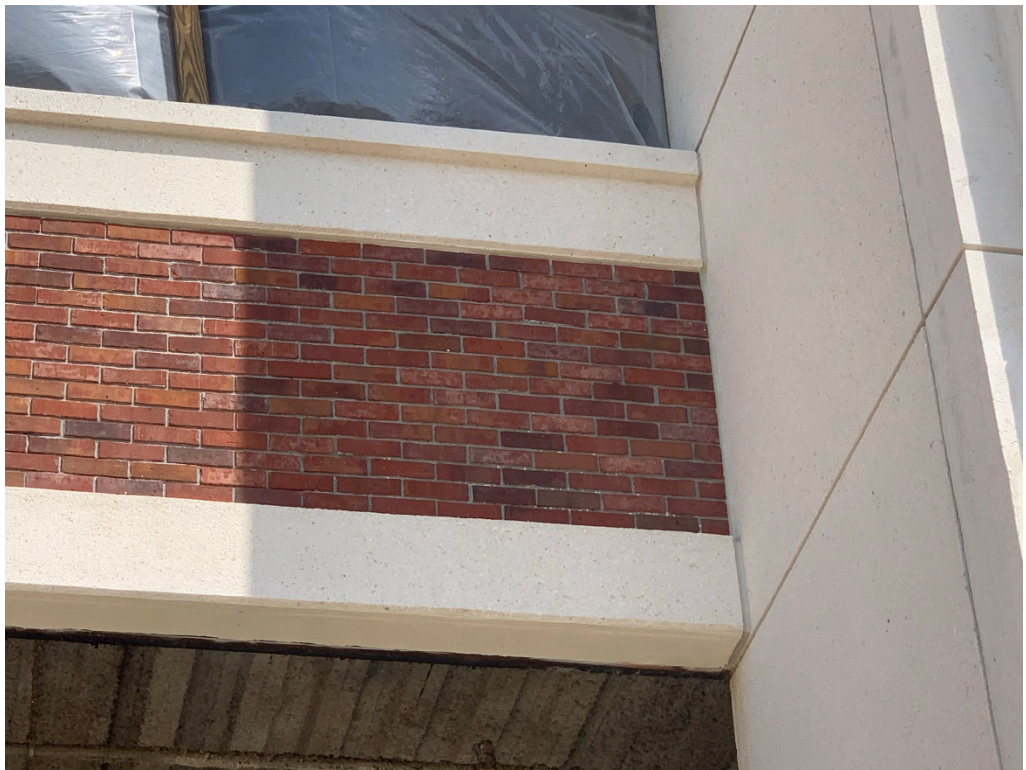
Figure 2 – White Sealant here looks good

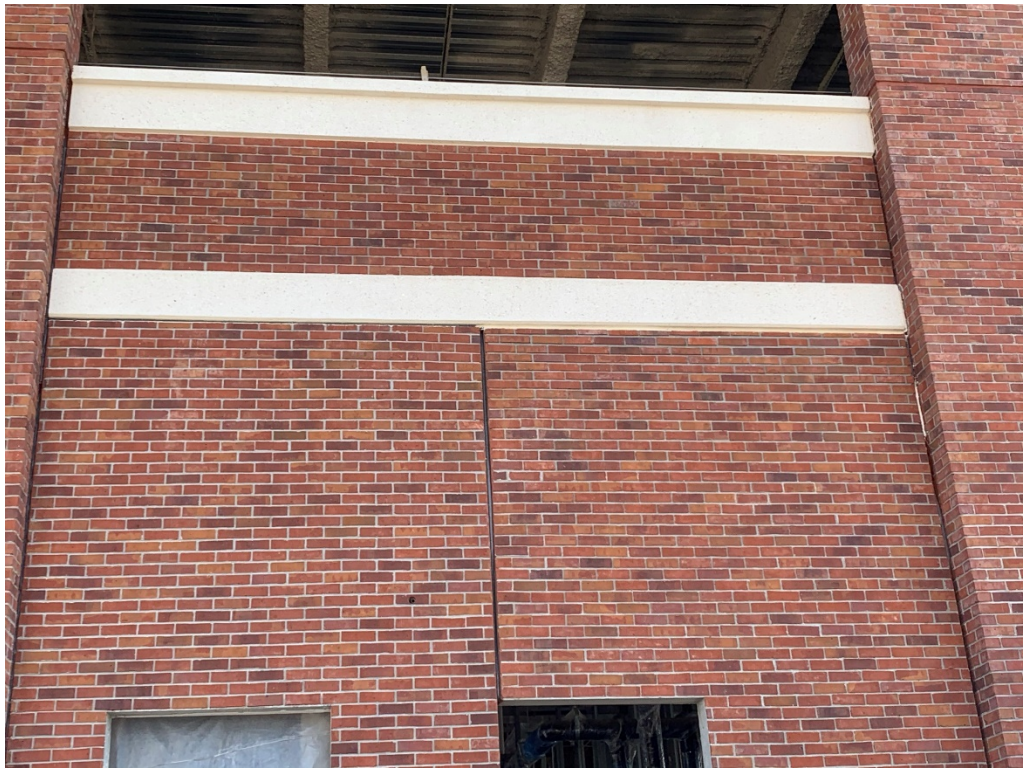
Sealant work is ongoing. I ran into Stan Green at the east side of the building. He mentioned the sealant contractor is in need of red sealant to move forward. He didn't give a timeframe.

Figure 3 – Sealant Progress Stalled due to Shortage of Material

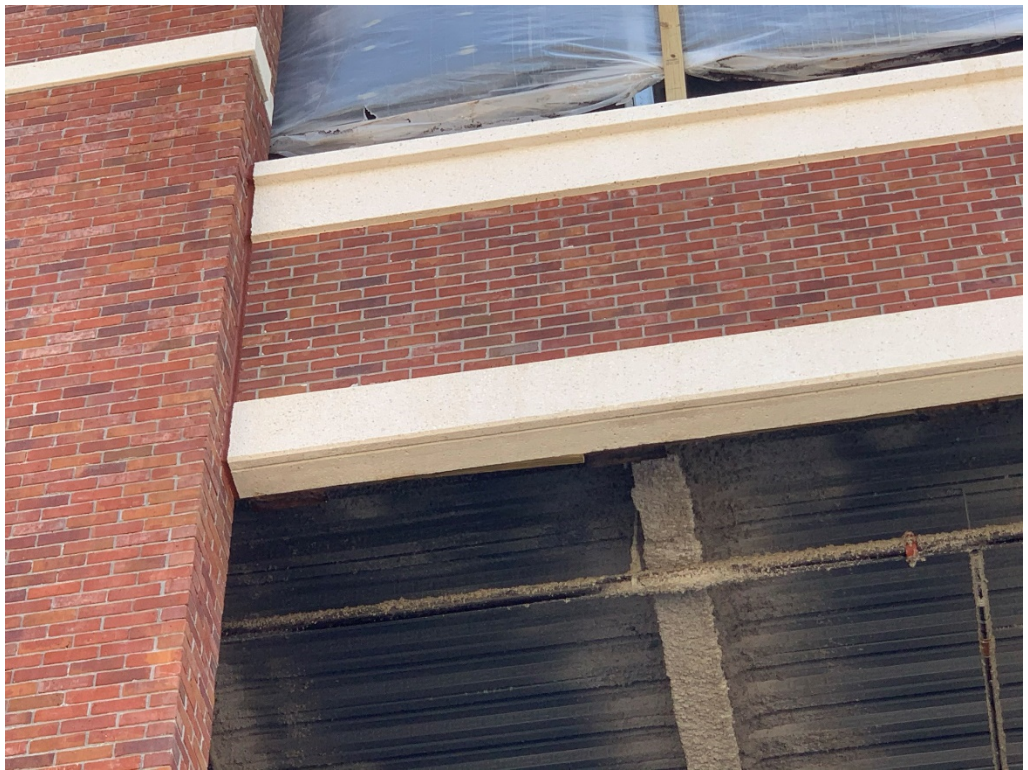
Figure 4 – Example of Red Sealant at Panels Looks Good

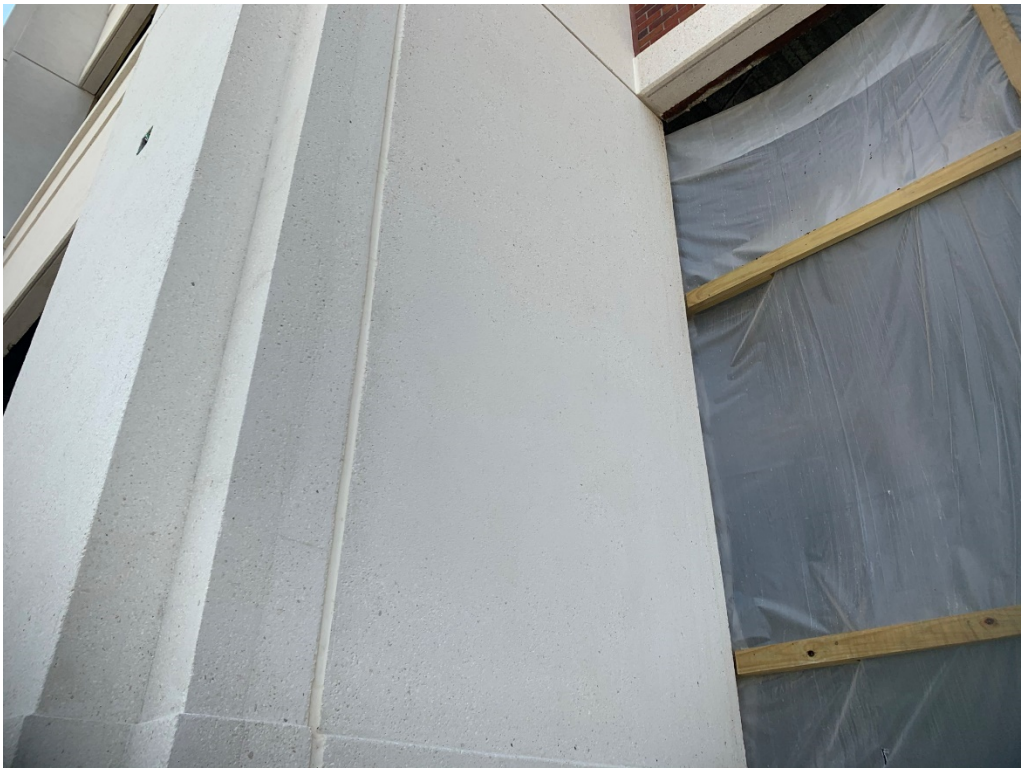
Figure 5 – Sealant Progress

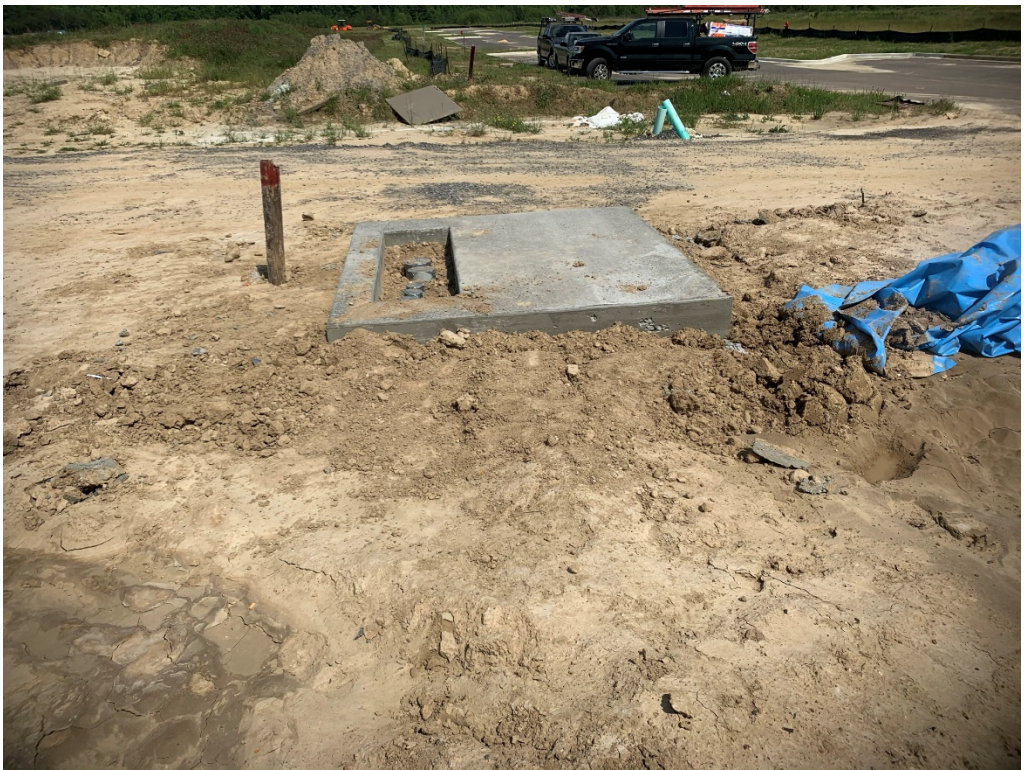
Figure 6 – Electrical Conduit to Transformer installed

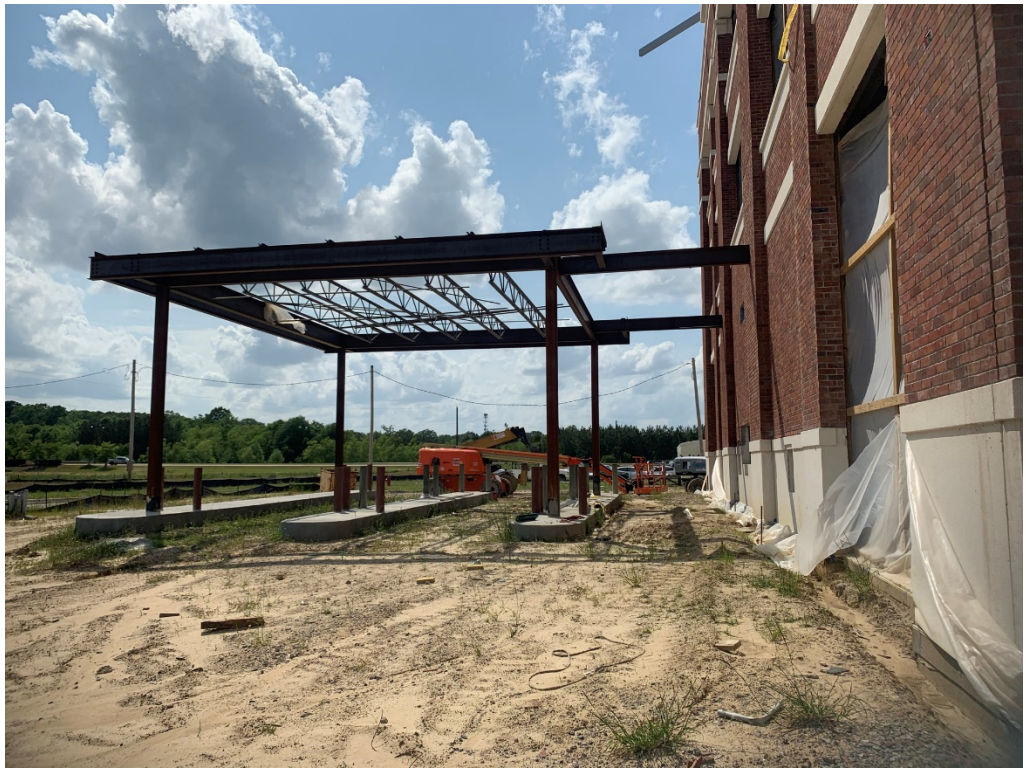
Figure 7 – Drive Thru Progress

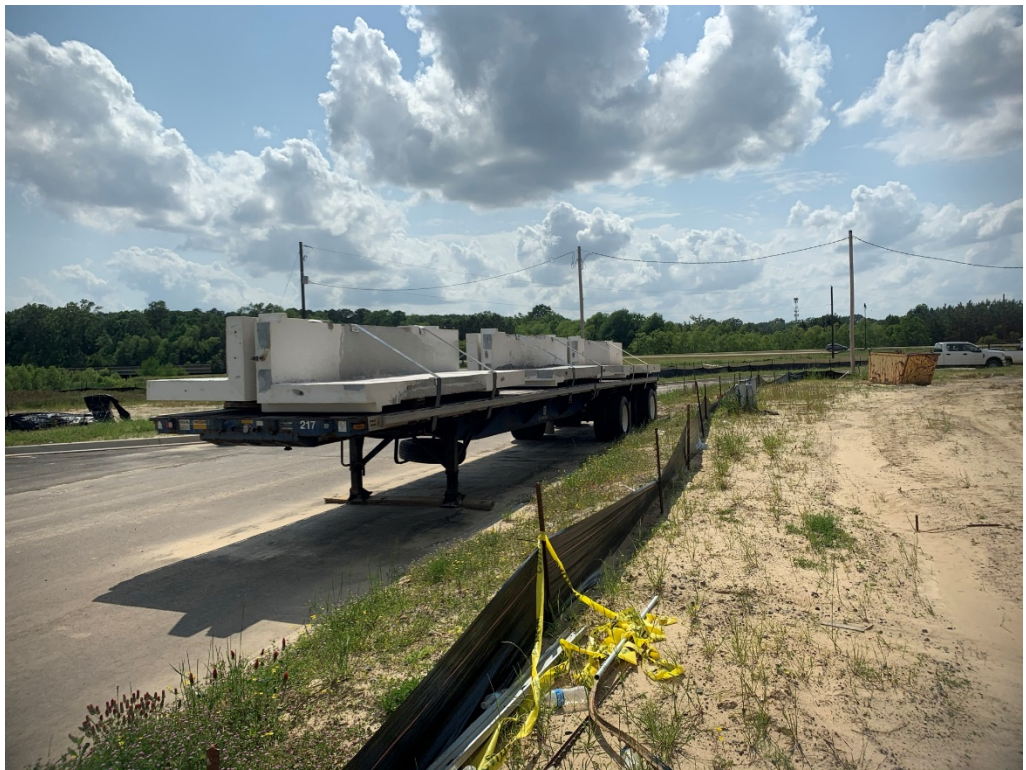
Figure 8 – Precast on Site Ready to Install

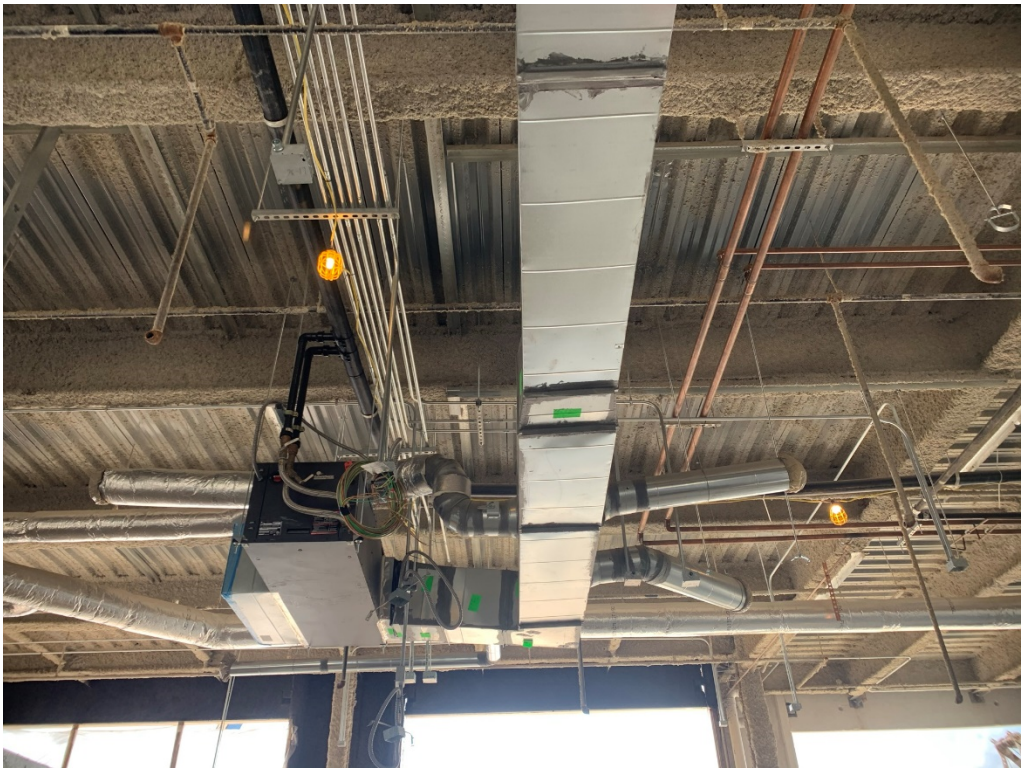
Figure 9 – Mechanical Work is Ongoing

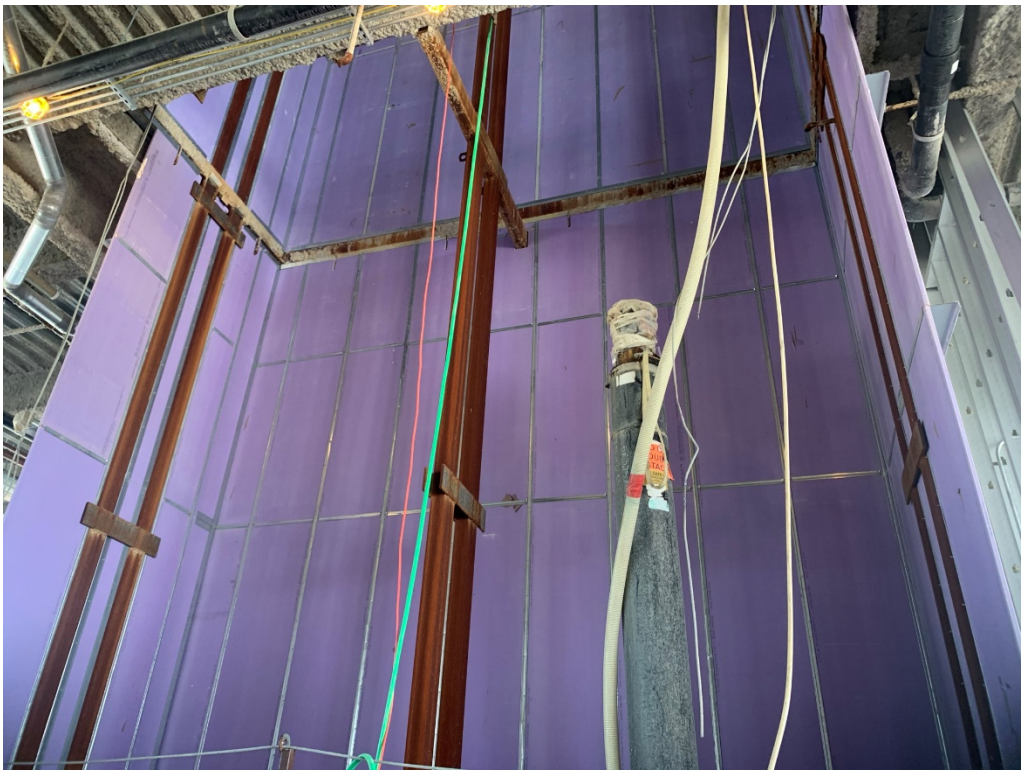
Figure 10 – Drywall at Shafts

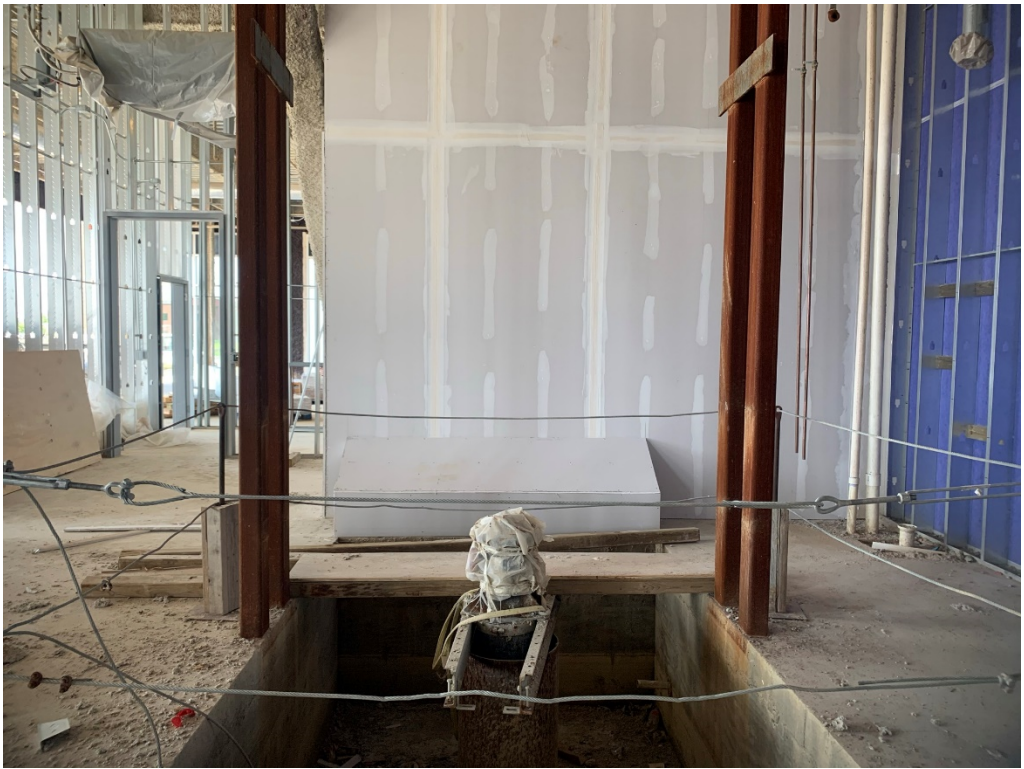
Figure 11 – Drywall at Shafts

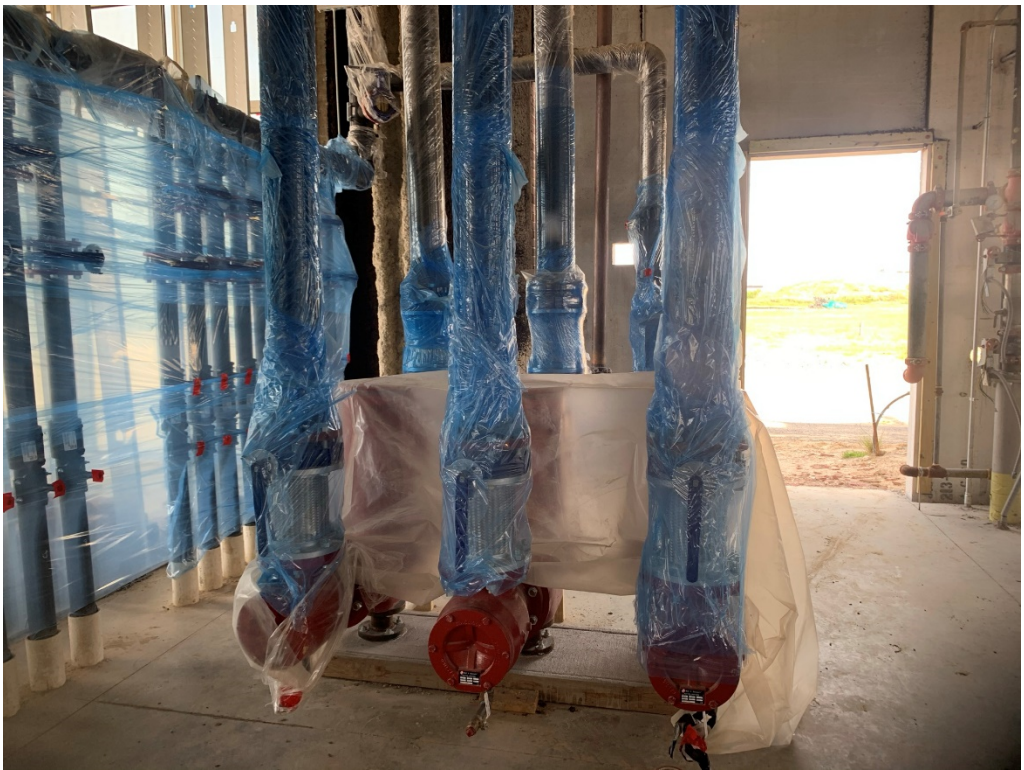
Figure 12 – Sprinkler Risers Protected

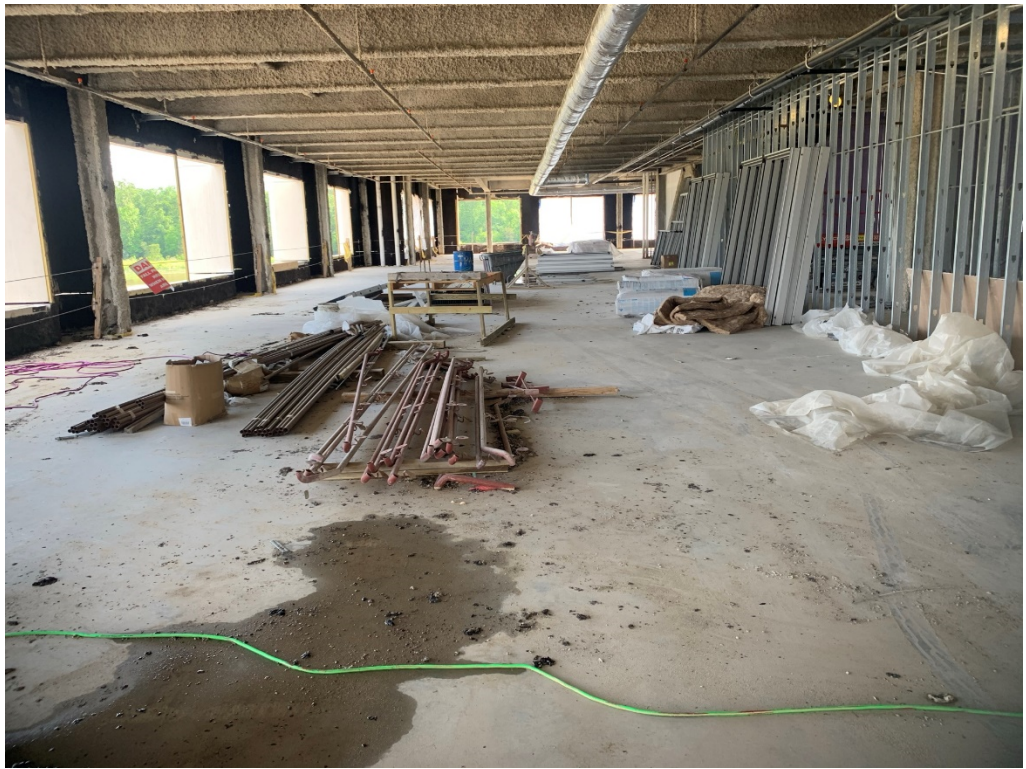
Figure 13 – 2<sup>nd</sup> Floor Progress

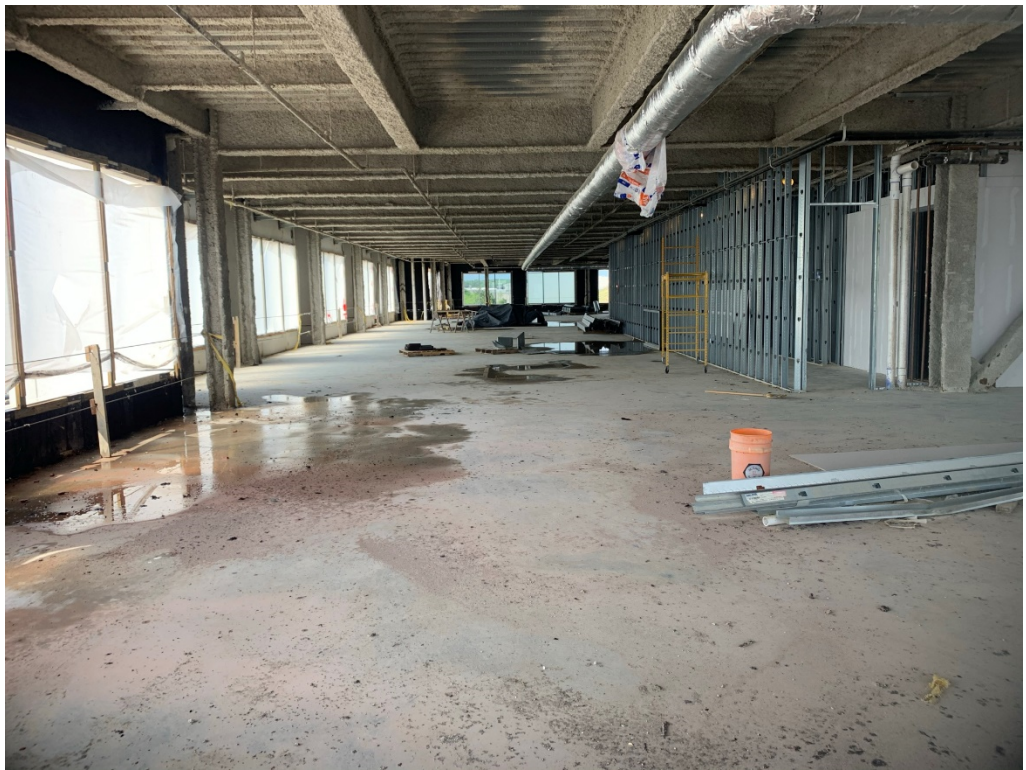
Figure 14 – 2<sup>nd</sup> Floor Progress

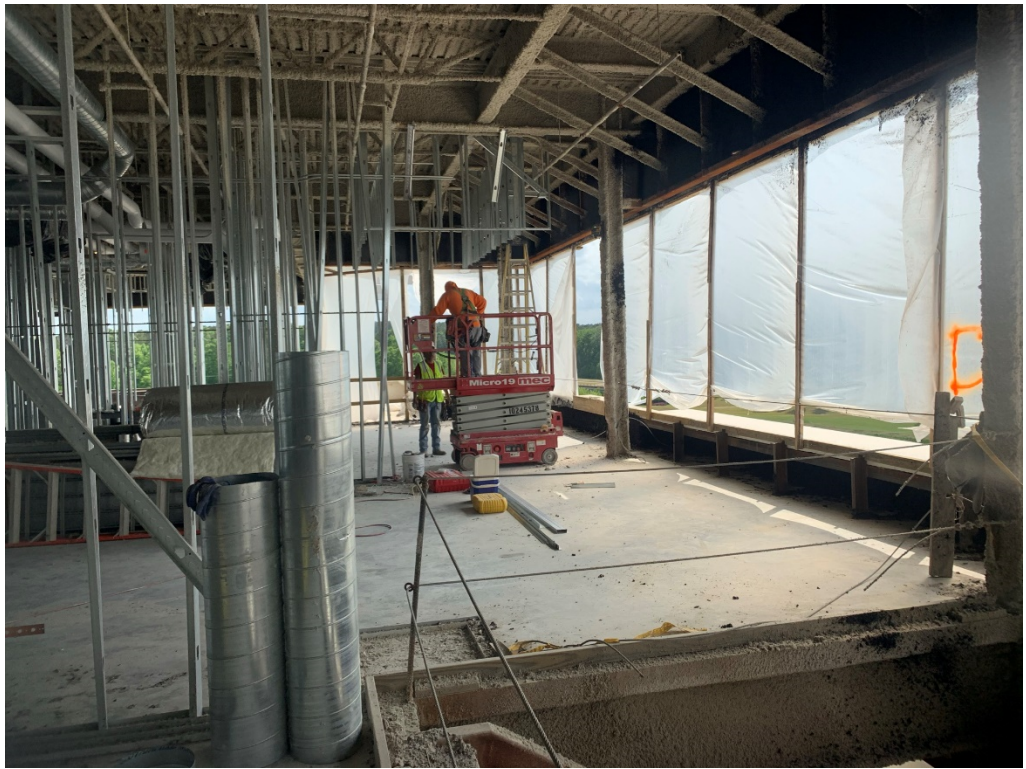
Figure 15 – Fourth Floor Framing is Ongoing

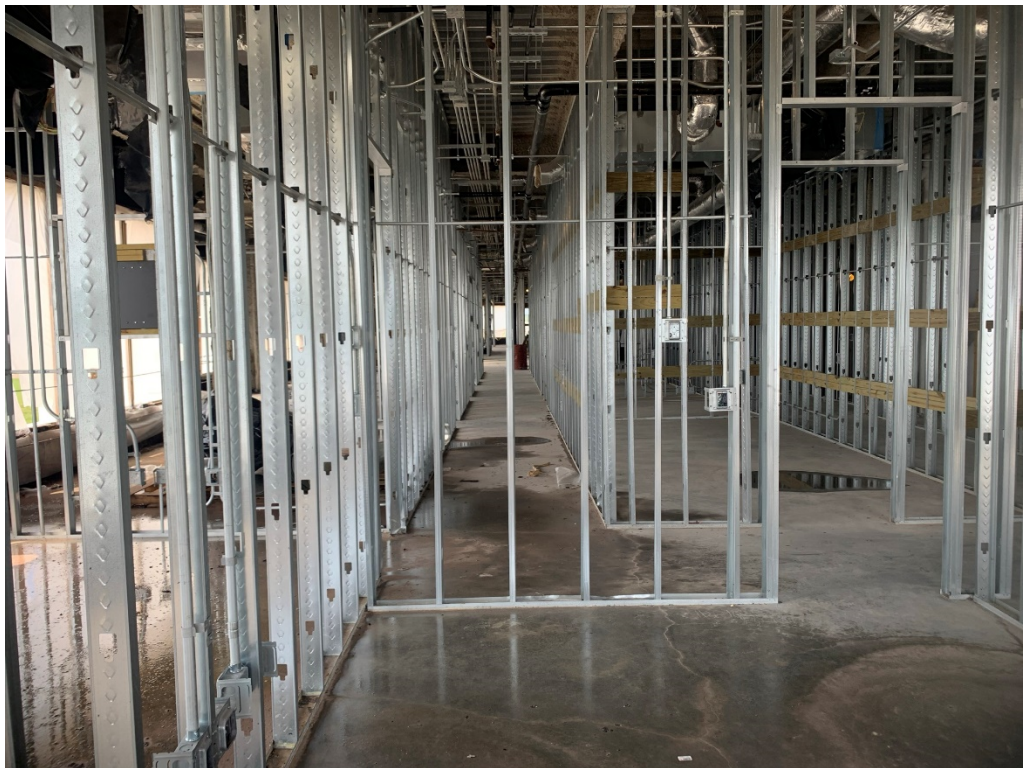
Figure 16 – 3<sup>rd</sup> Floor Framing Progress

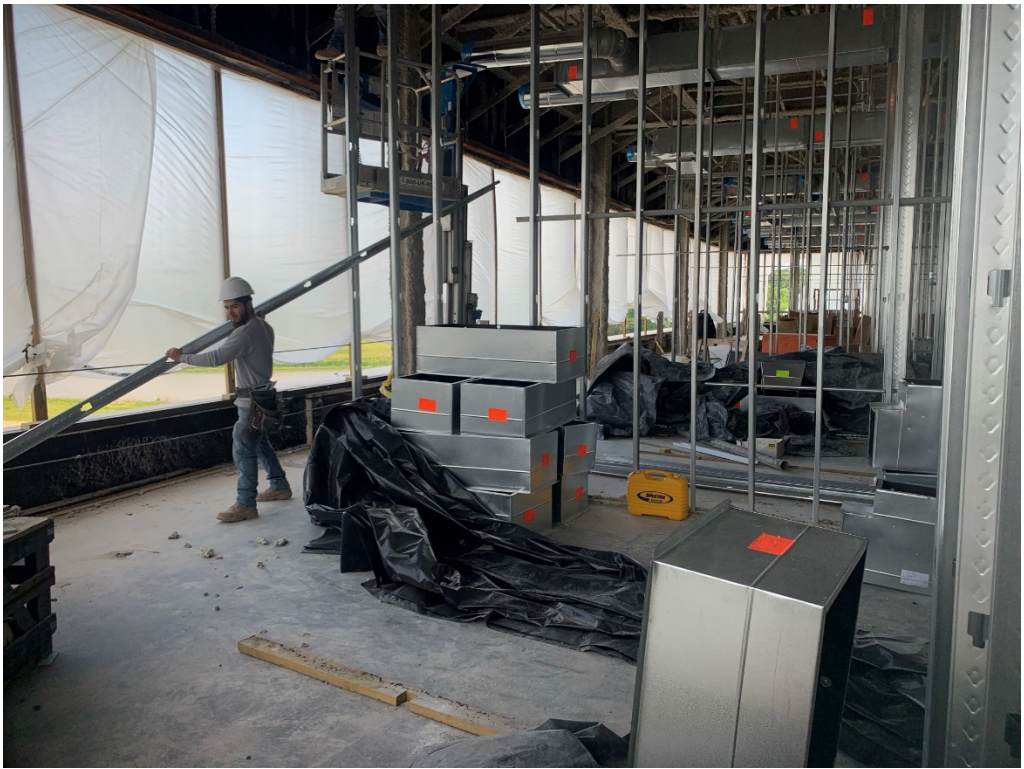
Figure 17 – Fourth Floor Framing is Ongoing

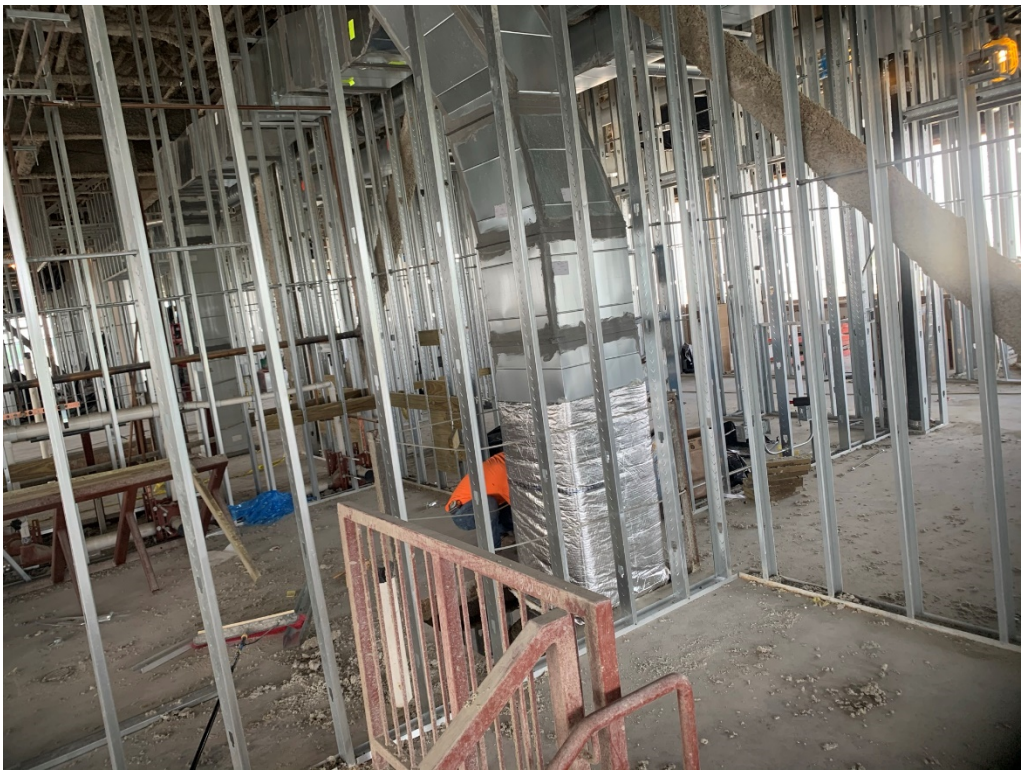
At the interior, insulation was in progress for both ducting and roof drain pipes. Framers were also at the fourth floor continuing their work.

Figure 18 – Duct Insulation is Ongoing
