Architect's Field Report

12 May 2021

15094 Community Bank Headquarters

Contract Fountain Construction Company, Inc.

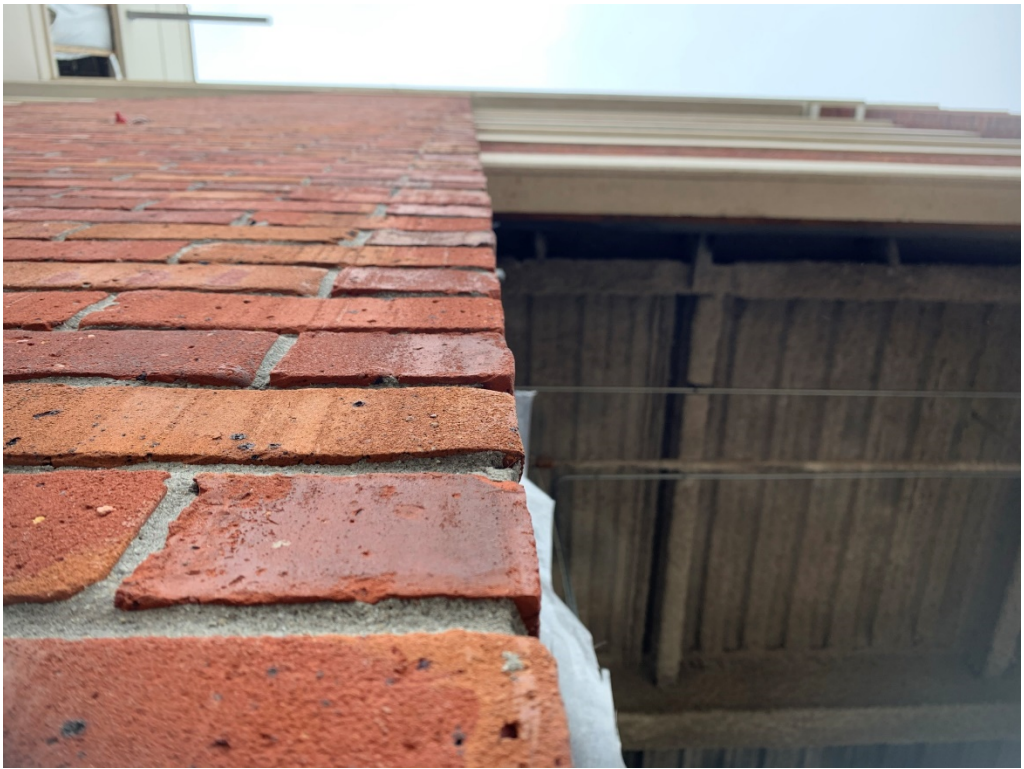
Figure 1 – Brick Corner at Repaired Panel at Front Elevation

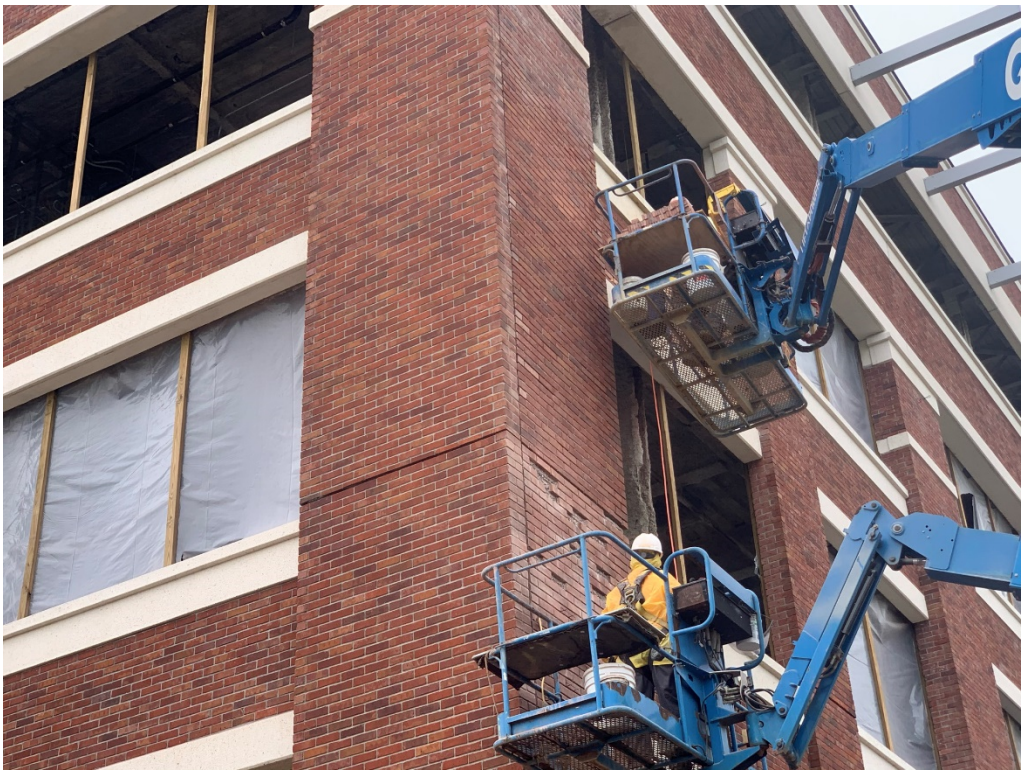
Figure 2 – Brick Repair at Cast Panels is Ongoing

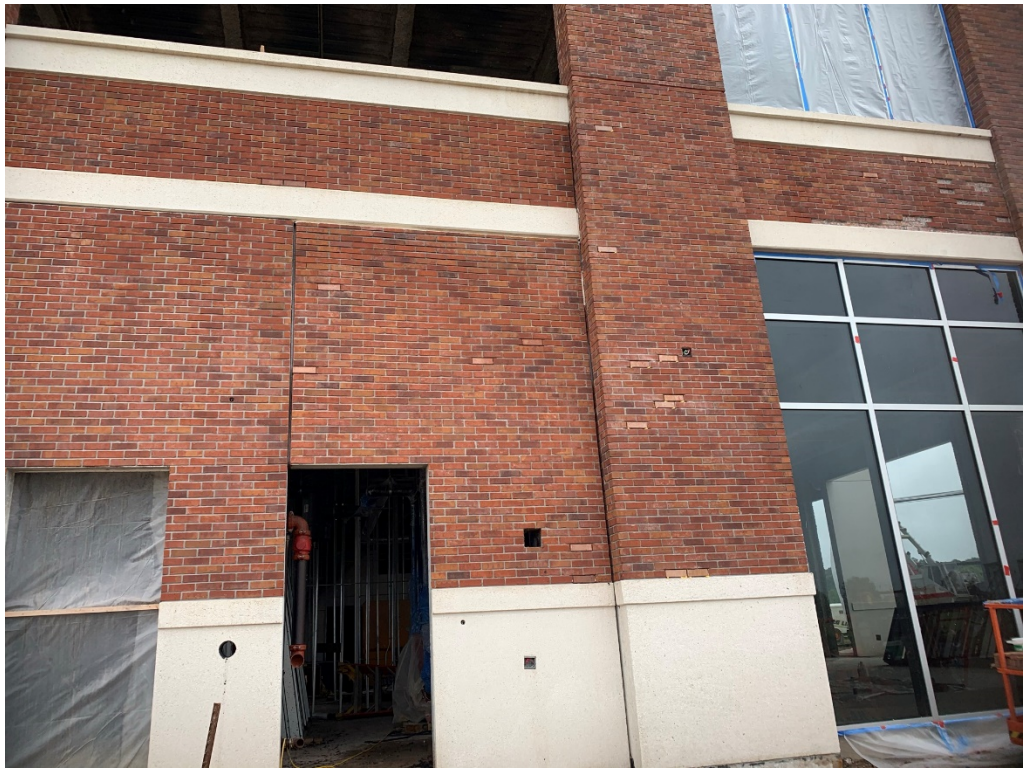
Figure 3 – Sealant Progress Stalled due to Shortage of Material and Rain

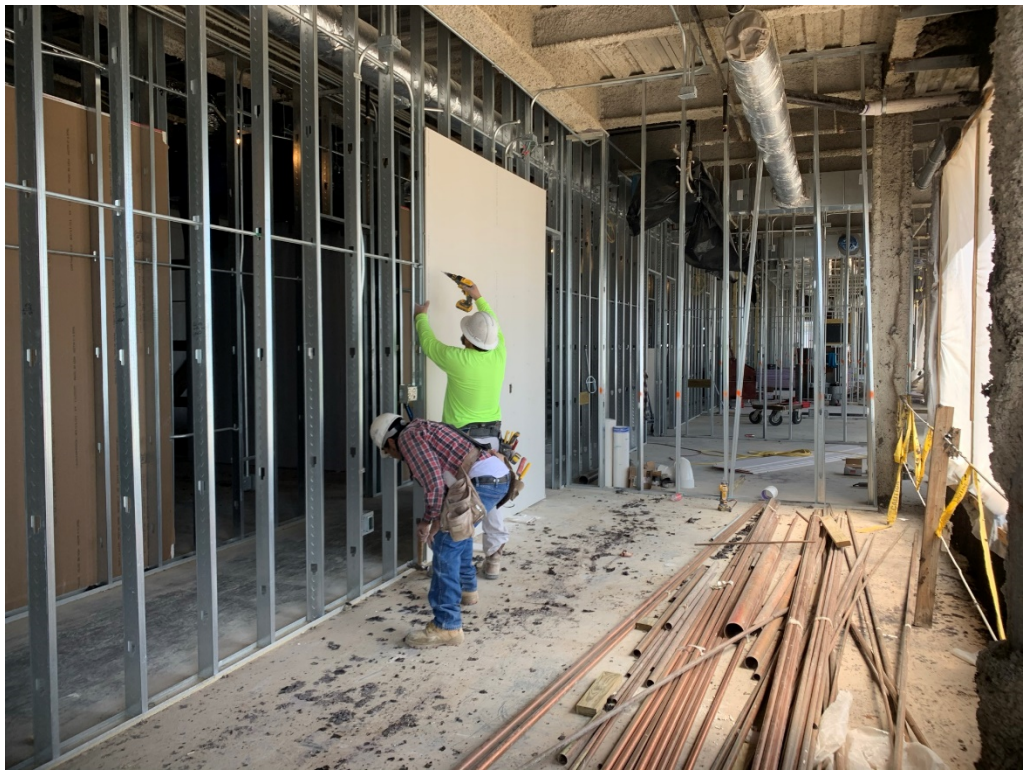
At the 3<sup>rd</sup> Floor, drywallers were installing gypsum. Approximately 25% of this floor has rock hung and work is ongoing. Also, at this level, framers were installing ceiling framework at the elevator lobby.

Figure 6 – Drywall at 3<sup>rd</sup> Floor

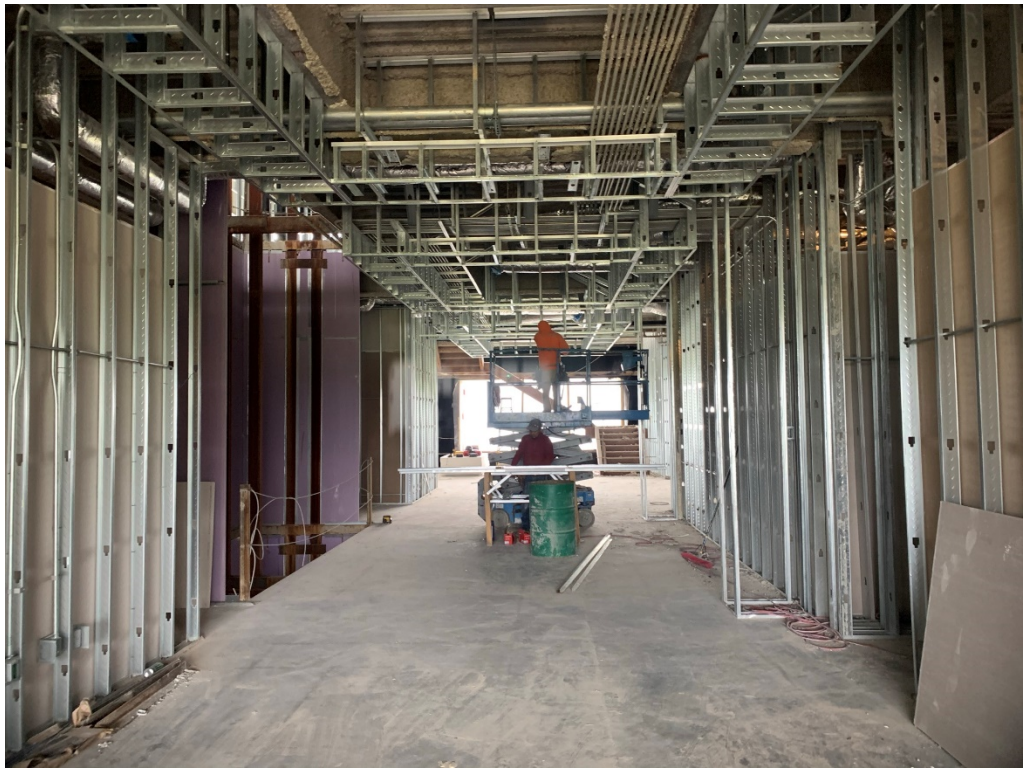
Figure 7 – 3<sup>rd</sup> Floor Ceiling Framing is Ongoing

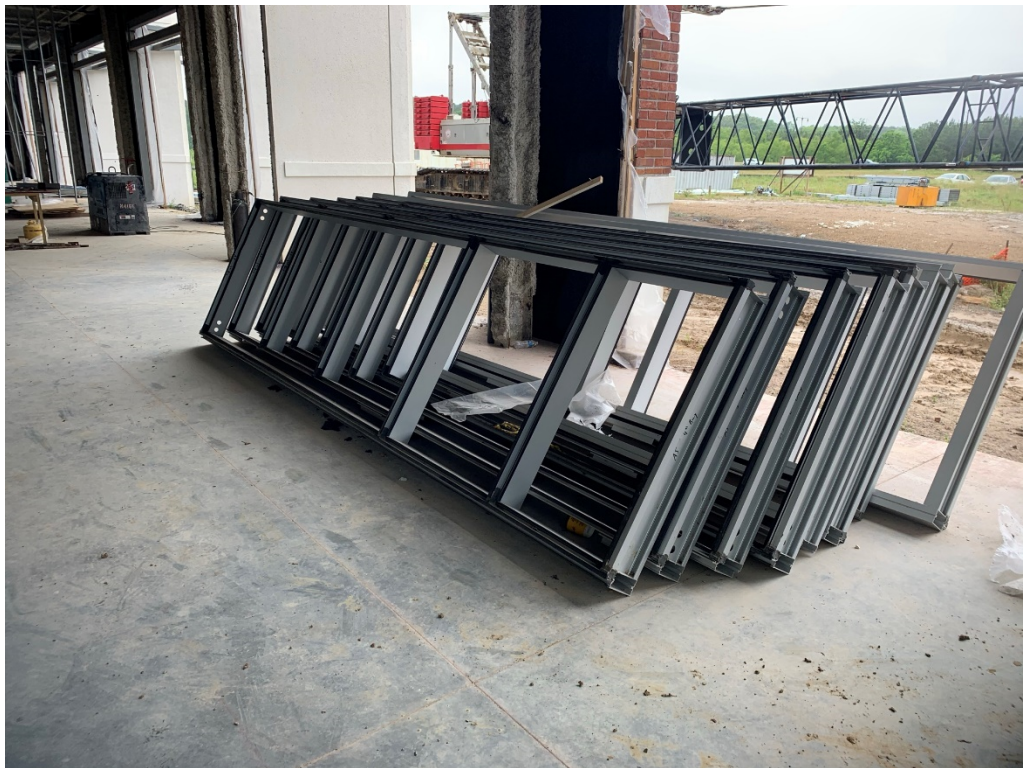
Figure 8 – Curtain Wall Stored at First Floor

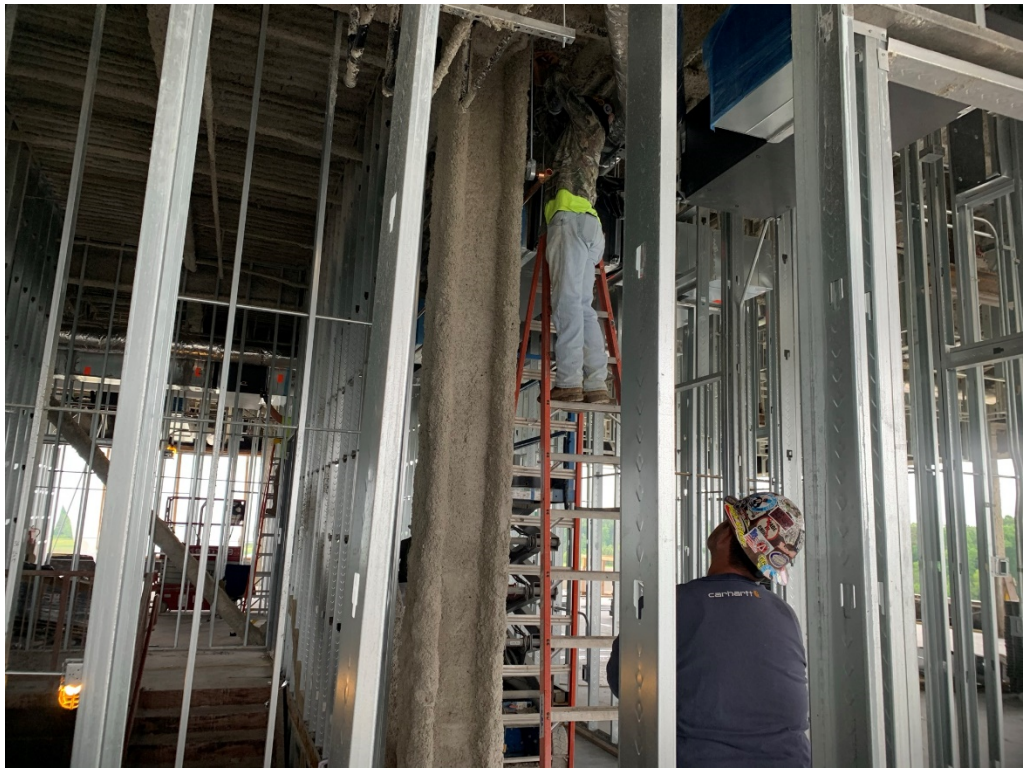
Figure 9 – Plumbers Installing Copper Pipe

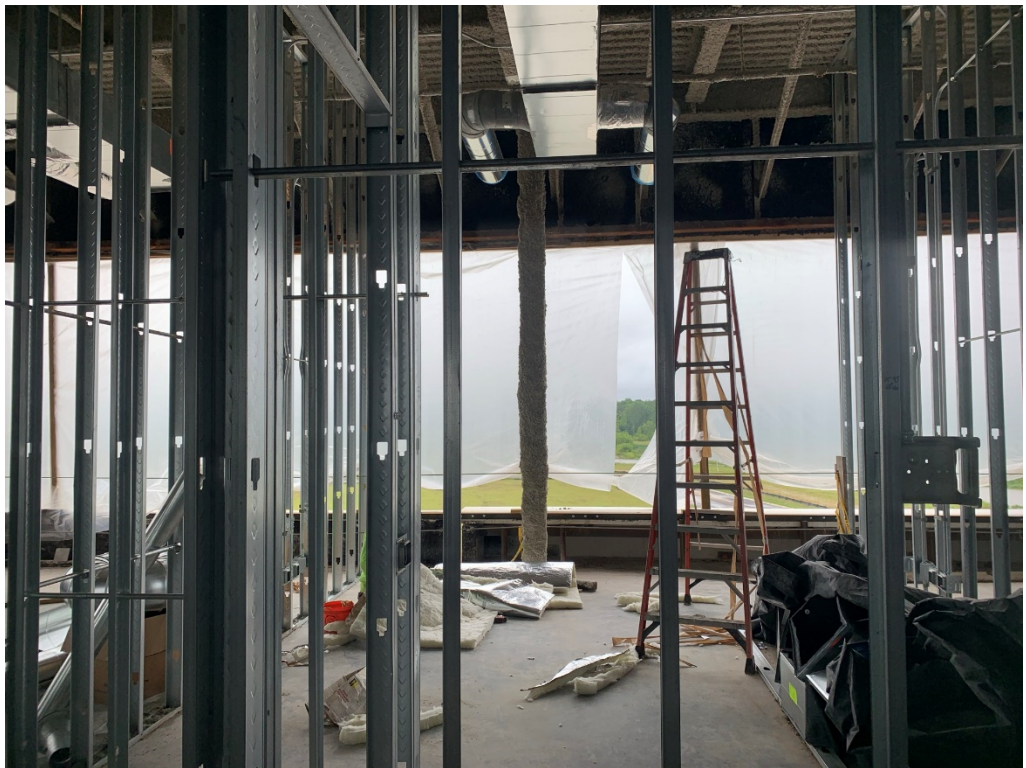
On the inside, mechanical workers were installing ducting and insulators were also working on insulating ductwork.

Figure 10 – Duct Insulation is Ongoing
