## Architect's Field Report

19 May 2021

15094 Community Bank Headquarters

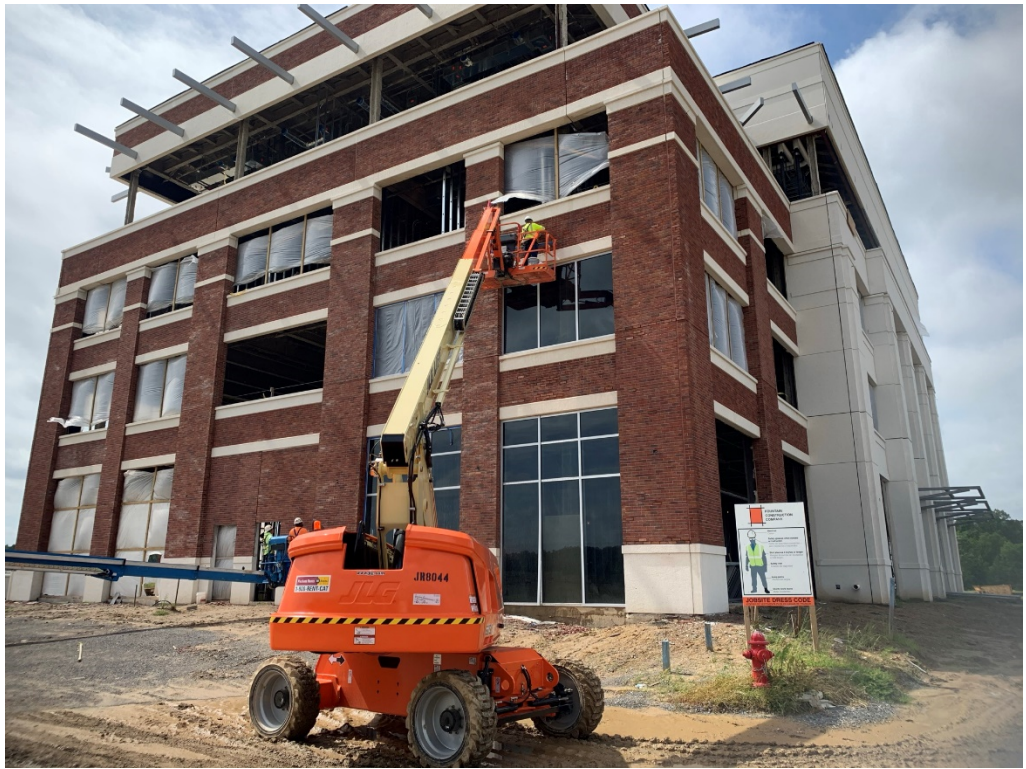
At the north elevation, a mason was reworking brick tile. This face is nearest completion, but still lacks mortar in several locations.

Figure 1 – North Elevation Progress at Panel Rework

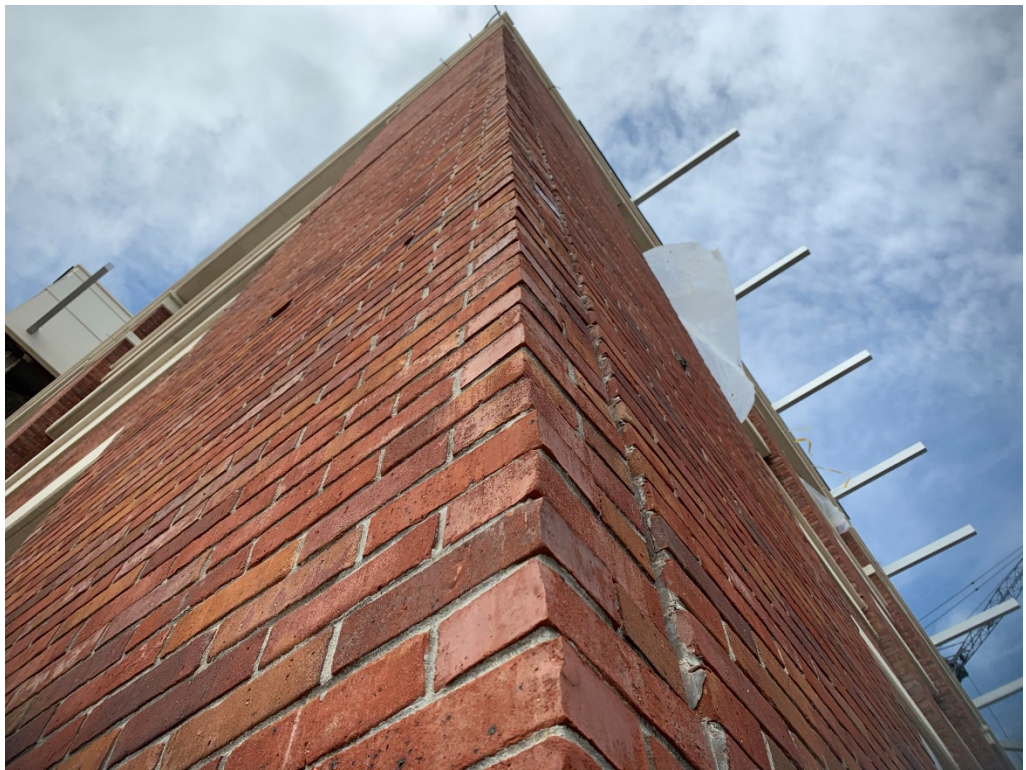
Figure 2 – NE Corner, reworked

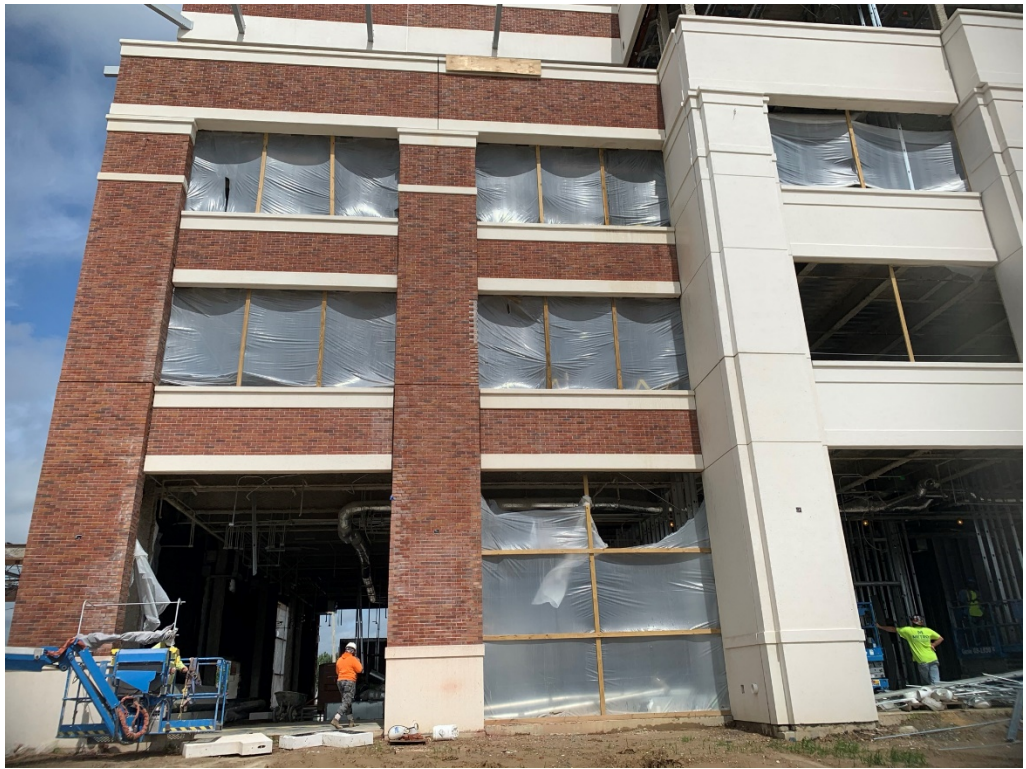
Observations After our bi-weekly OAC meeting, I walked the exterior with Robert Clay, FCC. We reviewed progress at the exterior and specifically looked at east facing panels that were still slated for rework. We discussed schedule and the rework of these panels is on it but after a couple other items, namely, erecting the drive-thru panels and a repair at the west face; he mentioned that we were still several weeks out from the rework.

Figure 3 – West Façade; white column at right of image slated for future rework

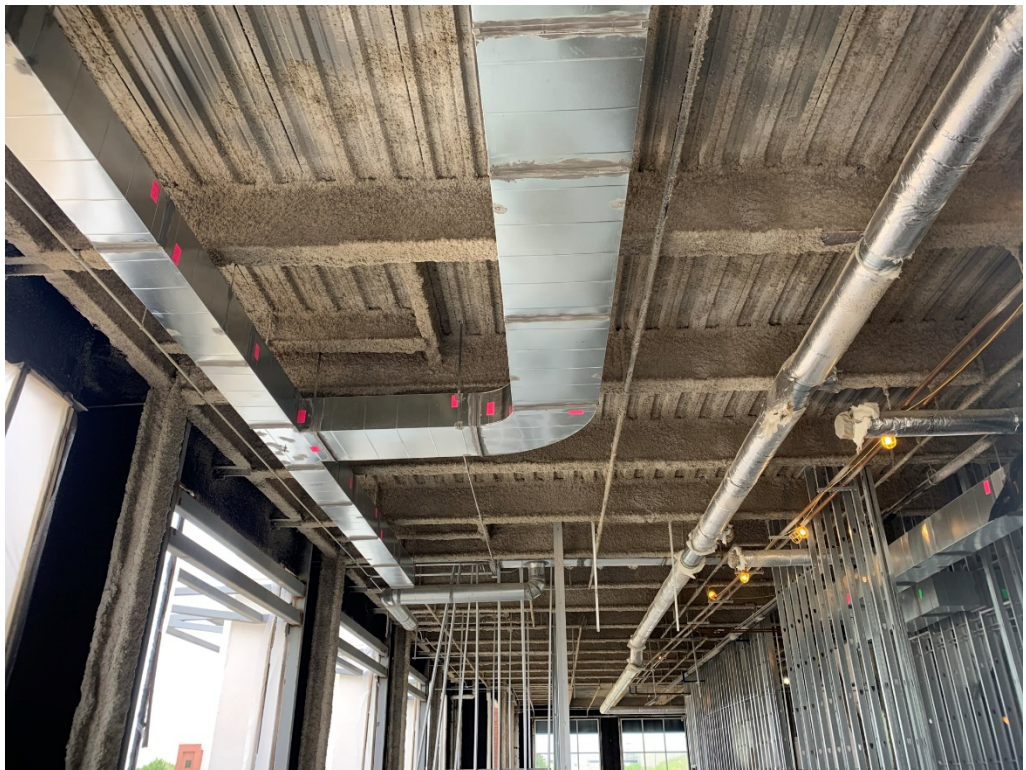
Figure 4 – Ongoing Duct Installation at 1<sup>st</sup> Floor

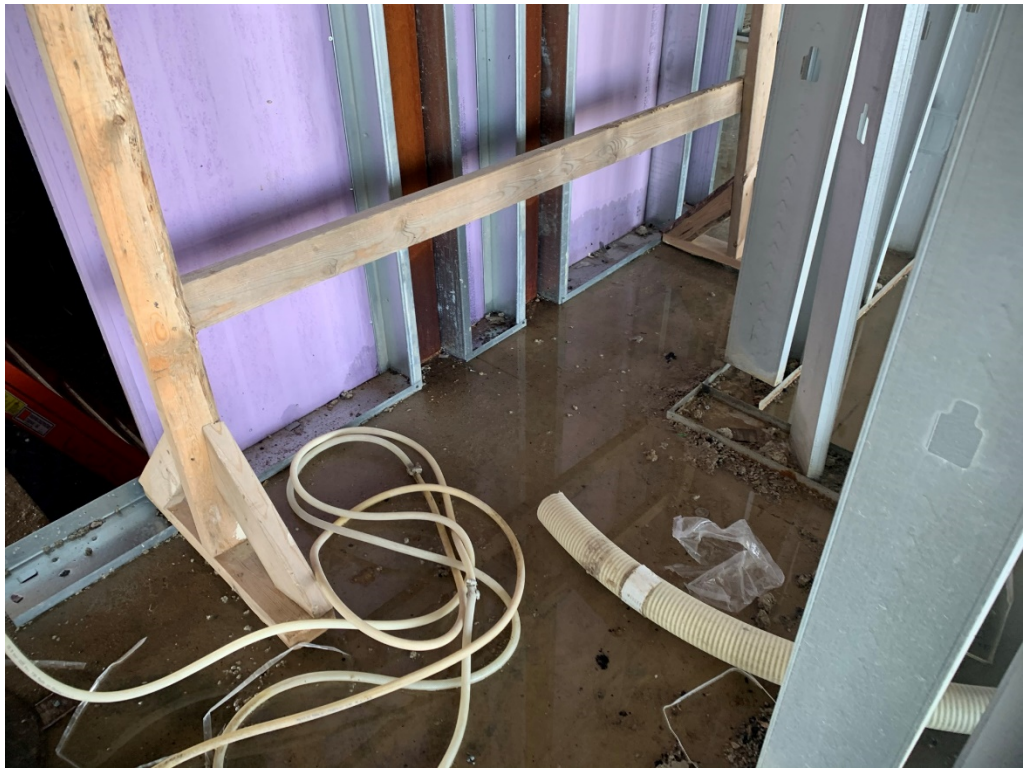
At the interior duct installers were busy throughout at both the first and 4<sup>th</sup> floors. Drywall finishes were also mudding in tape. There are several areas where water is pooled and soaking into the lower 6" of installed drywall. Over time, repetition of this will cause the paper to delaminate from the rock. The rock is up ½" from the floor, so the standing water must be deeper than ½". Contractor should take steps to remedy by removing water daily until façade is dried in. Also, be sure to check humidity levels after dried in and before install finishes.

Figure 5 – Standing Water at First Floor

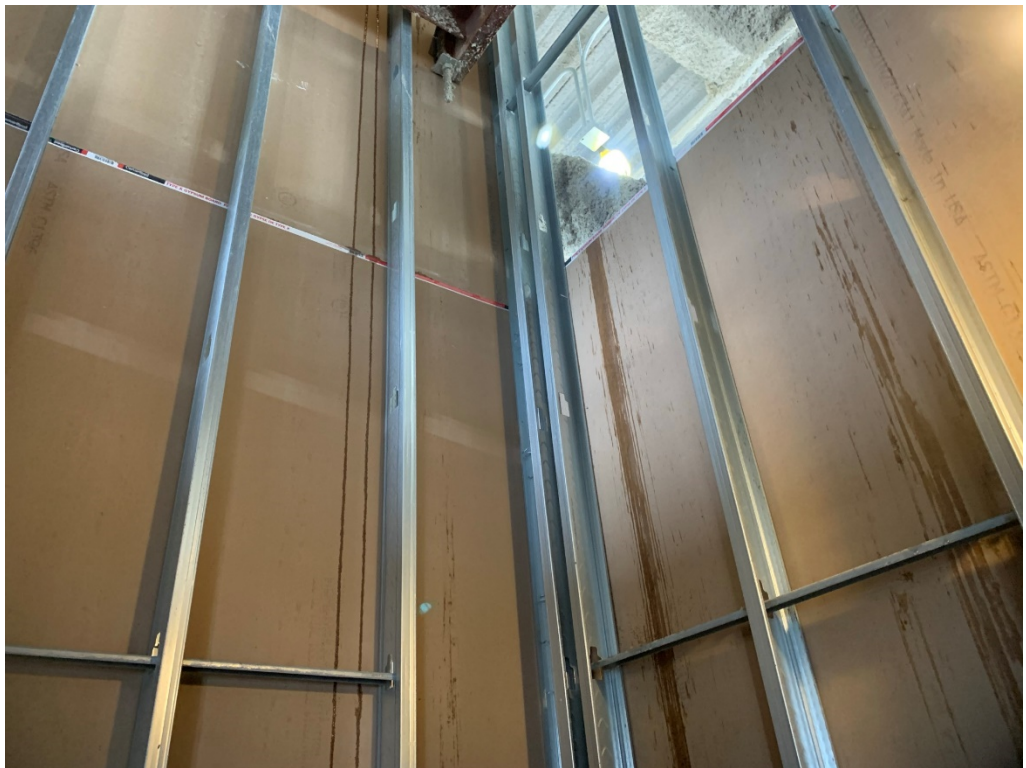
Figure 6 – Water at North Stairwell dripping down drywall interior face

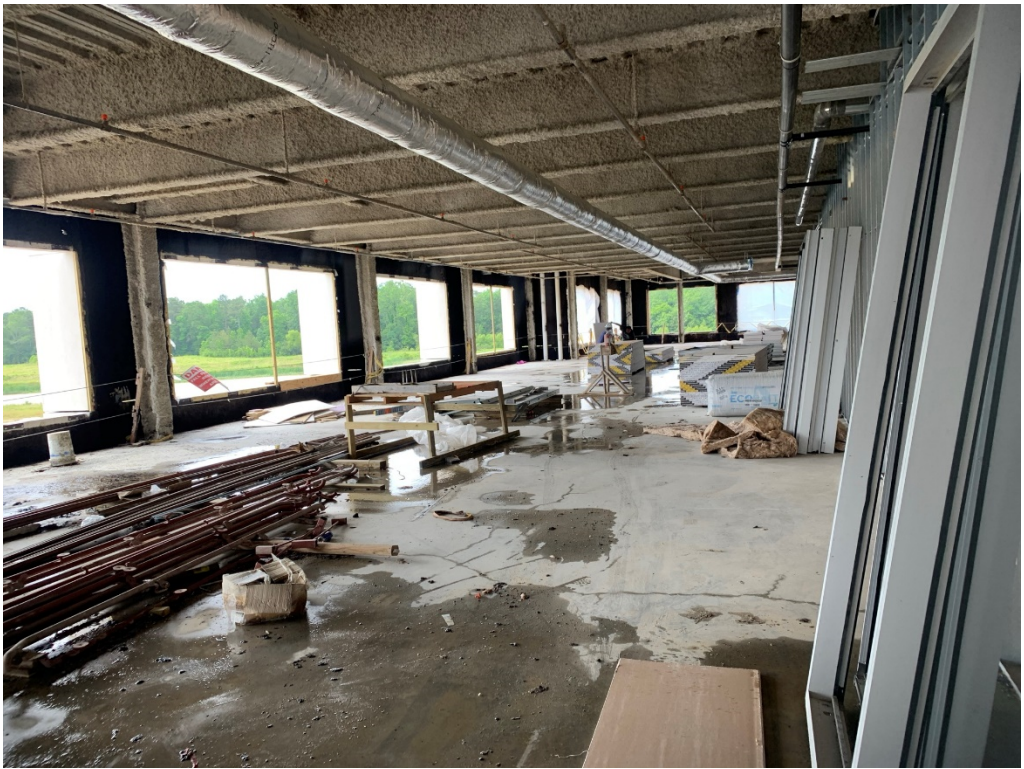
Figure 7 – 2<sup>nd</sup> Floor Staging

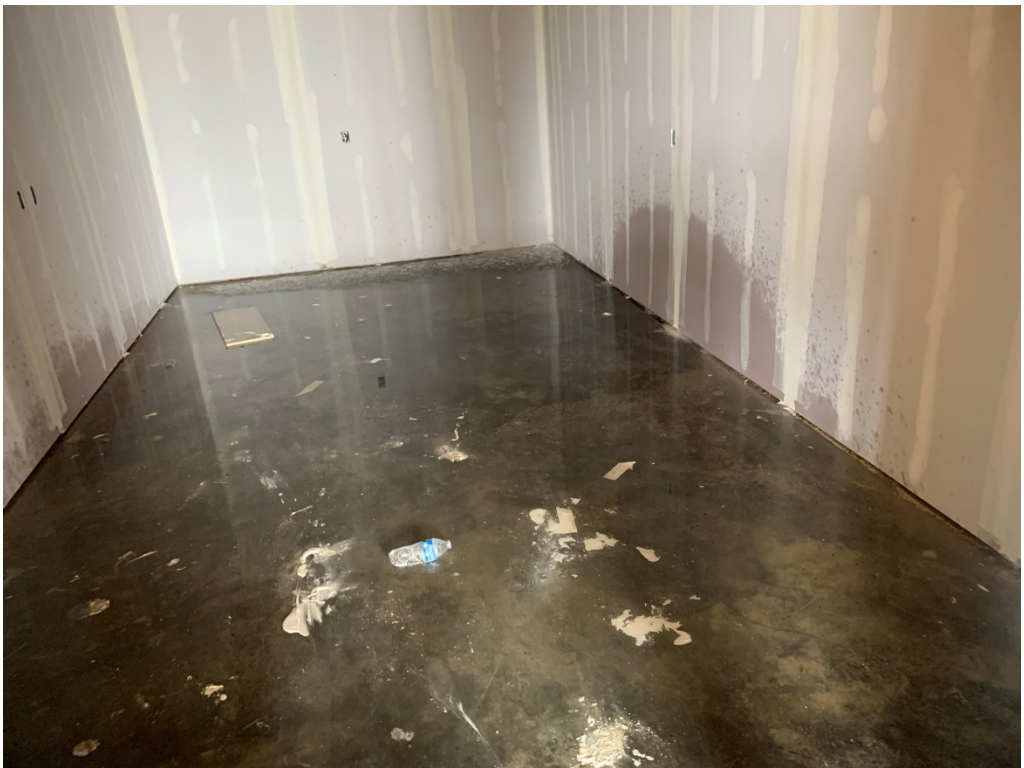
Figure 8 – Standing Water in 3<sup>rd</sup> Floor Room

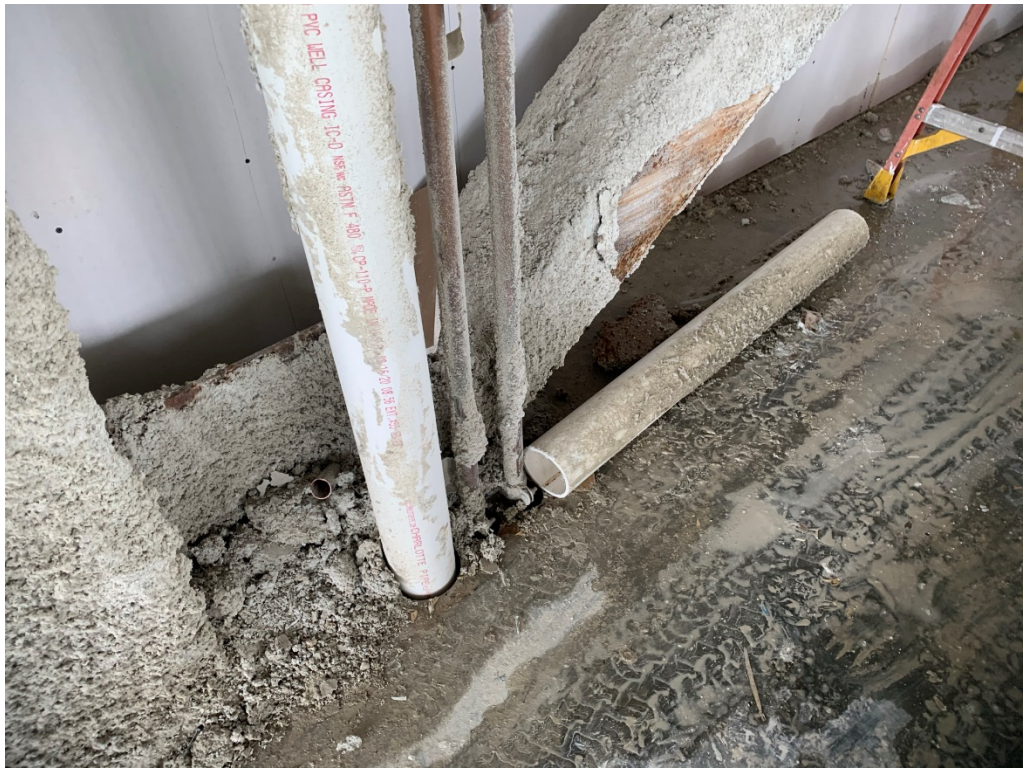
Figure 9 – Damaged Fire Insulation

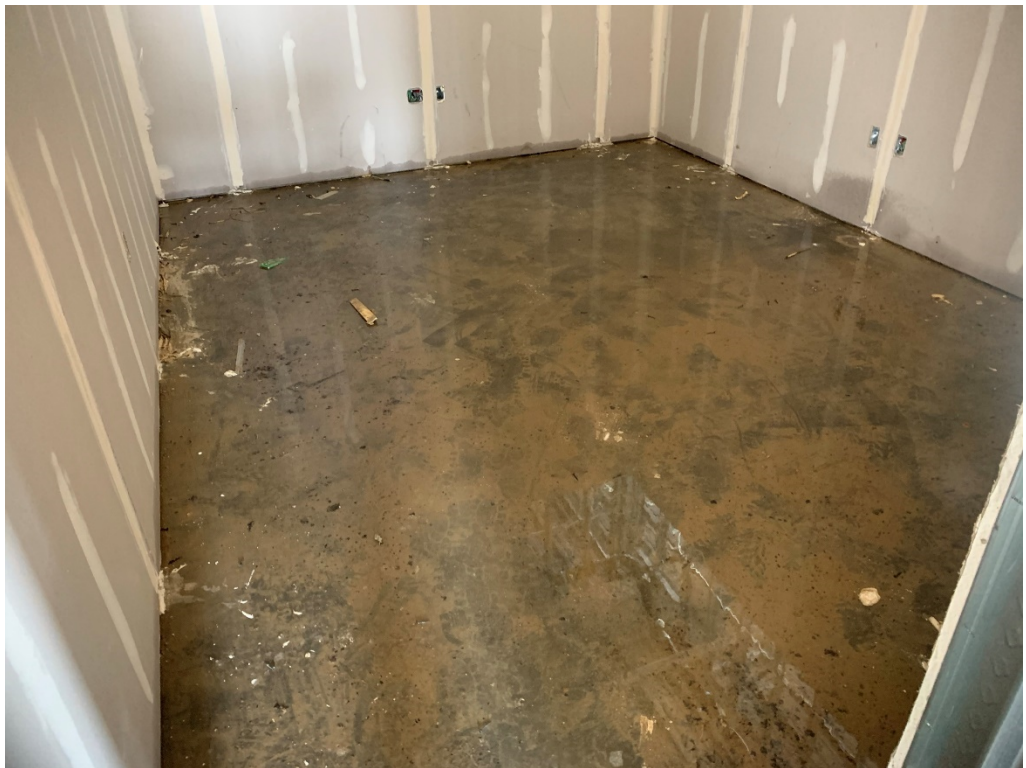
Figure 10 – Standing Water in 3<sup>rd</sup> Floor Room
