## Architect's Field Report

15094 Community Bank Headquarters

Date / Time 25 May 2021 / 12:00 PM

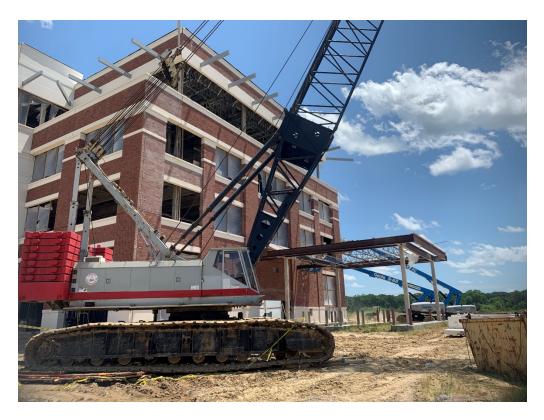
Figure 1 – Continued work on south elevation

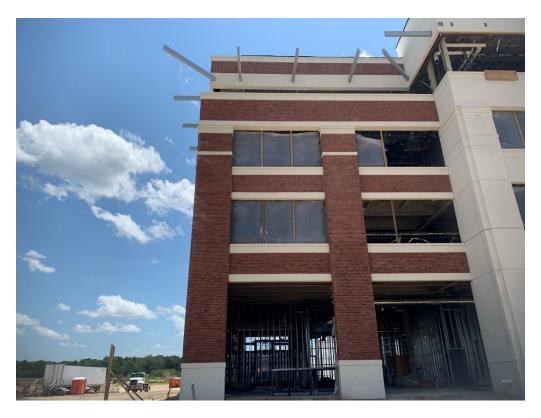
Figure 2 – NW Corner, reworked

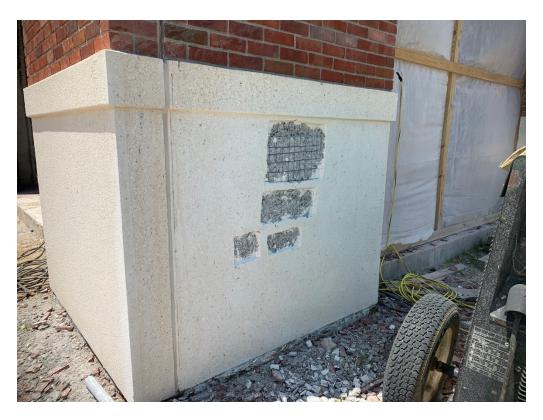
Figure 3 – Work at Precast Panel NE Corner

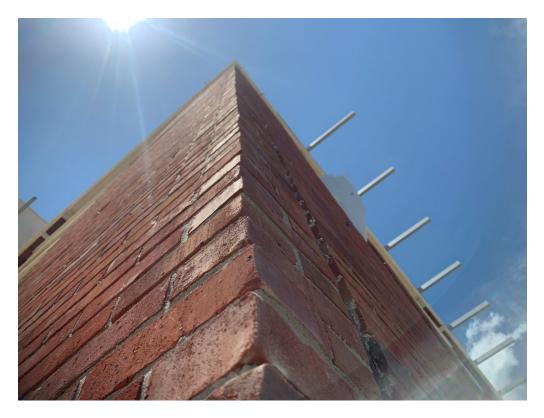
Figure 4 – NE Corner Brick Offset

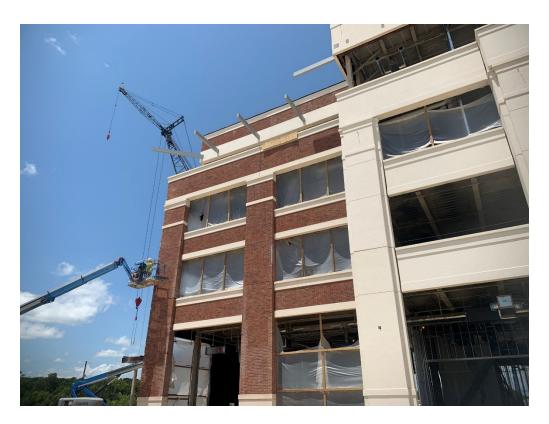
Figure 5 – SE Brick work at Corner

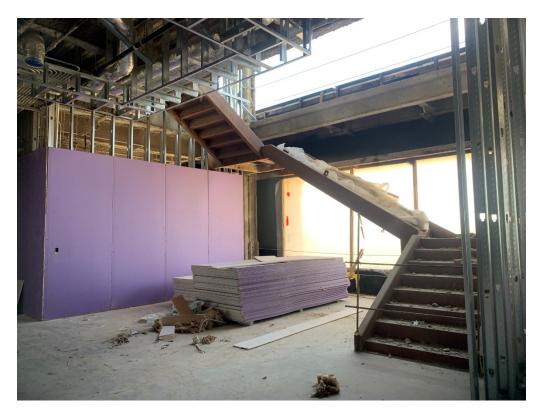
Figure 6 – Double Height Stair Space is Shaping Up

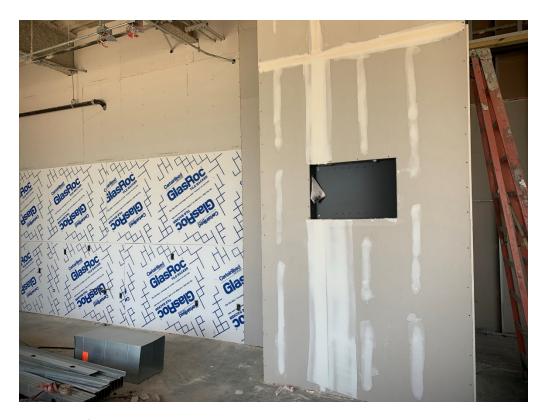
Figure 7 –  $3^{rd}$  Floor Break Room; GlasRoc installed at cabinet wall

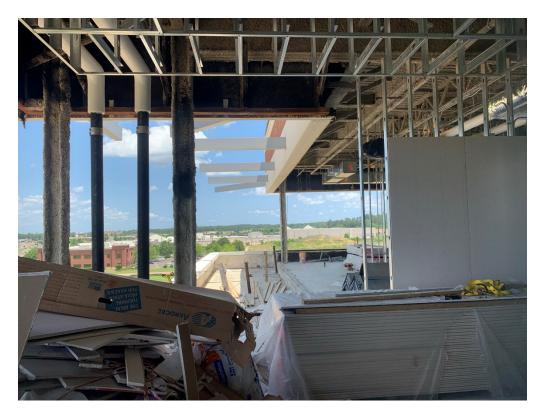
Figure 8 – Upper Floor Progress
