## Architect's Field Report

28 May 2021

15094 Community Bank Headquarters

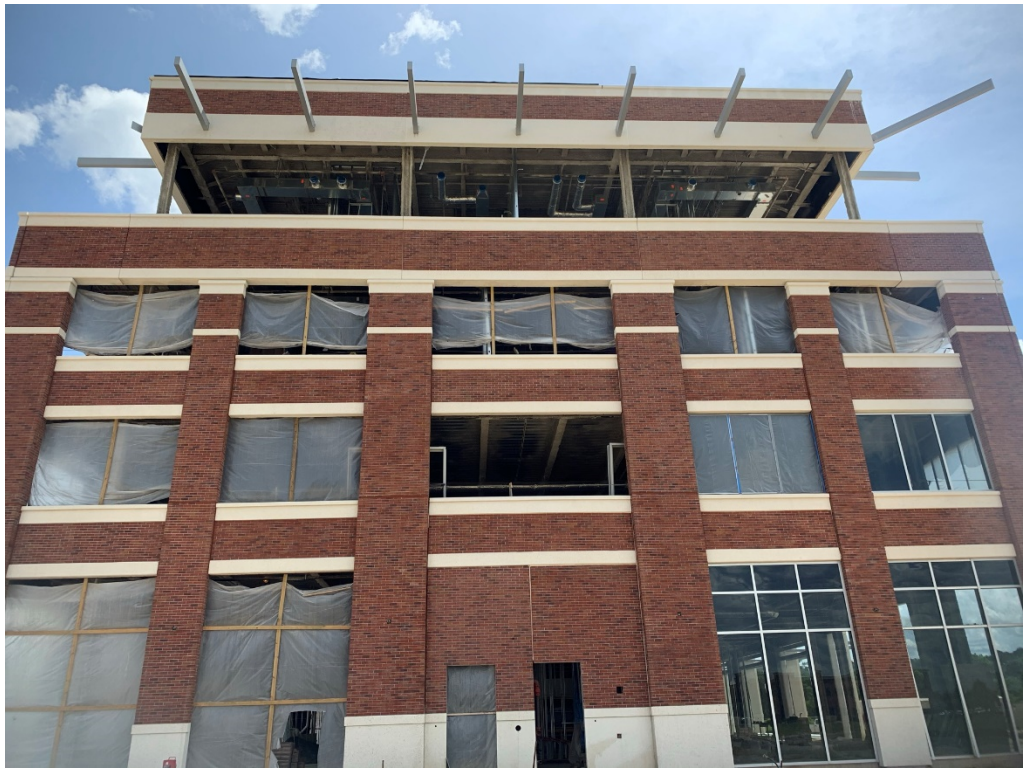
Figure 1 – Continued work on North elevation

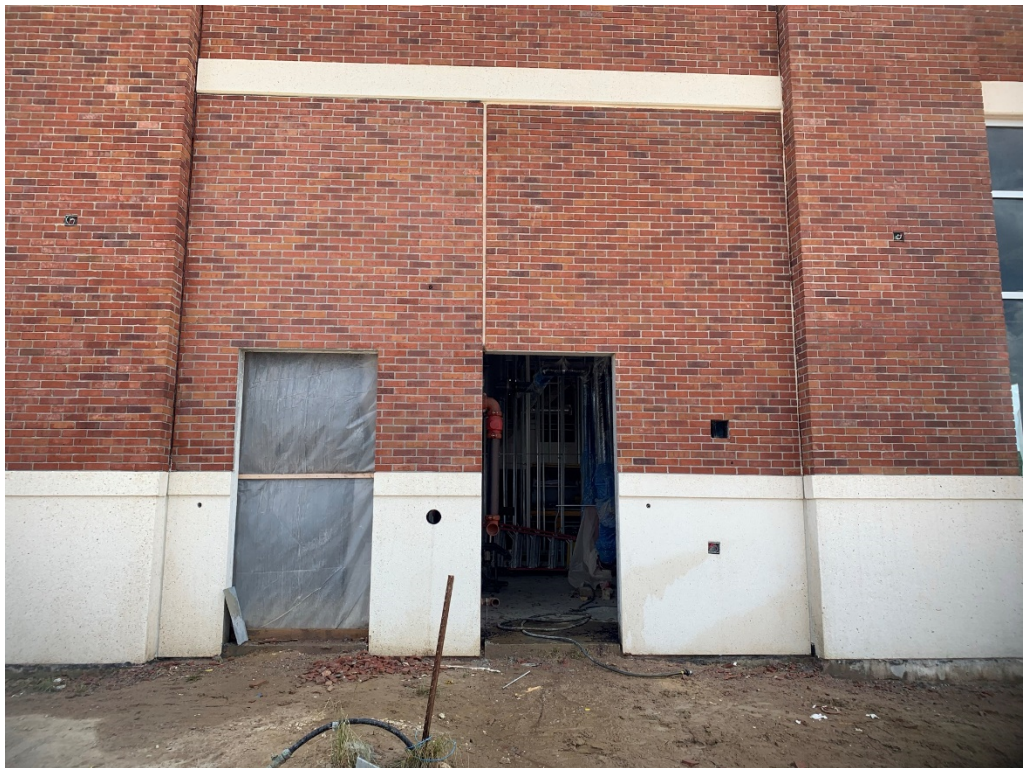
Observations On site, I met with Jeff Barnes, DP, Stan Green, FCC, Bobby Strobel, DP, Brad Fountain, FCC, and Chris Azeredo, a third-party finisher who's work we reviewed. Chris and his crew have made some strides in their work, but several issues still need addressing. On the north end, a grout coloring application was installed in an attempt to clear up grout discoloration. The grout color is not an exact match and needs some work still. This installation also caused a grey haze at the existing brick faces that will need correction. Chris tells me this will be corrected by this next Thursday.

Figure 2 – Left Panel has Grout "stain" installed; brick color is lighter now and does not match

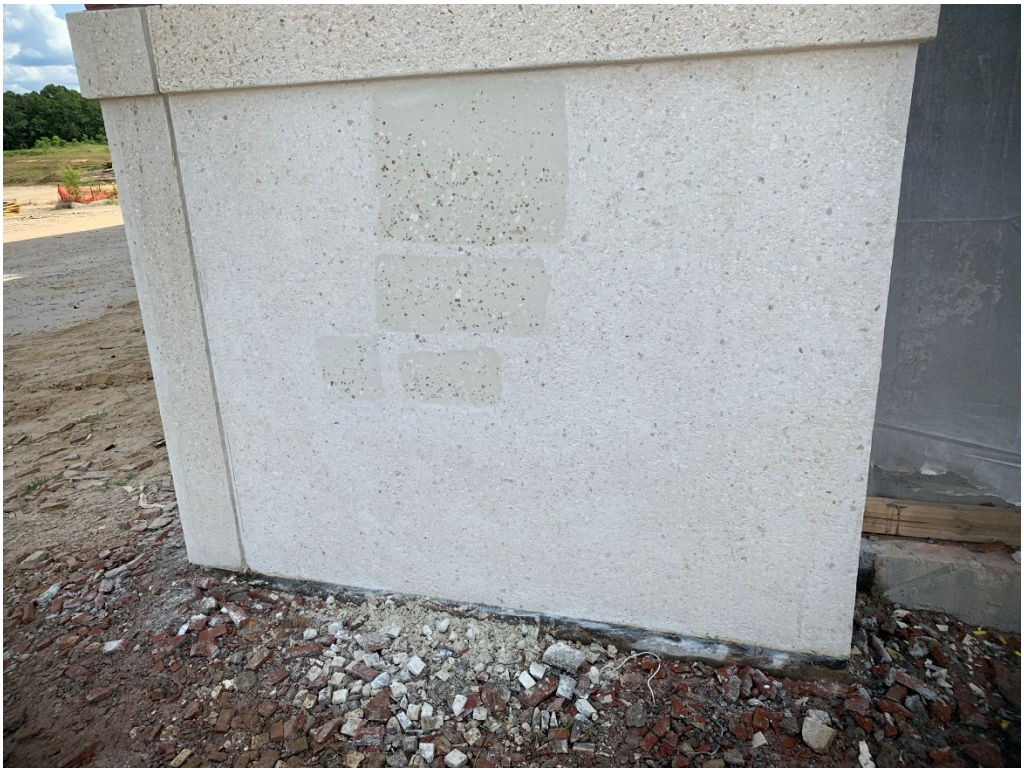
On the east side at our precast stone pilasters, some effort was made to correcting dimpling and vertical joint issues. A repair has been made but does not match in color. Chris says this will match after some days of curing (it was newly installed that morning).

Figure 3 – Panel Repaired with custom mix to cure the same color (freshly installed)

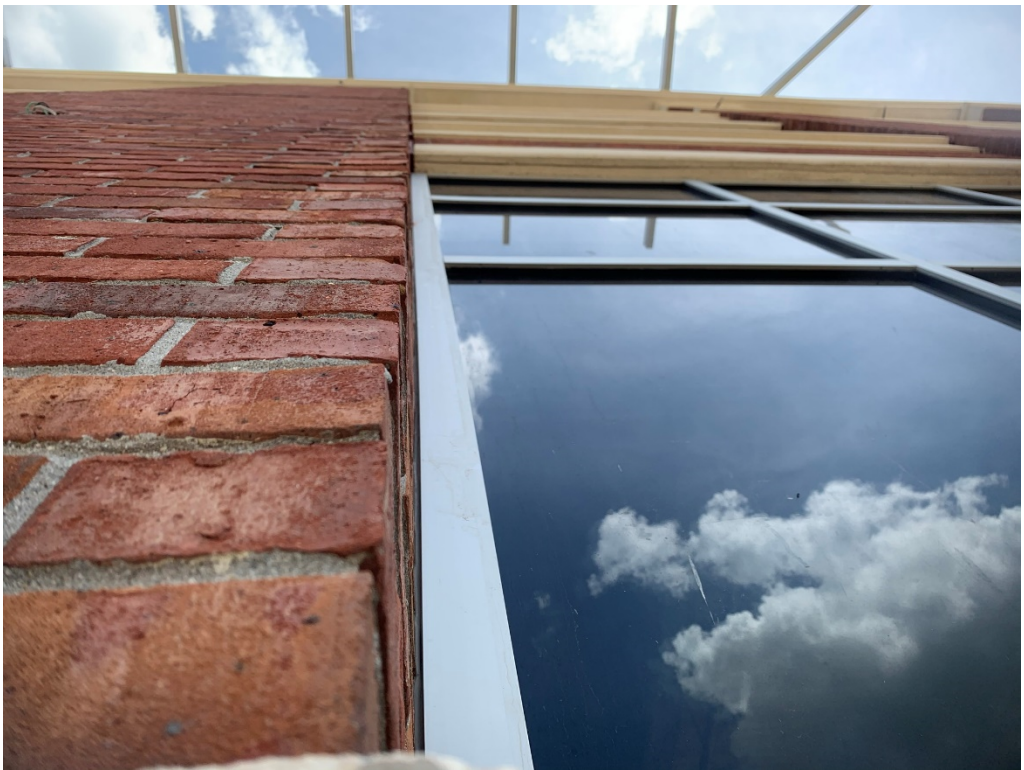
Figure 4 – Reworked Corner and storefront

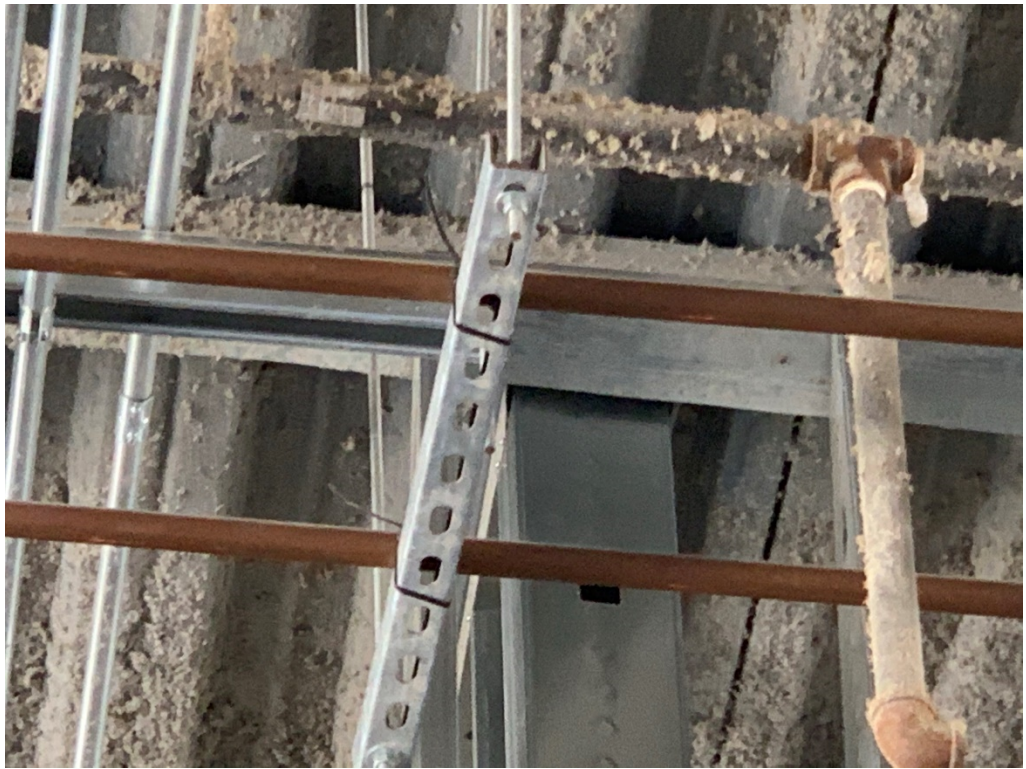
Figure 5 – Temporary Ties to be replaced

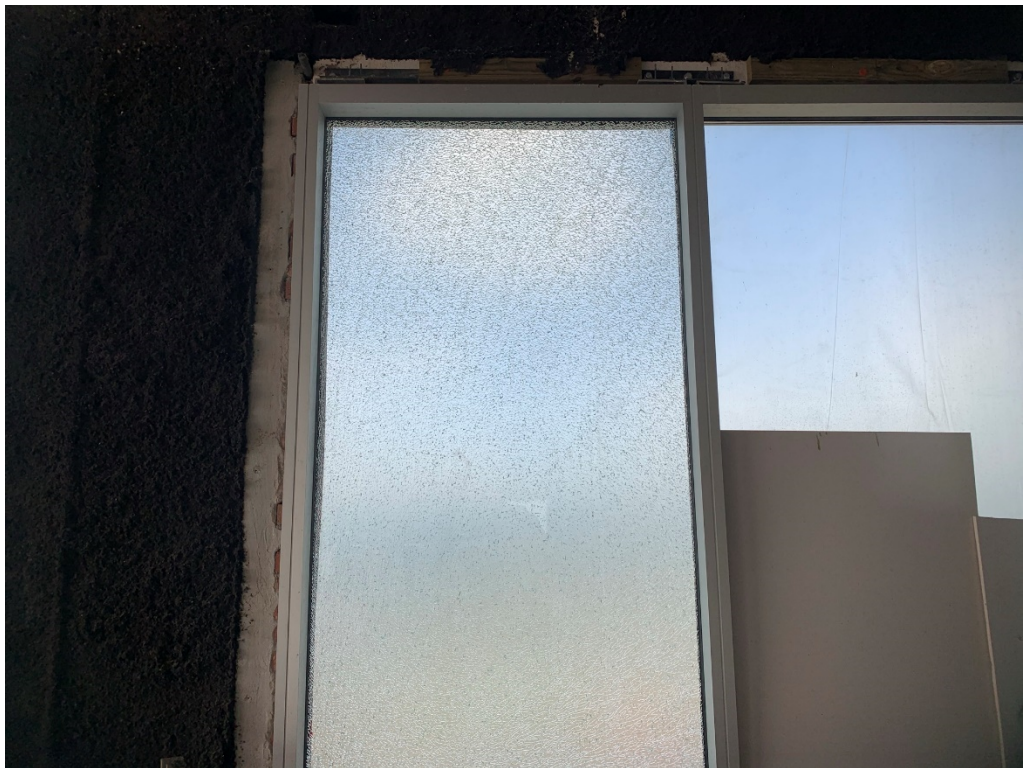
Storefront Installations are ongoing. One panel has been shattered.

Figure 6 – Shatter Glass after install

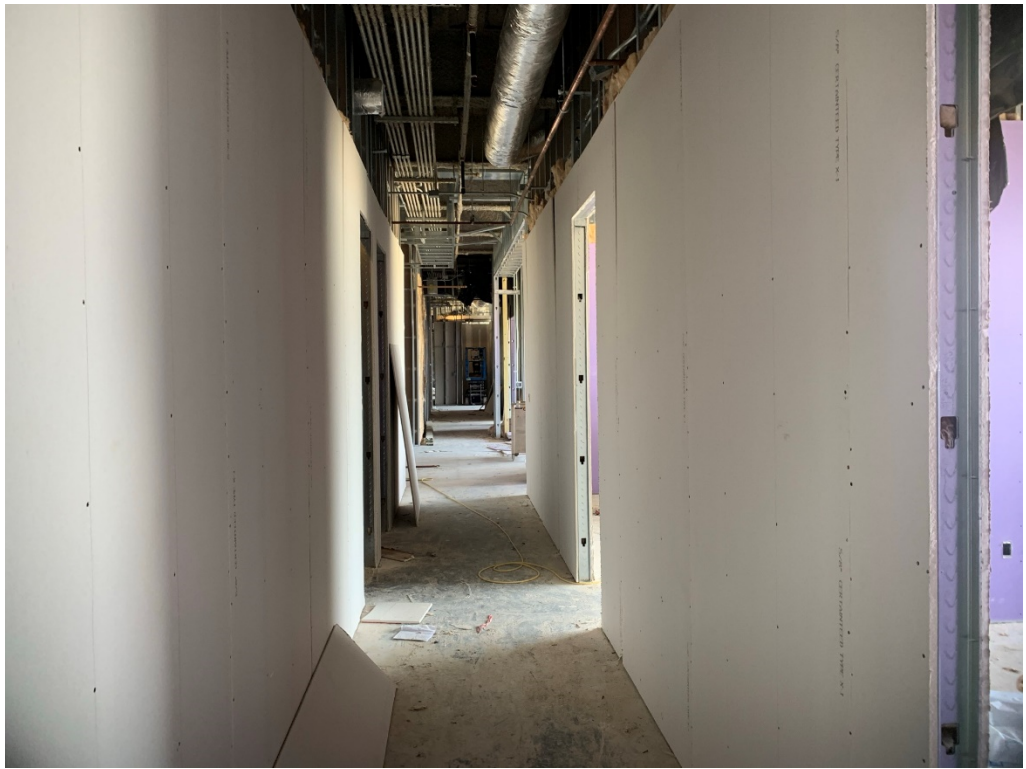
Figure 7 – Drywall Installation is Ongoing

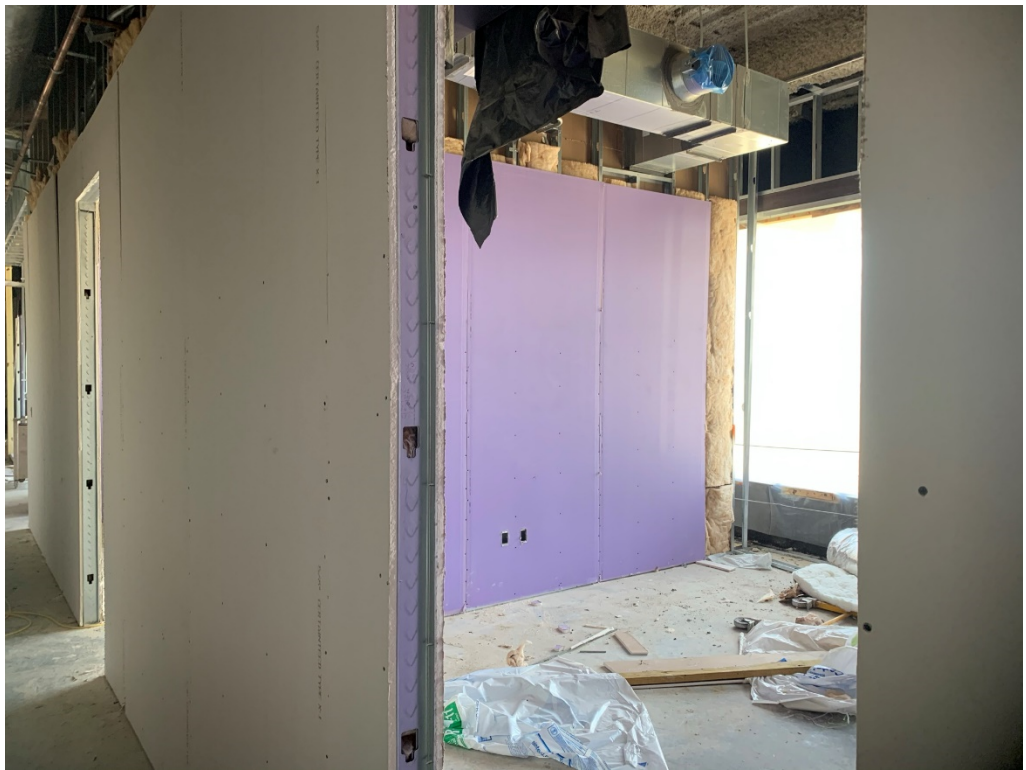
Figure 8 – Drywall Installation is Ongoing

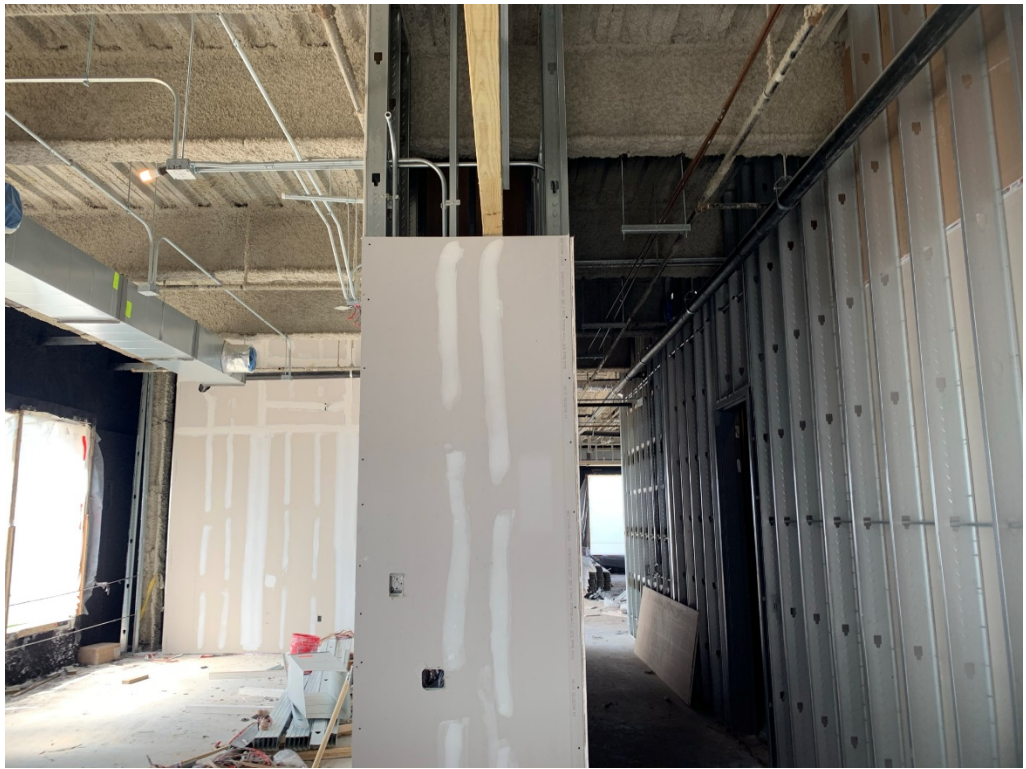
Figure 9 – Drywall Installation is Ongoing

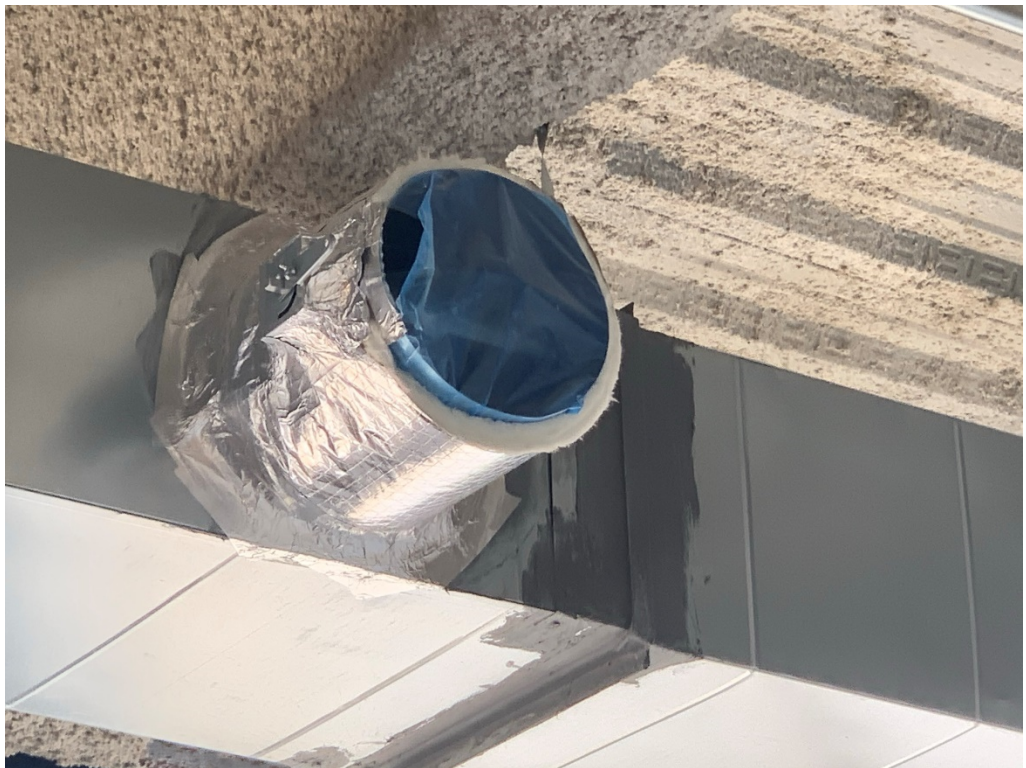
Figure 10 – Take care to seal all ducting per standards requirements
