Architect's Field Report

1 June 2021

15094 Community Bank Headquarters

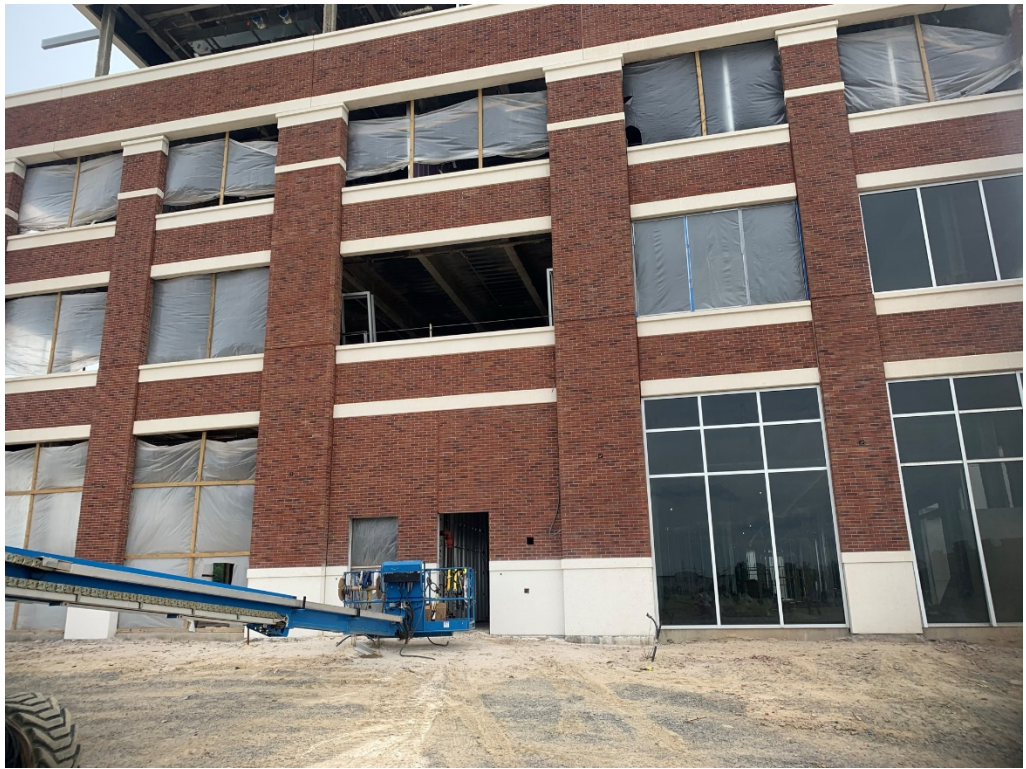
Observations Arriving on site, I walked the exterior. At the north side, a lift was resting and it appeared that some work has been done installing sealants.

Figure 1 – Continued work on North elevation

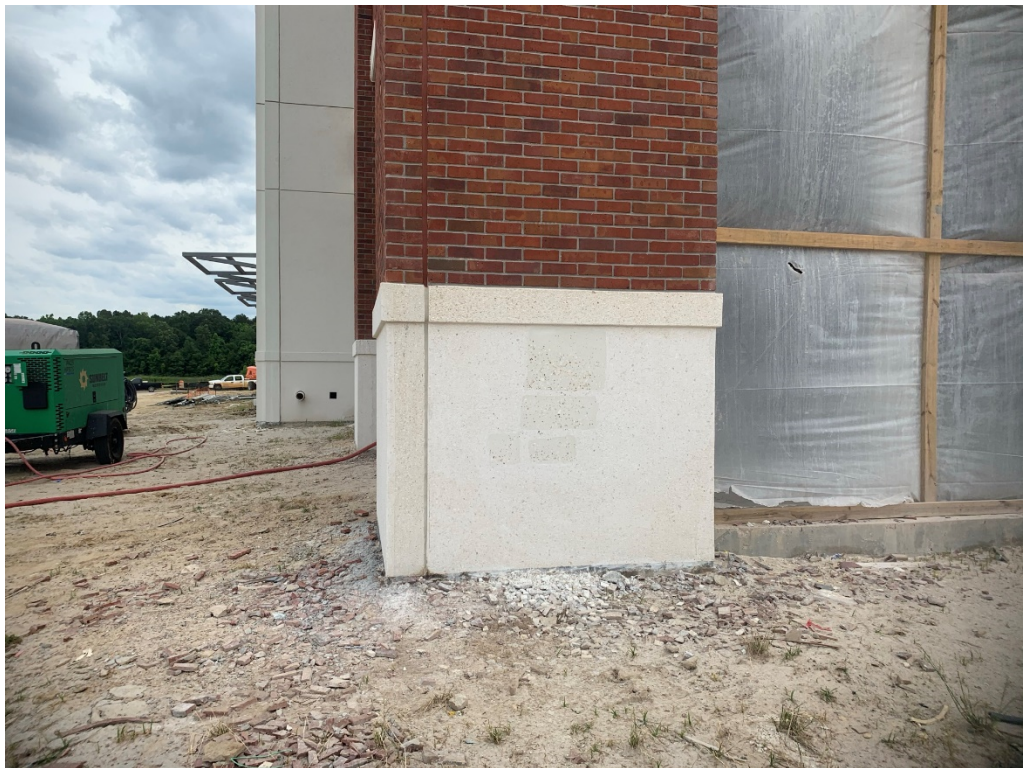
Figure 2 – Repair at Column after 5 days of cure time still not blending

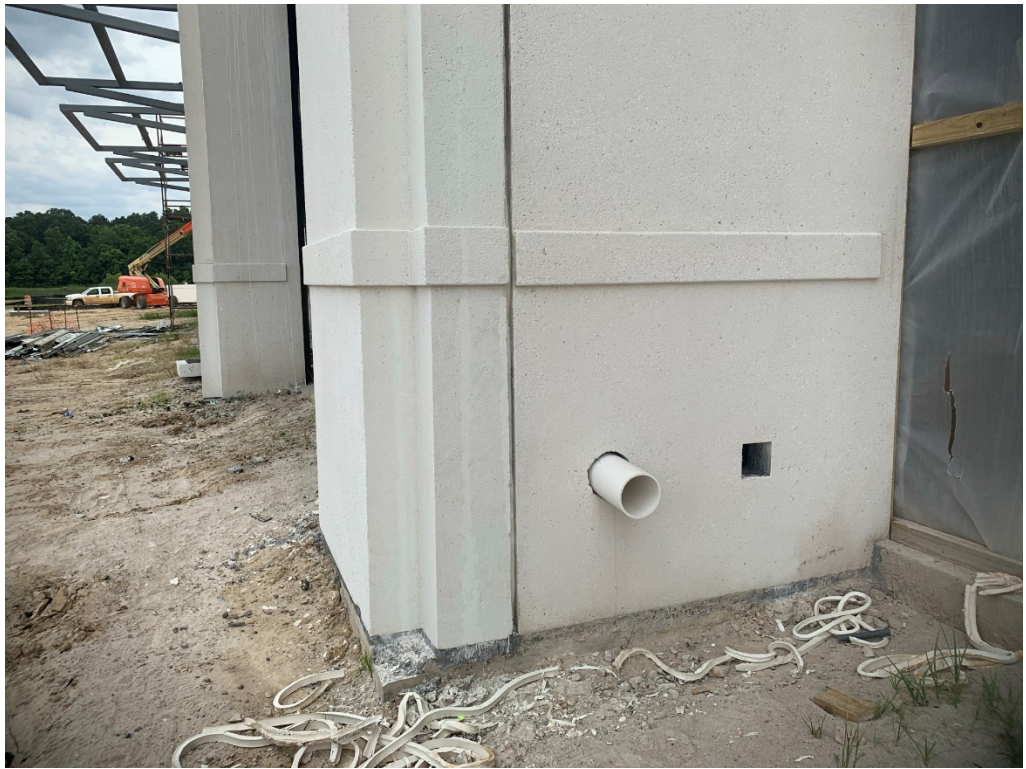
Figure 3 – Repair at Column after 5 days of cure time still not blending

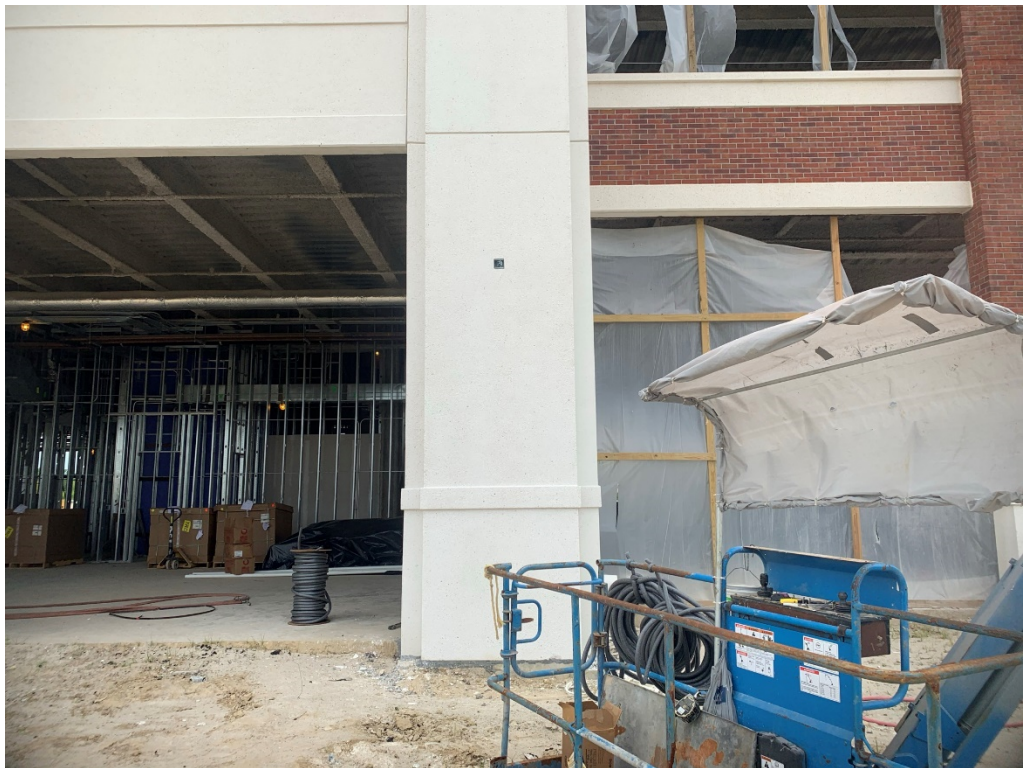
Figure 4 – Recessed edge on right has been colored and is different than the other faces

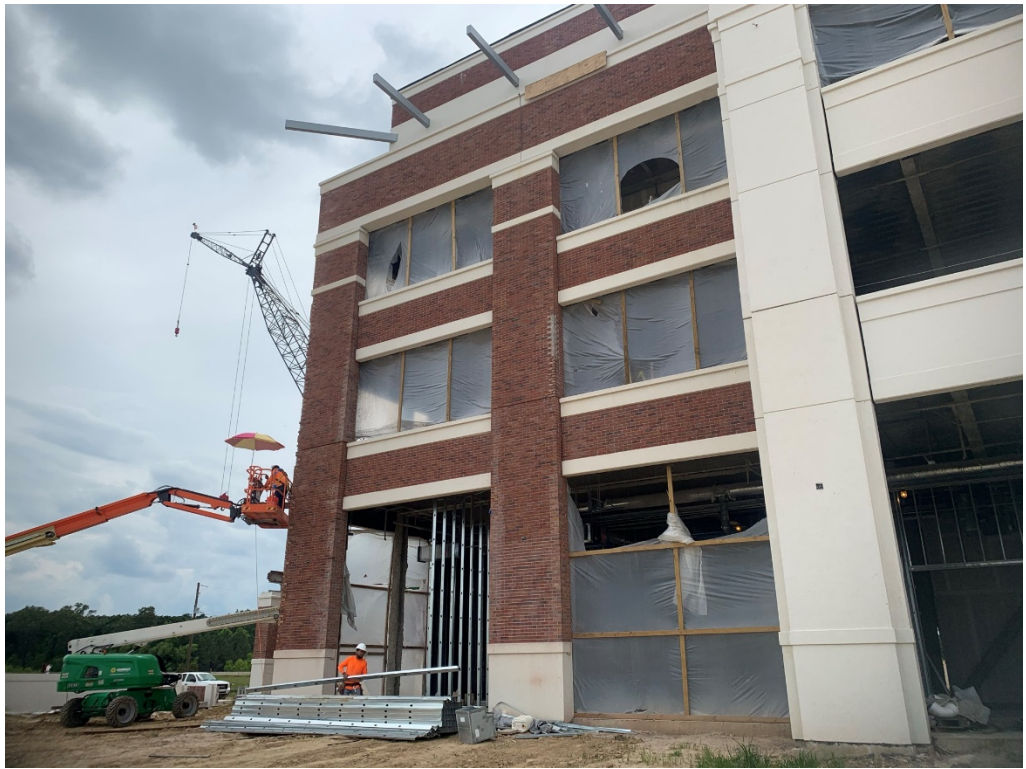
Figure 5 – Masonry is Ongoing

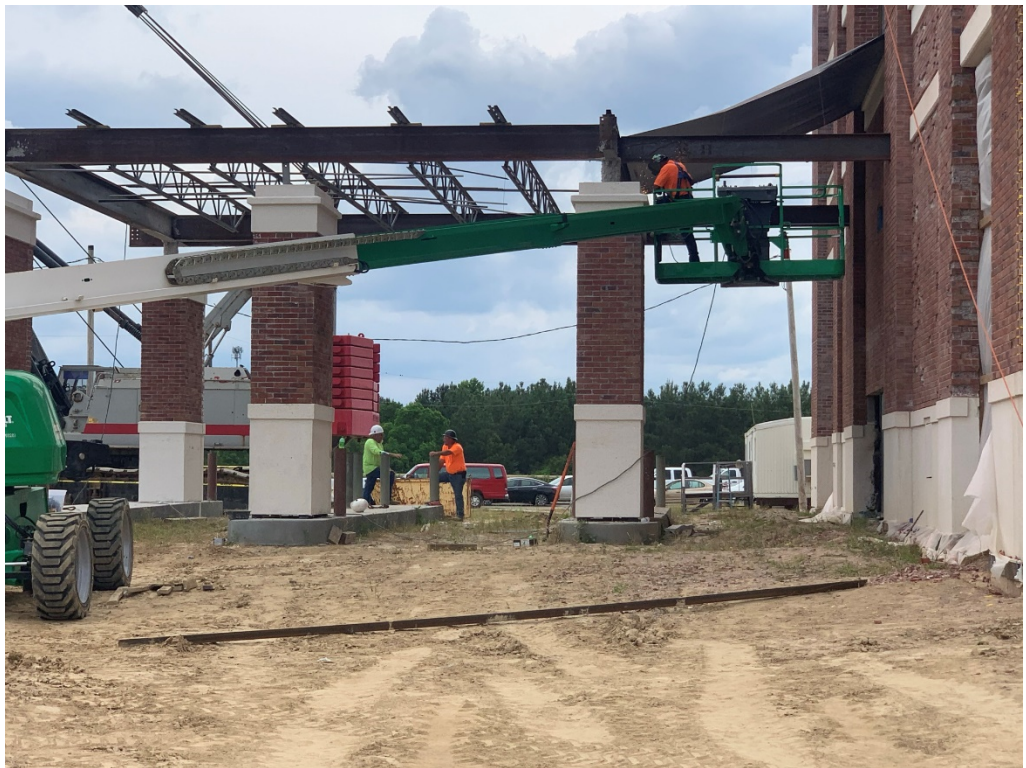
Figure 6 – Panel Install at Drive Thru

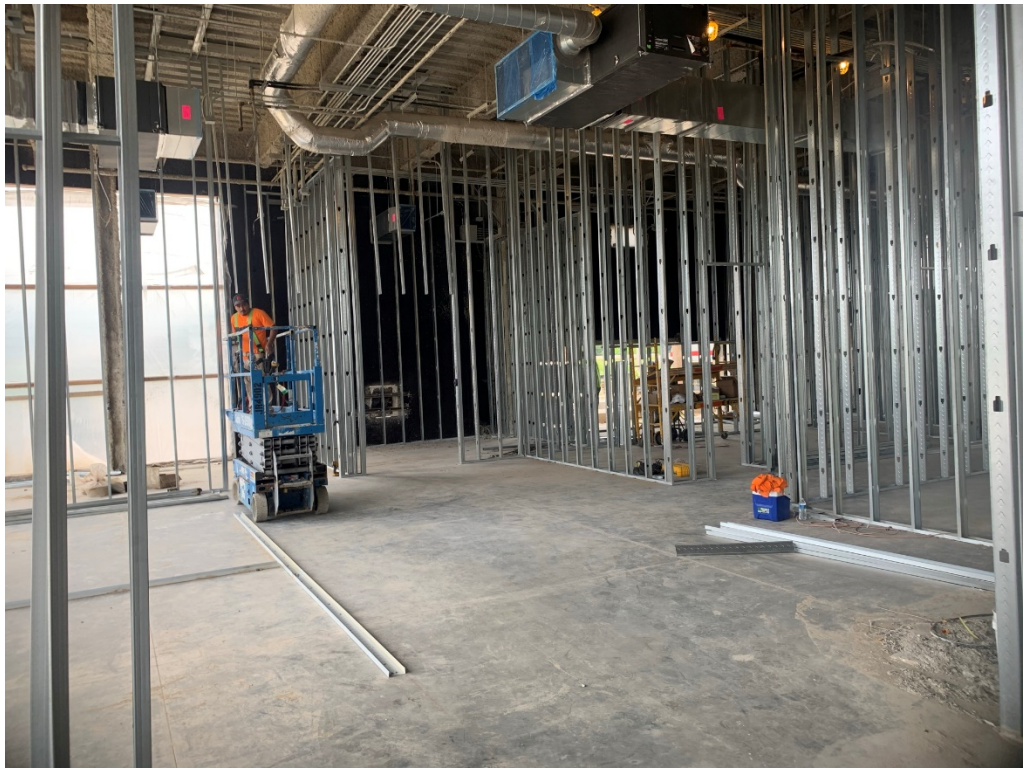
Figure 7 – Framing at 1st Floor

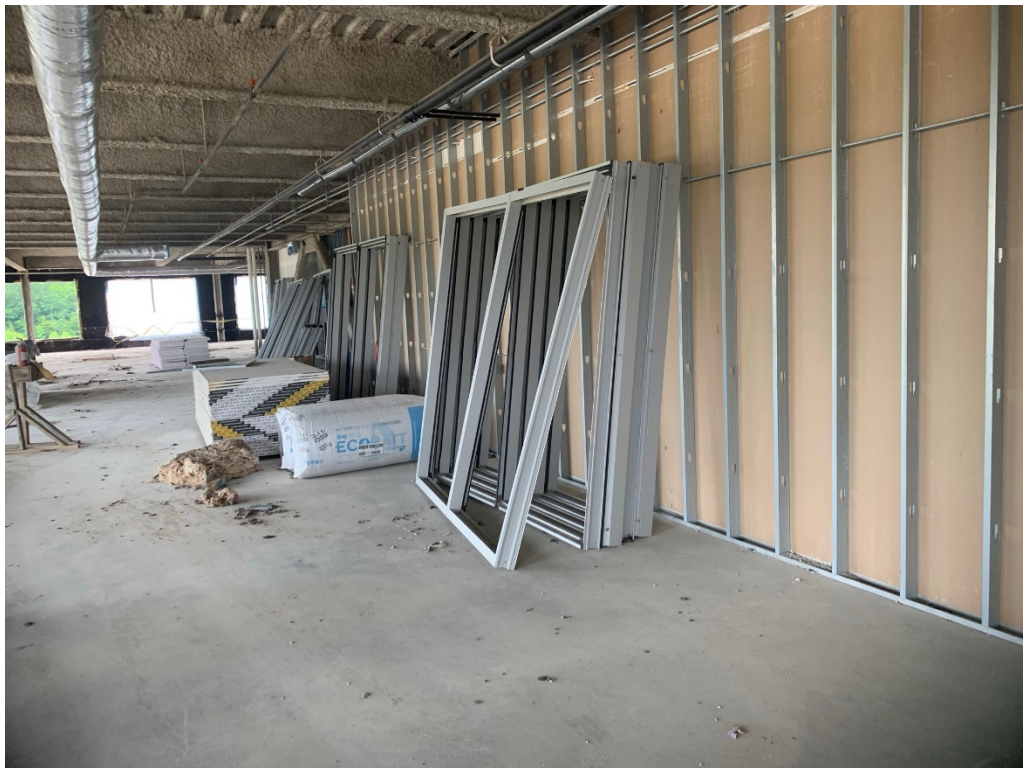
Figure 8 – Storefront Frames Stored on 2nd Floor

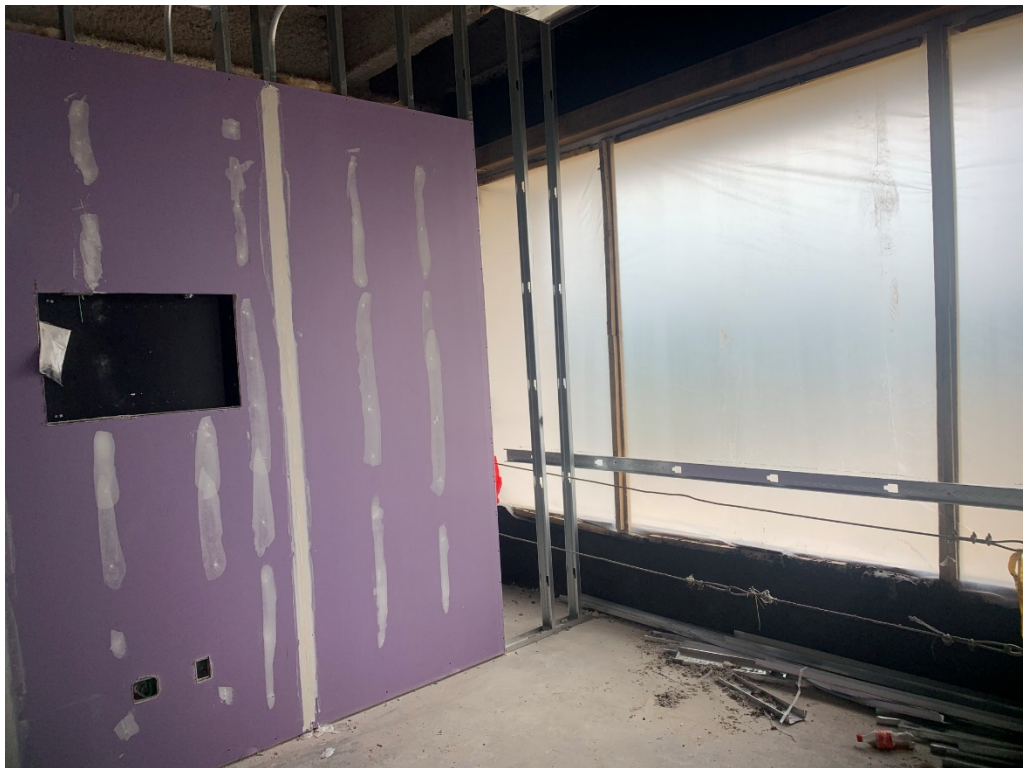
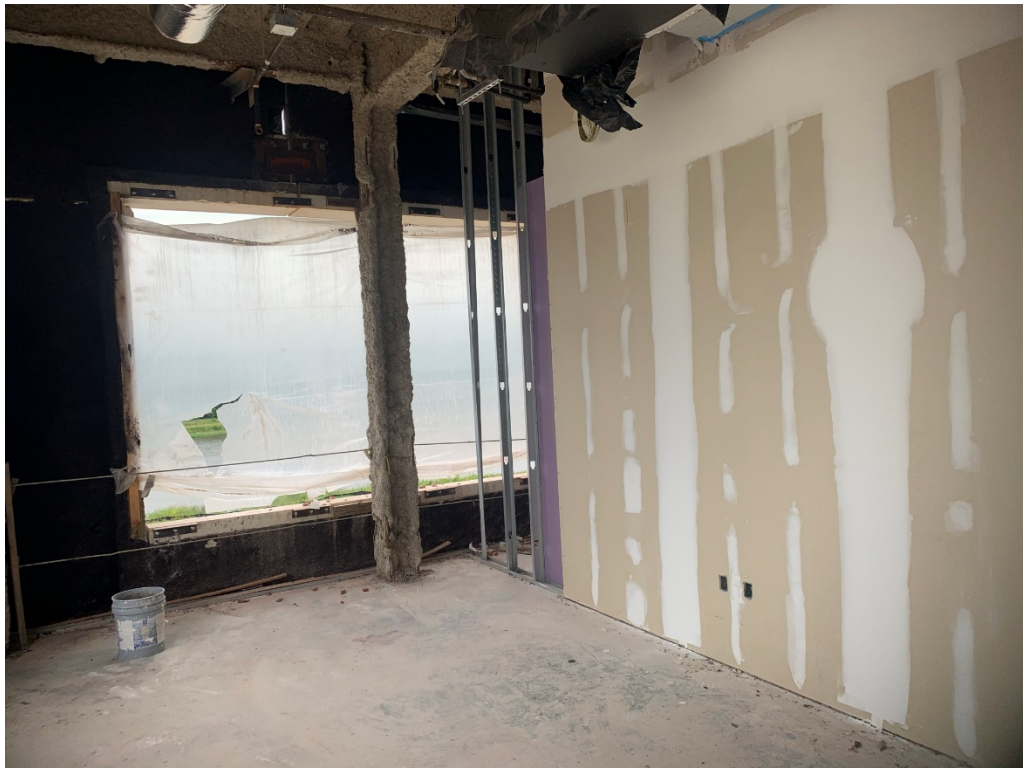
Figure 10 – Typical Recess of Finished Framing (pending storefront installation)

Figure 11 – Typical Recess of Finished Framing (pending storefront installation)

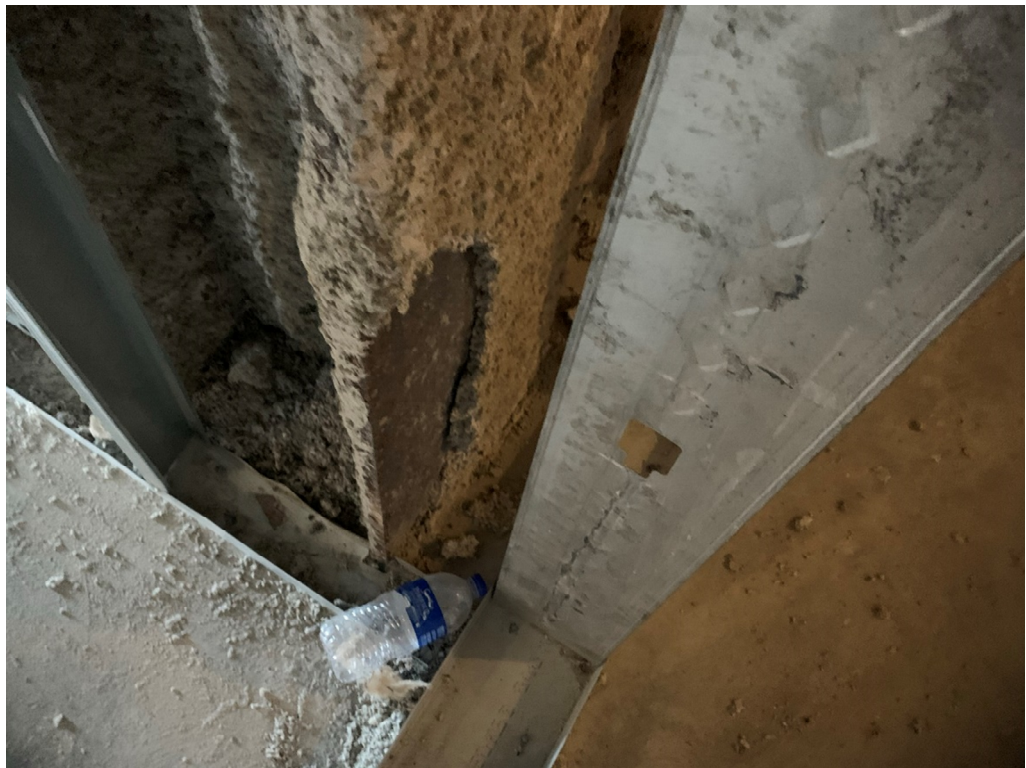
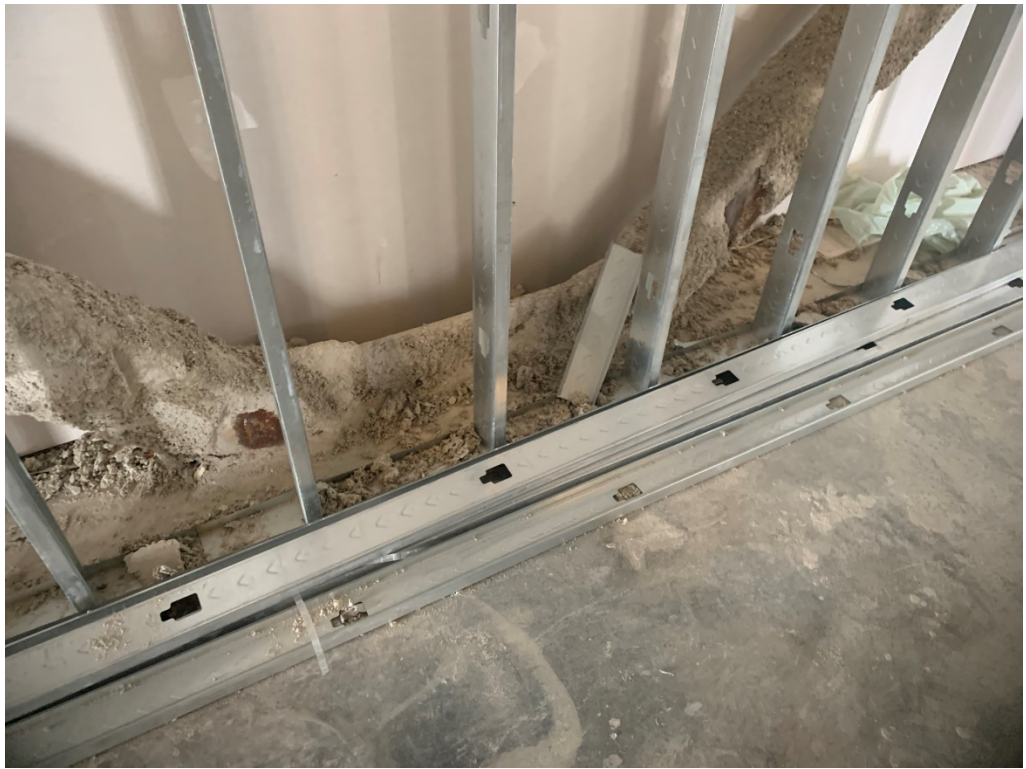
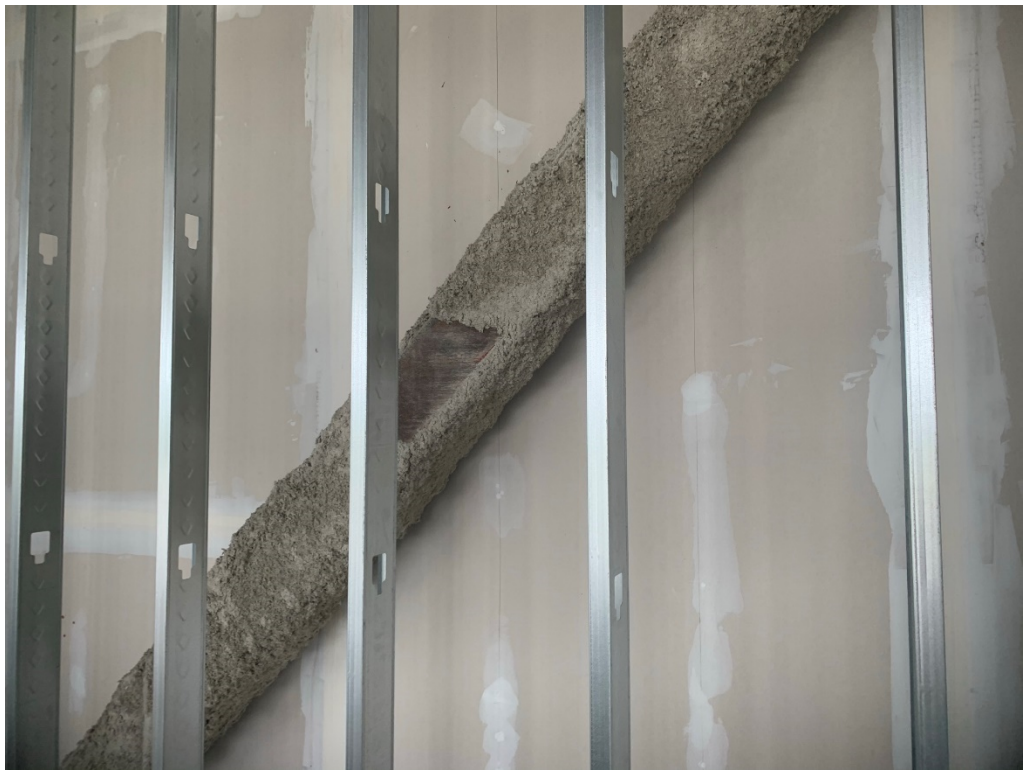
There are some areas where fire insulation has not been repaired that drywallers are close to installing their rock. Pay attention to these areas before closing in walls.

Figure 14 – Fire Insulation Needs Repair

Figure 15 – Fire Insulation Needs Repair

Figure 16 – Fire Insulation Needs Repair
