Architect's Field Report

7 June 2021

15094 Community Bank Headquarters

Contract Fountain Construction Company, Inc.

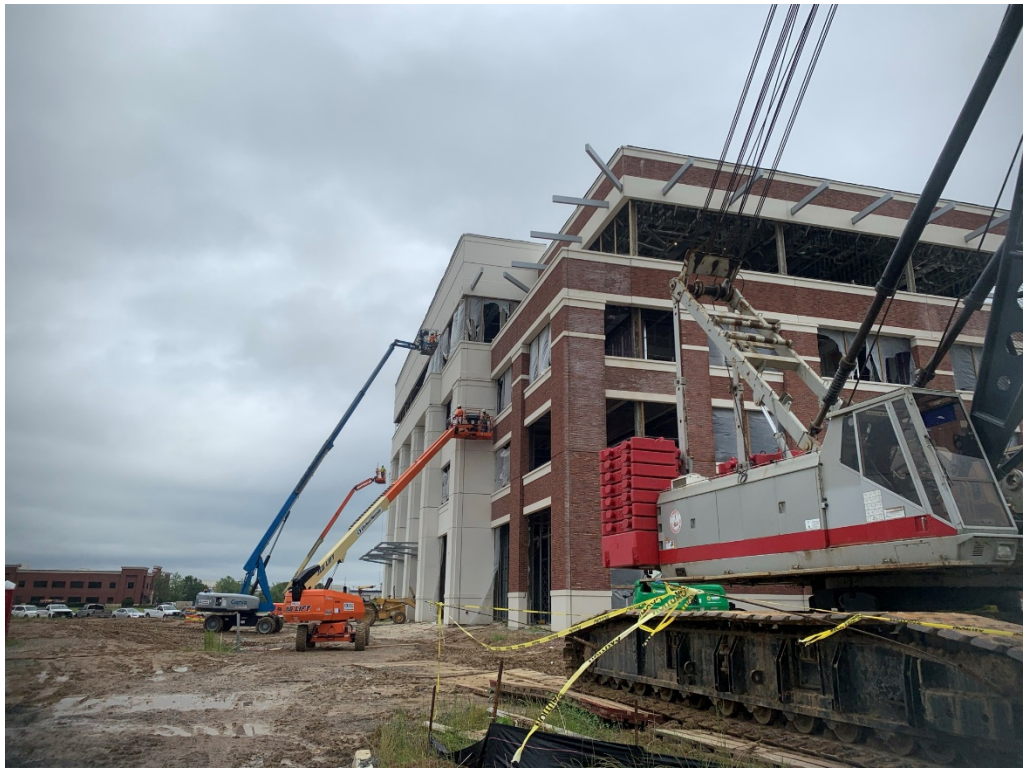
Figure 1 – Continued work on West Elevation

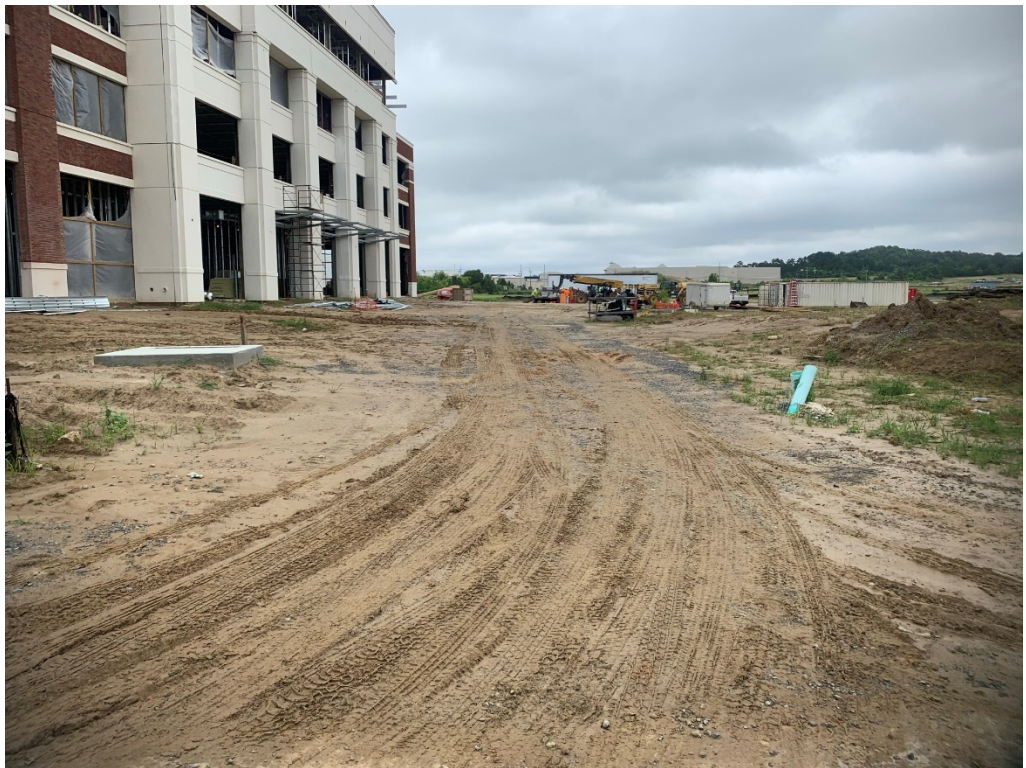
On the south east corner, the concrete pad for the transformer appears to be 24-25 feet from a couple of blue markers; do these markers represent the curb on the east side of this road? If so, the concrete pad may be too close.

Figure 2 – Concrete Pad is approximately 25' from markers on right

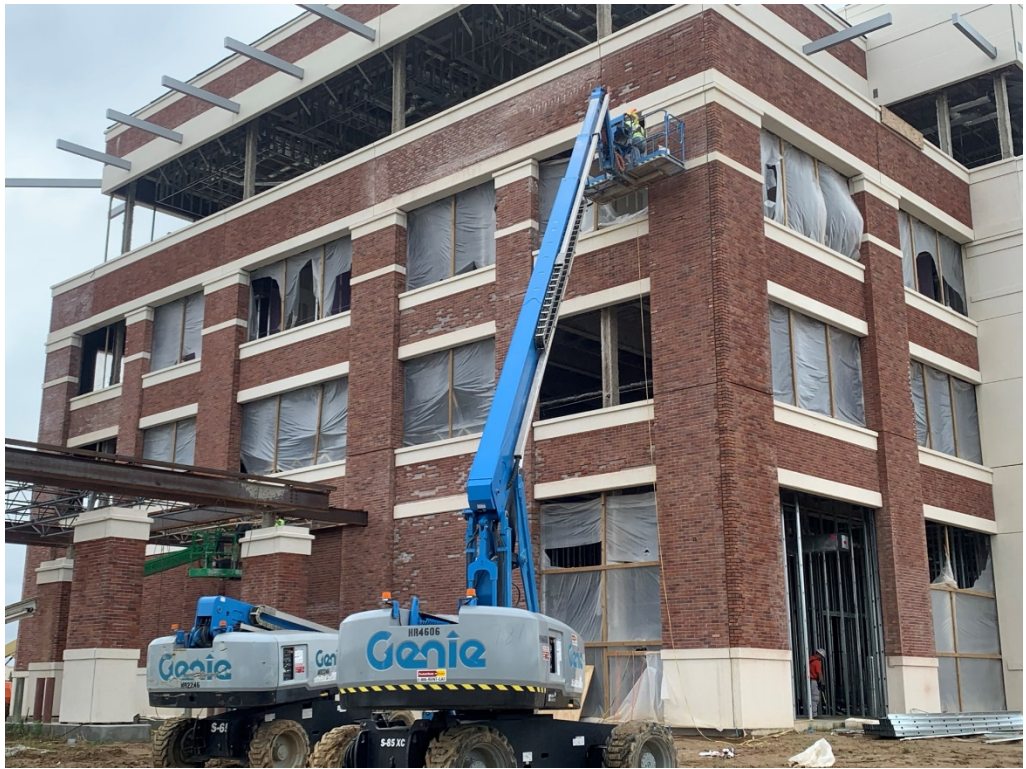
Figure 3 – South Façade Work is Ongoing

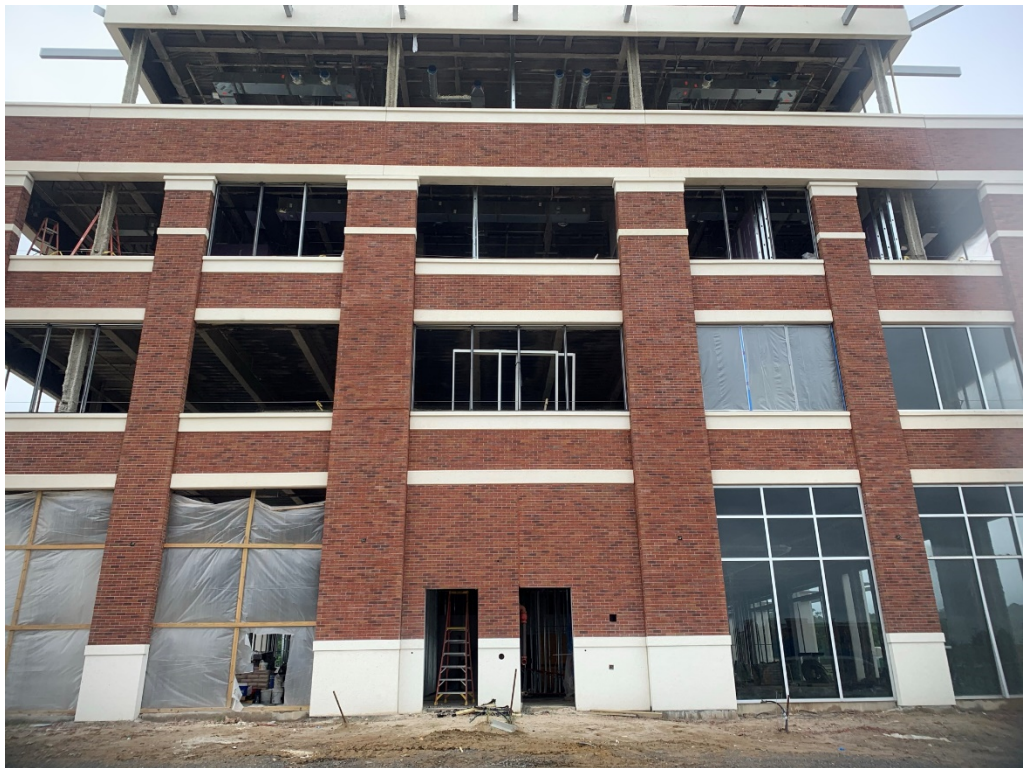
Observations On site, I walked the exterior noting improvements on the North side of the building. There are still some issues with coloring at the patched areas, but the mismatching brick panels do look closer.

Figure 4 – North Façade Progress

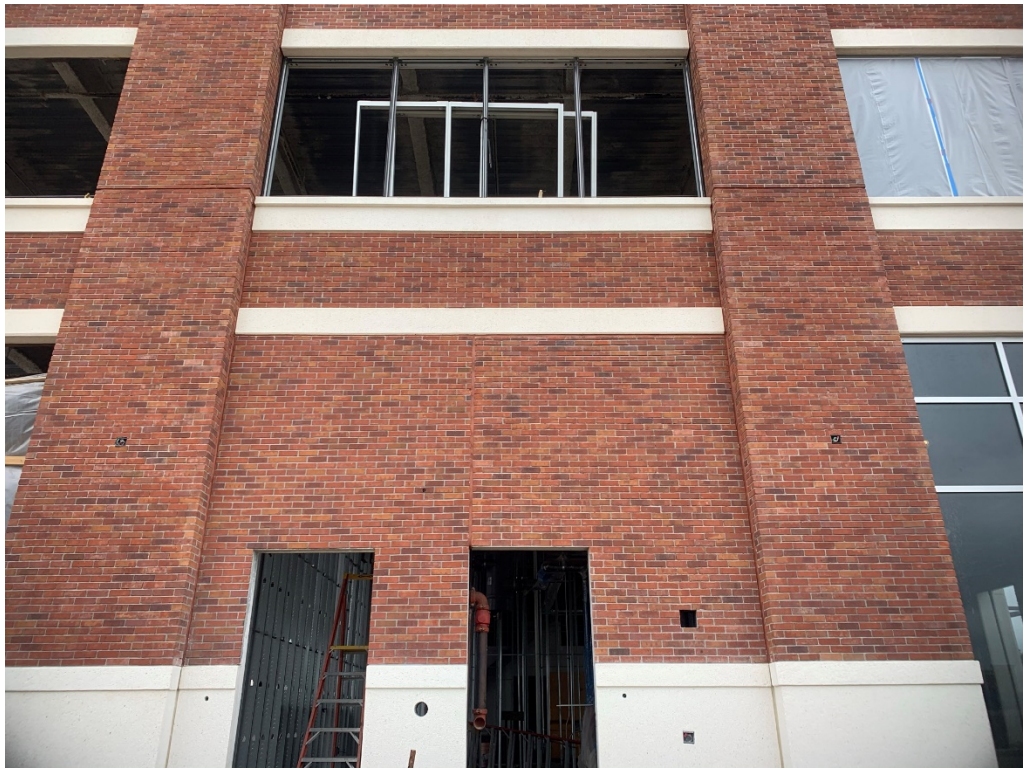
Figure 5 – Panels are much closer in coloring

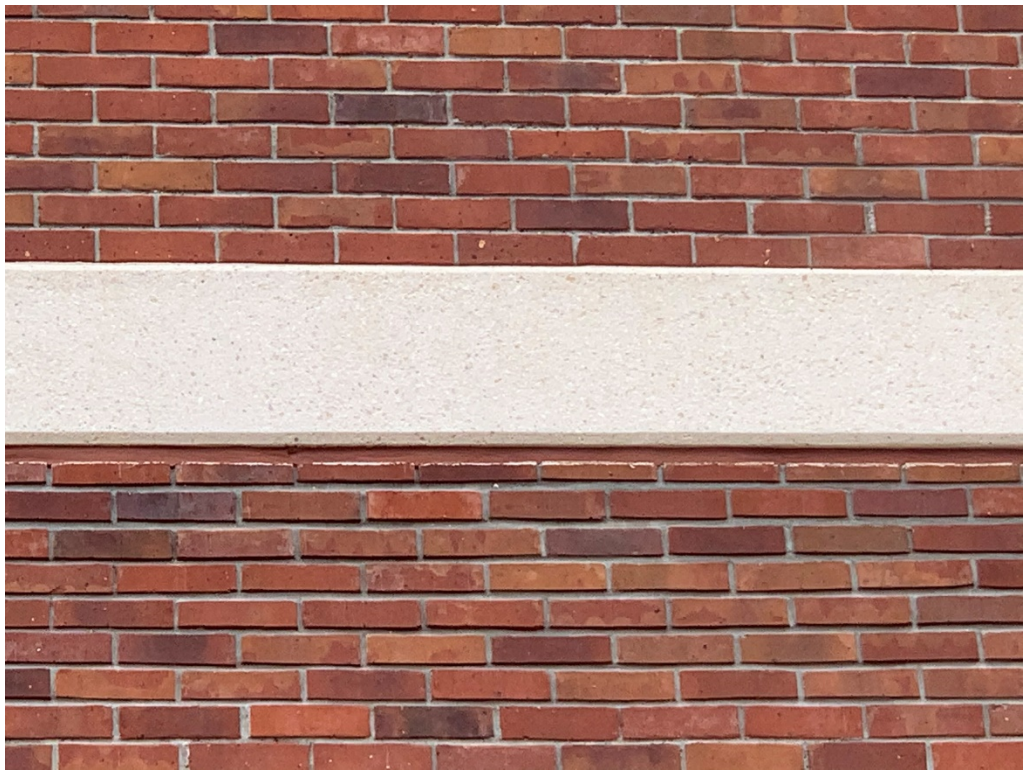
Figure 6 – White Caulk, previously installed, needs removal

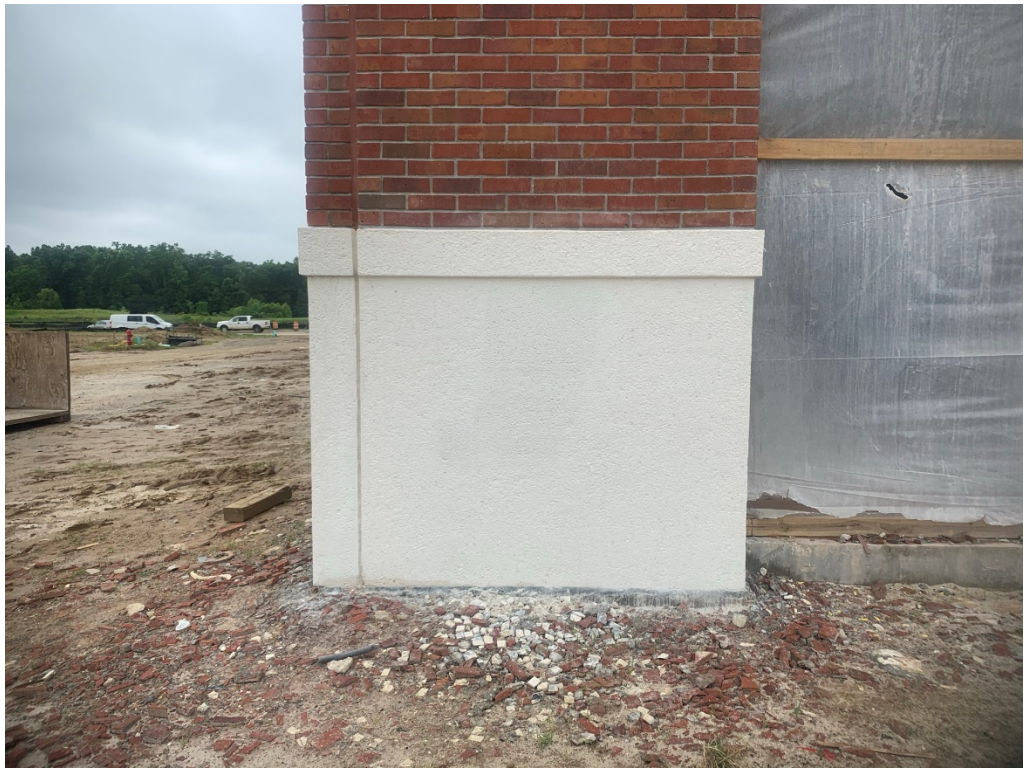
Figure 7 – Shade still showing through finished panel

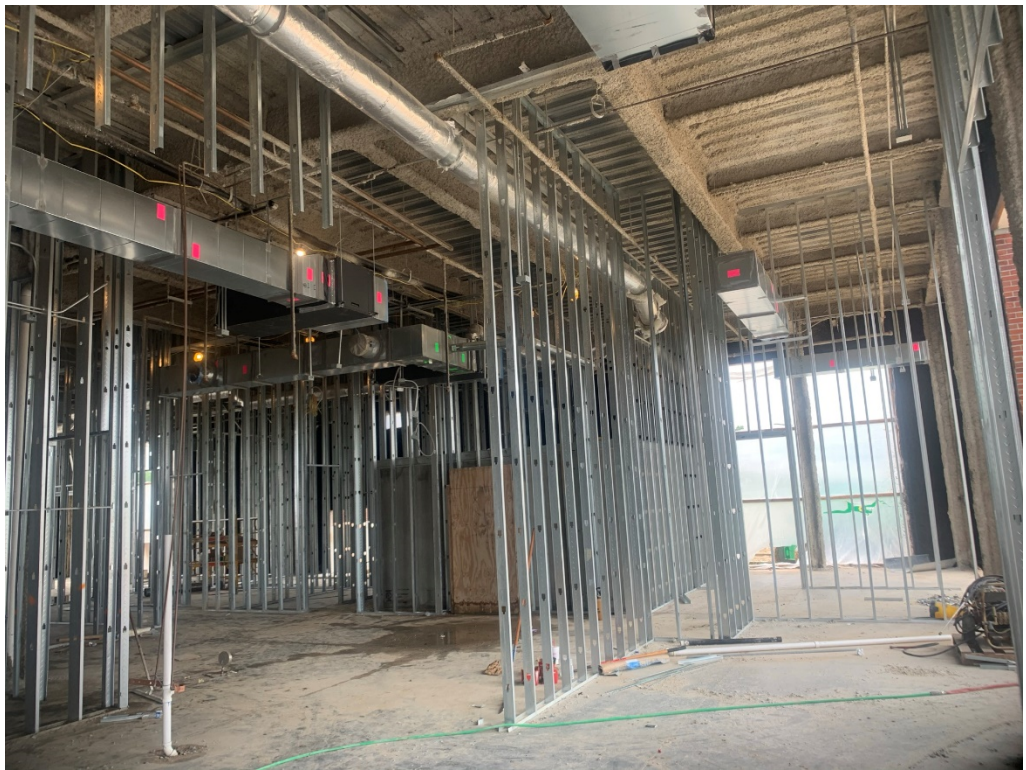
Figure 10 – 1st Floor Bank Area Framing Progress

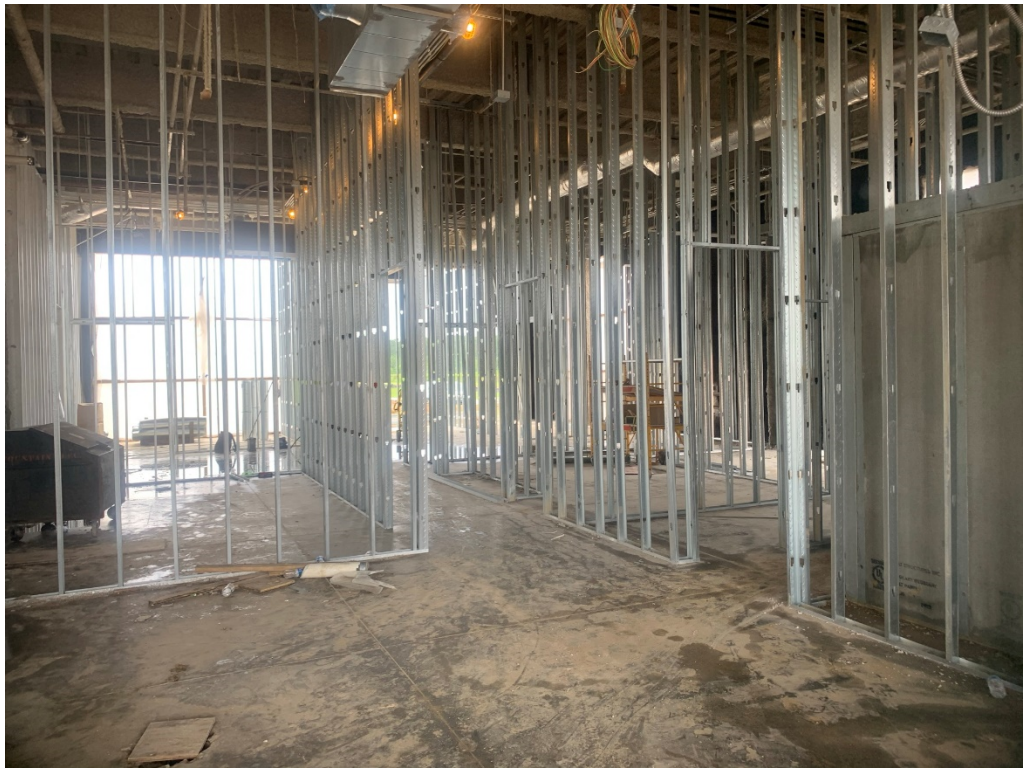
Figure 11 – 1st Floor Bank Area Framing Progress

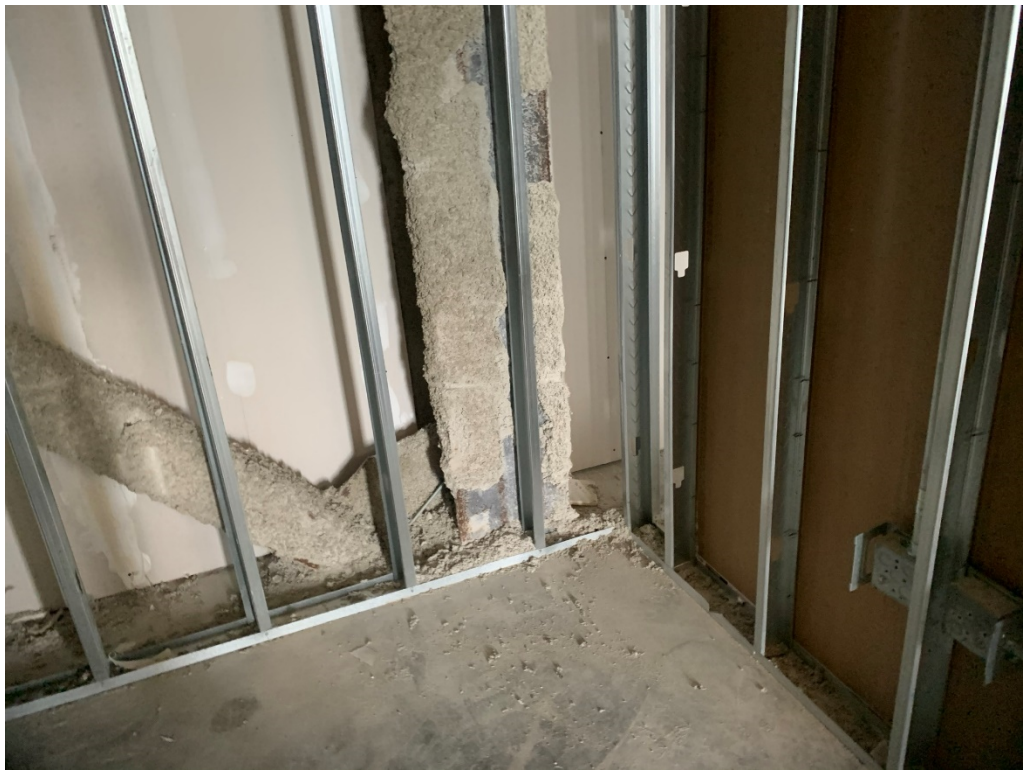
Figure 12 – Fire Insulation Still Missing in Areas

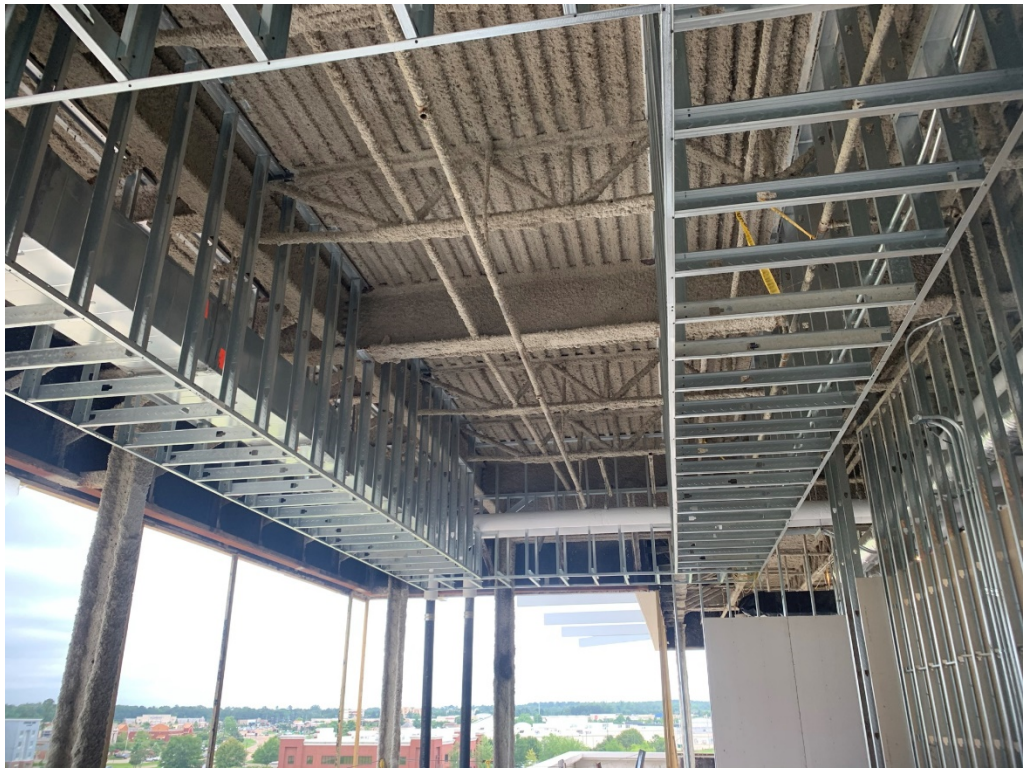
Figure 13 – Board Room Ceiling Framing

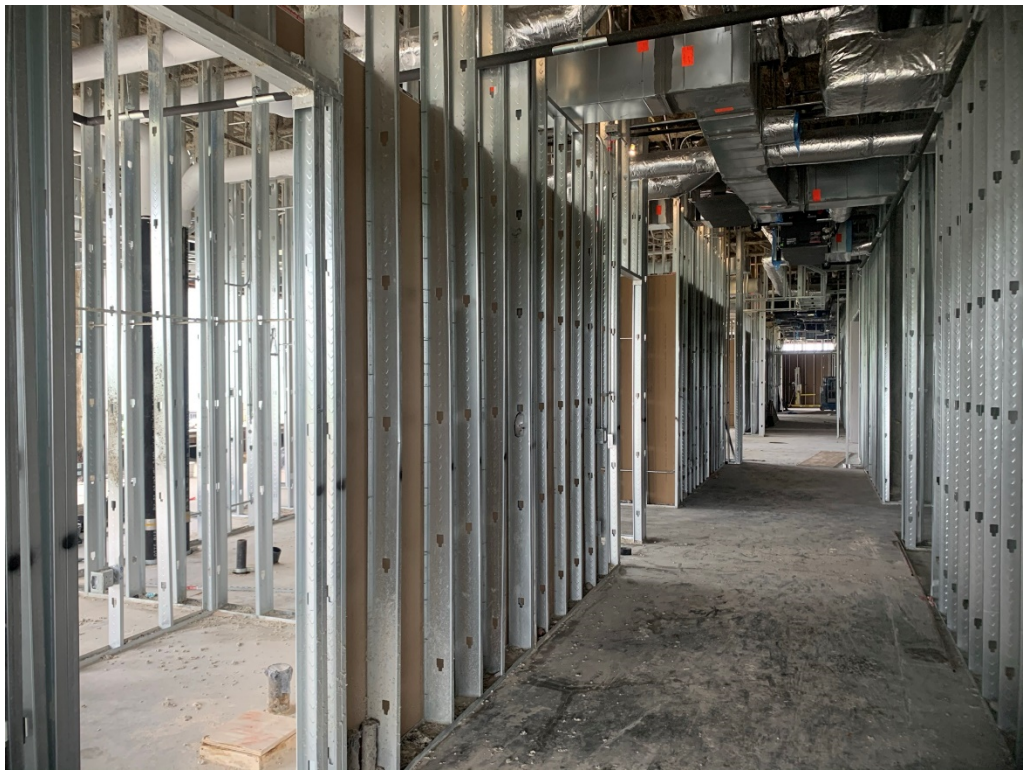
Figure 14 – Top Floor Progress
