Architect's Field Report

15 June 2021

15094 Community Bank Headquarters

Date / Time 14 June 2021 / 2:00 PM

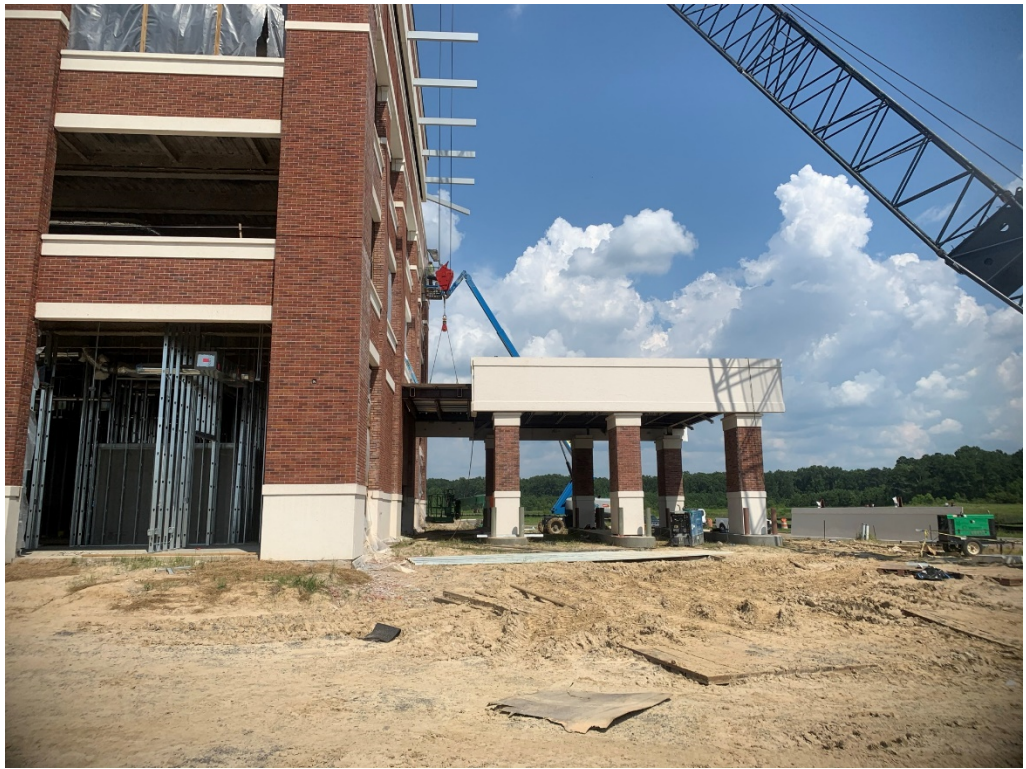
Observations Arriving on site, I first reviewed ongoing work at the drive thru. 90% of the panels here have been installed. Bracing was installed at the south panel beam that the contractor referred to in RFI 89, but not in accordance with the structural engineer's drawings. Additional steel is still to be added at beam per engineer's drawing.

Figure 1 – Panel Install at Drive-Thru

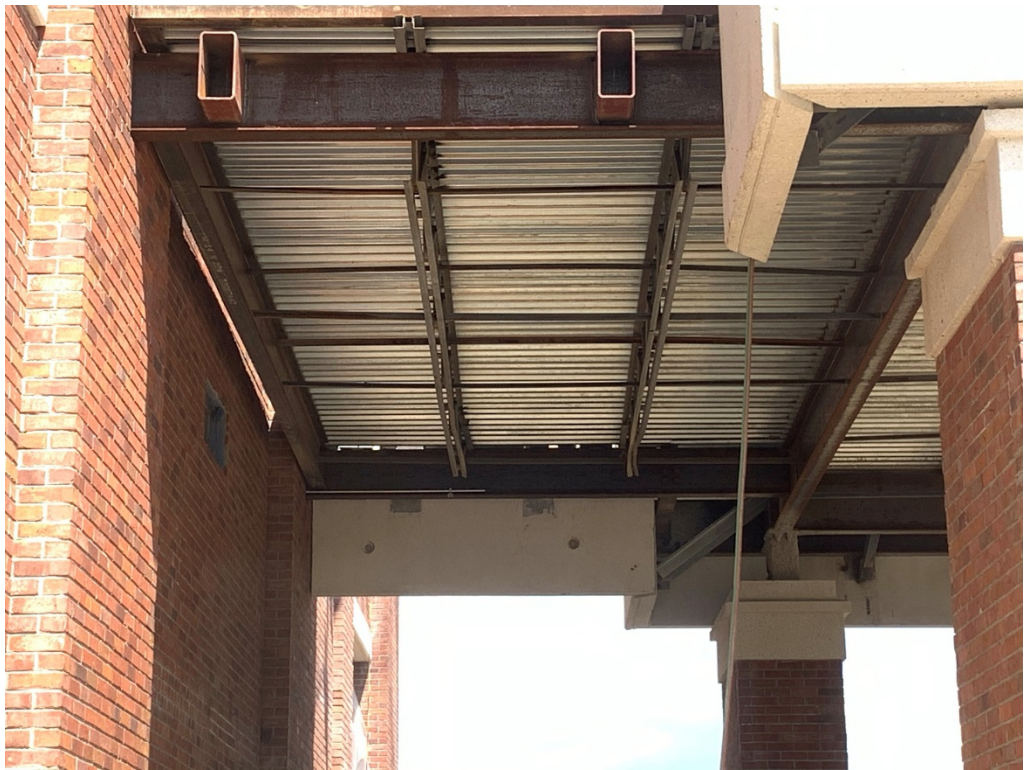
Figure 2 – Open Web joists Damaged and need straightening or replacement

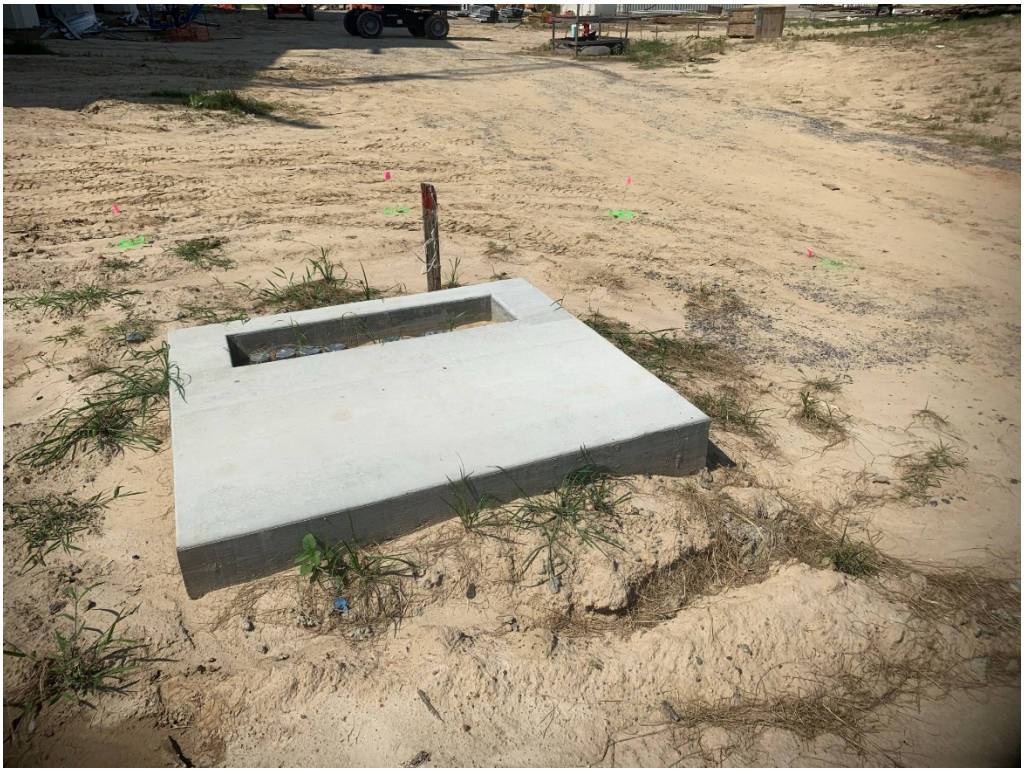
Figure 3 – Curb Marked Appears correct distance from Transformer Slab

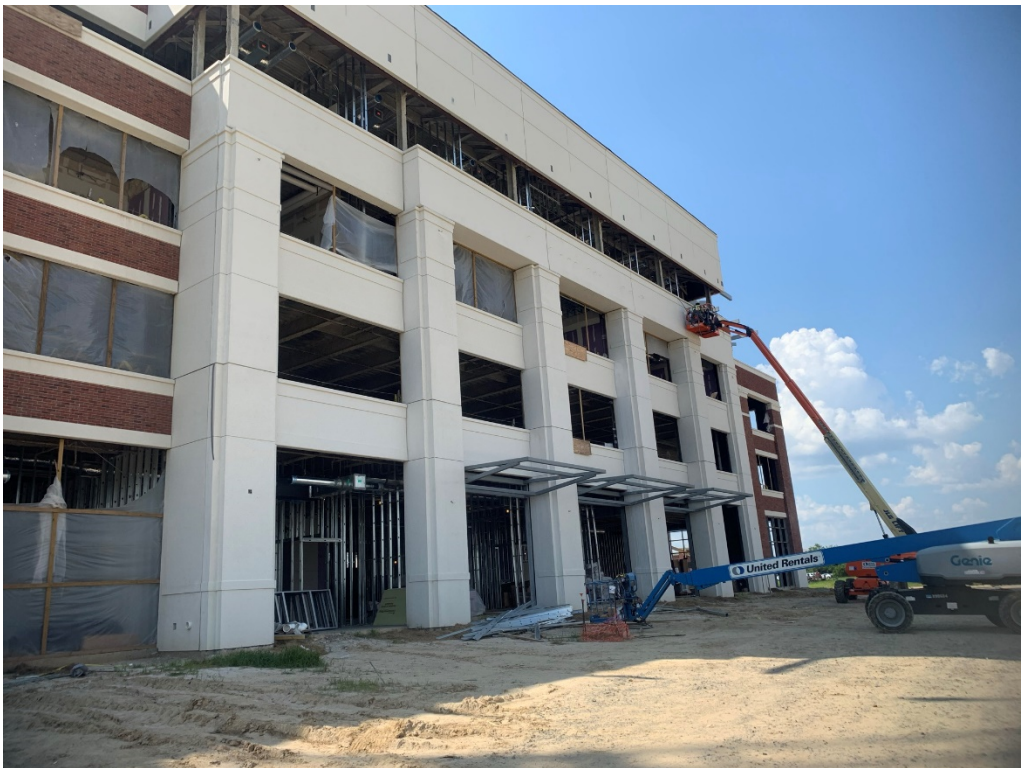
Curtain wall and sealant installation as well as masonry repair are ongoing and being work on throughout.

Figure 4 – Continued Work on Sealants at East Façade

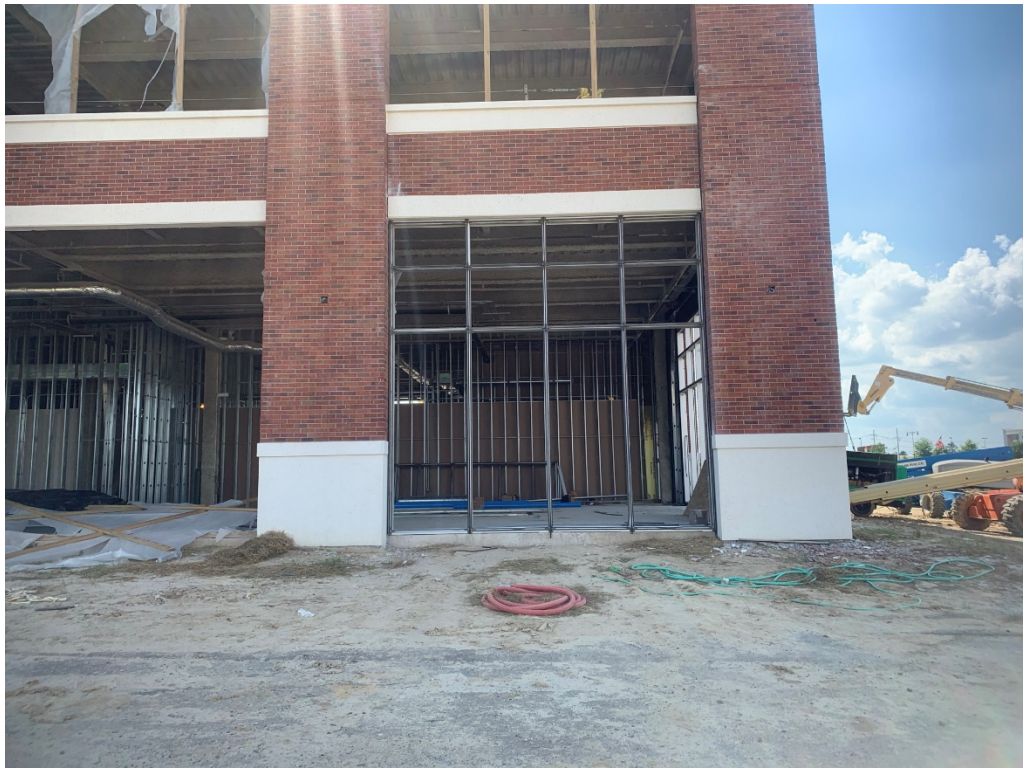
Figure 5 – Curtain Wall Install Ongoing

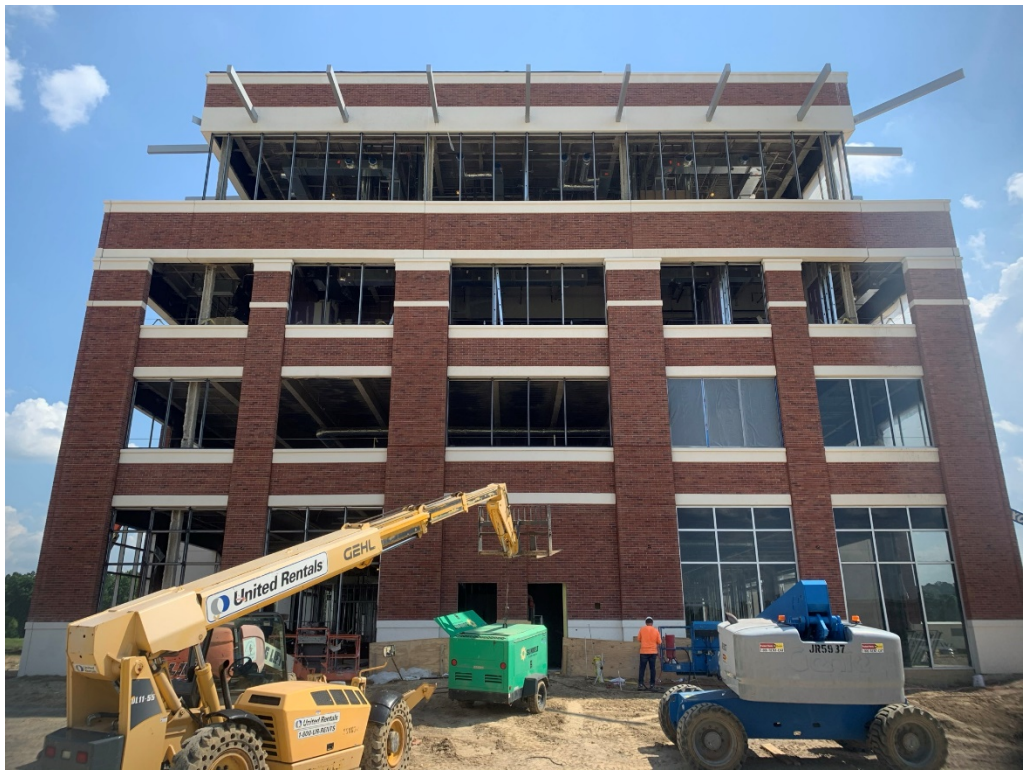
Figure 6 – North Elevation Progress

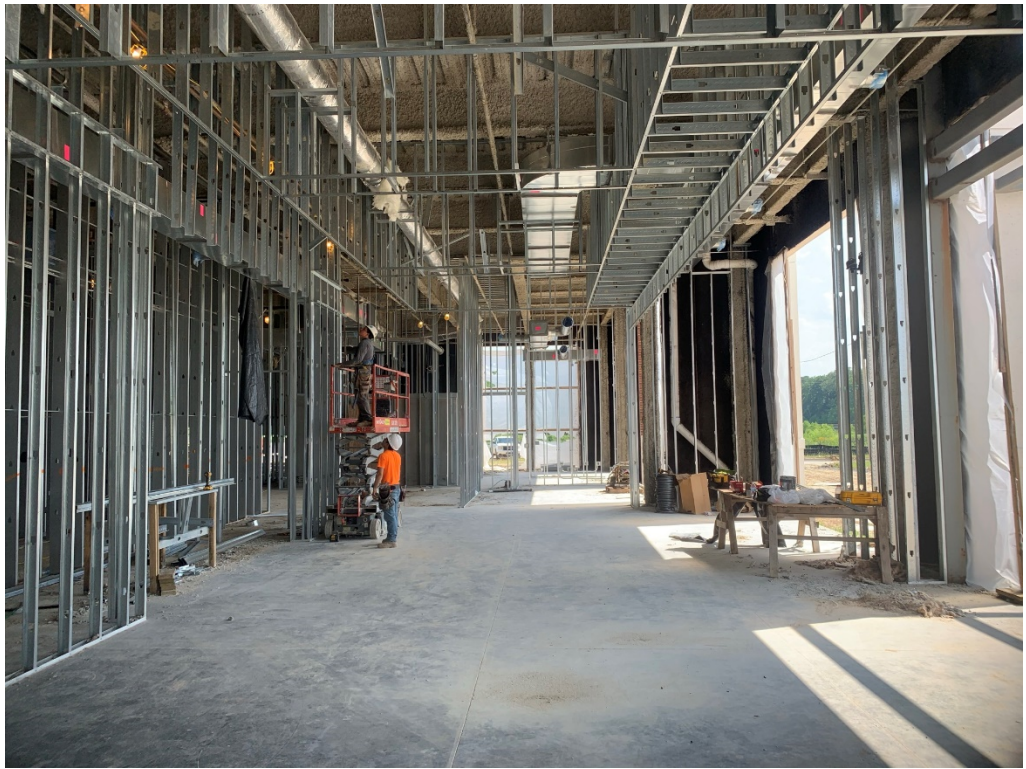
At the interior and on the first floor, framers were working out framing in the bank lobby area. At the 3rd and 4th floors, drywall finishers were working.

Figure 7 – 1st Floor Progress

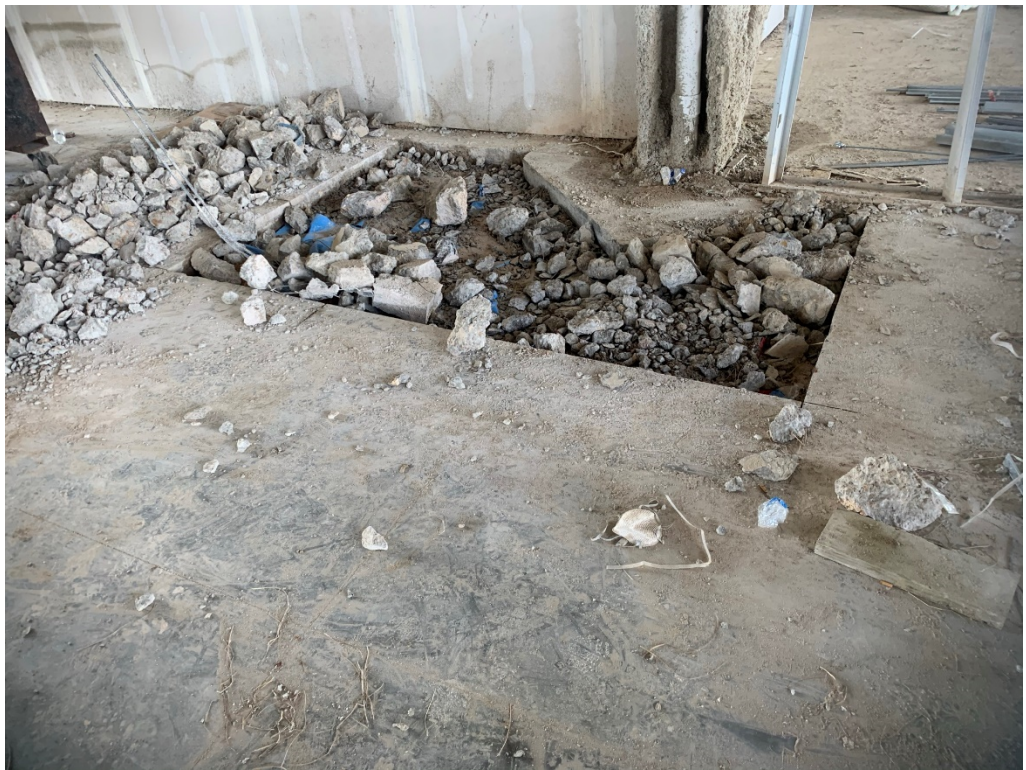
Figure 8 – Excavation at Employee Lounge

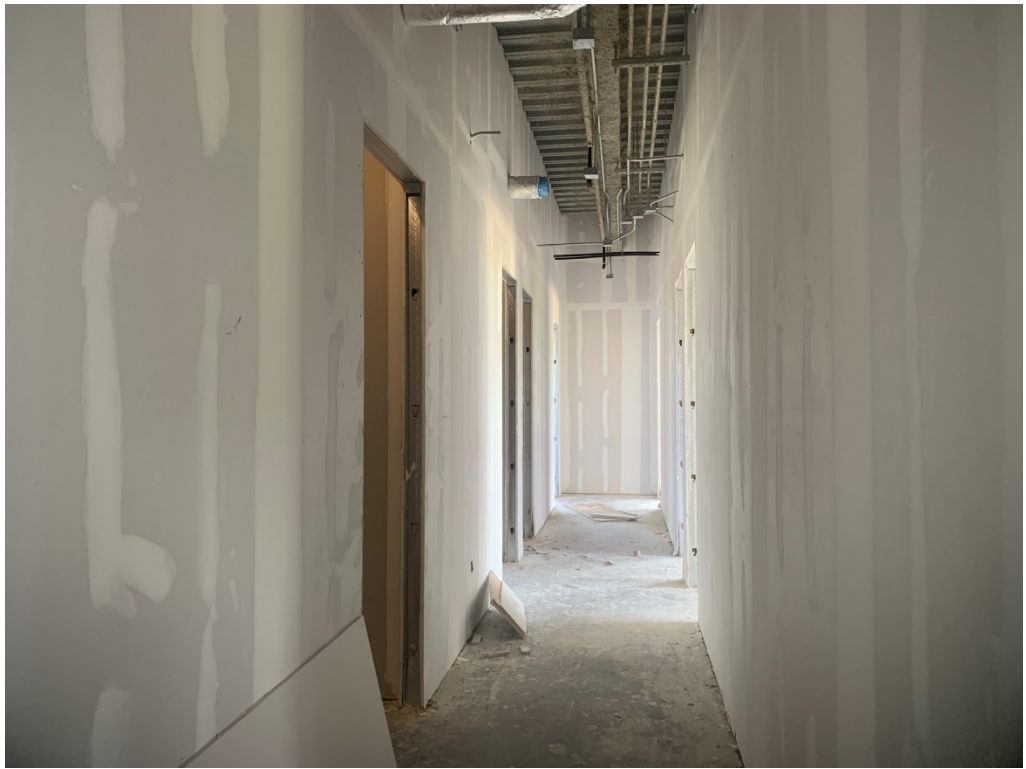
Figure 9 – 3rd Floor Progress

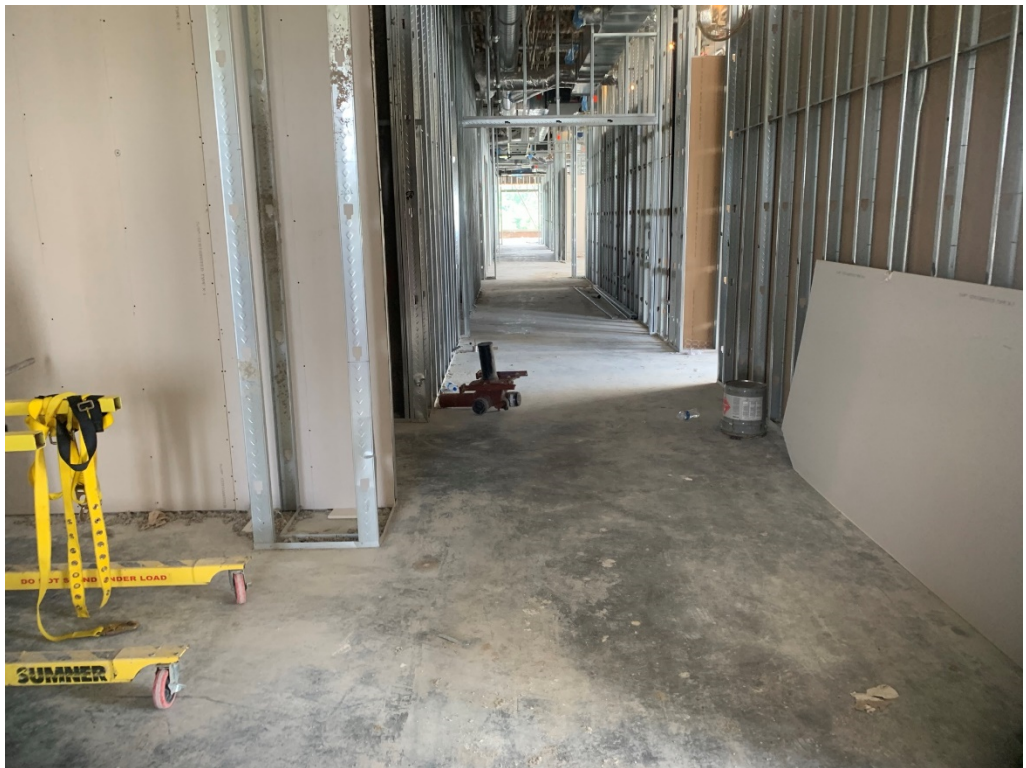
Figure 10 – 4th Floor Progress
