Architect's Field Report

17 June 2021

15094 Community Bank Headquarters

Contract Fountain Construction Company, Inc.

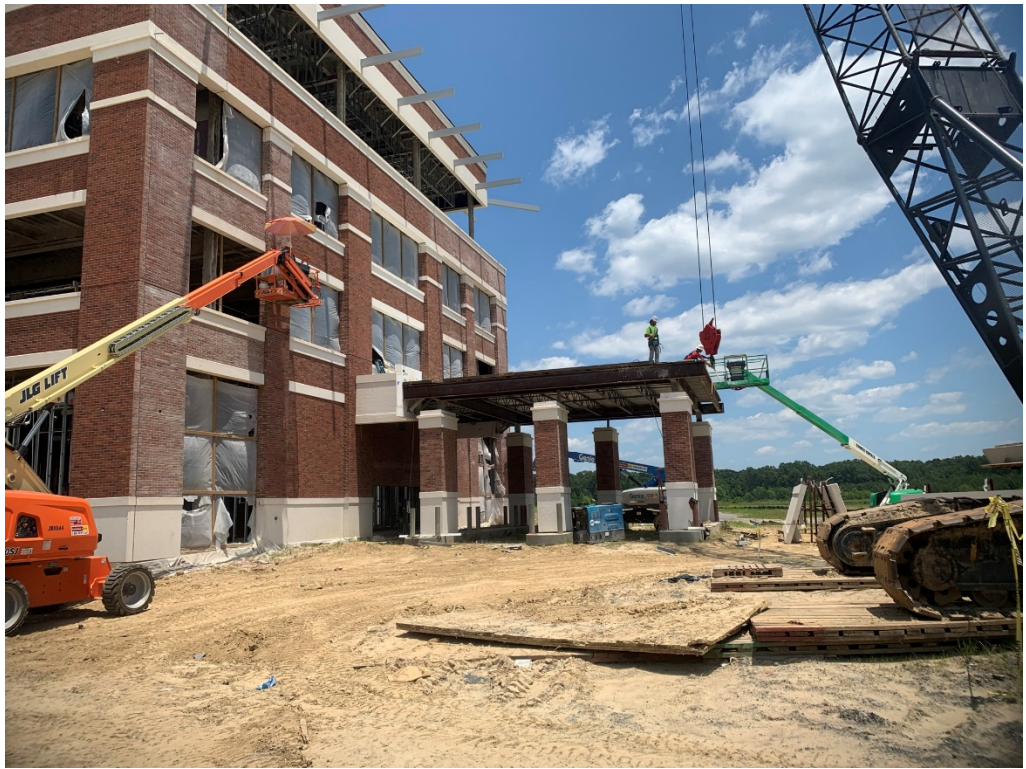
Observations On site, workers have removed the upper portion of paneling at the drive thru steel in order to brace steel according to engineers' drawings. Sealant workers were installing sealant and back rod at west façade. Concrete workers were pouring around sewer manhole at northwest corner of the site.

Figure 1 – Drive Thru Progress

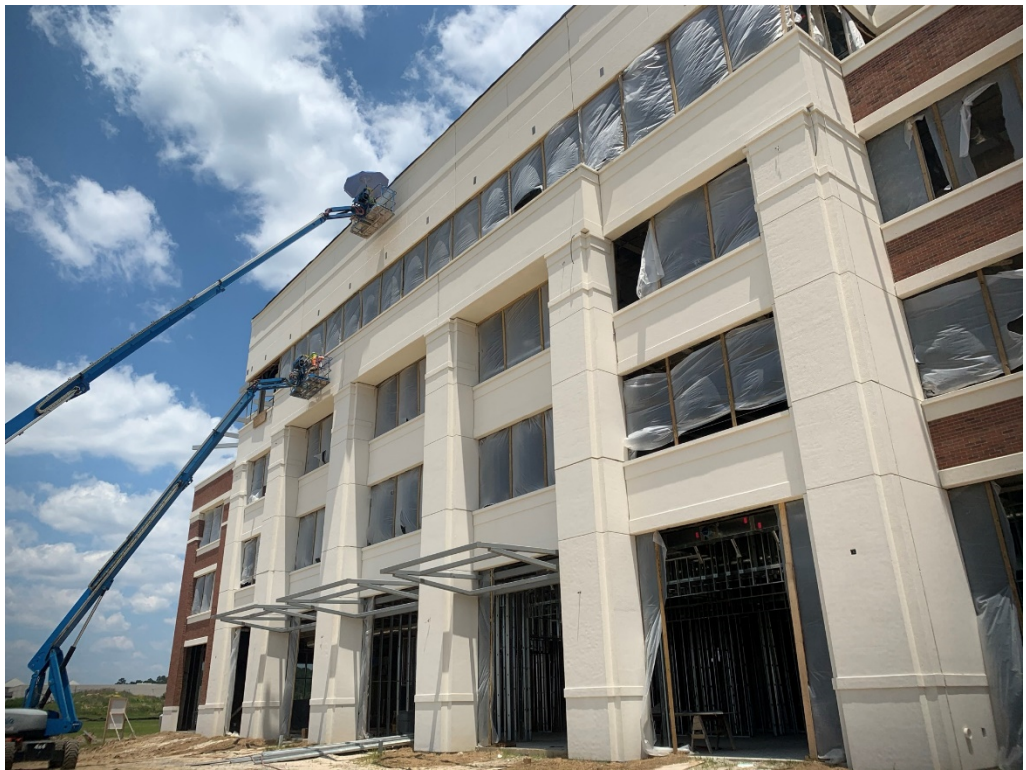
Figure 2 – Sealant Work is Ongoing

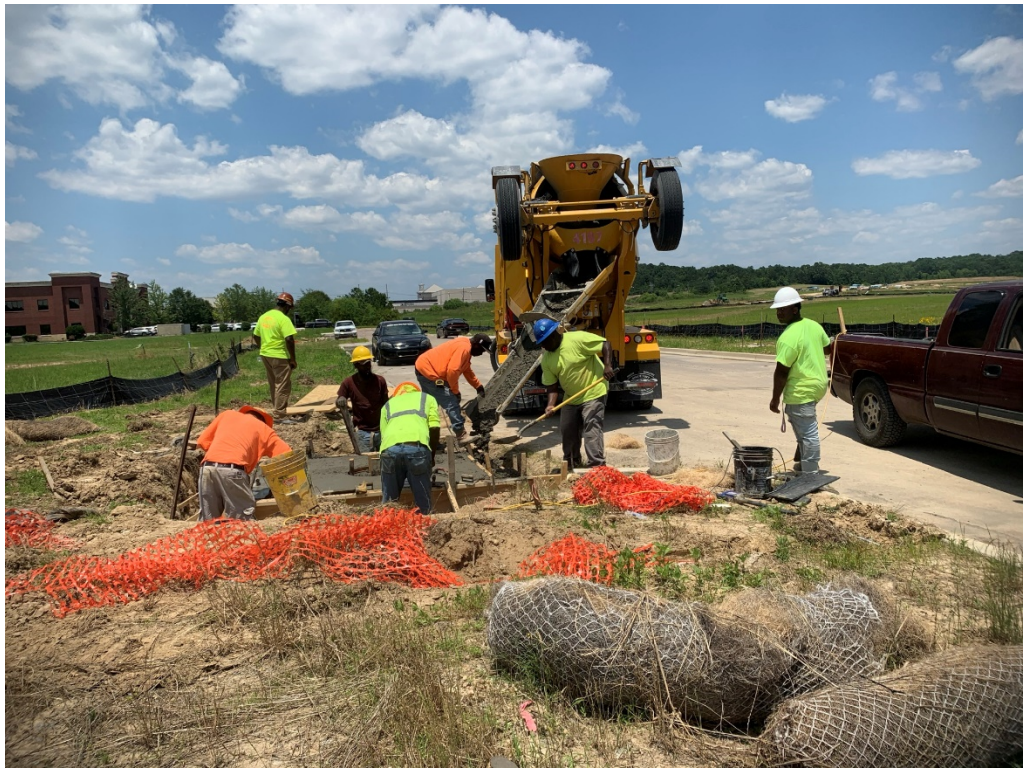
Figure 3 – Concrete Work at Site

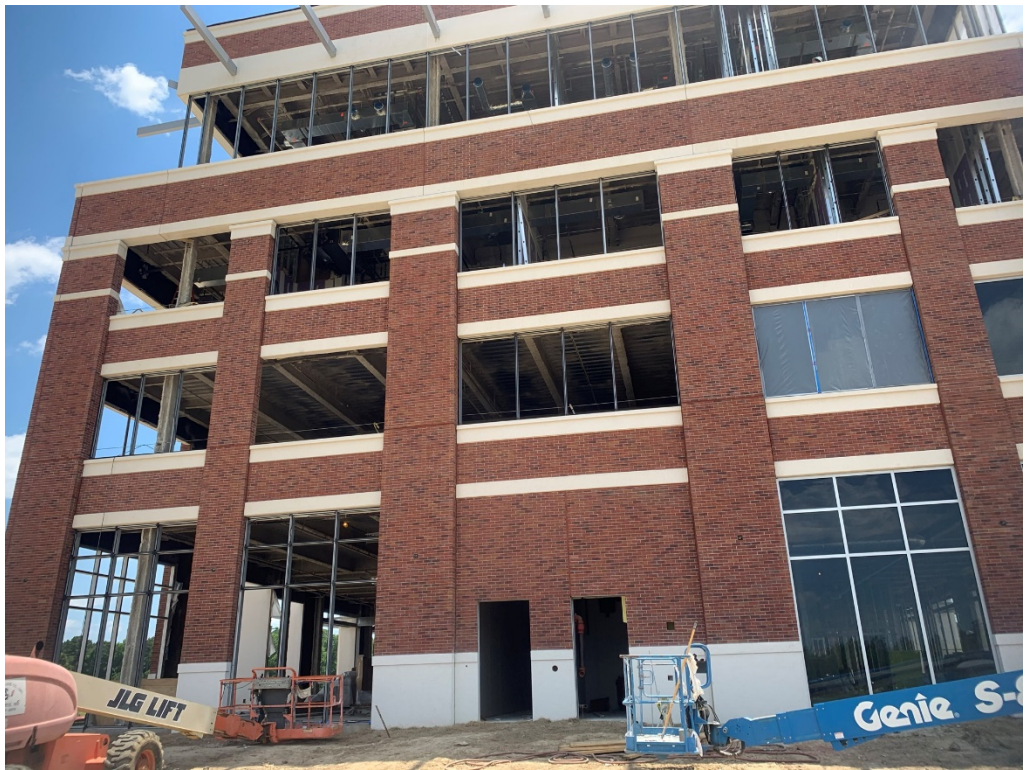
Figure 4 – North Façade Progress

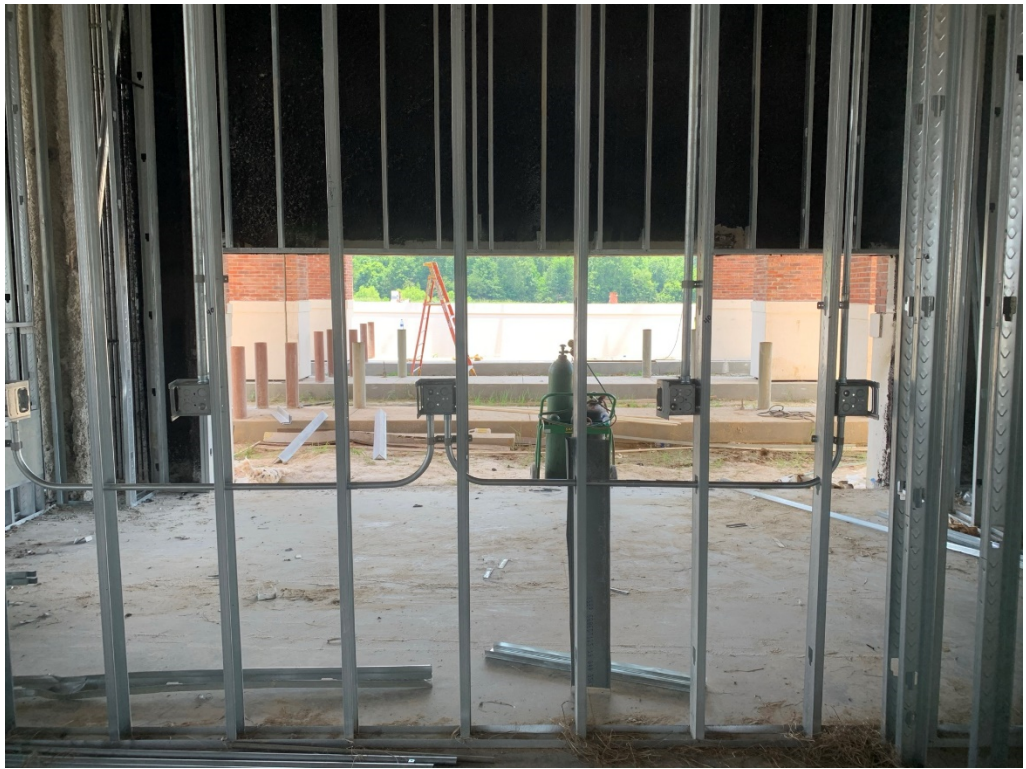
Figure 5 – Bank Window Room Progress

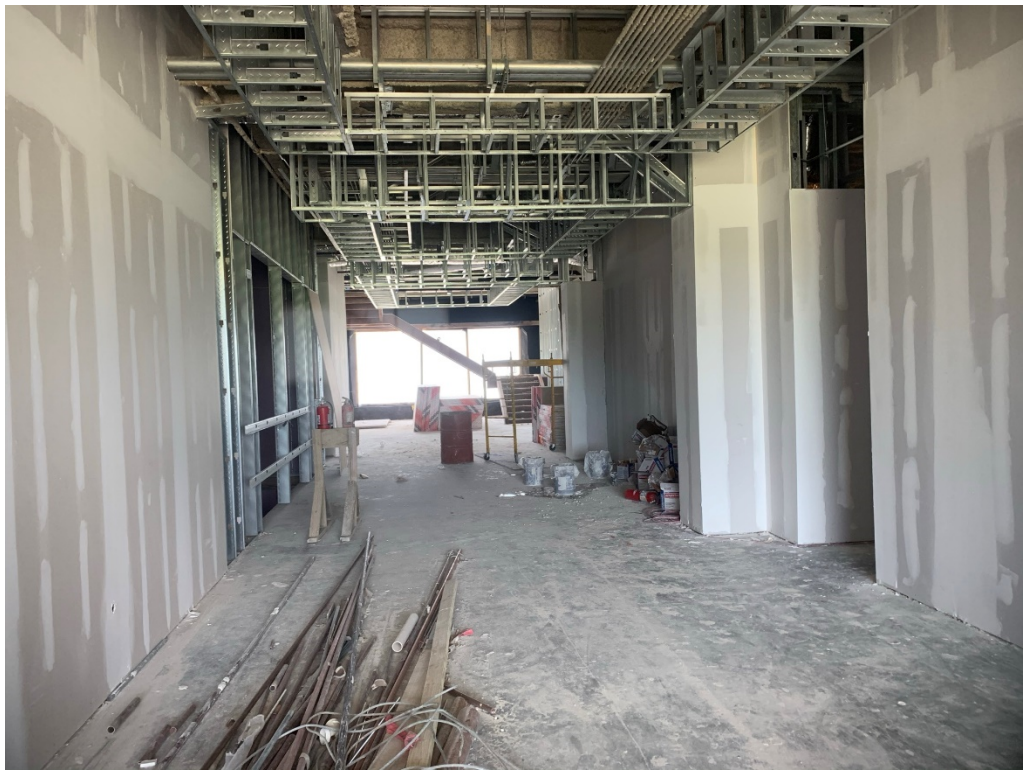
Figure 6 – Progress at 3rd Floor

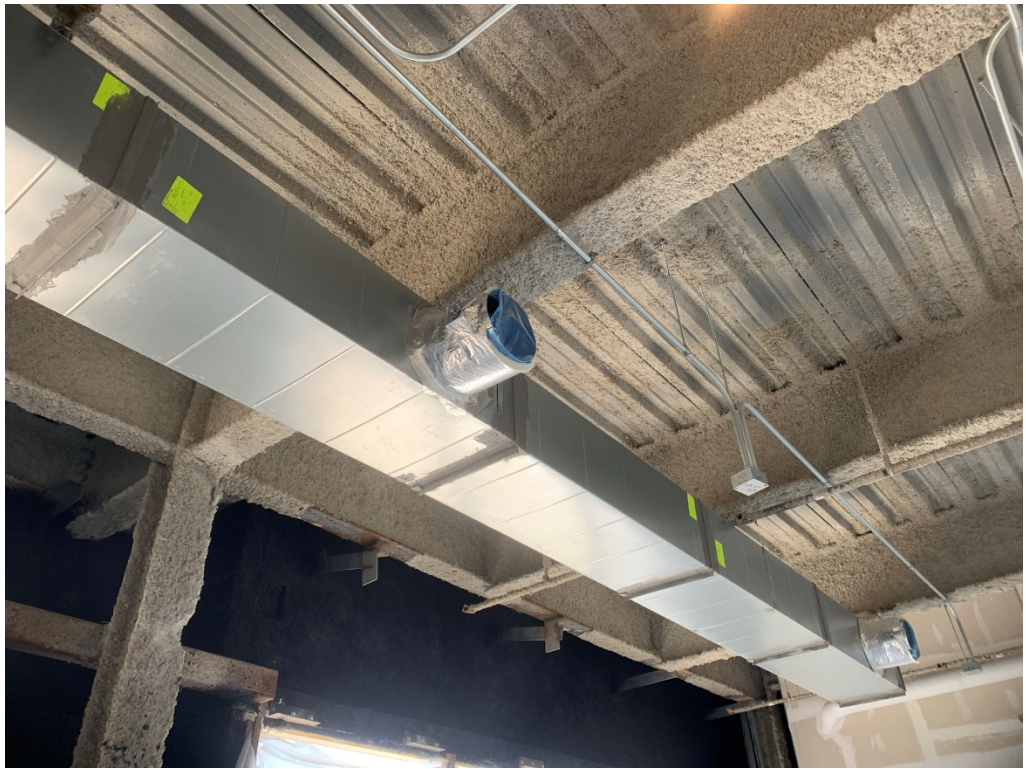
Figure 7 – Uncovered Ducting at 4th Floor

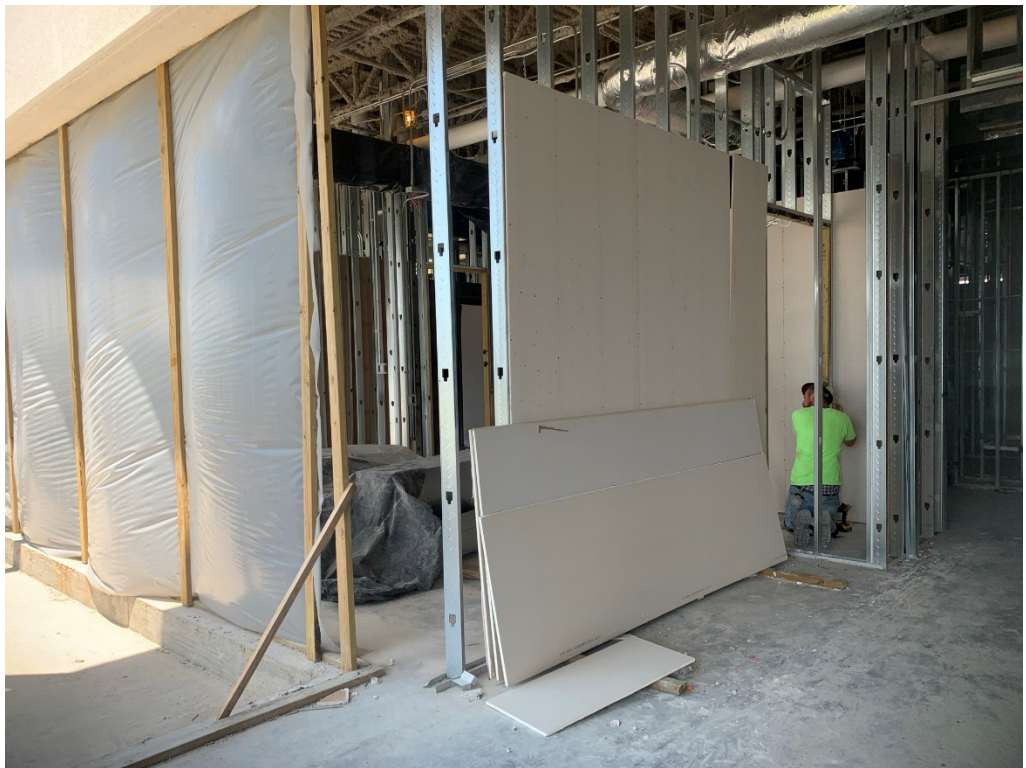
At the interior, workers were busy at the 1st and 4th floors installing framing and drywall.

Figure 8 – Drywall Installers at 4th Floor
