Architect's Field Report

22 June 2021

15094 Community Bank Headquarters

Date / Time 21 June 2021 / 1:00 PM

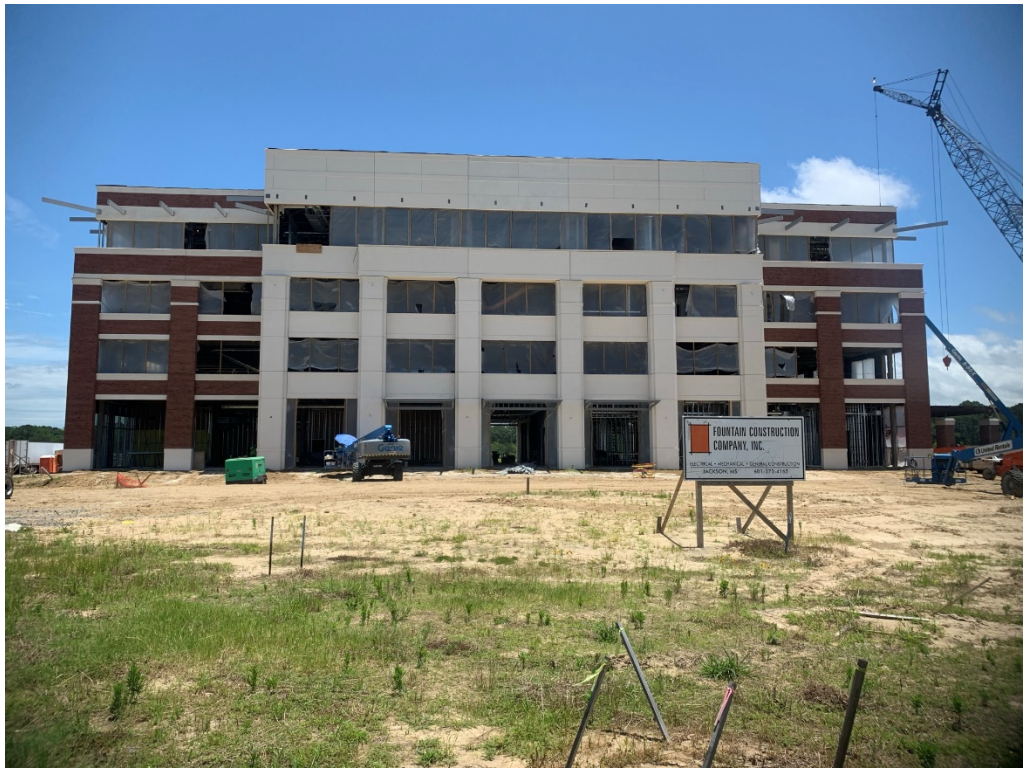
Figure 1 – West Elevation Progress

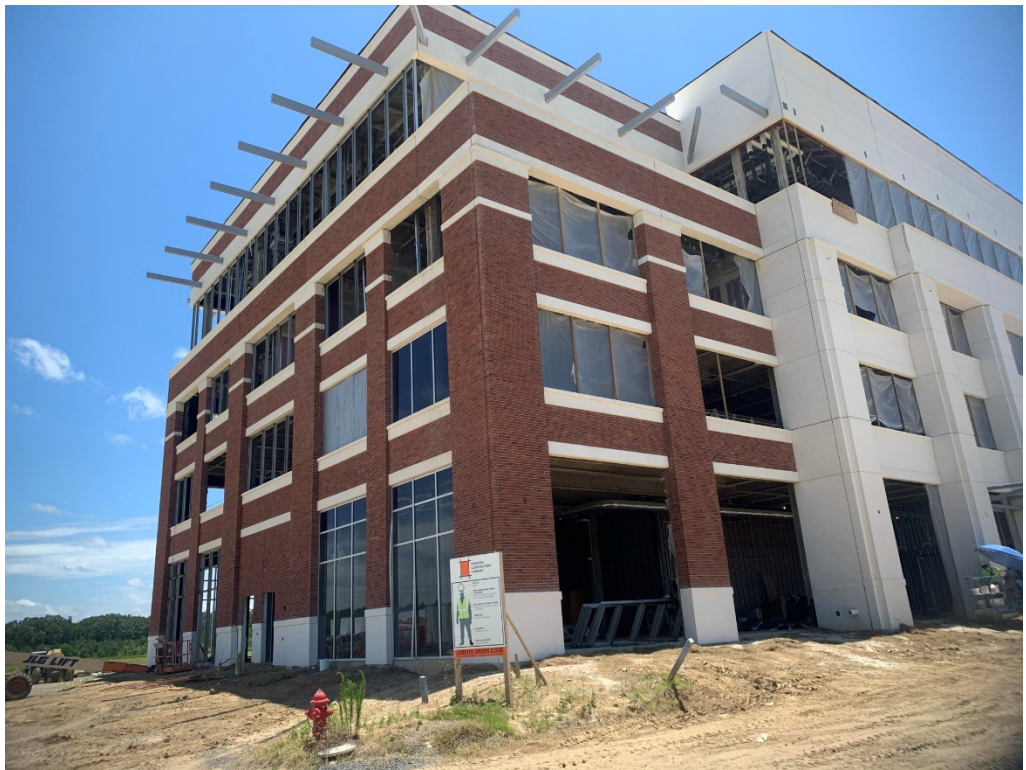
Figure 2 – Ongoing Work at North Façade

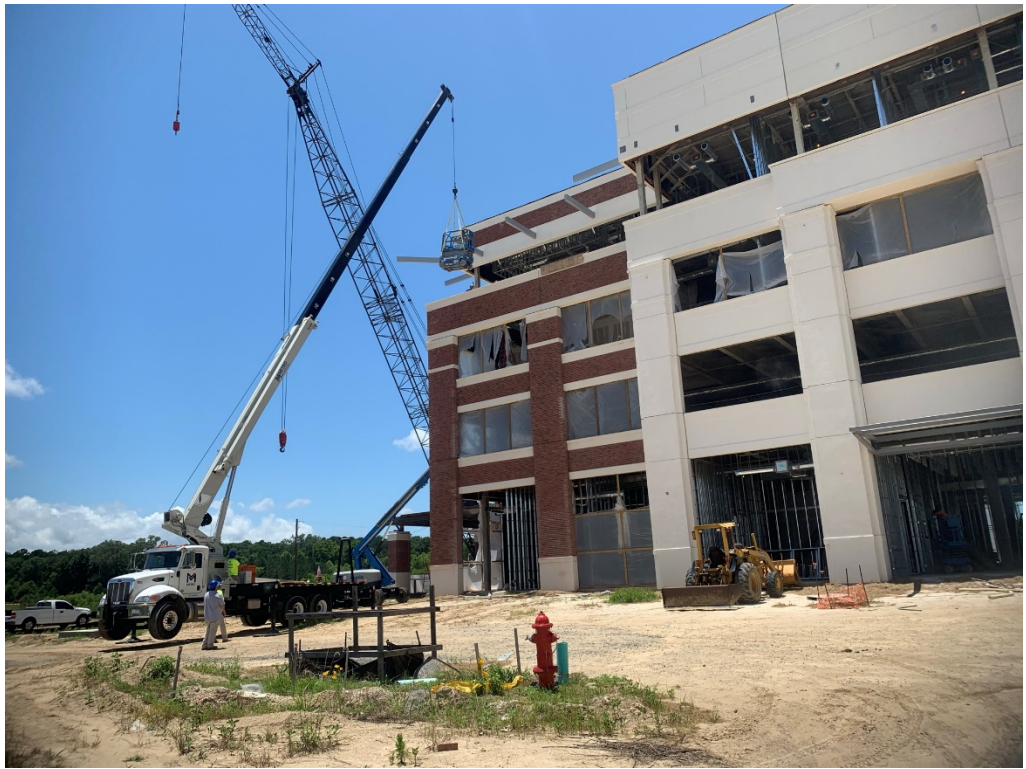
Figure 3 – Mechanical Installer De-Mobilizing

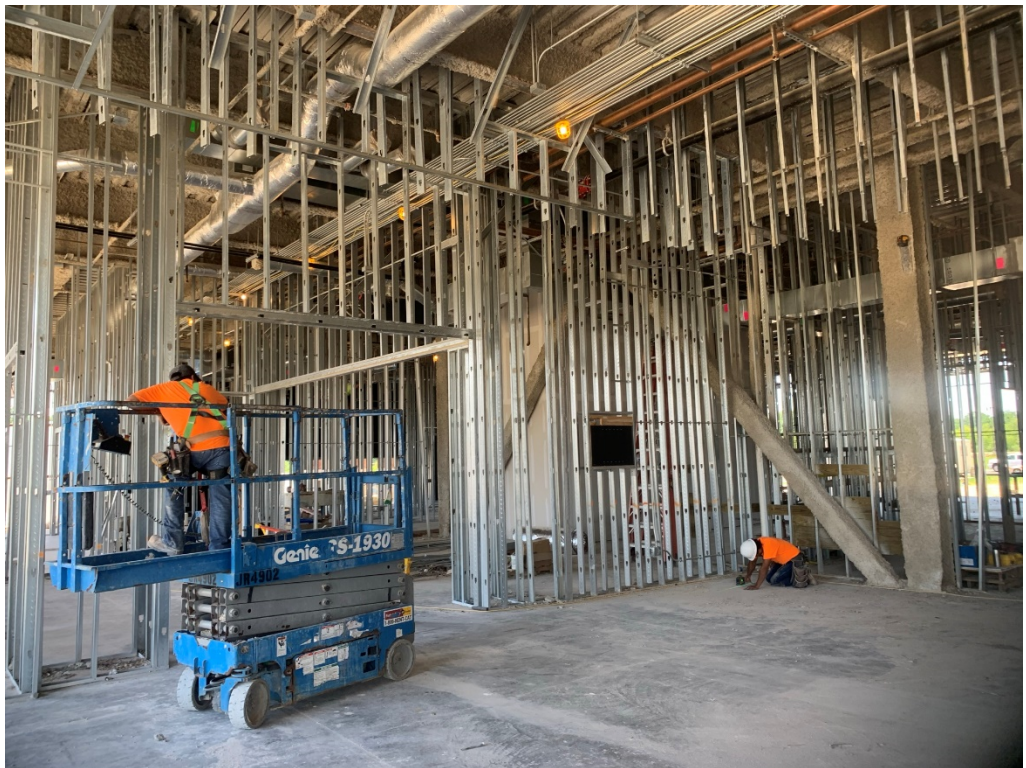
At the first floor, framers were working on furr downs. Welders were on the fourth floor adding to a carriage beam as required per recent design change at banquet hall.

Figure 4 – First Floor Framing is Ongoing

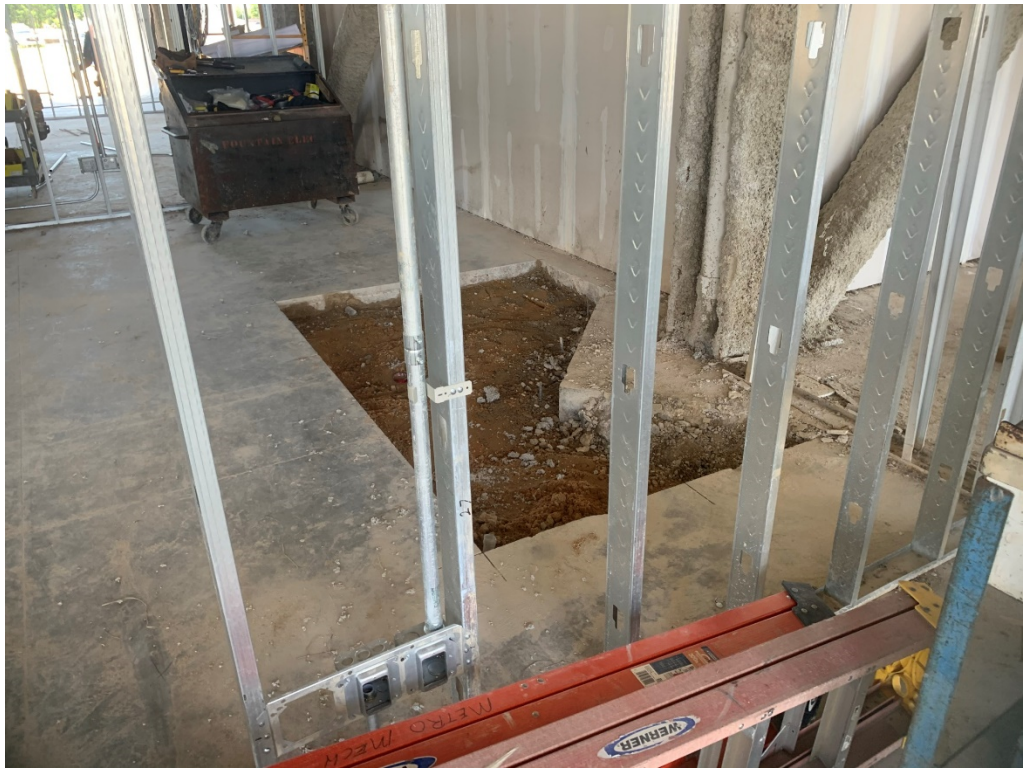
Figure 5 – Excavation Area Cleaned Up

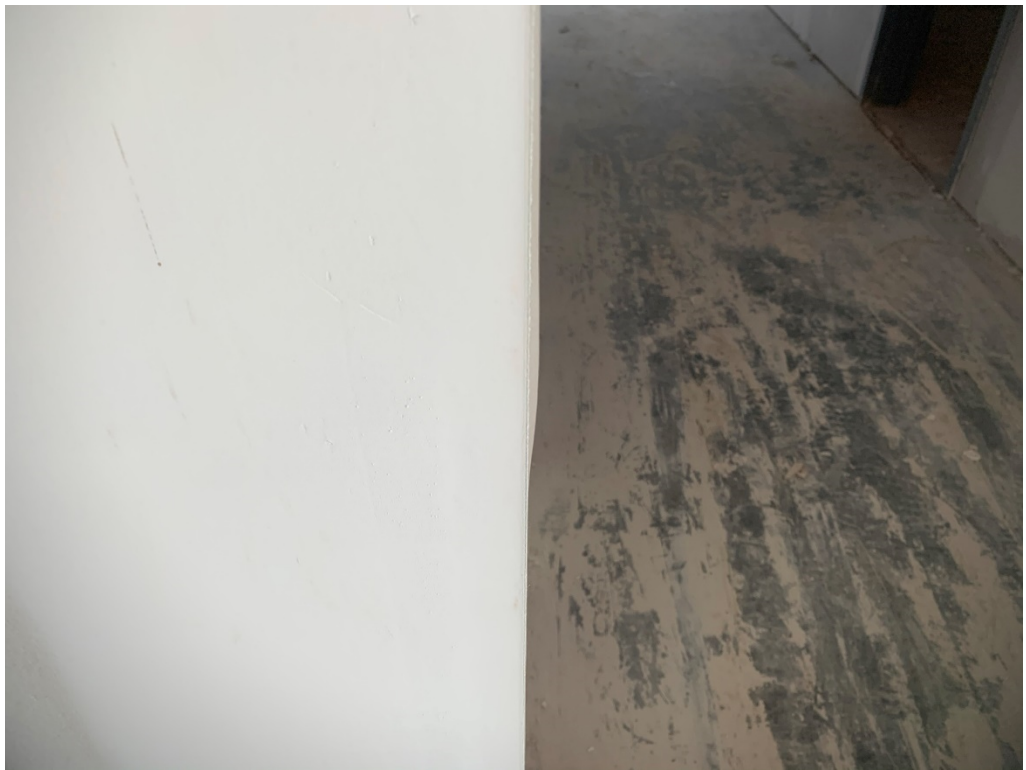
Figure 6 – Pay Special Attention to Corners for flatness and mud build up throughout

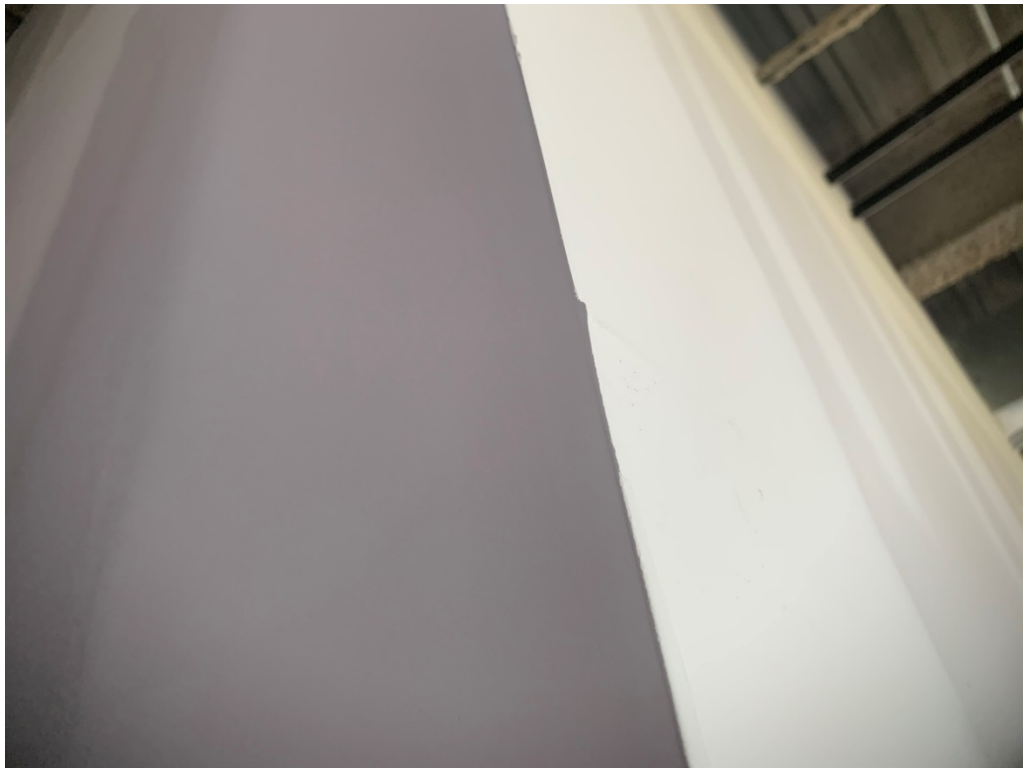
Figure 7 – Pay Special Attention to Corners for flatness and mud build up throughout

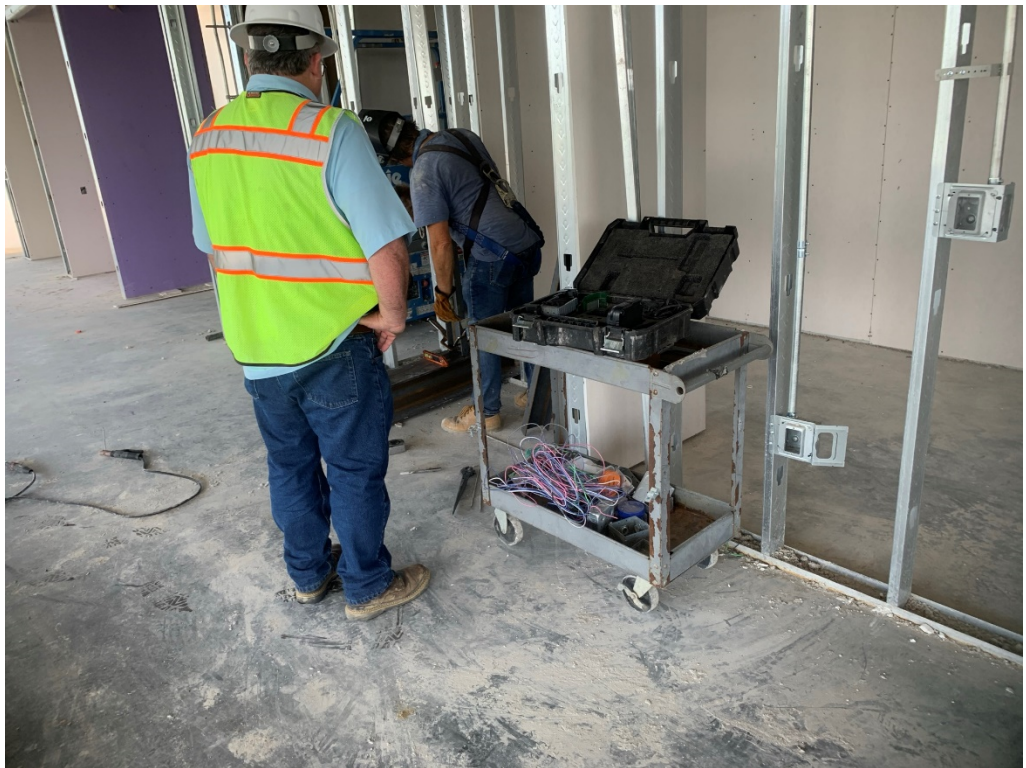
Figure 8 – Extended Steel Required for Redraw at Banquet
