Architect's Field Report

15094 Community Bank Headquarters

28 June 2021

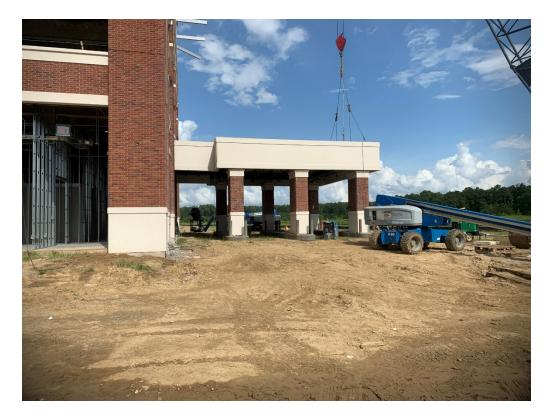
Figure 1 – Drive Thru Progress

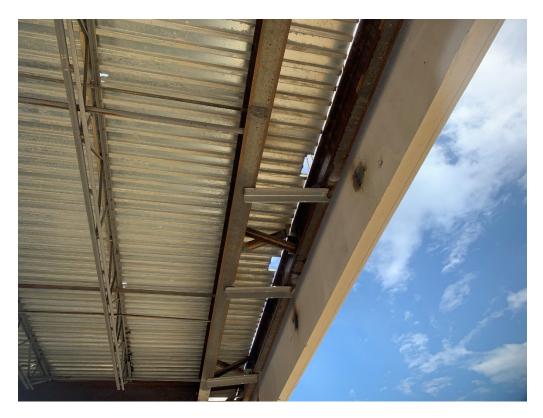
Figure 2 – Bracing at Drive Thru Panel

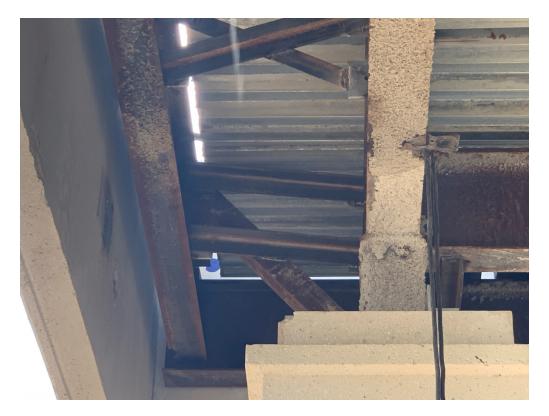
Figure 3 – Bracing at Drive Thru Panel

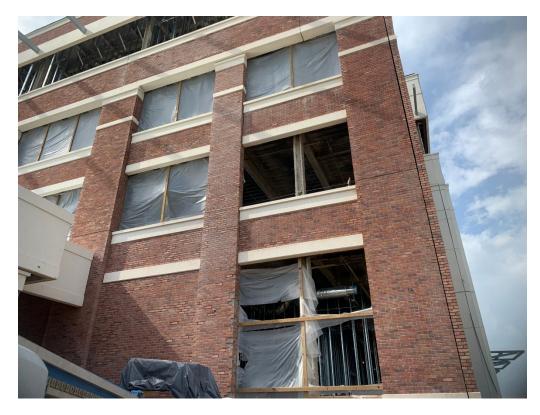
Figure 4 – Masonry work at the South Elevation is Ongoing

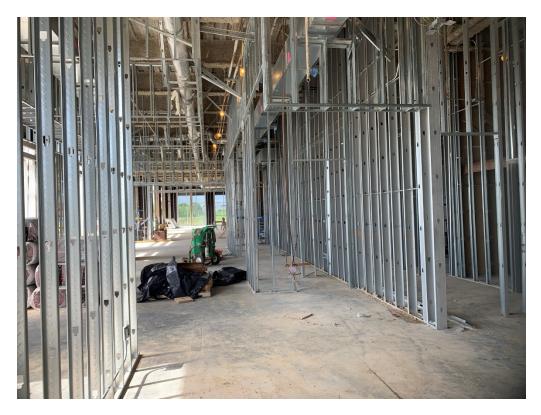
Figure 5 – Framing Progress at the First Floor

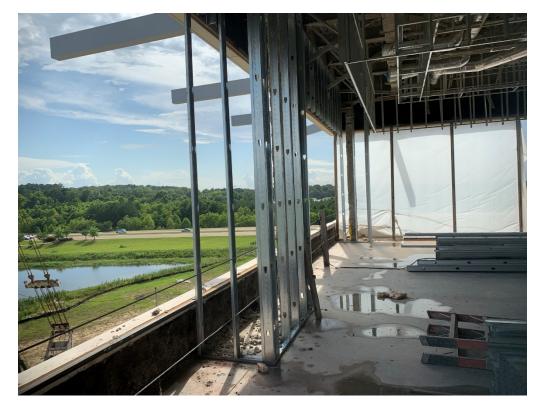
Figure 6 – Framing at the 4th Floor

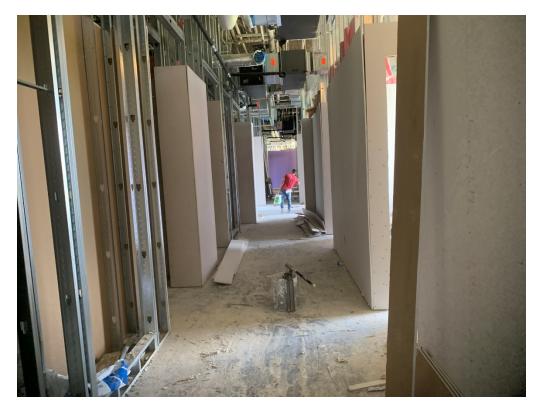
Figure 7 – Framing, Insulation, & Drywall Ongoing at the 4th Floor

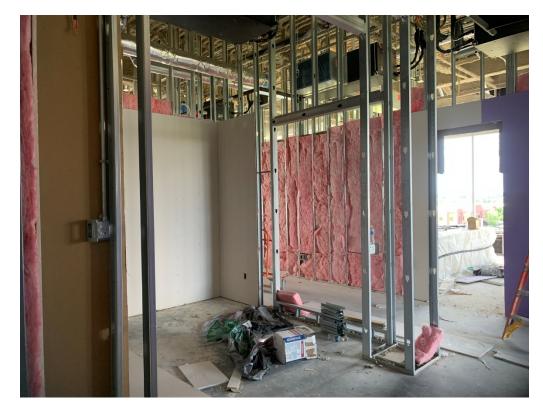
Figure 8 – Framing, Insulation, & Drywall Ongoing at the $4^{th}\,\text{Floor}$

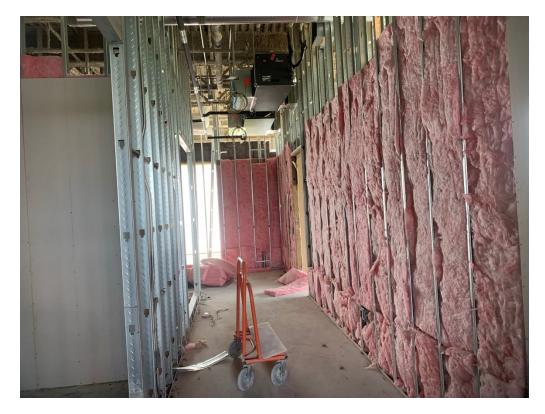
Figure 9 – Framing, Insulation, & Drywall Ongoing at the $4^{th}\,\text{Floor}$

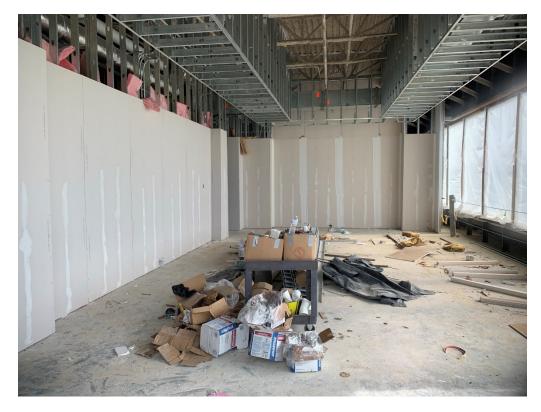
Figure 10 – Drywall Progress at 4th Floor
