Architect's Field Report

1 July 2021

15094 Community Bank Headquarters / Report Number 014

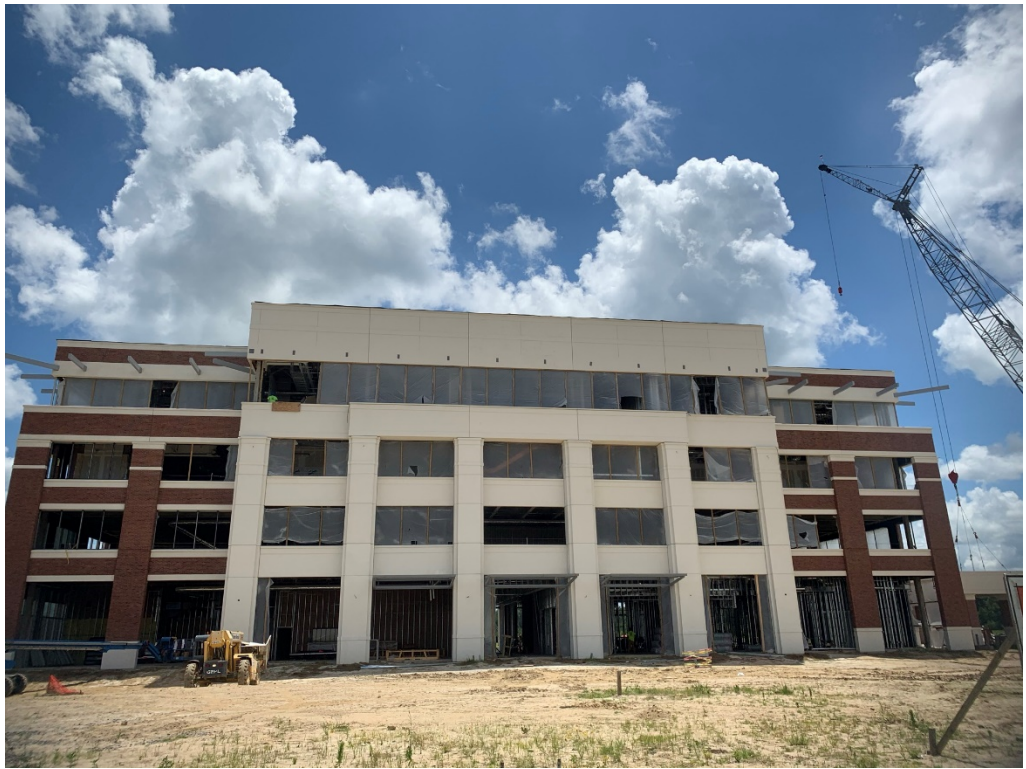
Figure 1 – Front Façade Progress on the 28th

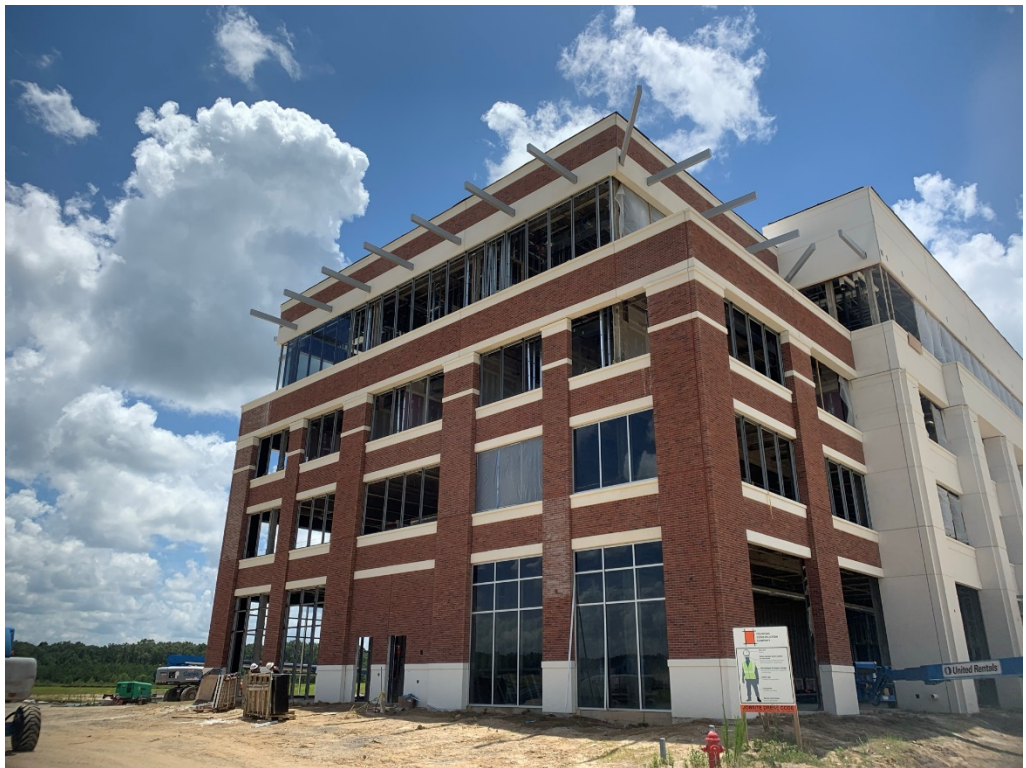
Figure 2 – North Façade Progress

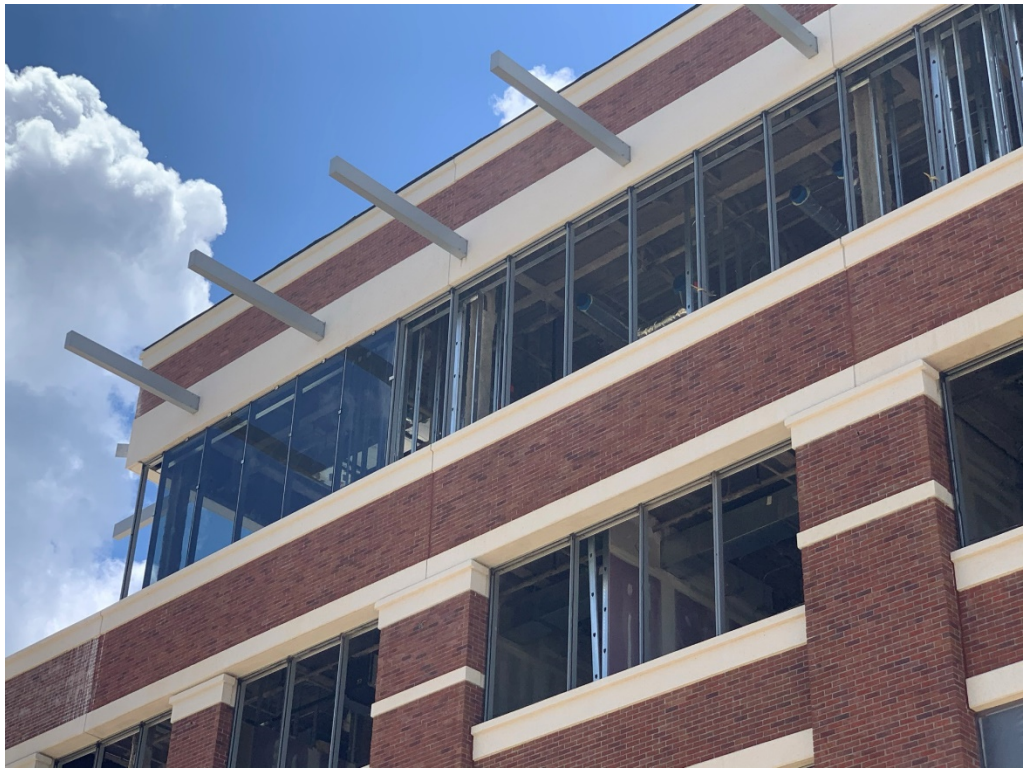
Figure 3 – Glazing Installation at 4th Floor

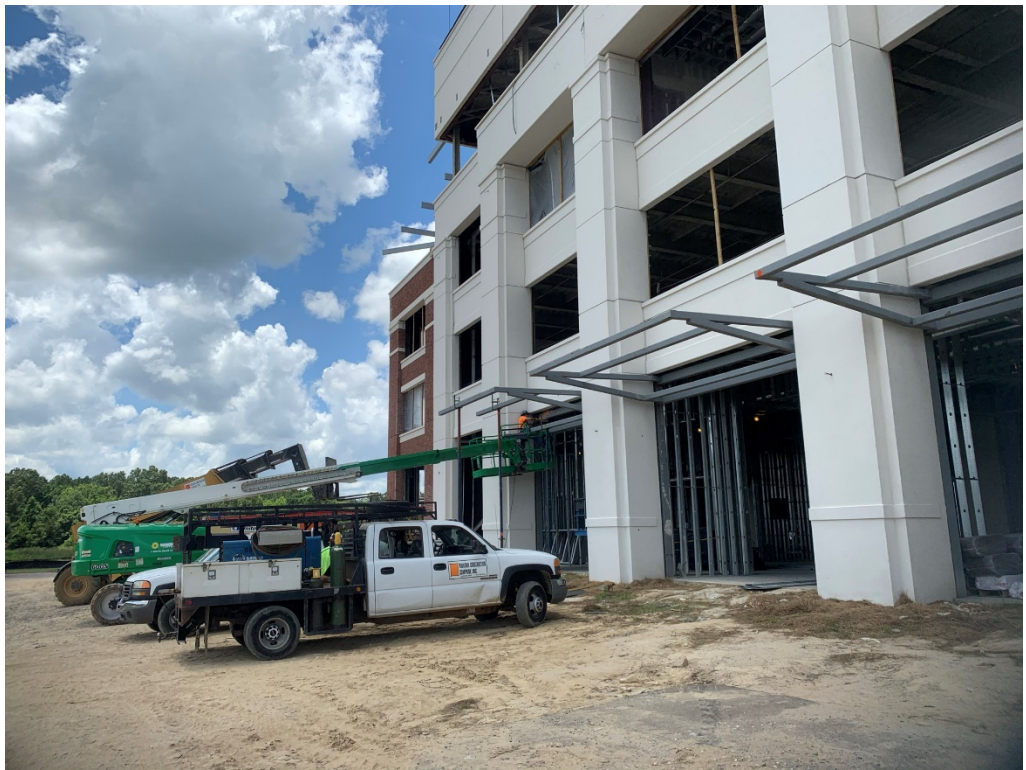
Figure 4 – Canopy Steel Rework

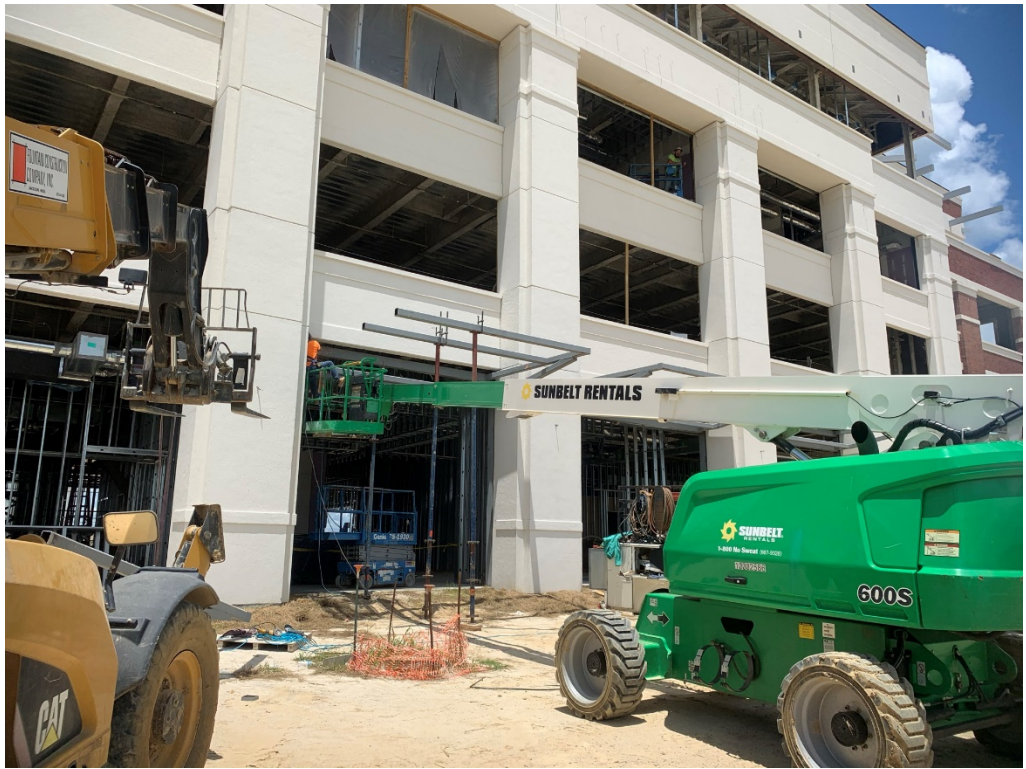
Figure 5 – Canopy Steel Rework

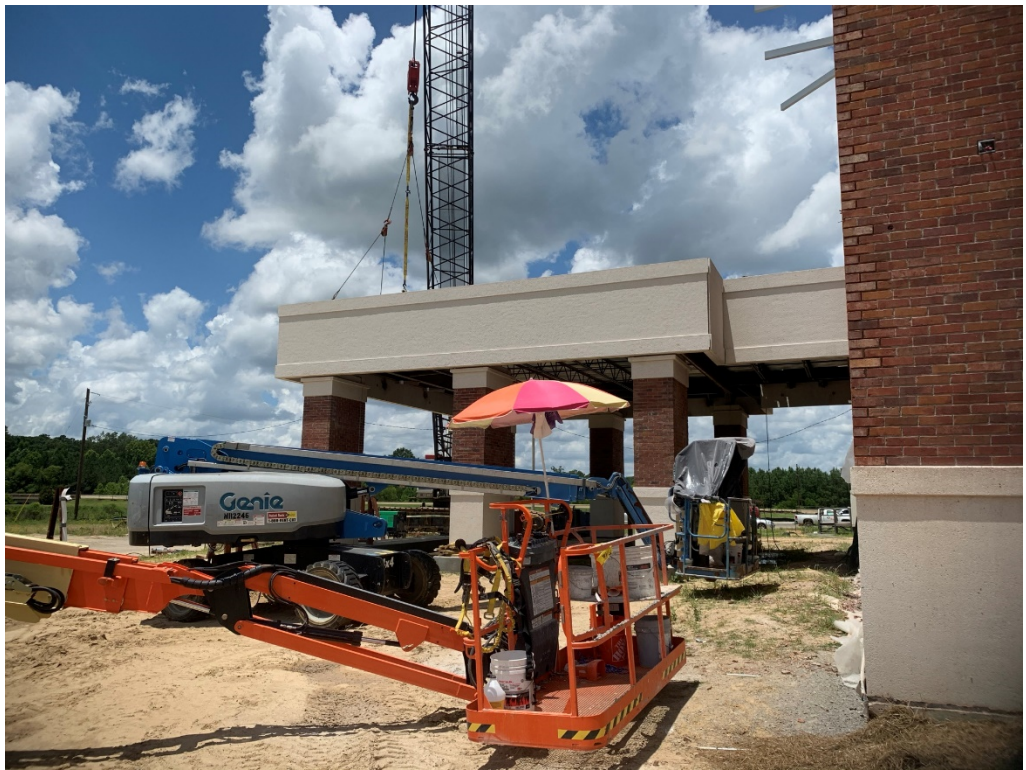
Figure 6 – Drive Thru Progress

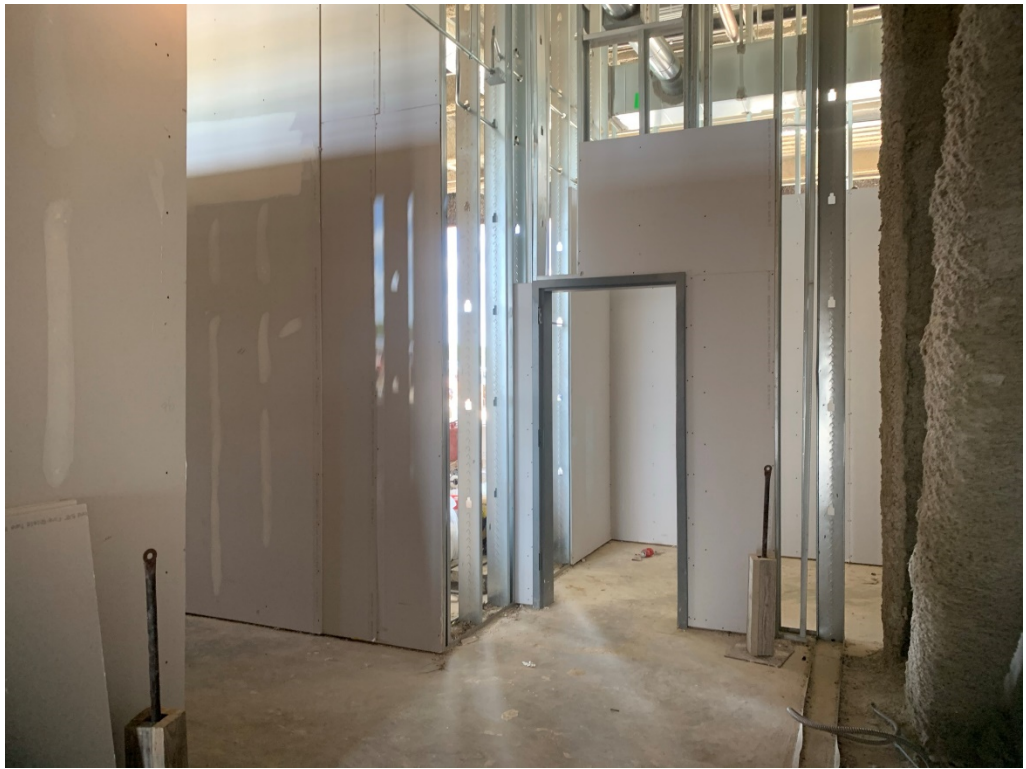
Figure 7 – Drywall Installation is Ongoing at the 4th Floor

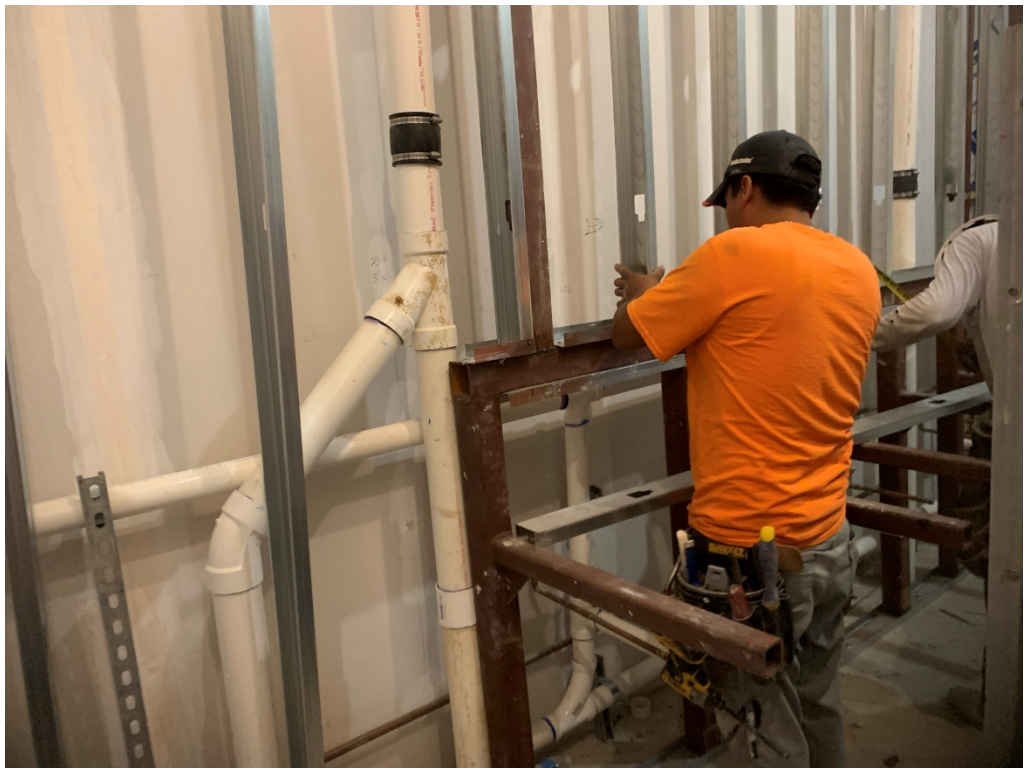
Figure 8 – Framing Work Behind Carriers at 4005

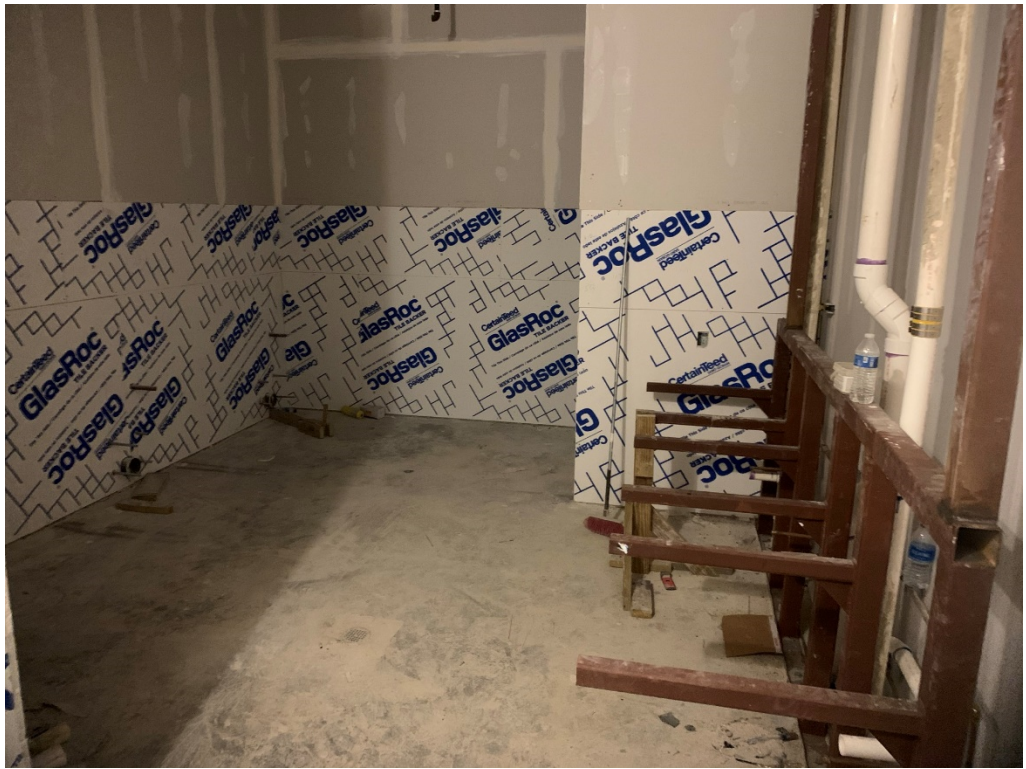
Figure 9 – Carriers installed at 4004

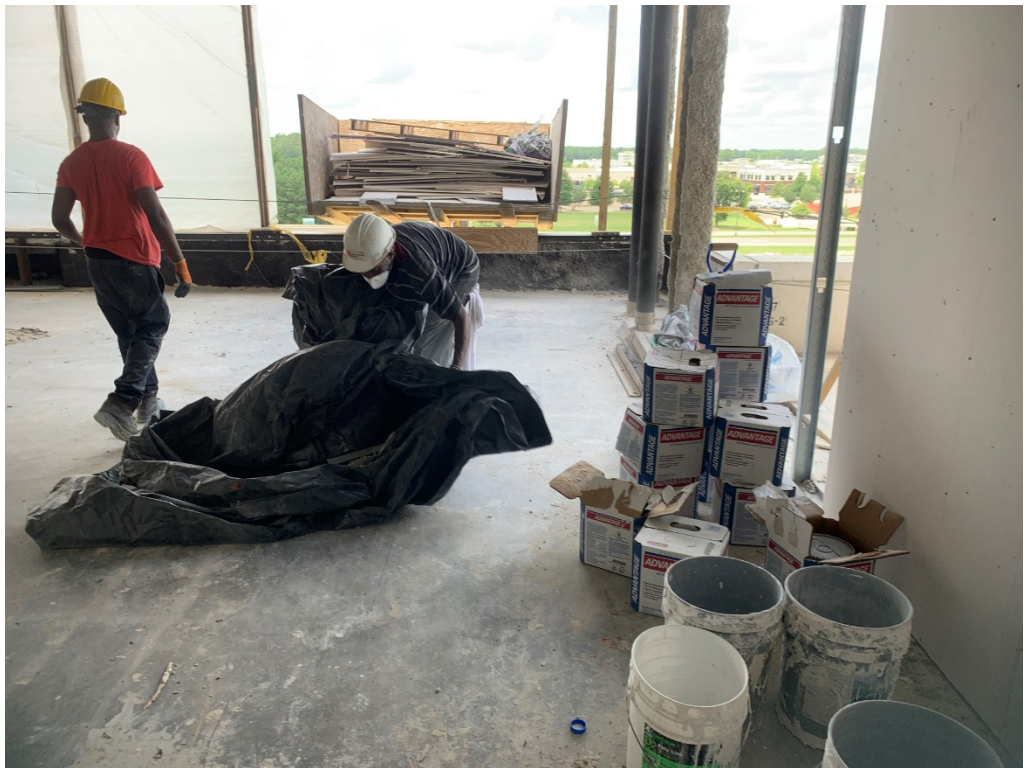
Figure 10 – Continued Debris Removal at 4th Floor

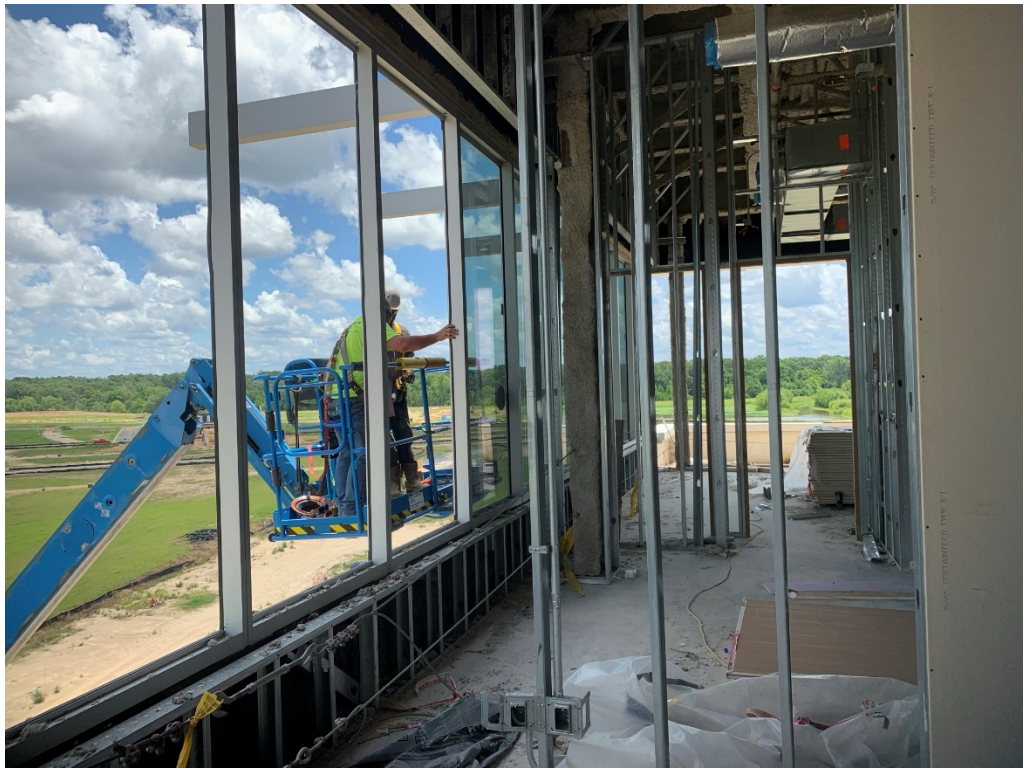
Figure 11 – Glazing Installation at 4th Floor

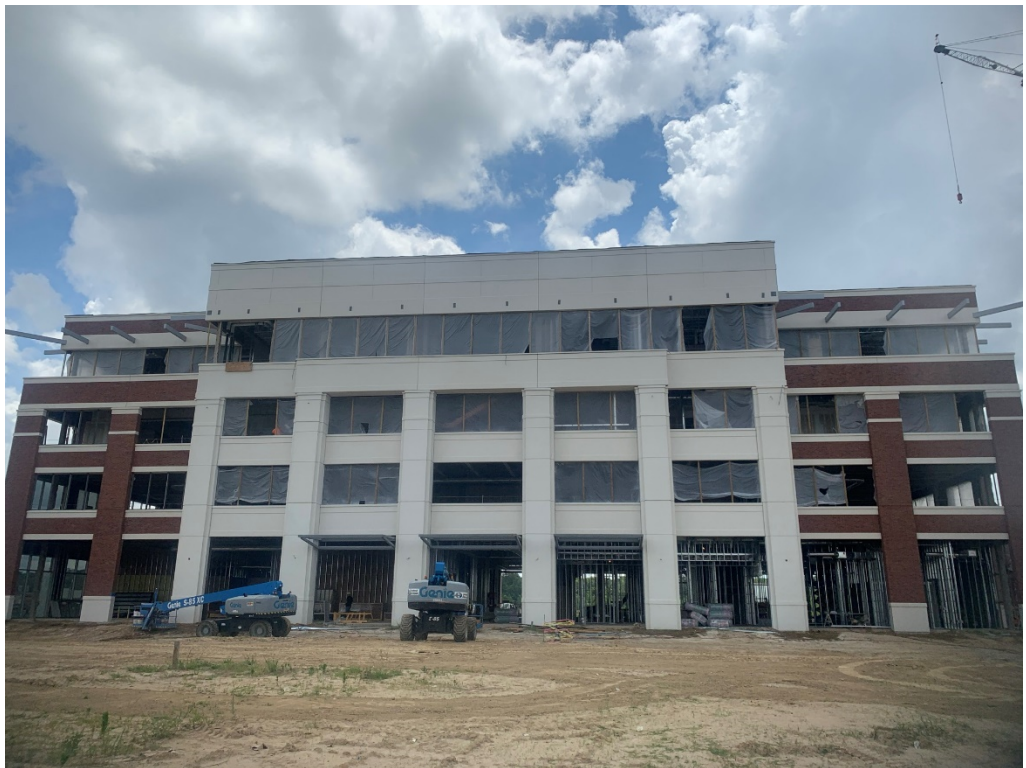
Figure 12 – Progress at Front Façade on the 1st

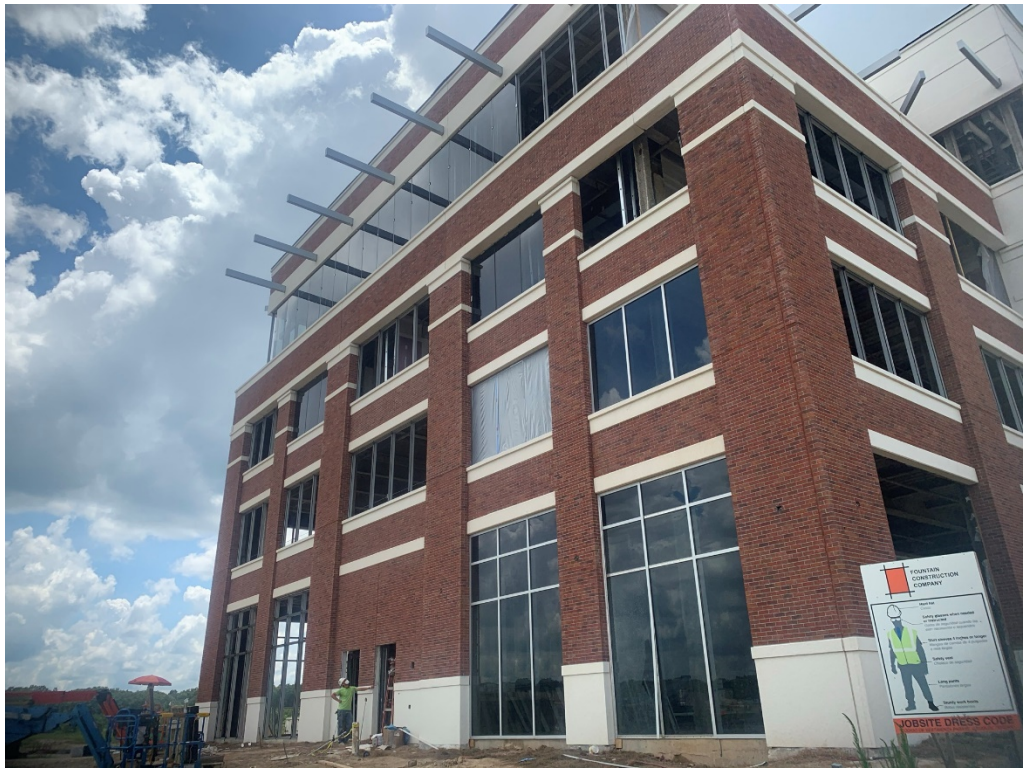
Figure 13 – Glazing Progress at North Facade

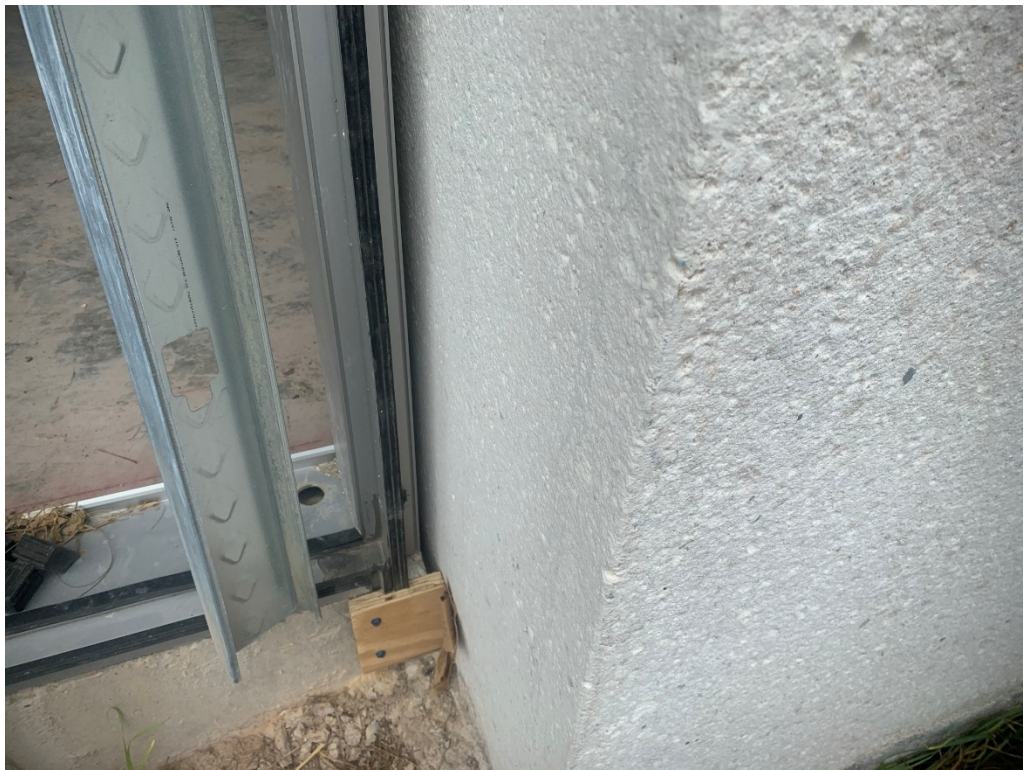
Figure 14 – Typical Gaps between curtain Wall and Panels (per manufacturer joints between $\frac{1}{2}$ " to 1" require $\frac{1}{2}$ " depth of sealant; over 1" require regional service consultation)

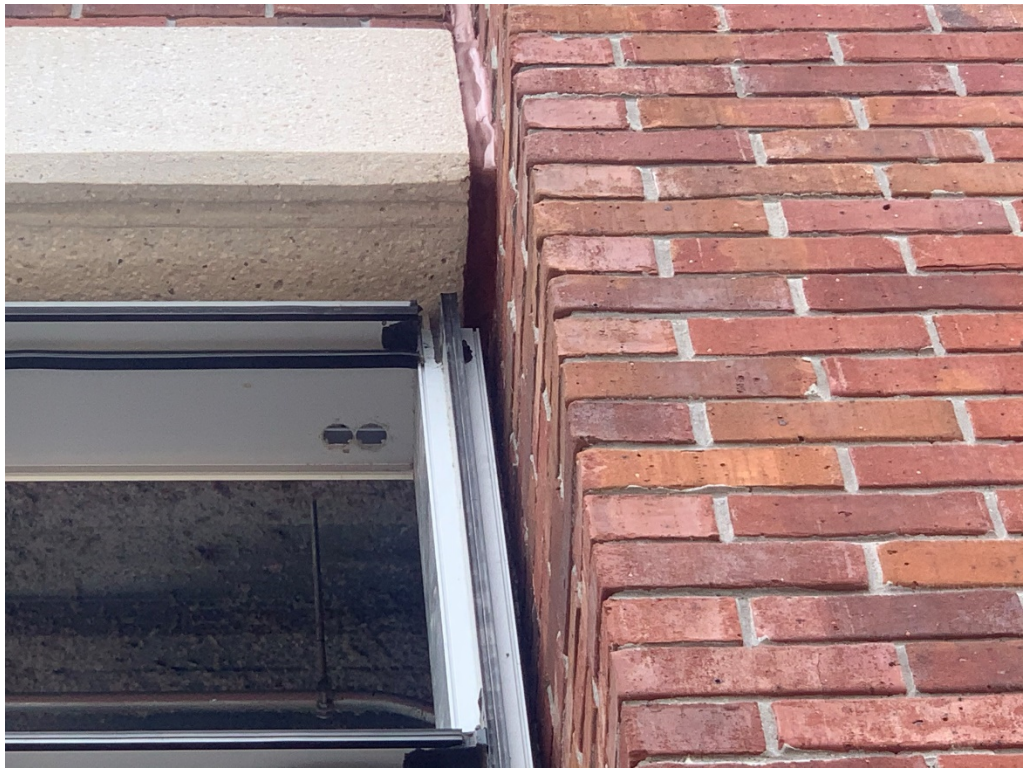
Figure 15 – Typical Gaps between curtain Wall and Panels (per manufacturer joints between ½" to 1" require ½" depth of sealant; over 1" require regional service consultation)

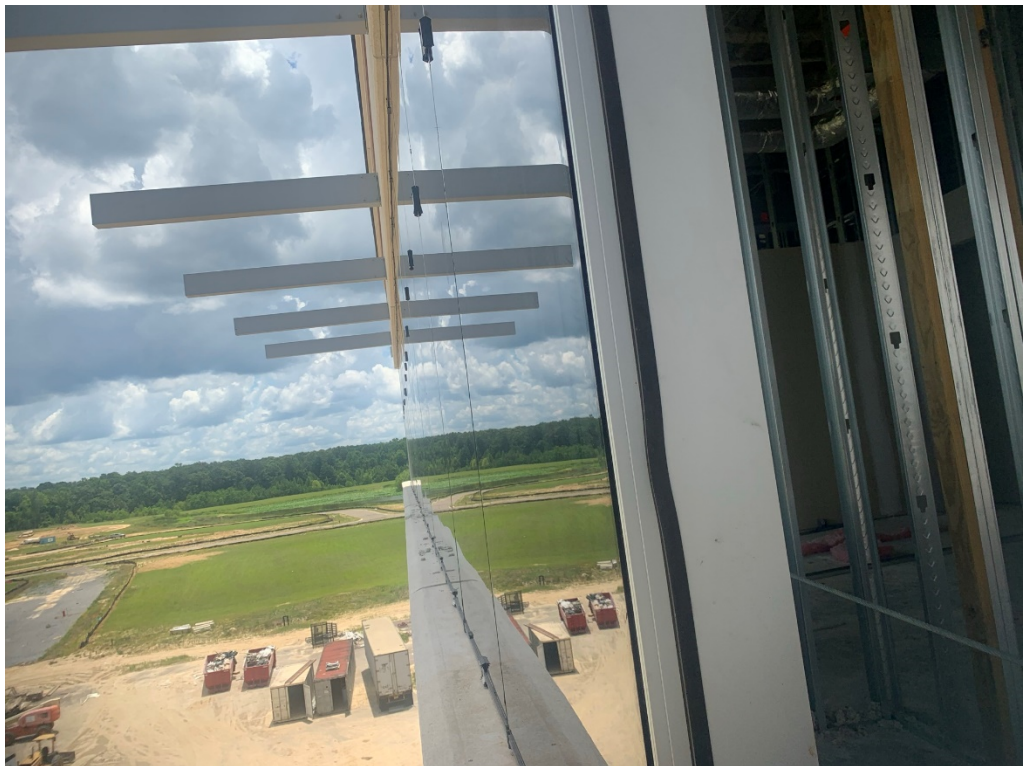
Figure 16 – Additional Glass Installed Since Monday
