Architect's Field Report

6 July 2021

15094 Community Bank Headquarters / Report Number 015

Date / Time 28 June 2021 / 12:30 PM

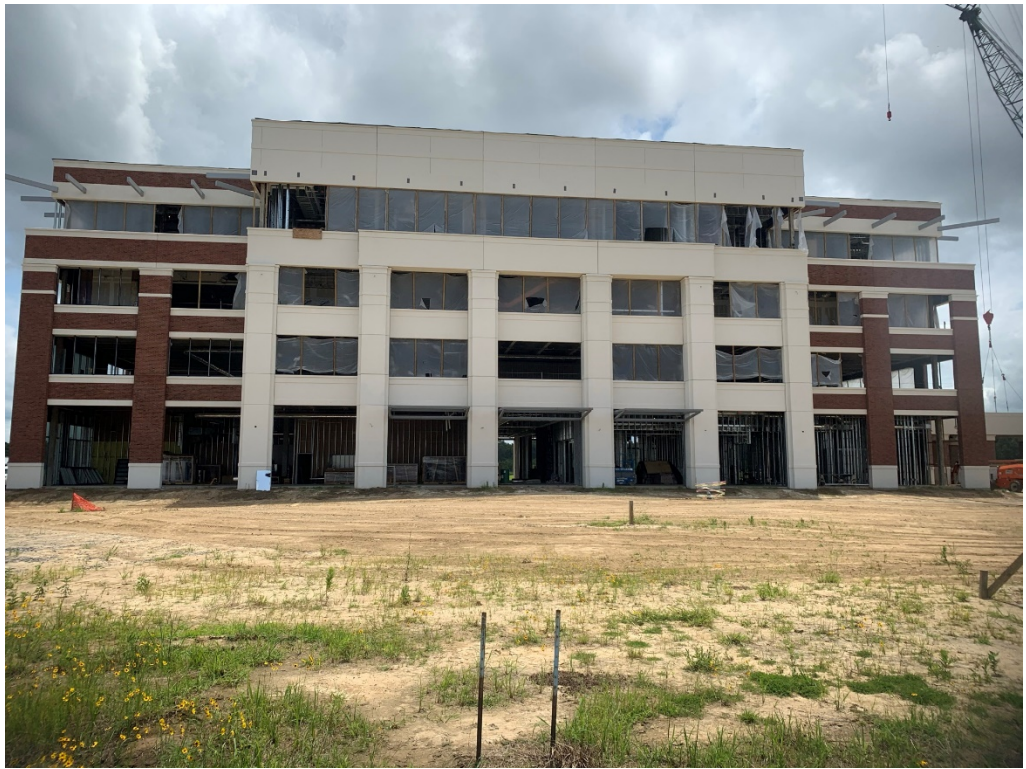
Figure 1 – Front Façade Progress

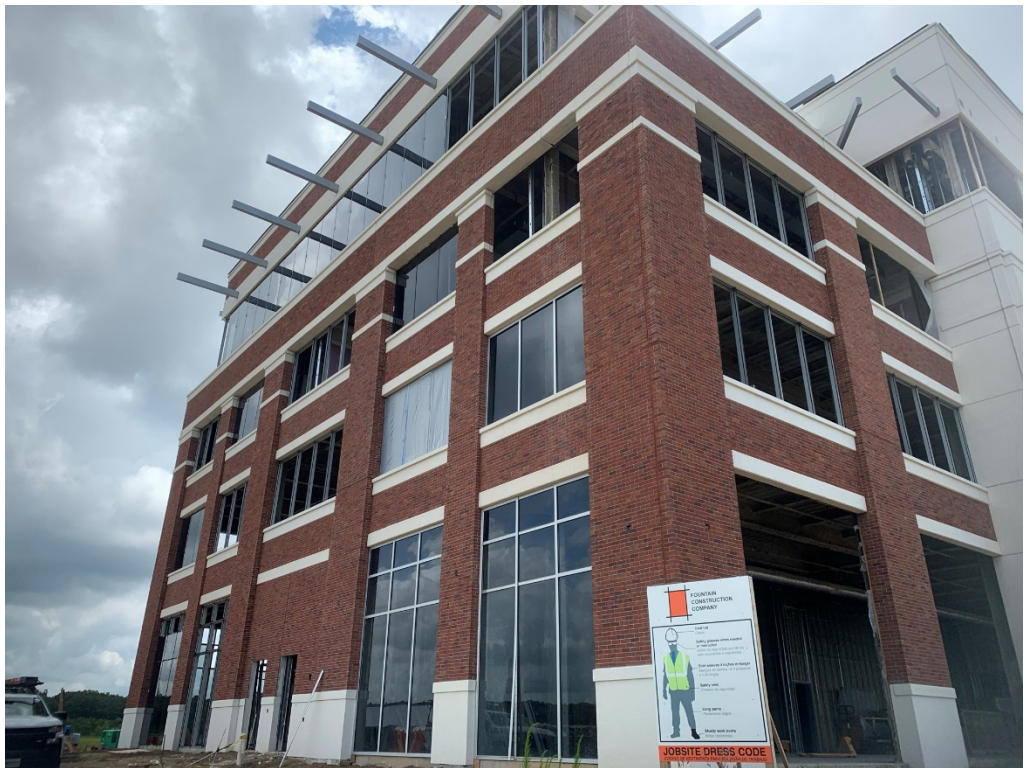
Observations At the north Façade, some progress has been made at glazing. Glass is about 60% installed.

Progress on the North façade is slow; it appears to me that a lack of personnel is the main issue as when I've seen people on site, things do get accomplished, however, I am not seeing many on site. I know you're doing your best to push subs, and please continue to do so.

Figure 2 – Glazing Progress at North Facade

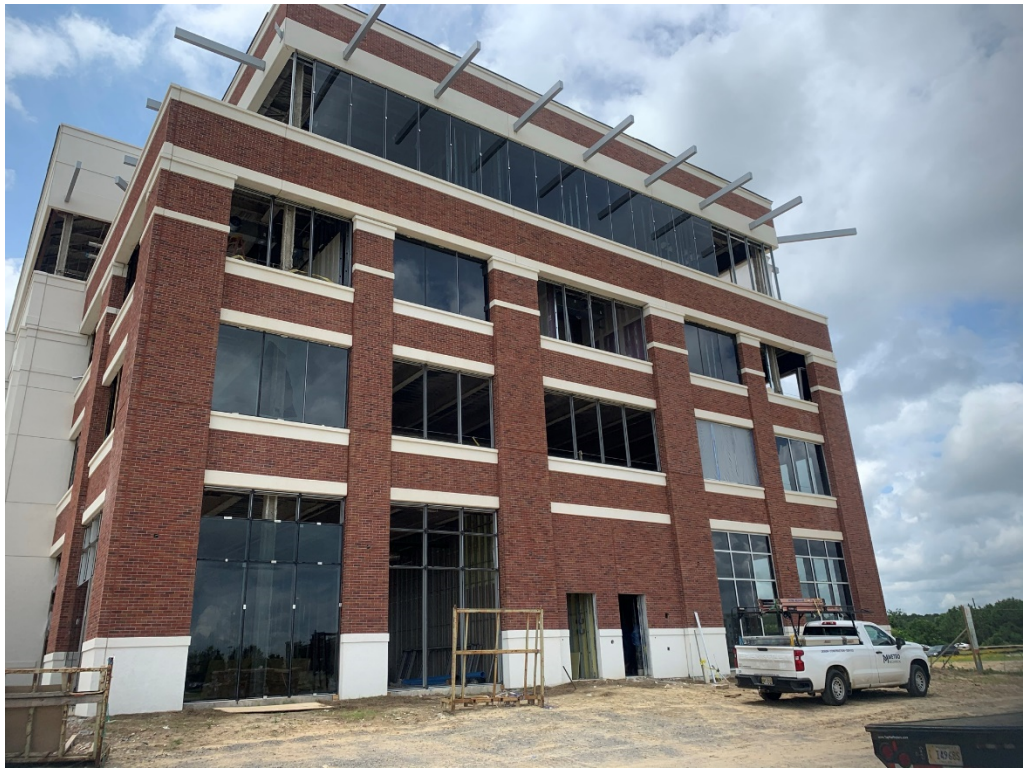
Figure 3 – Glazing Progress at North Facade

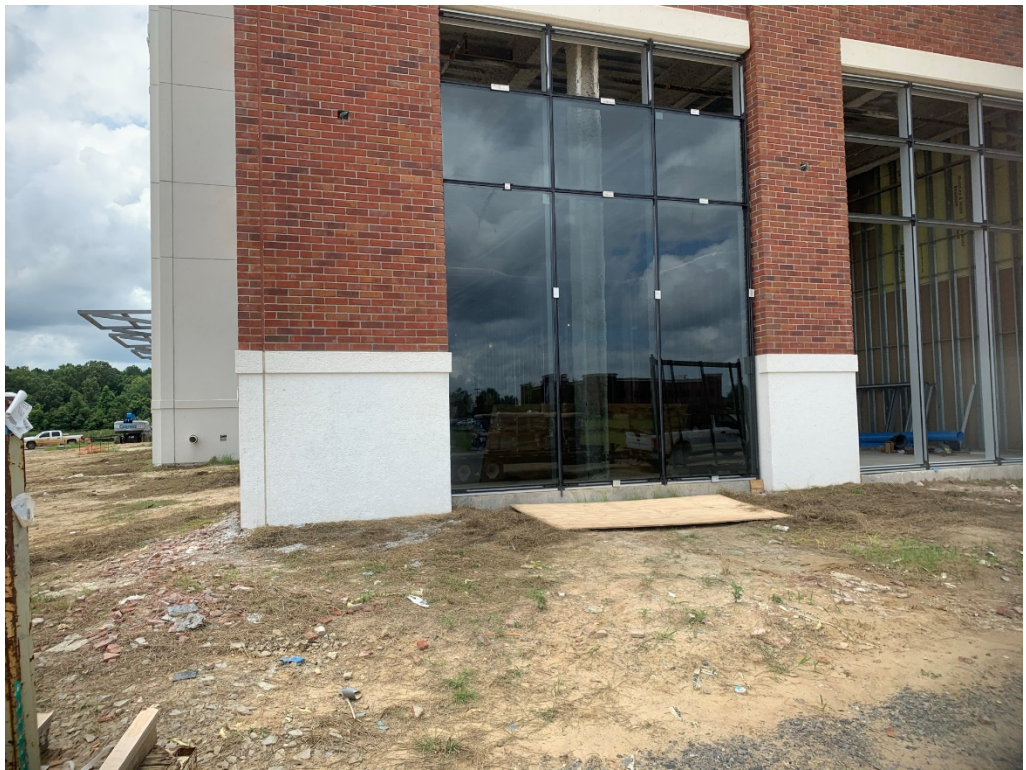
Figure 4 – NE Patch looks much better

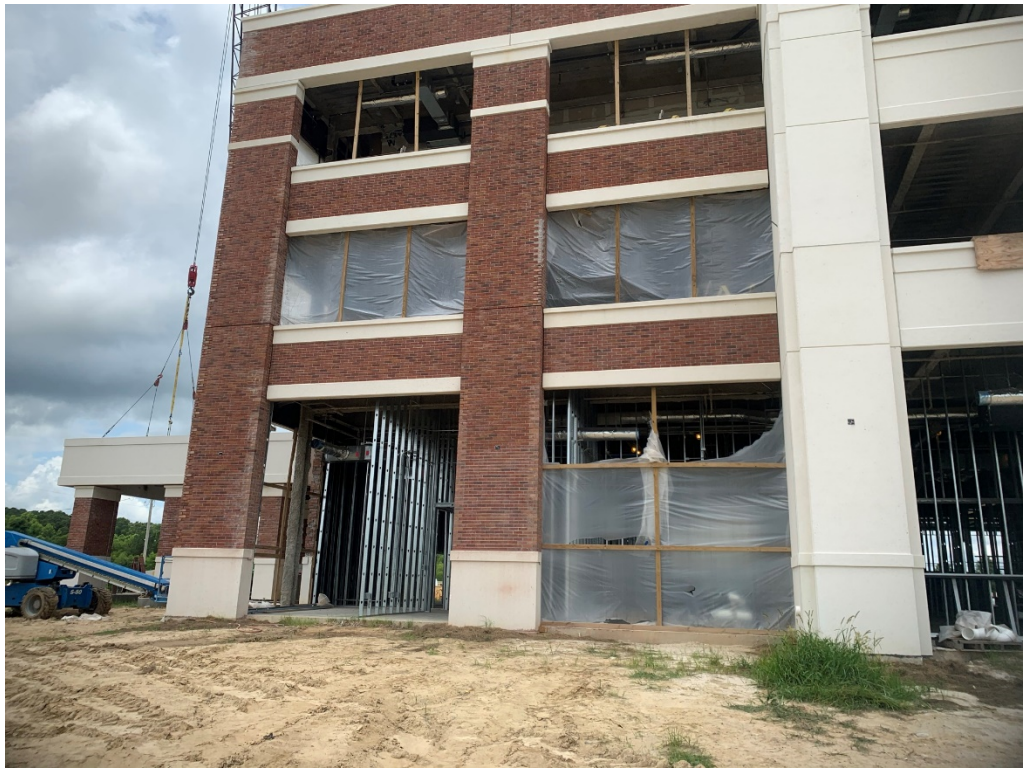
Figure 5 – Masonry is Ongoing

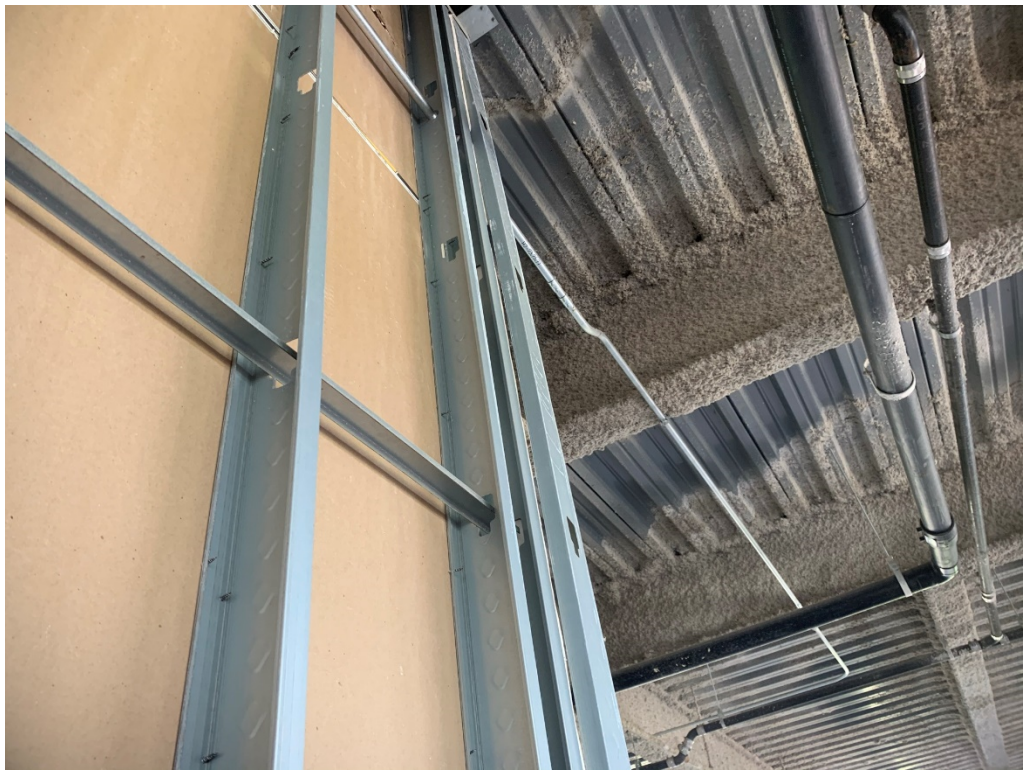
Figure 6 – Corner Framing needs to be locked in with neighboring member at NE corner at 2nd Floor

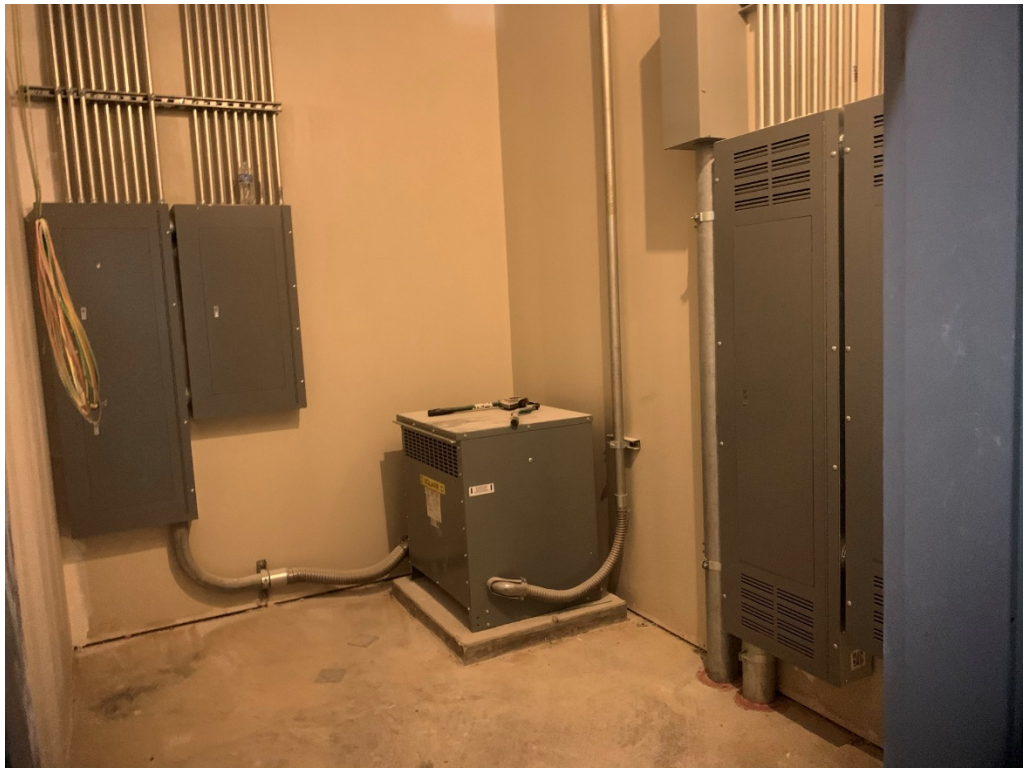
Figure 7 – Electrical at 3rd Floor 3010

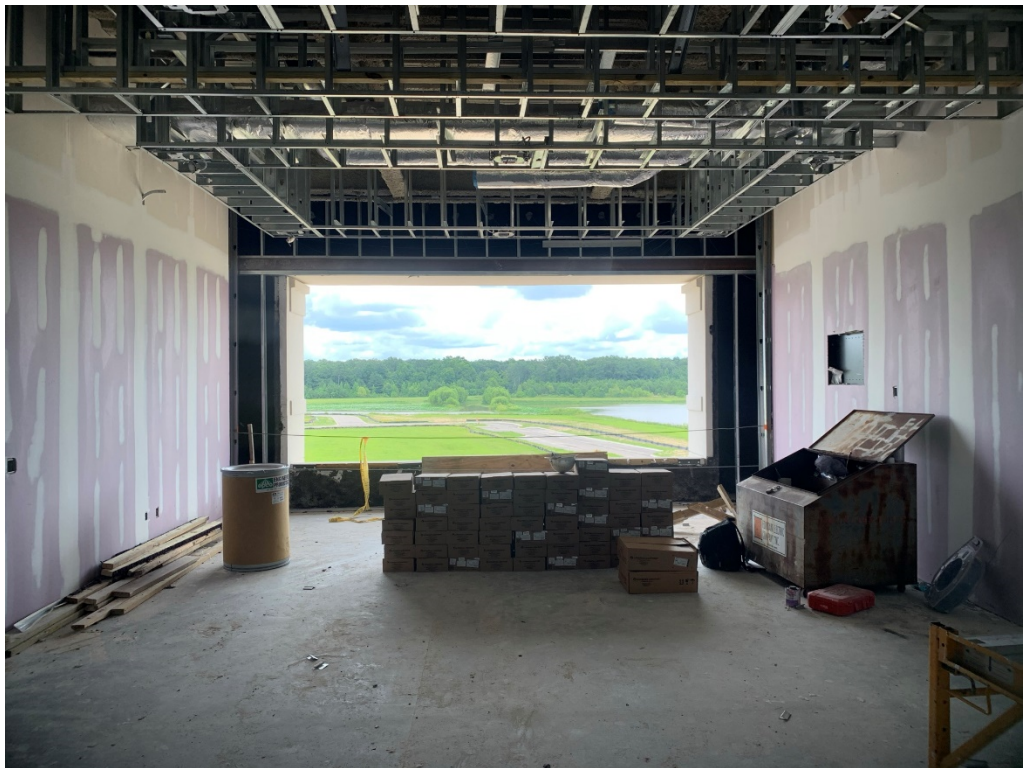
Figure 8 – Drywall finishing at 3rd Floor

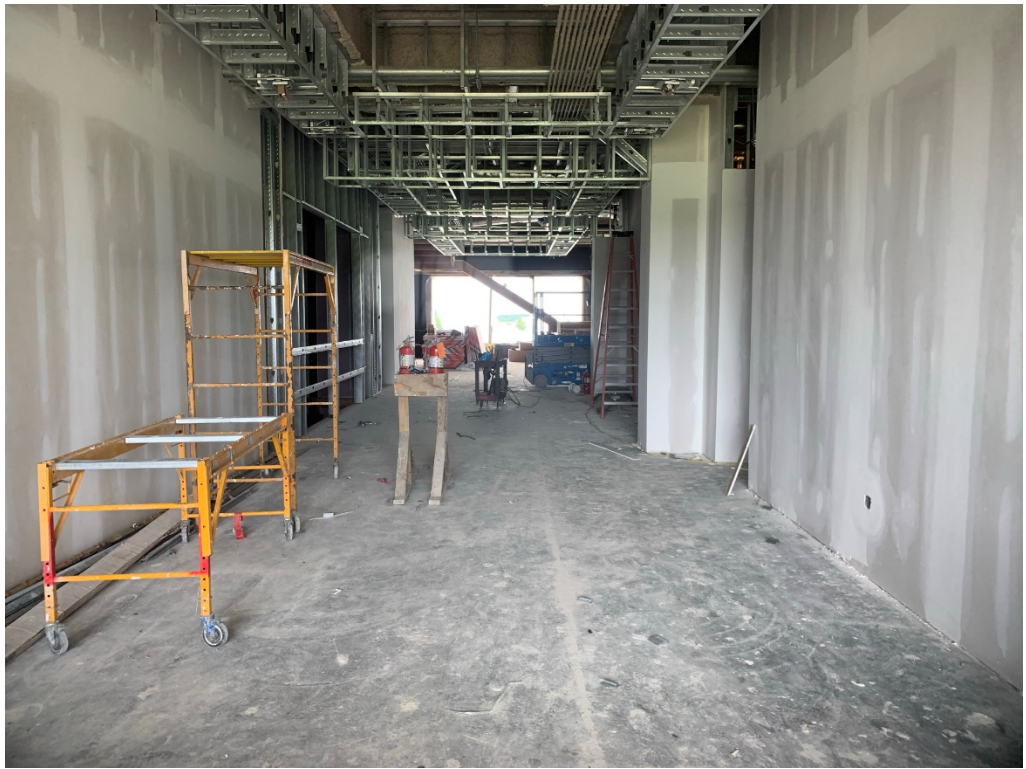
Figure 9 – Drywall finishing at 3rd Floor

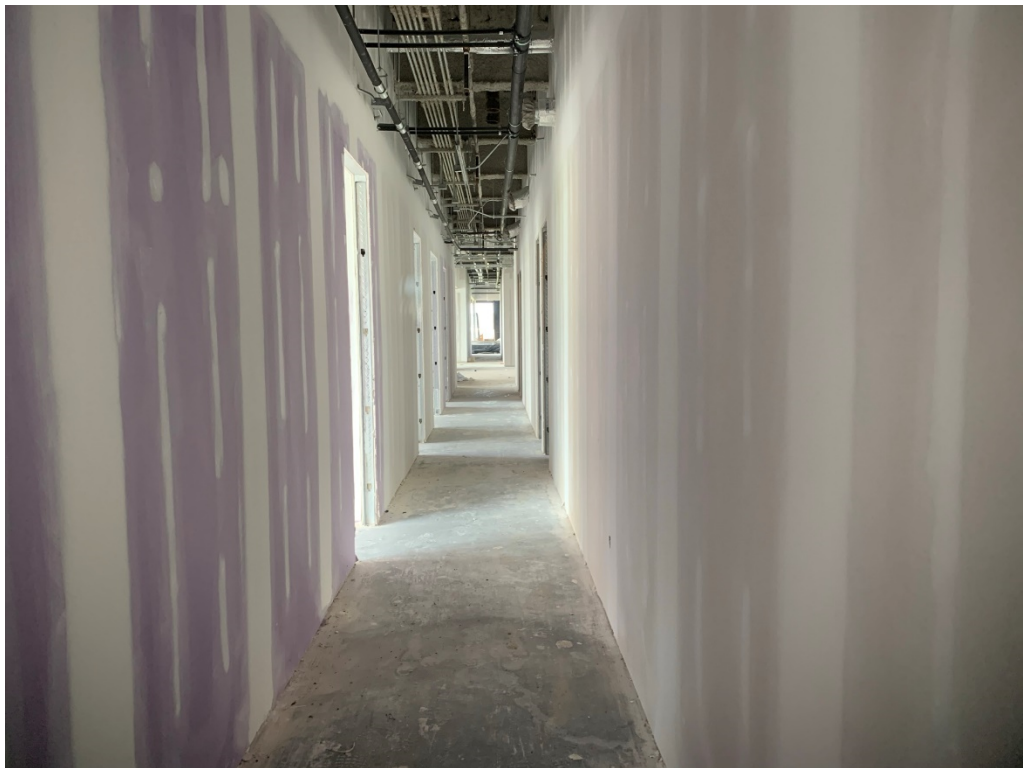
Figure 10 – Drywall finishing at 3rd Floor

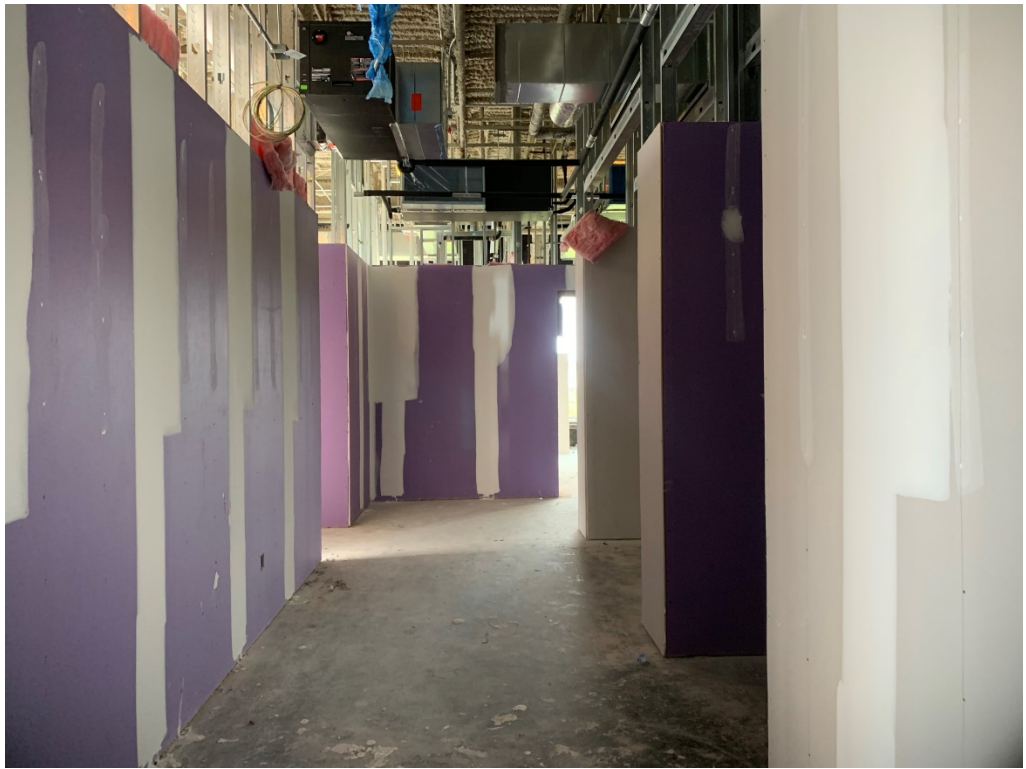
Figure 11 – Drywall finishing is also in progress at 4th floor

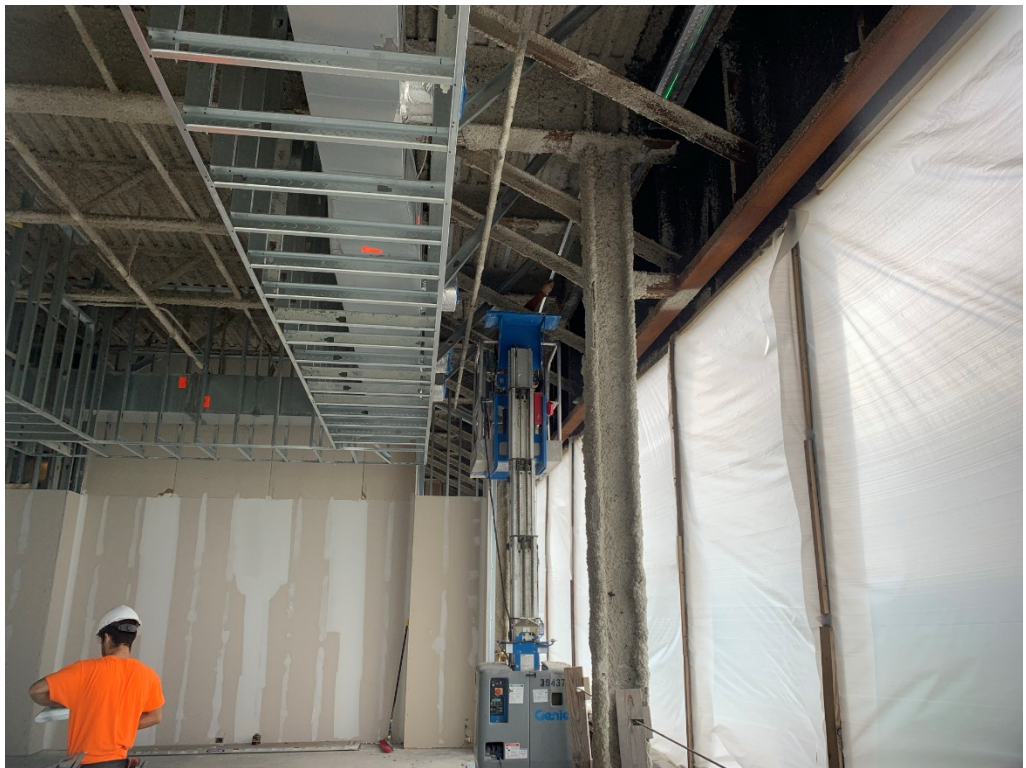
Figure 12 – Progress at Front Façade on the 1st

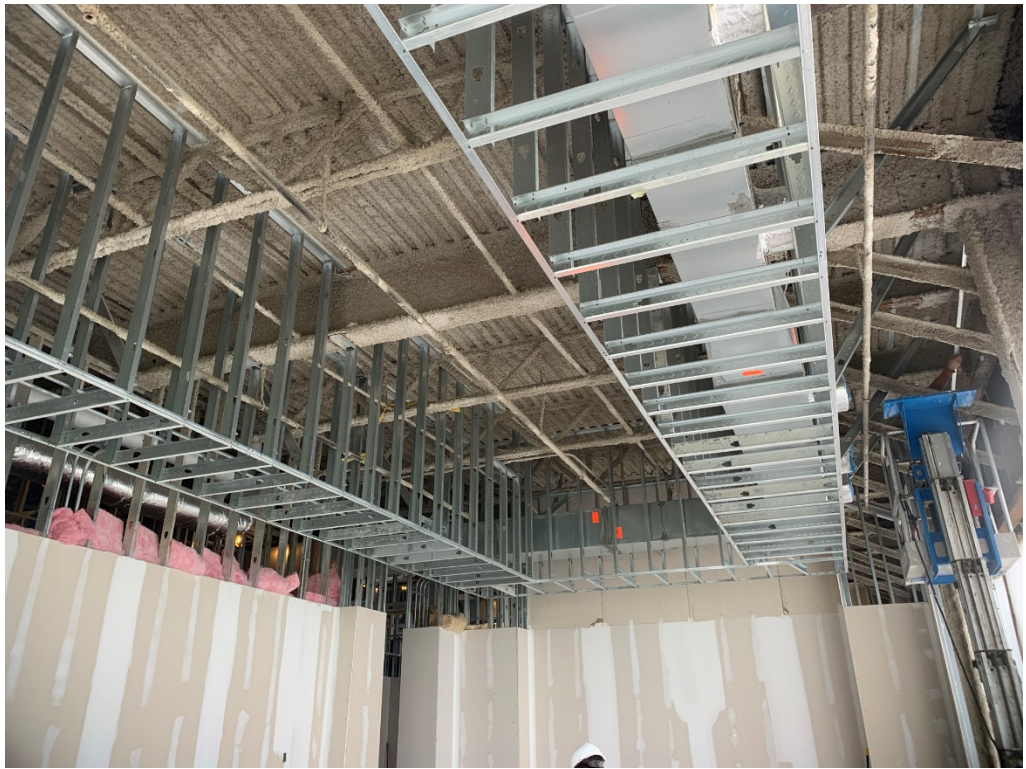
Figure 13 – Framing at Boardroom is Ongoing

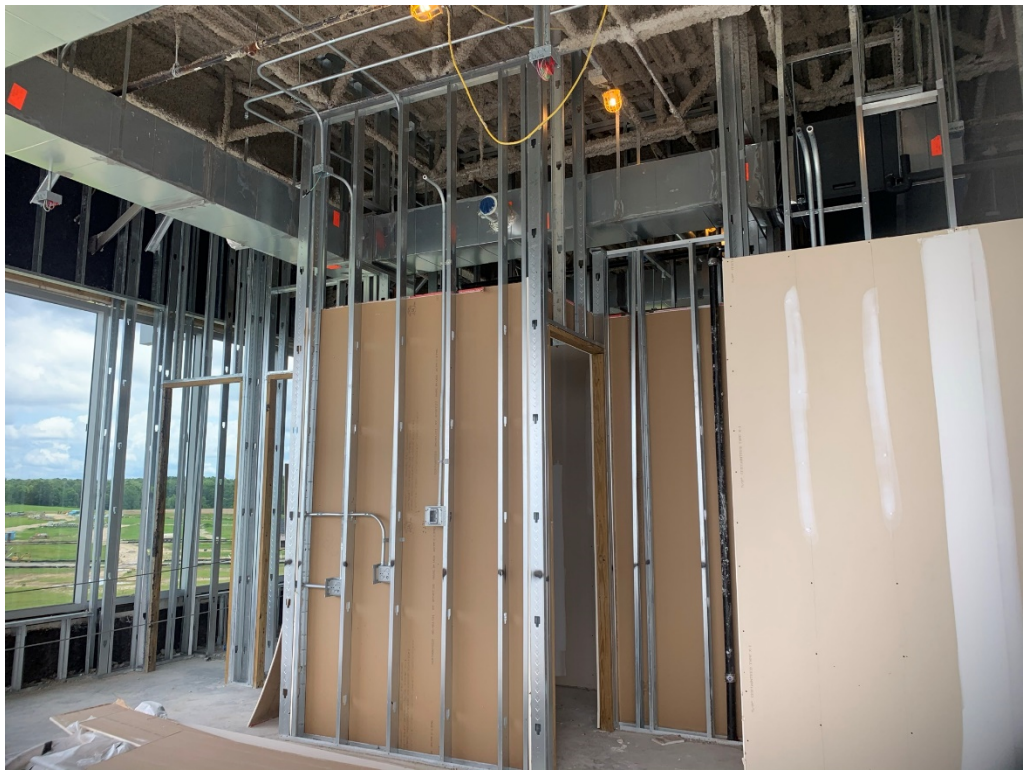
Figure 14 – 4th Floor Northeast section drywall is ongoing

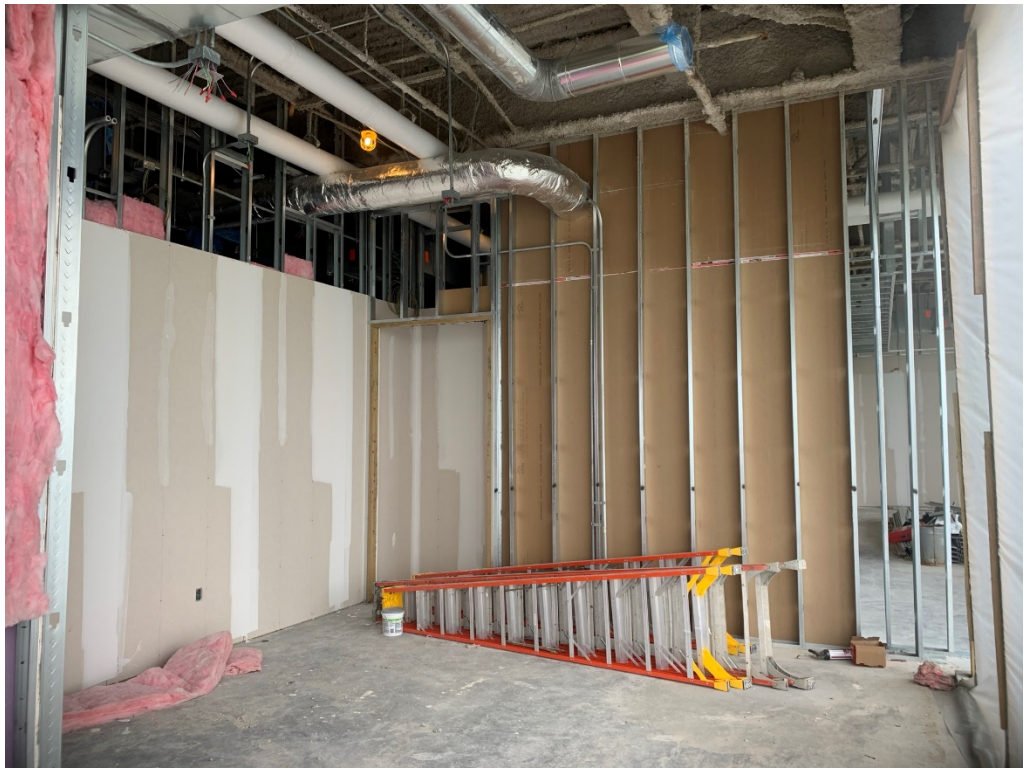
Figure 15 – Drywall Install is Ongoing at 4th Floor

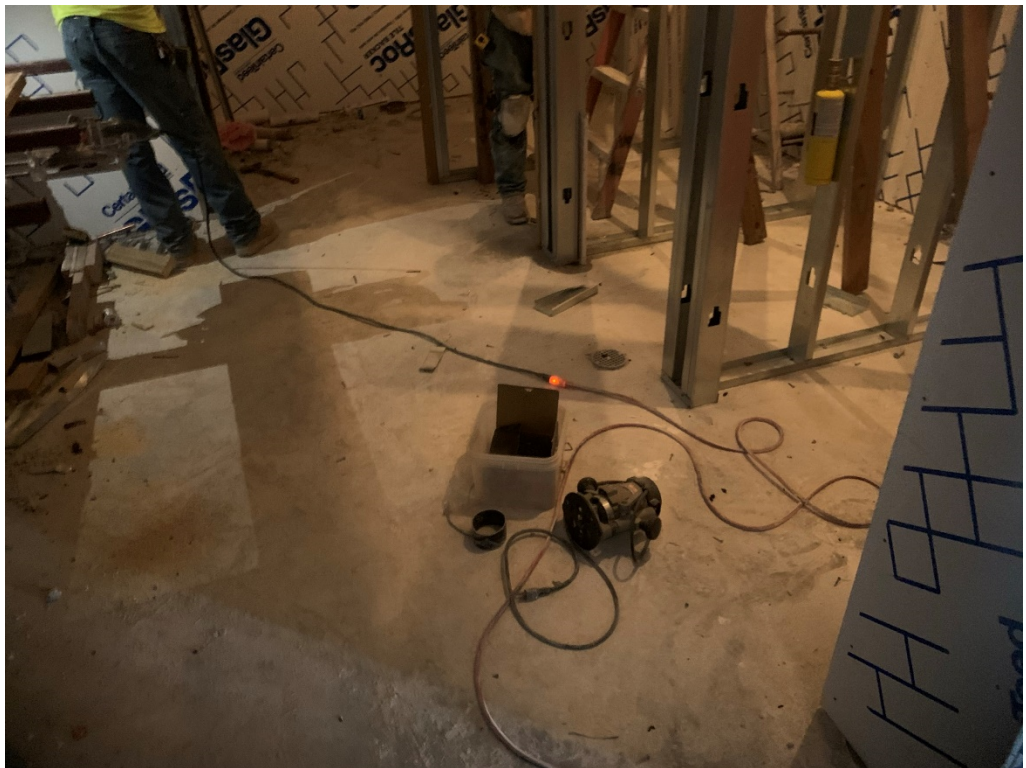
Figure 16 – 4th Floor Bathroom Bank continued Framing

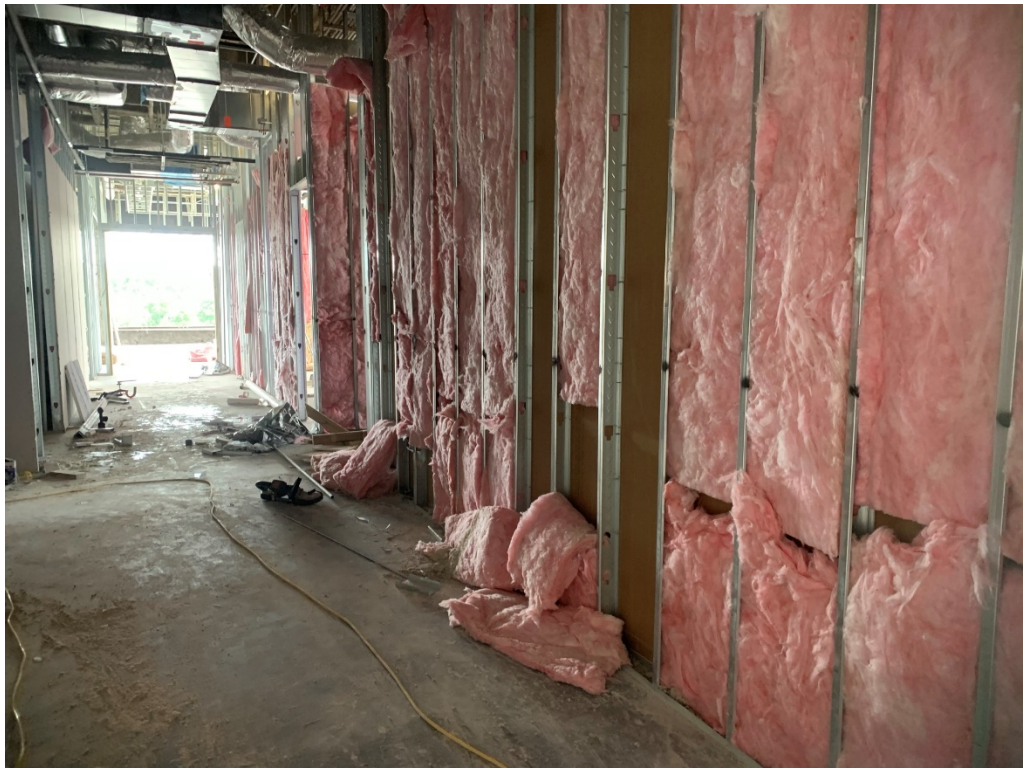
Figure 17 – South Section of Fourth Floor drywall install still ongoing

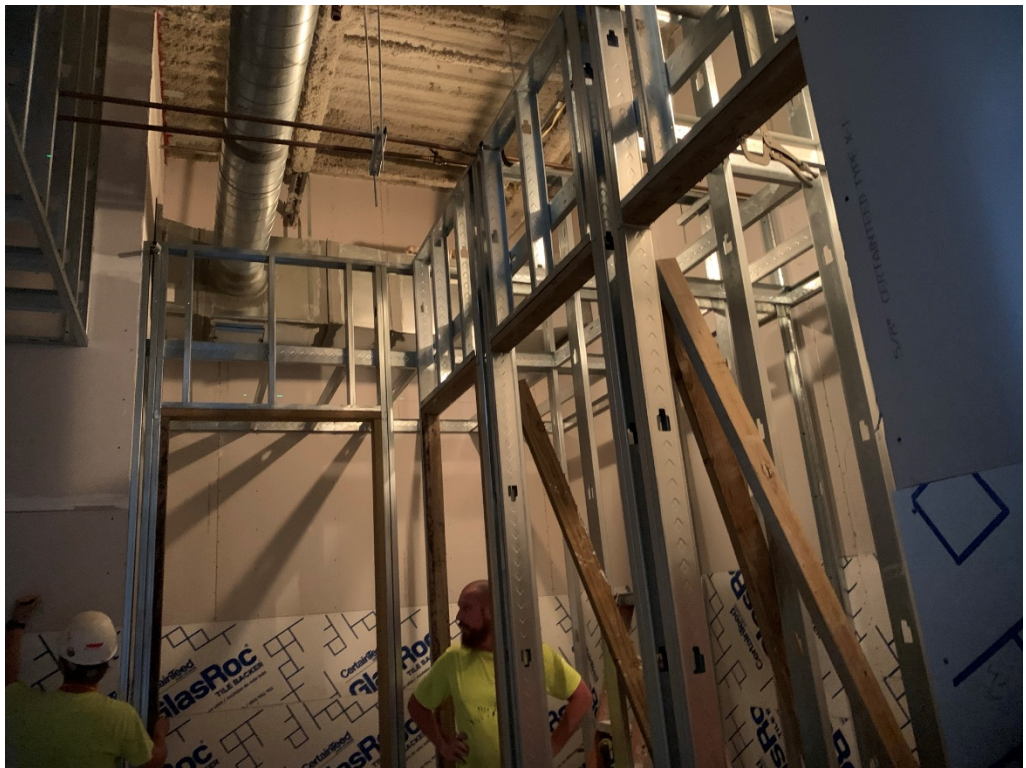
Figure 18 – 4th Floor Bathroom Bank continued Framing
