Architect's Field Report

12 July 2021

15094 Community Bank Headquarters / Report Number 016

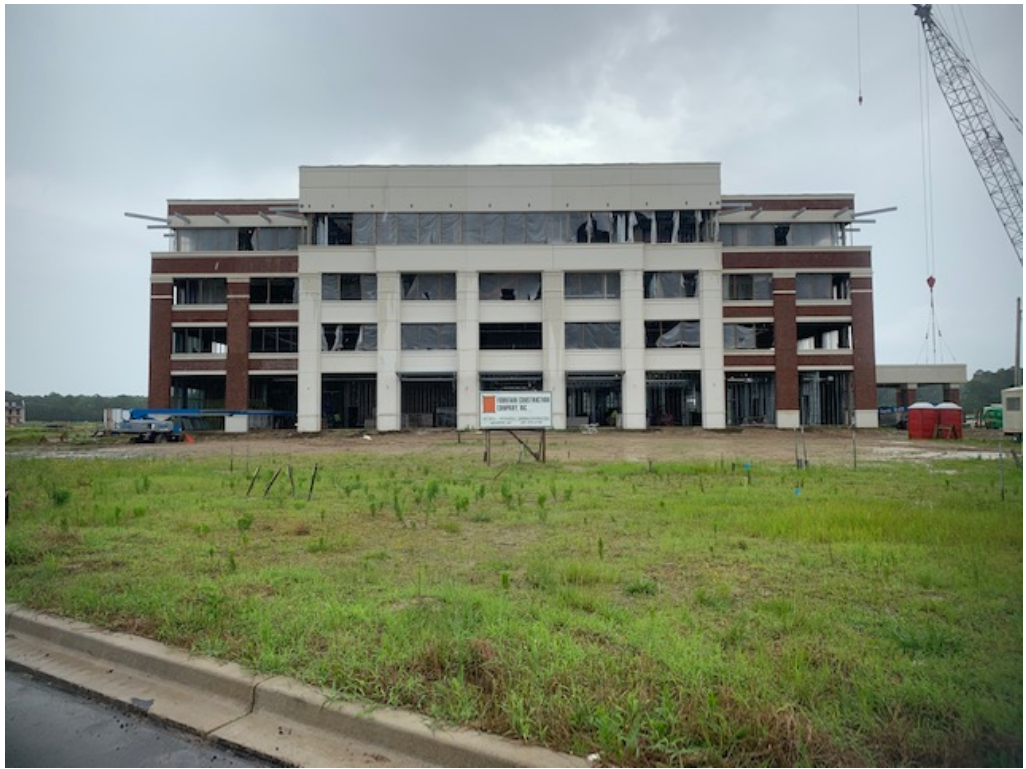
Figure 1 – Front Façade Progress

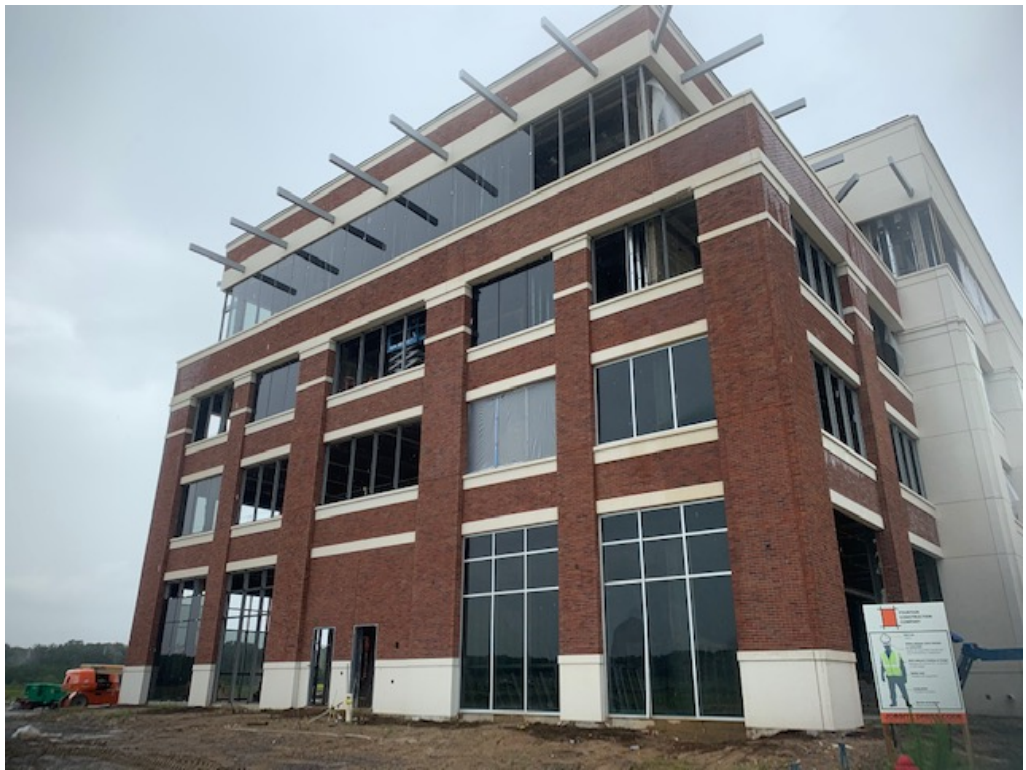
Figure 2 – Glazing Progress at North Facade

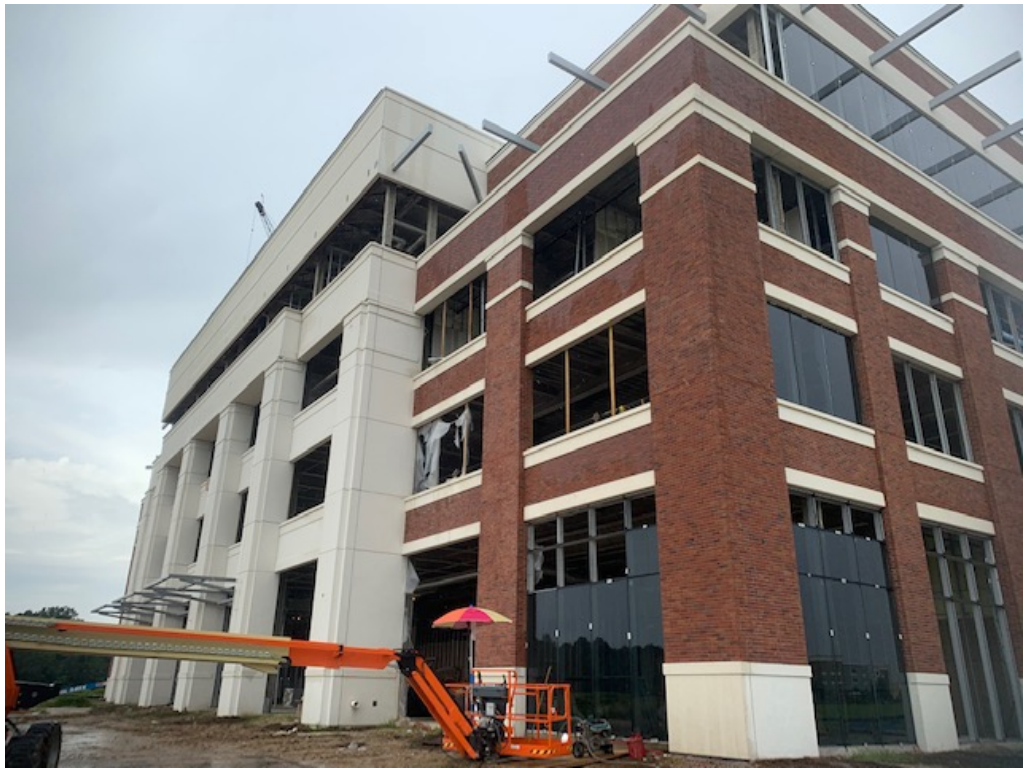
Figure 3 – East Façade

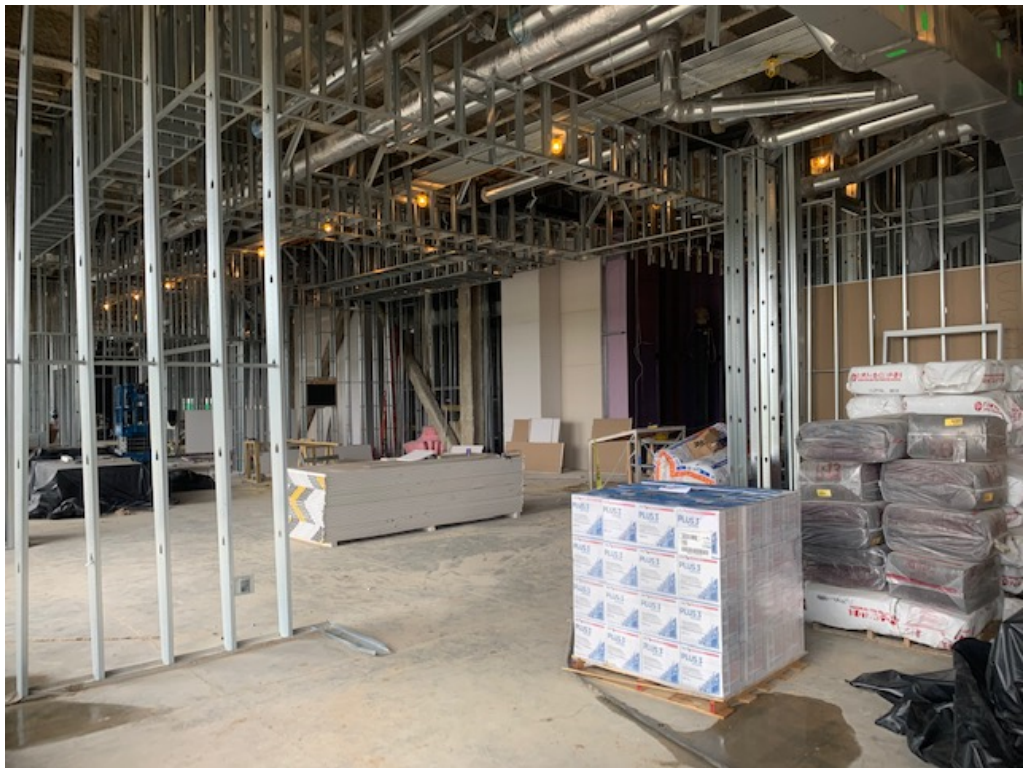
Figure 4 – 1st Floor Staging Area

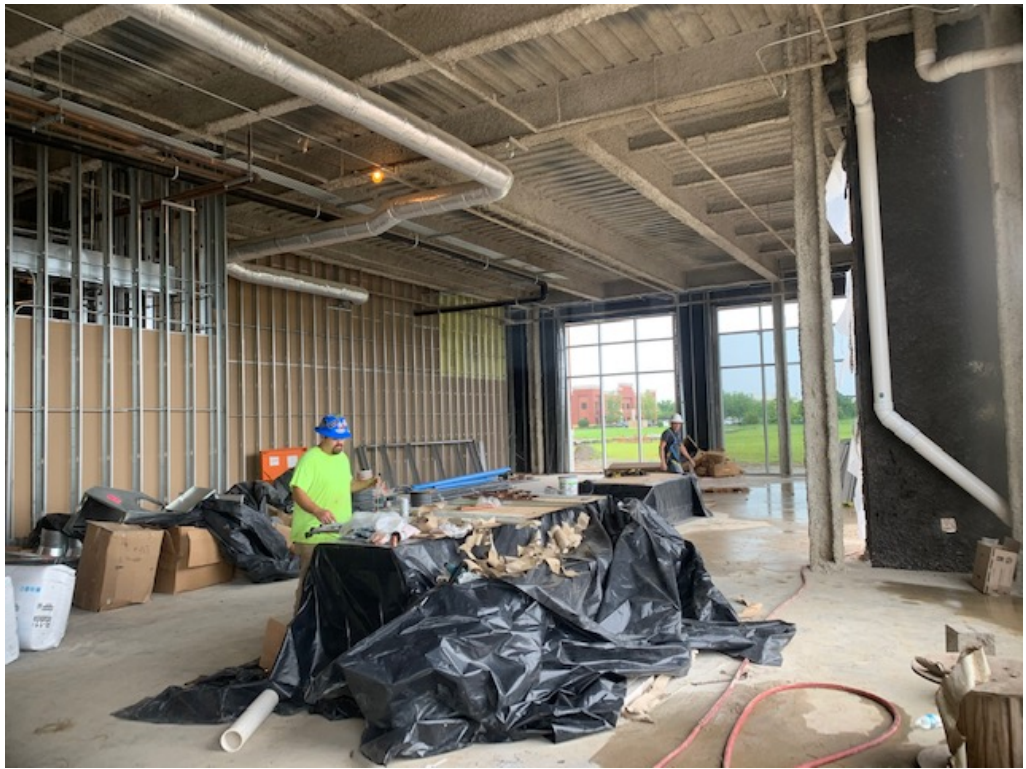
Figure 5 – 1st Floor Staging Area

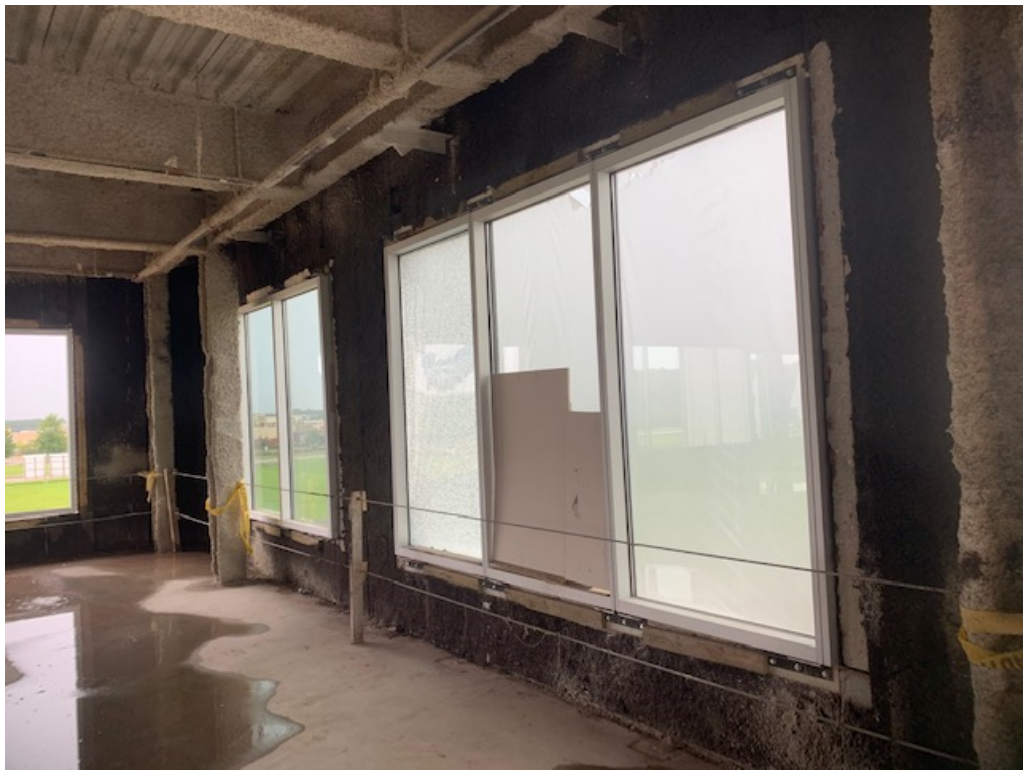
Figure 6 – Broken Glass at 2nd Floor North Windows

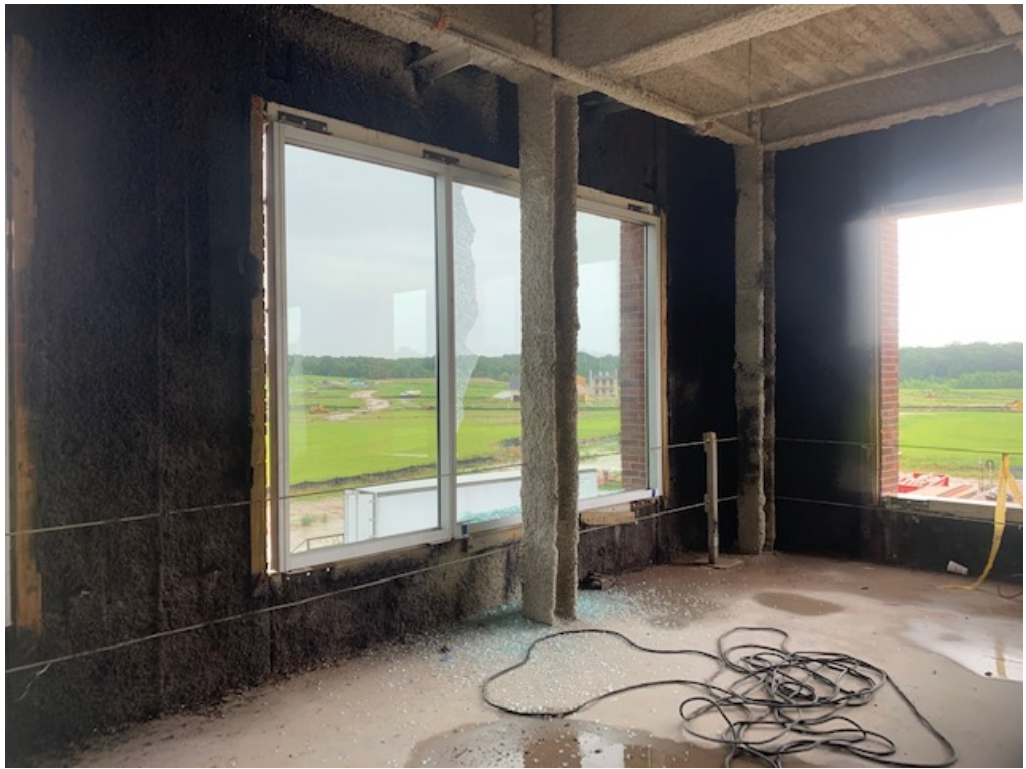
Figure 7 – Broken Glass at 2nd Floor North Windows

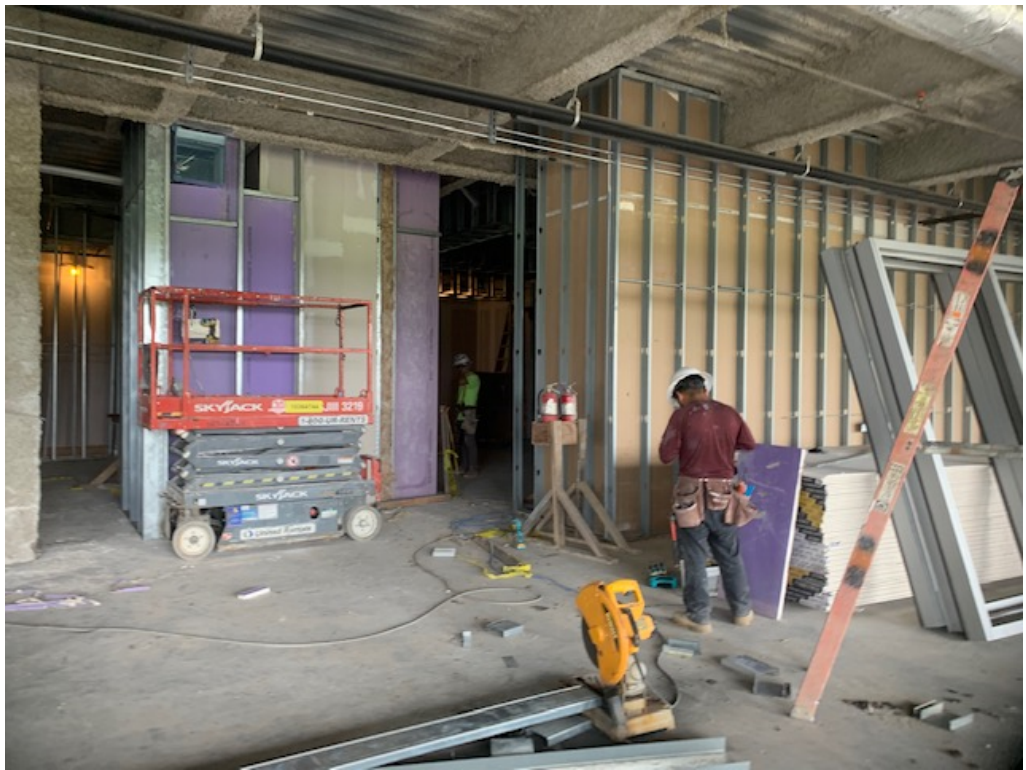
Figure 8 – Electrical Work at 2nd Floor Elevators

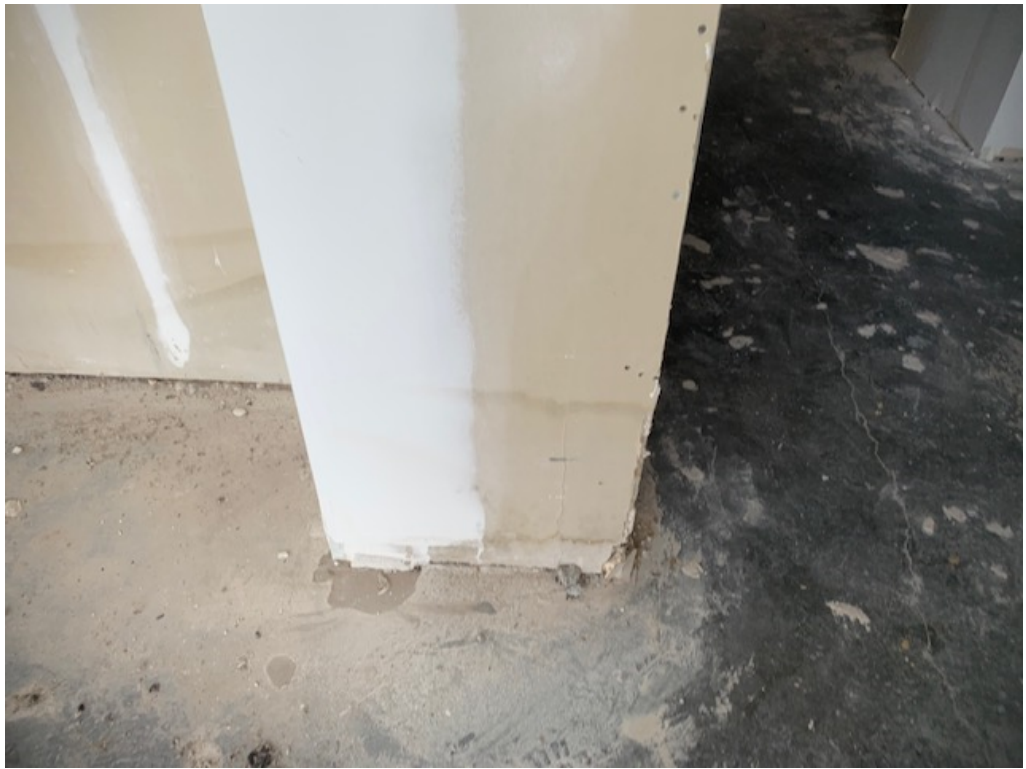
Figure 9 – Water Damaged Drywall Should be Replaced (noted primarily at 3rd floor SE)

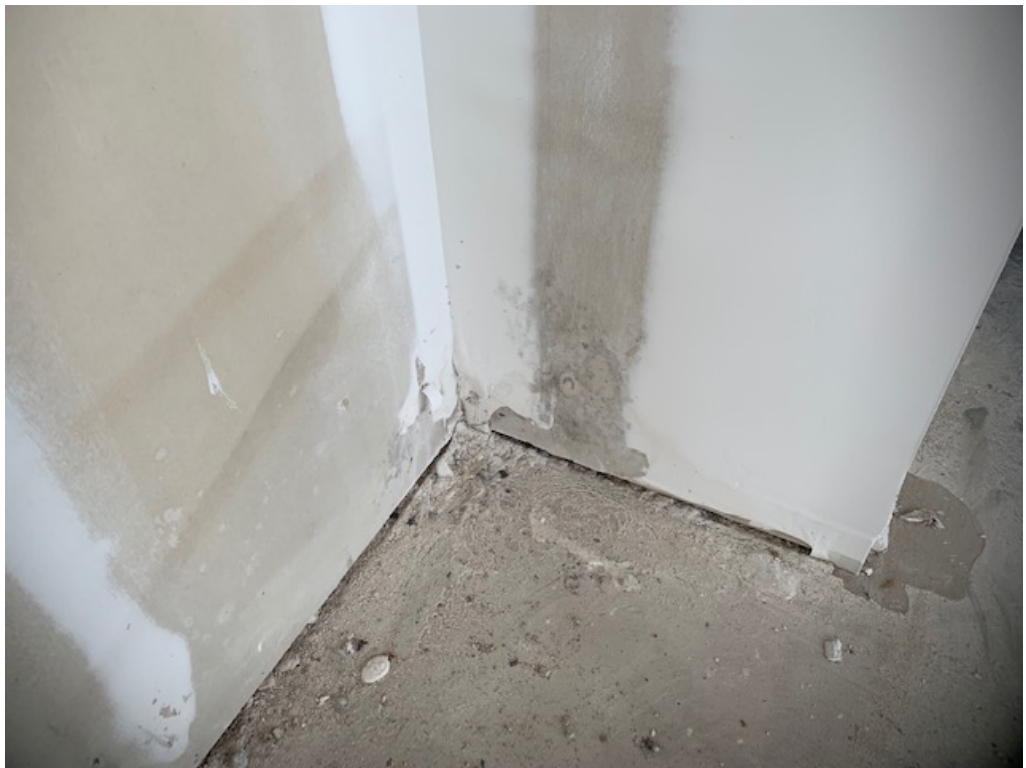
Figure 10 – Water Damaged Drywall Should be Replaced (noted primarily at 3rd floor SE)

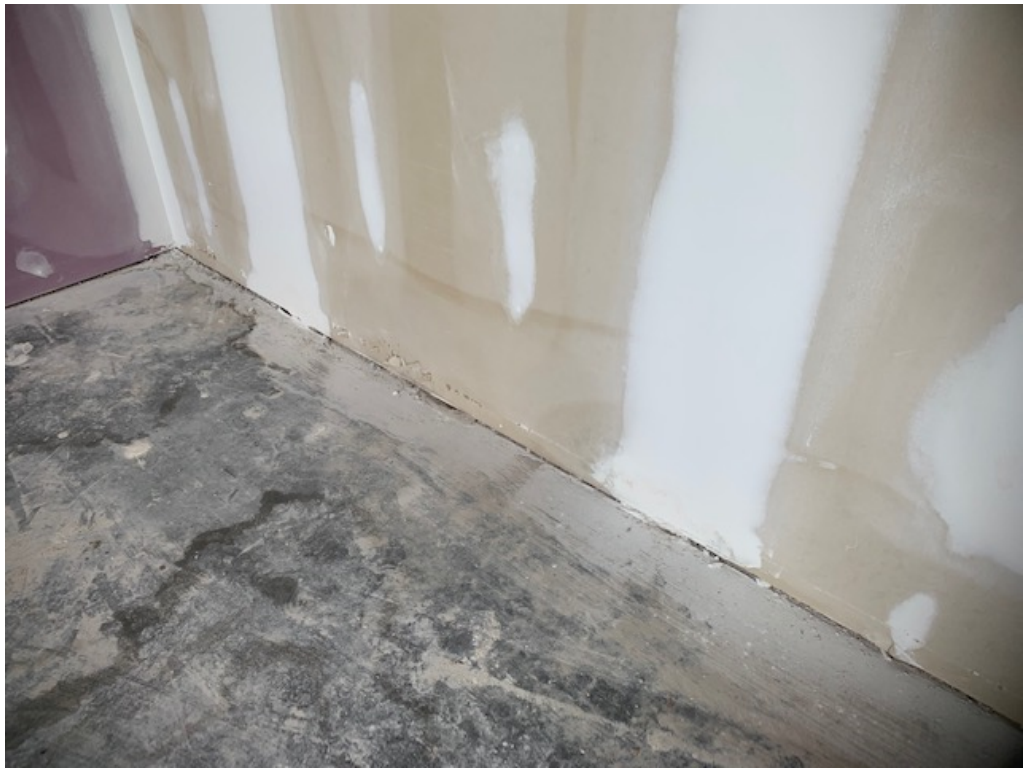
Figure 11 – Water Damaged Drywall Should be Replaced (noted primarily at 3rd floor SE)

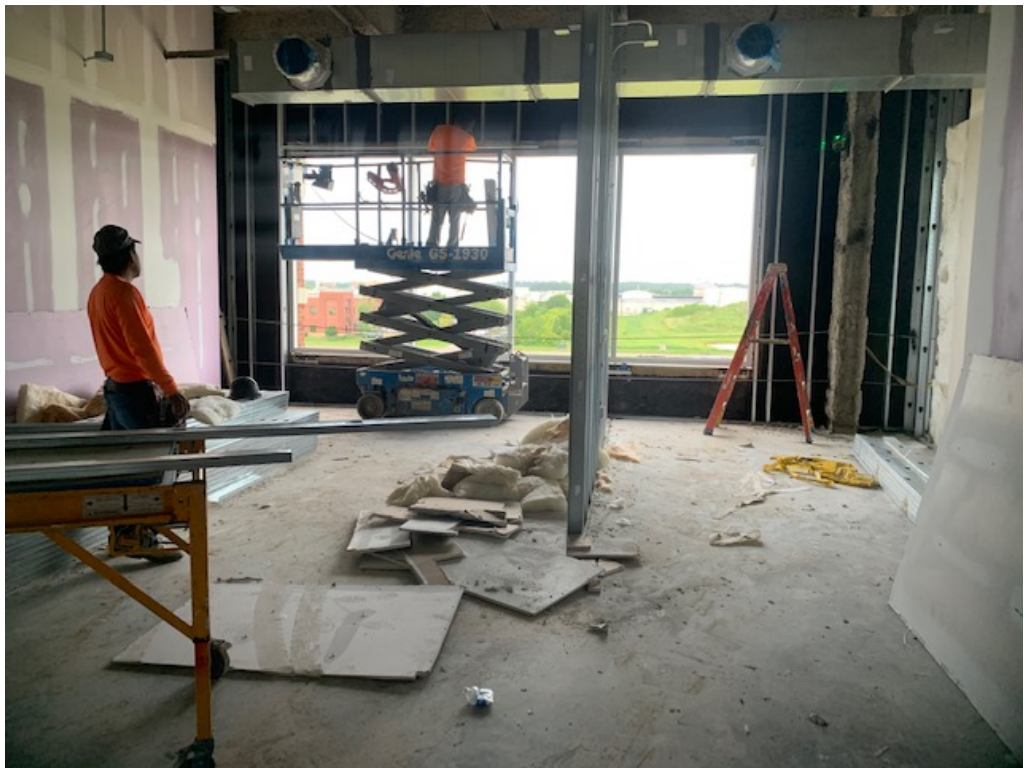
Figure 12 – Framing at 3rd Floor North Section

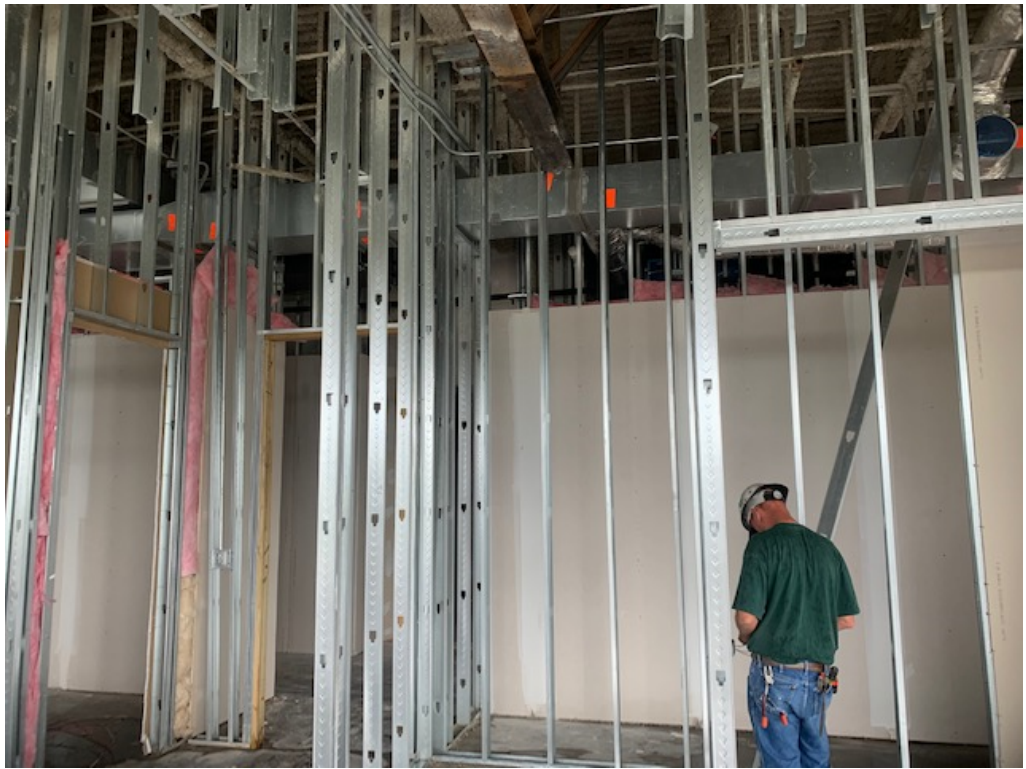
Figure 13 – Framing at Banquet Room

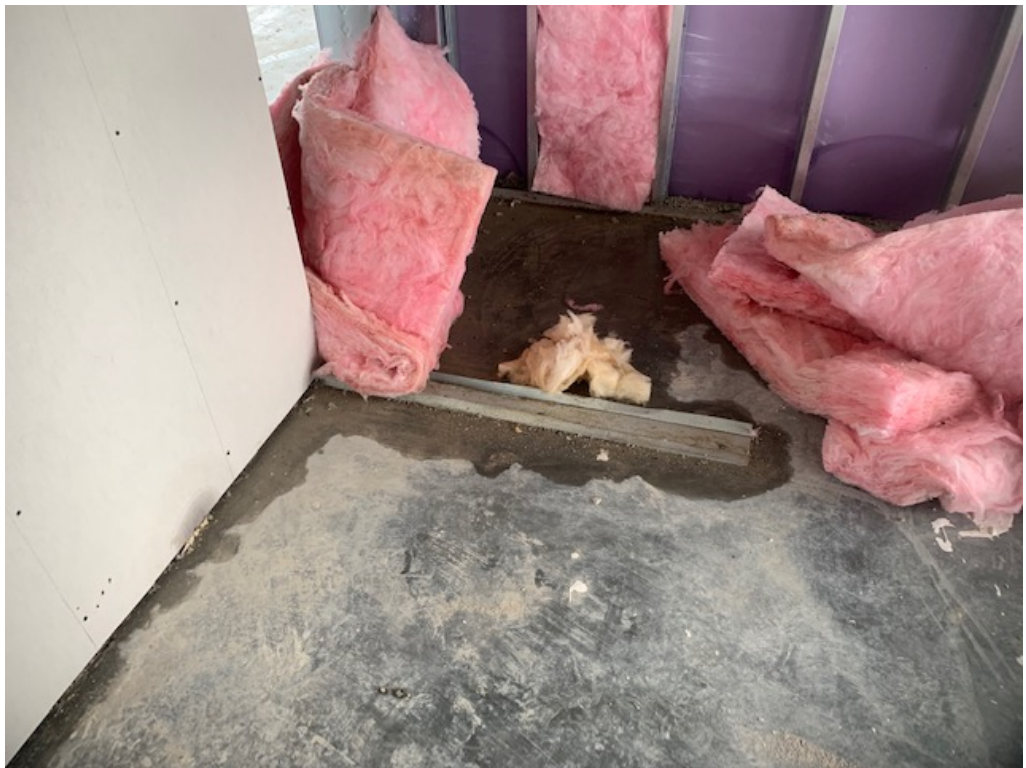
Figure 14 – Wet Insulation should be Discarded and Replaced

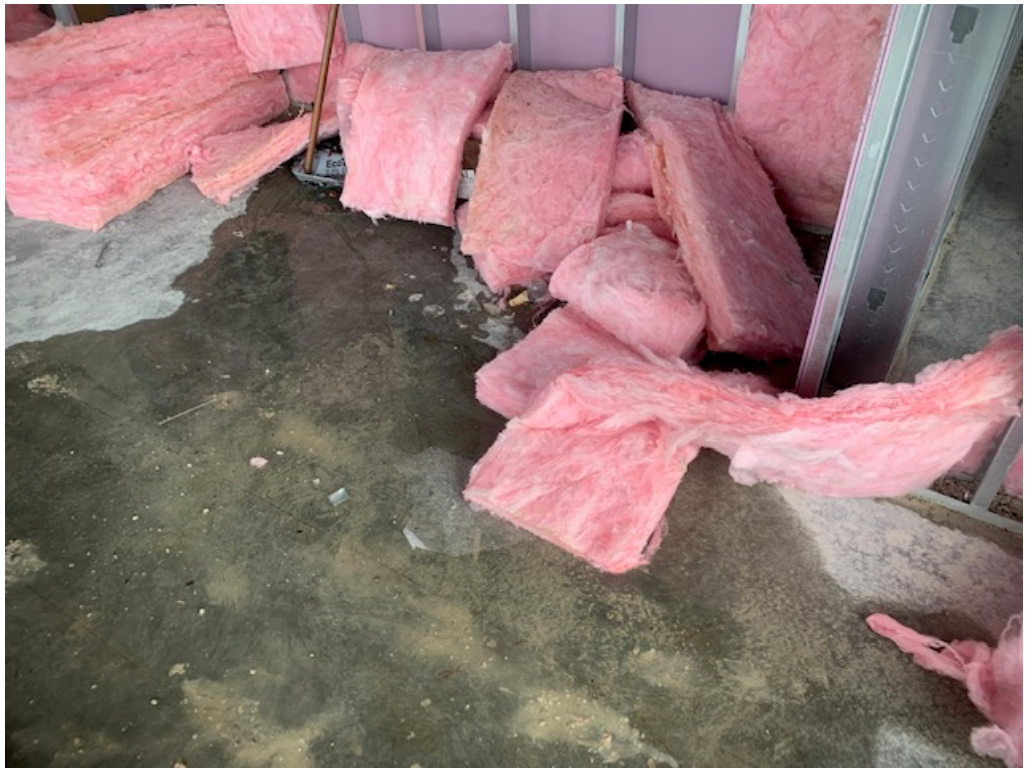
Figure 15 – Wet Insulation should be Discarded and Replaced

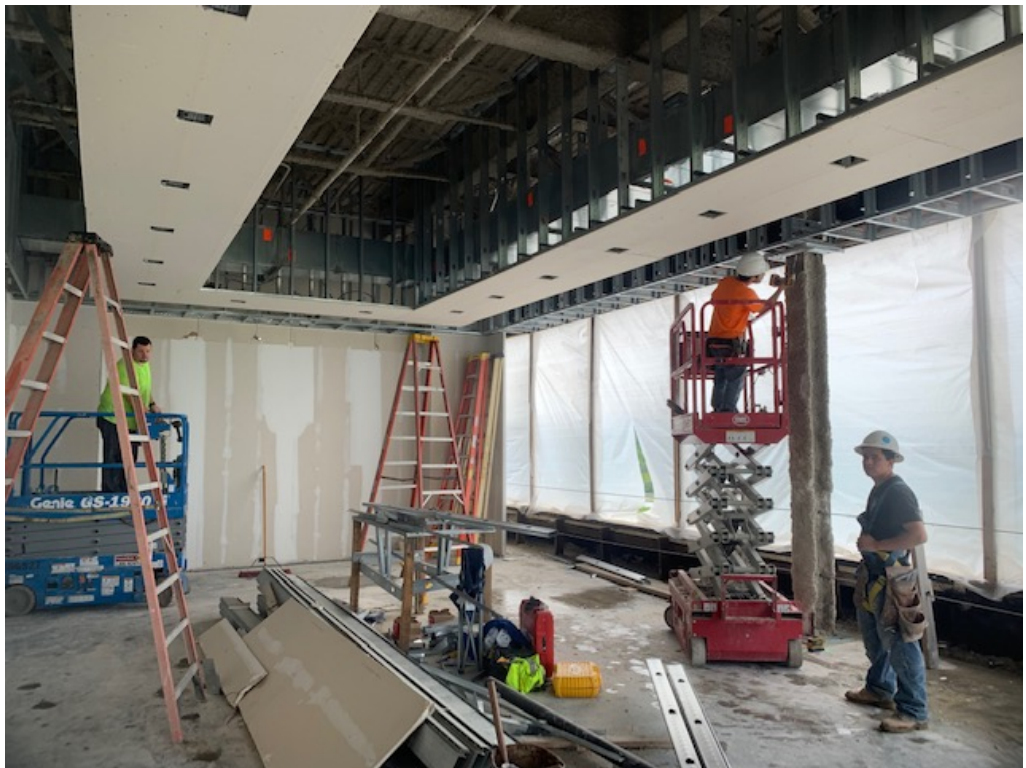
Figure 16 – Framing & Electrical at the Board Room

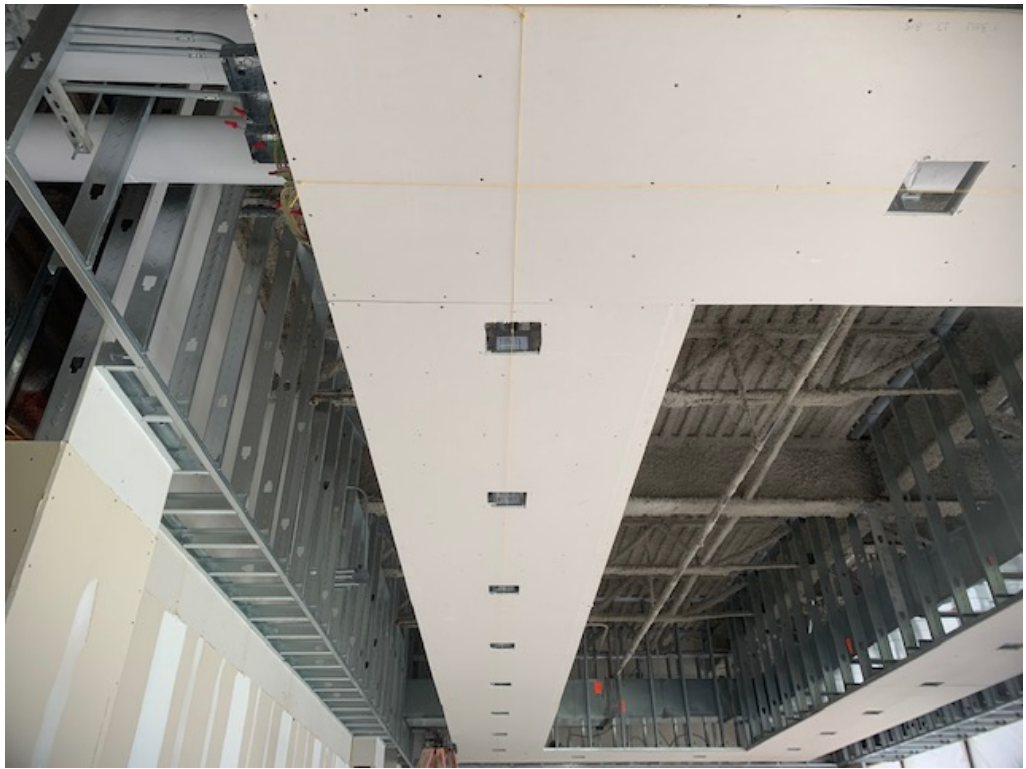
Figure 17 – Ceiling Lighting at Board Room

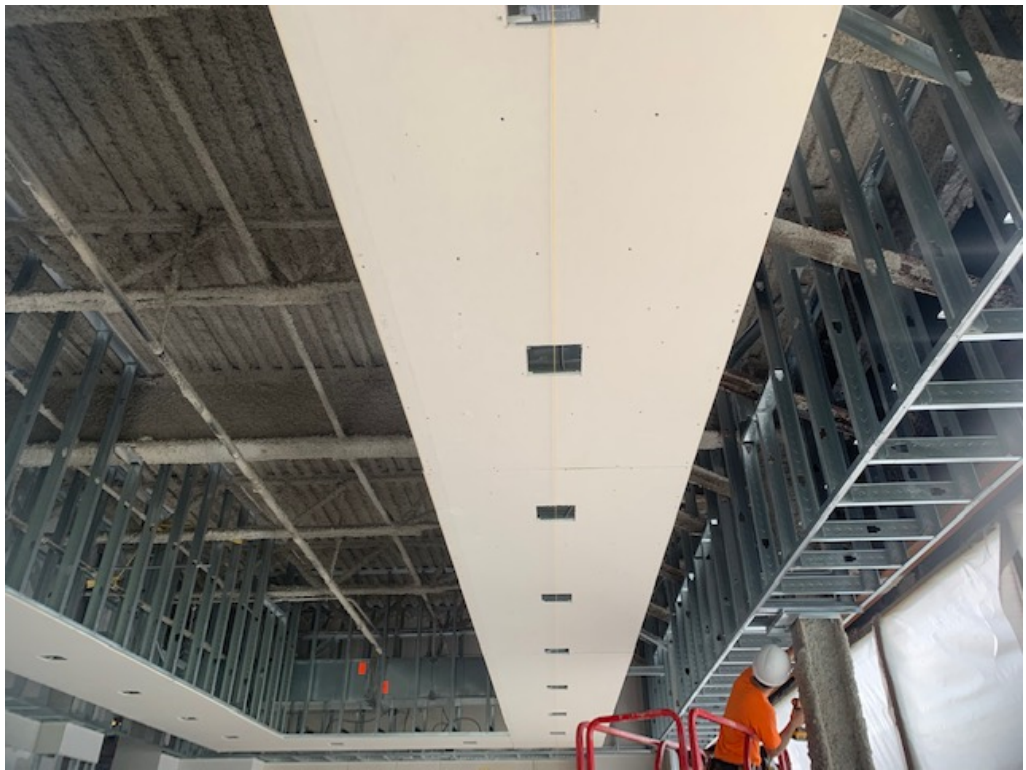
Figure 18 – Ceiling Lighting at Board Room

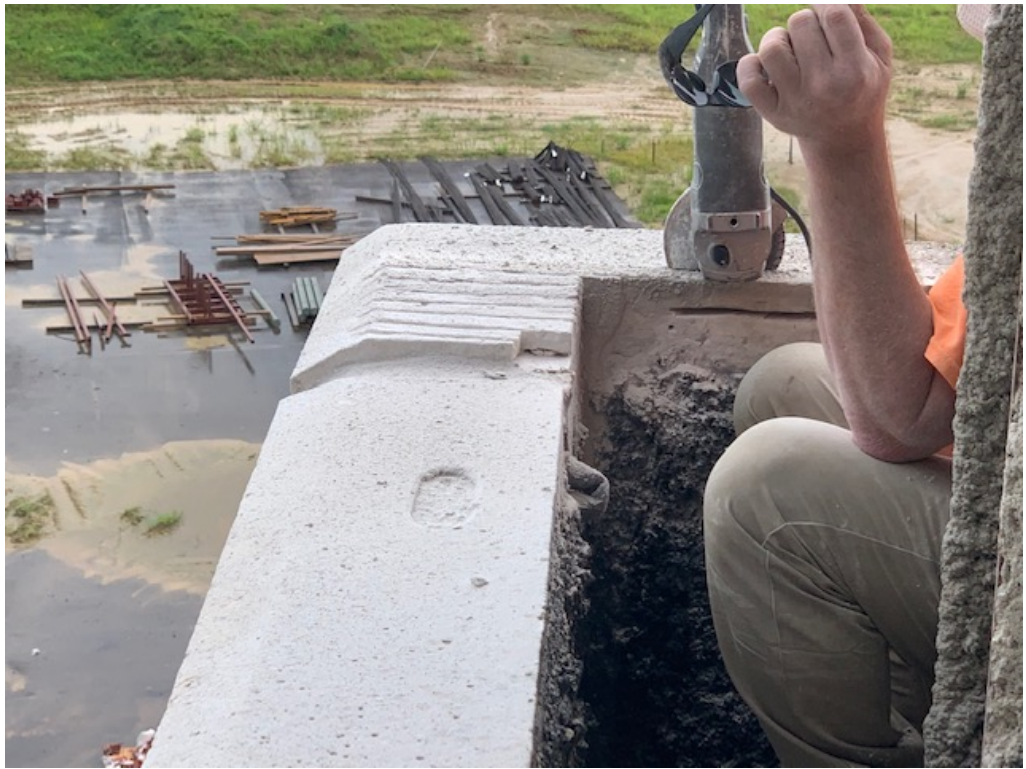
Figure 19 – Stone Worker Repairing Panel In place

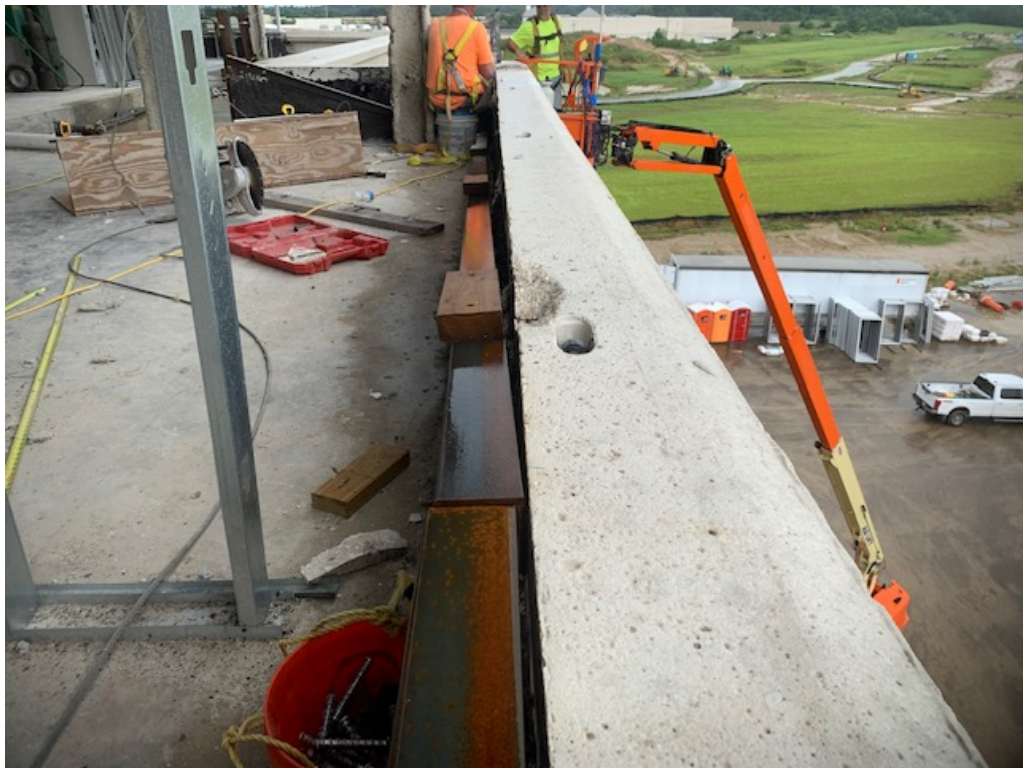
Figure 20 – Stone Worker Repairing Panel In place
