Architect's Field Report

21 July 2021

15094 Community Bank Headquarters / Report Number 017

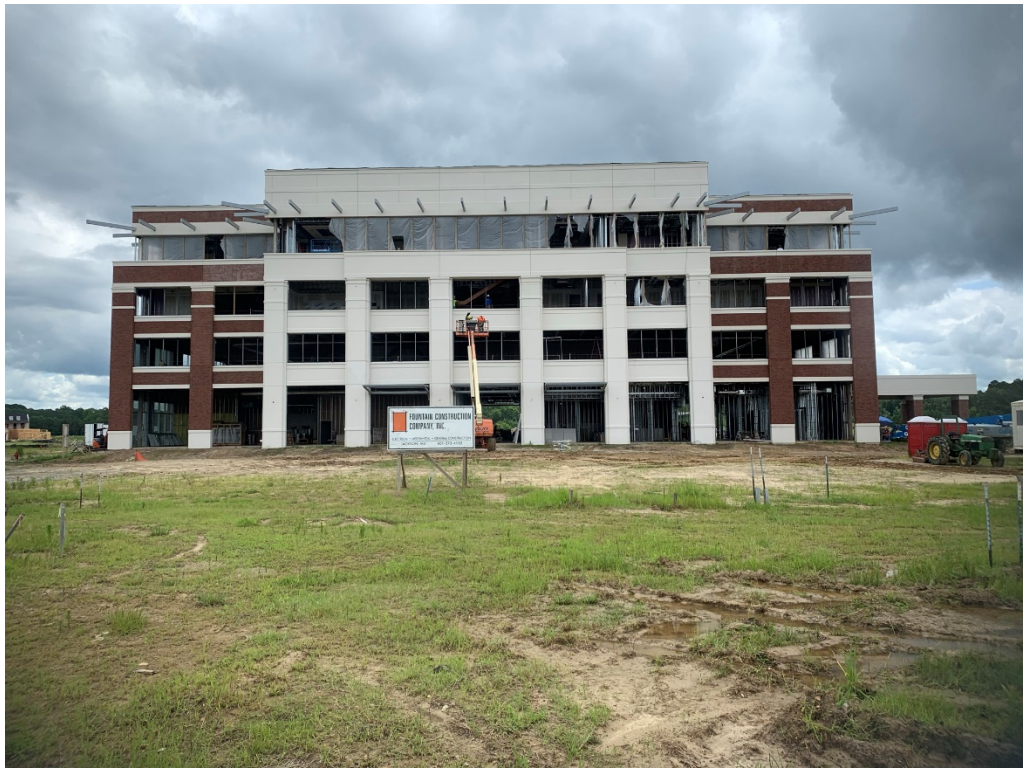
Figure 1 – Front Façade Progress

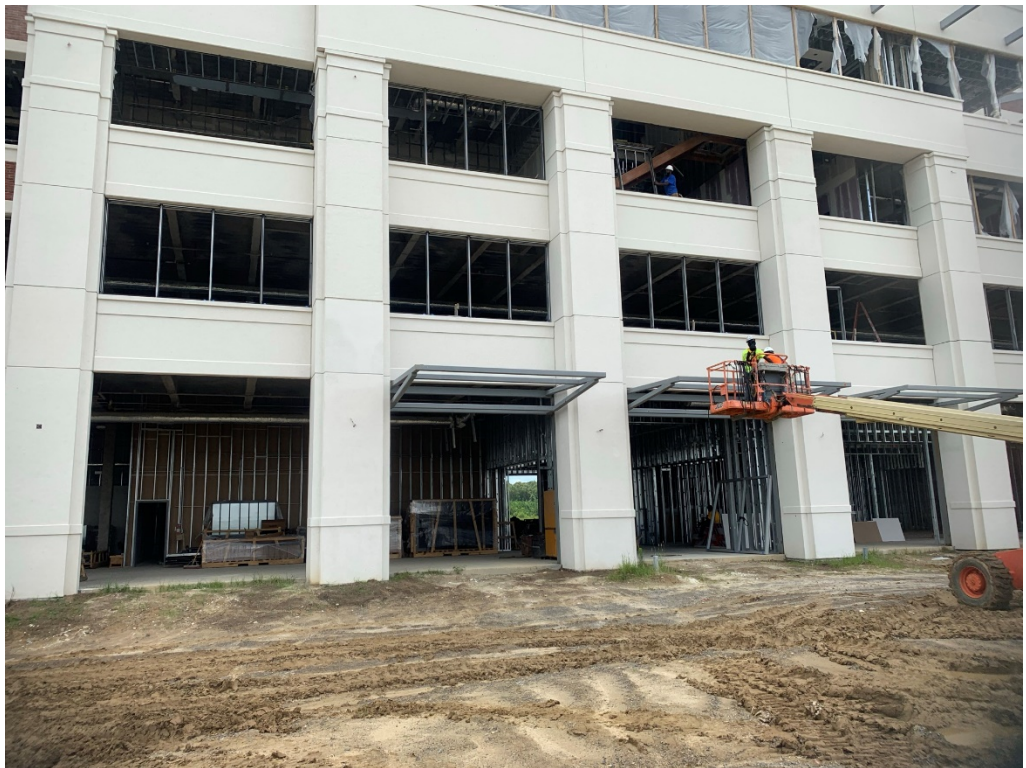
Figure 2 – West Curtainwall Installation is Ongoing

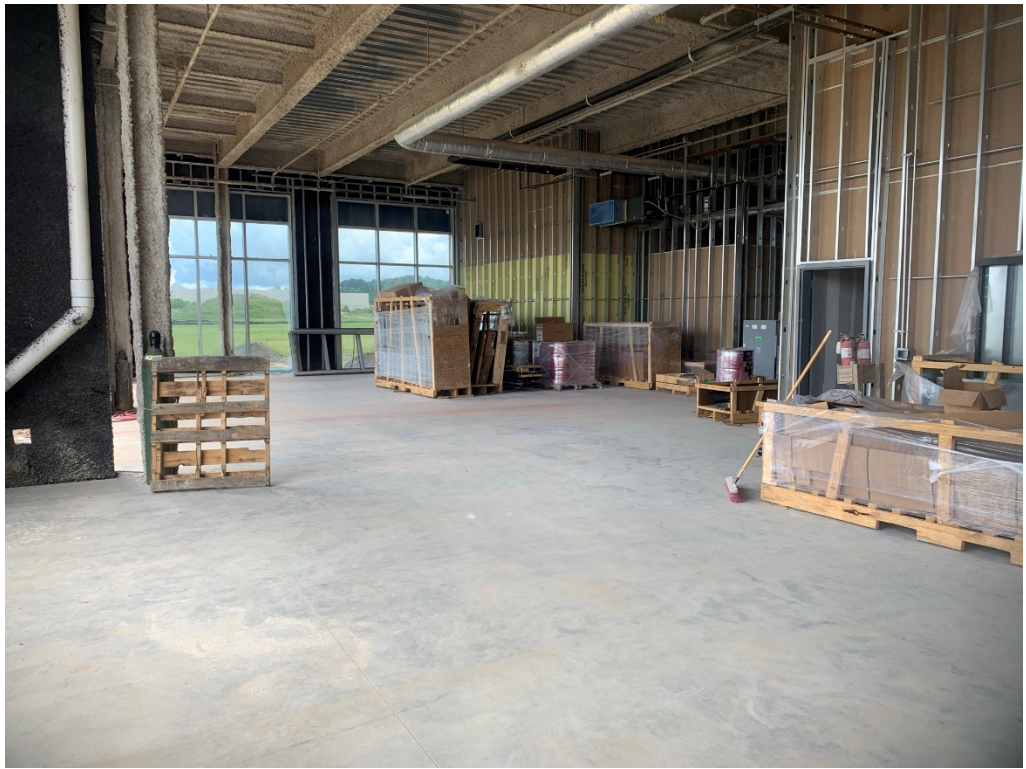
Figure 3 – Swept 1<sup>st</sup> Floor; Elevator Parts Stored Here

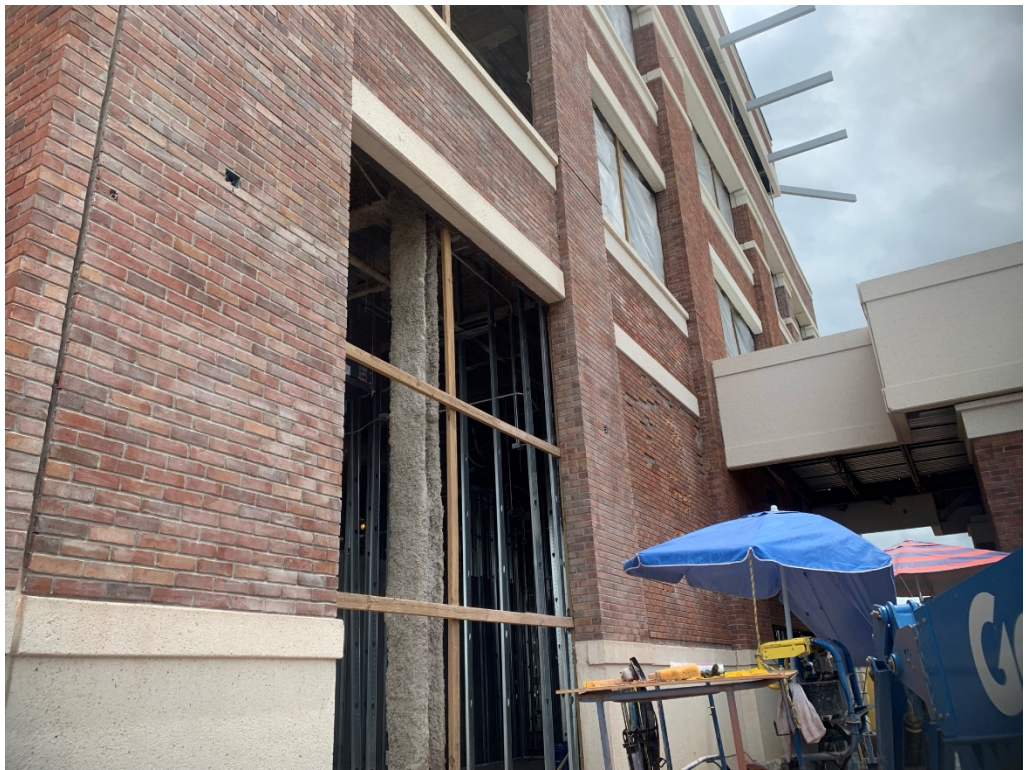
Figure 4 – South Façade Masonry is Ongoing

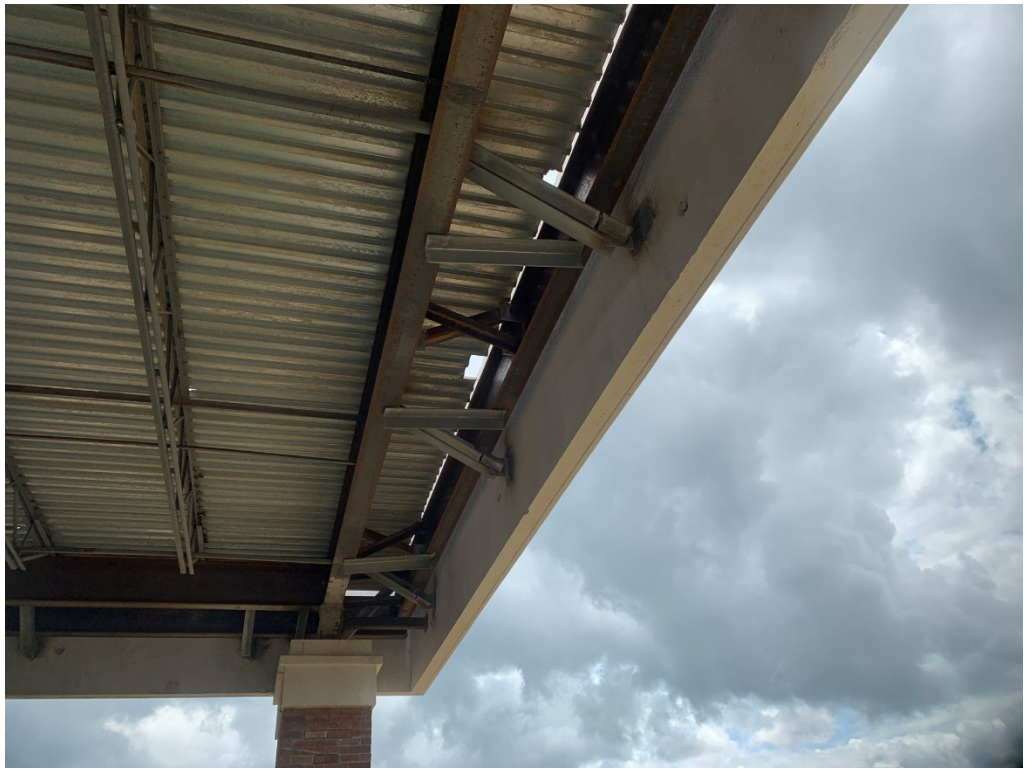
Figure 5 – Bracing at Drive Thru Canopy

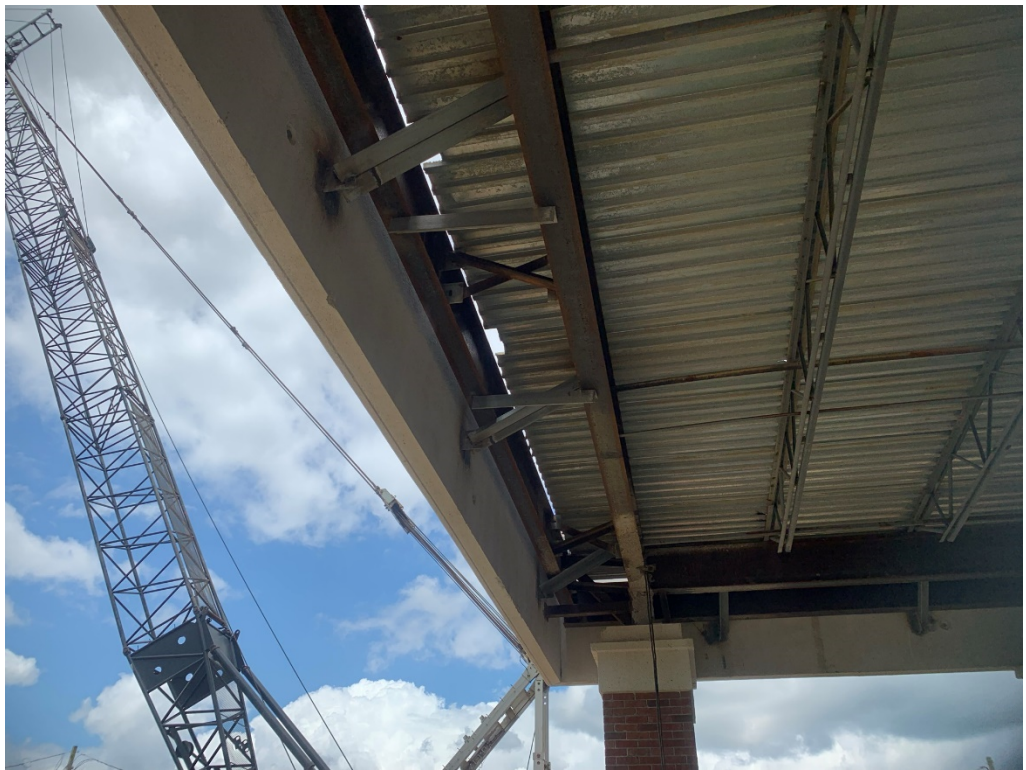
Figure 6 – Bracing at Drive Thru Canopy

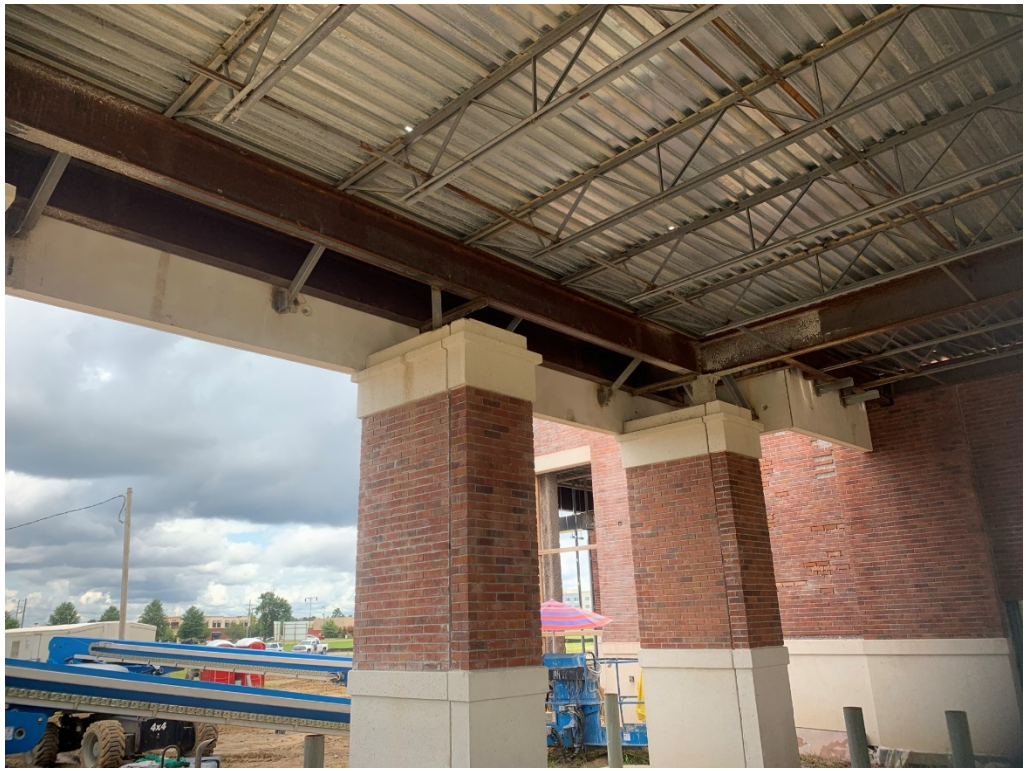
Figure 7 – Bracing at Drive Thru Canopy

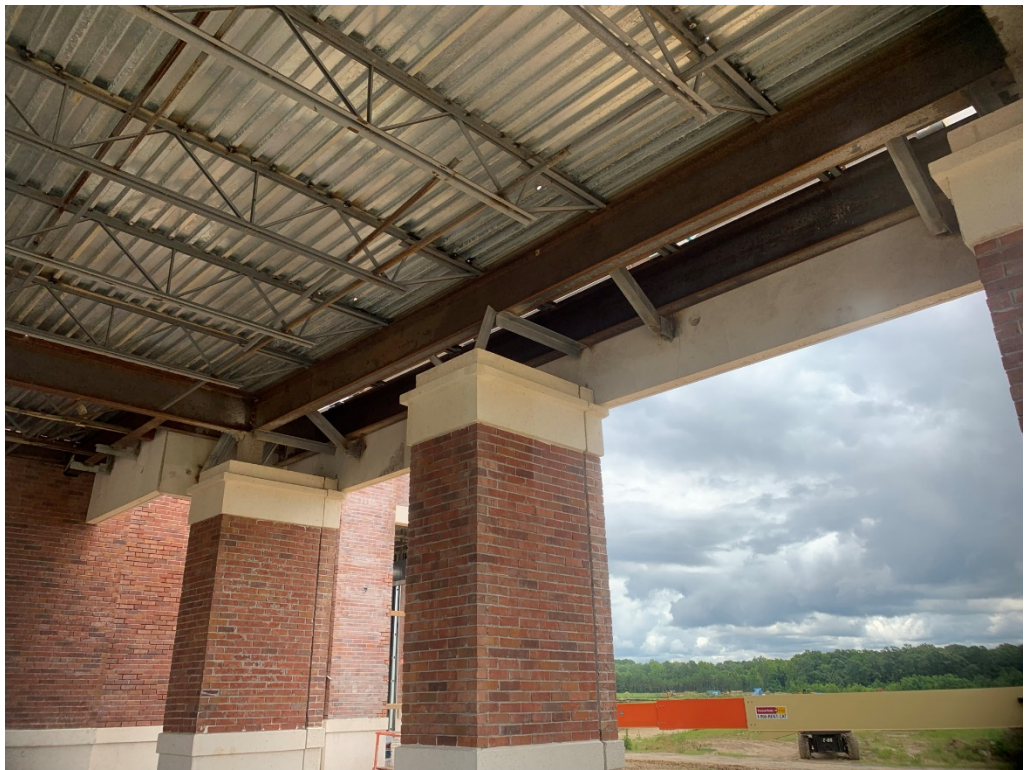
Figure 8 – Bracing at Drive Thru Canopy

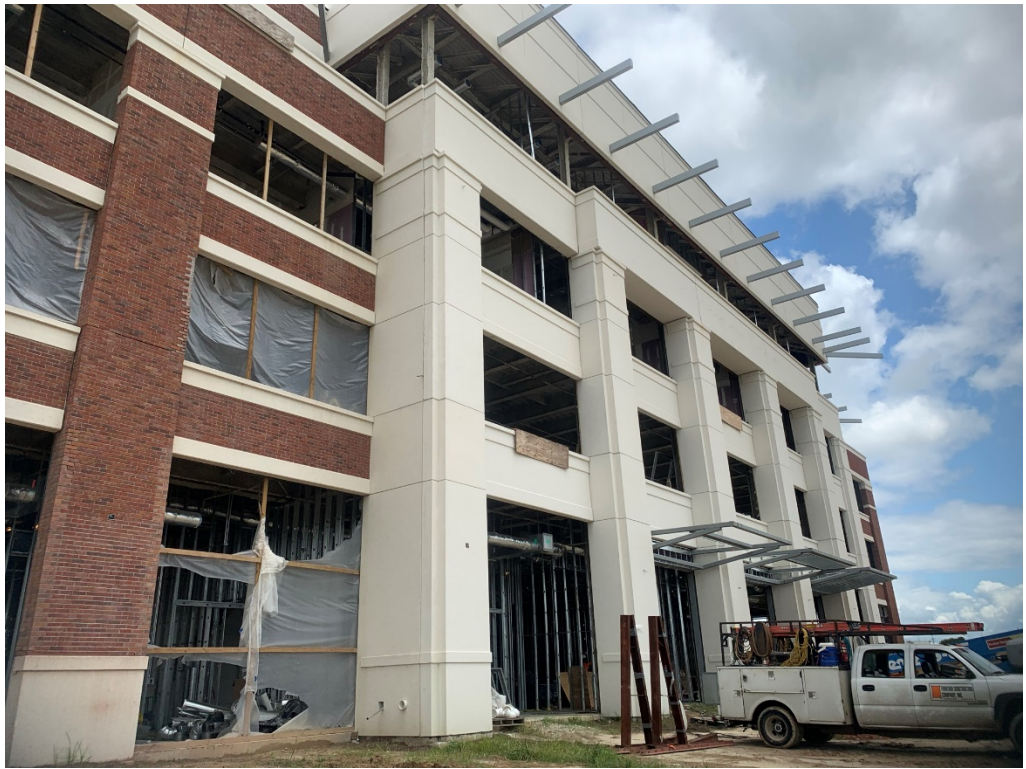
Figure 9 – East Façade Progress

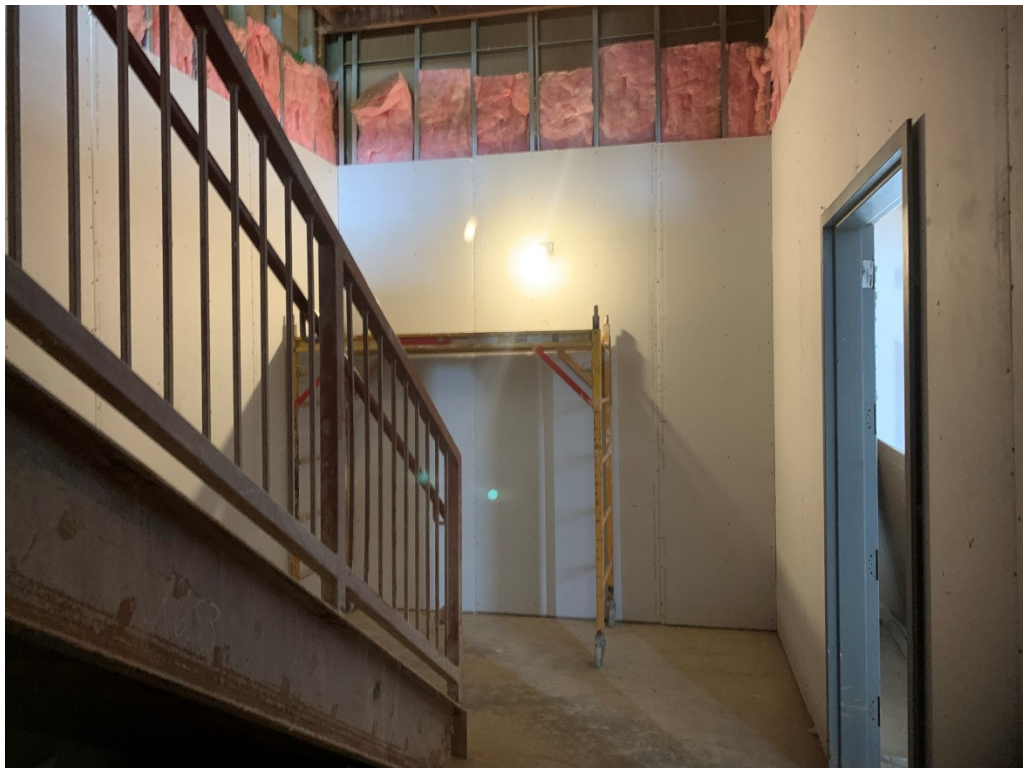
Figure 10 – Drywall Installation at North Stairwell

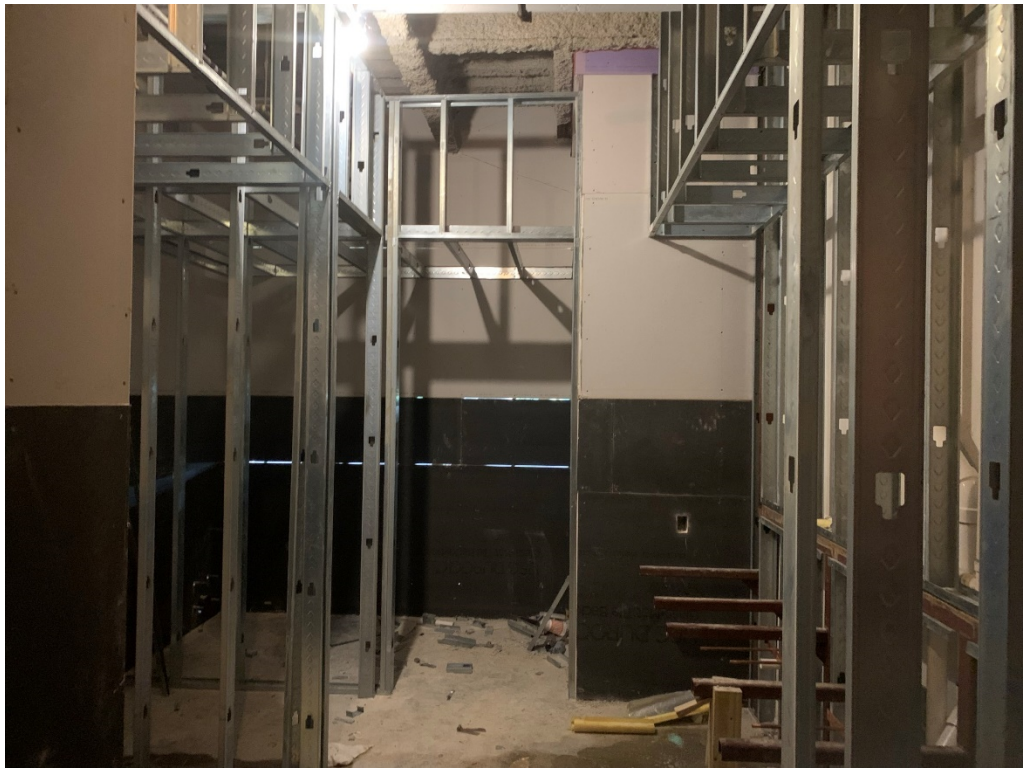
Figure 11 – 2<sup>nd</sup> Floor Bathroom

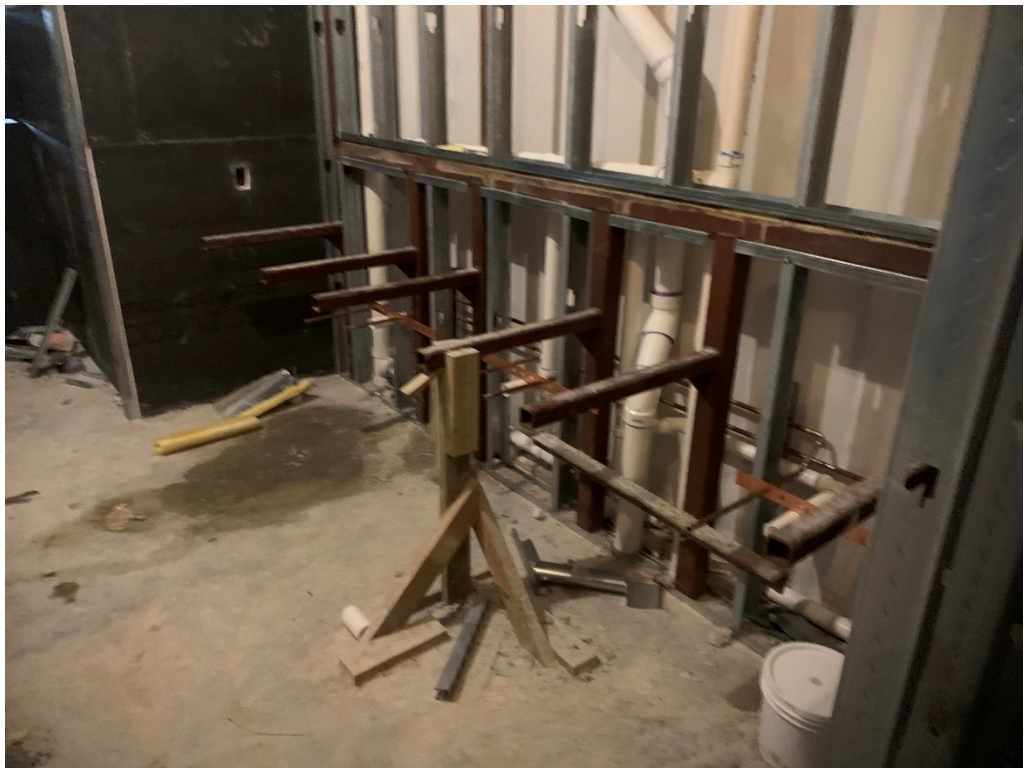
Figure 12 – 2<sup>nd</sup> Floor Bathroom Carriers

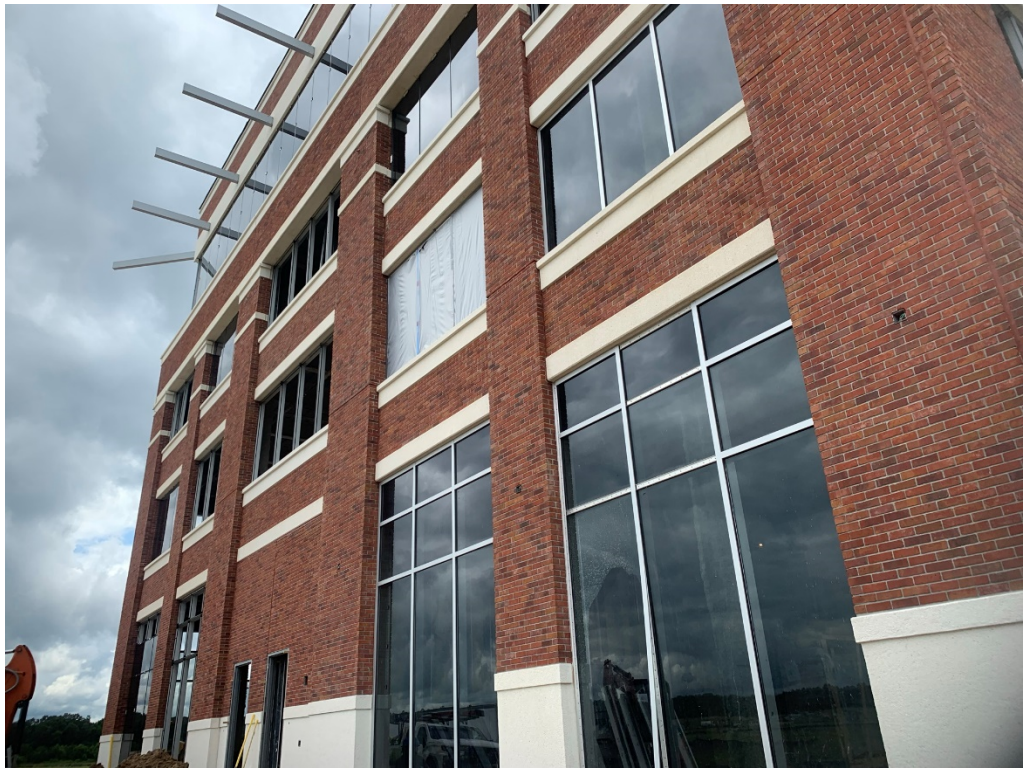
Figure 13 – North Façade Progress

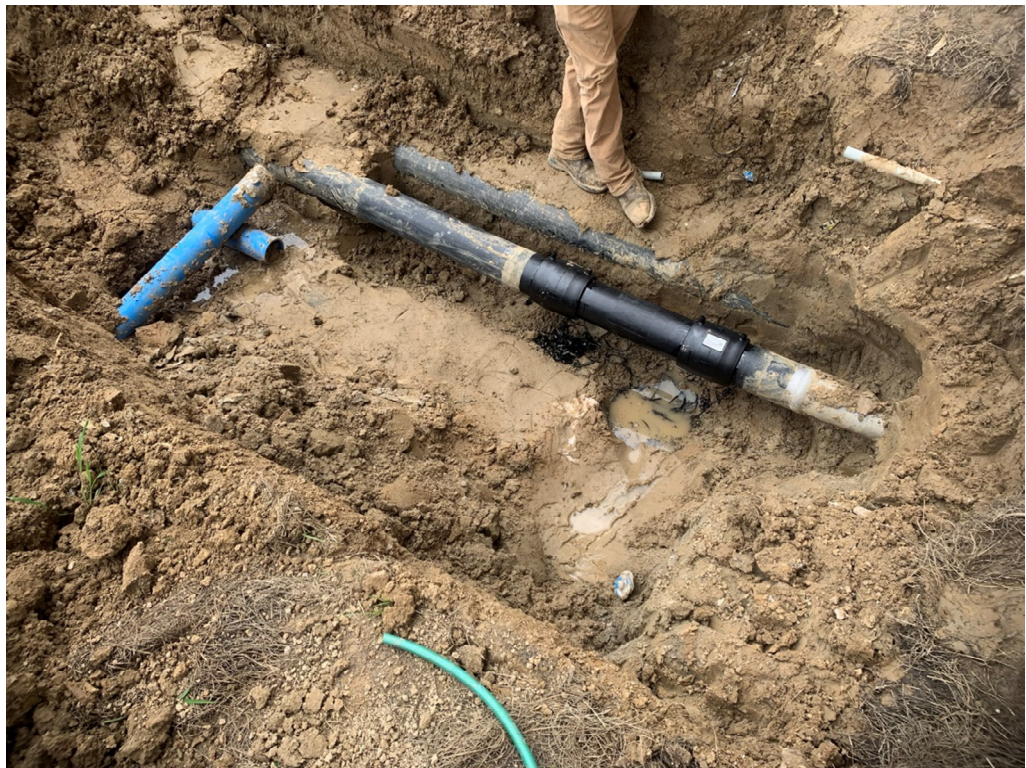
Figure 14 – Below Ground Work at North Facade
