Architect's Field Report

27 July 2021

15094 Community Bank Headquarters / Report Number 018

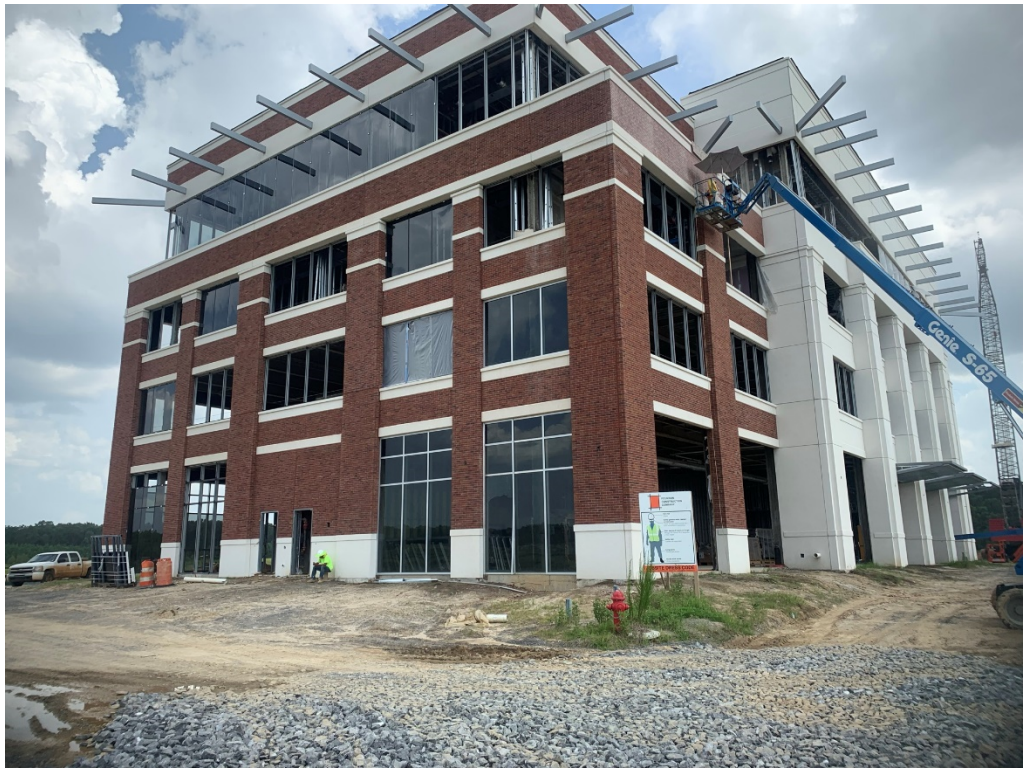
Figure 1 – Northwest Corner Progress

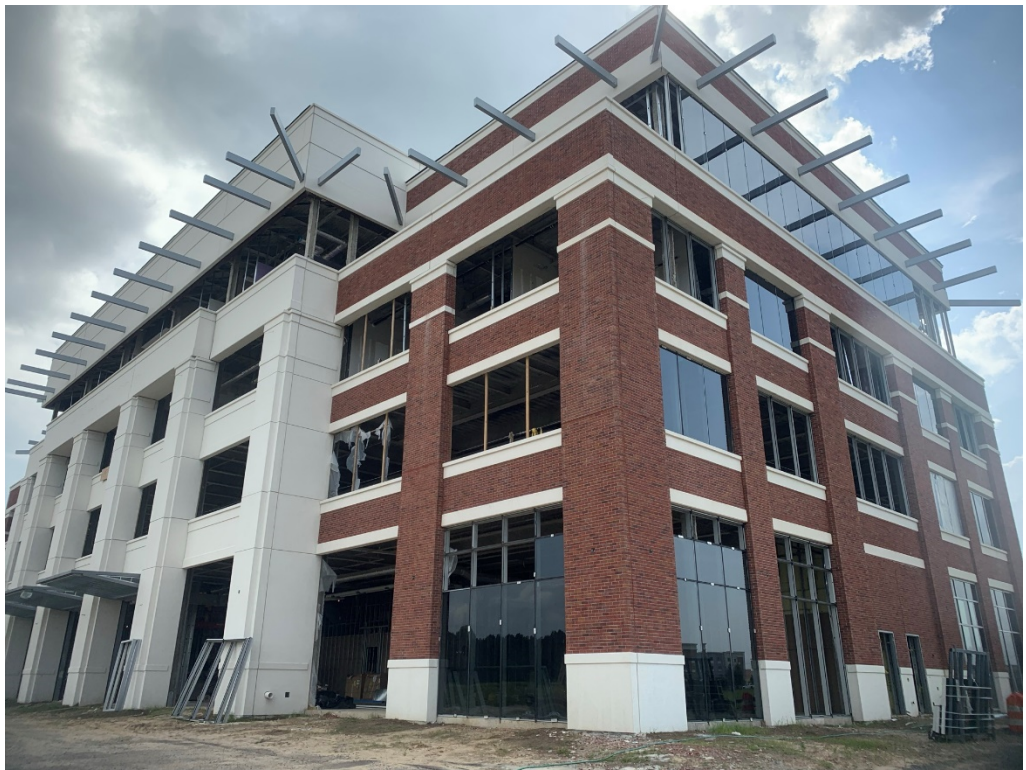
Figure 2 – Northeast Corner Progress

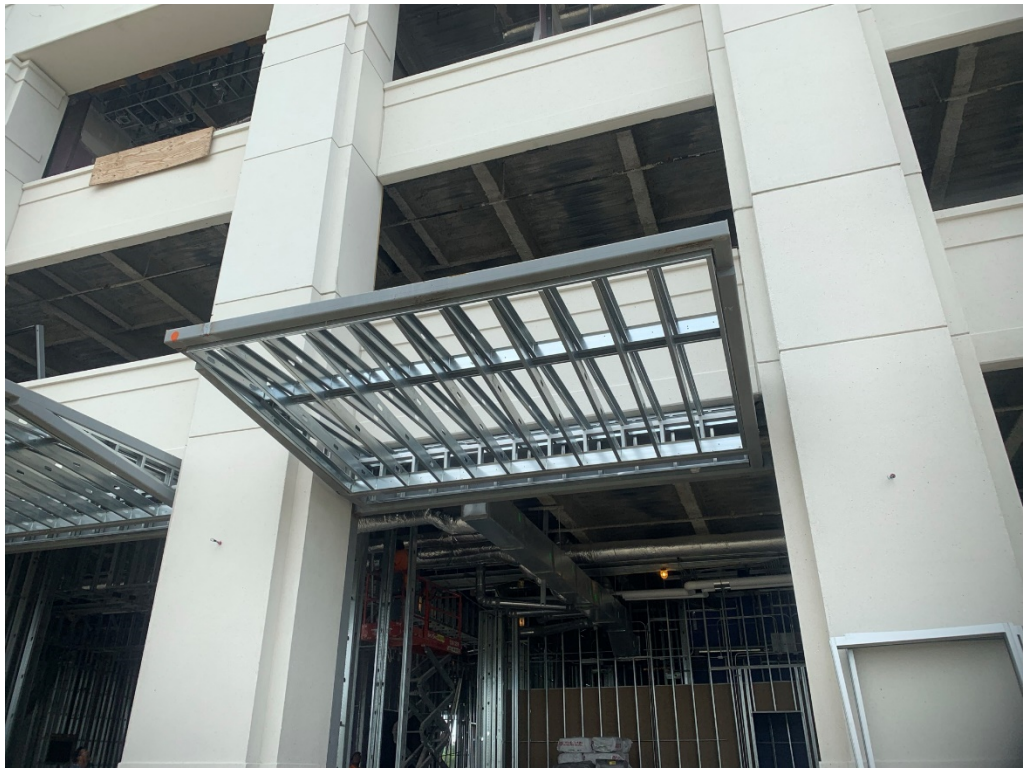
Figure 3 – Framing at Awnings

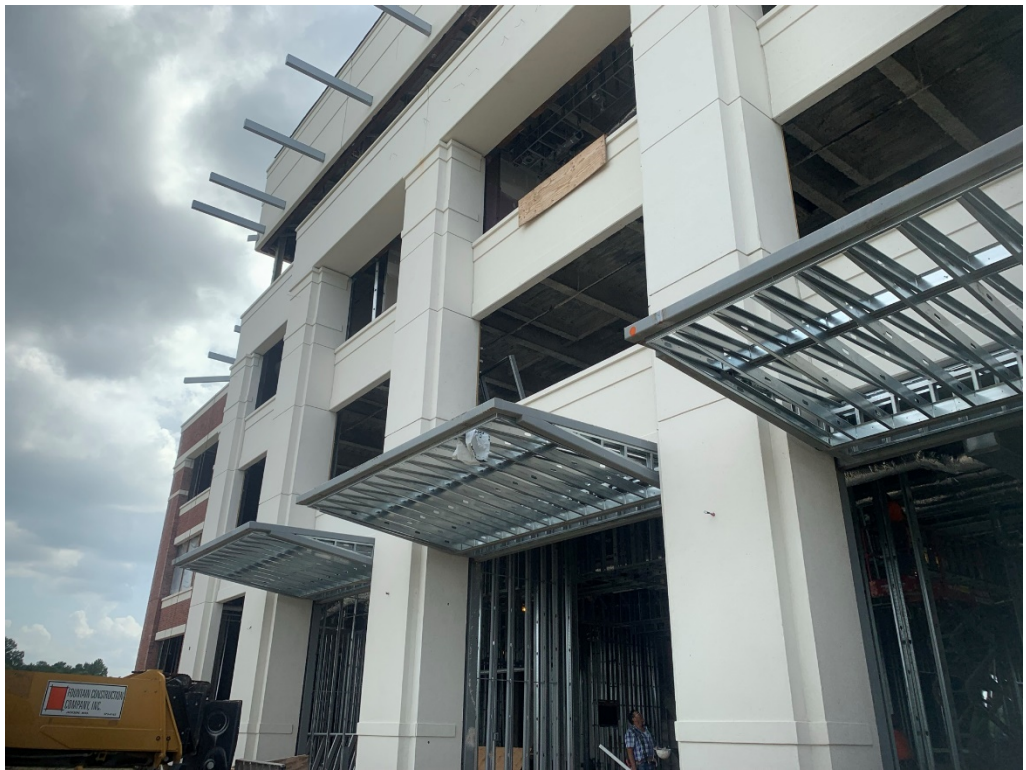
Figure 4 – Framing at Awnings

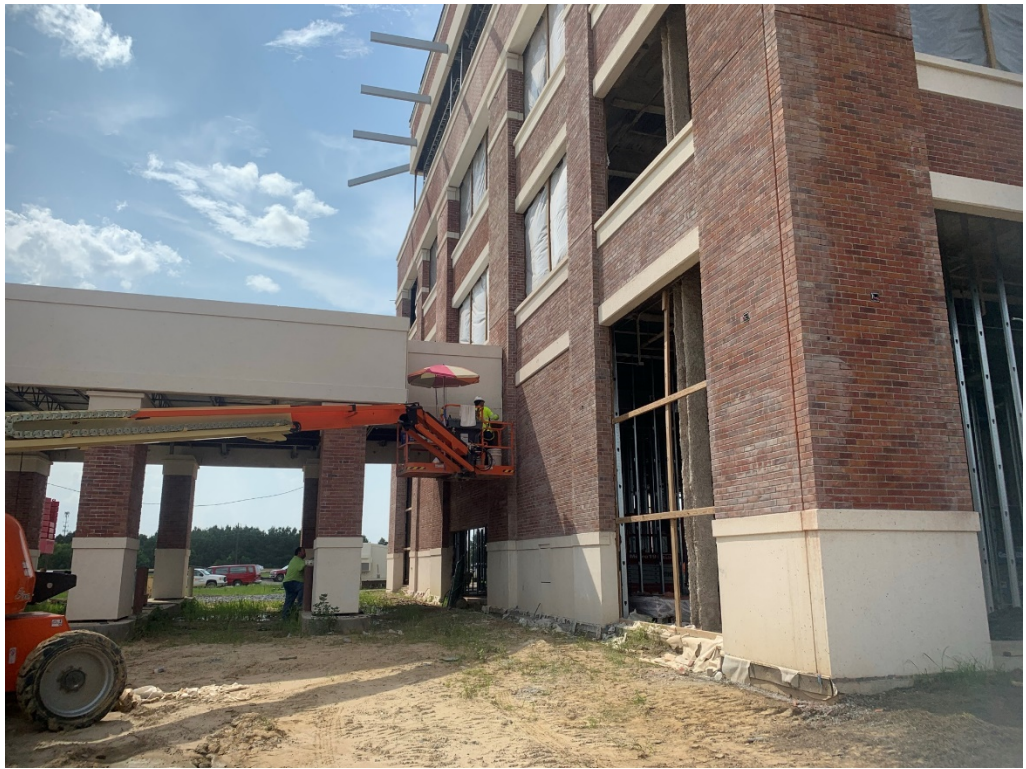
Observations Progress on the building is being made; masons are on site, cleaning up and reworking panels at both the west and south façades. Other work at brick has been performed since my last visit.

Figure 5 – Masonry is Ongoing

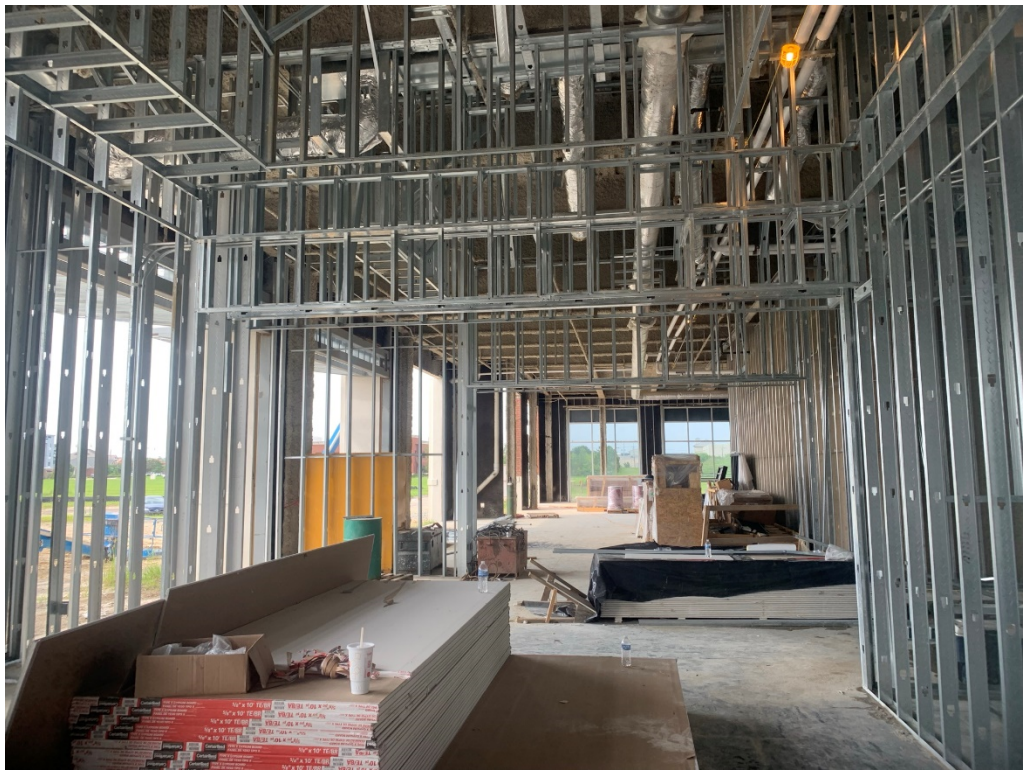
Figure 6 – Ceiling Framing @ 1<sup>st</sup> Floor

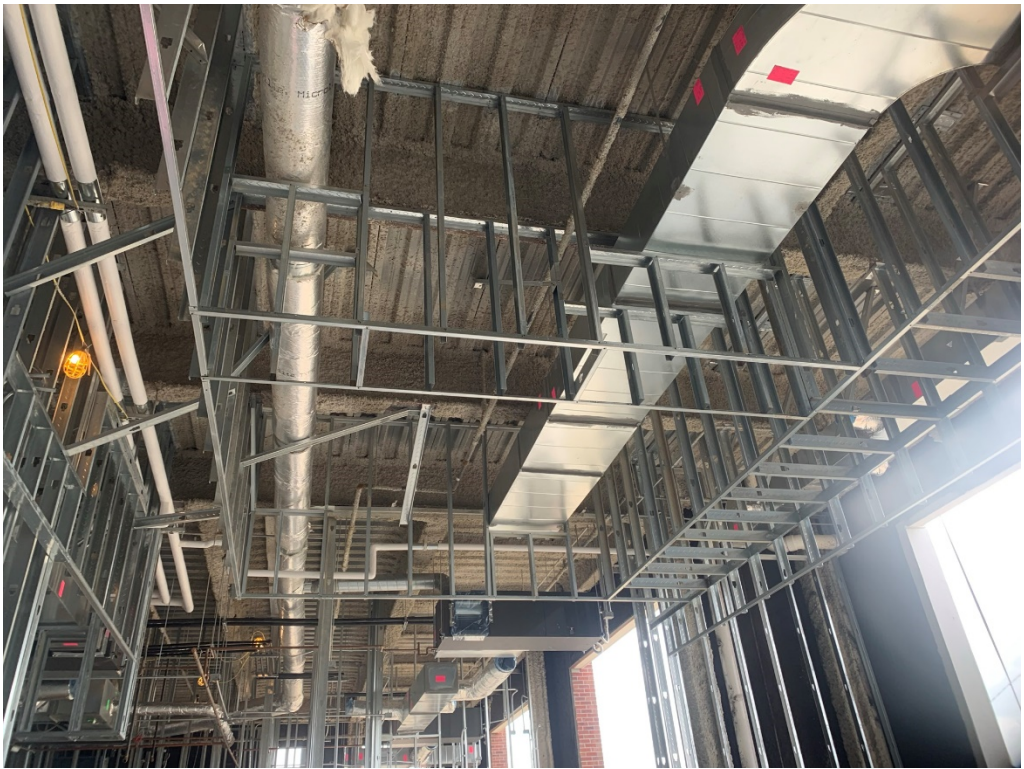
Figure 7 – Ceiling Framing @ 1<sup>st</sup> Floor

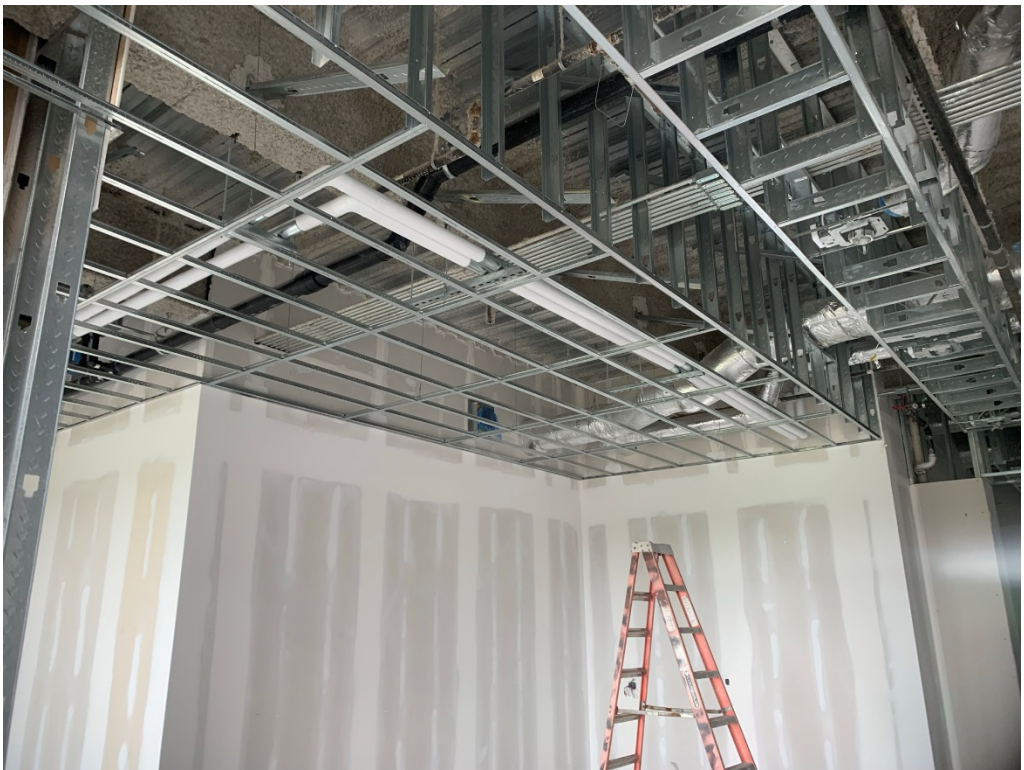
Figure 8 – Ceiling Framing @ 4<sup>th</sup> Floor

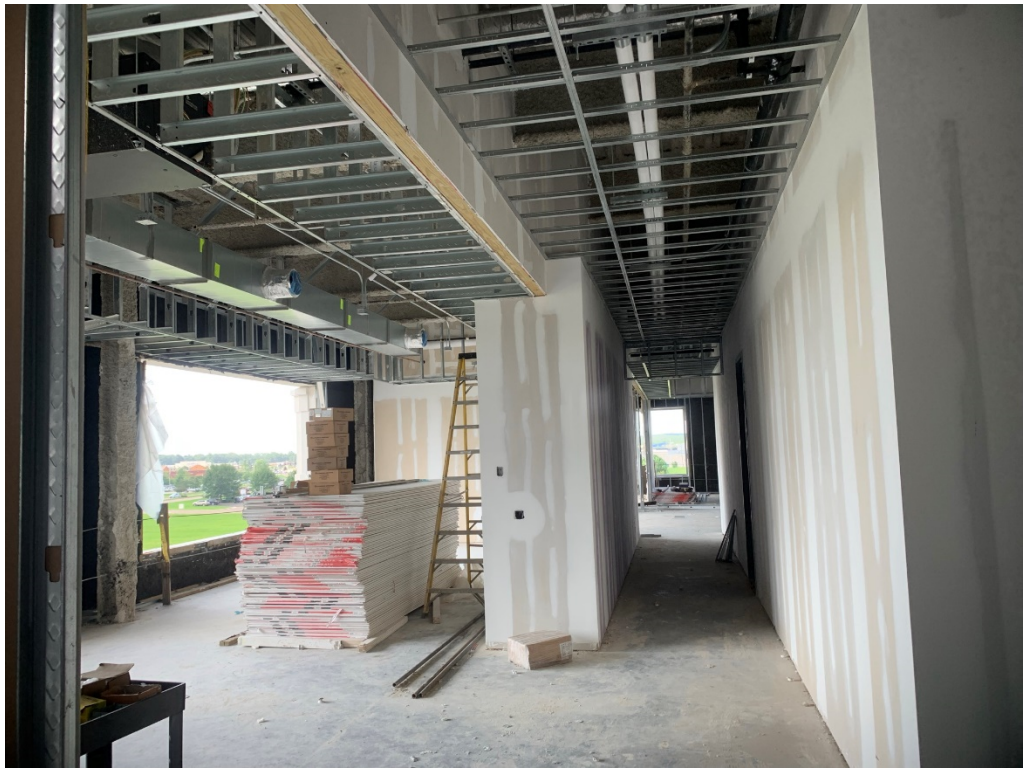
Figure 9 – Ceiling Framing @ 4<sup>th</sup> Floor

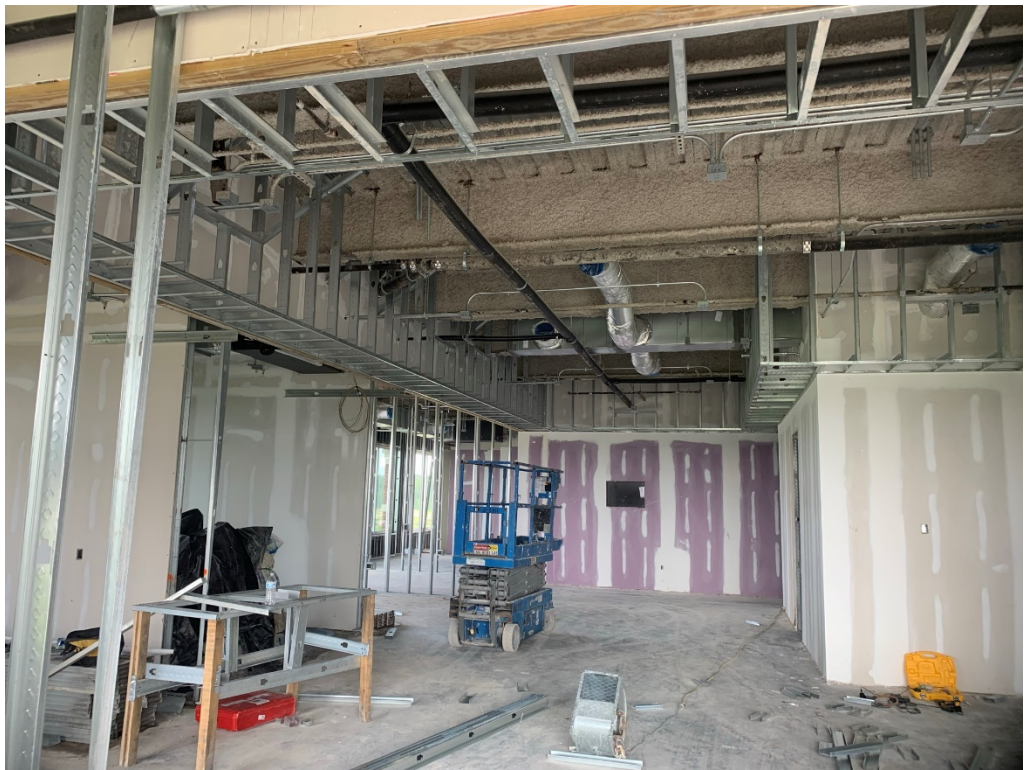
Figure 10 – Ceiling Framing @ 4<sup>th</sup> Floor
