## Architect's Field Report

30 July 2021

15094 Community Bank Headquarters / Report Number 019

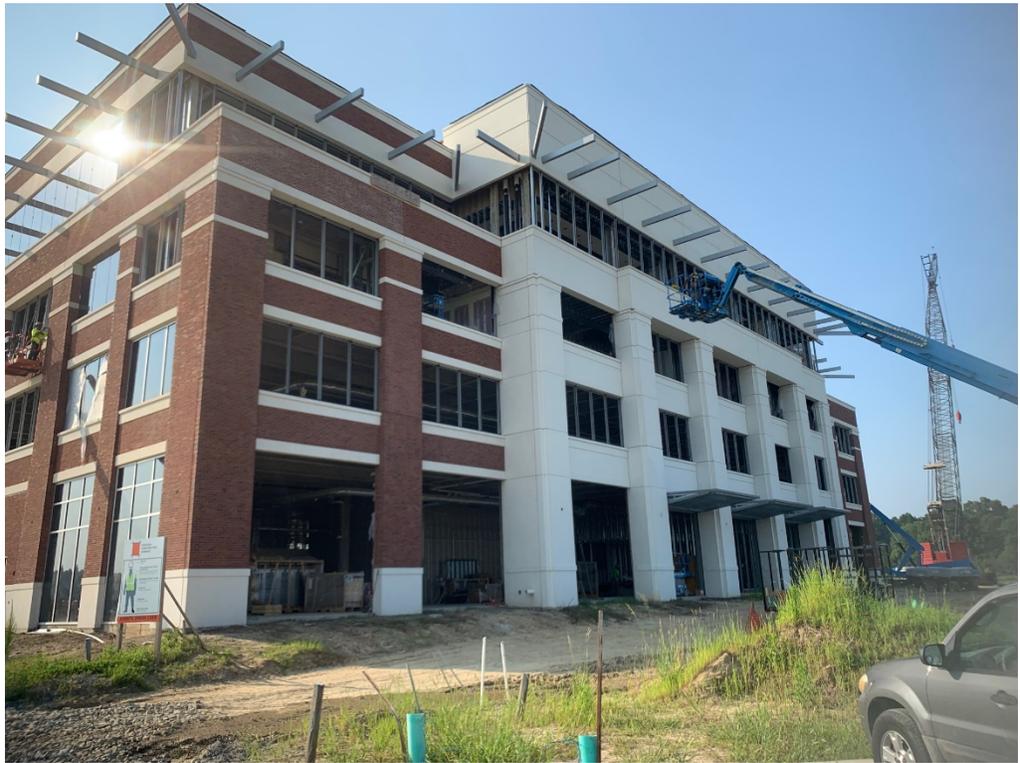
**Observations** On site, workers were busy in several areas inside and out. Curtain wall framing is going in according to schedule. Concerning framing, the north side is complete and it appears that the west is at least 40% done. If this pace is maintained, they should be on schedule to complete curtain walls frames by mid-august. I spoke with Robert clay about the glass for all of this and he anticipates that over 50% will be installed by the end of August. Electricians were also at work on the south façade, drilling through wall panels for lighting circuits.

Figure 1 – West Façade Progress

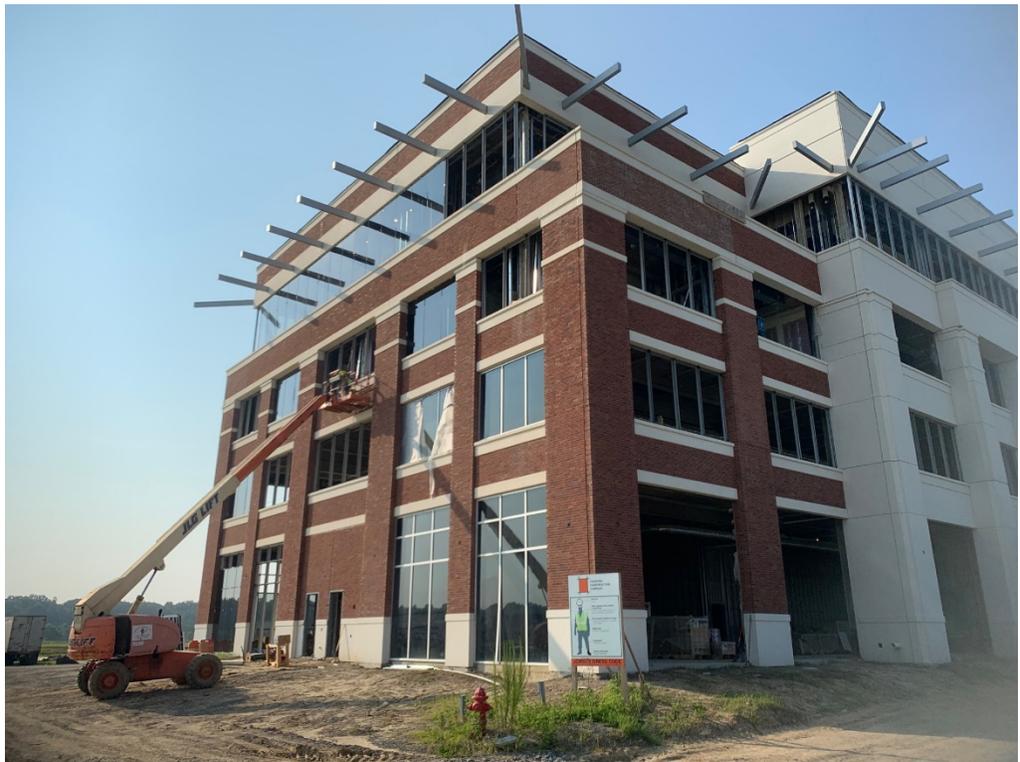
Figure 2 – North Façade Progress

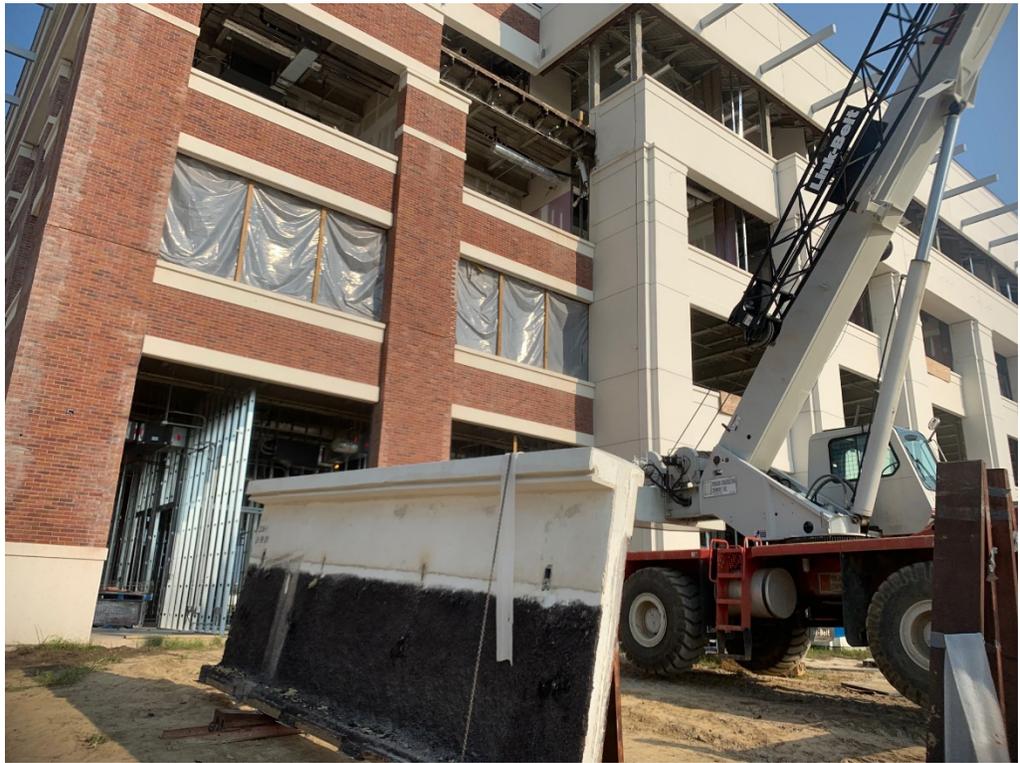
Figure 3 – Removed Panel for Resetting

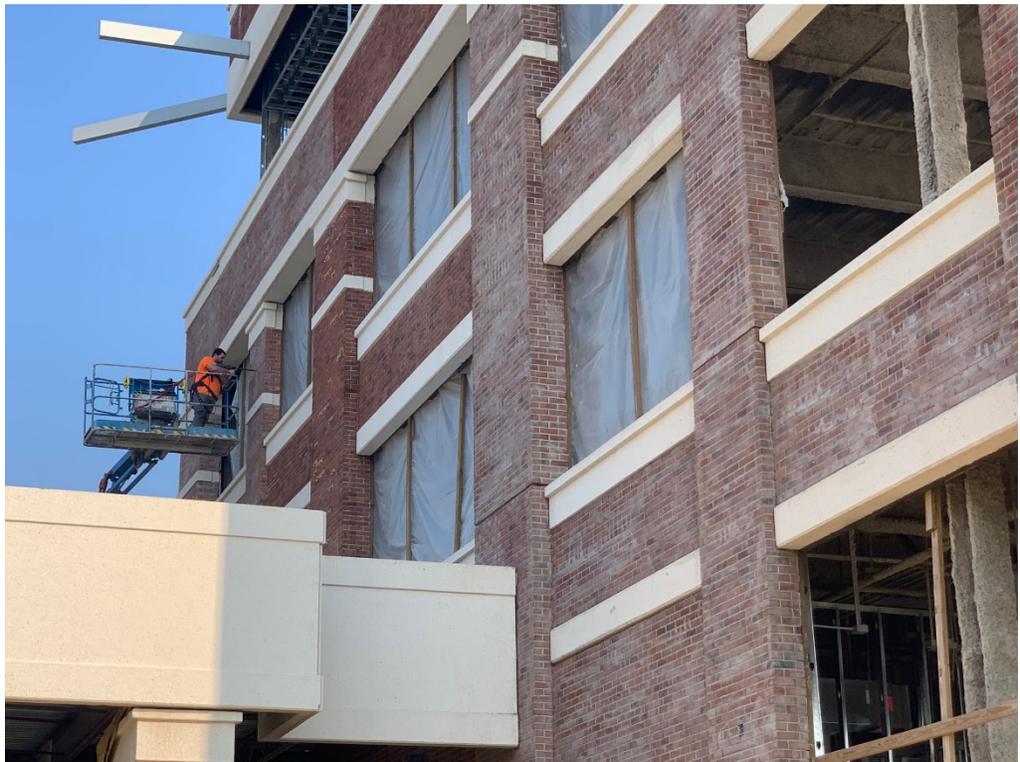
Figure 4 – Electricians Installing Circuits

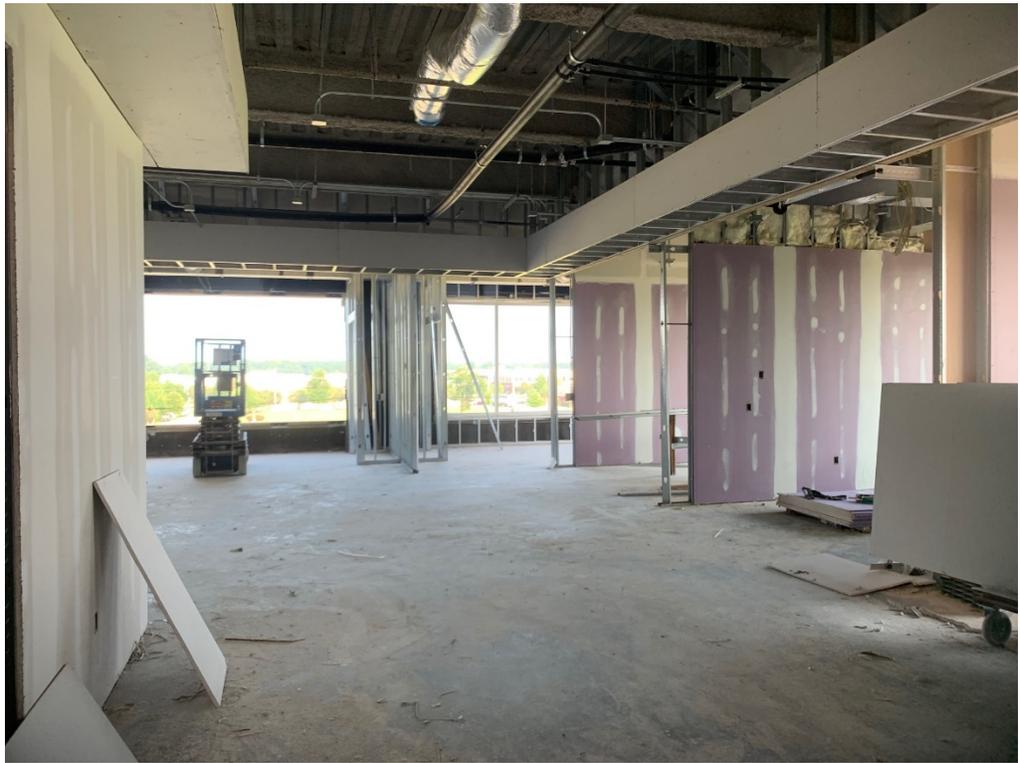
Figure 5 – 3<sup>rd</sup> Floor Drywall & Framing are Ongoing

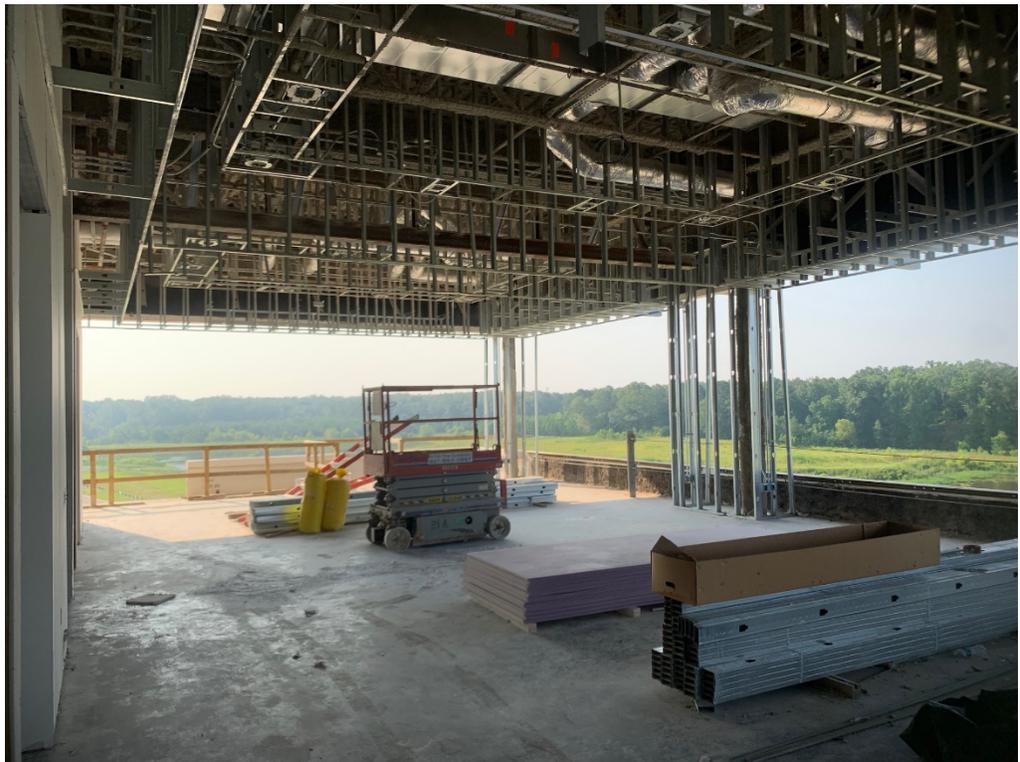
Figure 6 – Banquet Room Progress

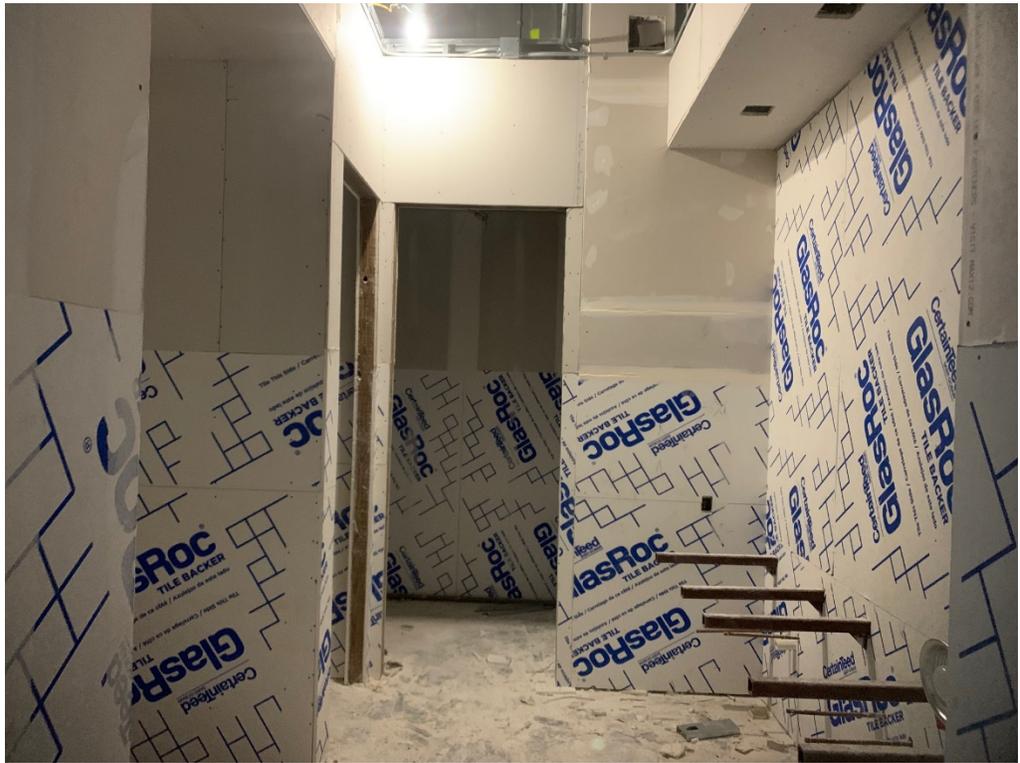
Figure 7 – 3<sup>rd</sup> Floor Bathroom Progress

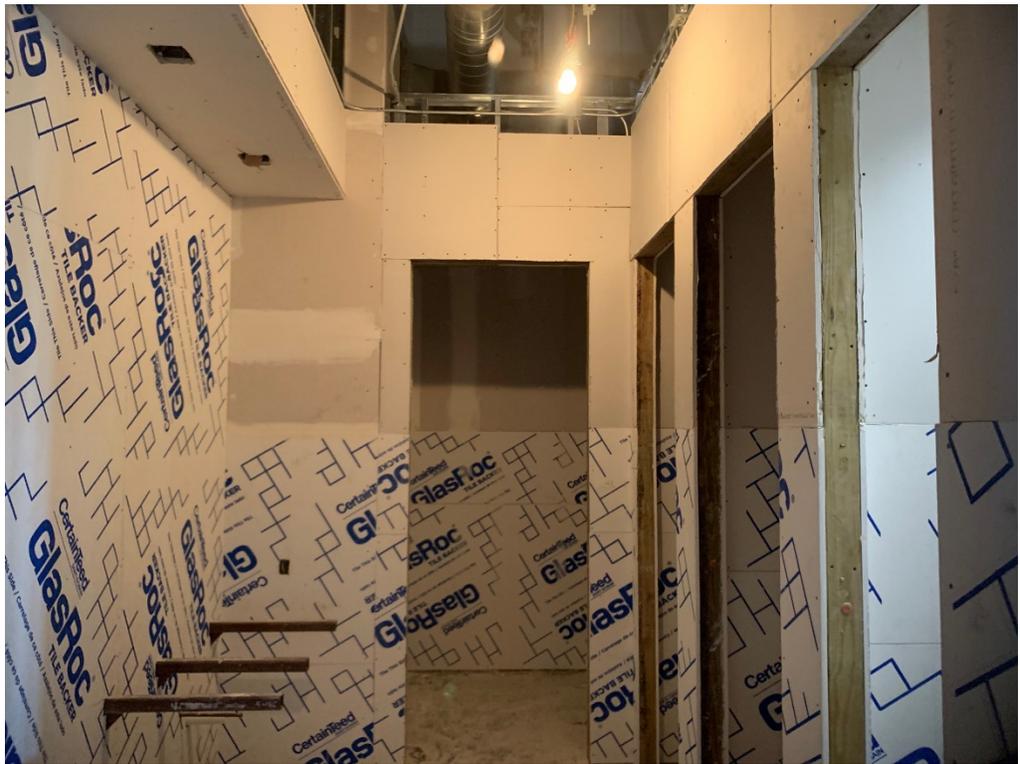
Figure 8 – 3<sup>rd</sup> Floor Bathroom Progress

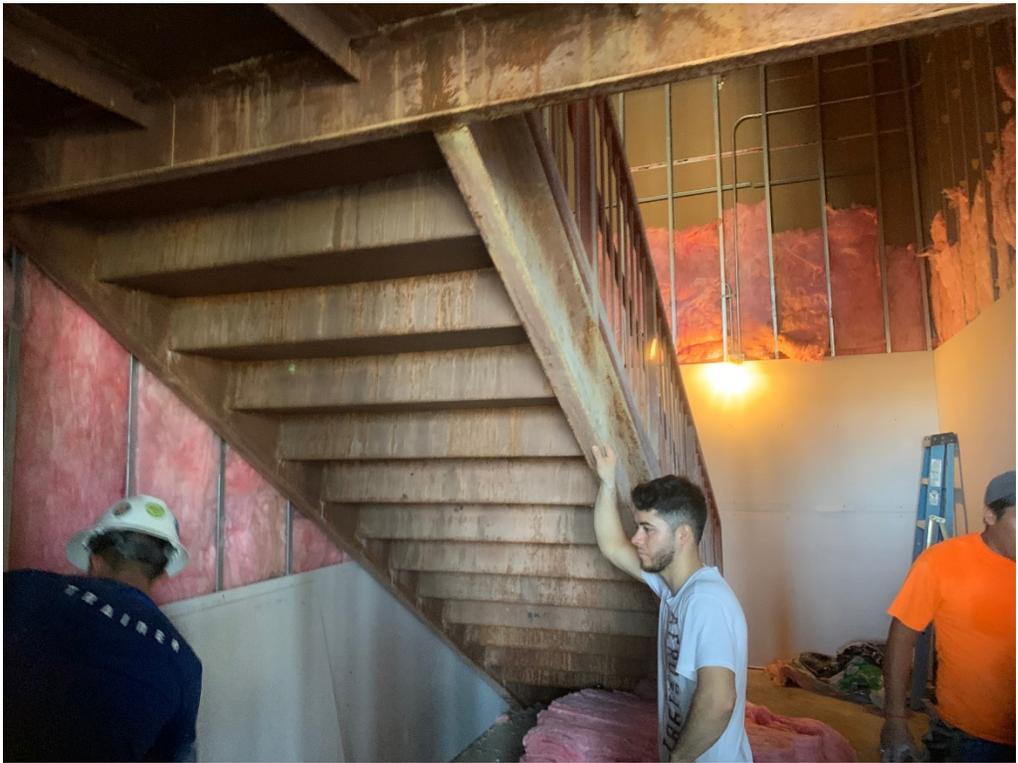
Figure 9 – Drywall Installation at North Stairwell

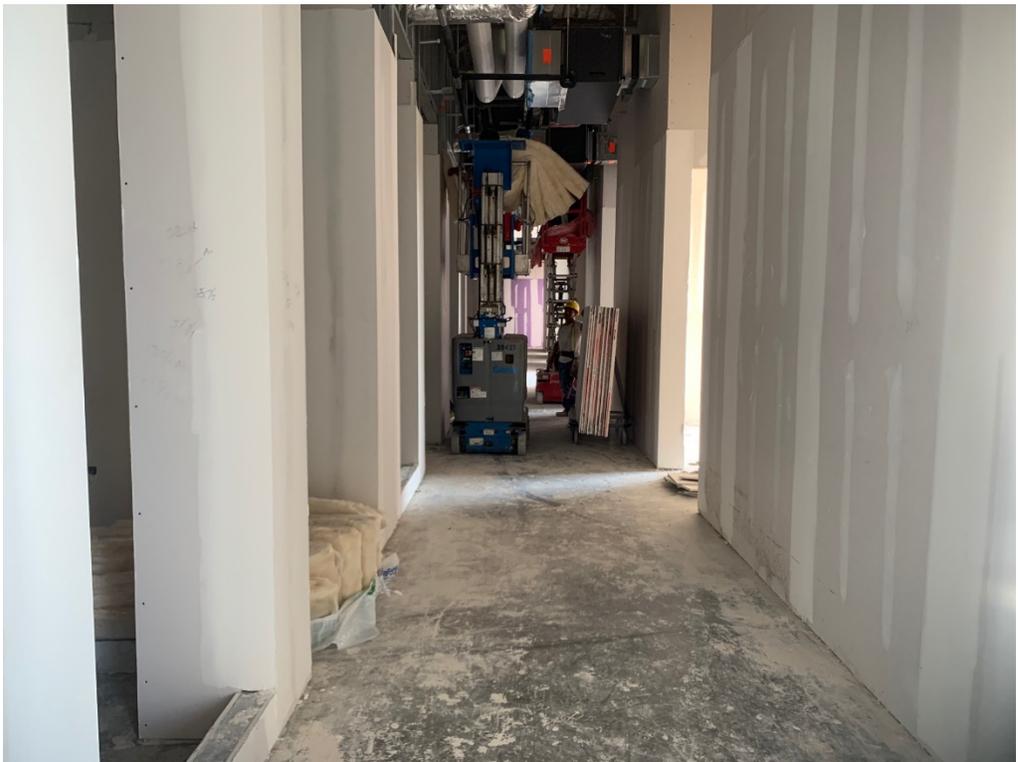
Figure 10 – Insulation Installers at 4<sup>th</sup> Floor
