Architect's Field Report

6 August 2021

15094 Community Bank Headquarters / Report Number 020

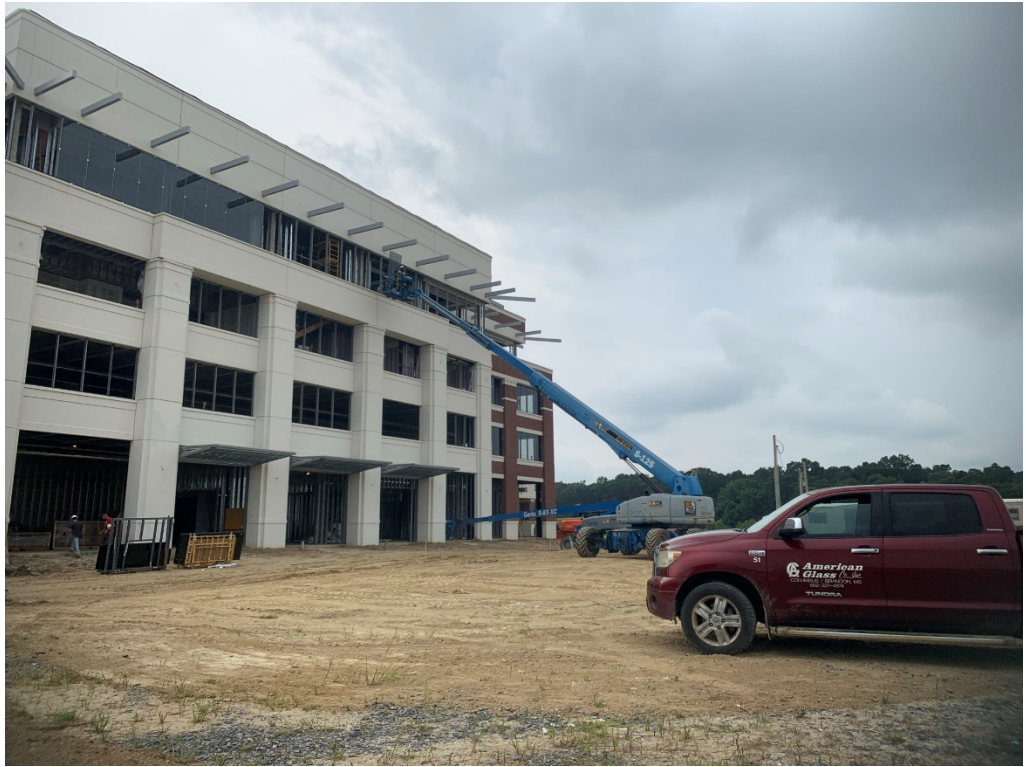
Observations Arriving on site, I entered the west yard, which has been cleared and graded and looks to be in good condition. The glass contractor was parked out here and had a crew on a boom, installing glass panels at the 4<sup>th</sup> floor on the western façade. Around the east side of the building, glass is being stored from a recent delivery. It is a large order and appears to be in good condition.

Figure 1 – Glazing Install is Ongoing

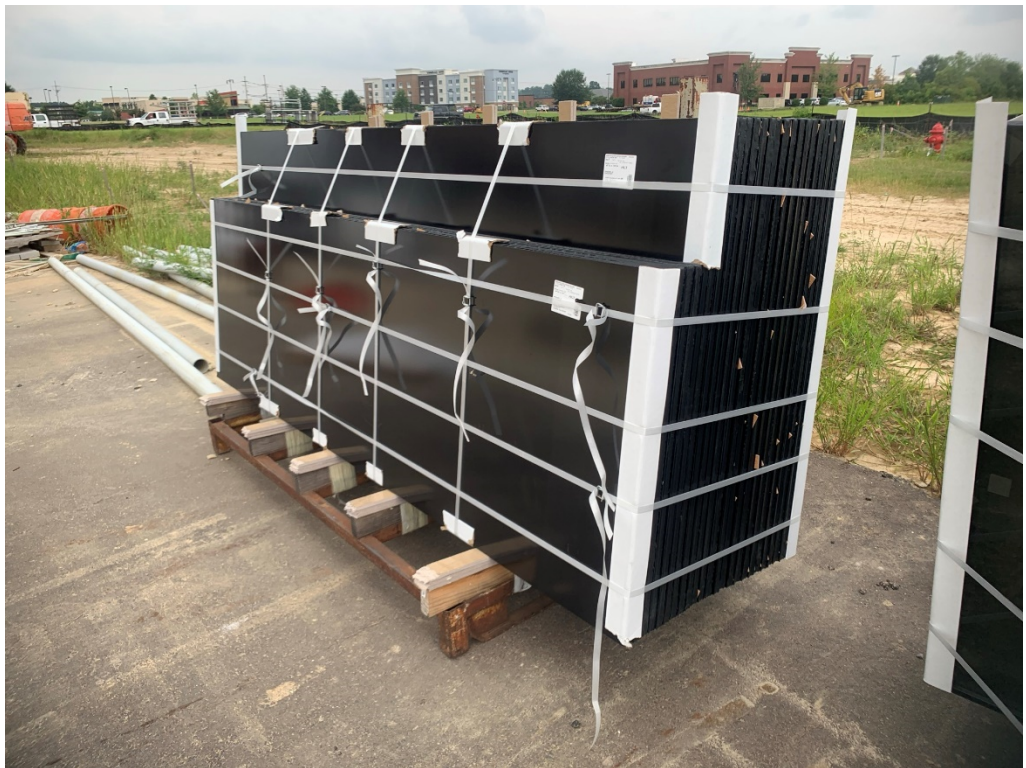
Figure 2 – Received Glazing

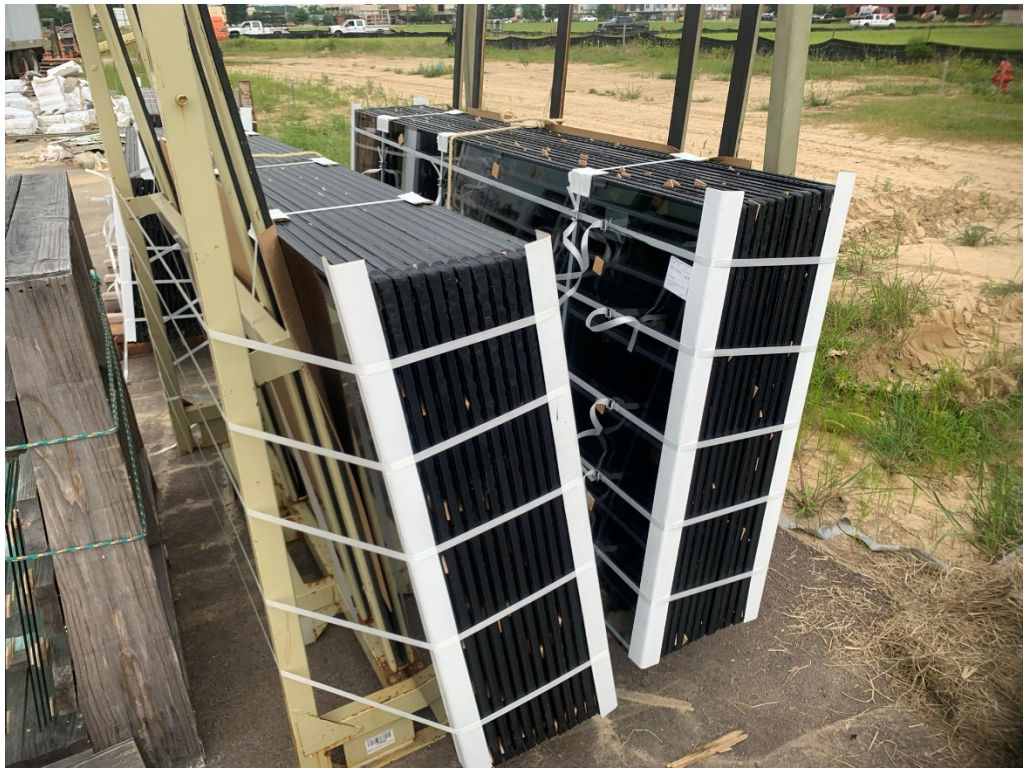
Figure 3 – Received Glazing

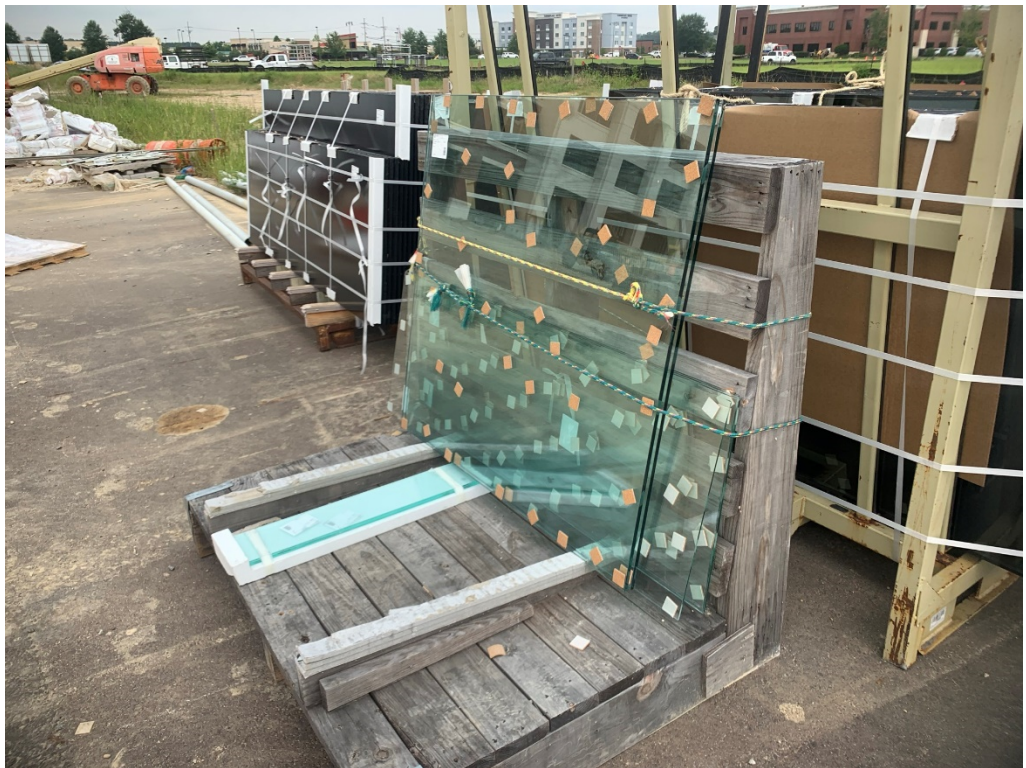
Figure 4 – Received Glazing

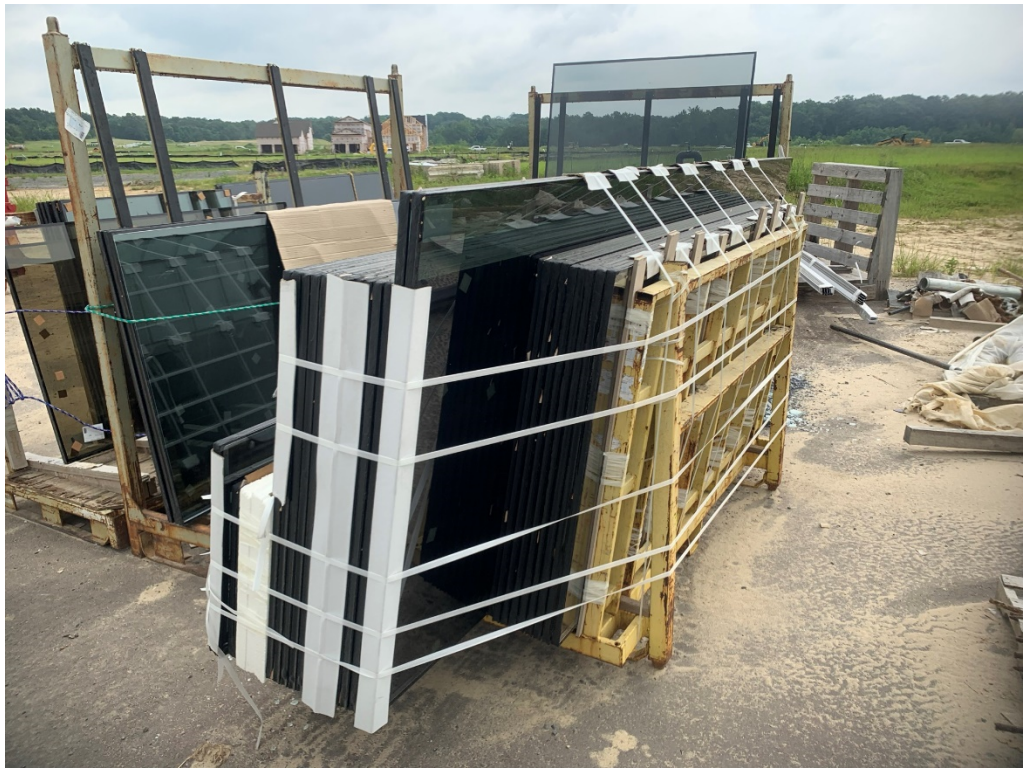
Figure 5 – Received Glazing

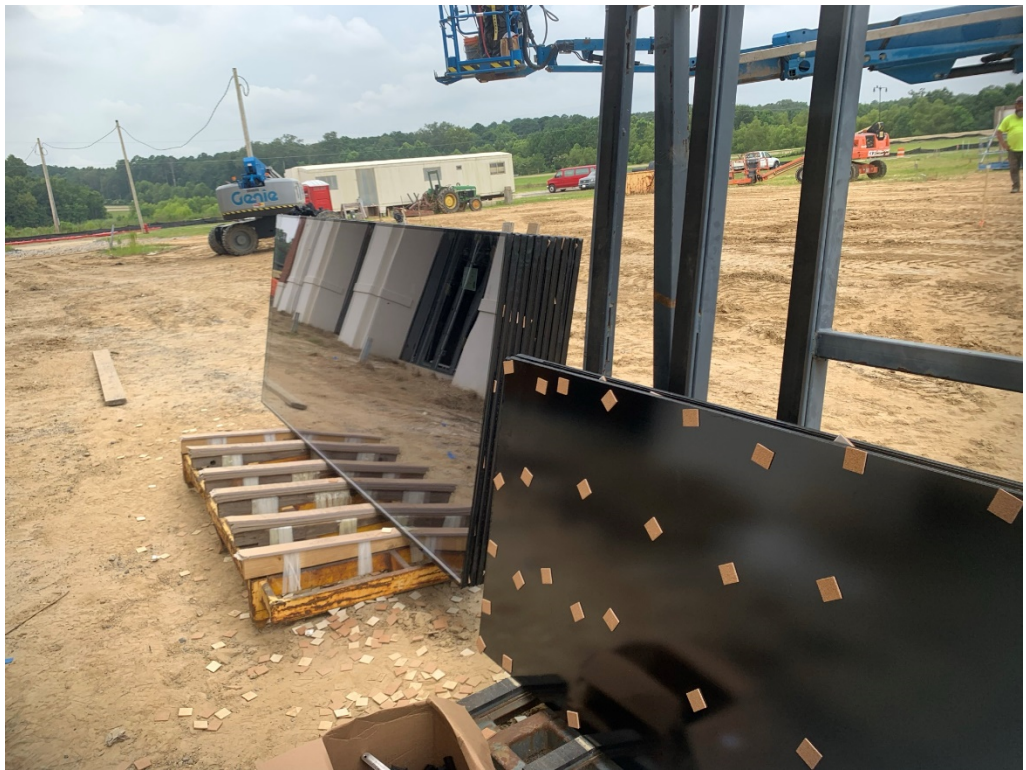
Figure 6 – Received Glazing

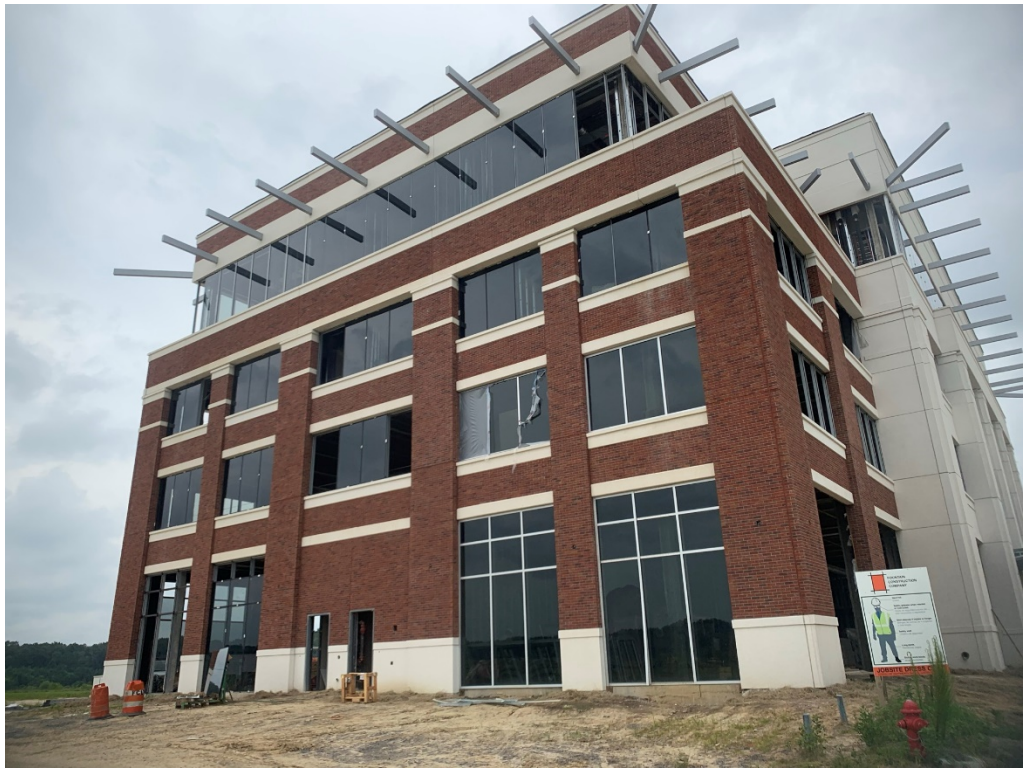
Figure 7 – North Façade Glazing Progress

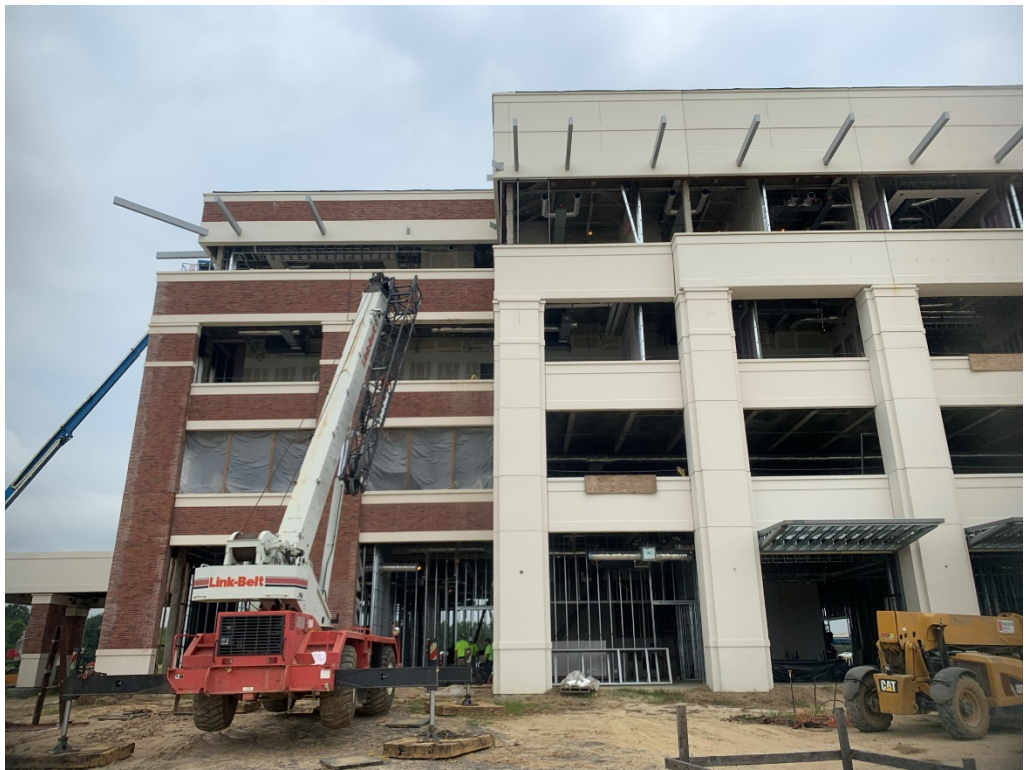
Figure 8 – Reinstalled and Straightened Panels (appear in good condition)

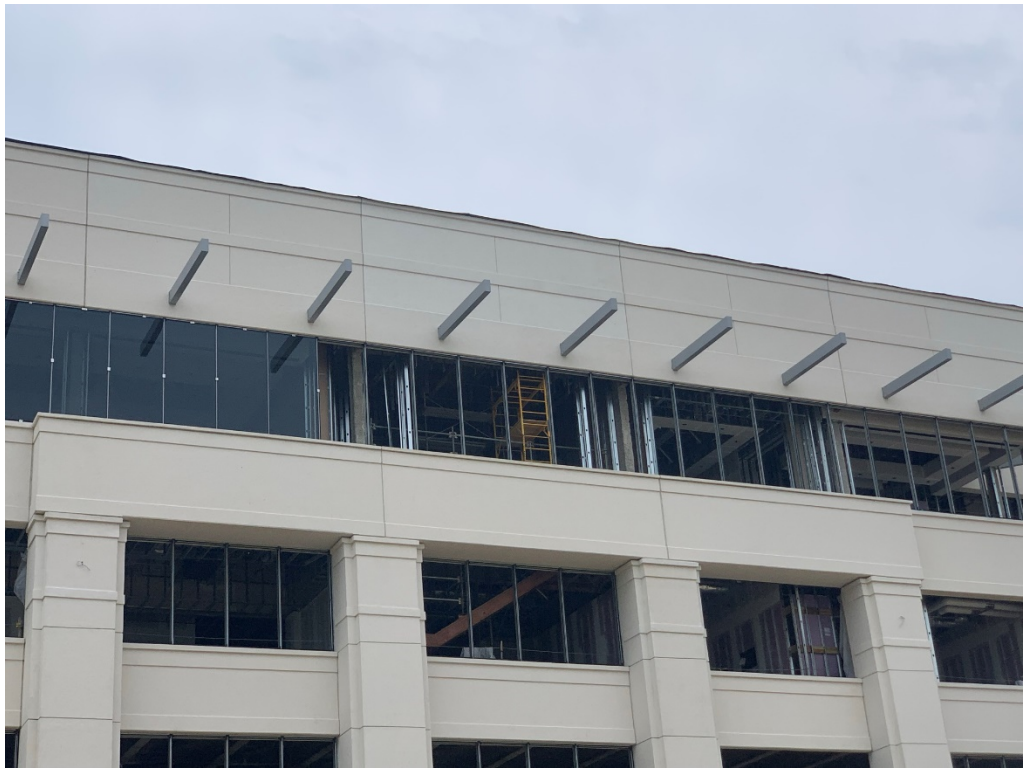
Remediation work at the façade's panels is ongoing. Workers were on the south side of the building; the south façade appears to be most reworked but still requires cleaning. Around to the western face of the building, patching and other remediation work is still to be done.

Figure 9 – Discolored Panel Remediation is Ongoing

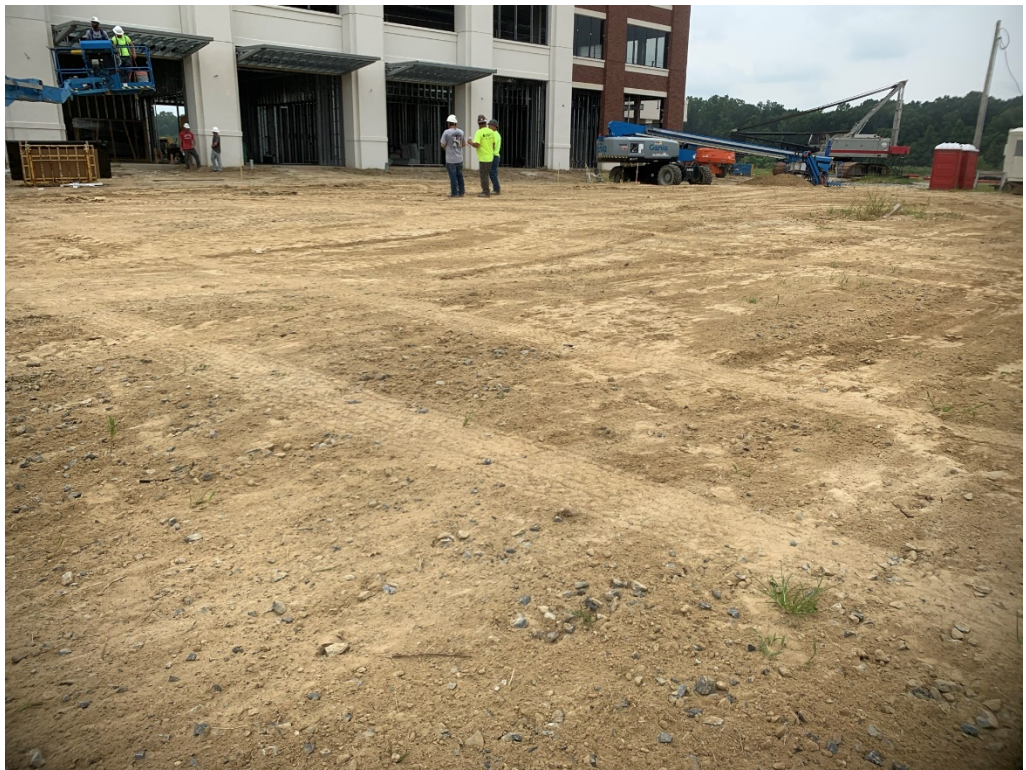
Figure 10 – West Front Yard Grading and Clean Up

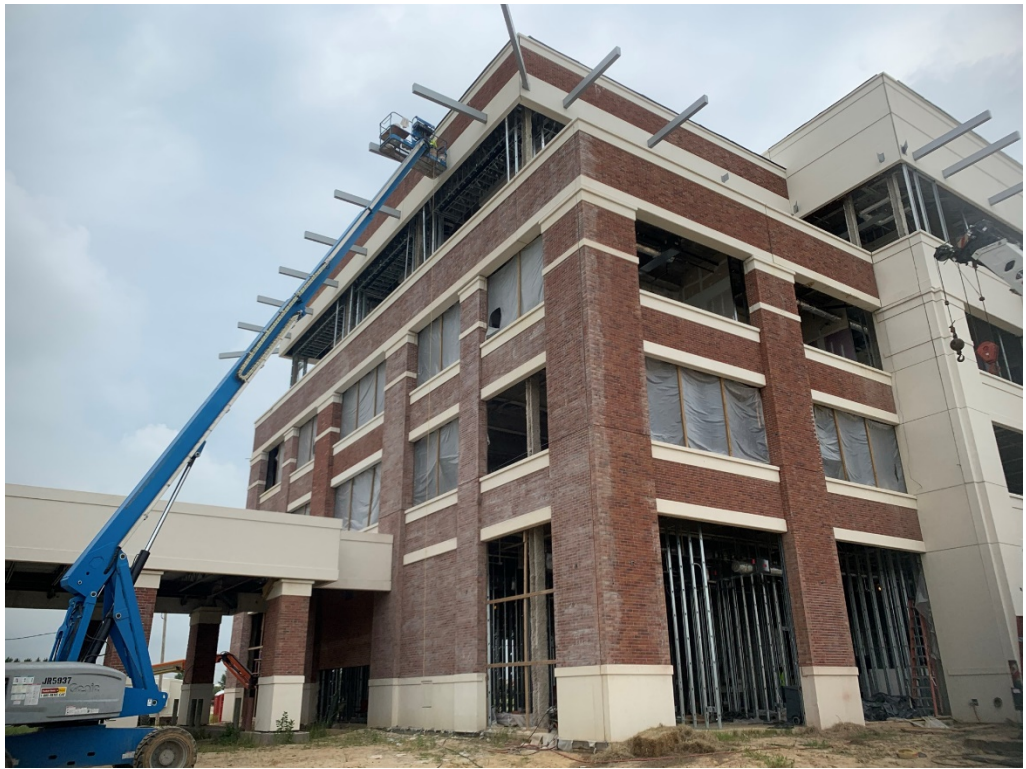
Figure 11 – Remediation work is Ongoing

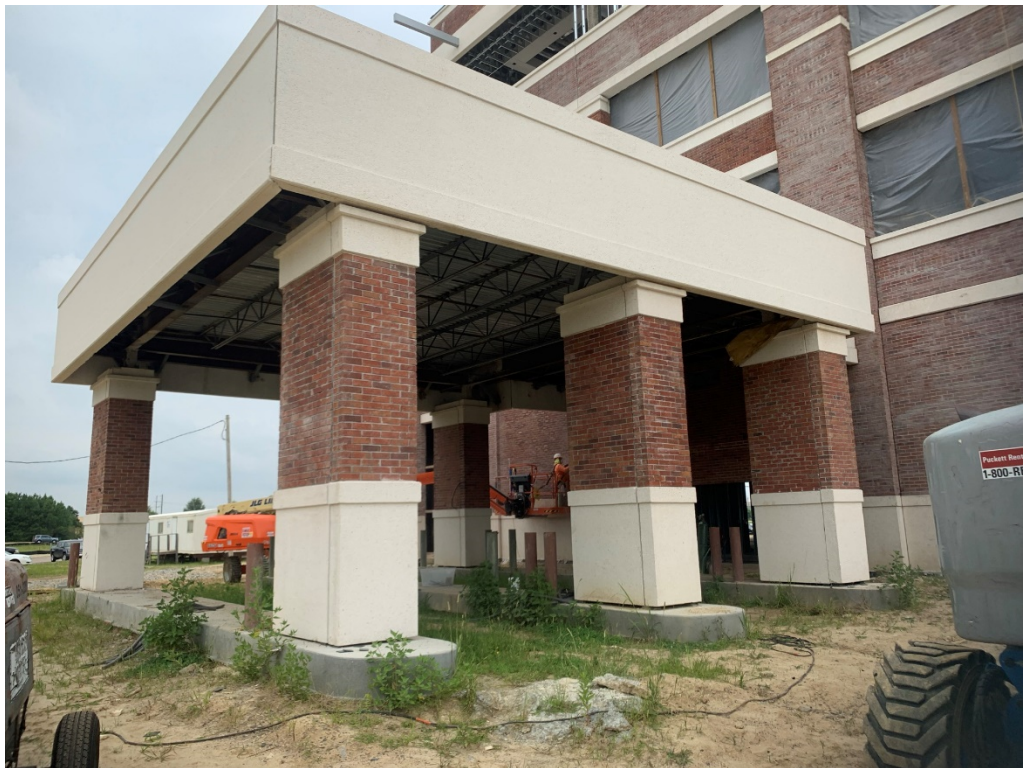
Figure 12 – Drive Thru Progress

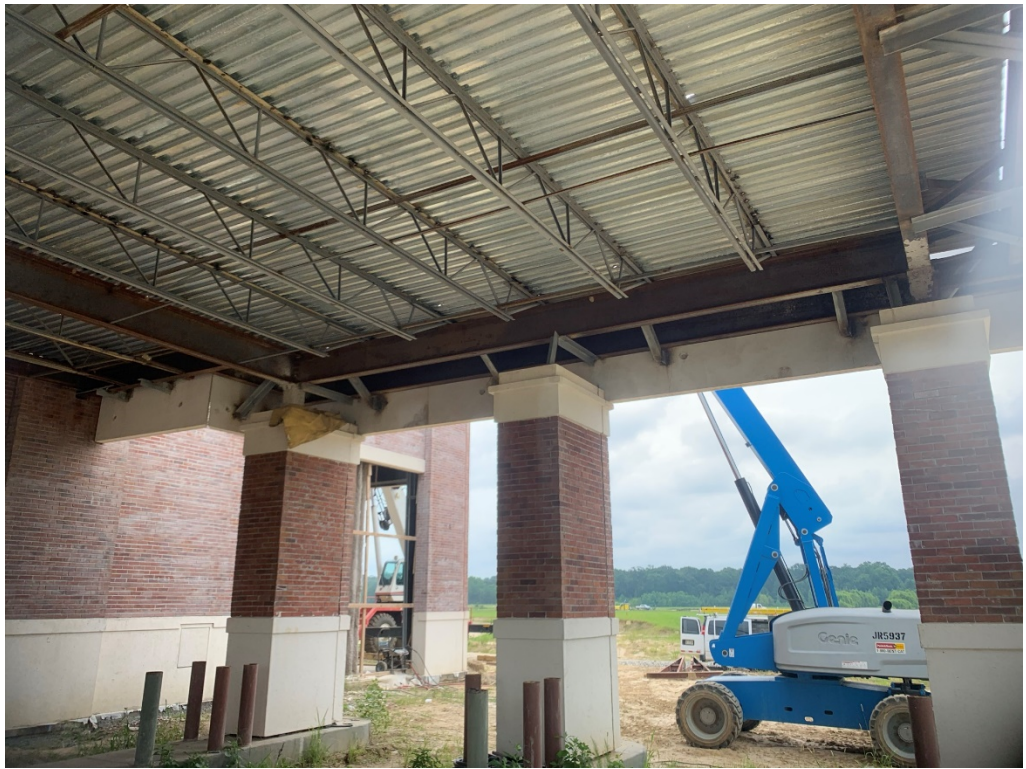
Figure 13 – Structure @ Drive Thru

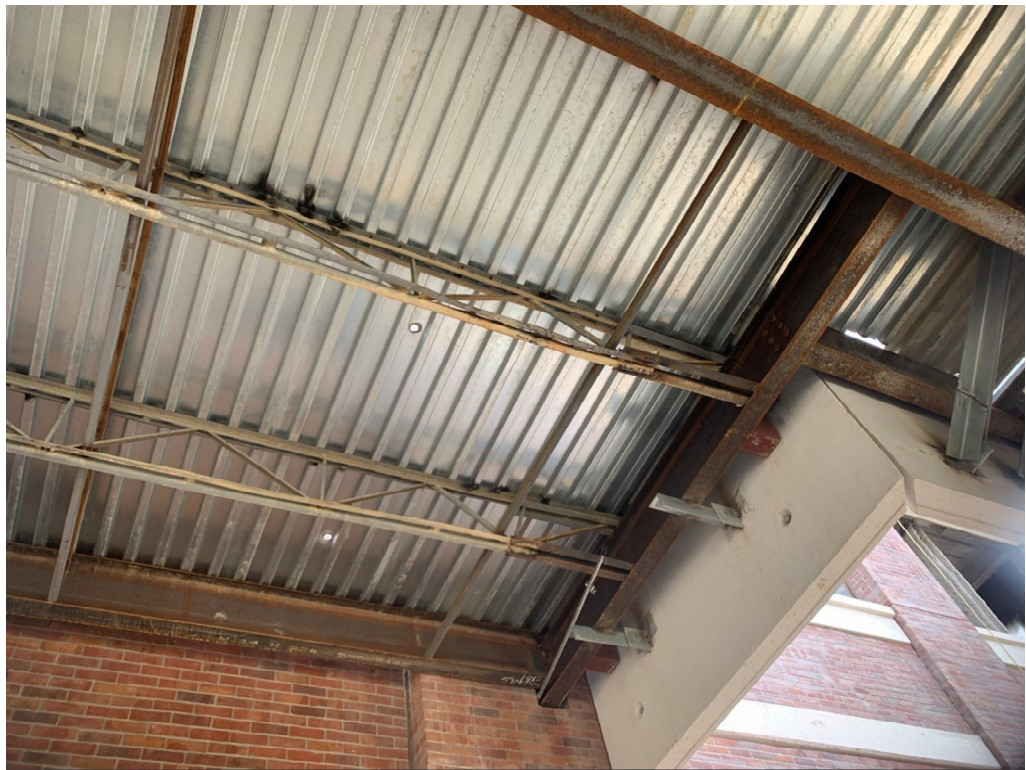
Figure 14 – Structural Repair at Drive Thru

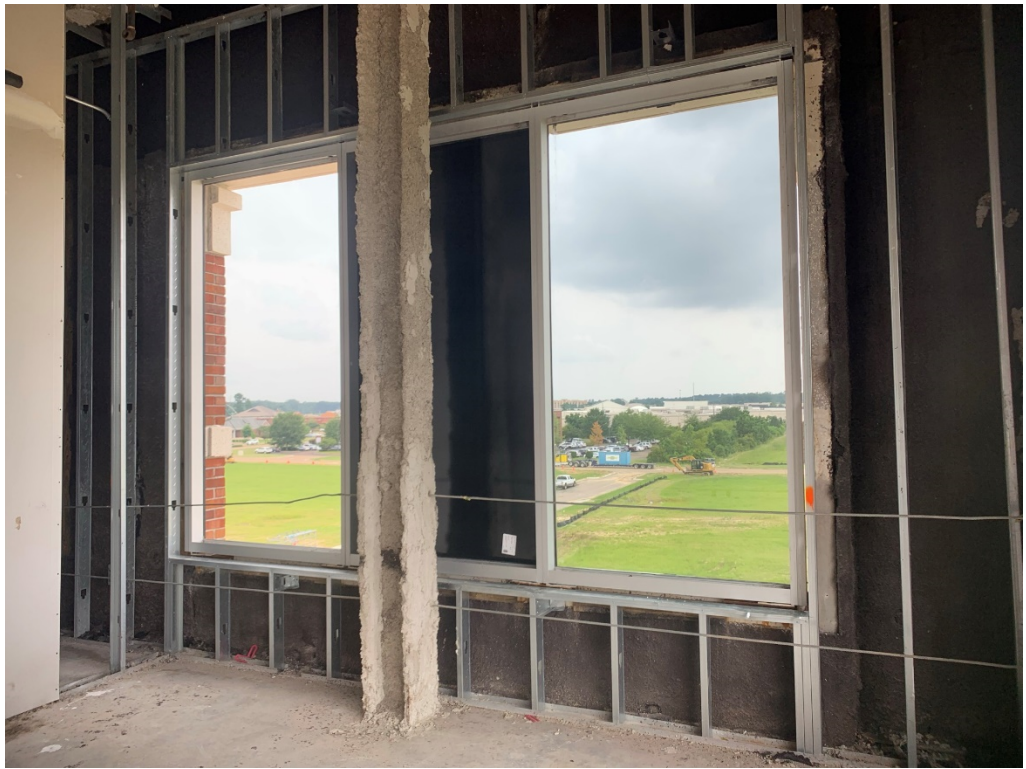
Figure 15 – Spandrel Glass Panels installed at Column Glazing

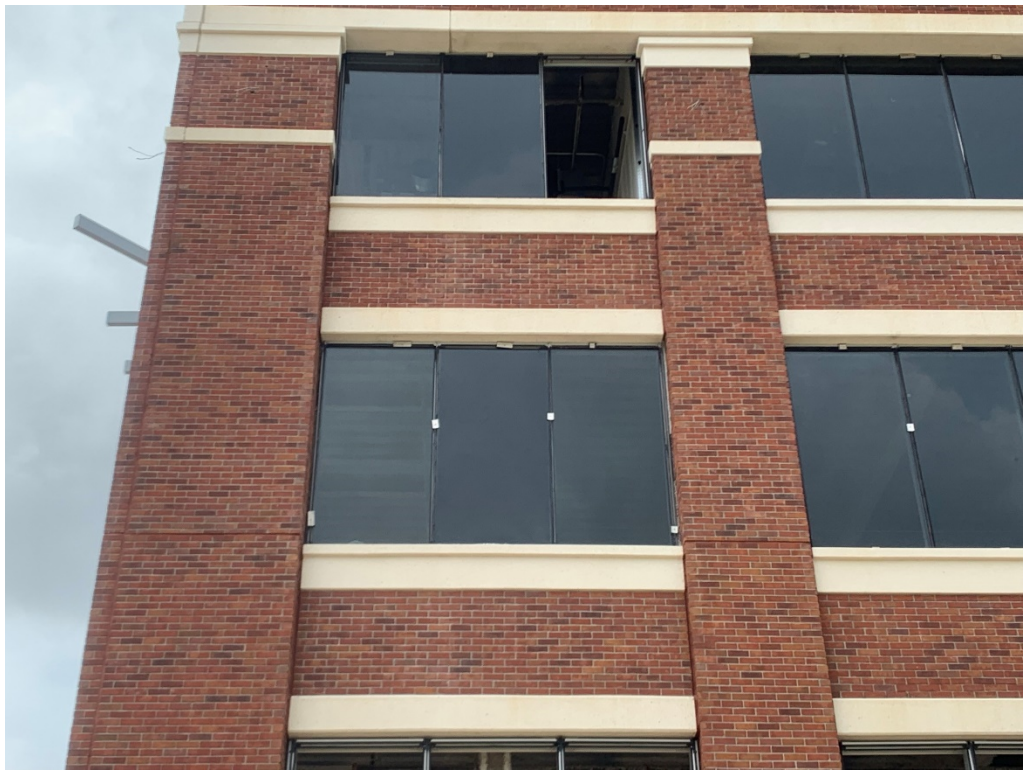
Figure 16 – Spandrel Glass Panels from Outside

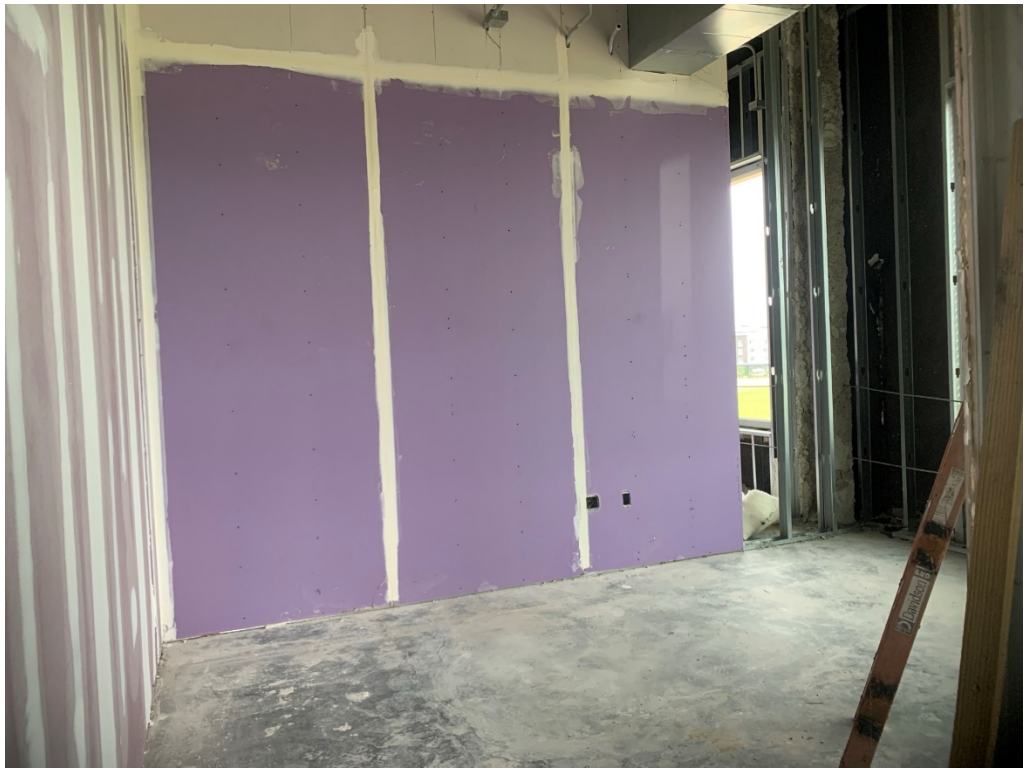
Drywall hangers were at the interior working. Painters were in the north stair, applying a first coat to the handrail.

Figure 17 – Drywall hanging and finishing is ongoing

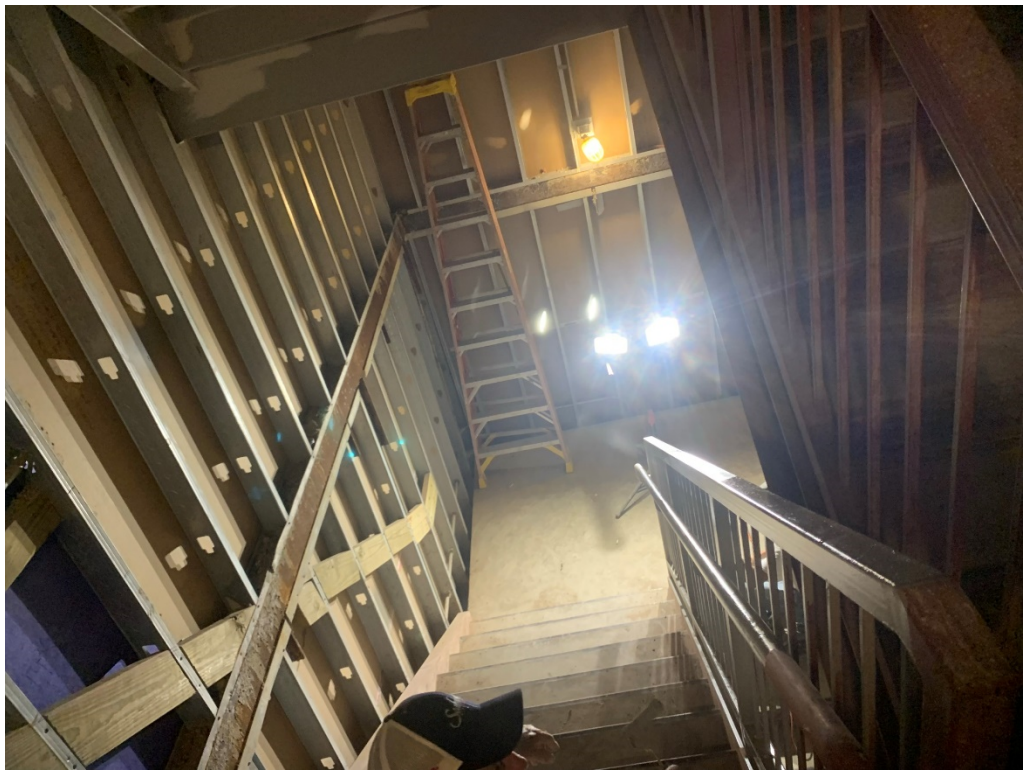
Figure 18 – North Stairwell Handrail getting first coat of paint

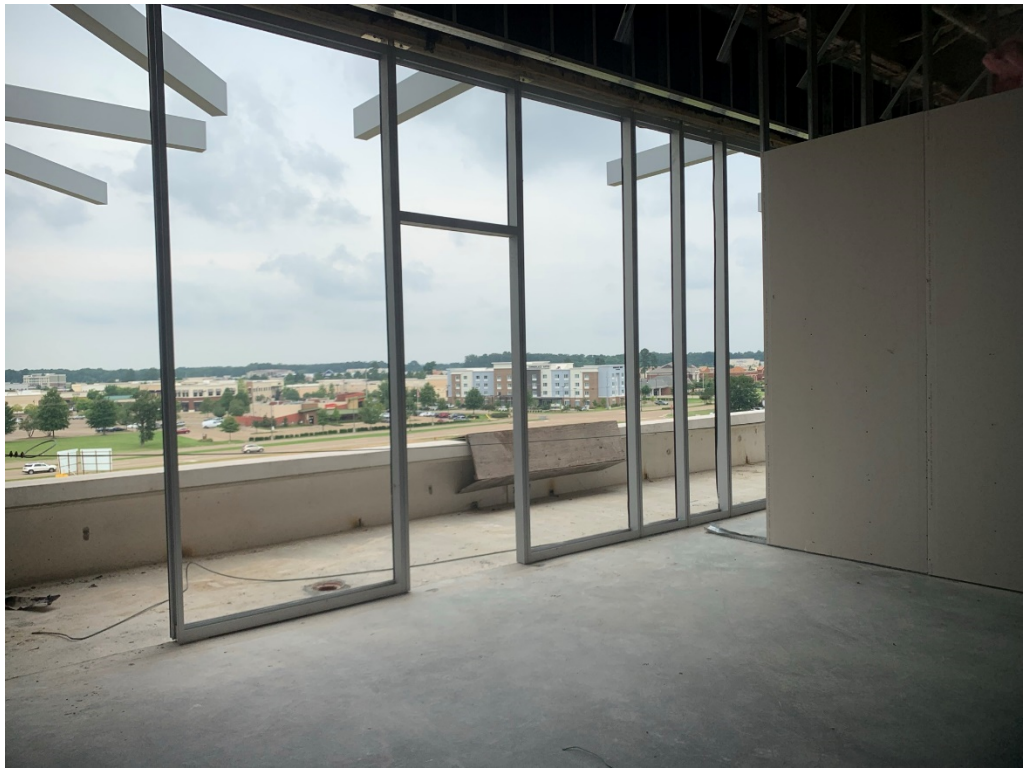
Curtain wall install is still to be performed throughout the structure, but it does appear that a large portion of the frames are built and on site.

Figure 19 – Curtain Wall Progress at Office 4111

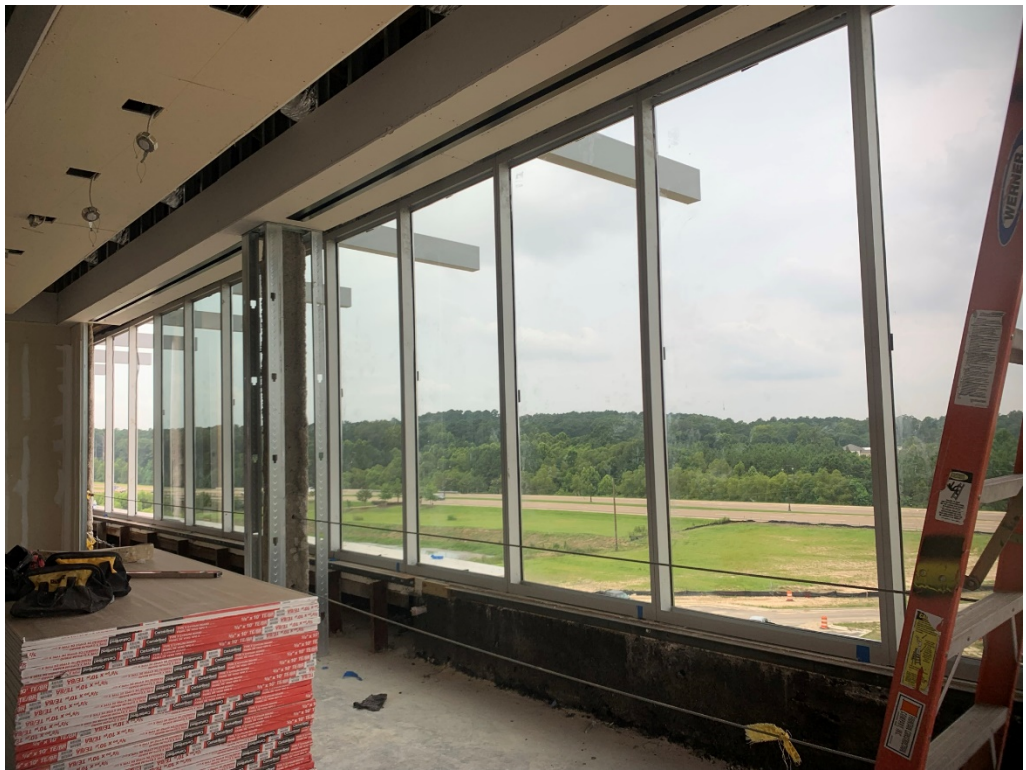
Figure 20 – Glass Installation @ Curtain Wall Top Floor
