Architect's Field Report

13 August 2021

15094 Community Bank Headquarters / Report Number 021

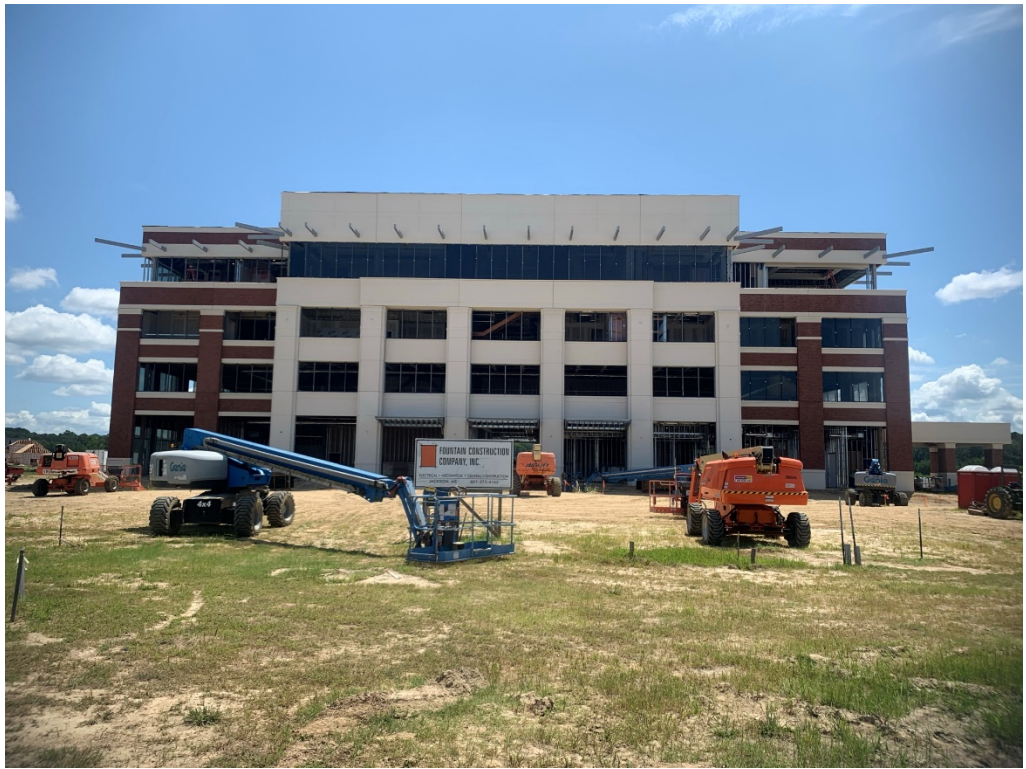
14 New pieces of glass have been set since last Friday at the 4th Floor west façade. I did not see any new Curtain wall frames installed since then.

Figure 1 – West Façade Progress

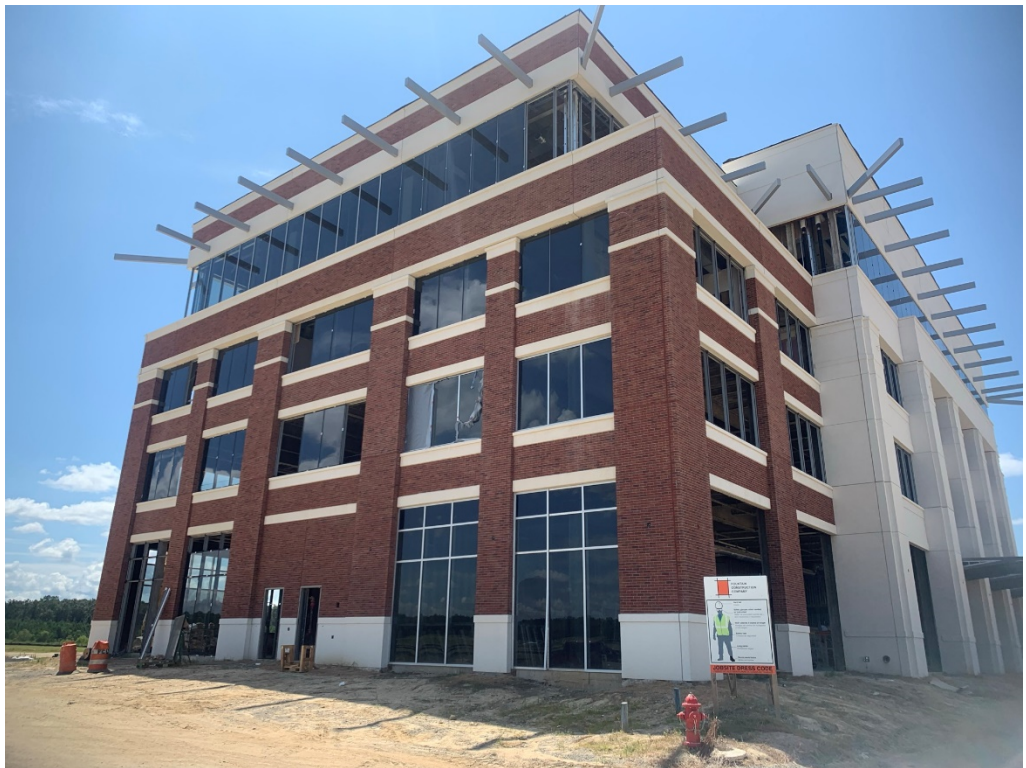
Figure 2 – North Façade Progress

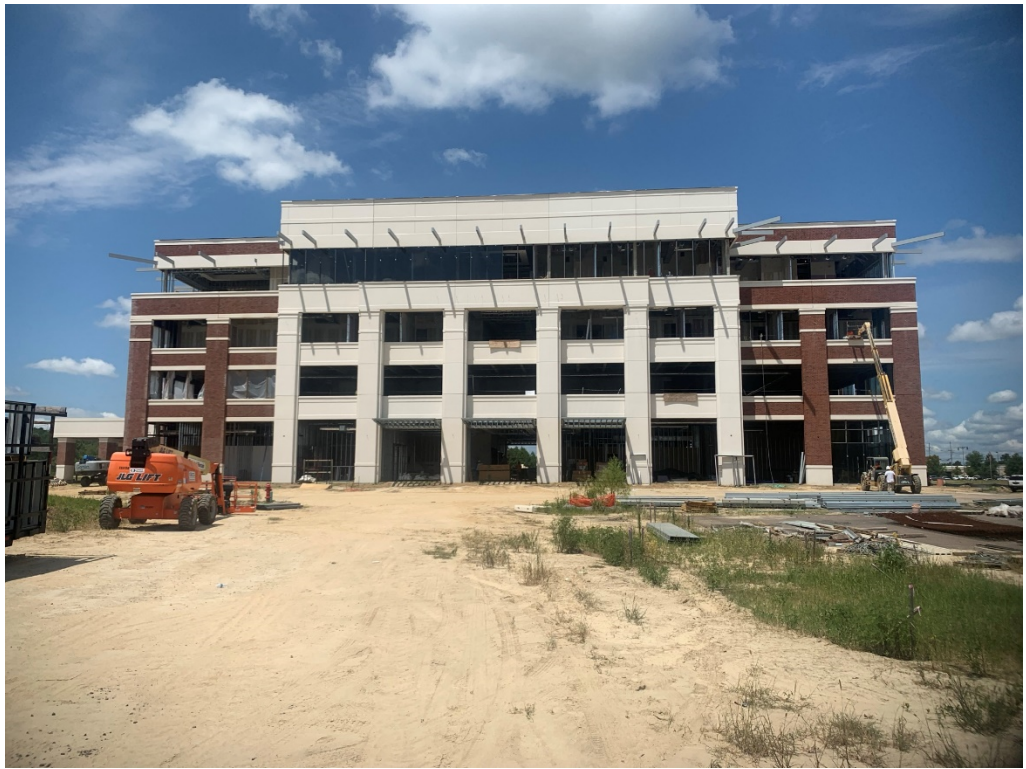
Figure 3 – East Façade Progress

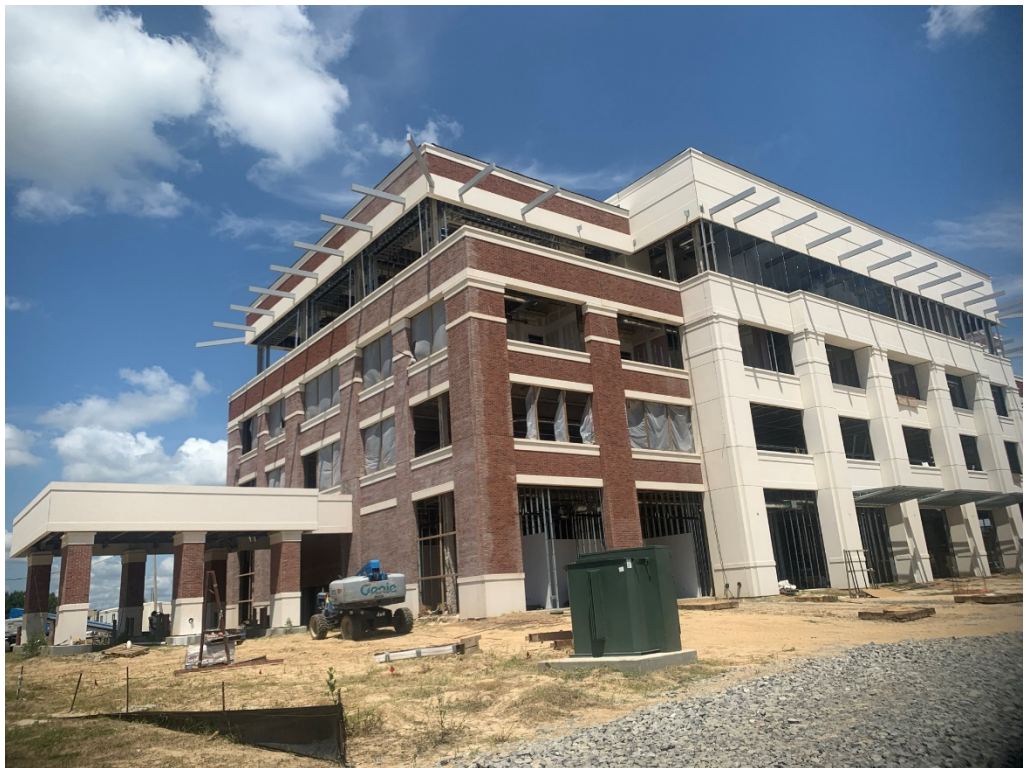
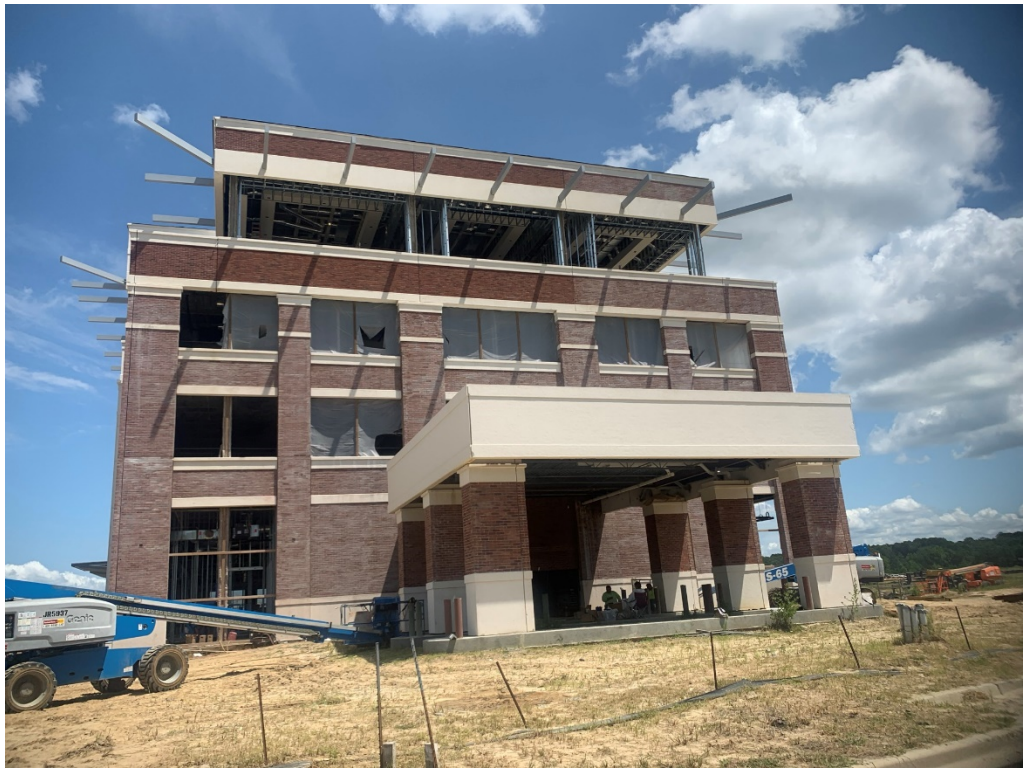
Observations On site, progress has been made in several areas. Brick Remediation appears to be nearing completion on the South façade (excluding drive-thru columns). 85% of the Brick at the South façade has been gone over and by the remediation team.

Figure 4 – South Façade Progress

Figure 5 – South Façade Progress

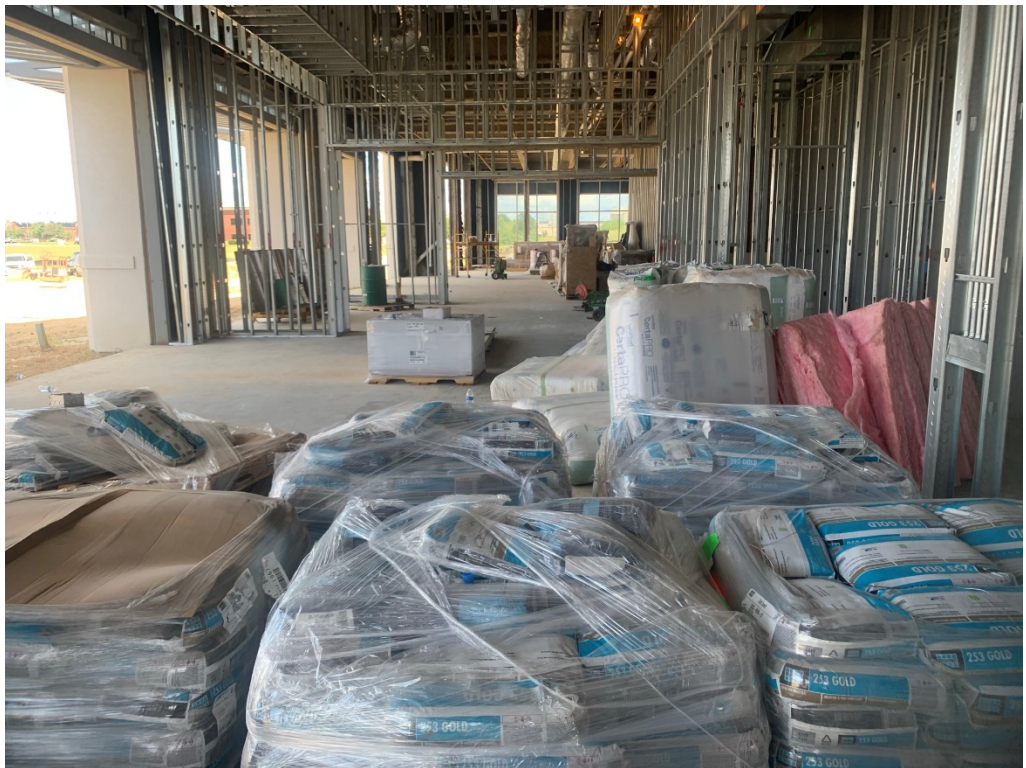
Figure 6 – Staged Mortar & Grout

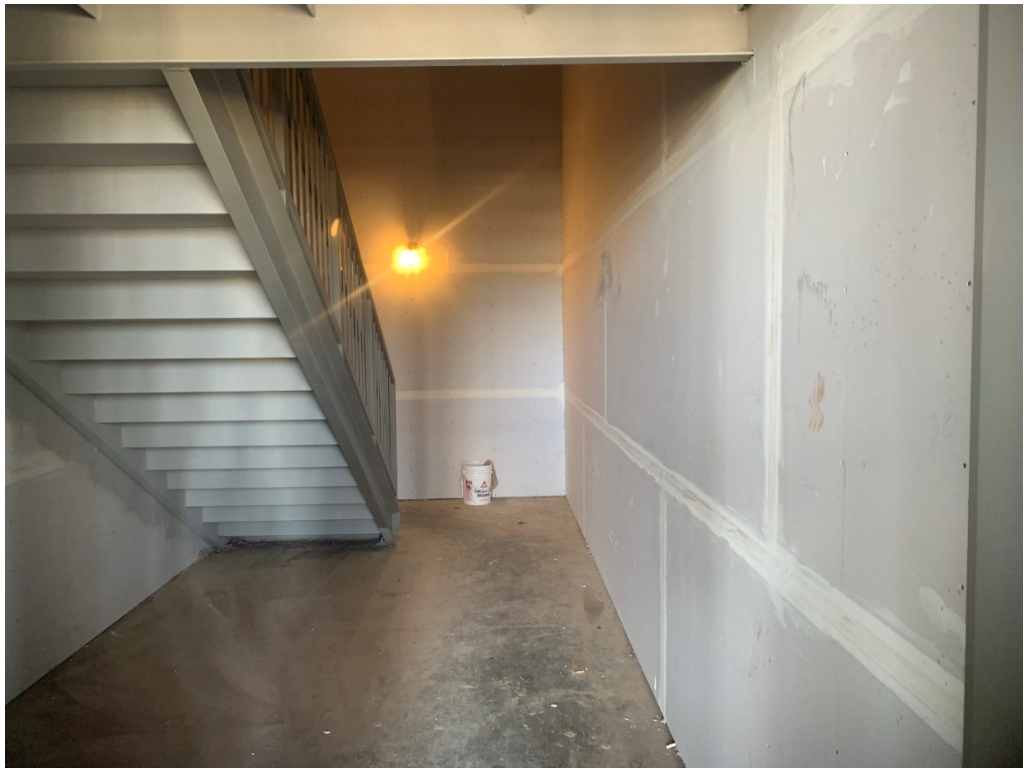
Inside, workers continue installing sheetrock at the fourth floor. The south stair sheetrock has been fully installed with a tape coat of mud. Framers were also installing light gauge metal studs at the exterior building walls.

Figure 7 – South Stair Sheetrock Installed

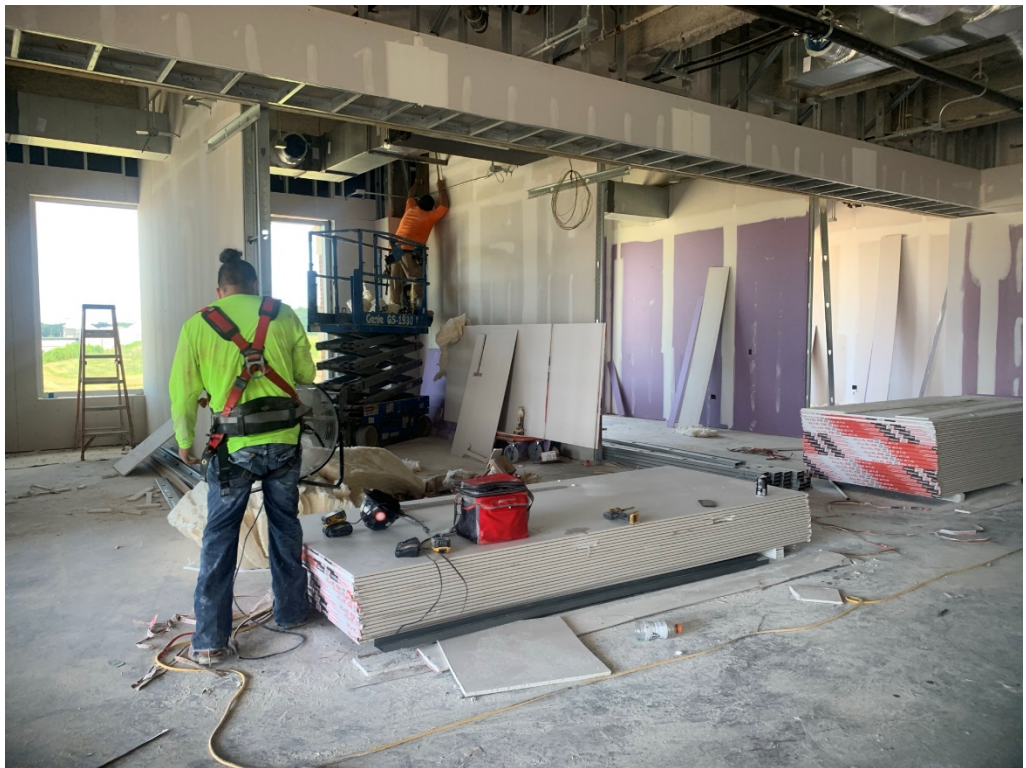
Figure 8 – Gypsum Install is Ongoing

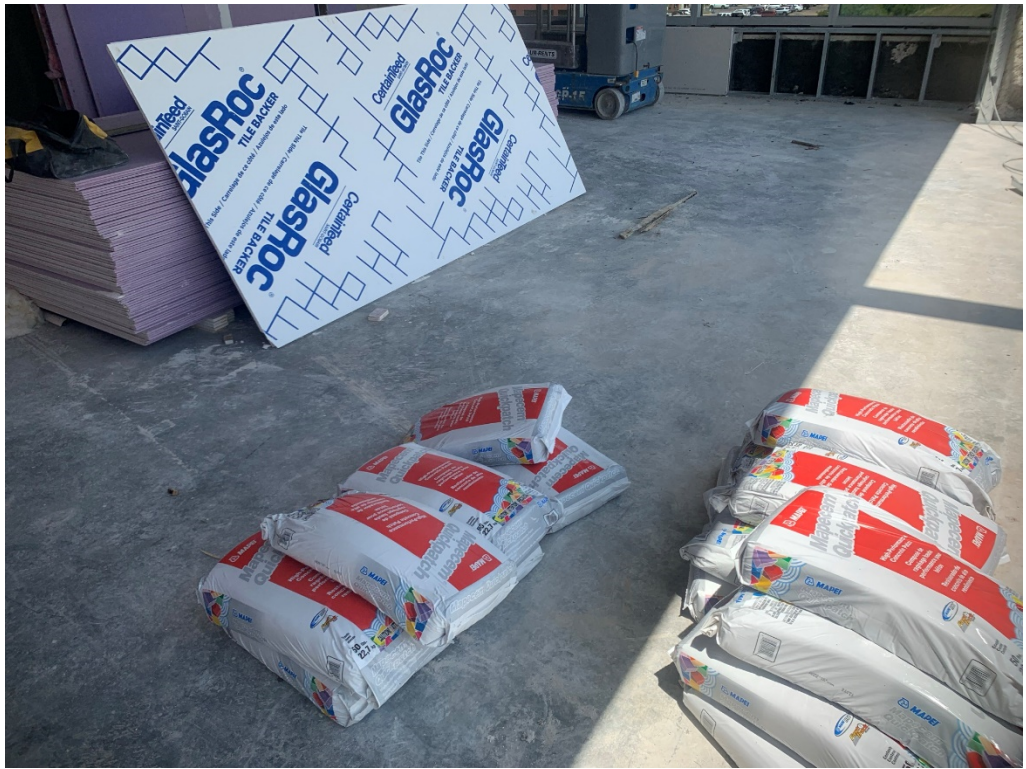
Workers have prepped the women's 4th floor bathroom and mortar & tile have been lifted to the top floor.

Figure 9 – Mortar Lifted to 4th Floor for Tile Install

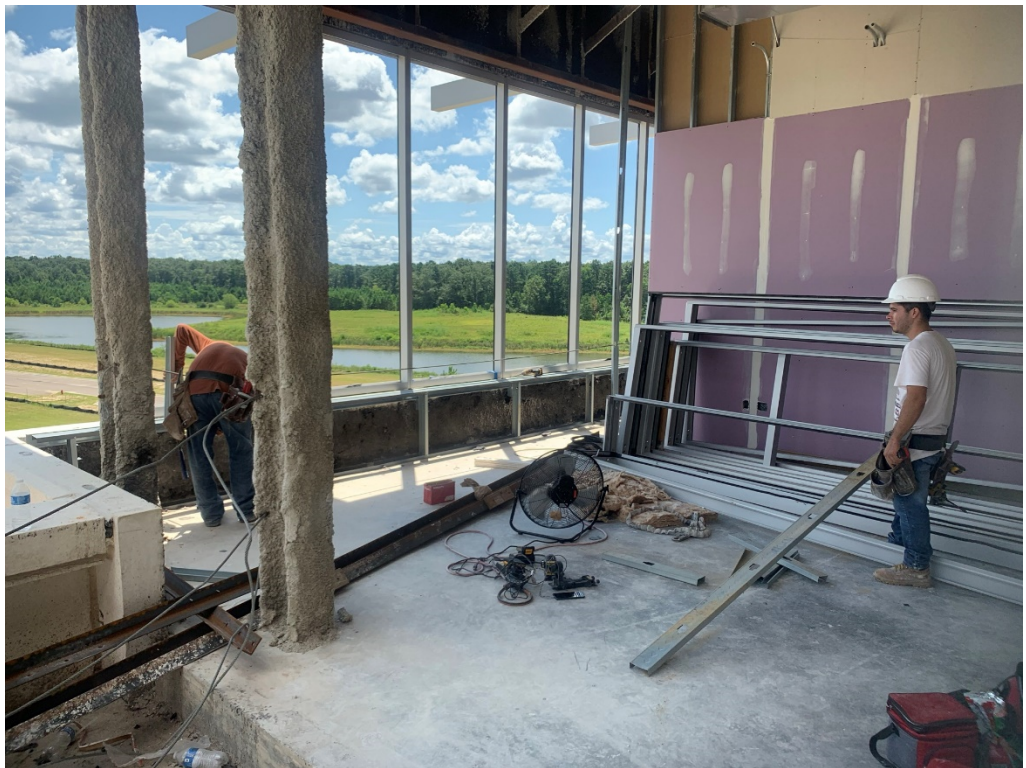
Figure 10 – Ongoing Framing

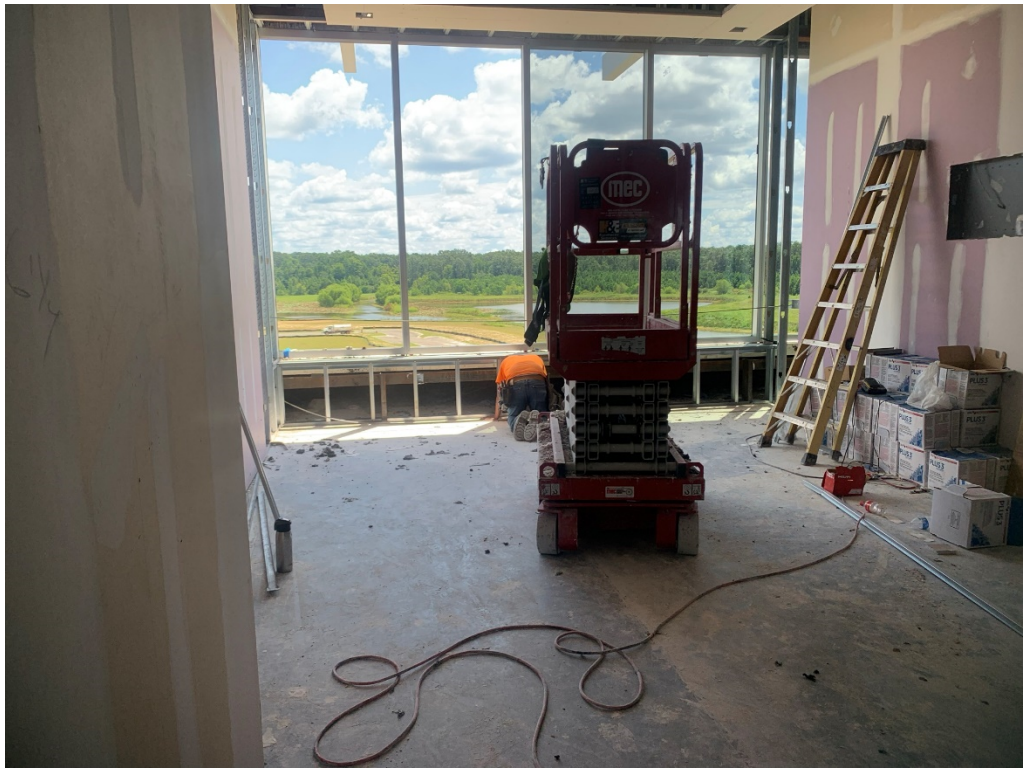
Figure 11 – Framing is Ongoing Throughout

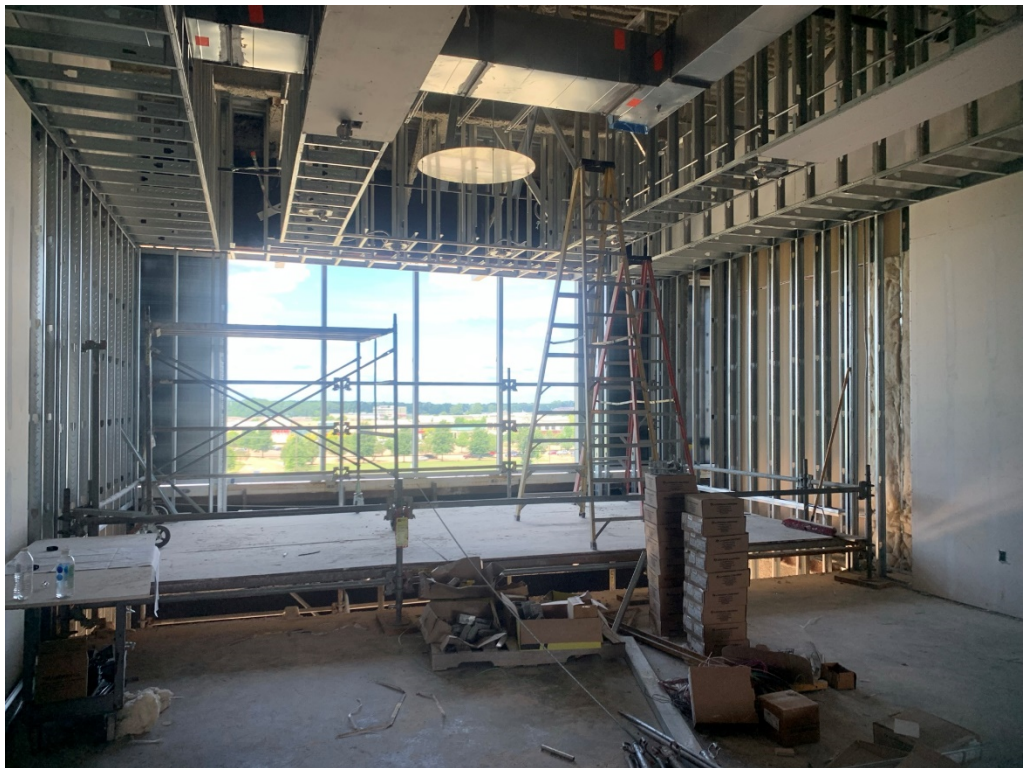
Figure 12 – Ongoing Ceiling work at 4th Floor Monumental Stair

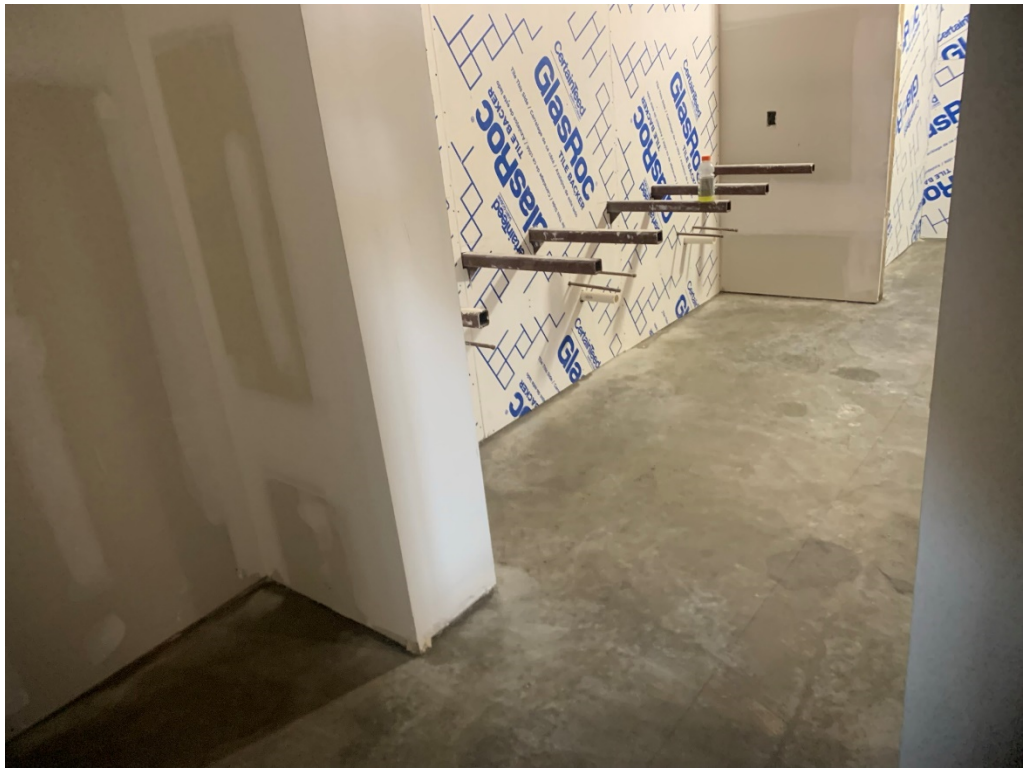
Figure 13 – Cleaned and Prepped 4th Floor Bathroom 4005; ready for tile install

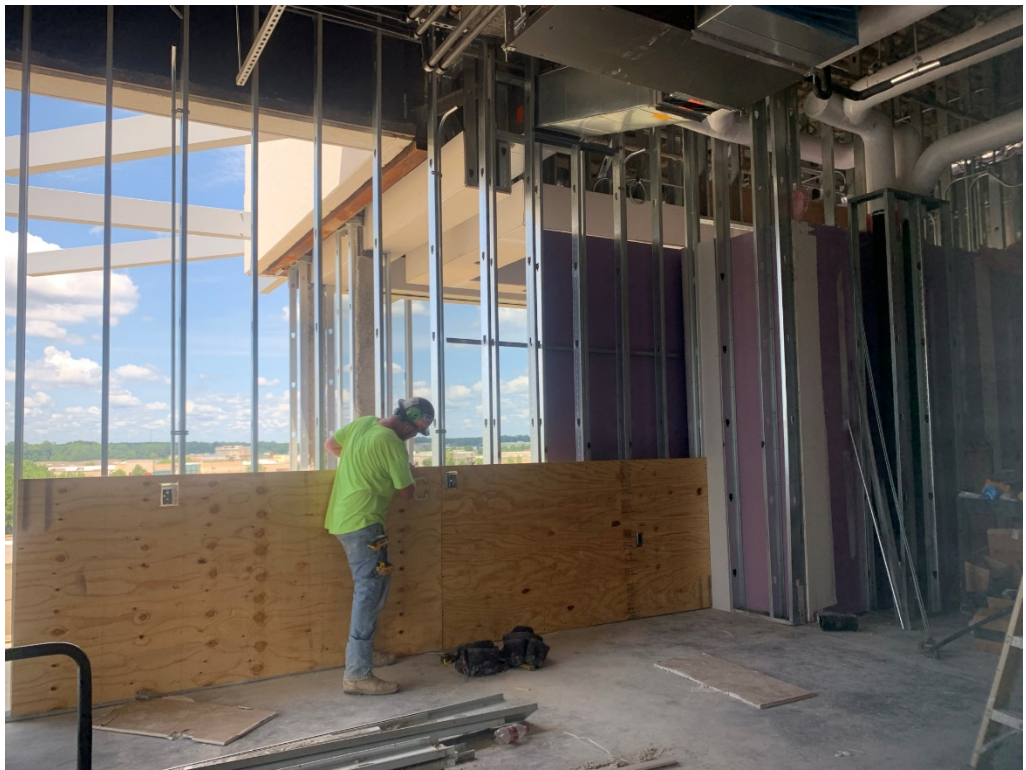
Figure 14 – Added Plywood to Revised Staging Floor Plan per WCPR-26

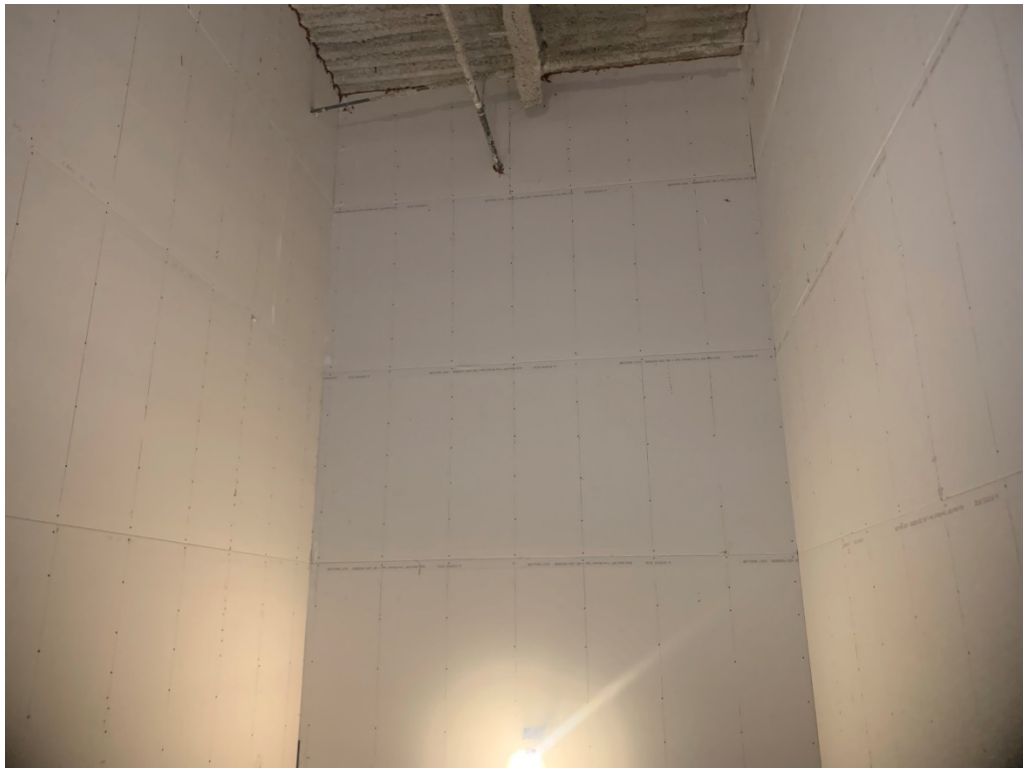
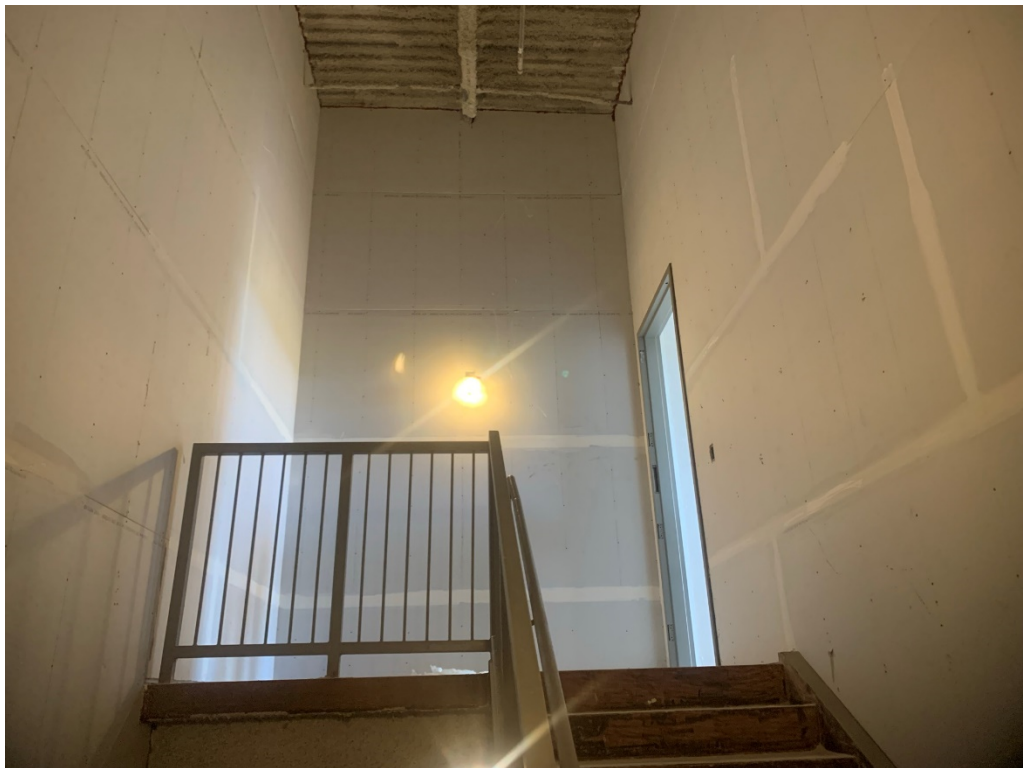
Figure 15 – South Stairwell Sheetrock Fully Installed

Figure 16 – South Stairwell Sheetrock Fully Installed
