Architect's Field Report

20 August 2021

15094 Community Bank Headquarters / Report Number 022

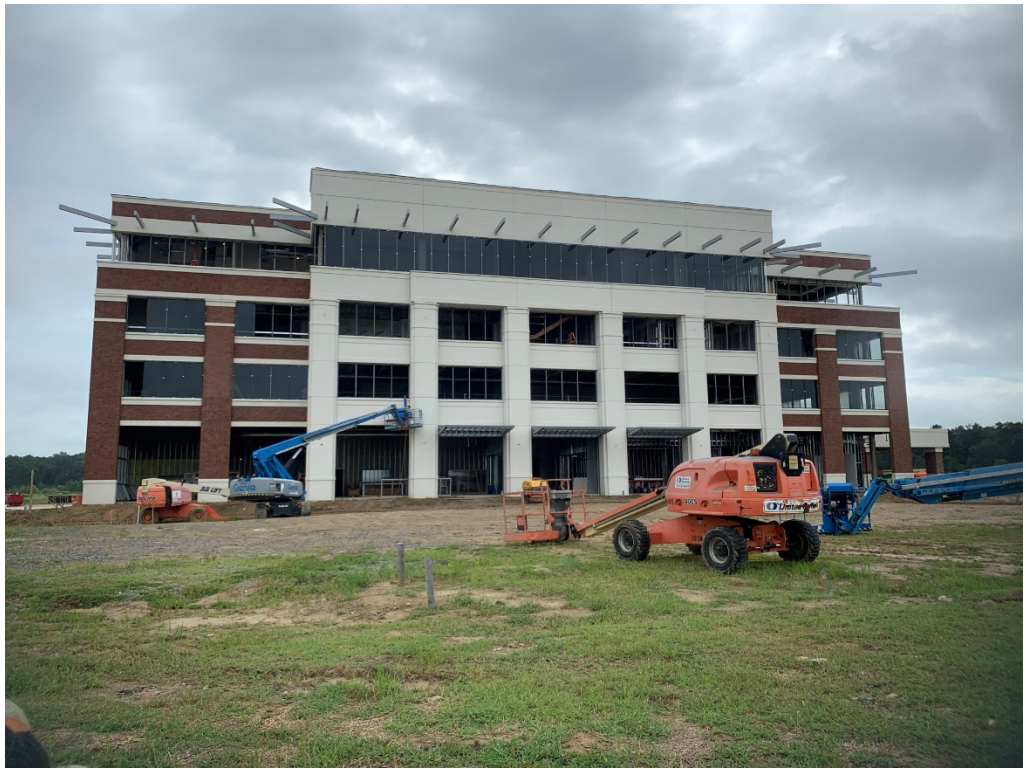
Figure 1 – West Façade Progress

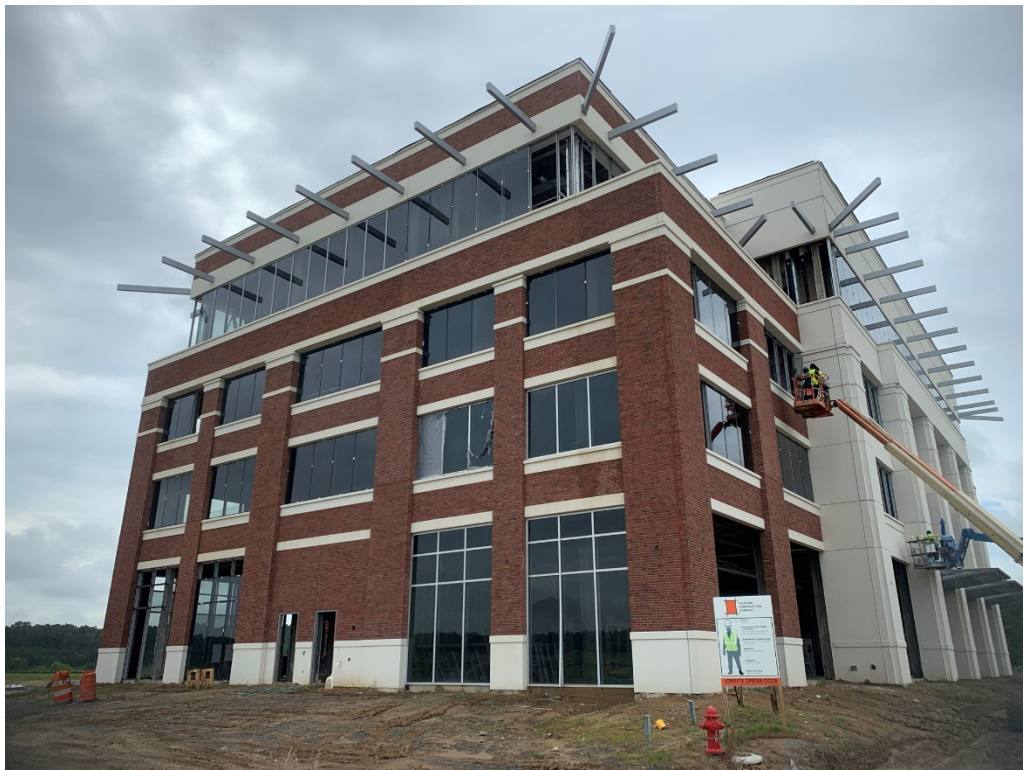
Figure 2 – North Façade Progress

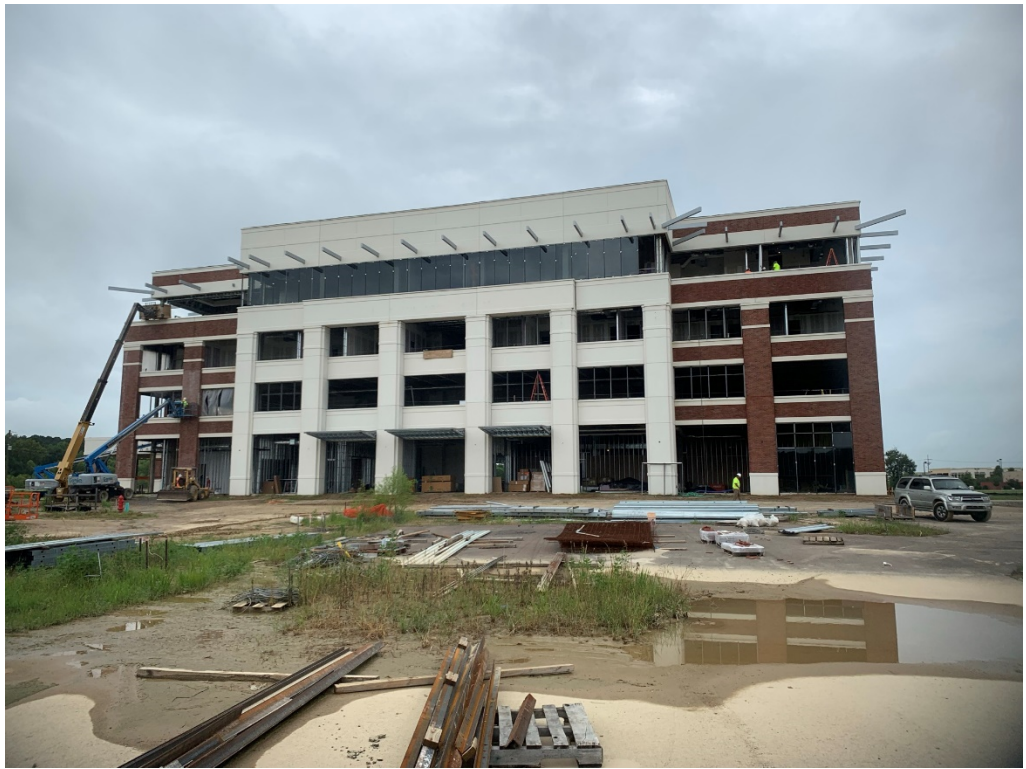
Figure 3 – East Facade

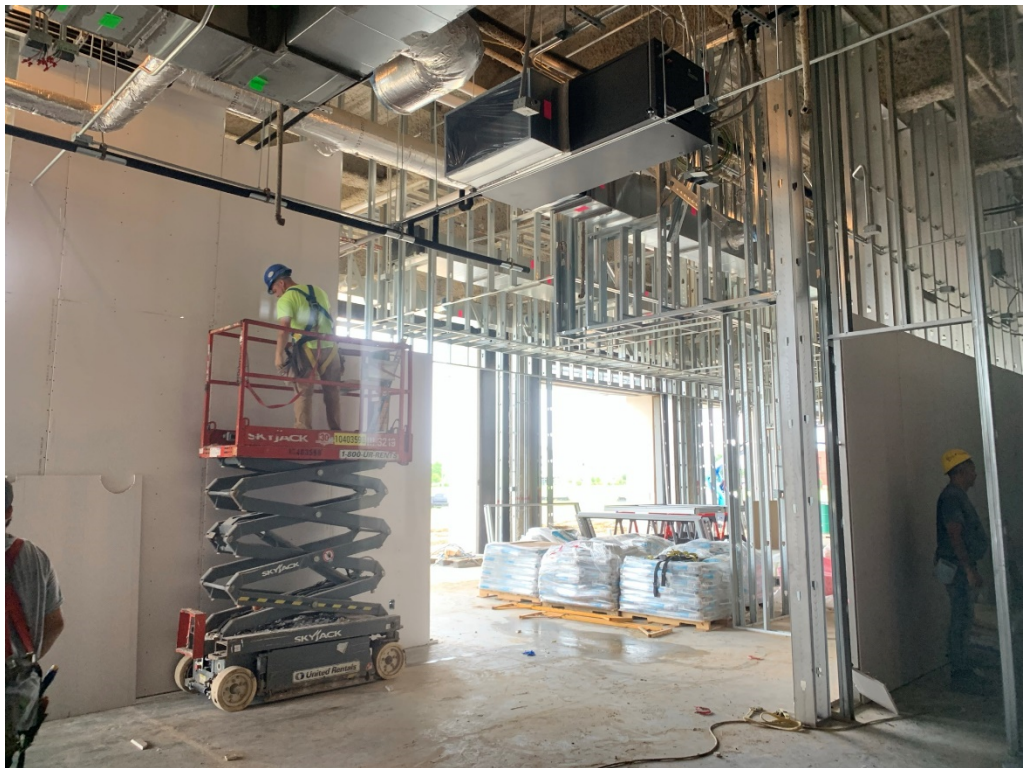
Figure 4 – Drywall Started at the 1<sup>st</sup> Floor

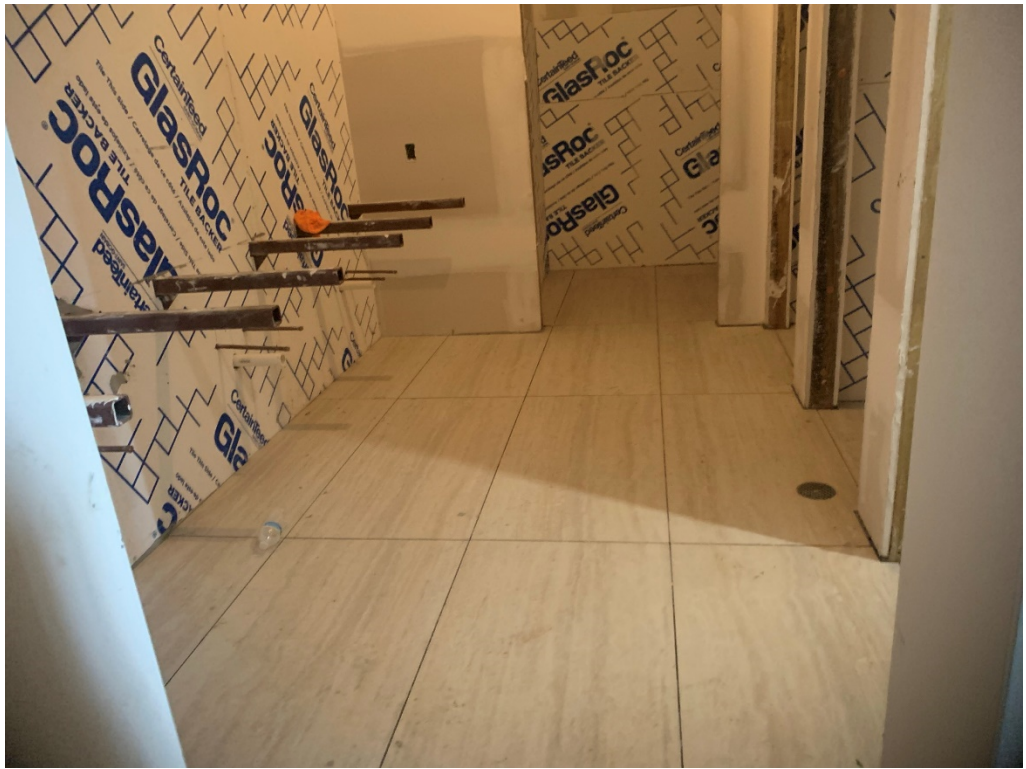
Figure 5 – Tile is installed in both 4<sup>th</sup> floor main bathrooms

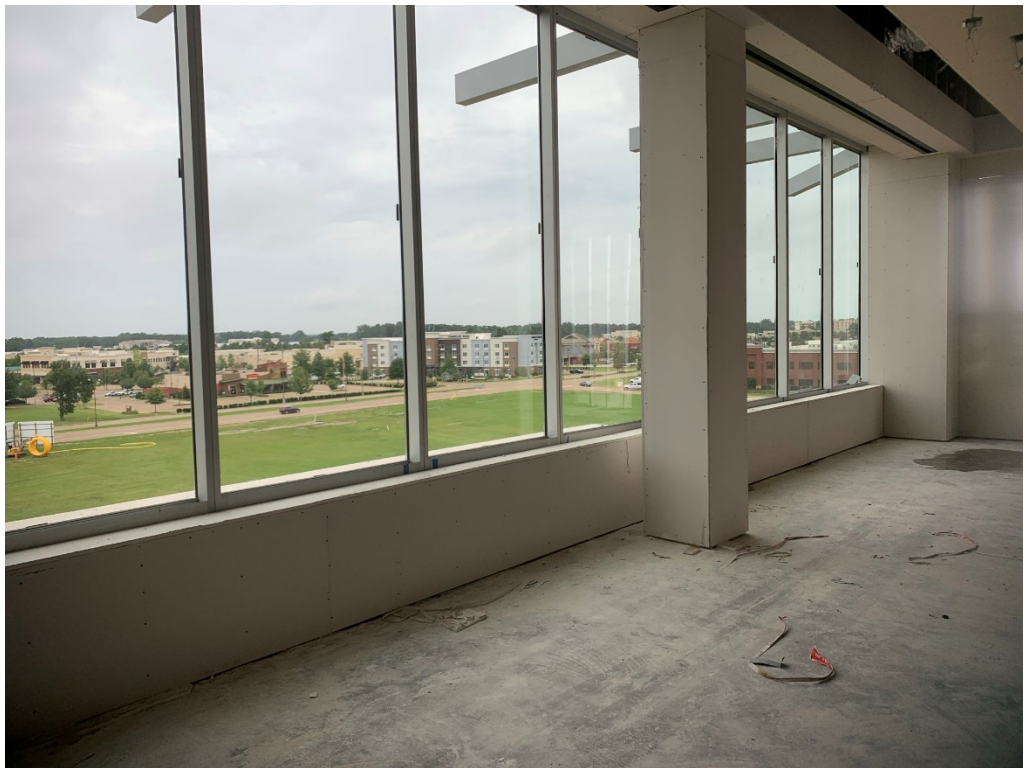
Figure 6 – Framing & Gypsum at Board Room Exterior Wall

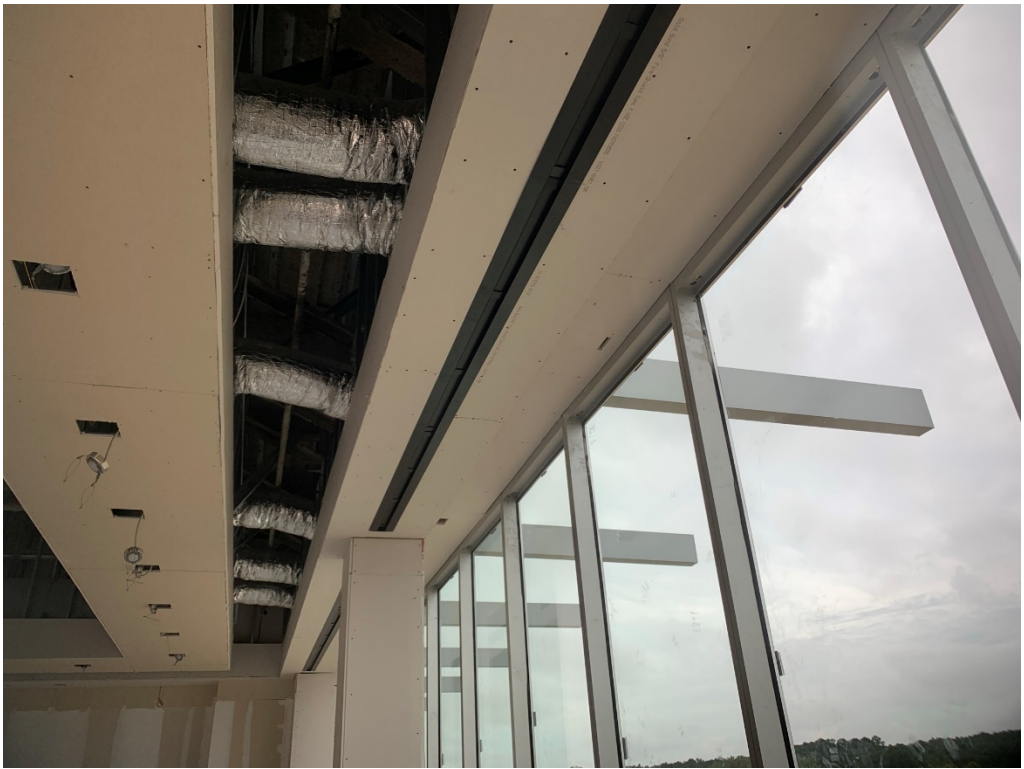
Figure 7 – Boardroom Ceiling and Glazing Progress

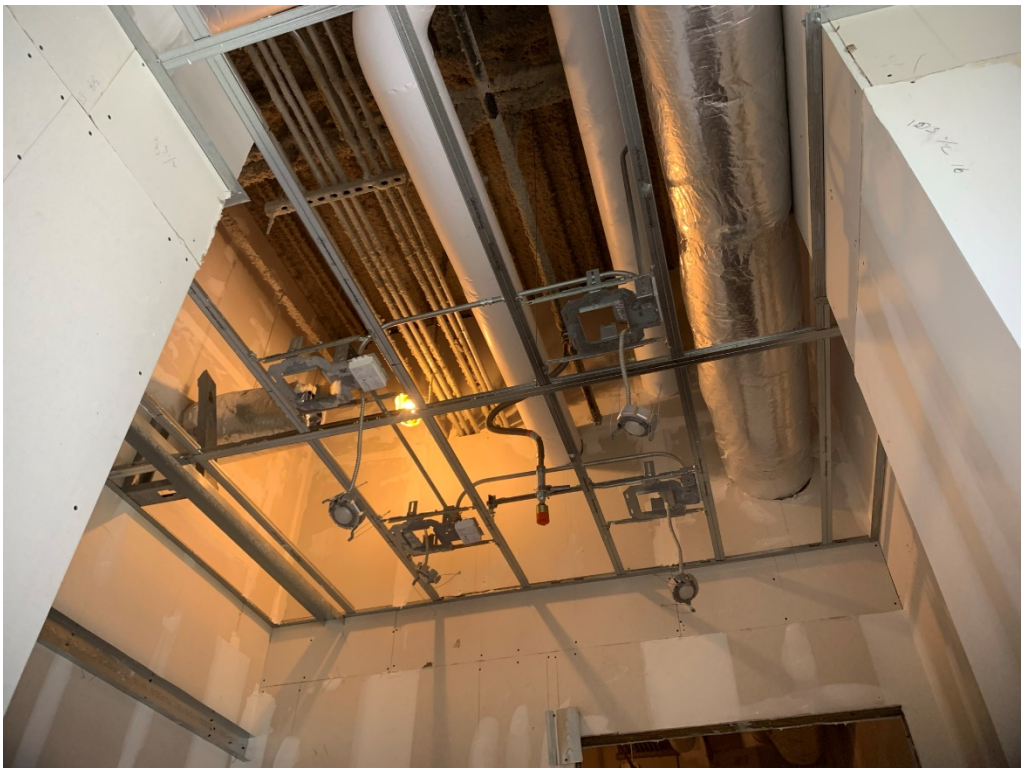
Figure 8 – Ceiling progress on 4<sup>th</sup> Floor

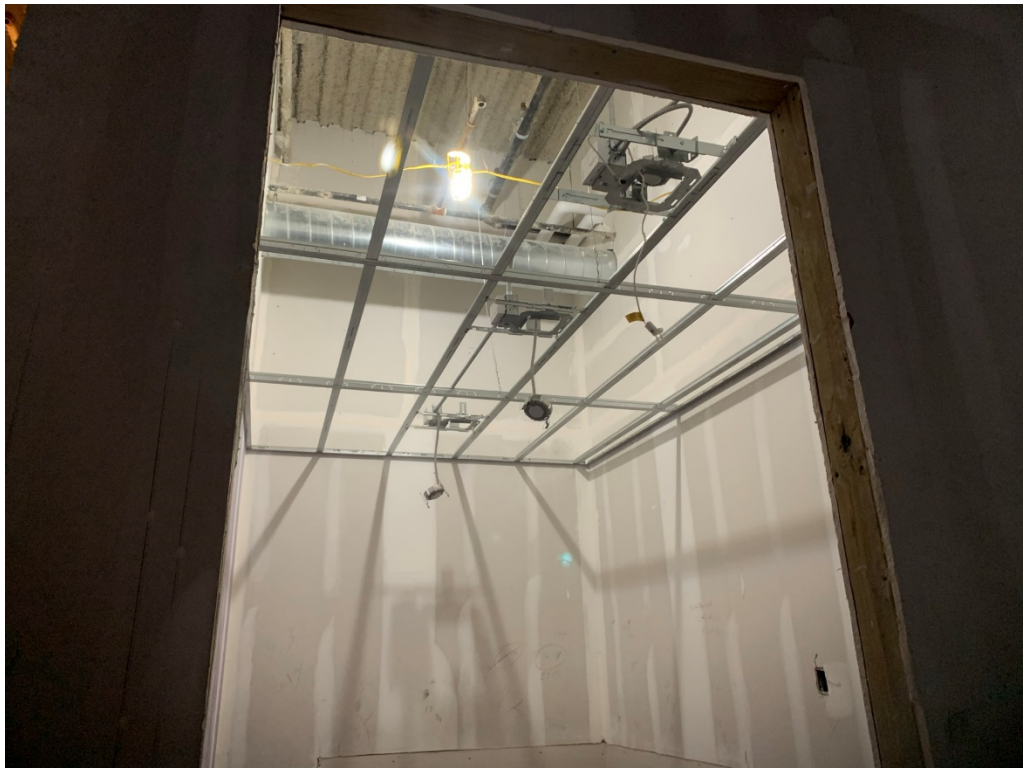
Figure 9 – Ceiling progress on 4<sup>th</sup> Floor

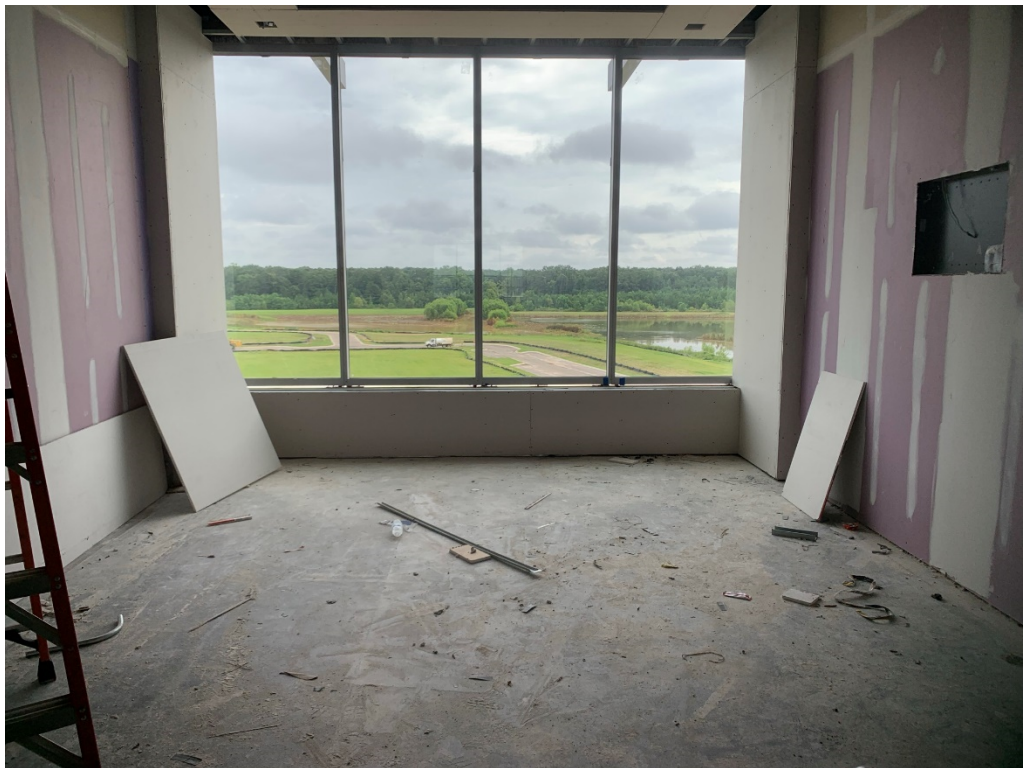
Figure 10 – Drywall & Framing Progress where Glass Is Installed

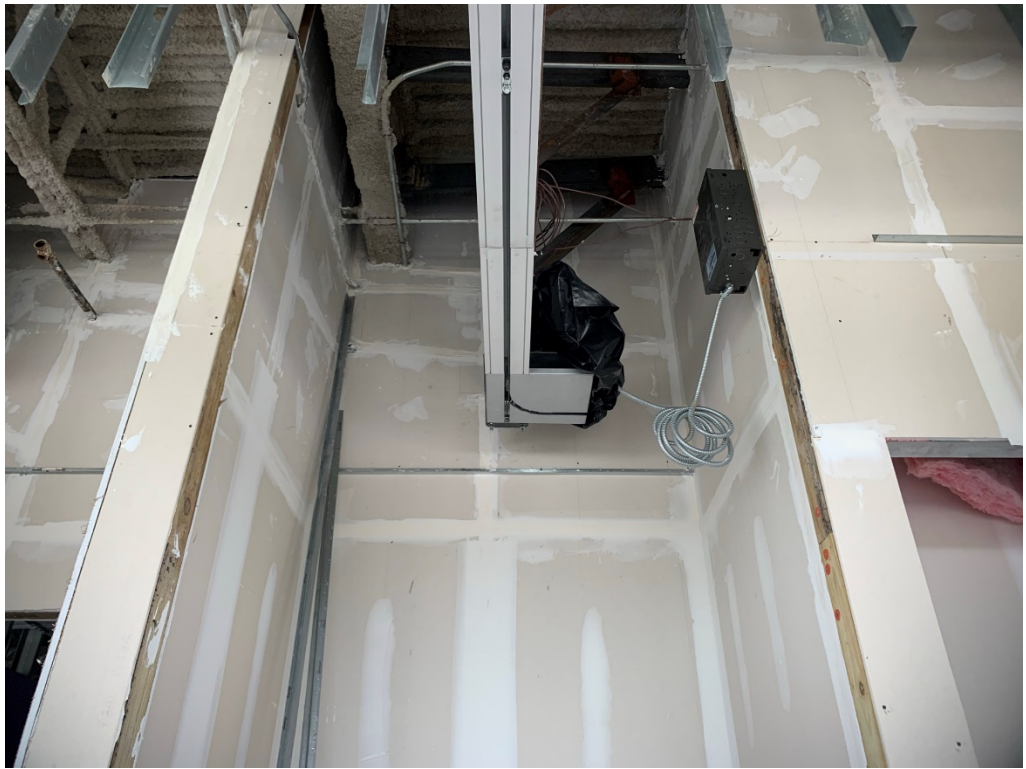
Figure 11 – Sliding Tracks Installed

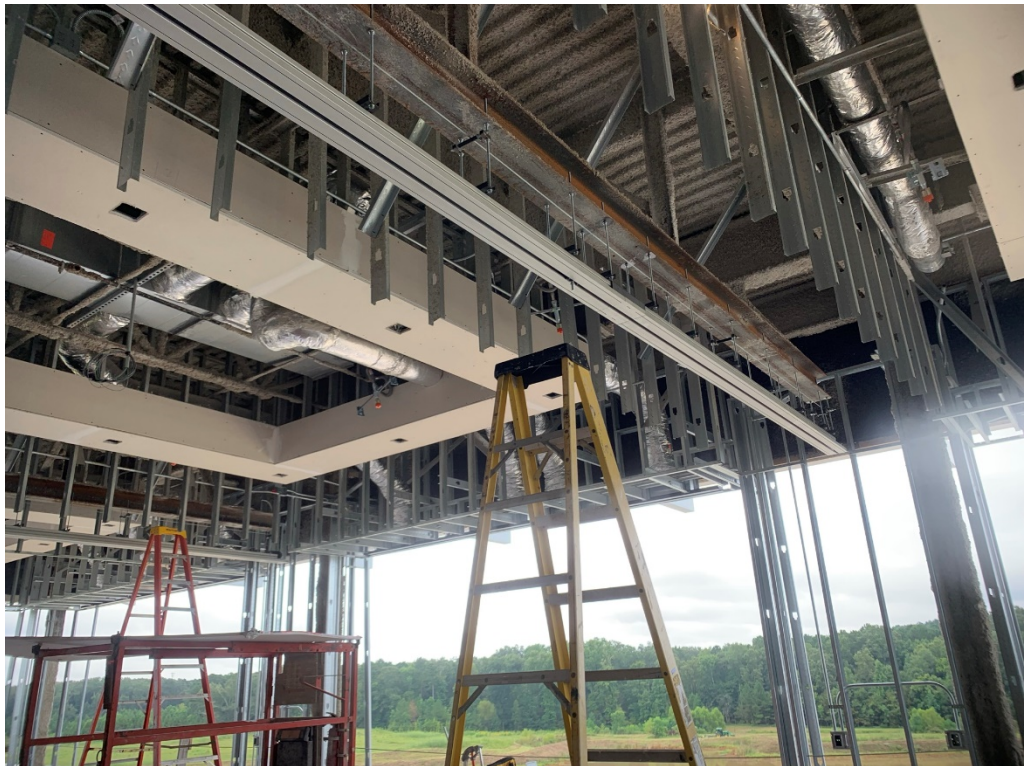
Figure 12 – Sliding Tracks Installed
