Architect's Field Report

30 August 2021

15094 Community Bank Headquarters / Report Number 023

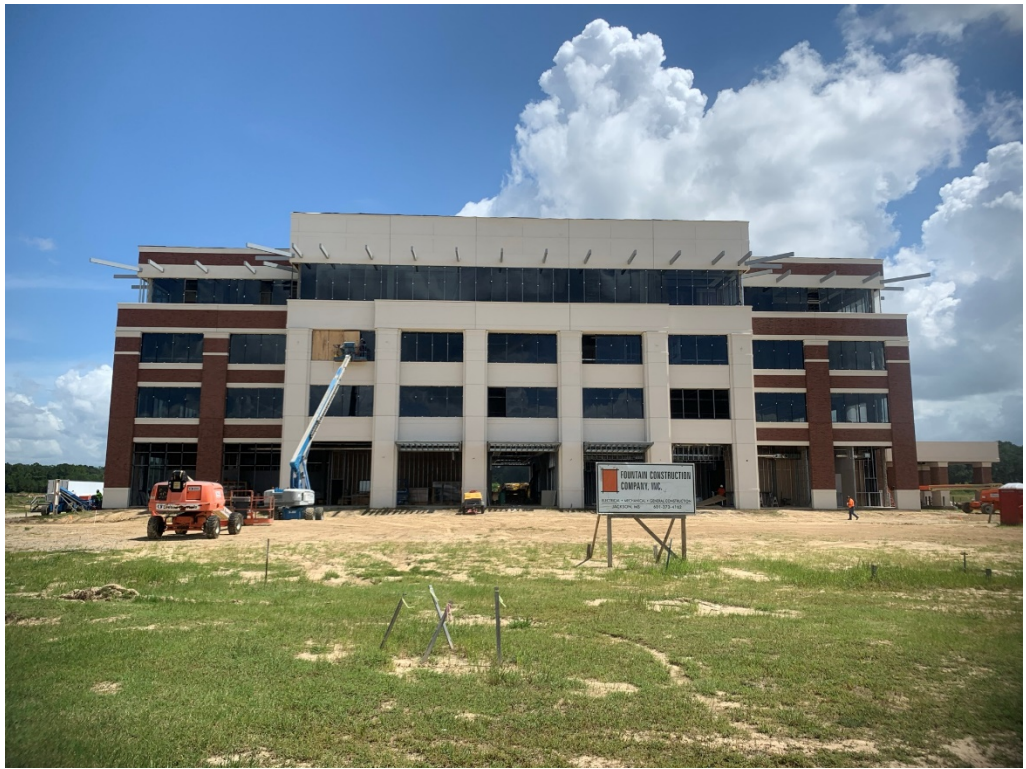
Figure 1 – West Façade Progress

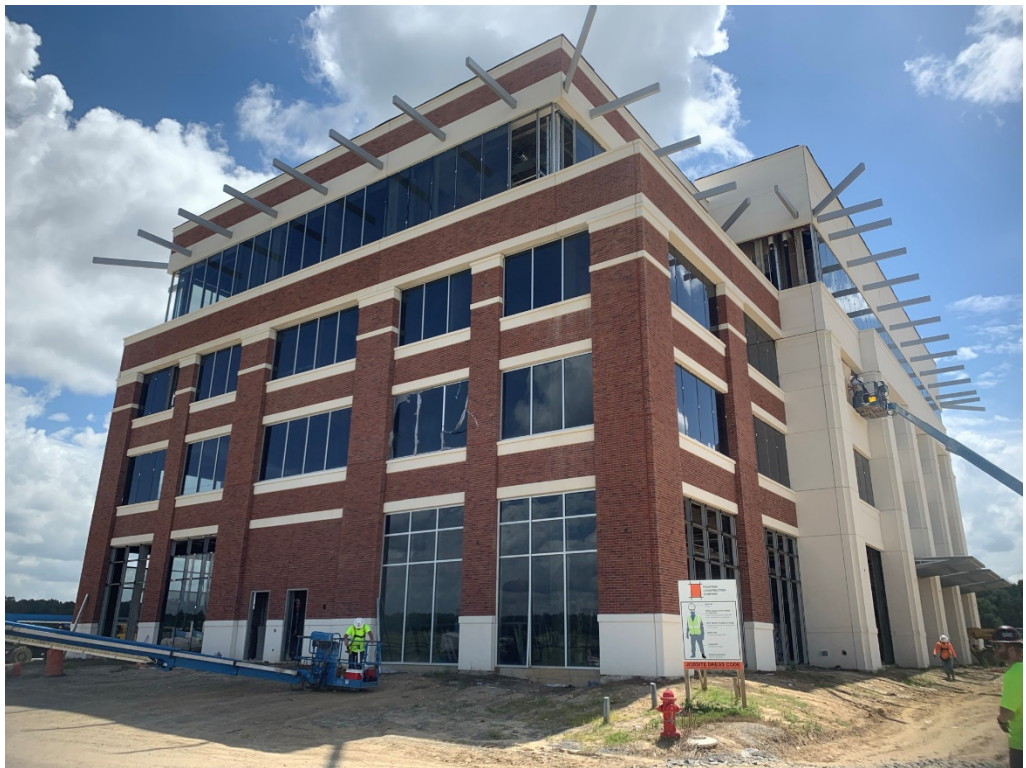
Figure 2 – North Façade Progress

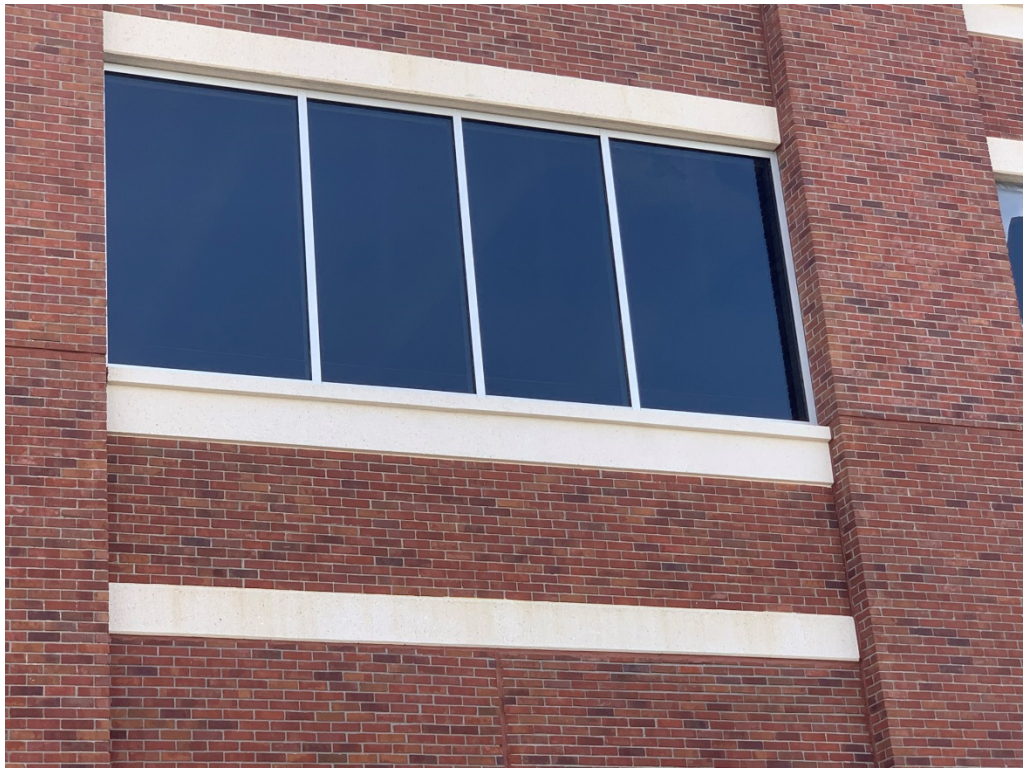
Figure 3 – Curtain Trim Install has begun

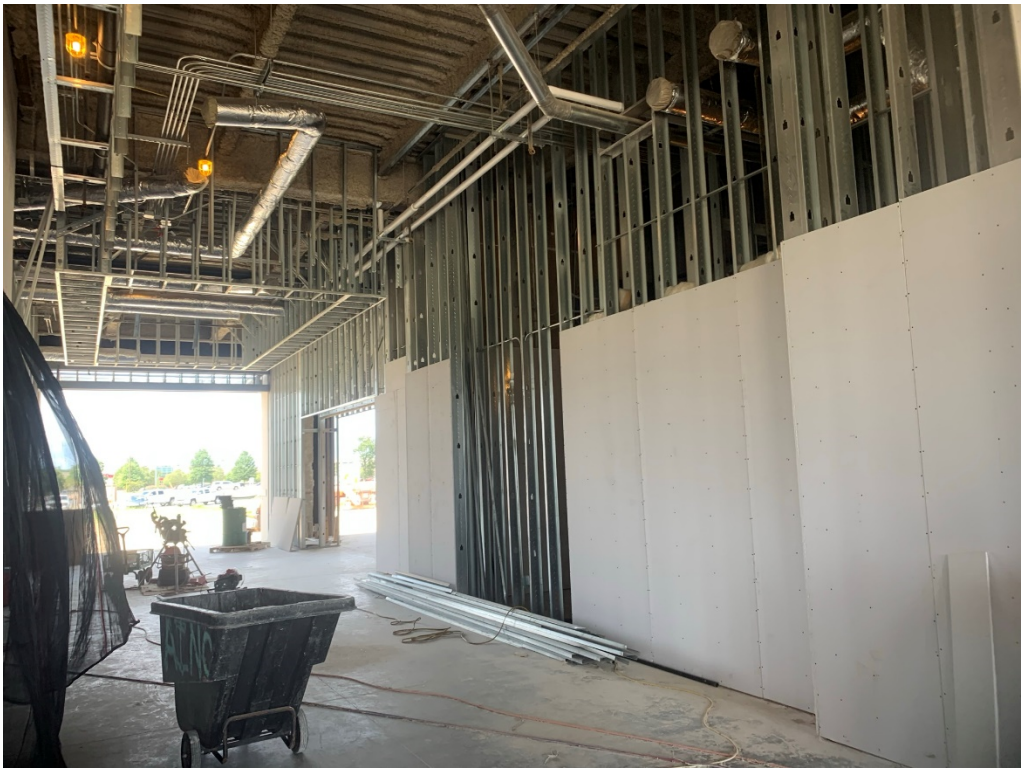
Inside drywall crews are still working on the 1st and fourth floors.

Figure 7 – 1st Floor Drywall is Ongoing

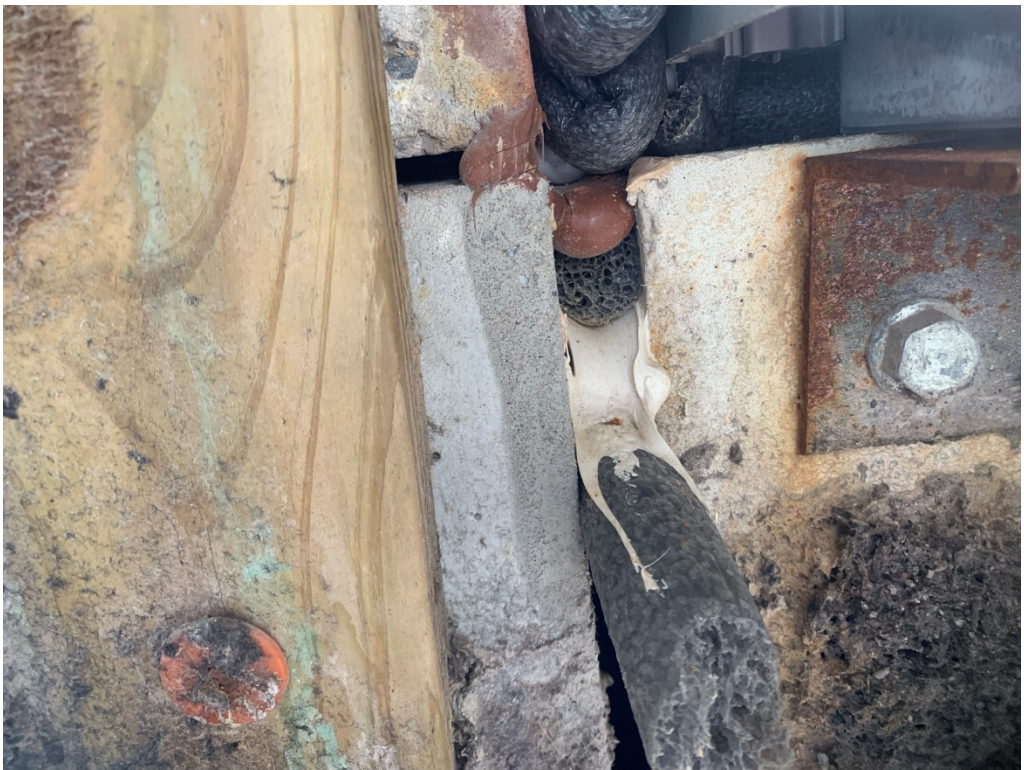
Per shop drawings submitted for these curtain walls, there is mastic installed on both side of the curtain wall. I have not seen any evidence of this being installed anywhere. Check with your installer and confirm that this is on his scope. Drywall has been installed to the edge of the curtain in many places. This will need to be removed for installation of the sealant.

Figure 8 – Evidence of Correct Mastic Installation

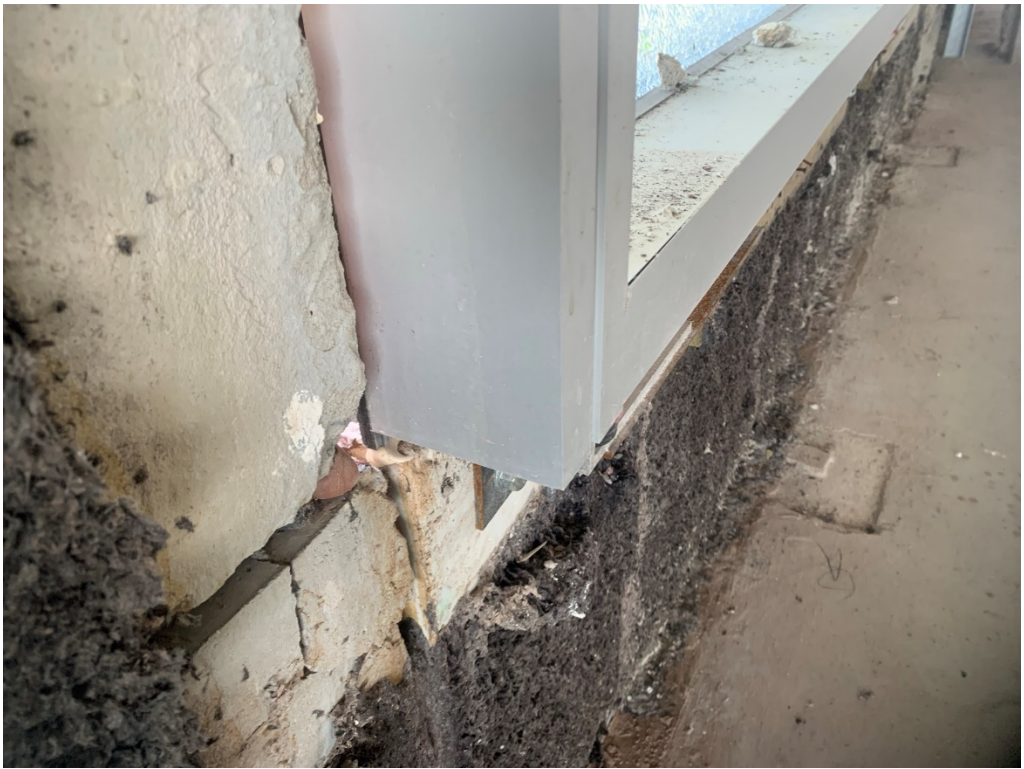
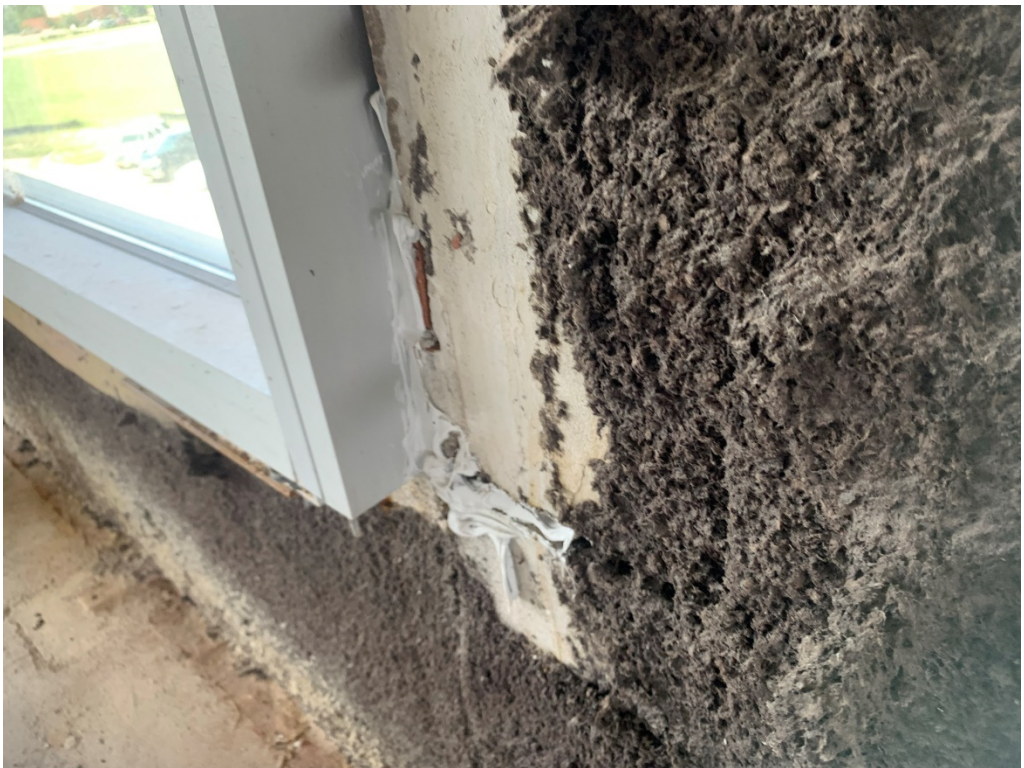
On the second floor there appears to be a unit that is not set plumb. IT could very well be the precast panel that is out, but there is a difference in the depth of the jambs. Check and confirm that the recess is not also varied on the exterior side.

Figure 9 – 2nd Floor North Unit; check for plumbness (recess appears to vary)

Figure 10 – 2nd Floor North Unit; check for plumbness (recess appears to vary)

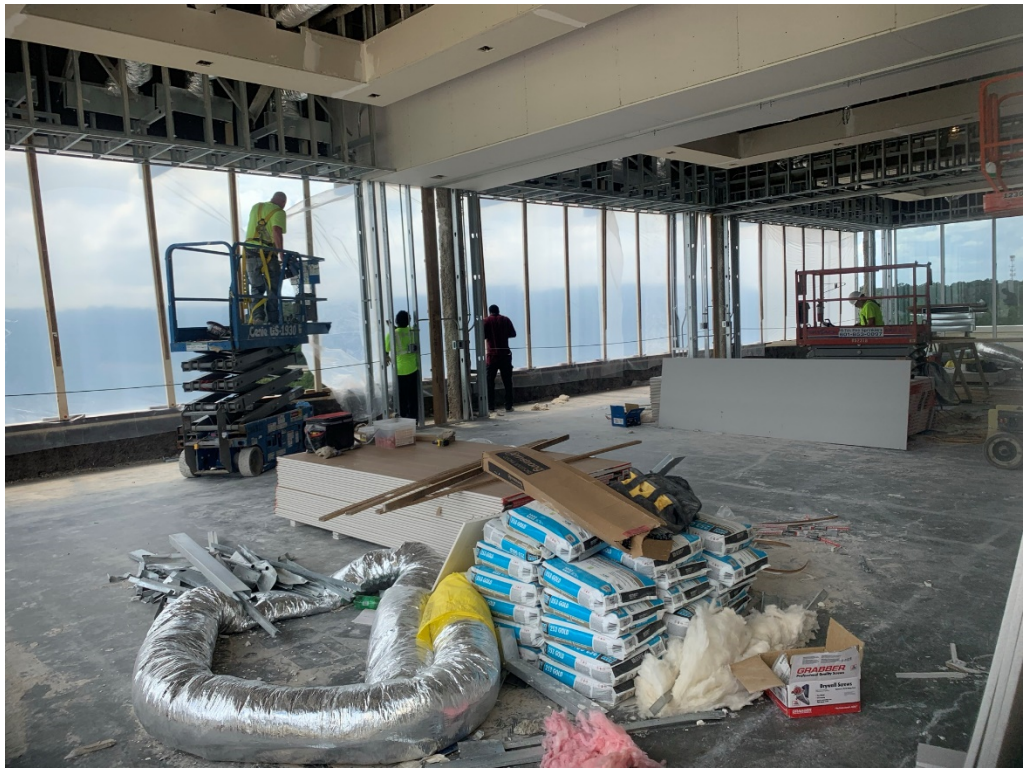
Figure 11 – Plastic Install in preparation for Hurricane

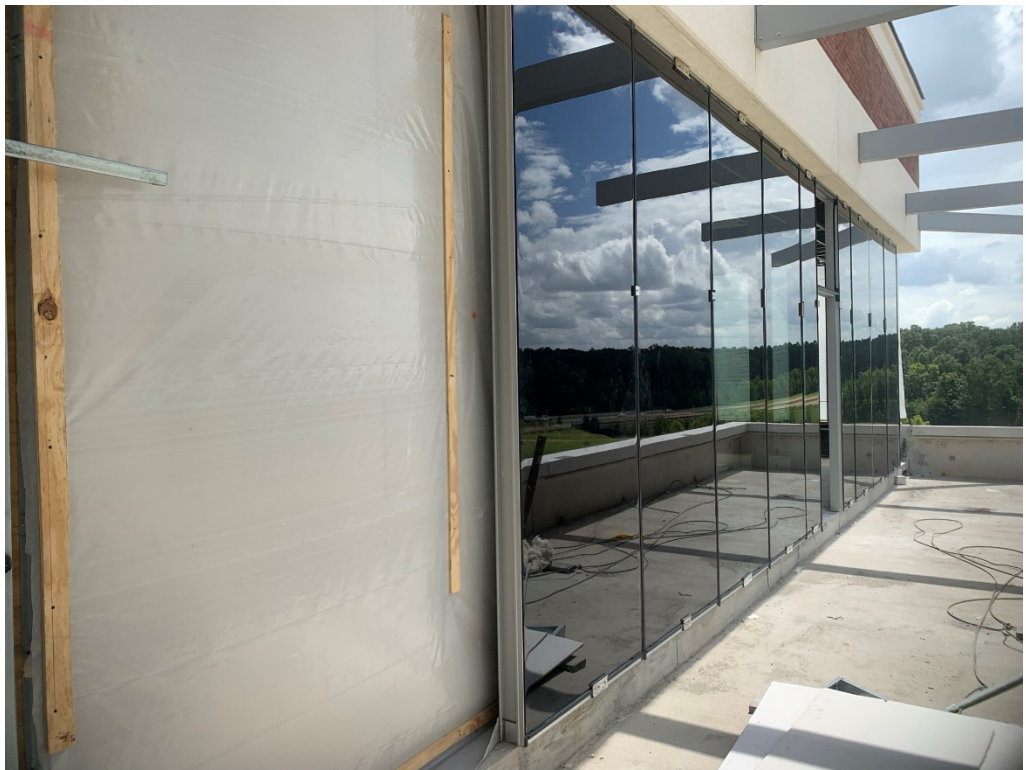
Figure 12 – Window Curtain install at 4th floor SW

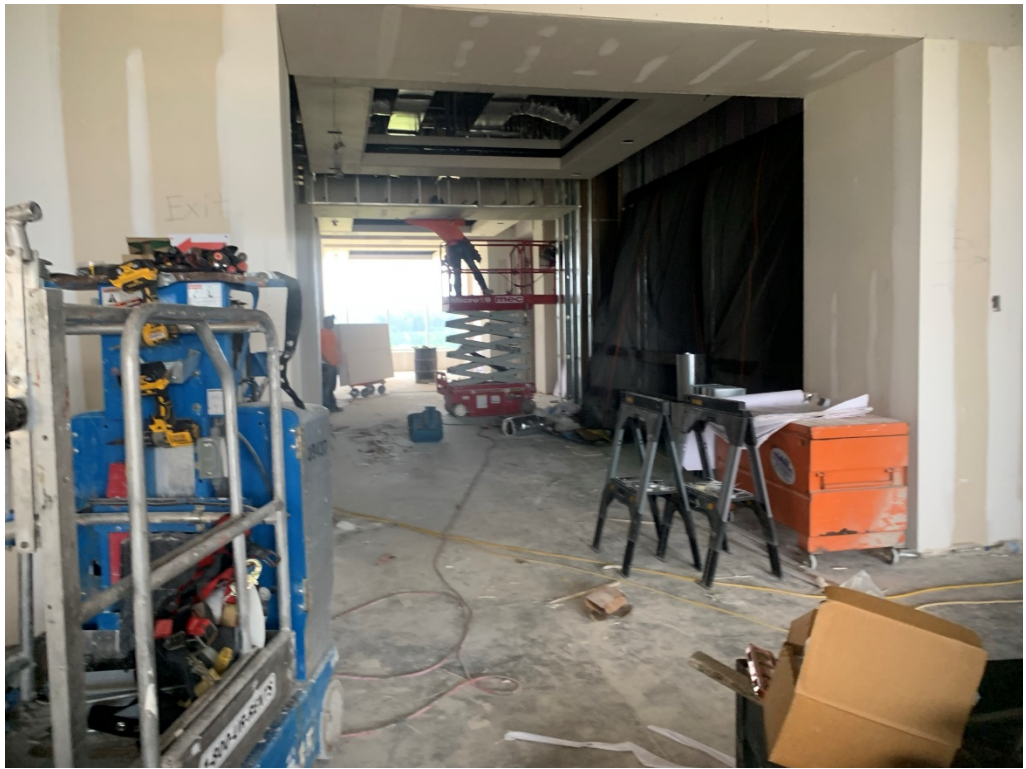
Figure 13 – 4th floor sheetrock install is ongoing

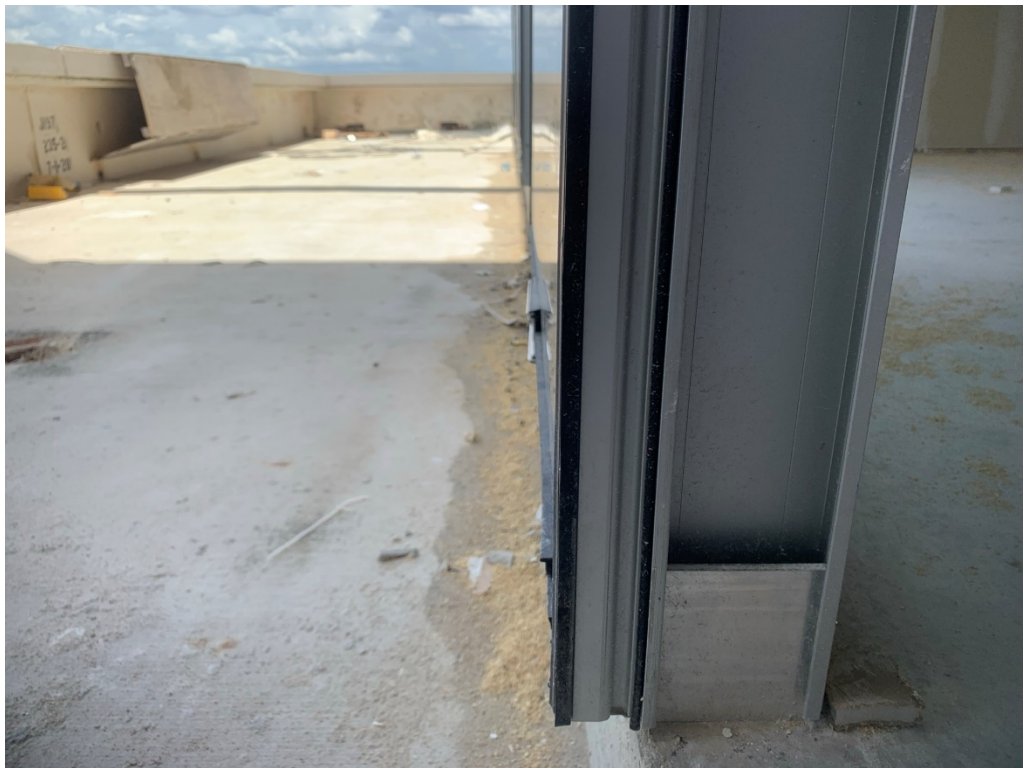
At the fourth floor, there is also a curtain wall on the NW corner that appear to have a slight bow in it; this may be an optical illusion, but please check with line and confirm straightness.

Figure 14 – 4th Floor NW Curtain wall; check for straightness
