Architect's Field Report

6 September 2021

15094 Community Bank Headquarters / Report Number 024

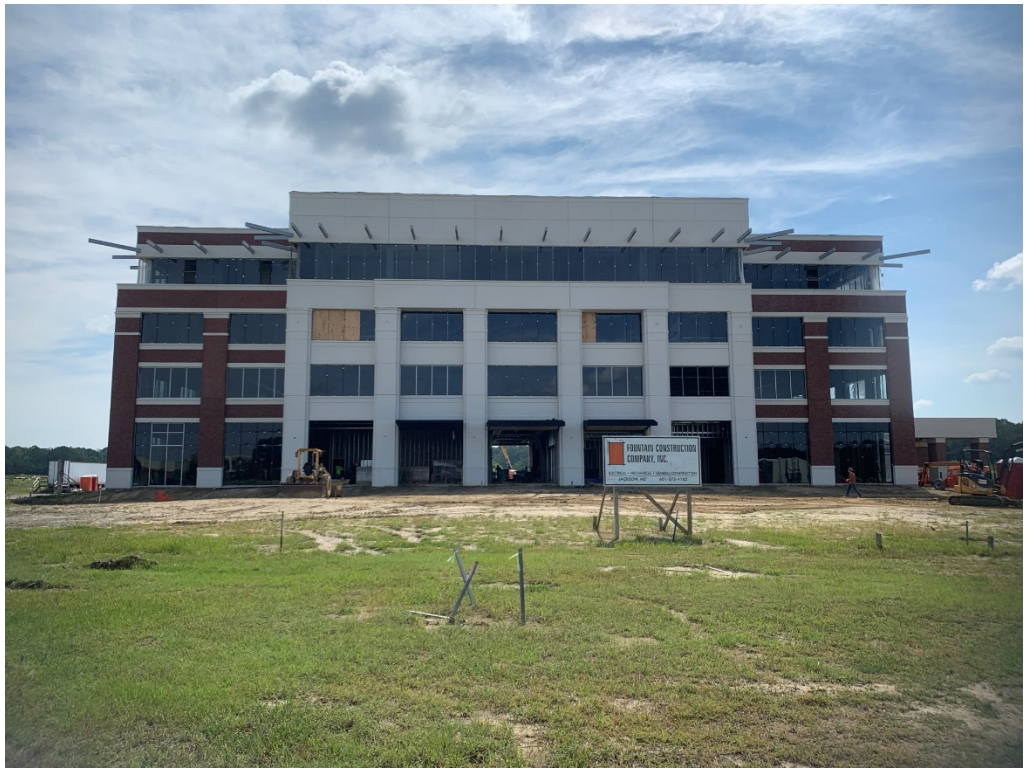
Figure 1 – West Façade Progress

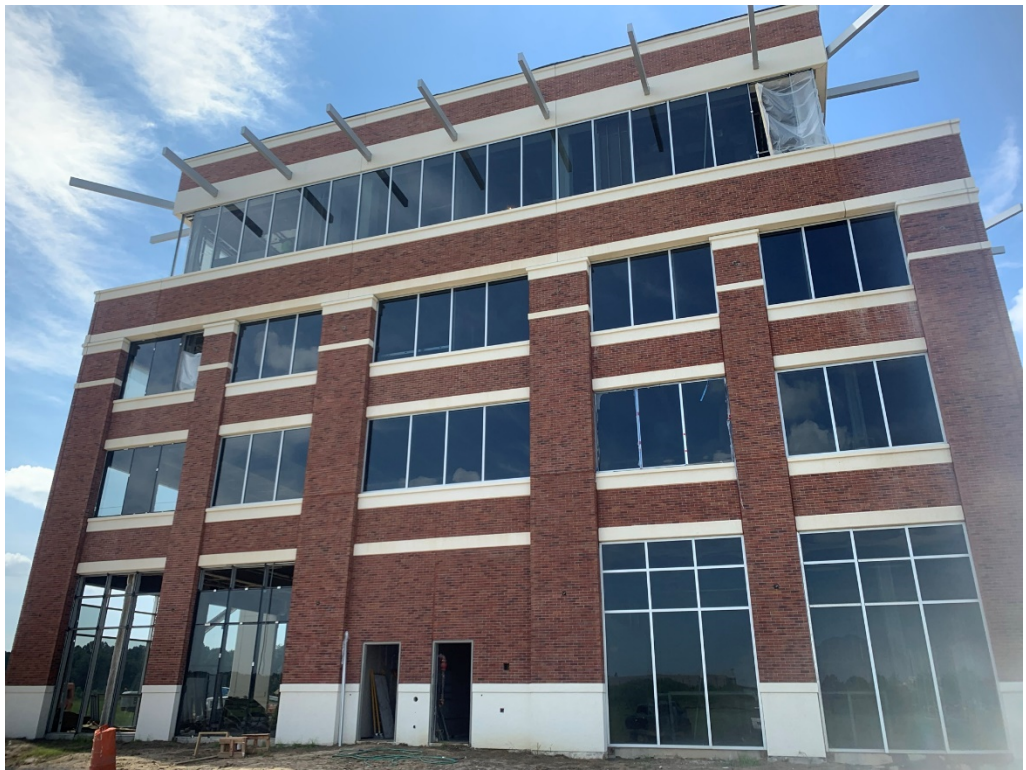
Figure 2 – North Façade Progress

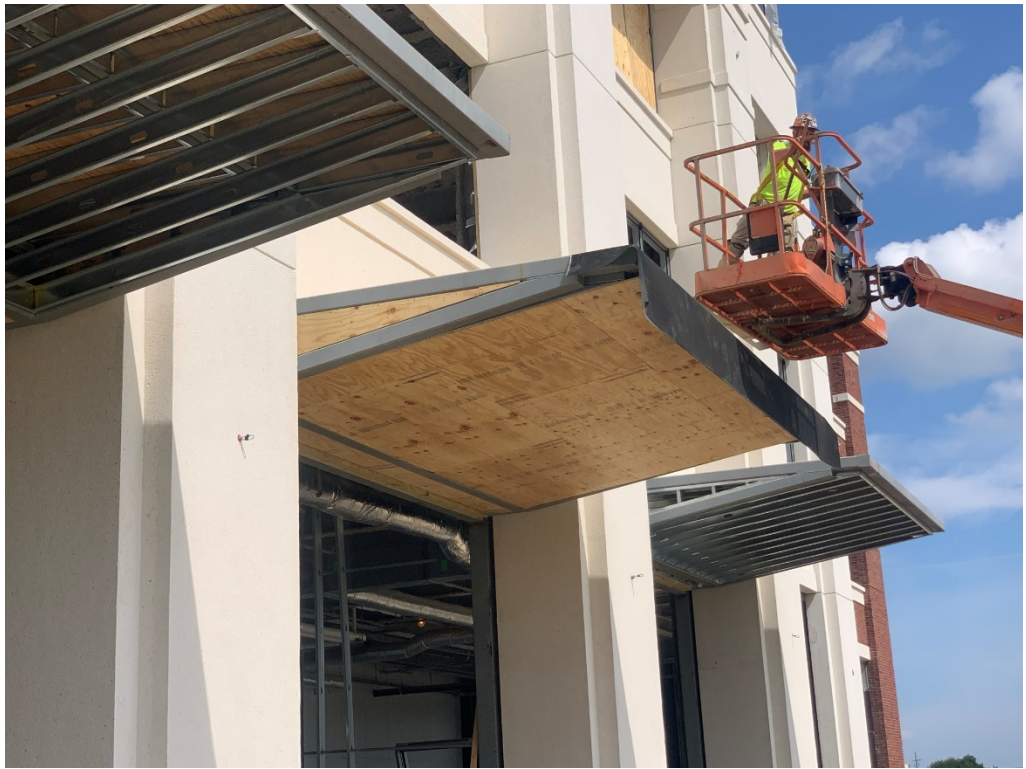
Figure 5 – Awning Decking and Roofing work

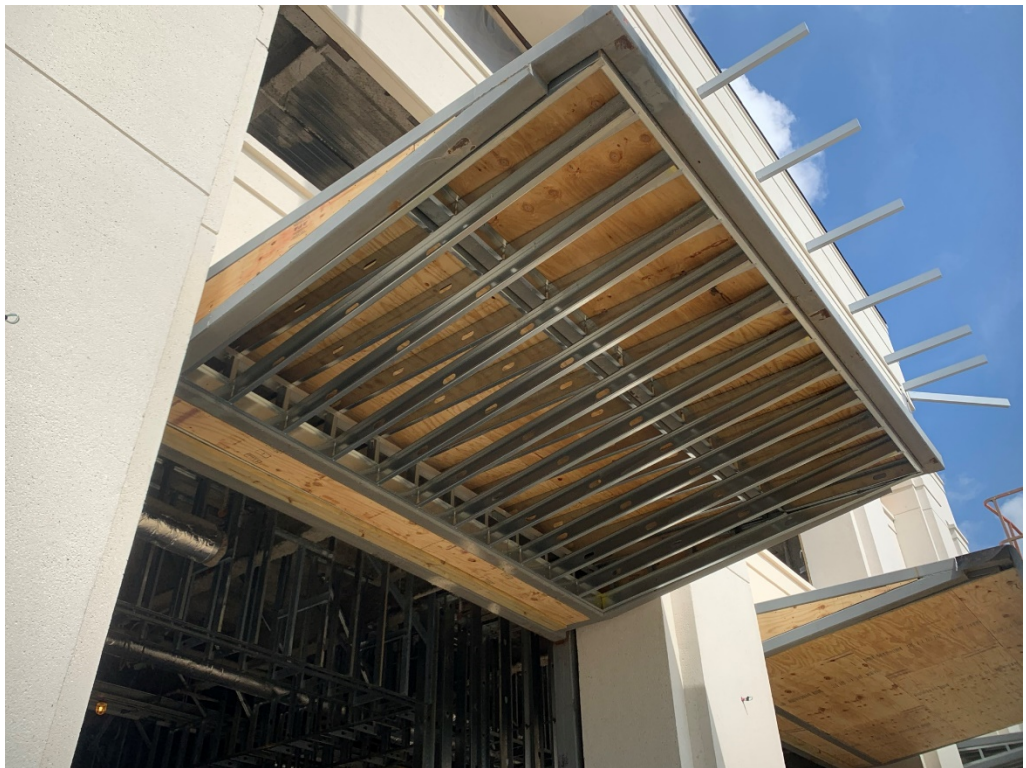
Figure 6 – Awning Decking and Roofing work

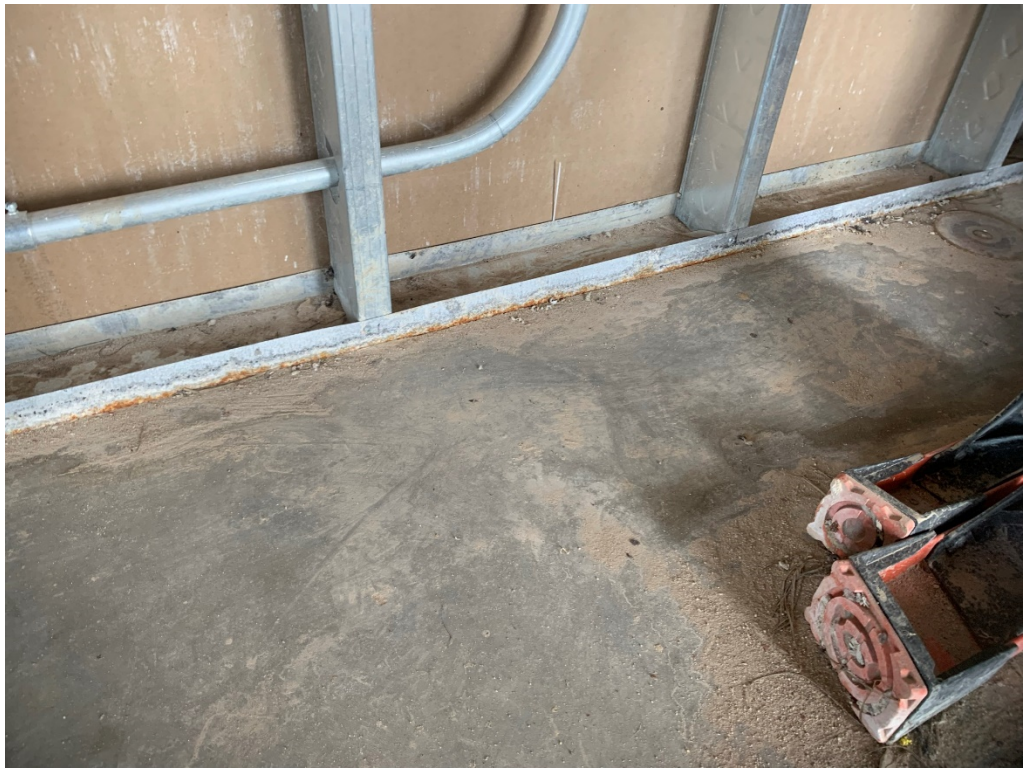
Figure 7 – This is evidence of significant rust at the first floor walls; bottom plate should be replaced after project is dried in.

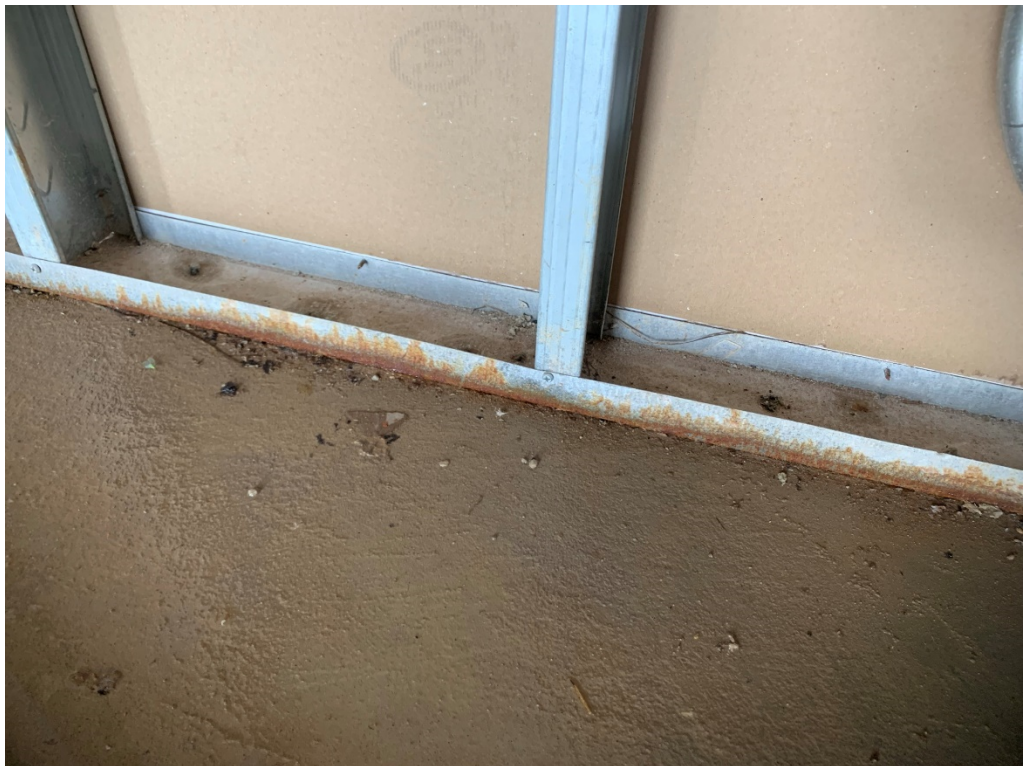
Figure 8 – This is evidence of significant rust at the first floor walls; bottom plate should be replaced after project is dried in.

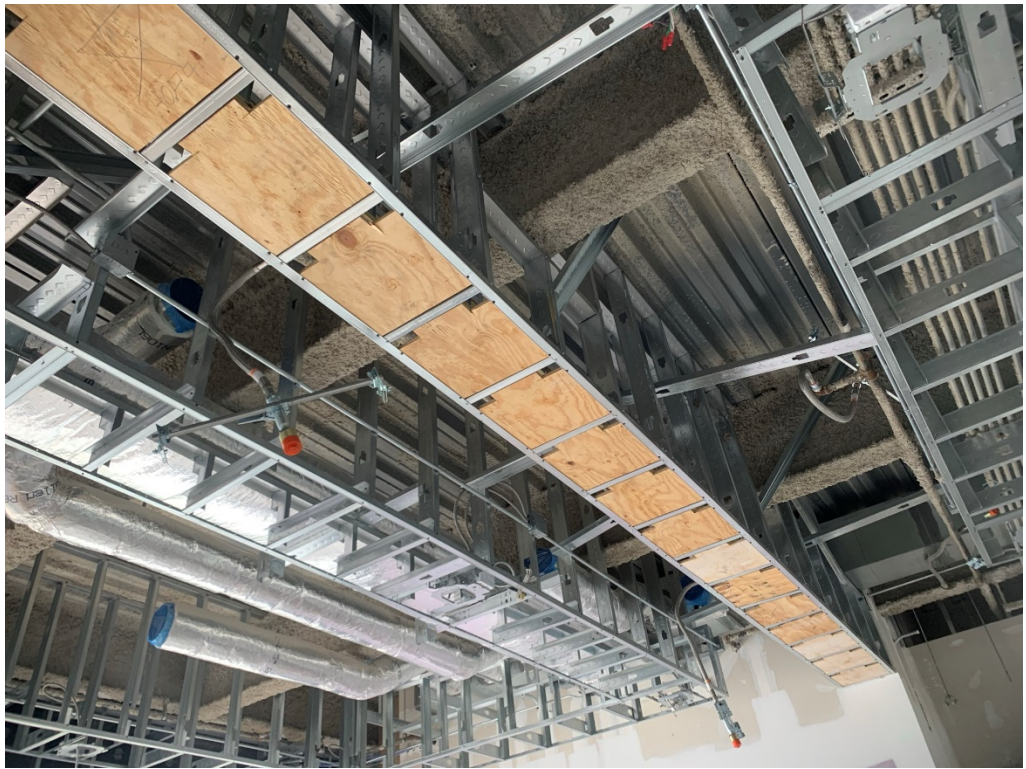
Figure 9 – Blocking and Framing are ongoing

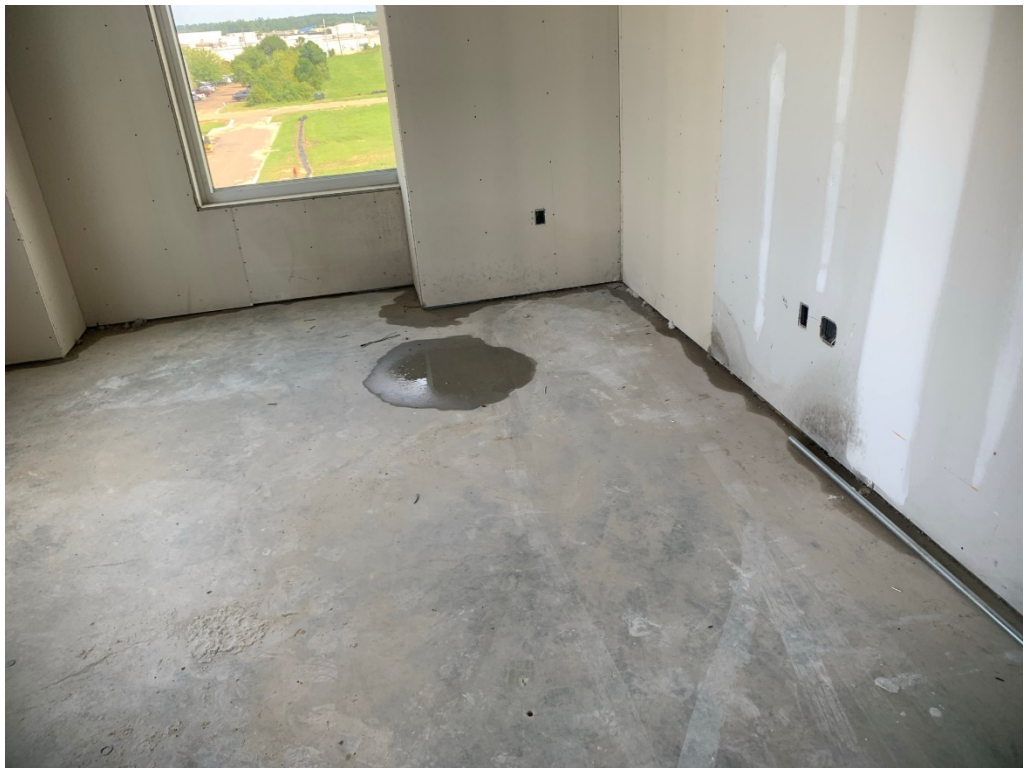
Figure 10 – This NW 3rd Floor Corner Office should have all sheetrock removed and insulation for drying

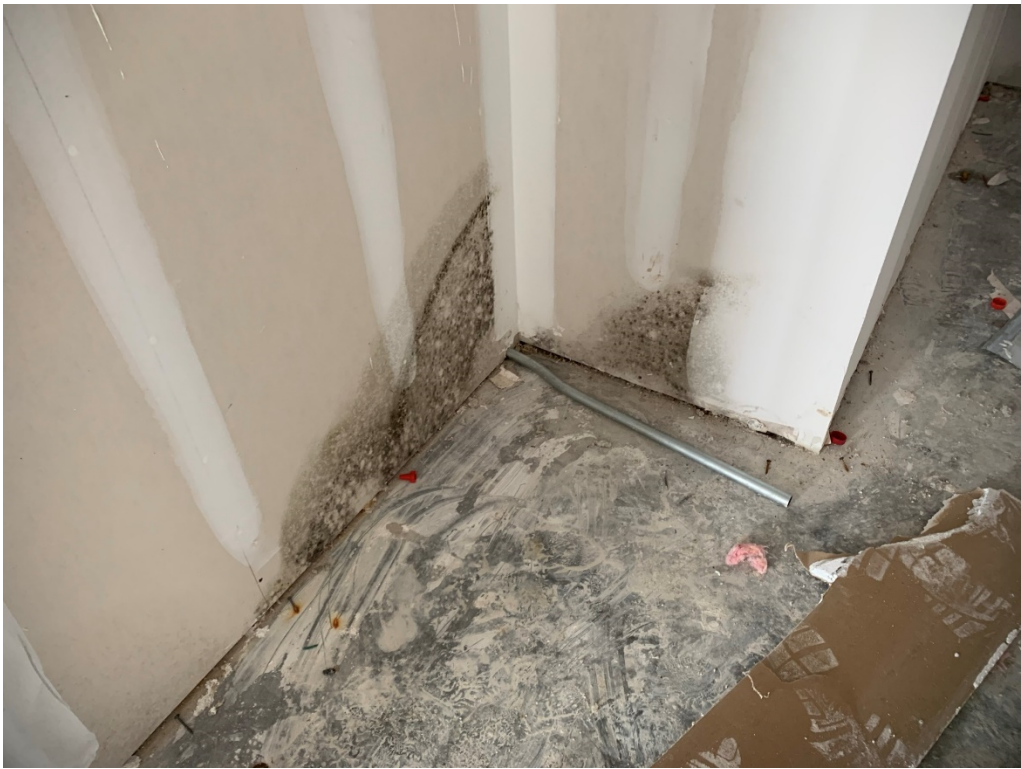
Figure 11 – Interior Walls should be cut 24" from floor wherever mold has set in and insulation removed for drying

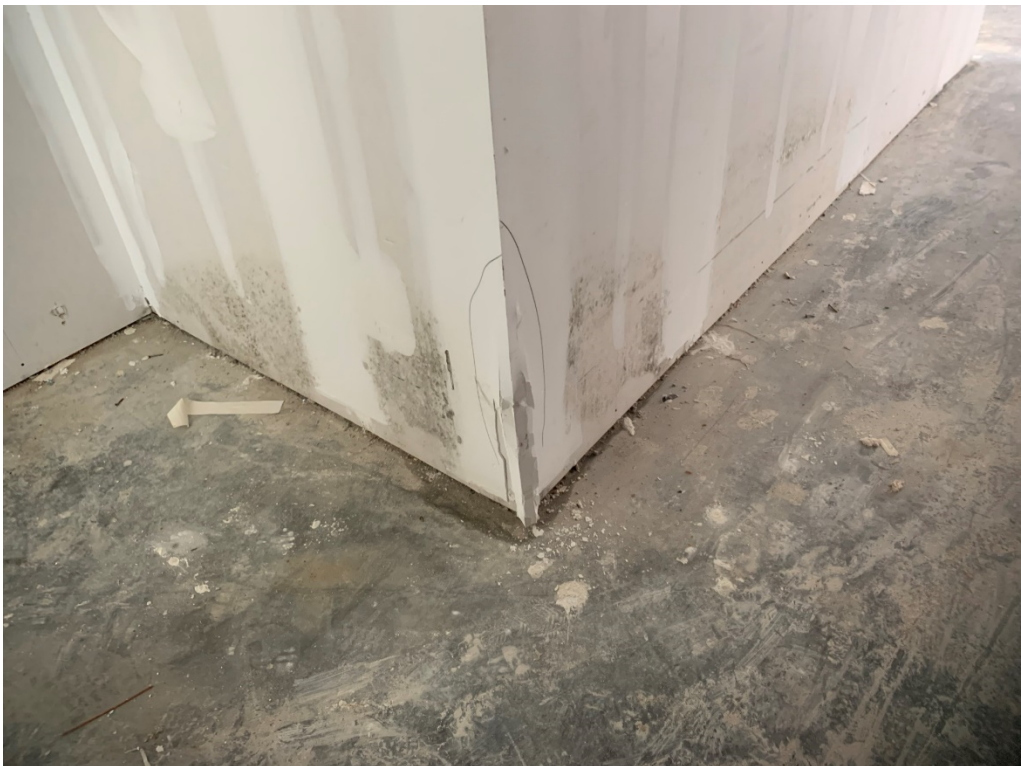
Figure 12 – Interior Walls should be cut 24" from floor wherever mold has set in and insulation removed for drying
