Architect's Field Report

17 September 2021

15094 Community Bank Headquarters / Report Number 025

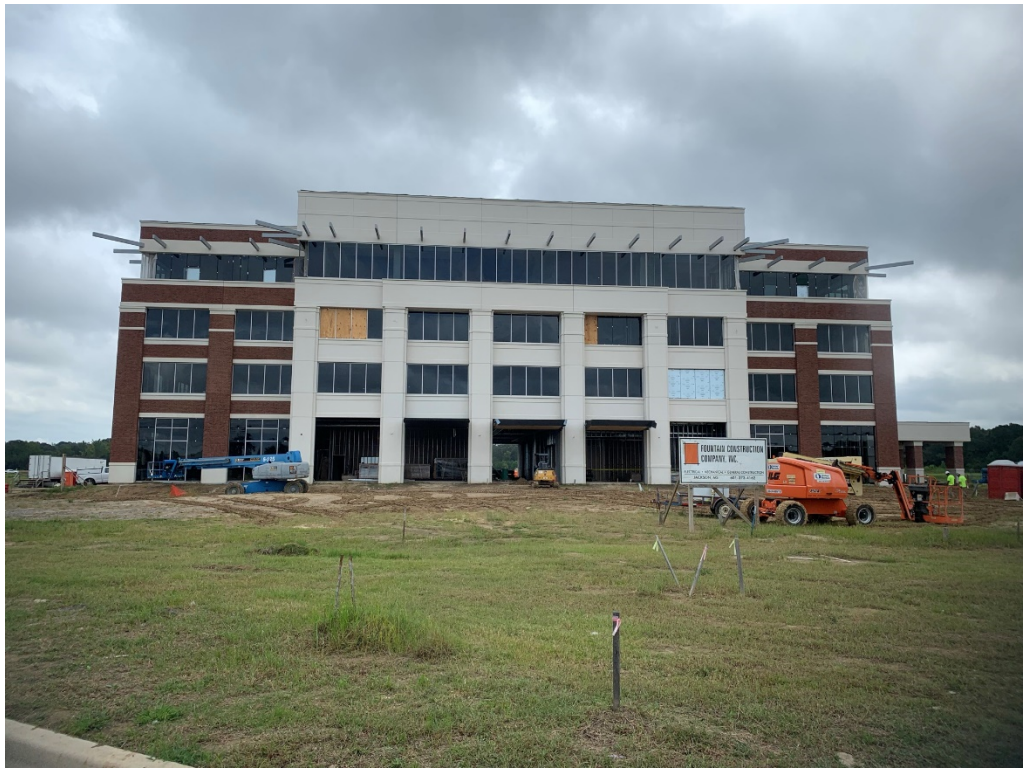
Figure 1 – West Façade Progress

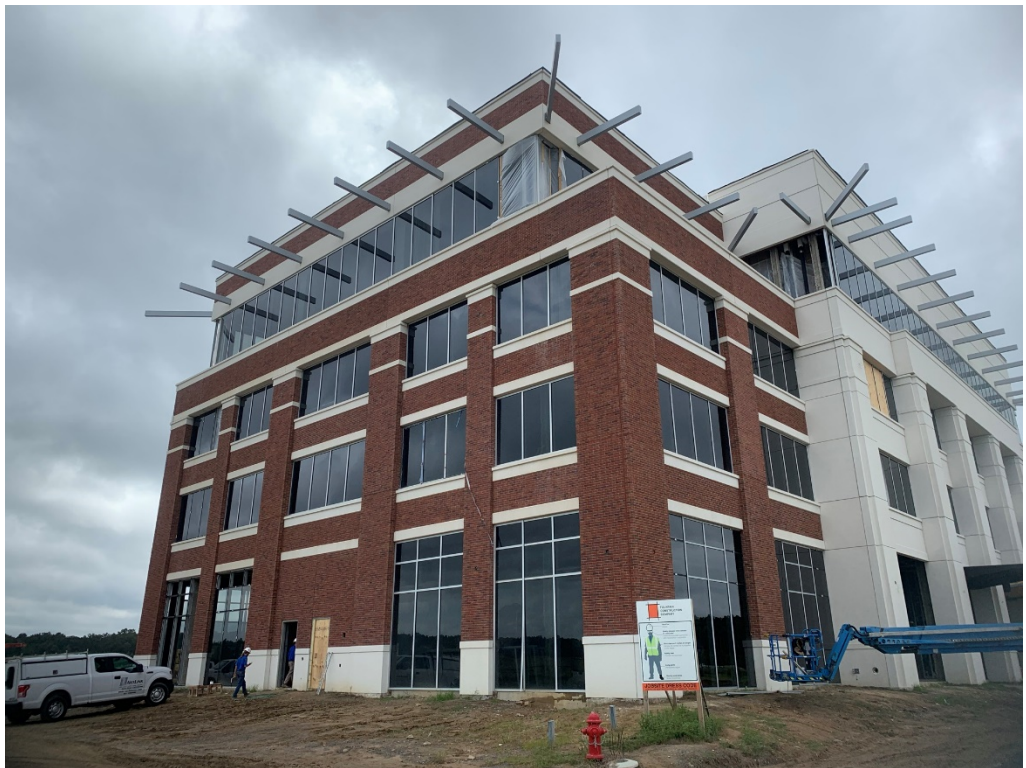
Figure 2 – North Façade Progress

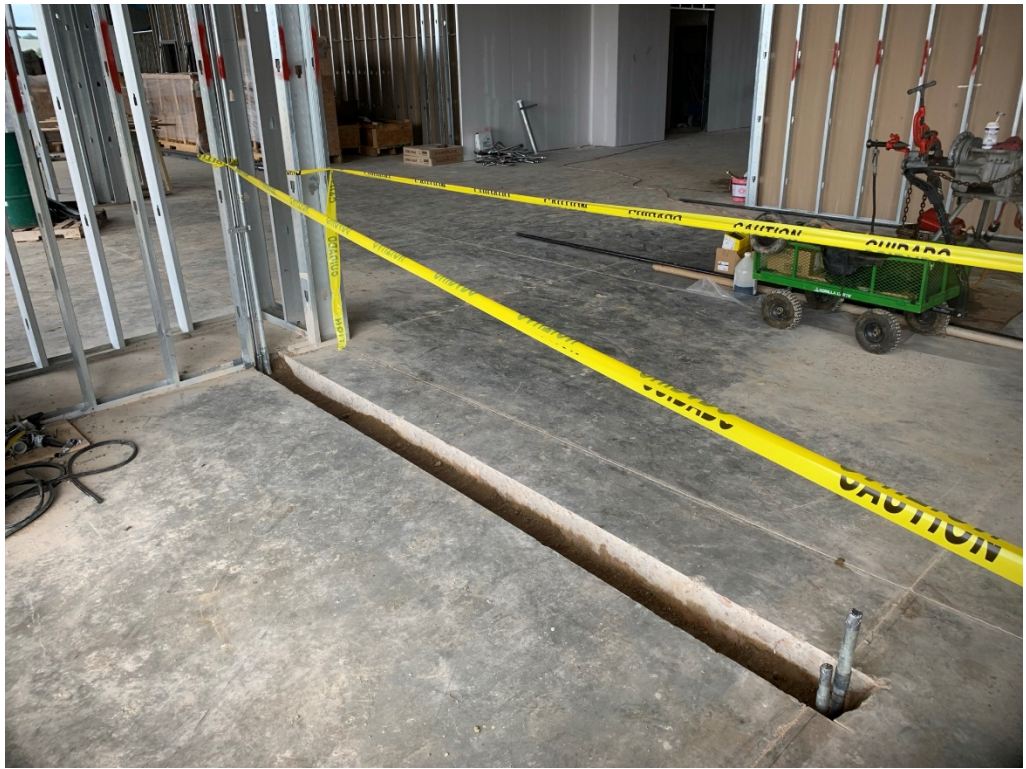
Figure 5 – Trenches for added conduit

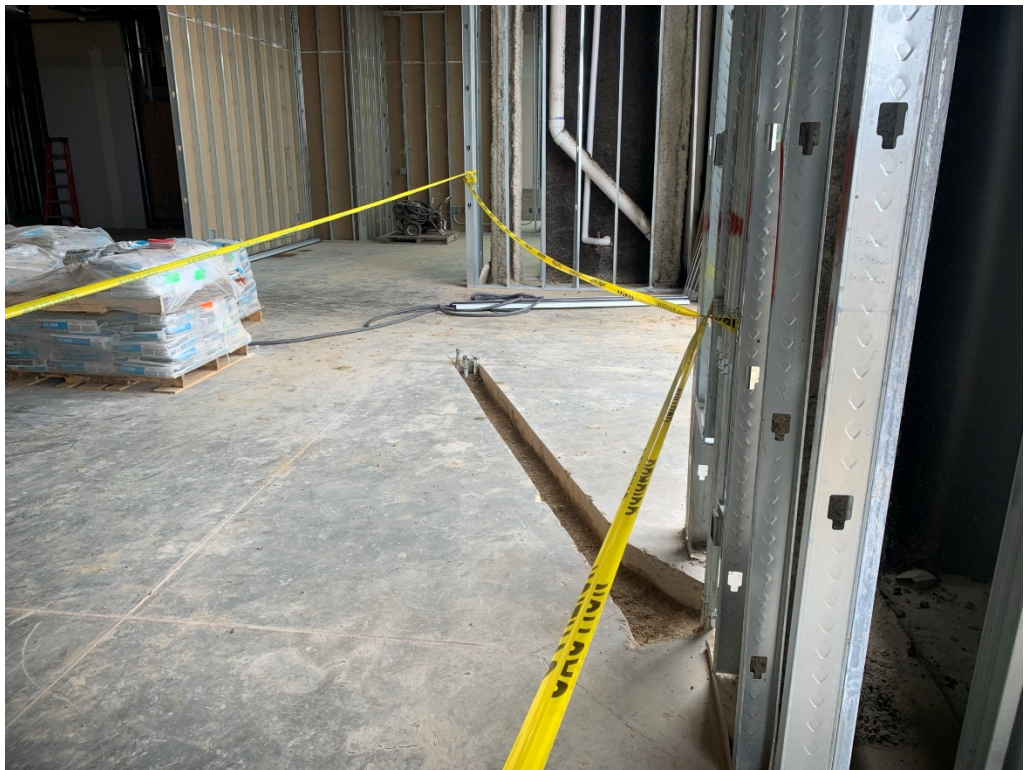
Figure 6 – Trenches for added conduit

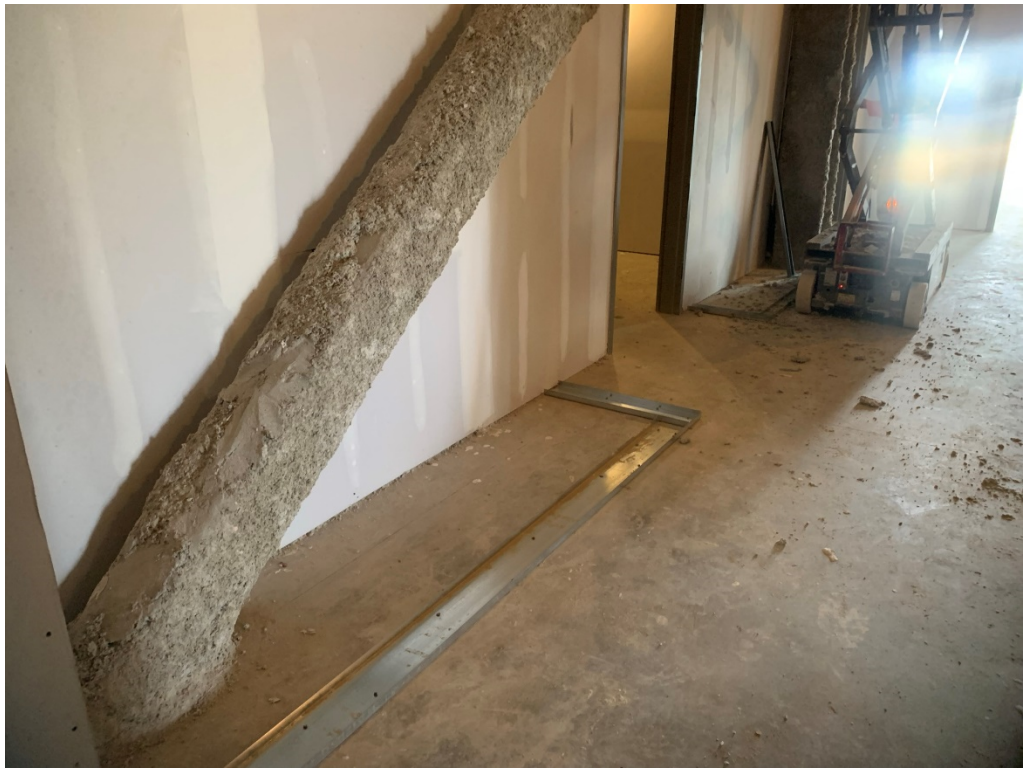
Figure 7 – Framing at the first floor is ongoing

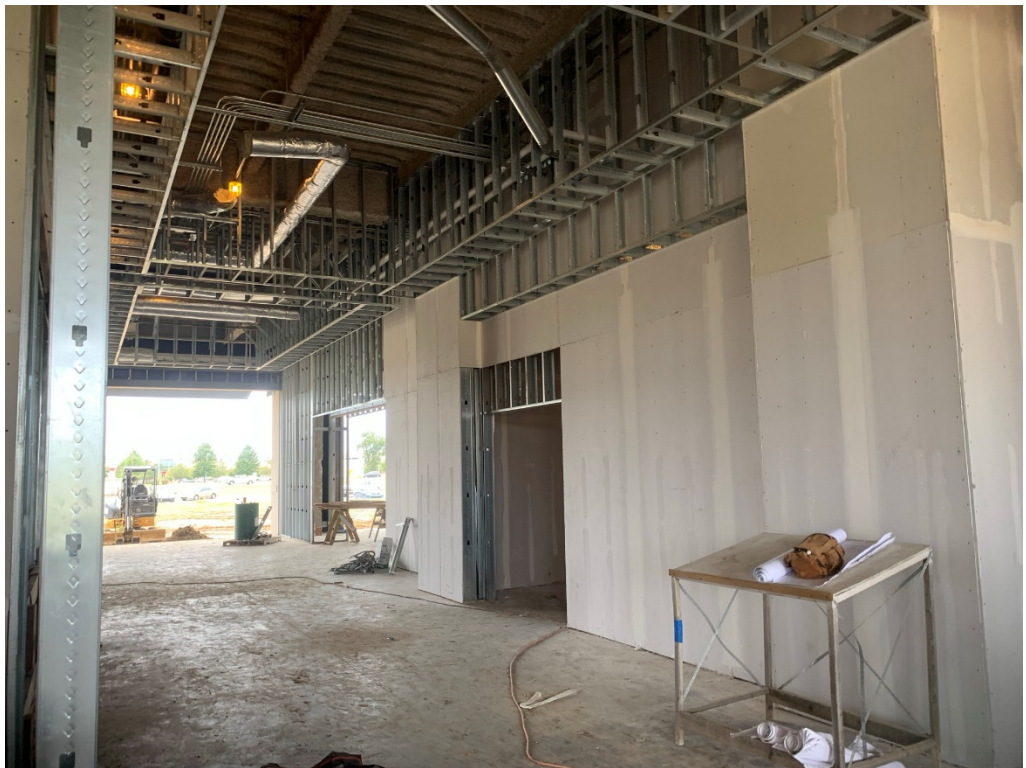
Figure 8 – Ceiling Framing at the First Floor

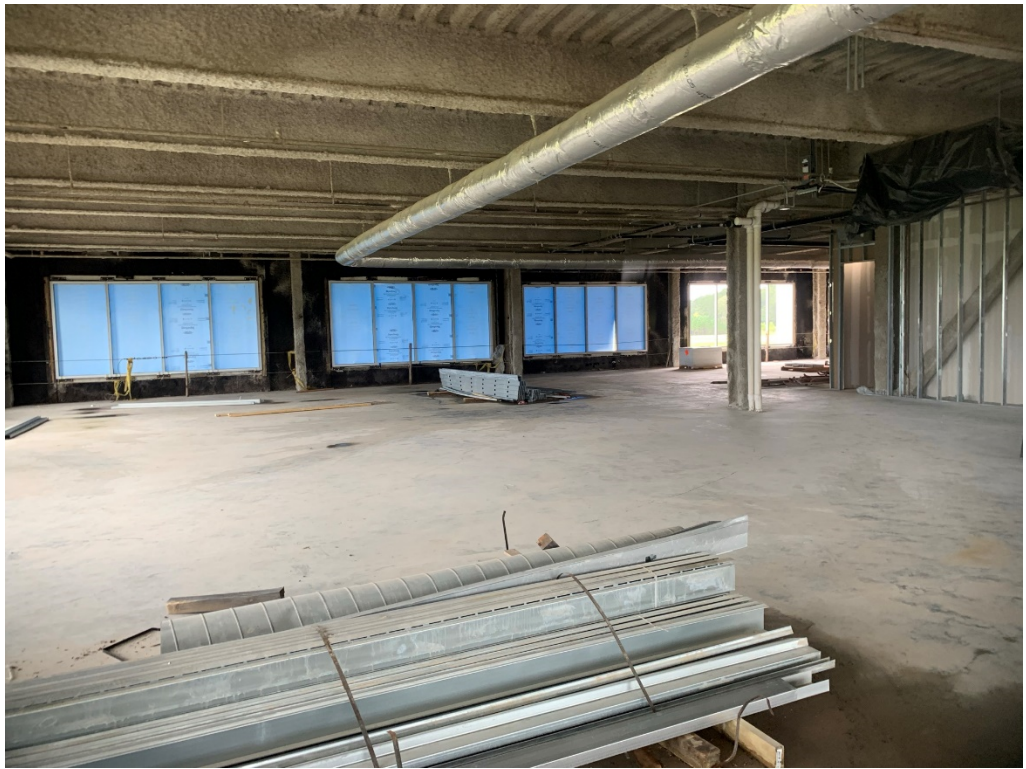
Air at the 3rd floor is running but there are several gaps in plastic and rigid foam board. I'm not sure the foam board is strong enough to make a good temporary covering in the window frames and/or it is being installed quite poorly in some areas leaving large gaps.

Figure 9 – rigid insulation installed at windows

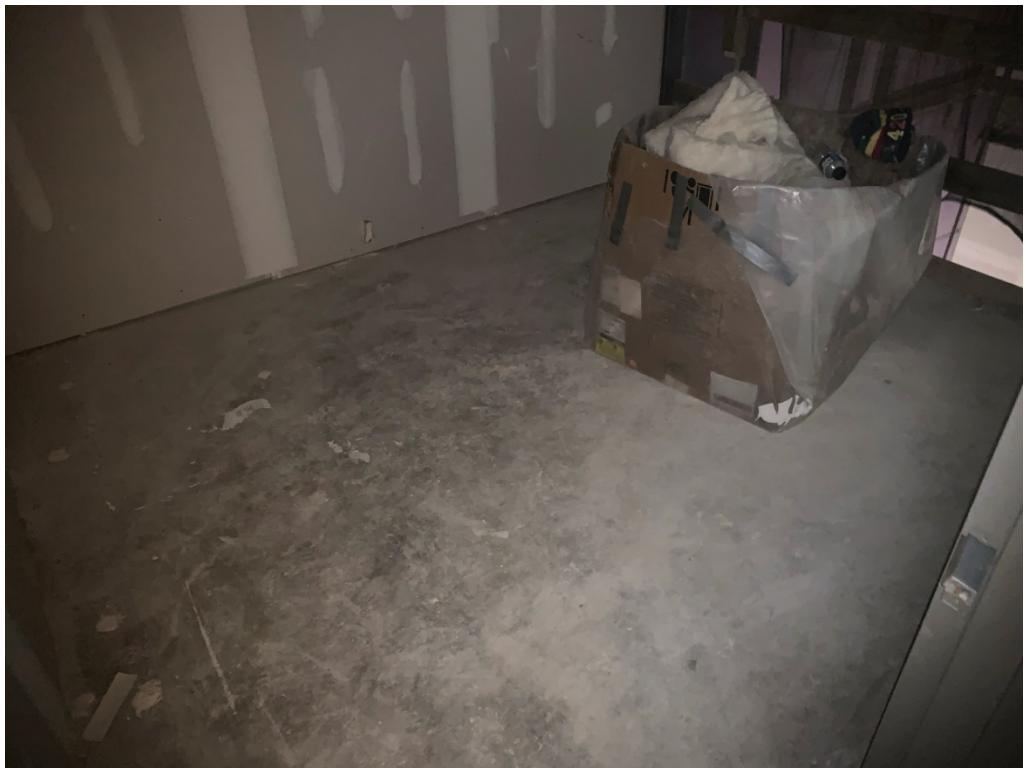
Figure 10 – Support 2007: this floor seems to be very out of level and may need additional leveling installed at the floor

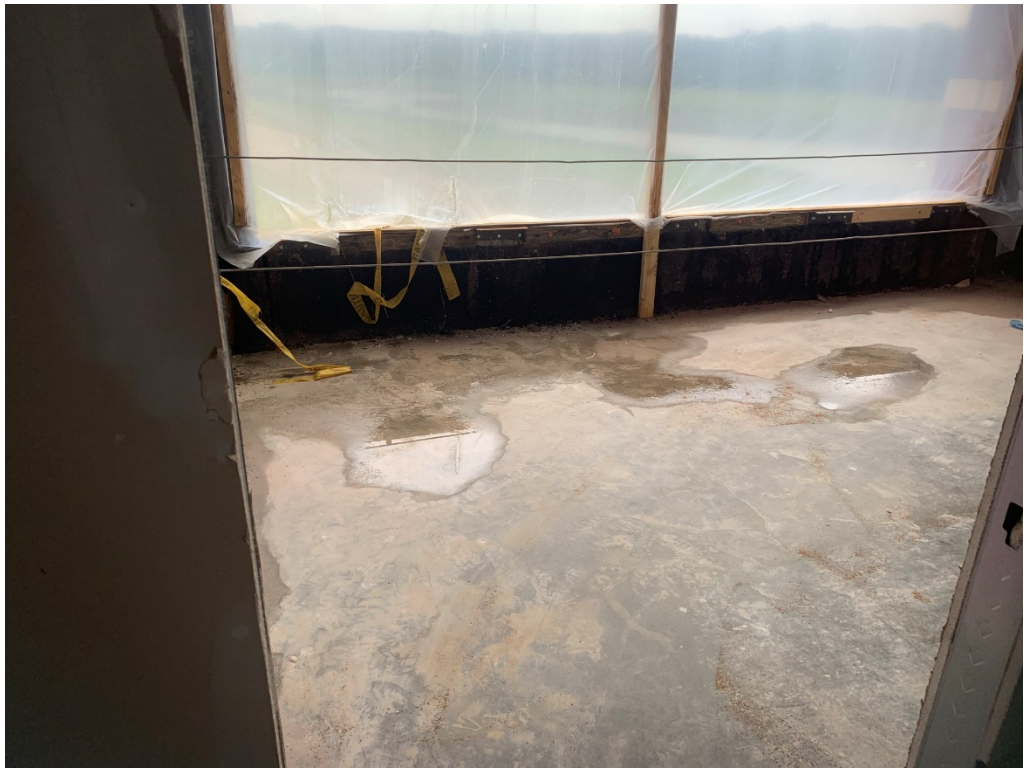
Figure 11 – Water Intrusion is ongoing

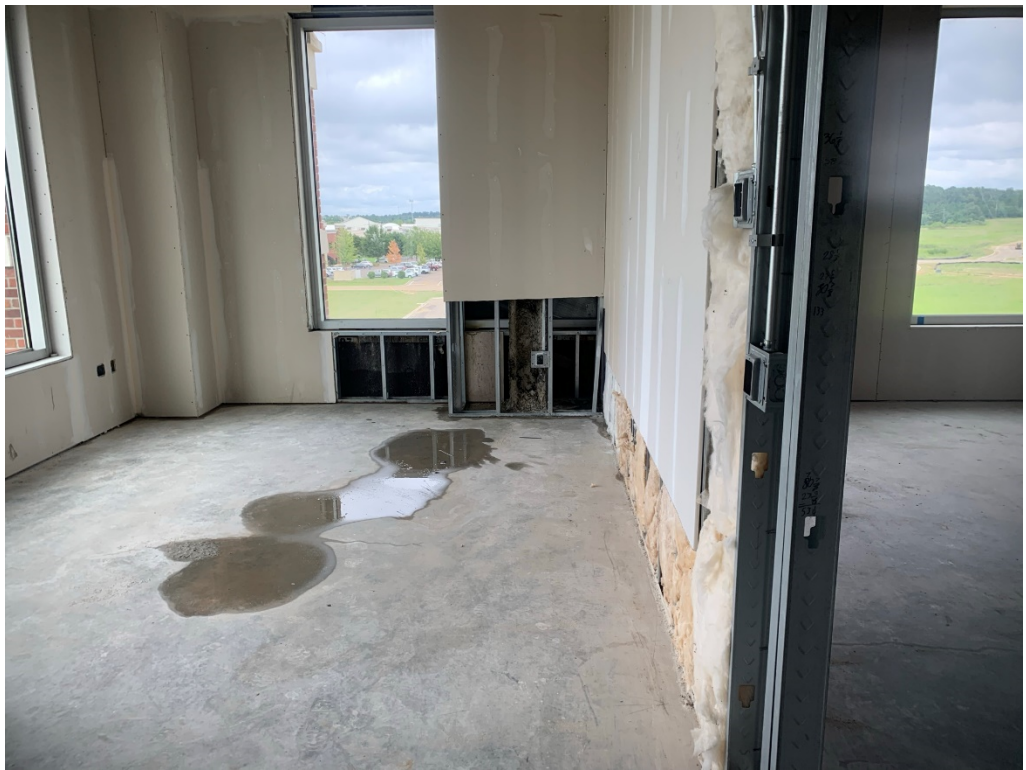
Figure 12 – Water Intrusion is ongoing

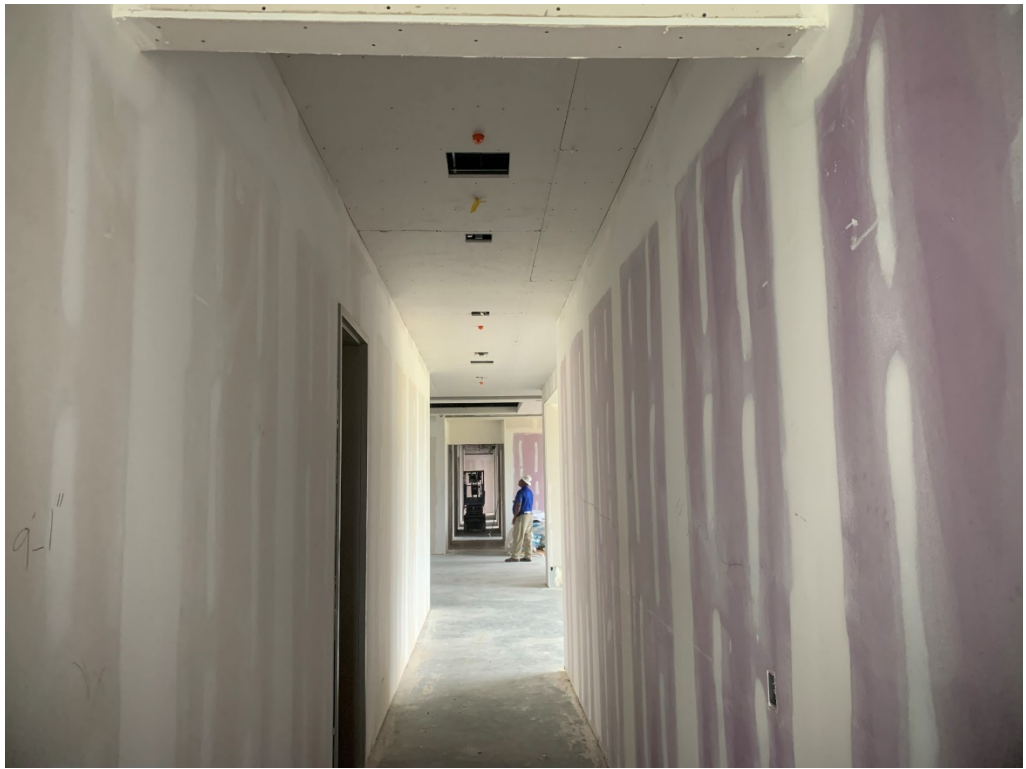
Inside, framing and drywall are continuing. Drywall Ceilings at the 3rd floor have been installed throughout.

Figure 13 – Hard Ceiling Installation at the 3rd Floor

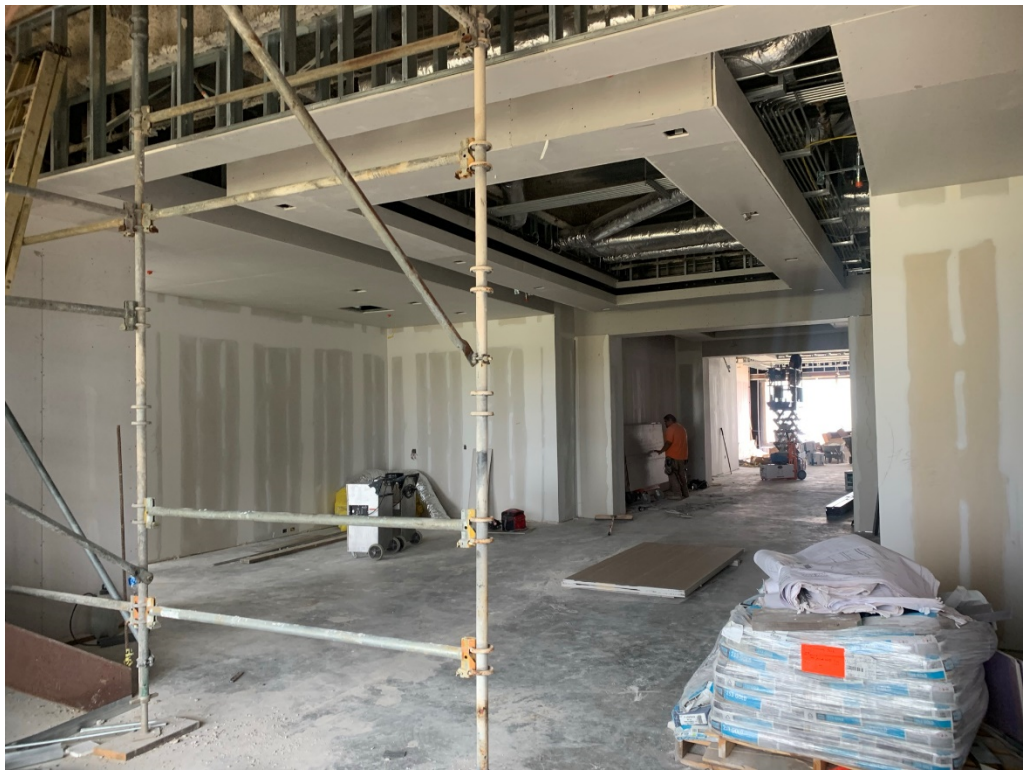
Figure 14 – Hard Ceiling Installation at the 3rd Floor

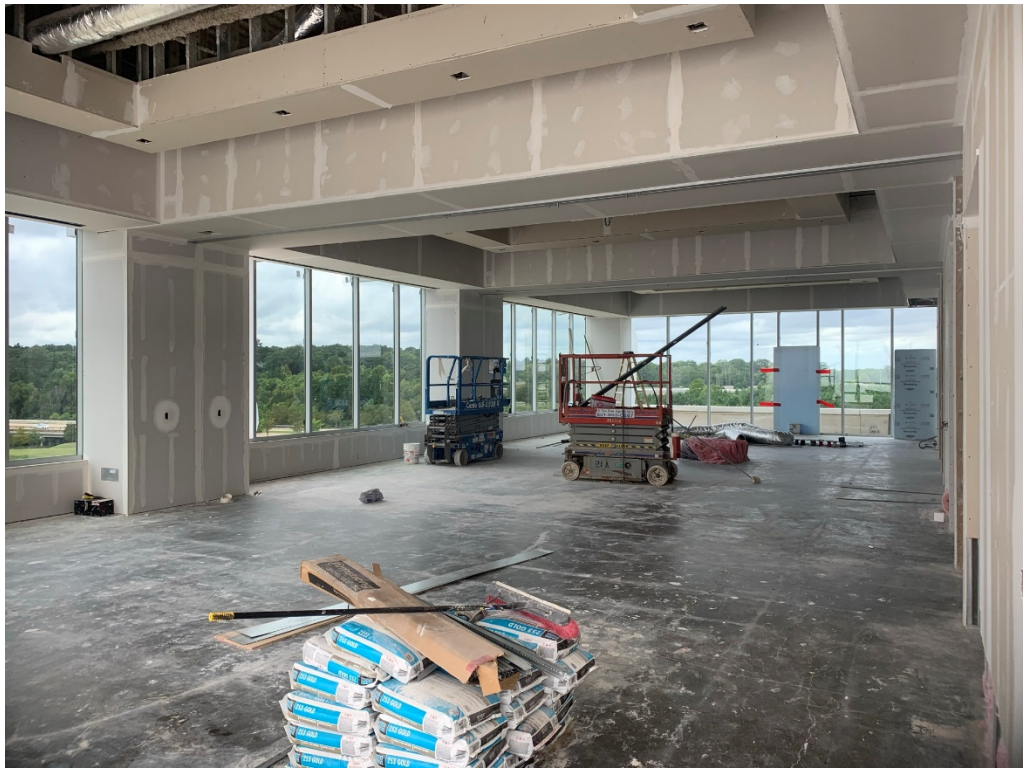
Figure 15 – Continued Drywall at Banquet 4th Floor

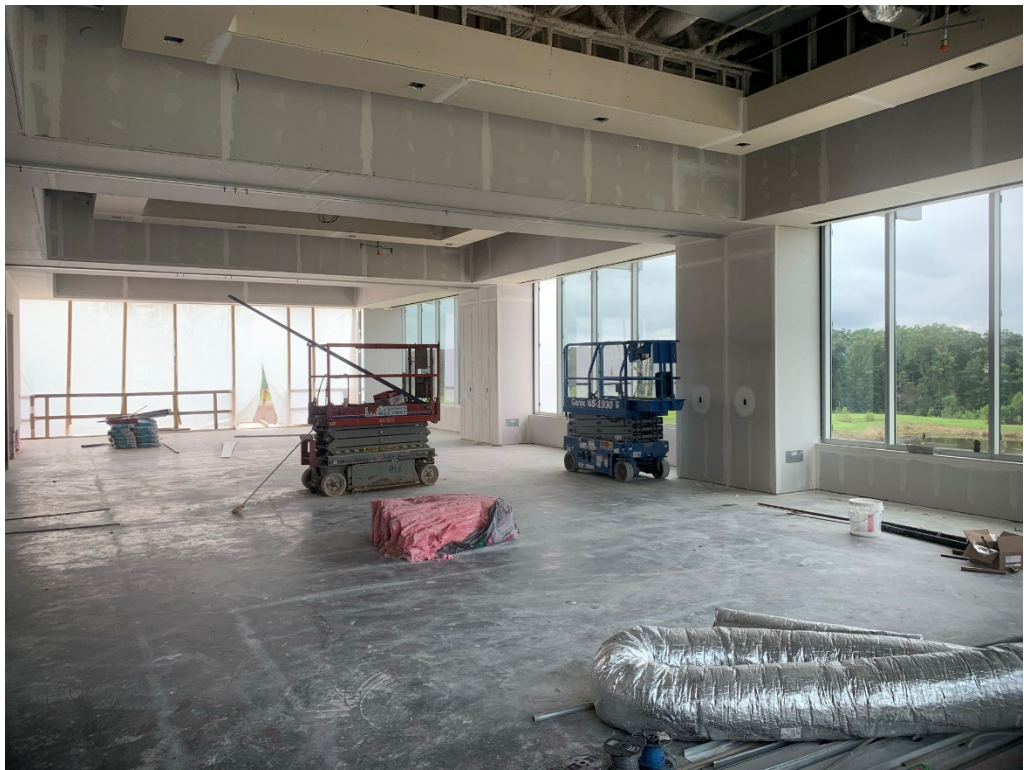
Figure 16 – Continued Drywall at Banquet 4th Floor
