Architect's Field Report

1 October 2021

15094 Community Bank Headquarters / Report Number 026

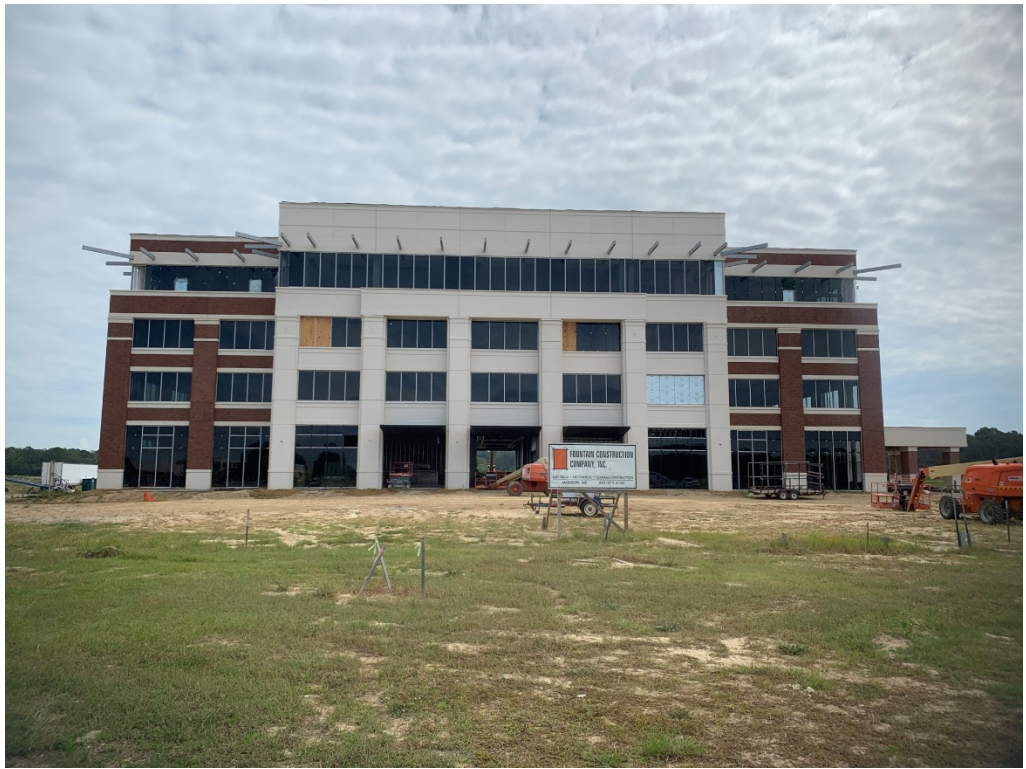
Figure 1 – West Façade Progress

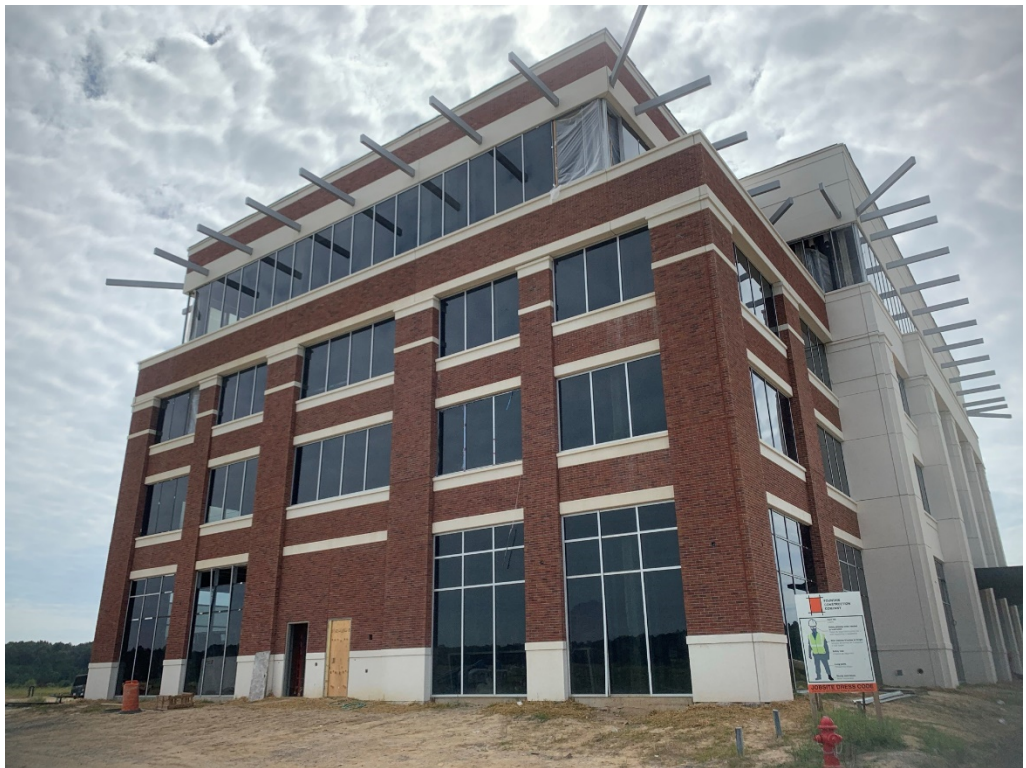
Figure 2 – North Façade Progress

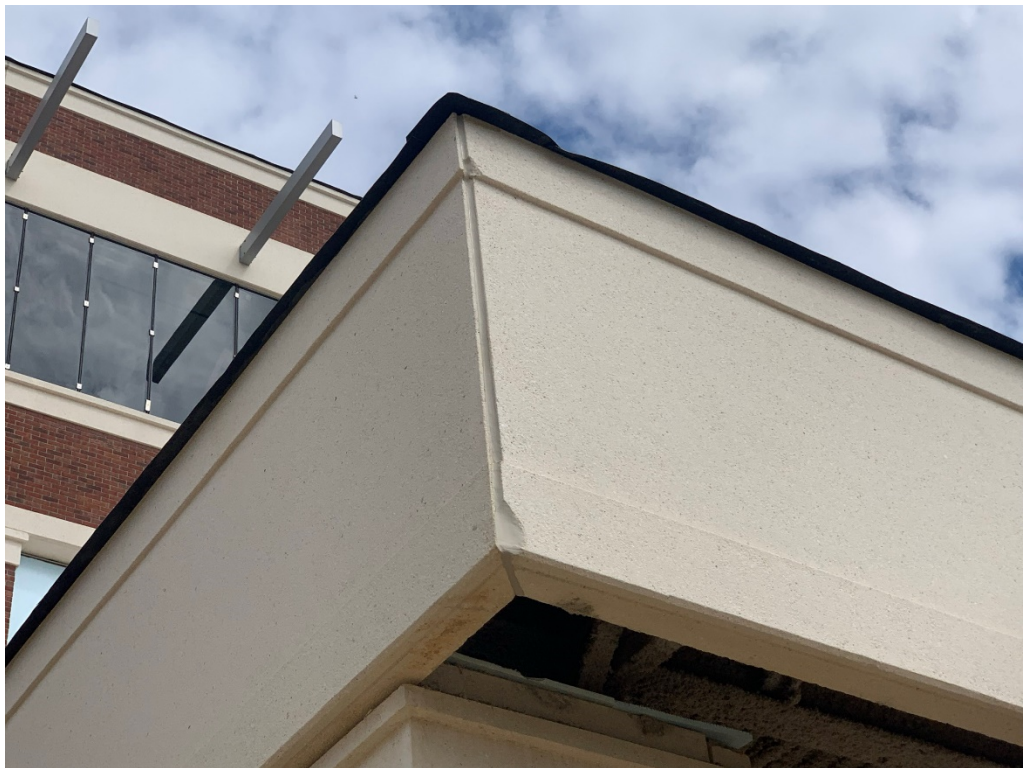
At the south drive through, sealant installers have filled corners at our precast panels. These corners still need a lot of attention by our precast finishing team. Gaps need to close up and chipped corners need to be repaired.

Figure 6 – Corners are not acceptable; missing chipped areas need repair

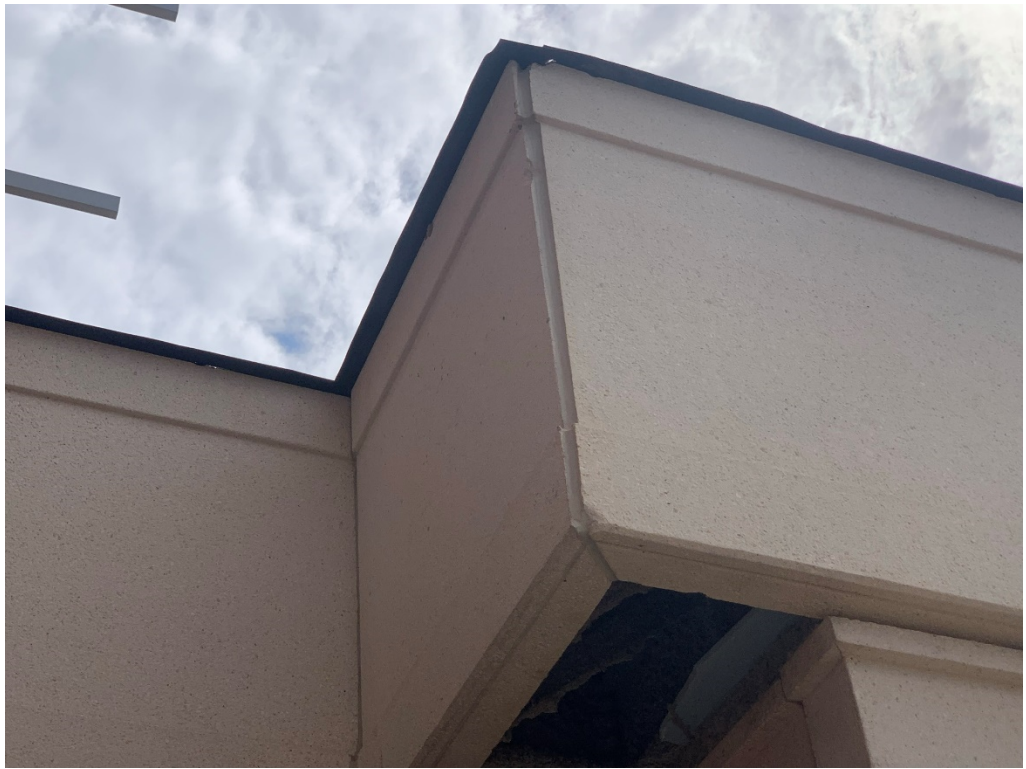
Figure 7 – Corners are not acceptable; missing chipped areas need repair

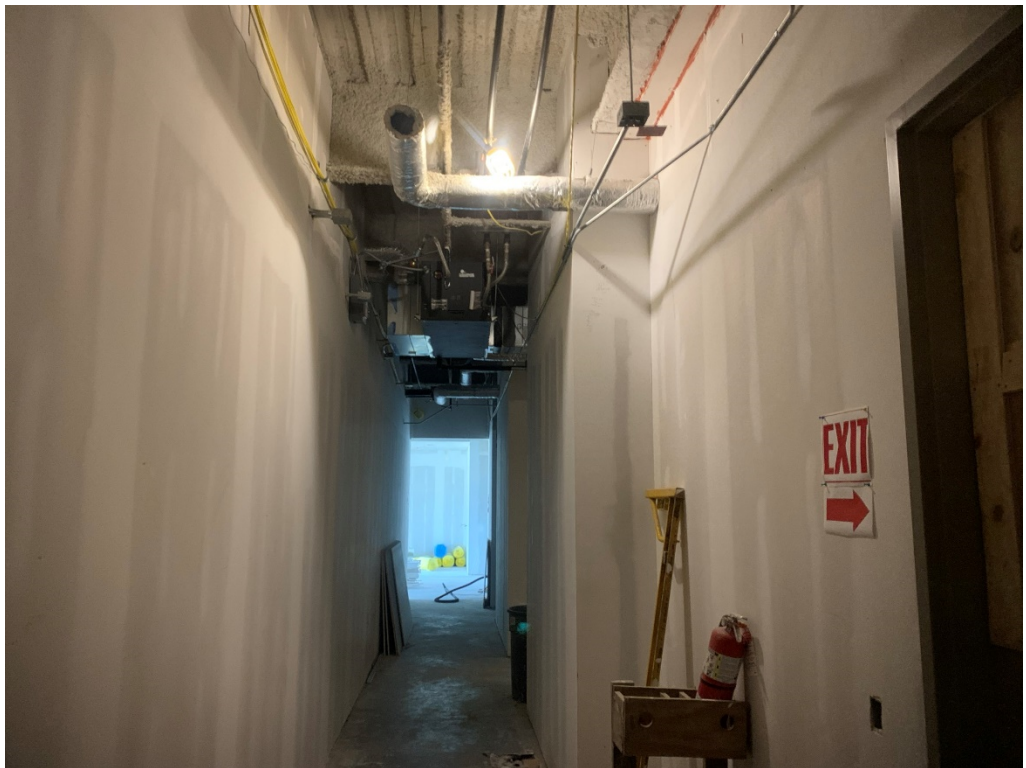
Figure 10 – Drywall is Ongoing

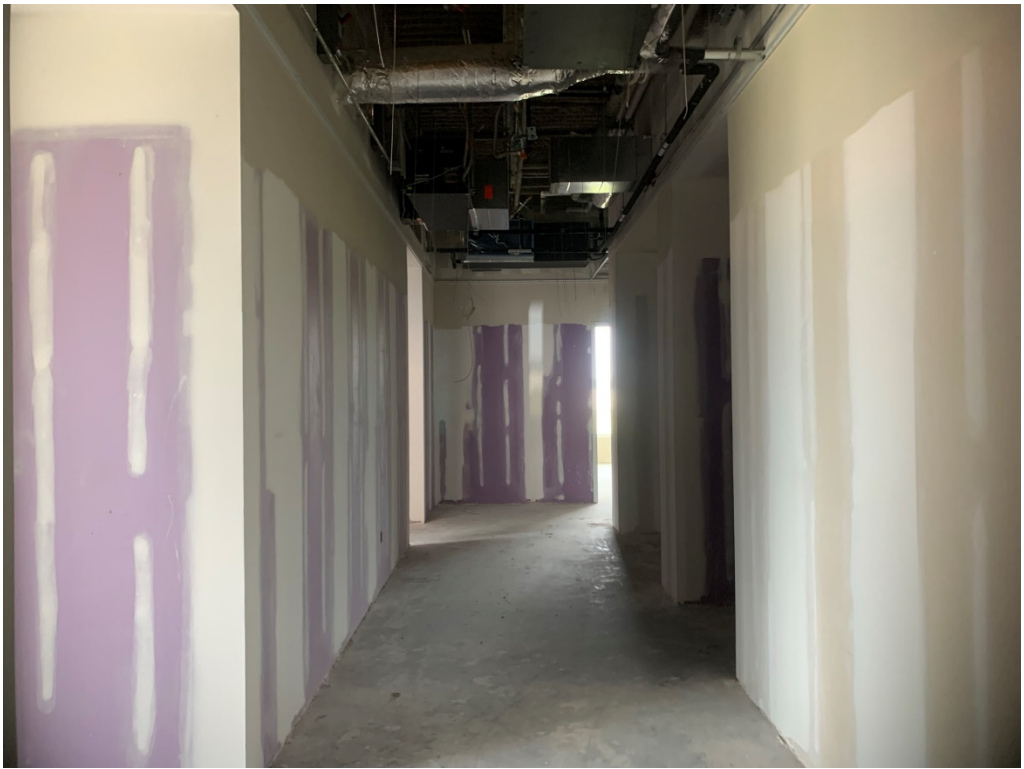
Figure 11 – Drywall is Ongoing

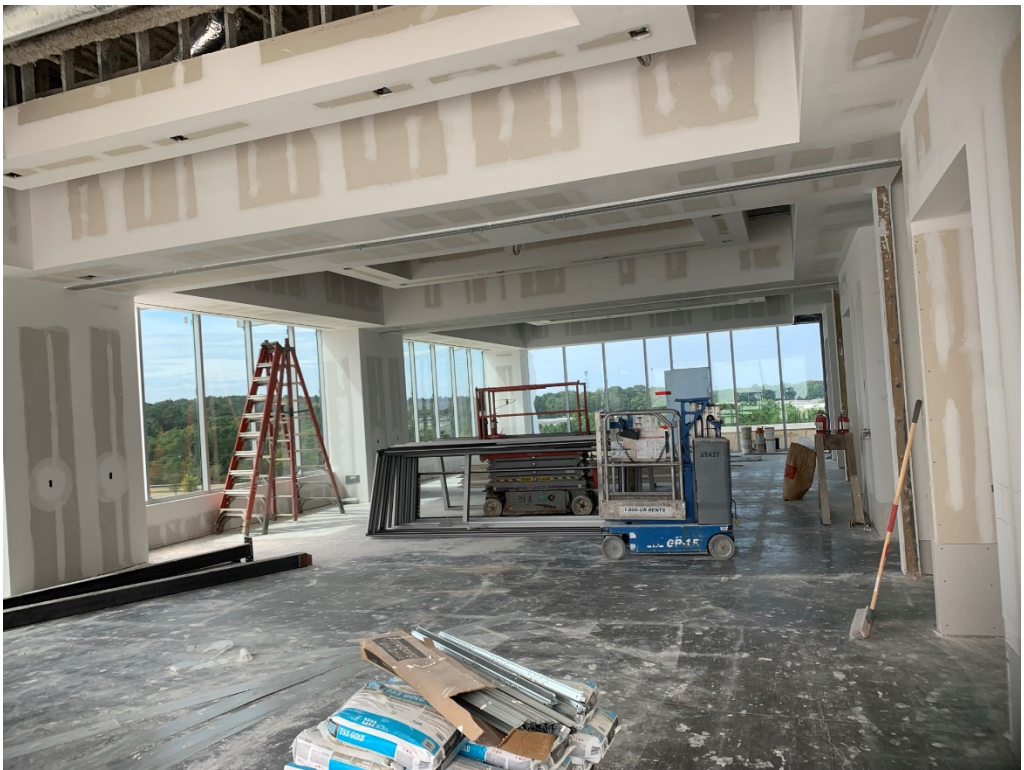
Figure 12 – Banquet Hall Progress

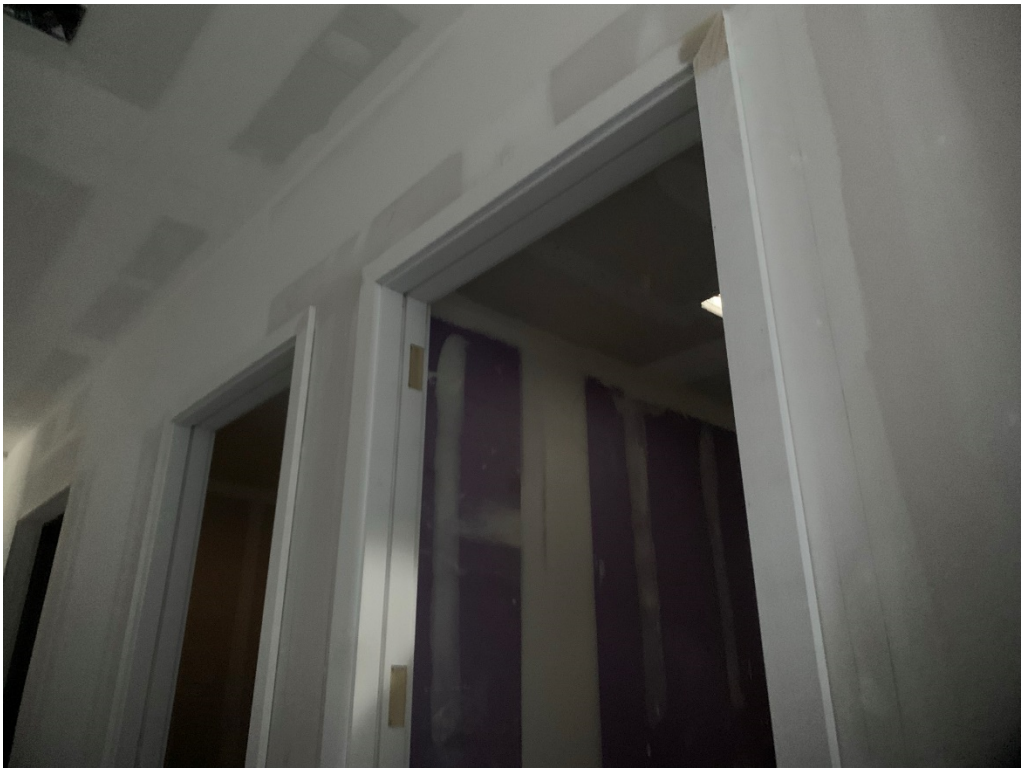
Figure 13 – Wood Jamb Installation @ Exec. Tlts

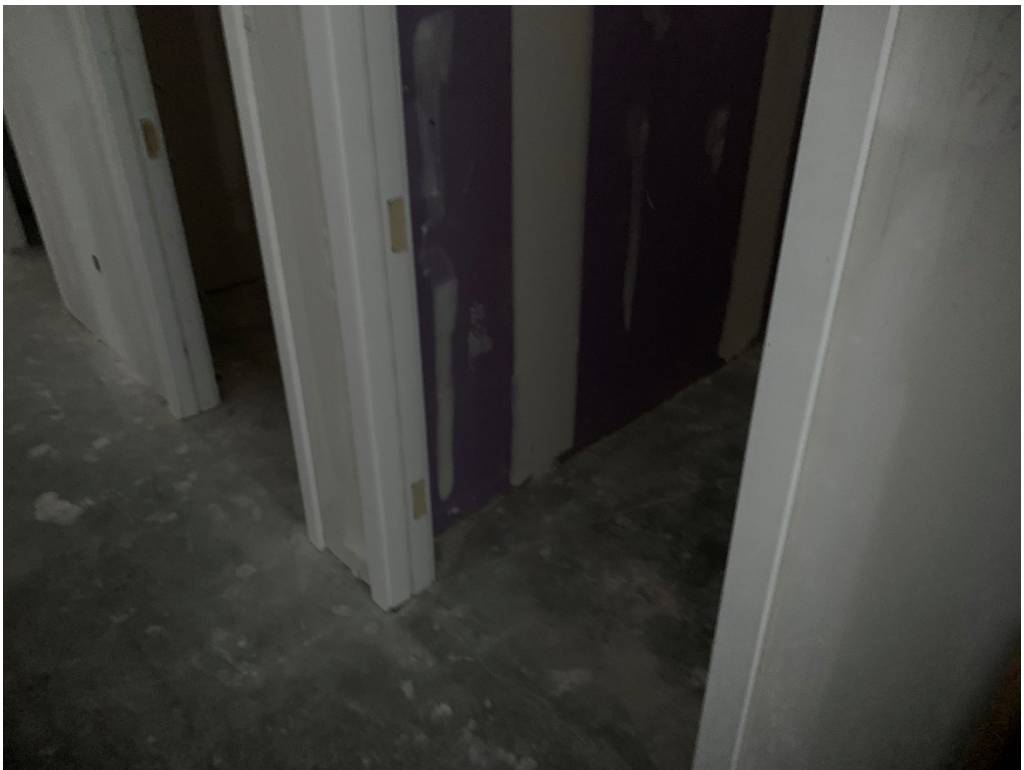
Figure 14 – Wood Jamb Installation @ Exec. Tlts
