Architect's Field Report

8 October 2021

15094 Community Bank Headquarters / Report Number 027

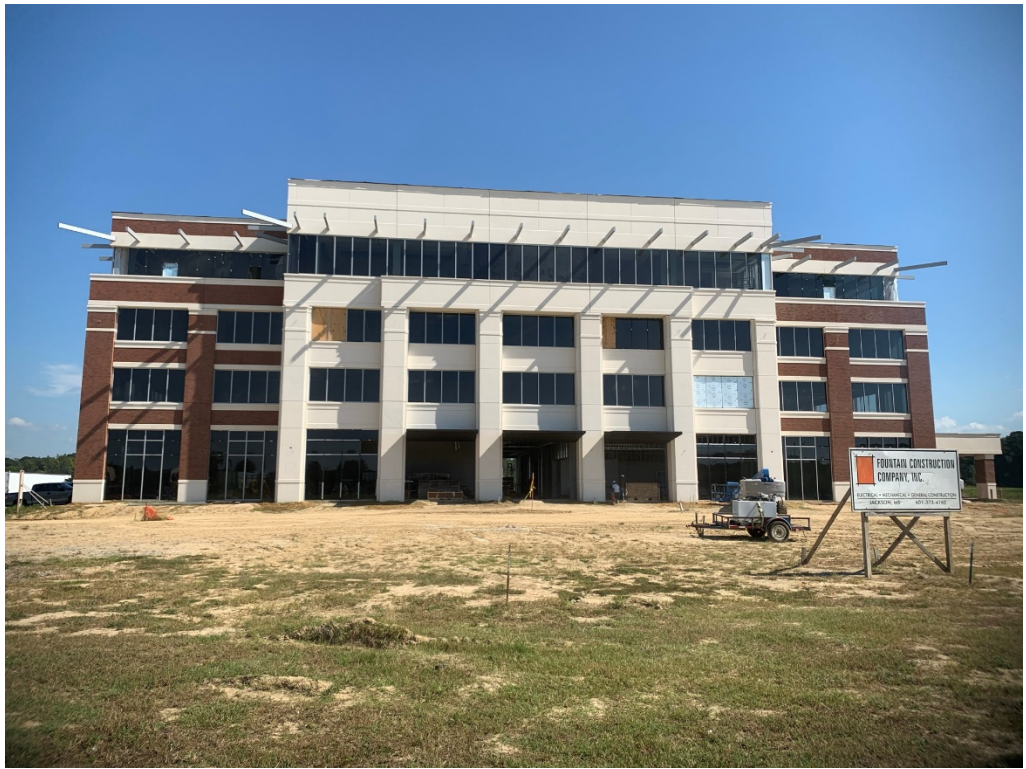
Figure 1 – West Façade Progress

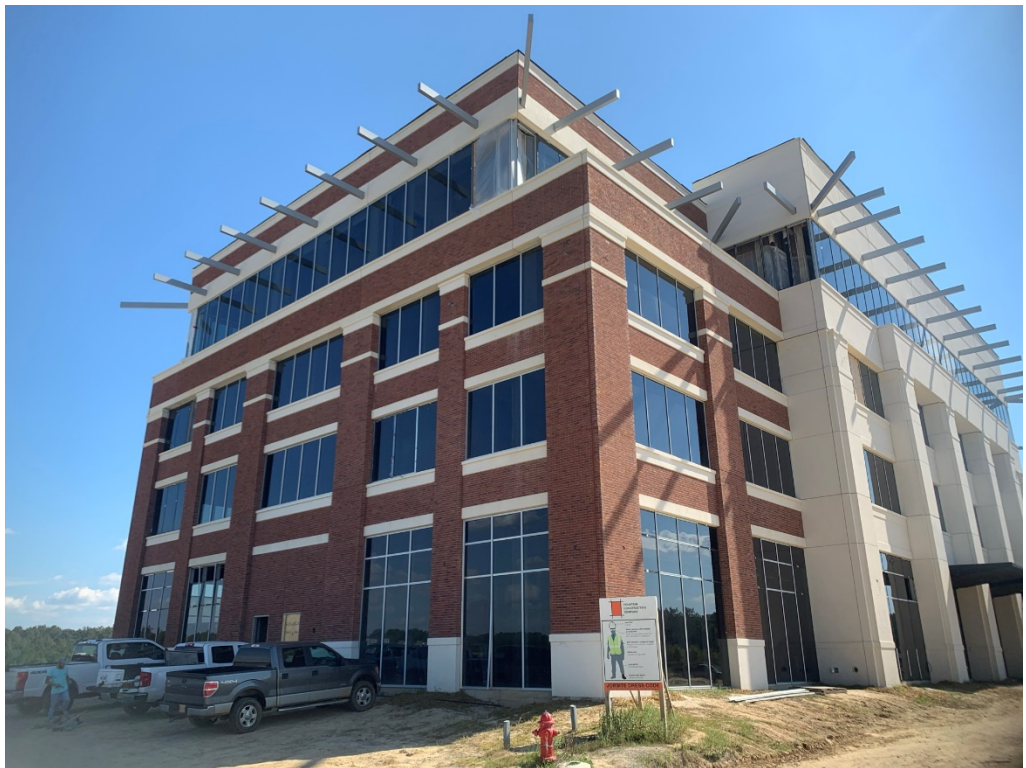
Figure 2 – North Façade Progress

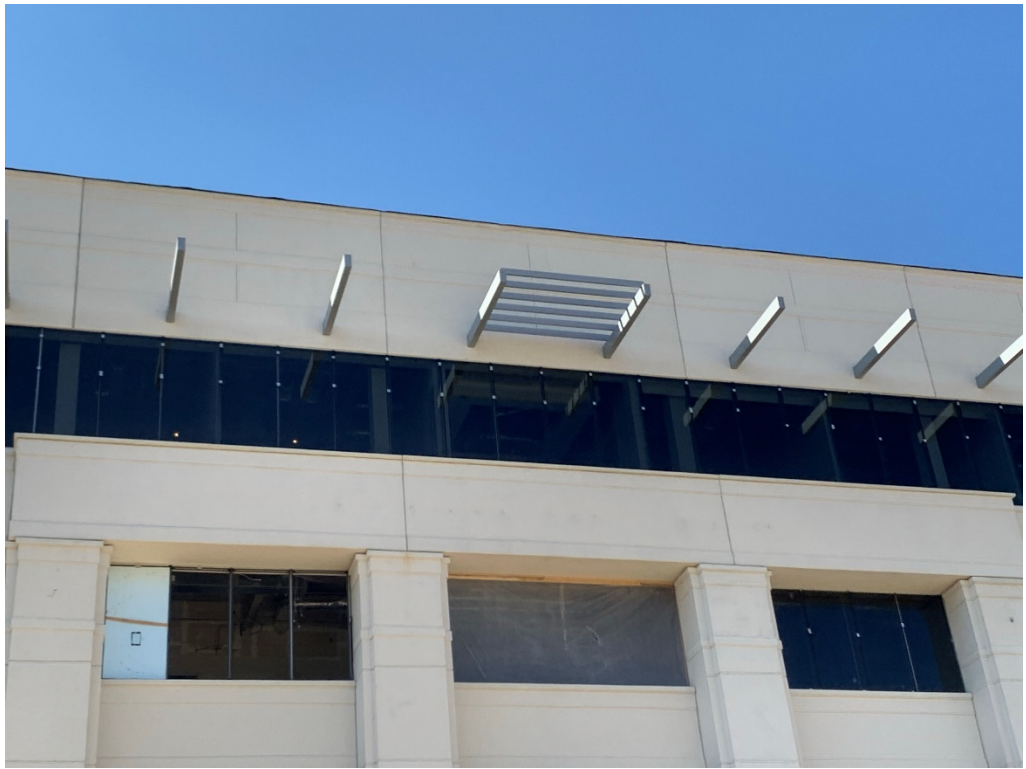
Figure 5 – Sun Shade Section Installed

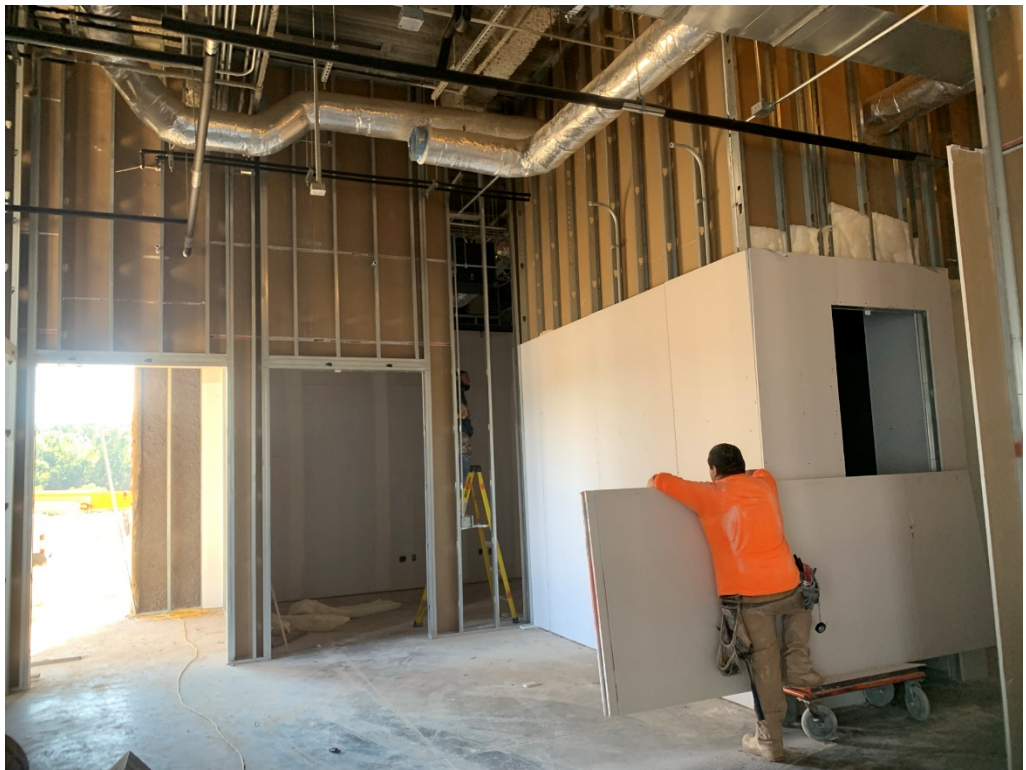
Figure 6 – Drywall at 1sr Floor is ongoing

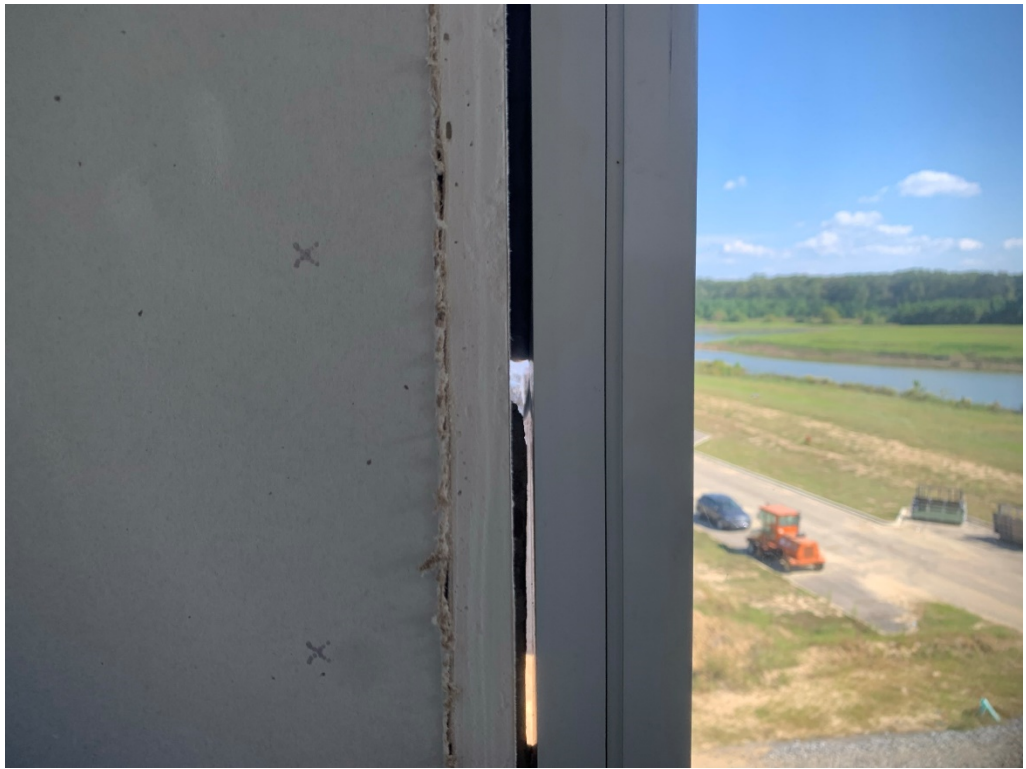
Figure 7 – Sealant at AL Storefront is ongoing

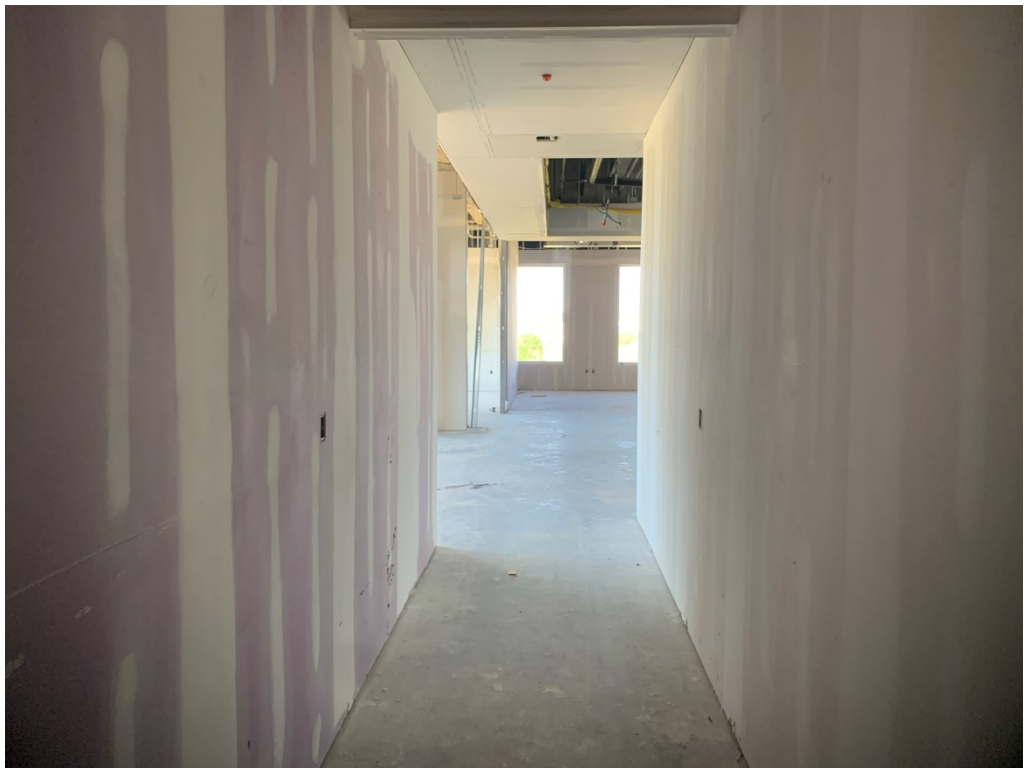
Figure 8 – Drywall finishing is on going @ 3rd Floor

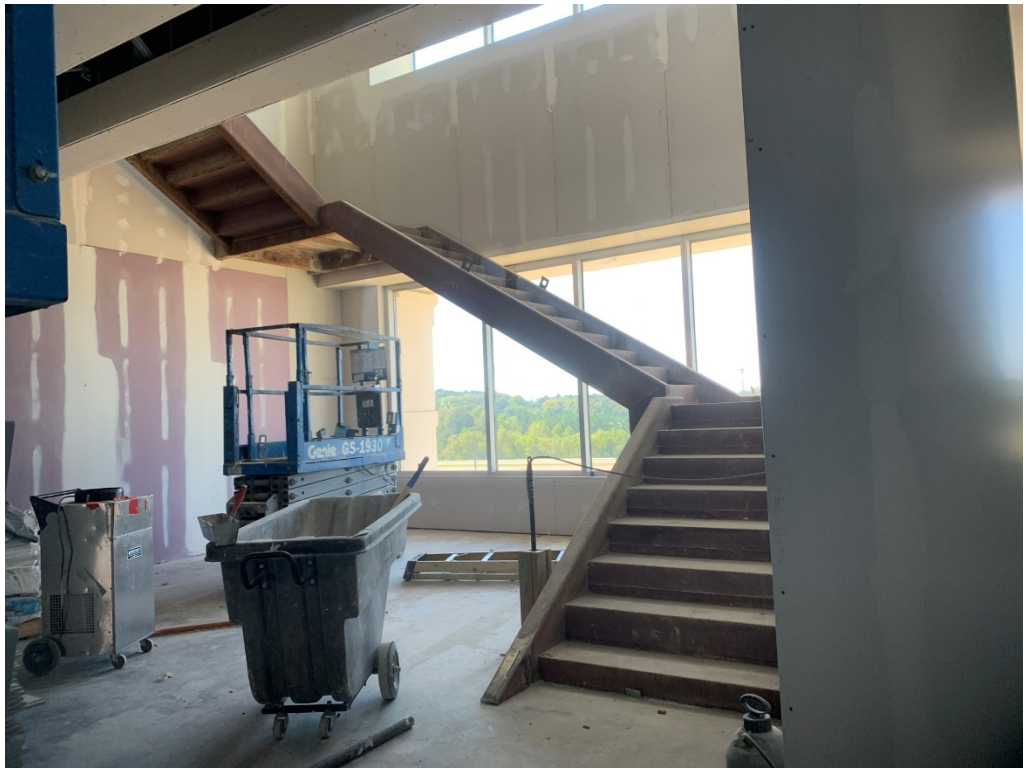
Figure 9 – Monumental Stair Progress

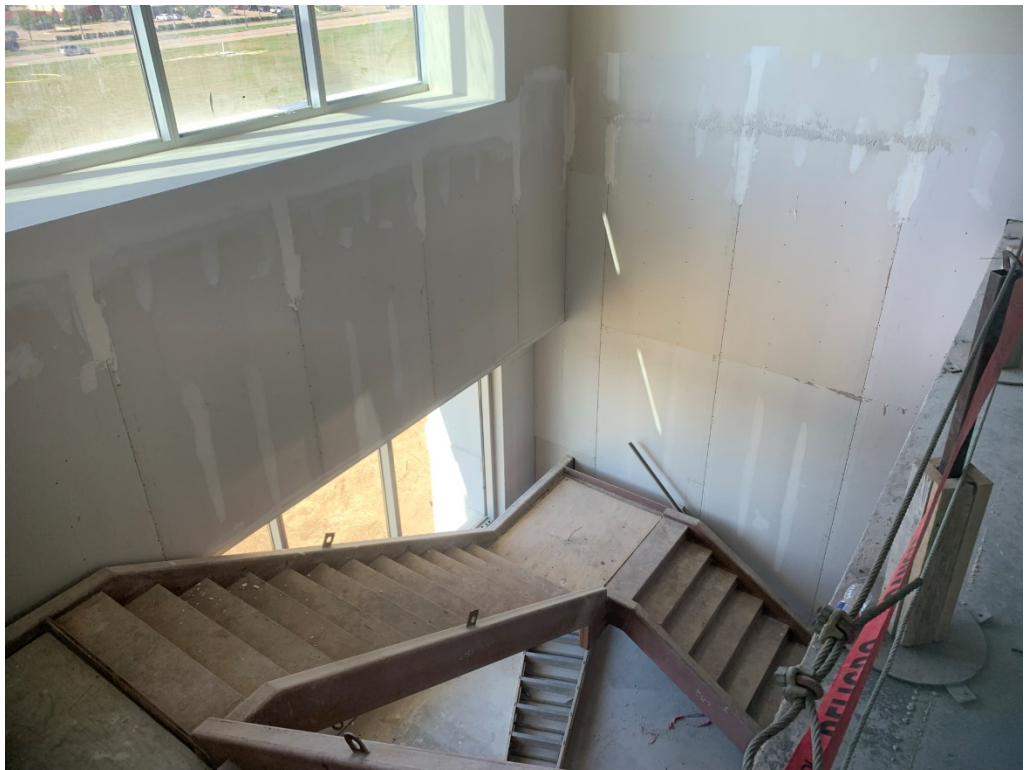
Figure 10 – Monumental Stair Progress

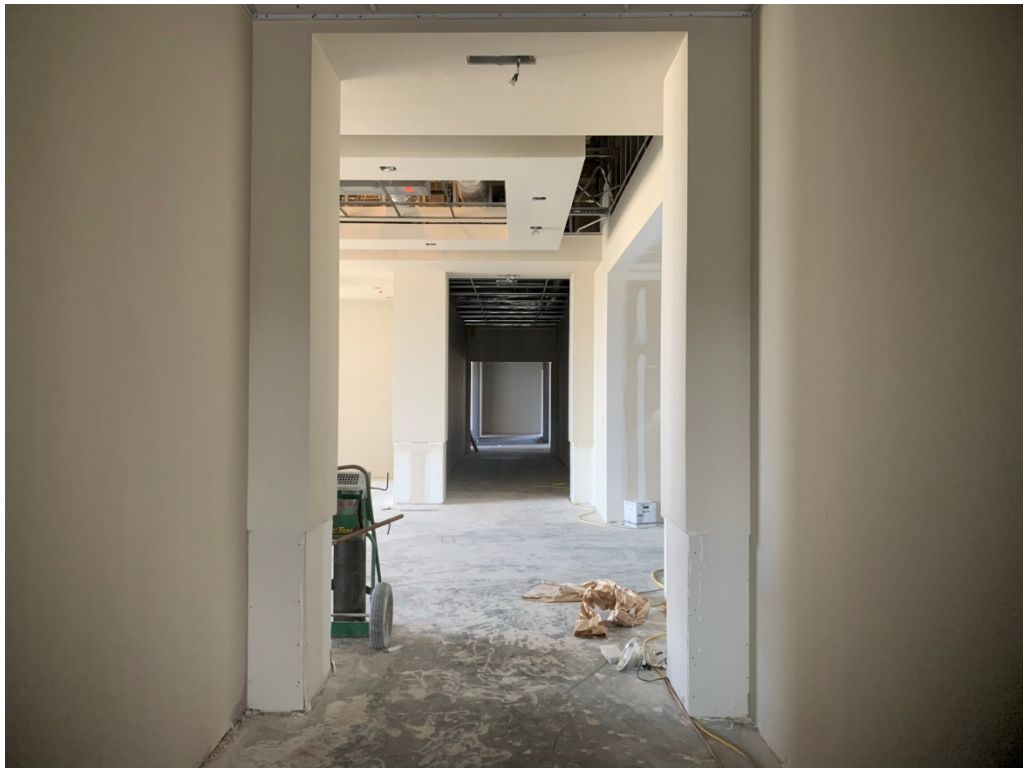
Figure 11 – A large portion of the 4th floor has at least 1 coat

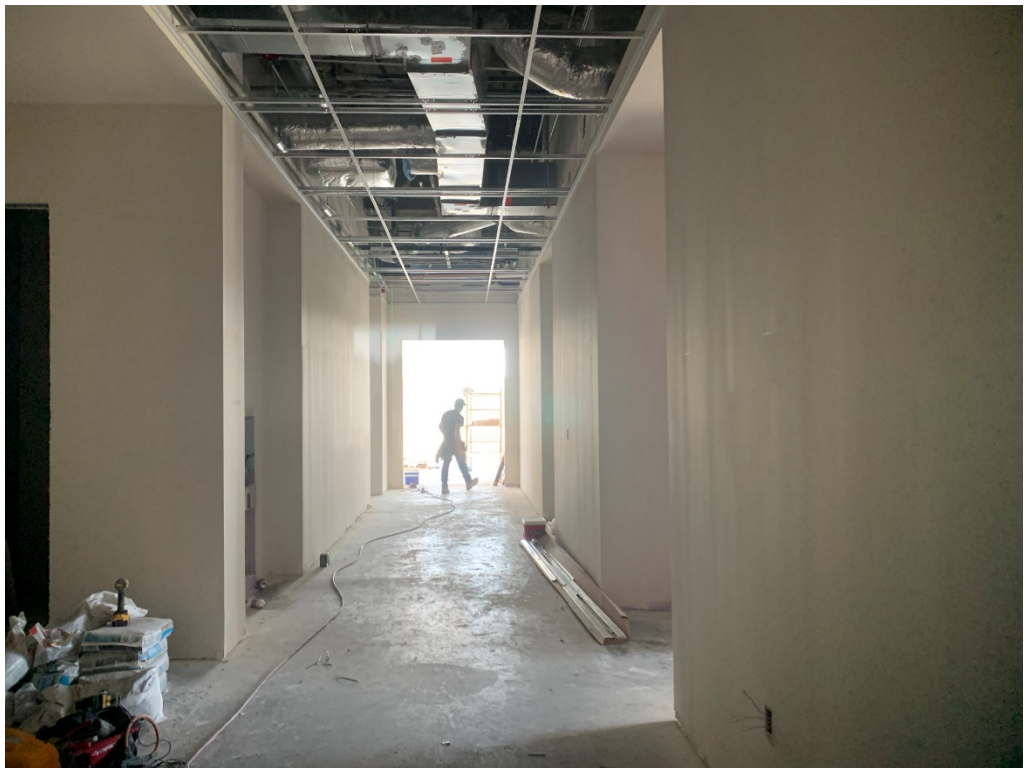
Figure 12 – Ceiling Work is Ongoing at 4th Floor
