Architect's Field Report

22 October 2021

15094 Community Bank Headquarters / Report Number 028

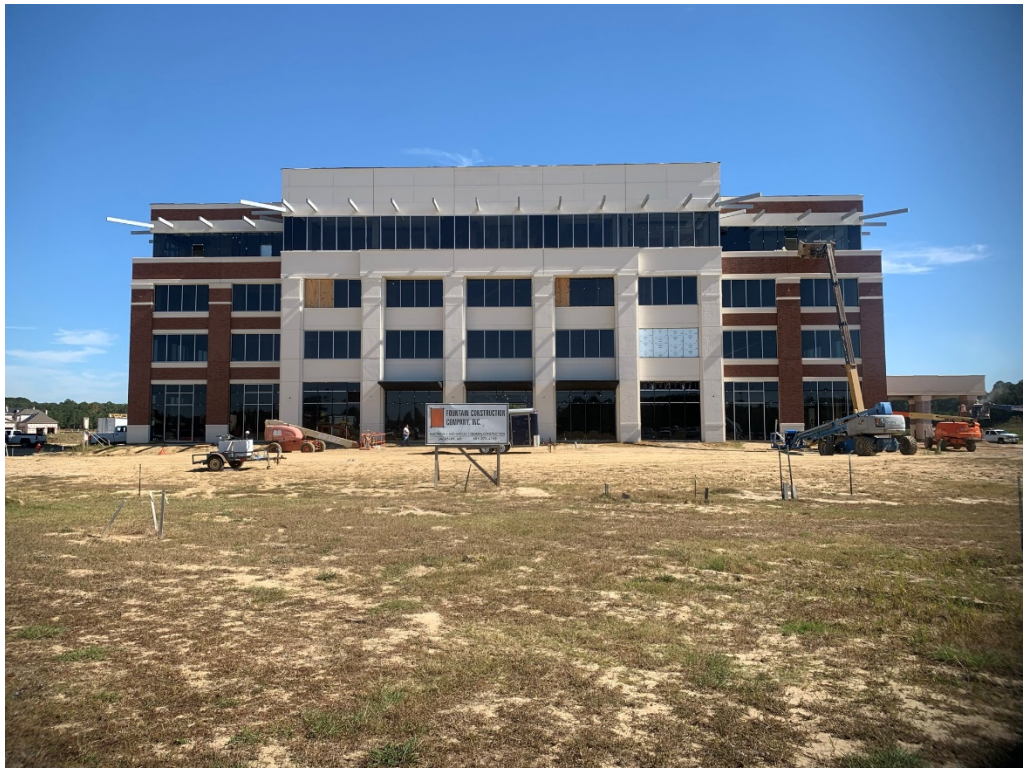
Figure 1 – West Façade Progress

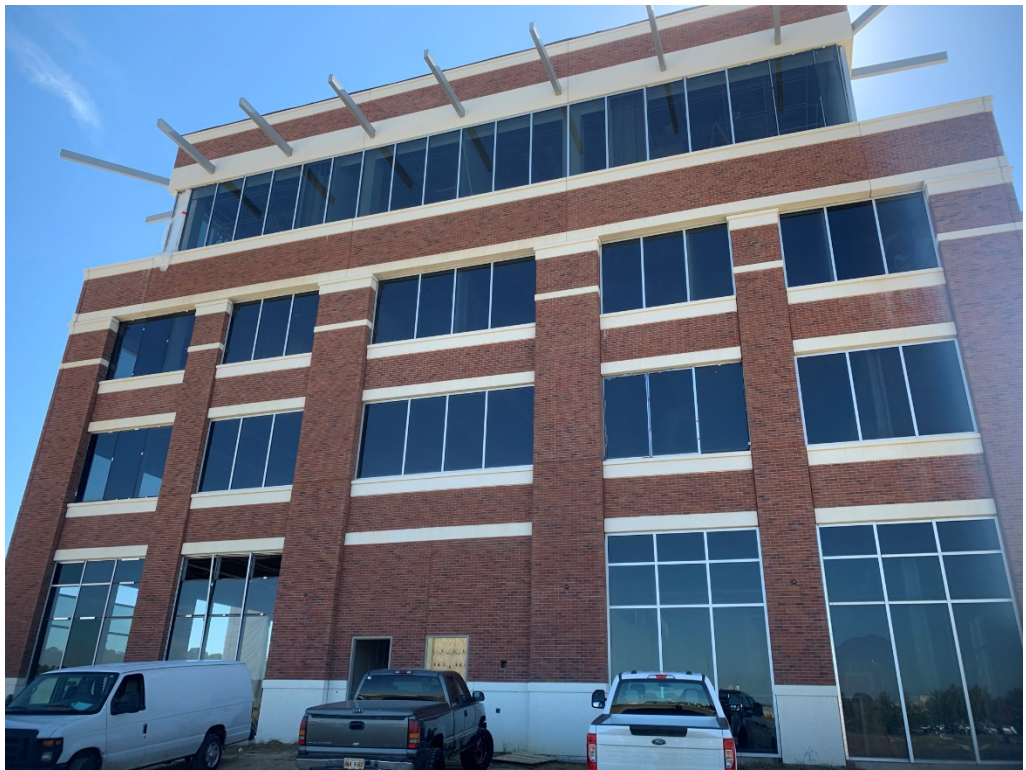
Figure 2 – North Façade Progress

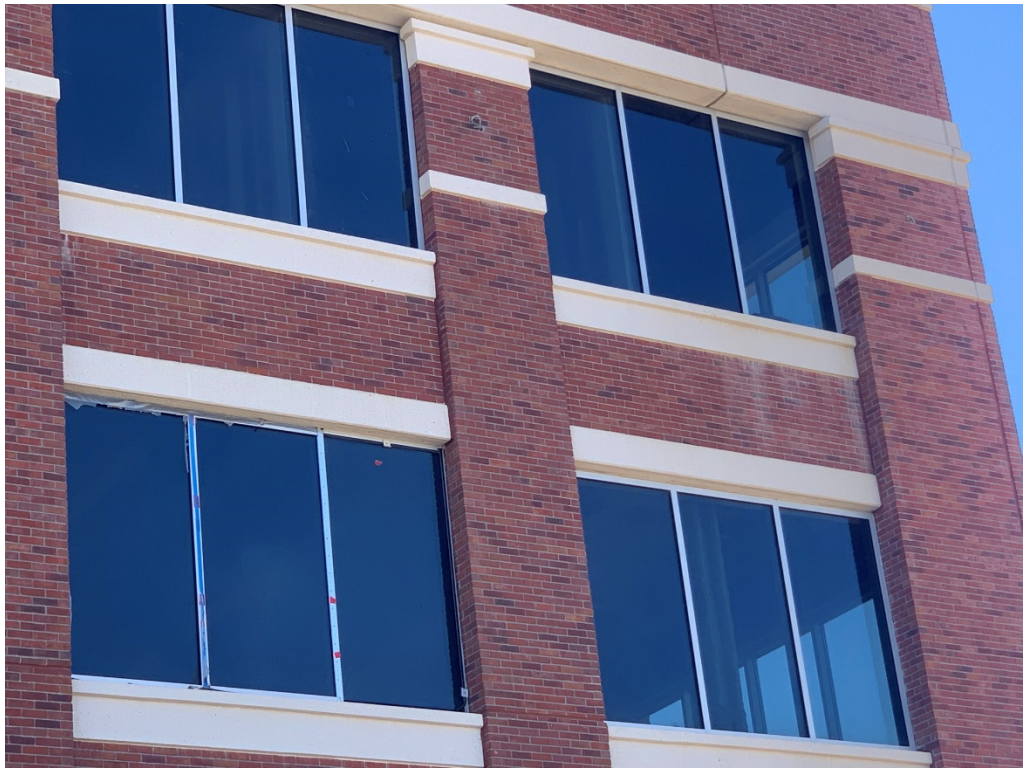
Figure 5 – Effervescence showing at 3rd story panel when water was received in wall; this will require cleaning; also, have sealant contractor confirm water tightness

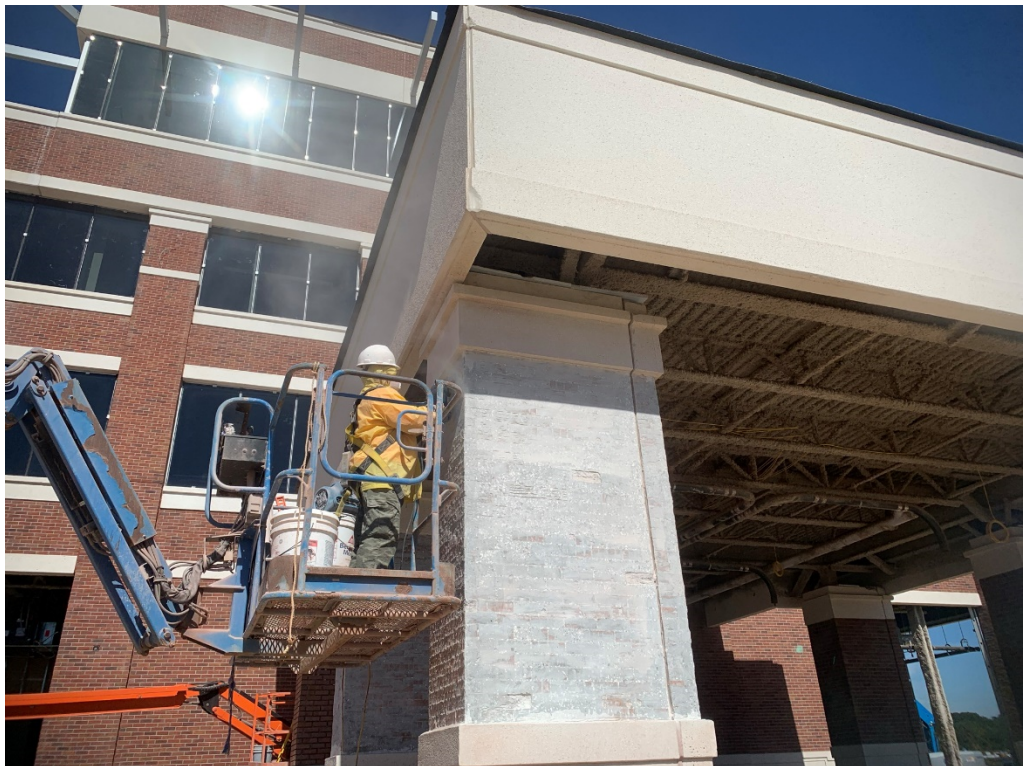
Figure 6 – Panel Rework at the drive thru is ongoing

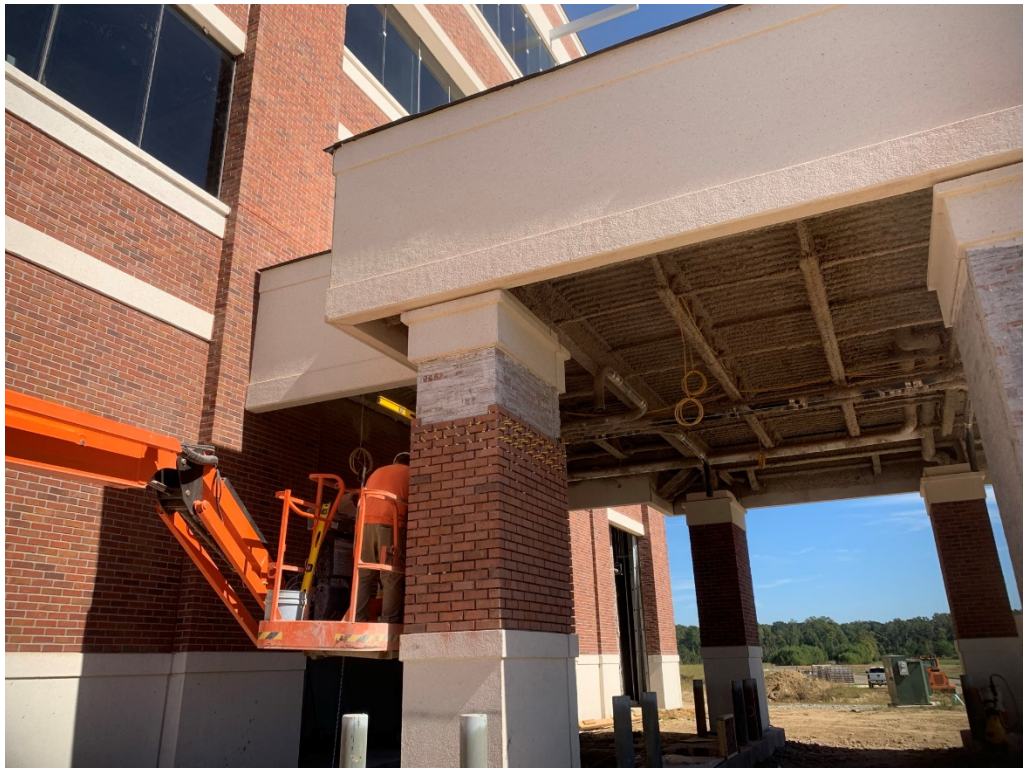
Figure 7 – Panel Rework at the drive thru is ongoing

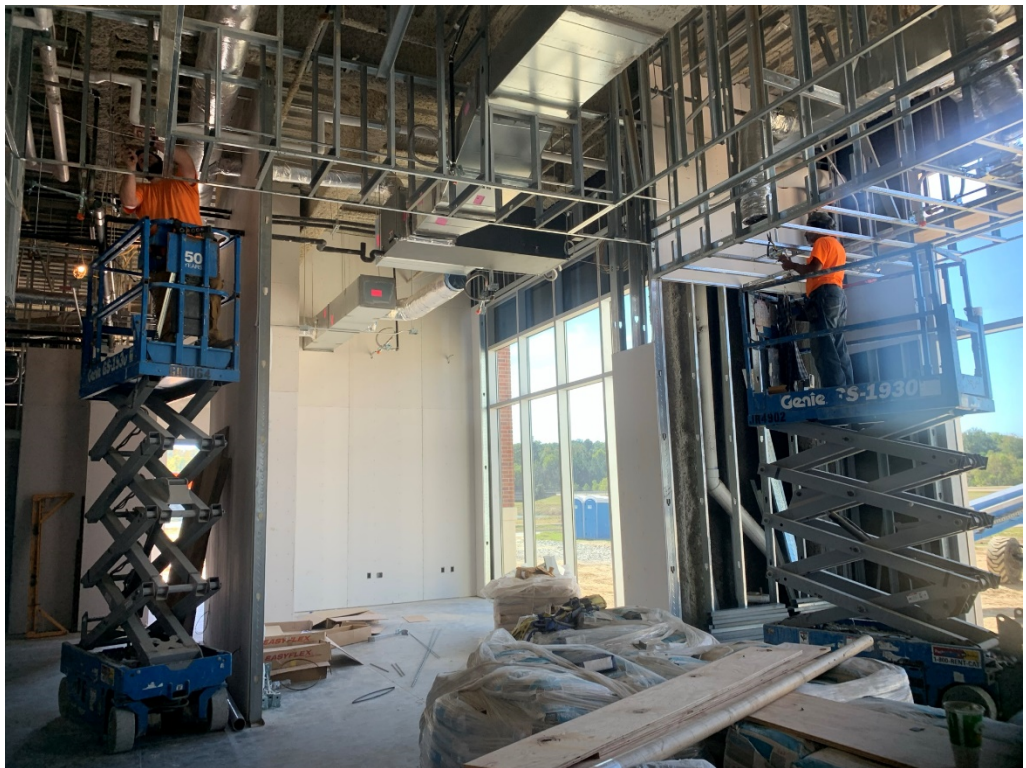
Figure 8 – Electrical is Ongoing

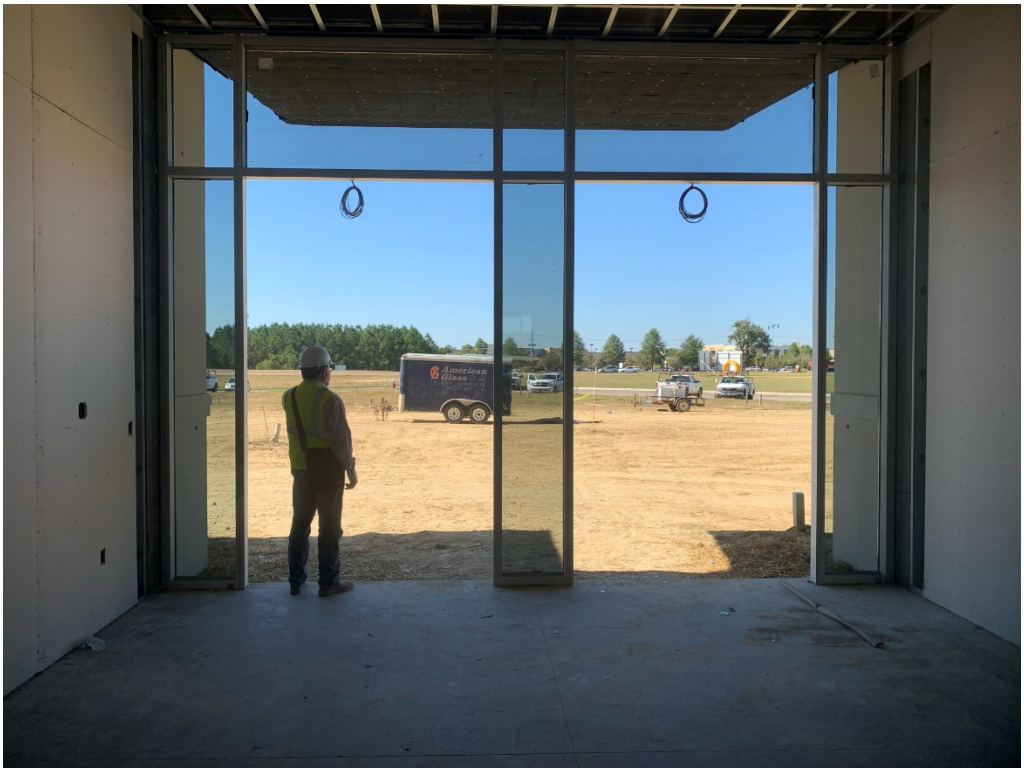
Figure 9 – Storefront install is ongoing

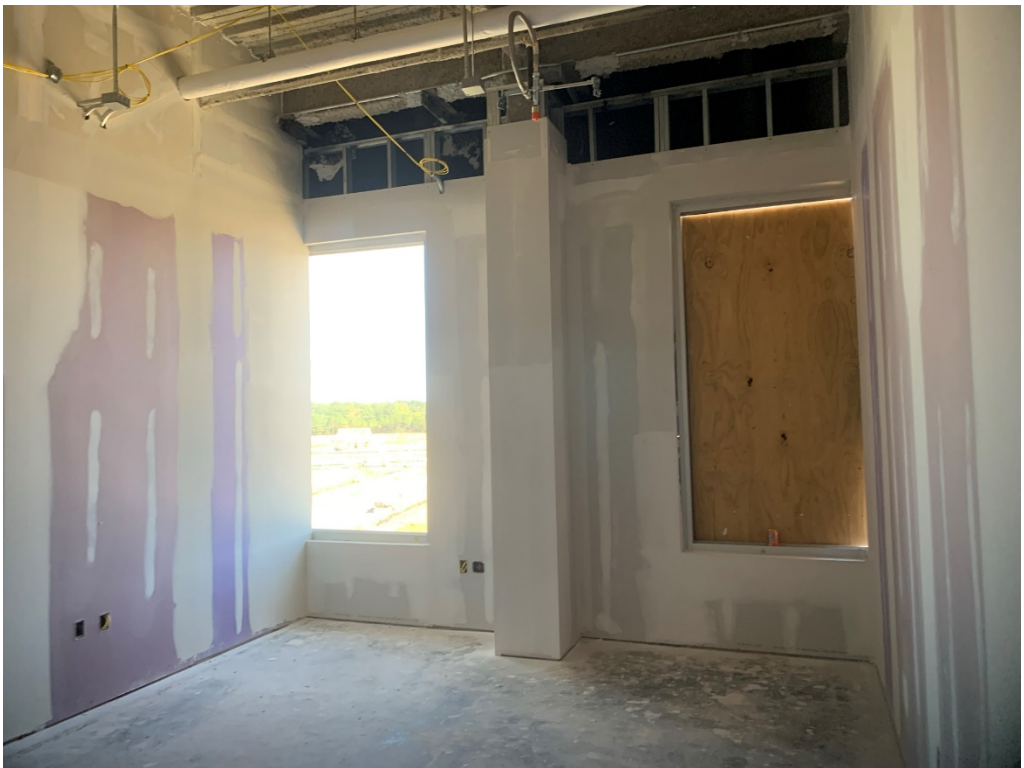
Figure 10 – Drywall is ongoing

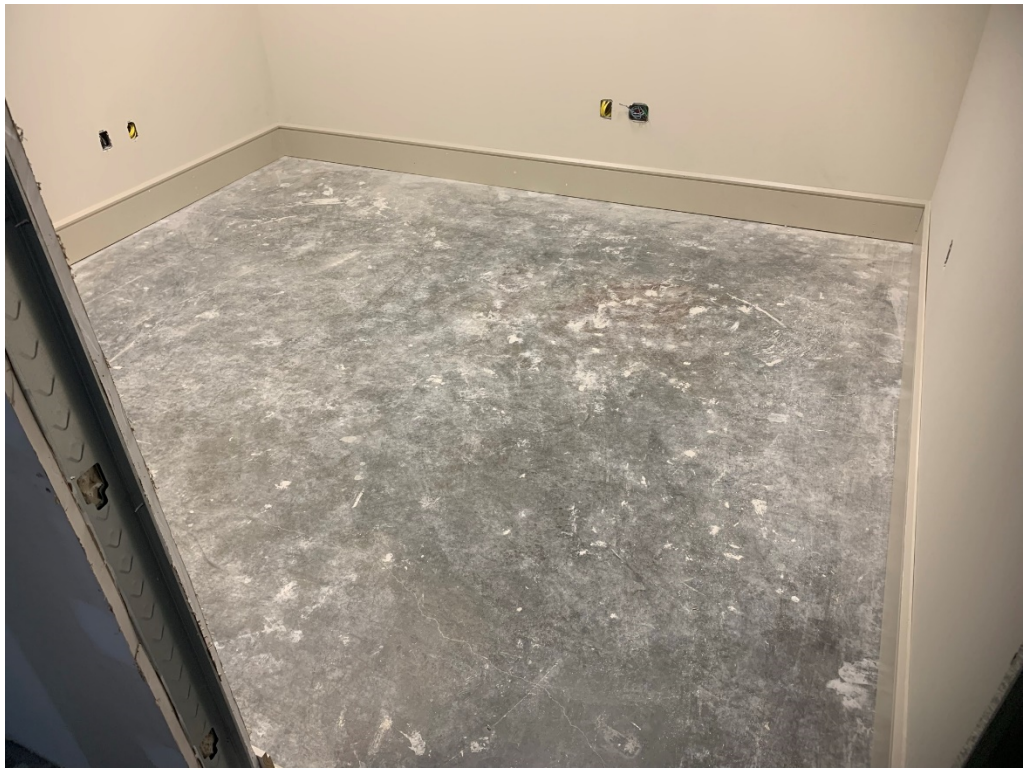
Figure 11 – Base trim install has begun

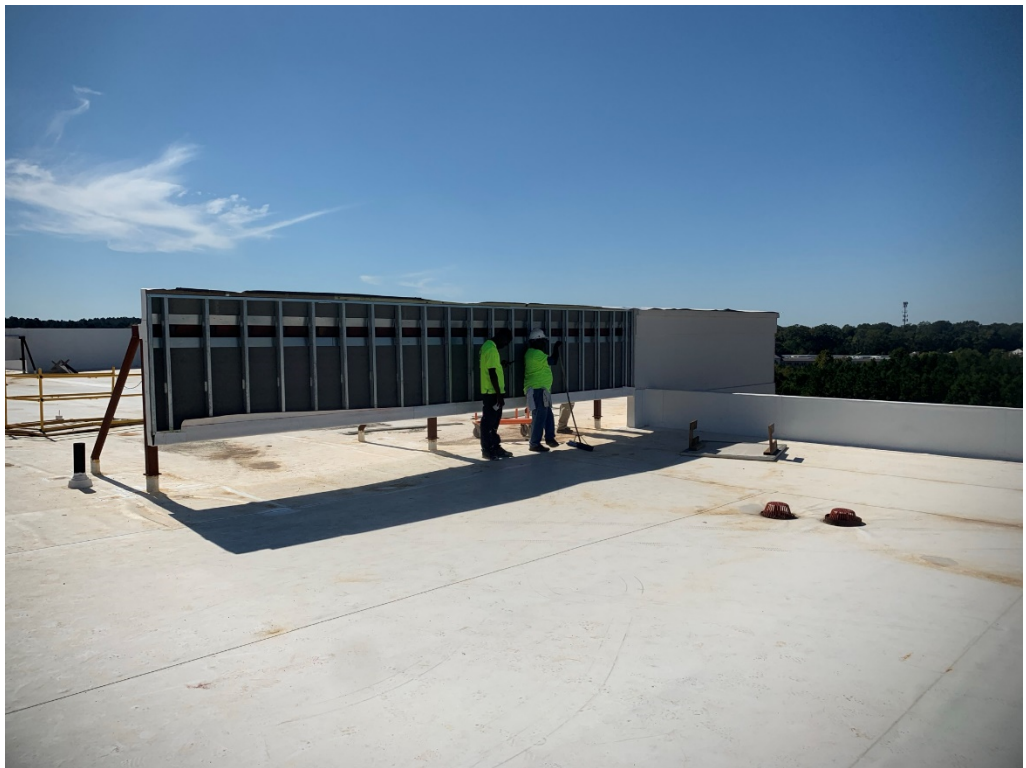
Figure 12 – Roof work in ongoing
