Architect's Field Report

12 November 2021

15094 Community Bank Headquarters / Report Number 029

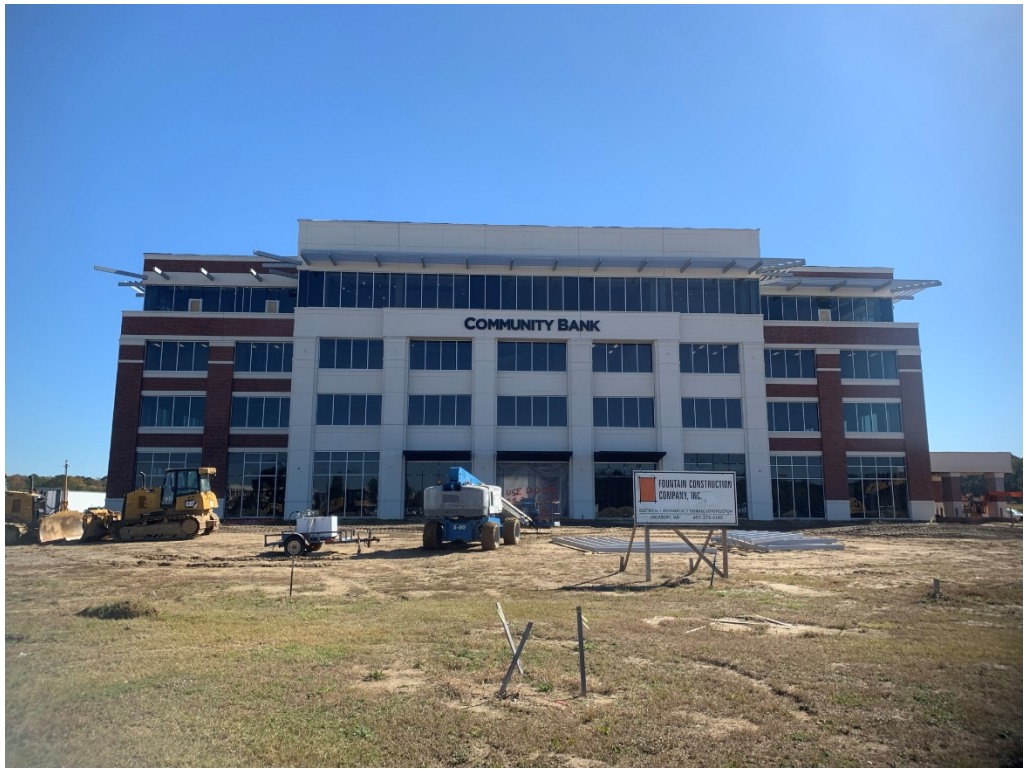
Figure 1 – West Façade Progress

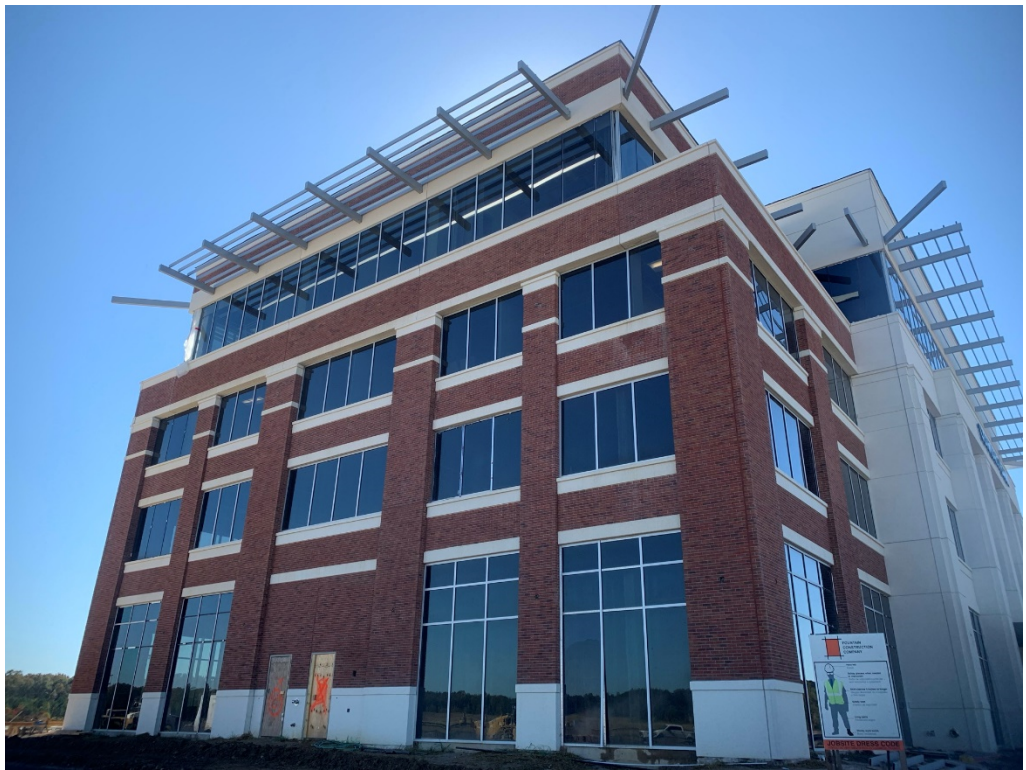
Figure 2 – North Façade Progress

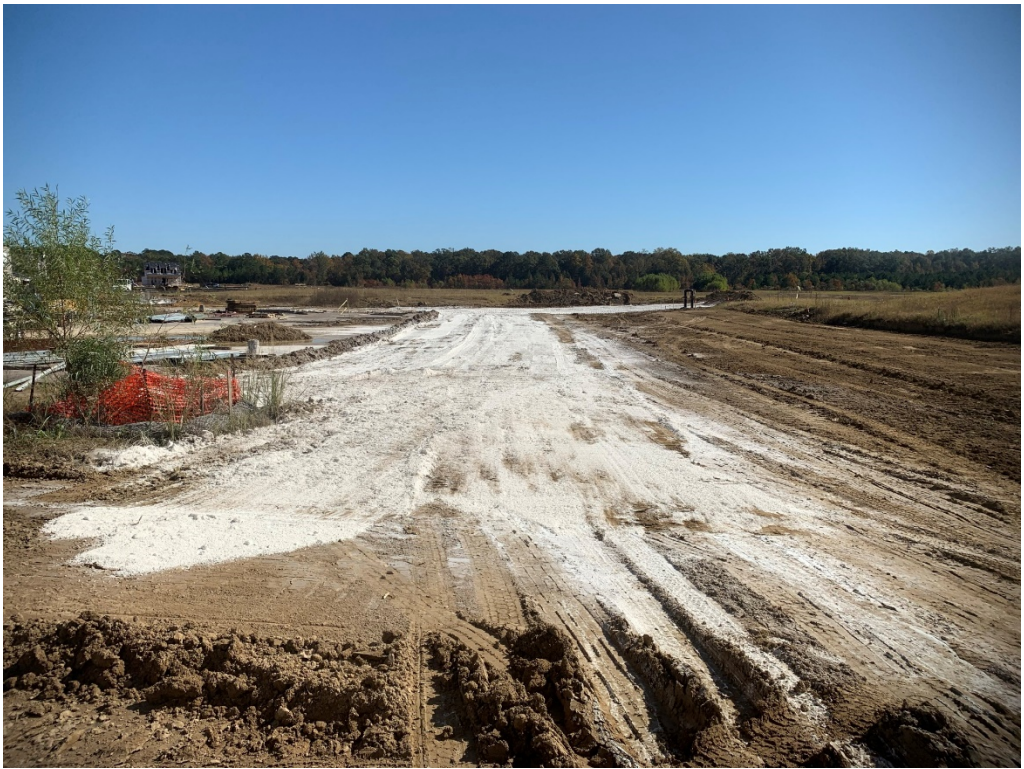
Figure 5 – Lime at sitework is ongoing

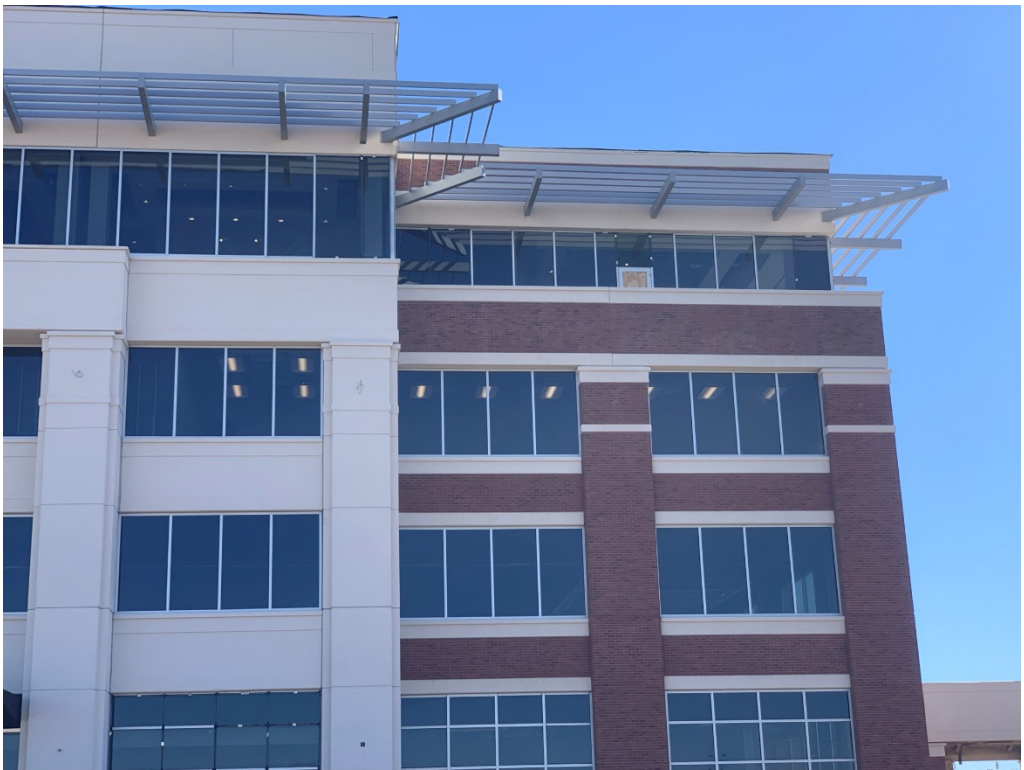
Figure 6 – Sun Shades are 80% Installed

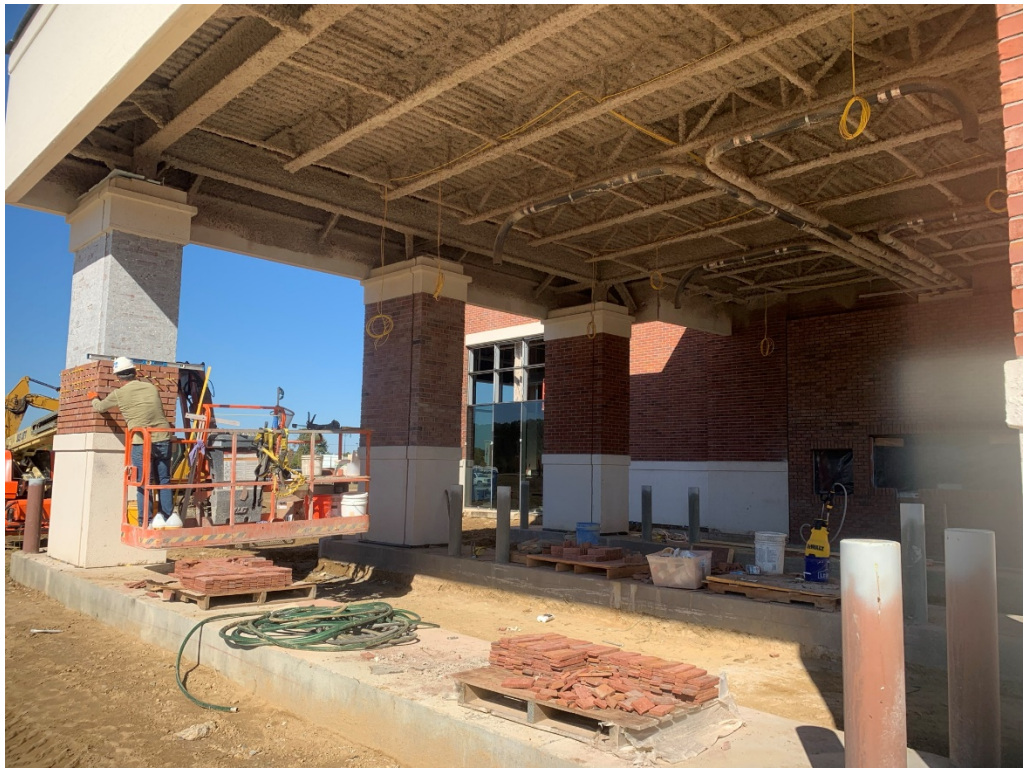
Figure 7 – Brick Progress

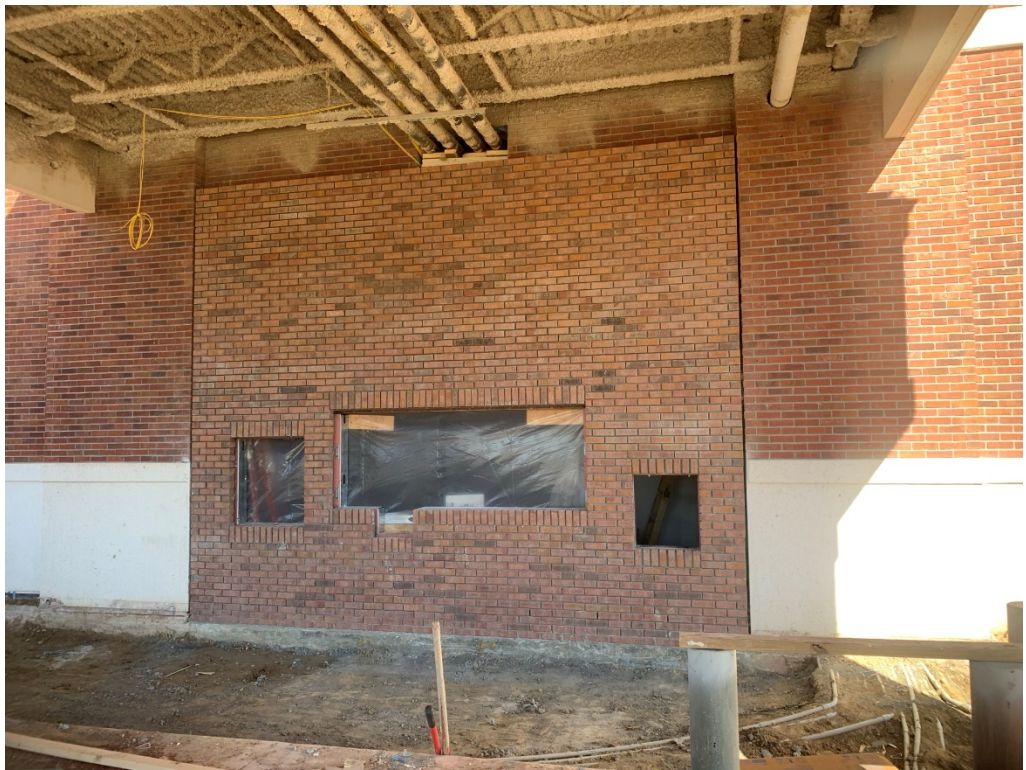
Figure 8 – Brick Progress

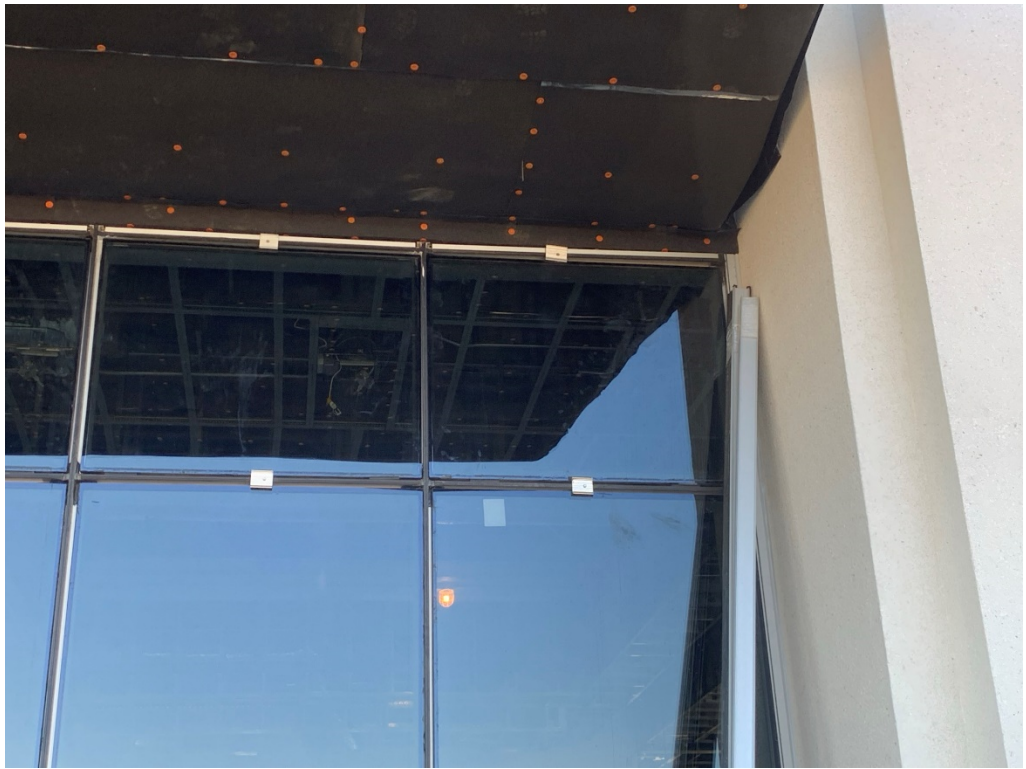
Figure 9 – This opening at column line E is crooked at the top corner

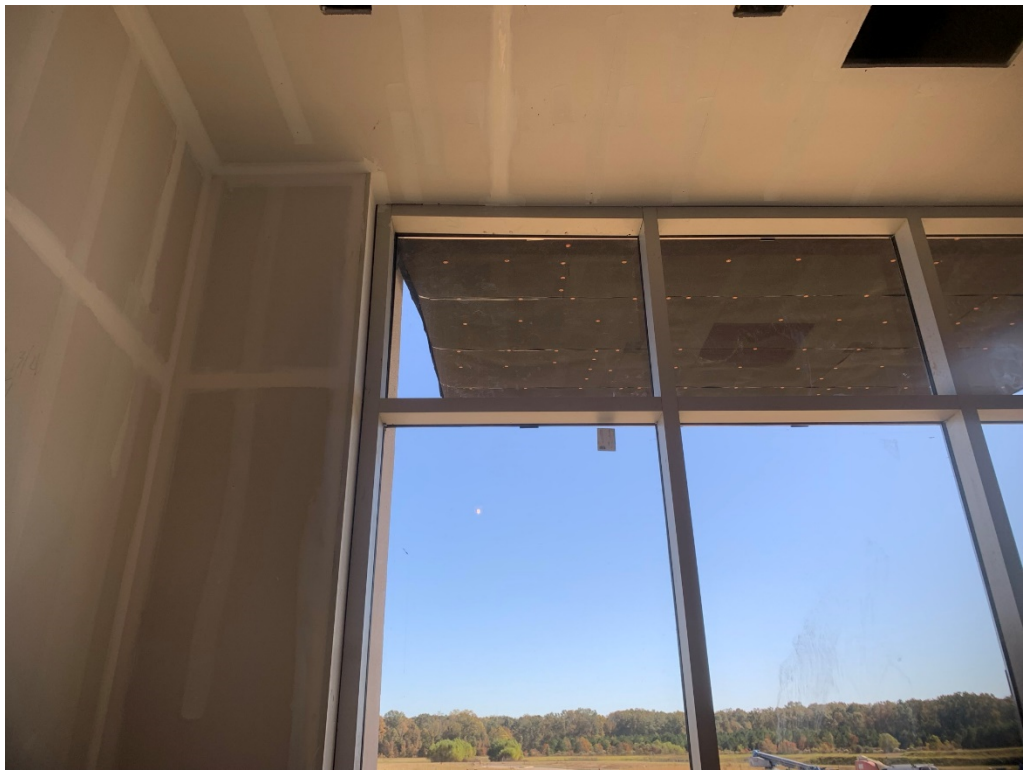
Figure 10 – This opening at column line E is crooked at the top corner

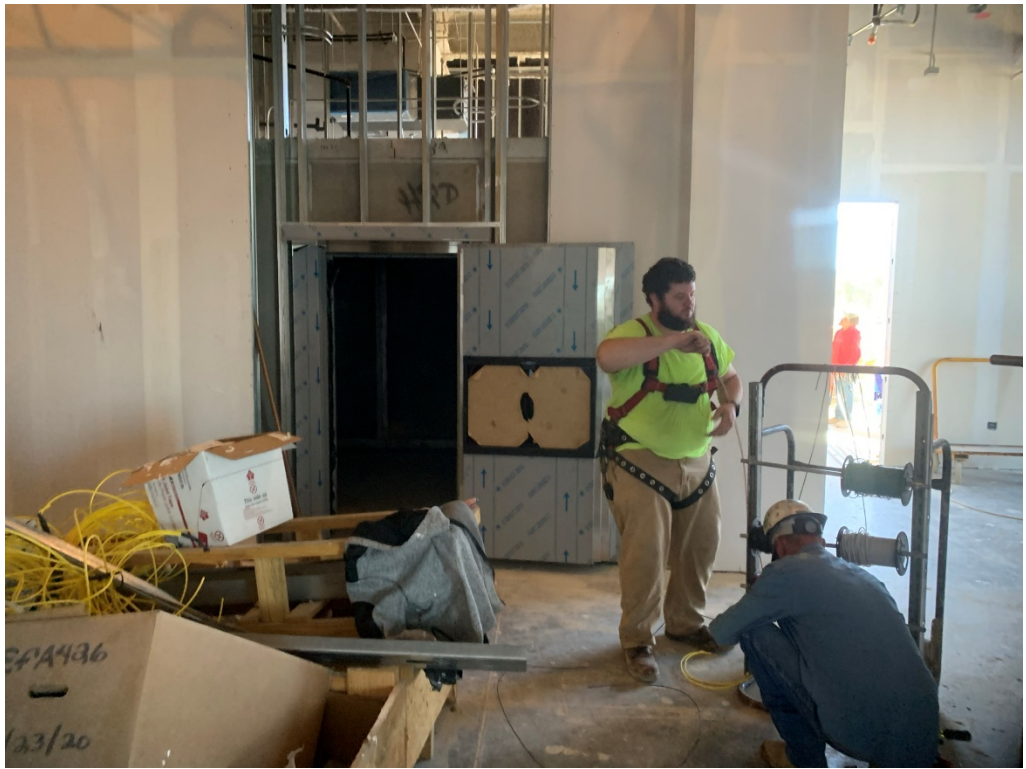
Figure 11 – Electrical is ongoing

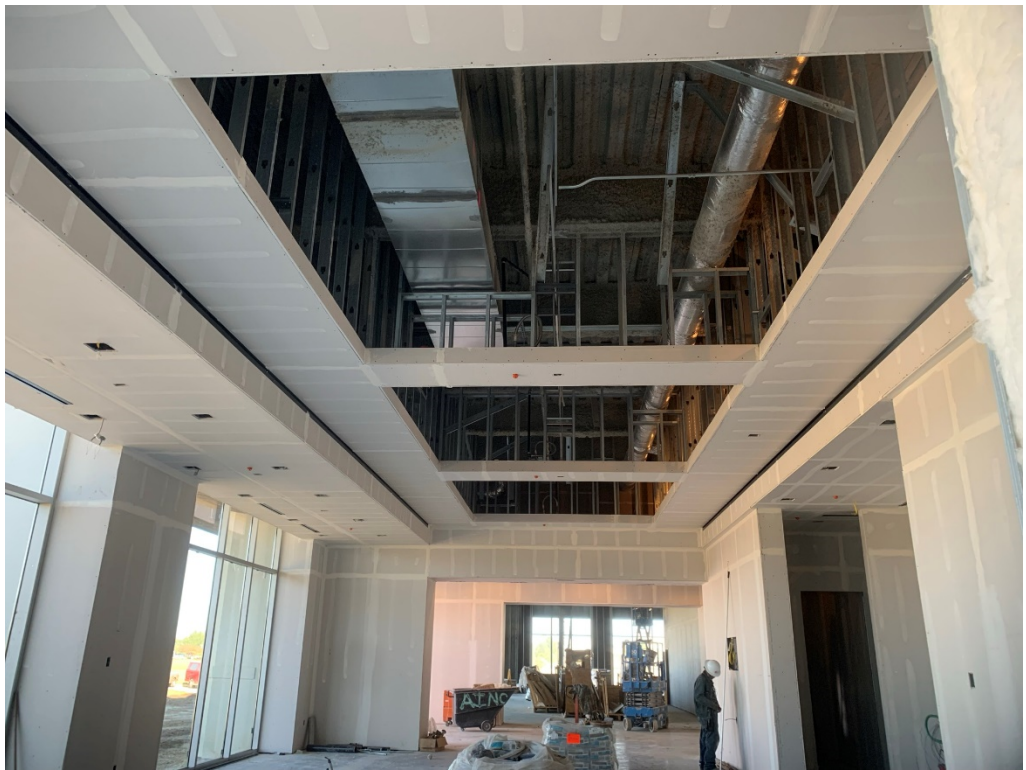
Figure 12 – Ceiling work at 1<sup>st</sup> floor

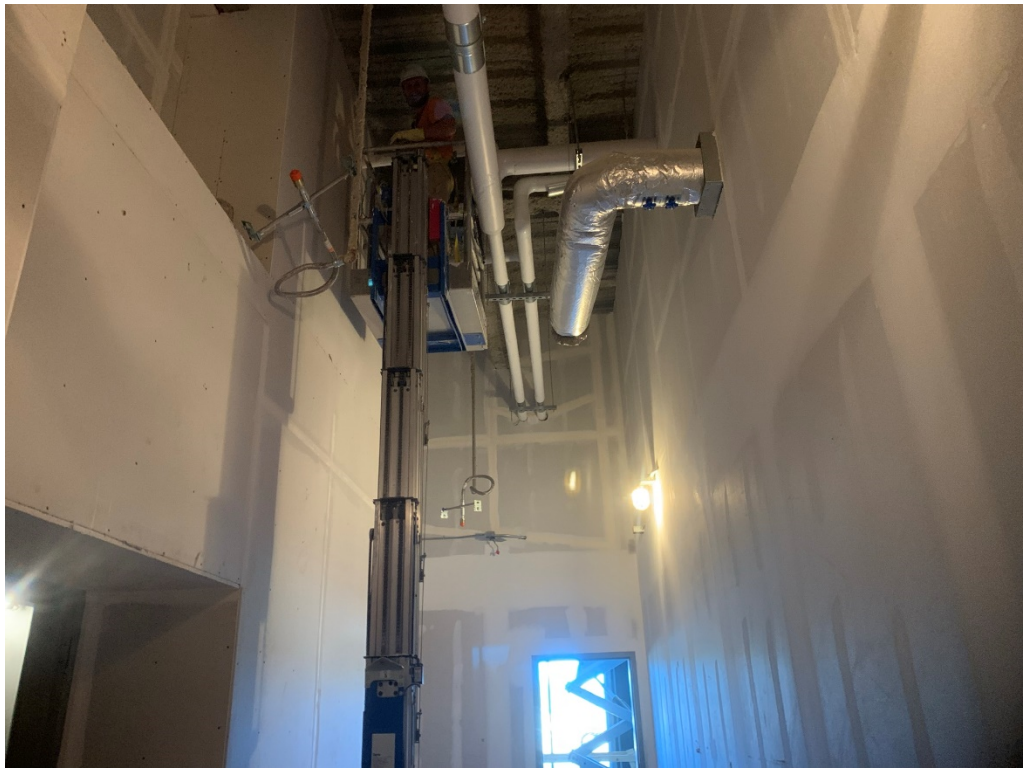
Figure 13 – Repair of fireproofing in ongoing

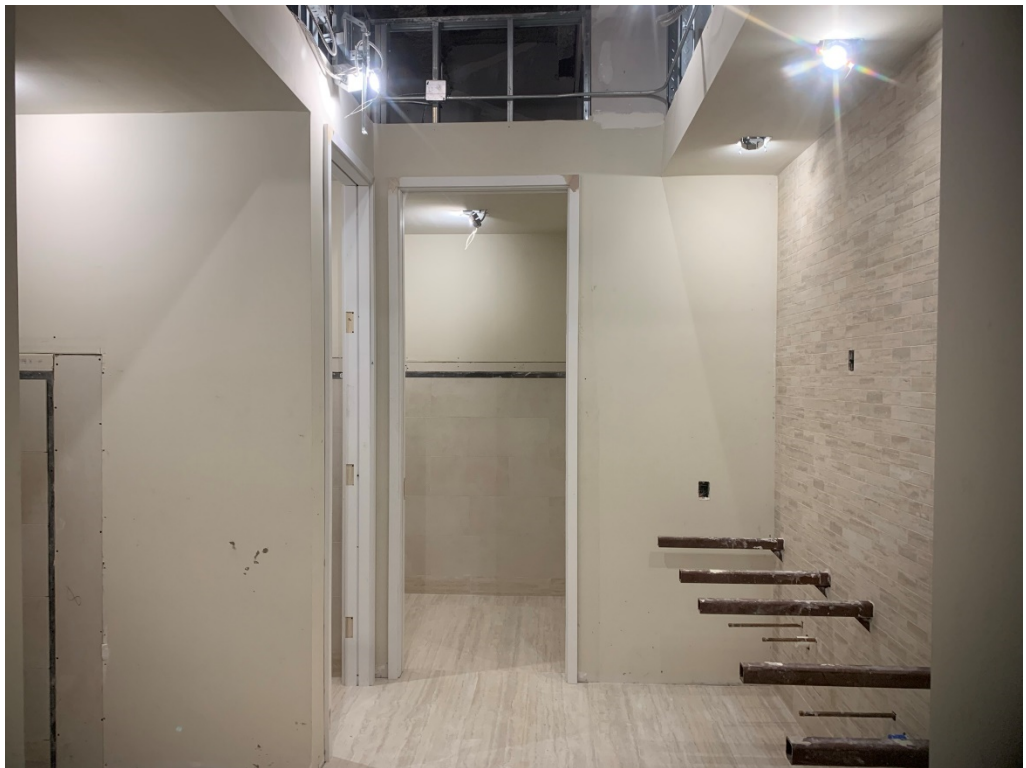
Figure 14 – Tile is ongoing at toilet rooms

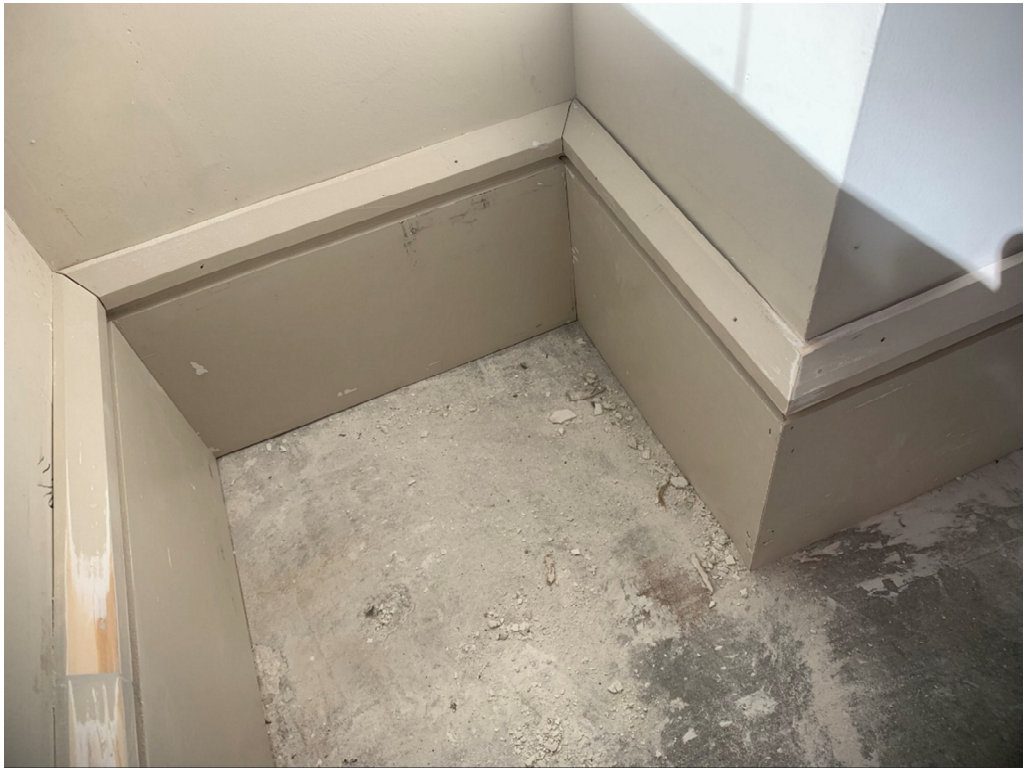
Figure 15 – Good attention to detail; trim work is moving along

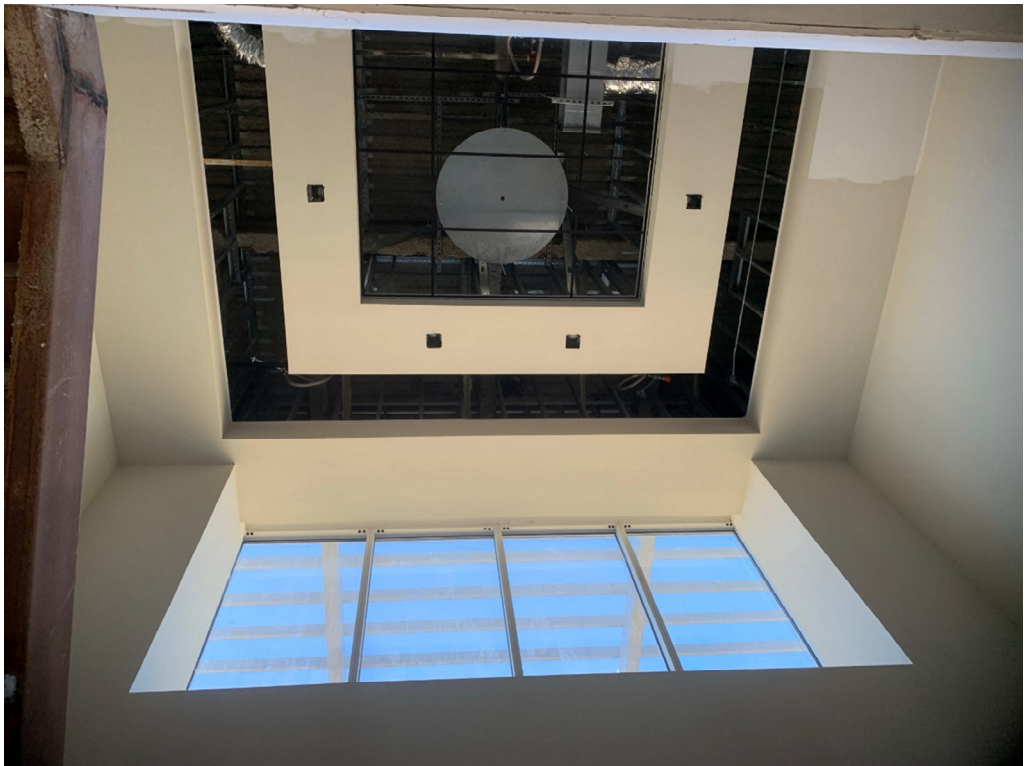
Figure 16 – Monumental stair Ceiling

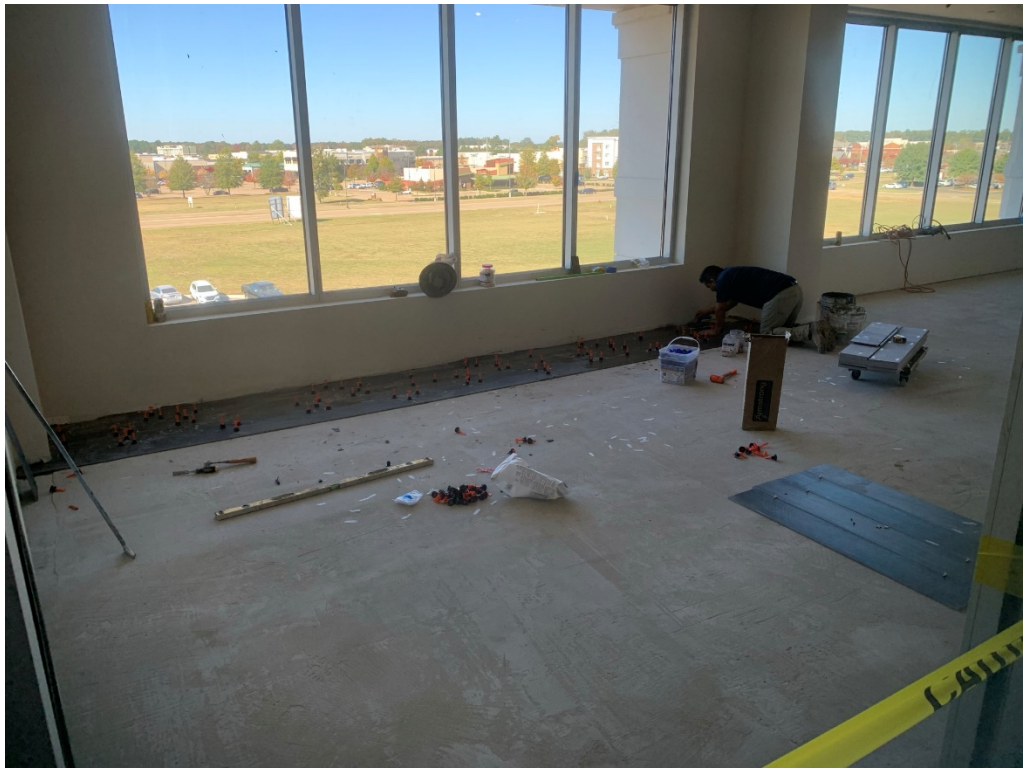
Figure 17 – Tile at break room is started and ongoing

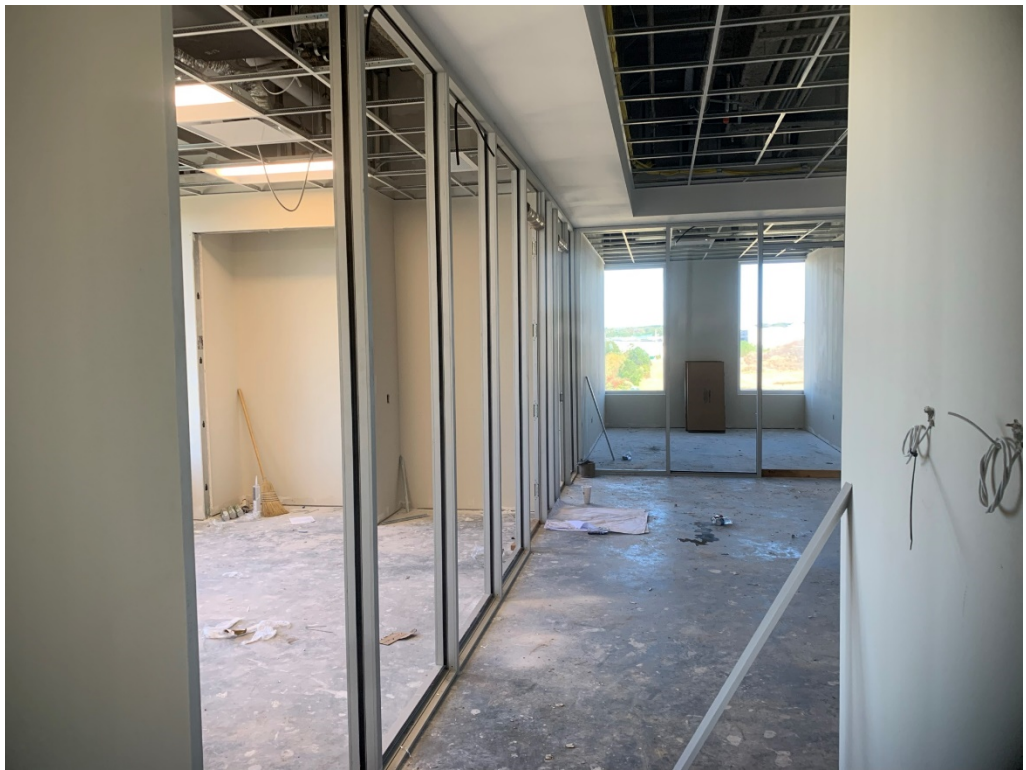
Figure 18 – 3<sup>rd</sup> Floor Open Office Progress

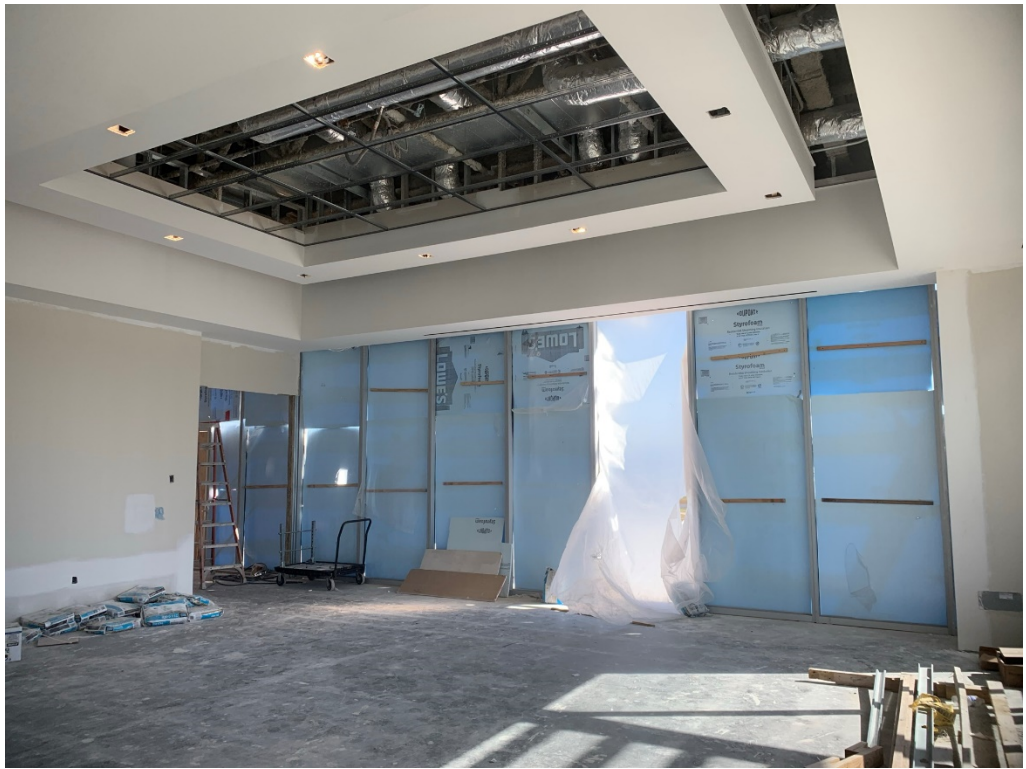
Figure 19 – Banquet room progress ( one of the last areas to receive glass)

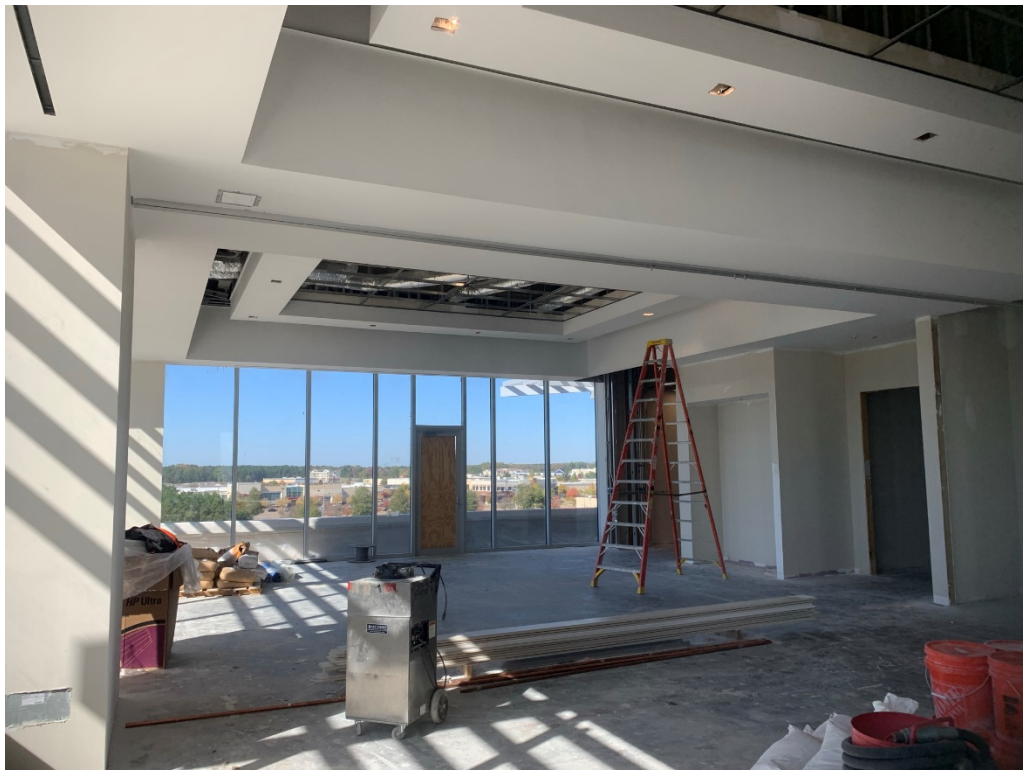
Figure 20 – Banquet room progress

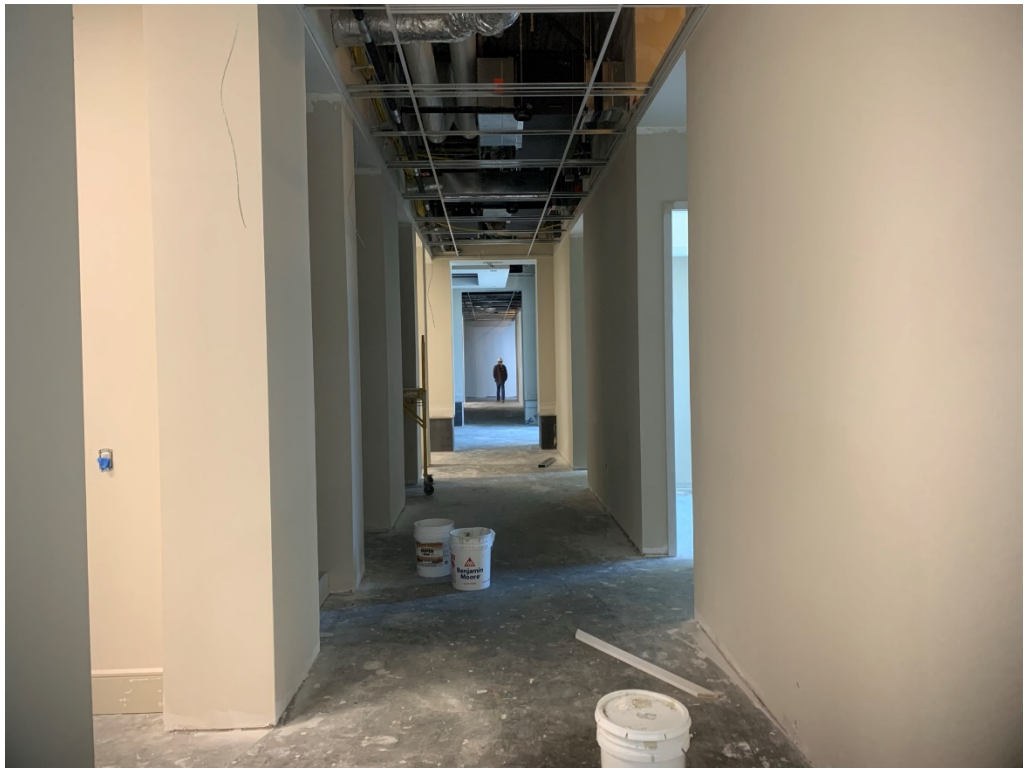
Figure 21 – 4<sup>th</sup> floor hallway progress (typical)

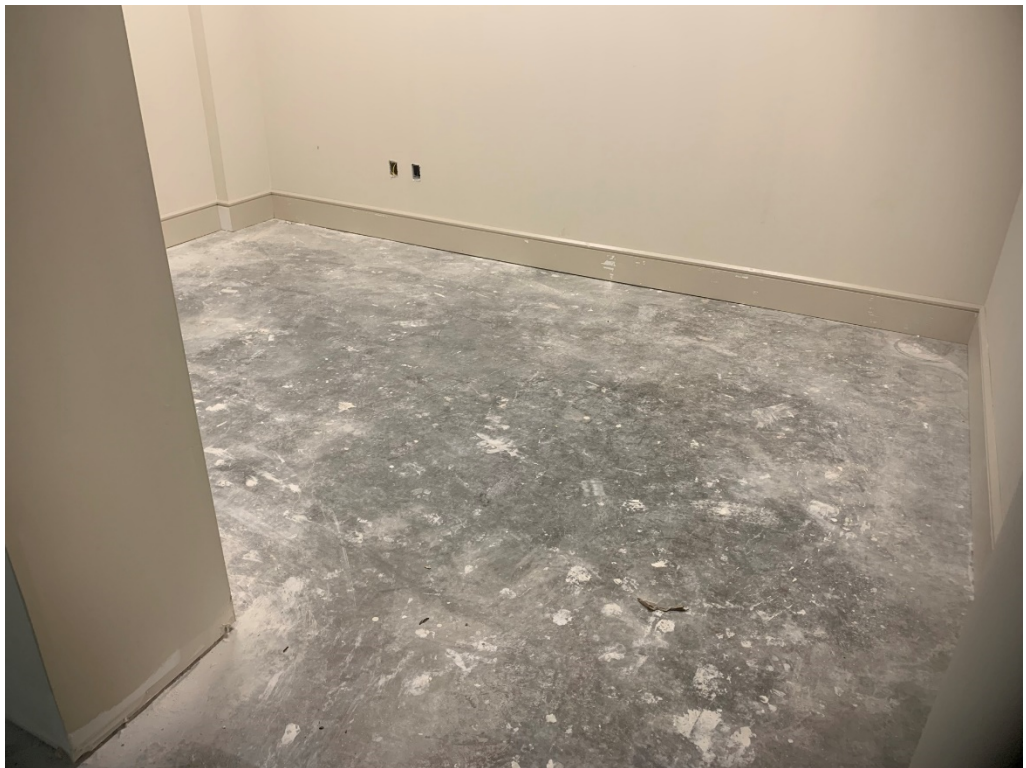
Figure 22 – Trim work at base is ongoing

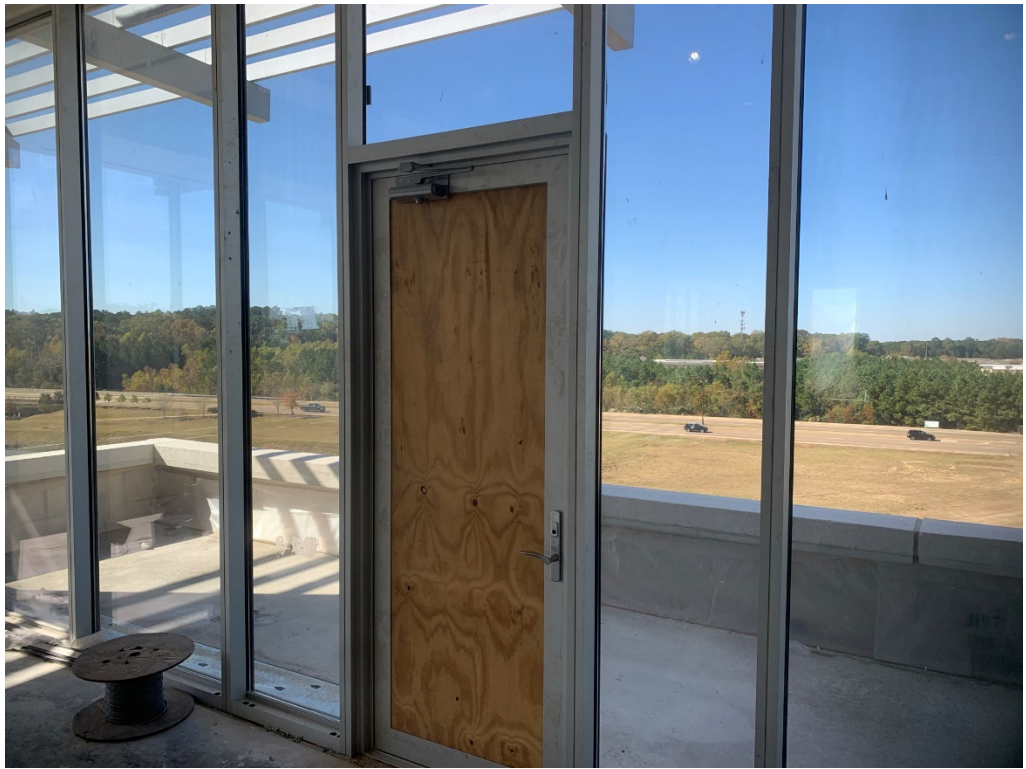
Figure 23 – Door hardware installed

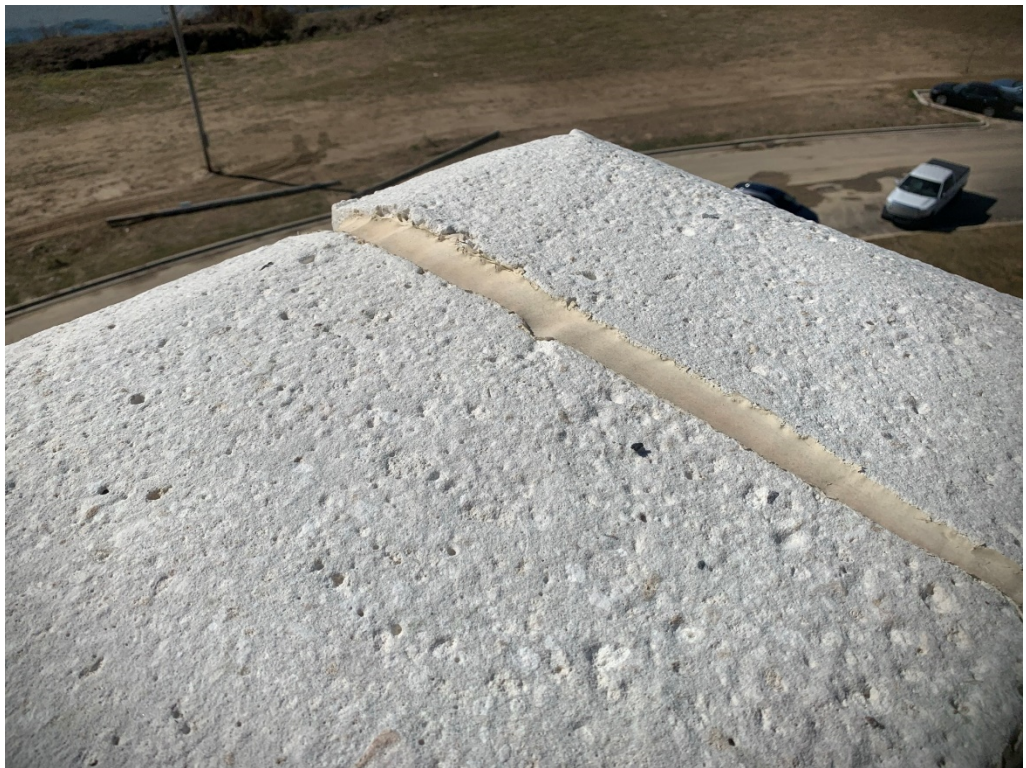
Figure 24 – Are we still awaiting remediation on the sill stones? (these don't line up at the top)

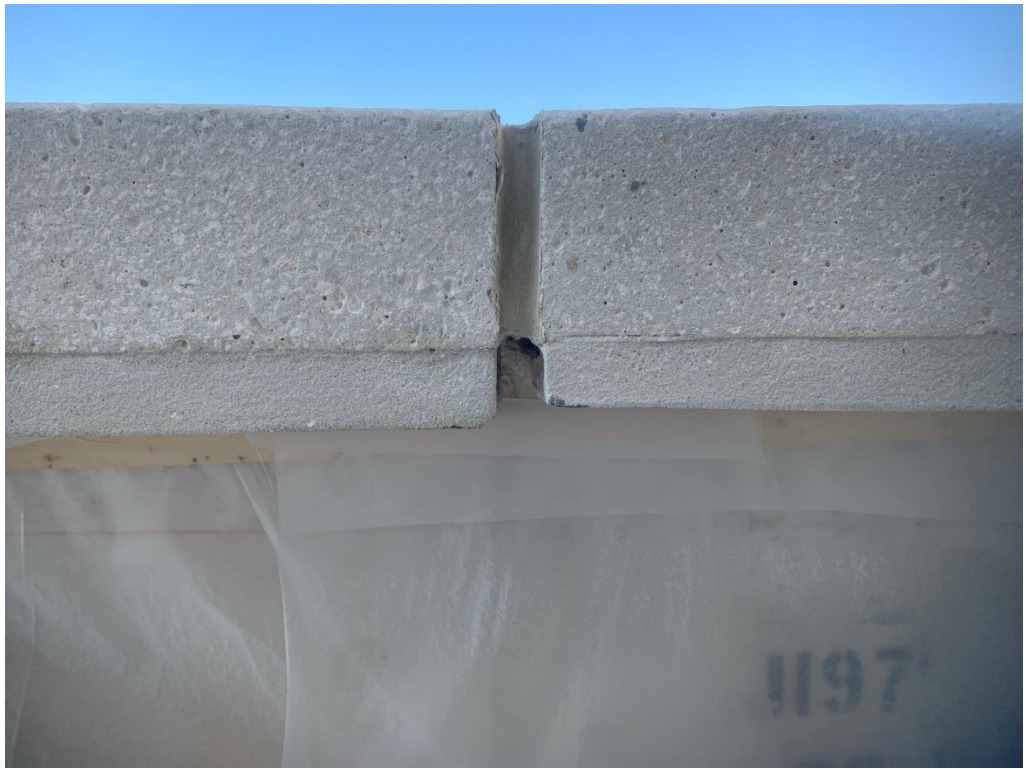
Figure 25 – Mis aligned repair (Is this repair complete or ongoing?)

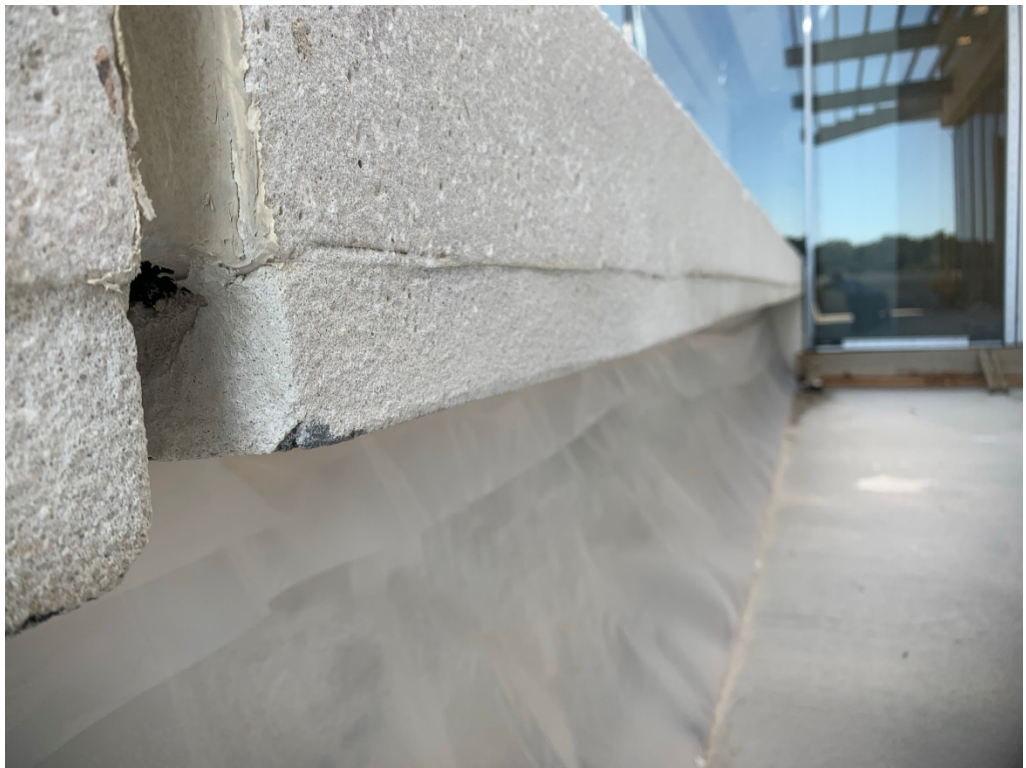
Figure 26 – Mis aligned repair (Is this repair complete or ongoing?)
