Architect's Field Report

22 November 2021

15094 Community Bank Headquarters / Report Number 030

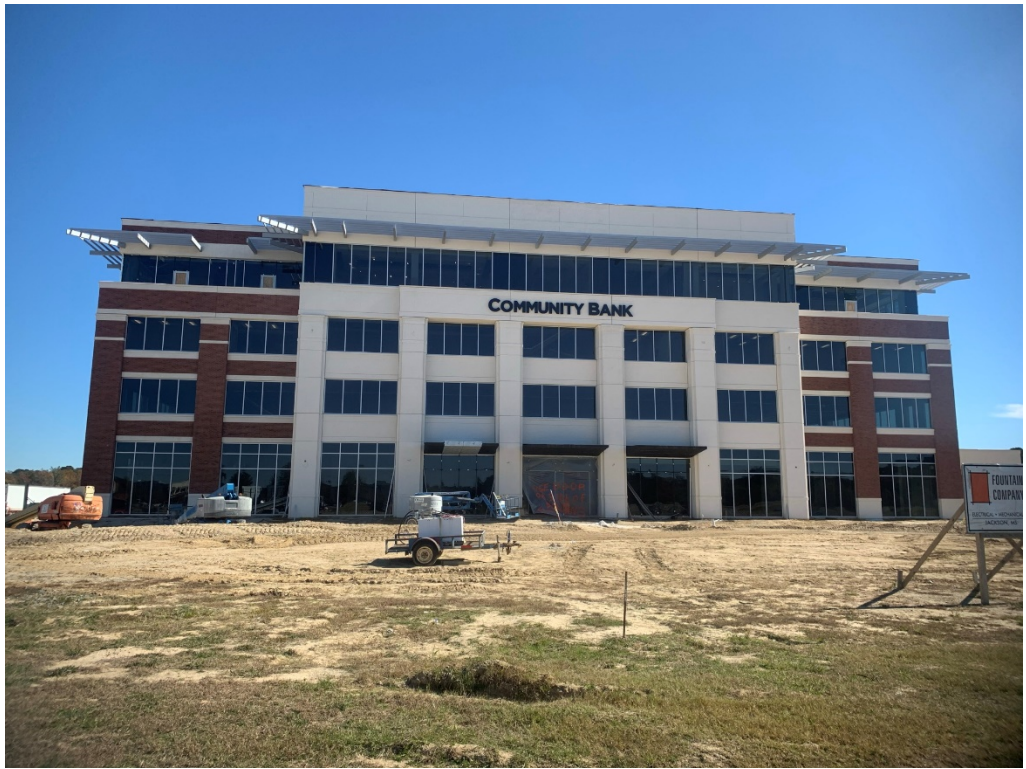
Figure 1 – West Façade Progress

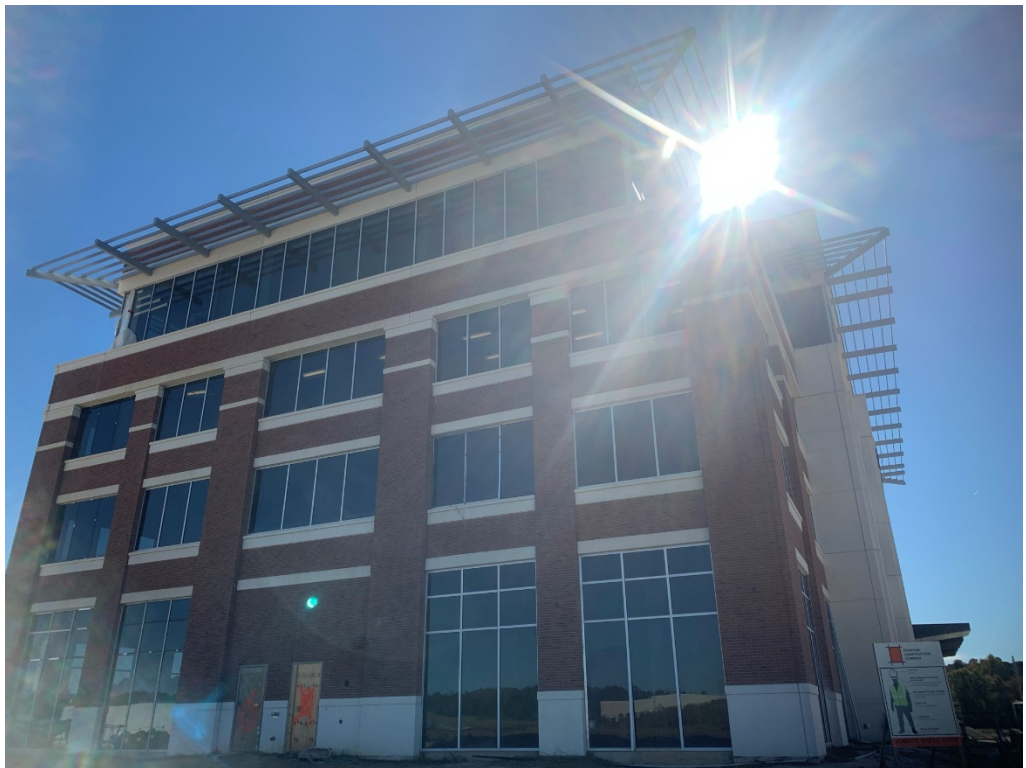
Figure 2 – North Façade Progress

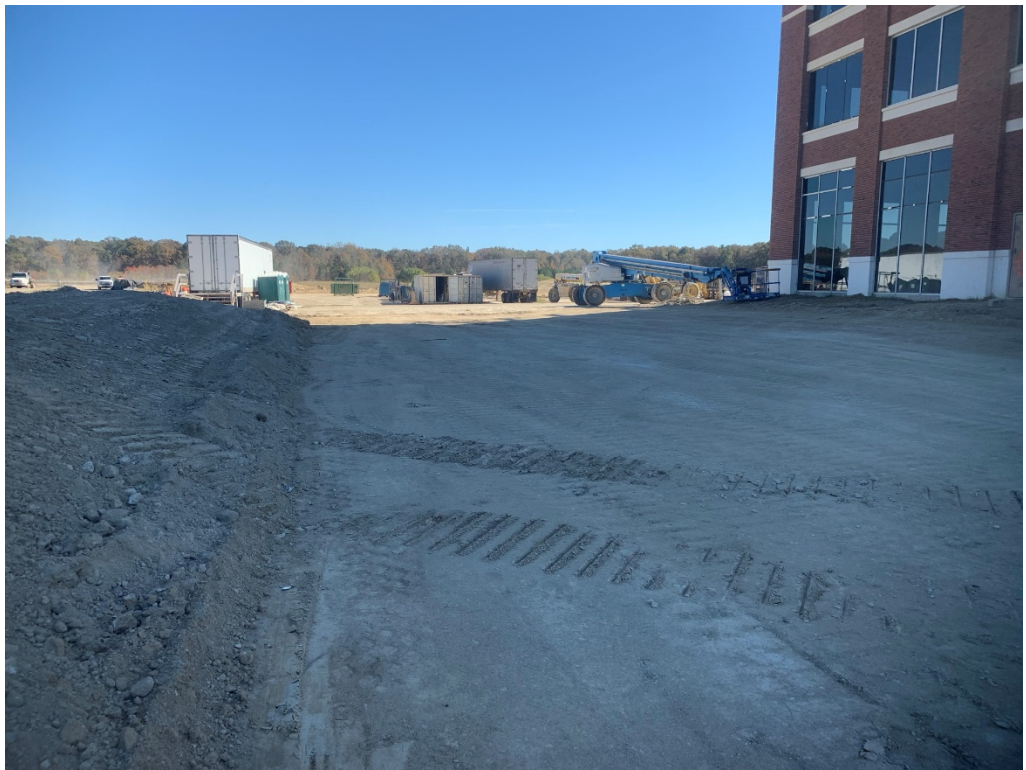
Figure 6 – Lot Limed and Packed

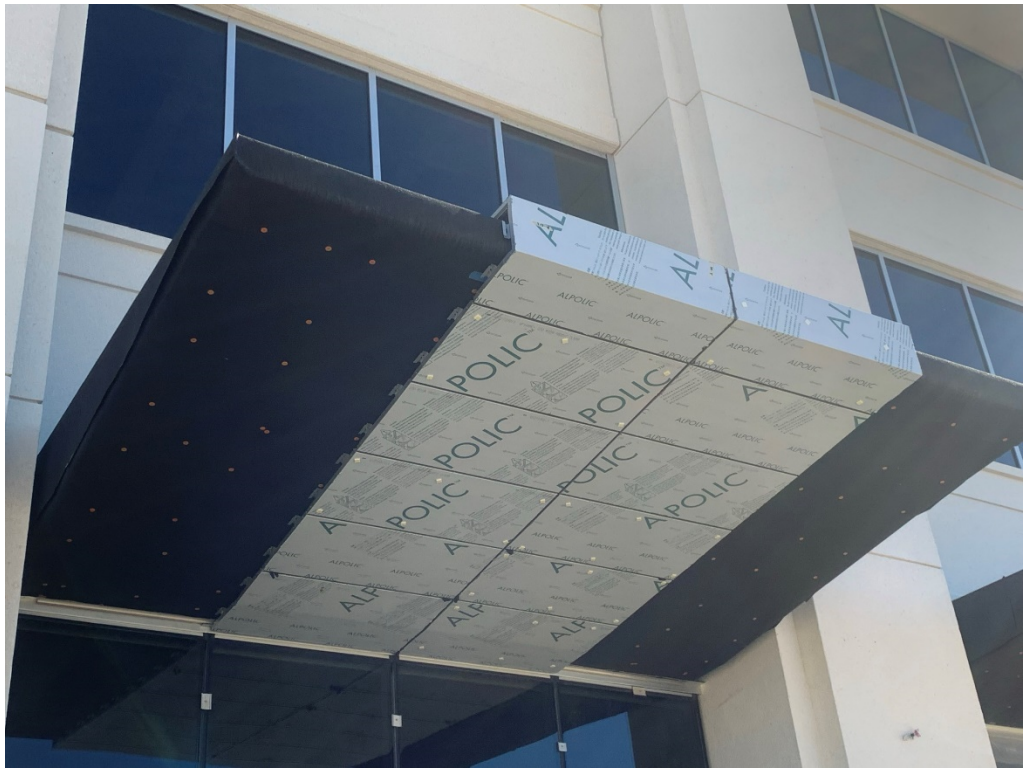
Figure 7 – Aluminum Clad Panel Installation Progress

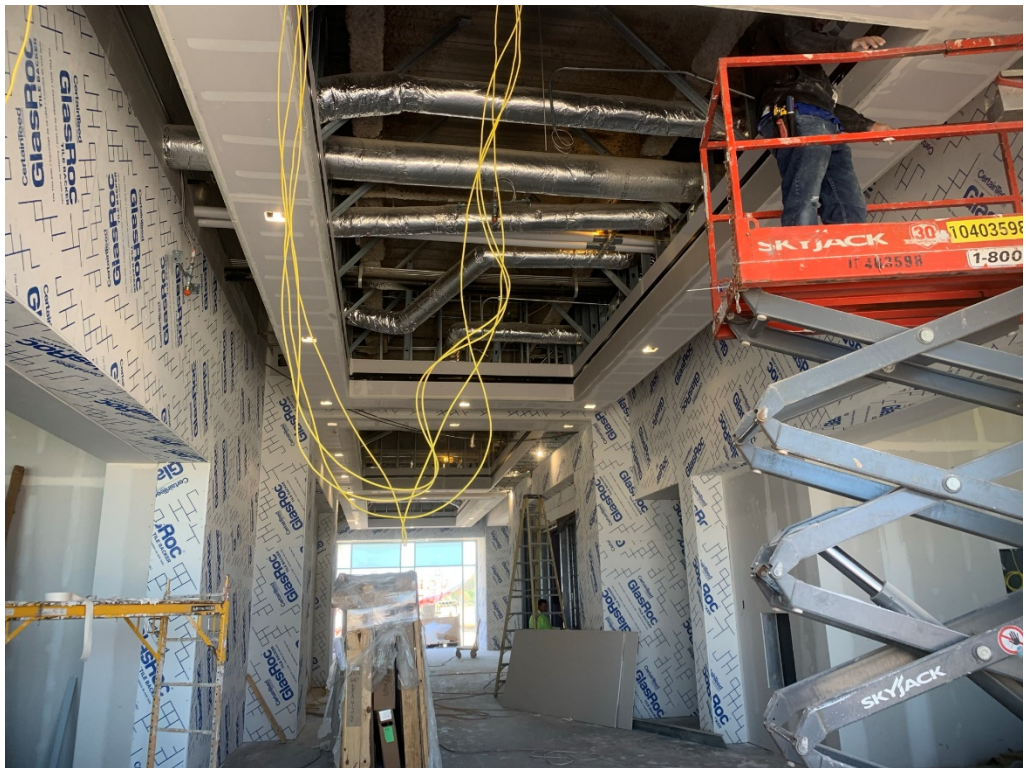
Figure 8 – First Floor Lobby Progress

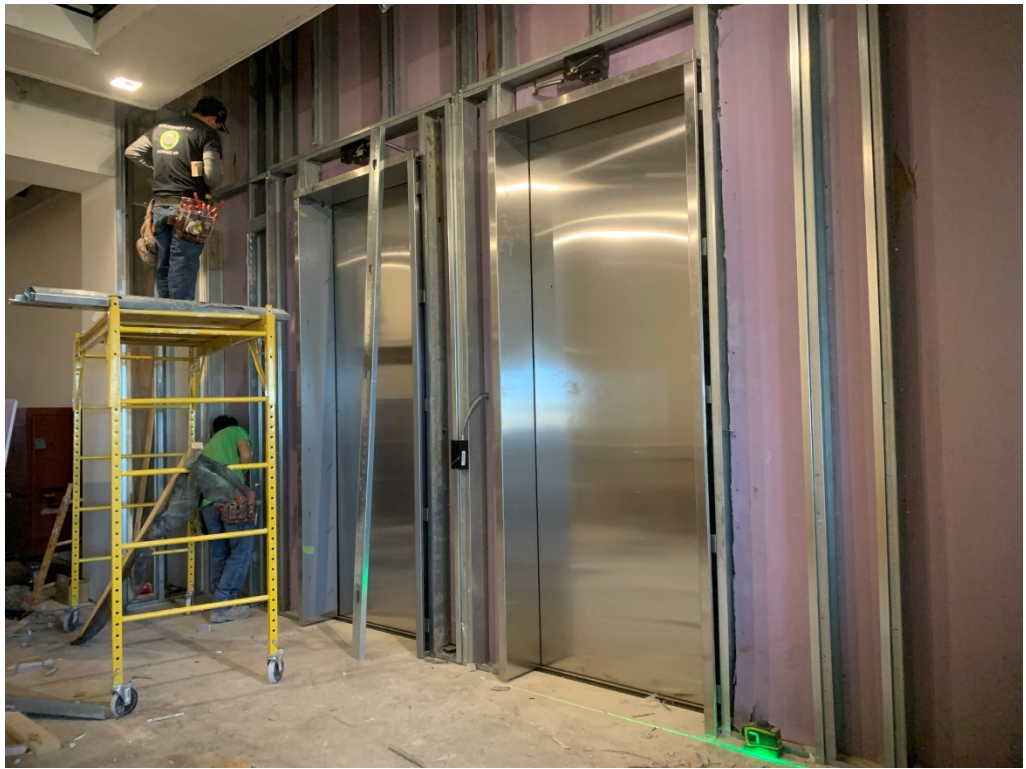
Figure 9 – Main Elevator work is ongoing

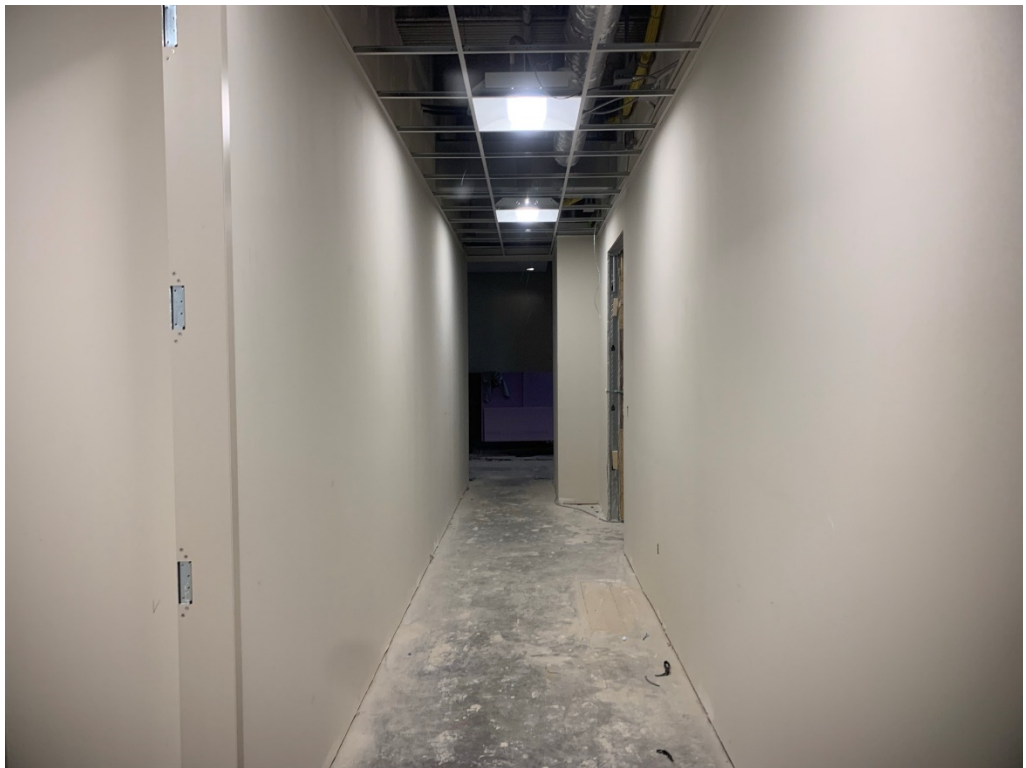
Figure 10 – Painting and Finishing is ongoing

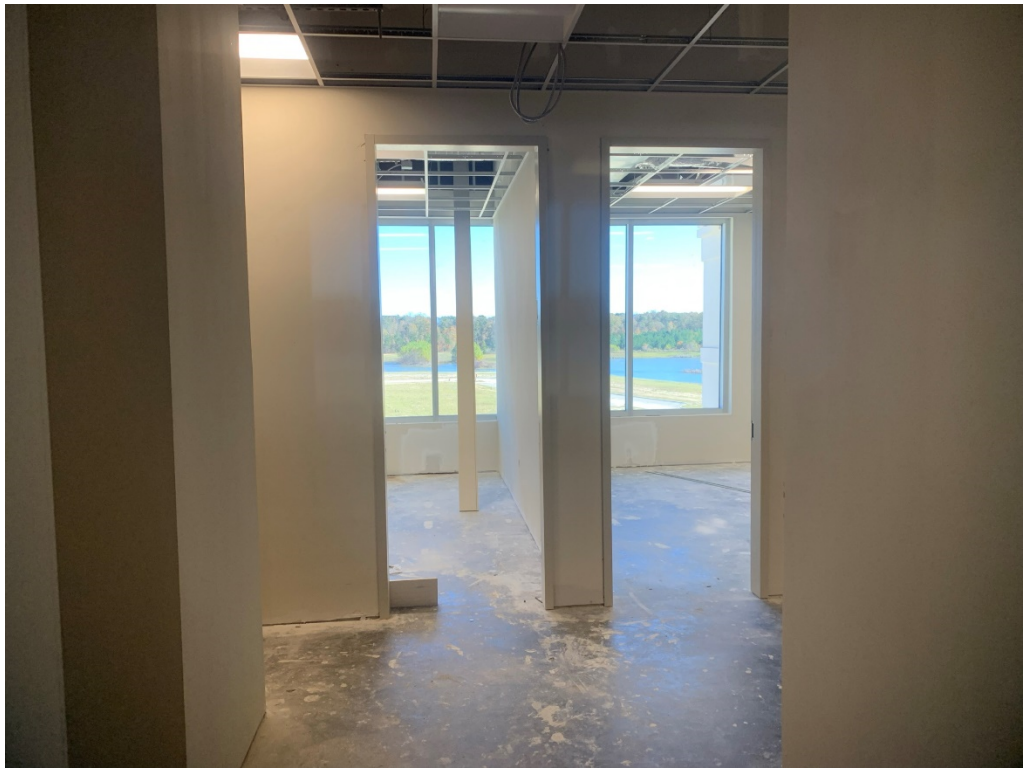
Figure 11 – Painting and Finishing is ongoing

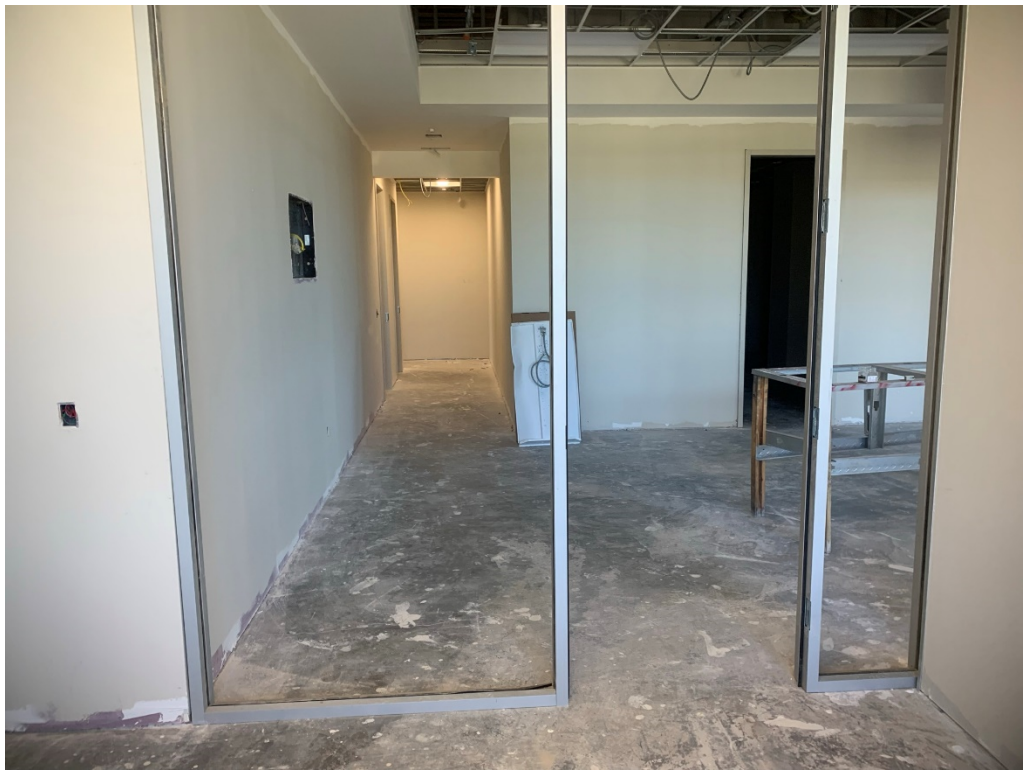
Figure 12 – Interior Frames installed throughout

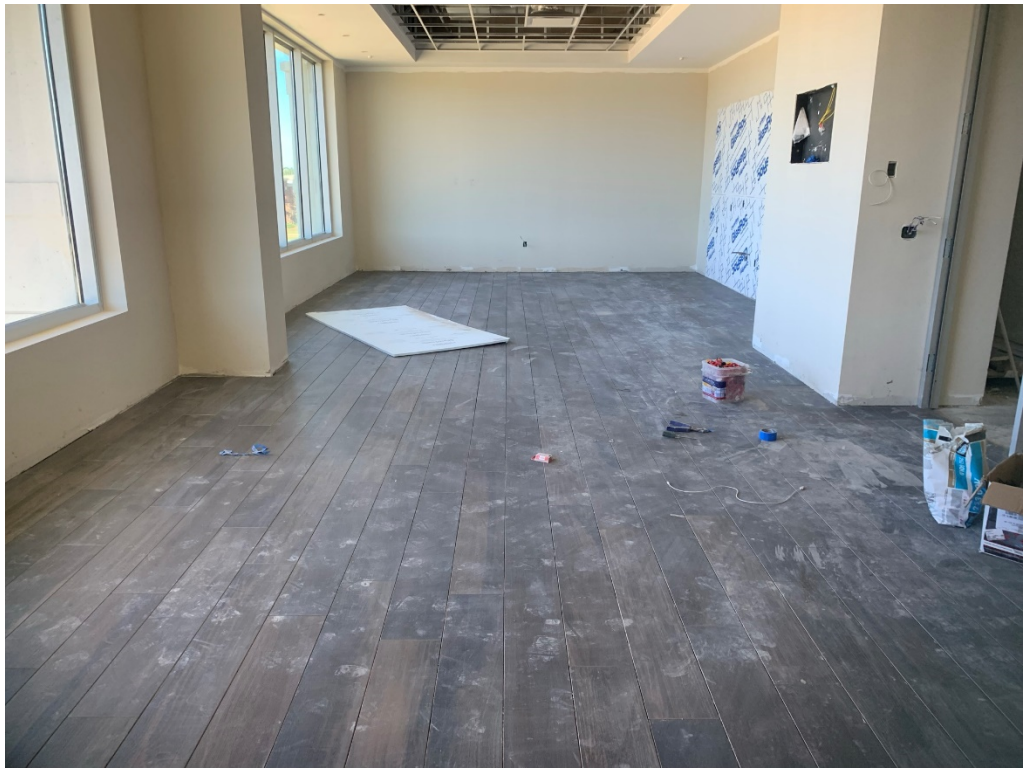
Figure 13 – Tile at Break Area Laid

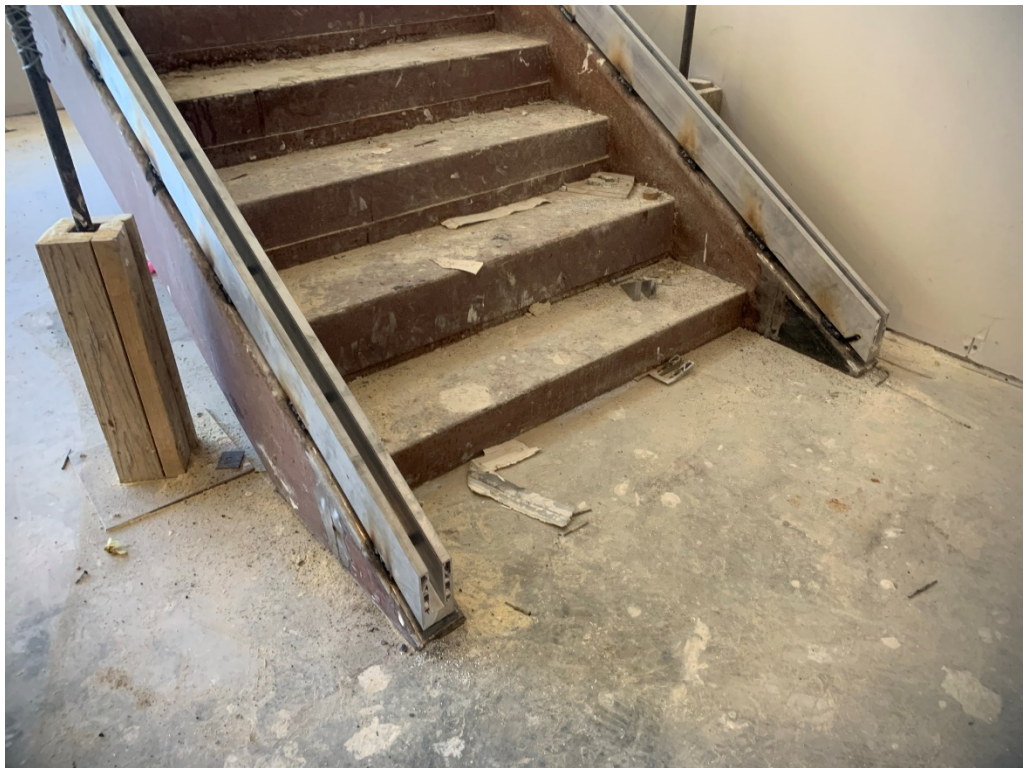
Figure 14 – Glass Handrail Base Fitted and Secured

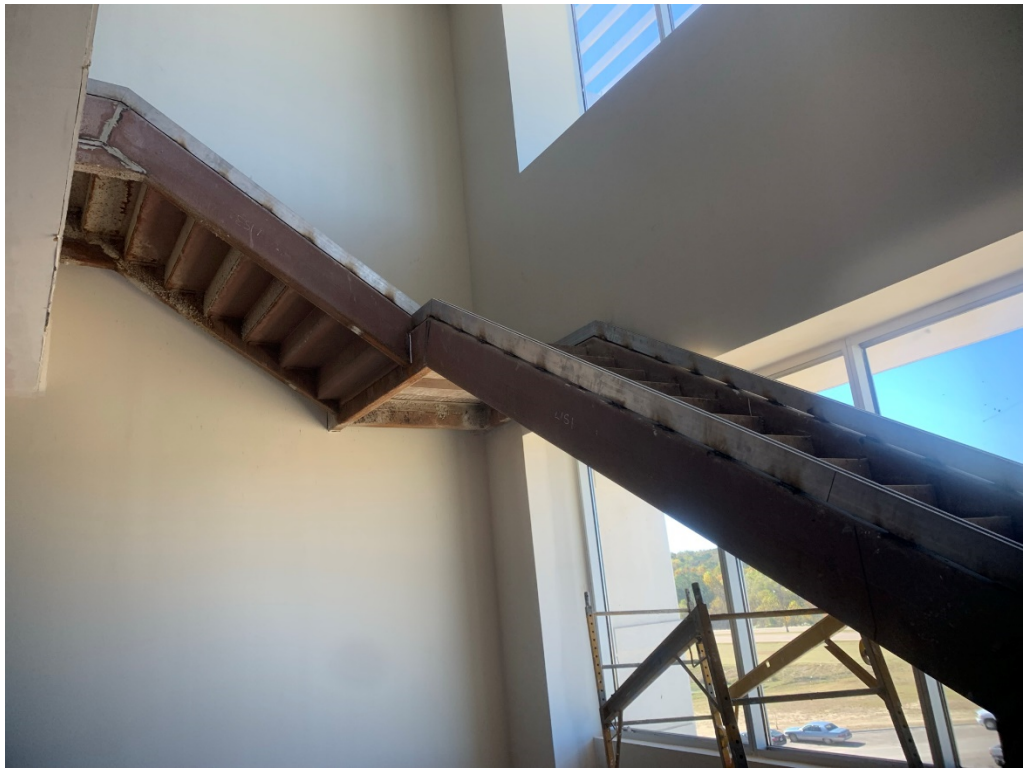
Figure 15 – Glass Handrail Base Fitted and Secured

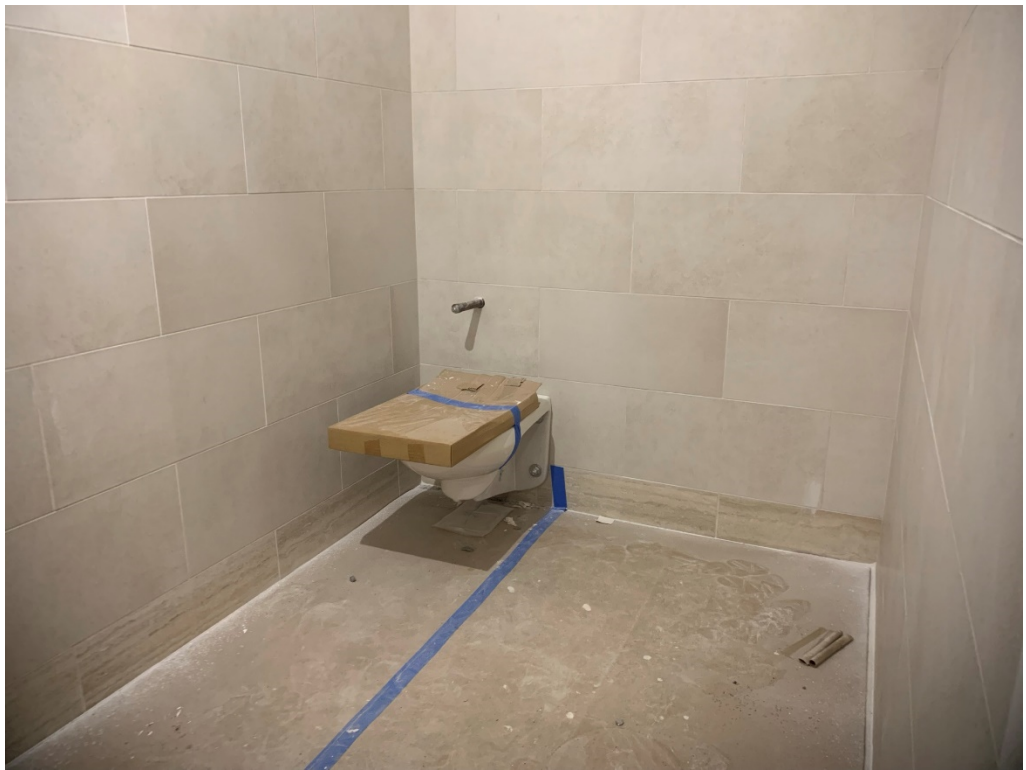
Figure 16 – Toilets are being installed Throughout

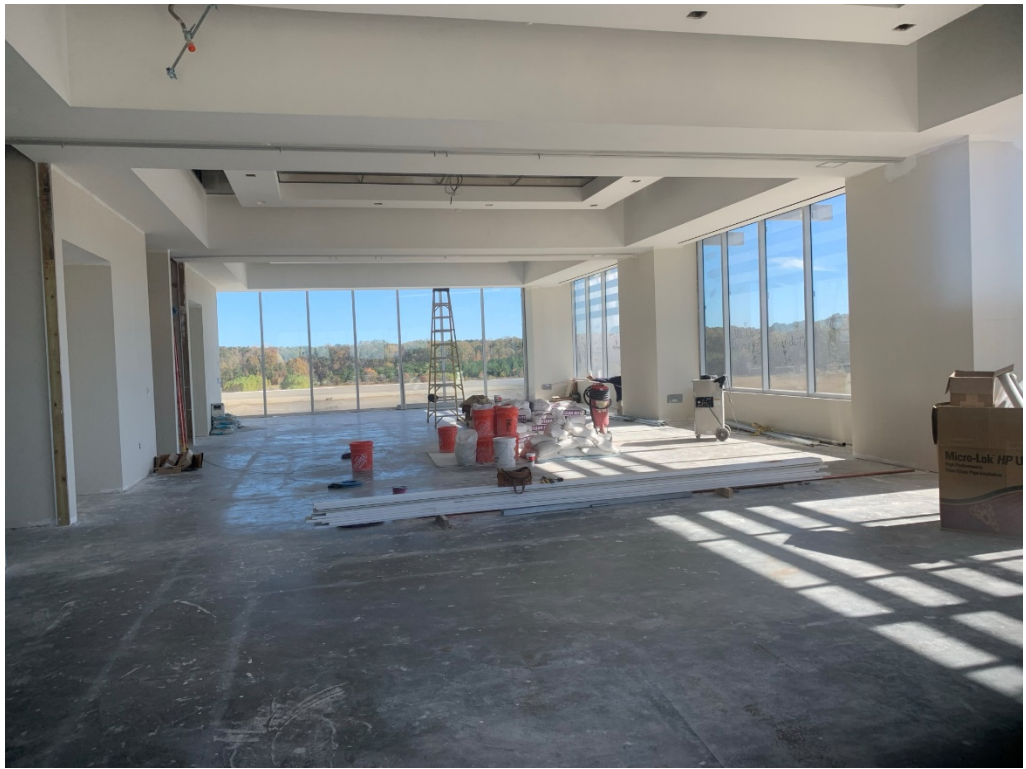
Figure 17 – Banquet Room Progress

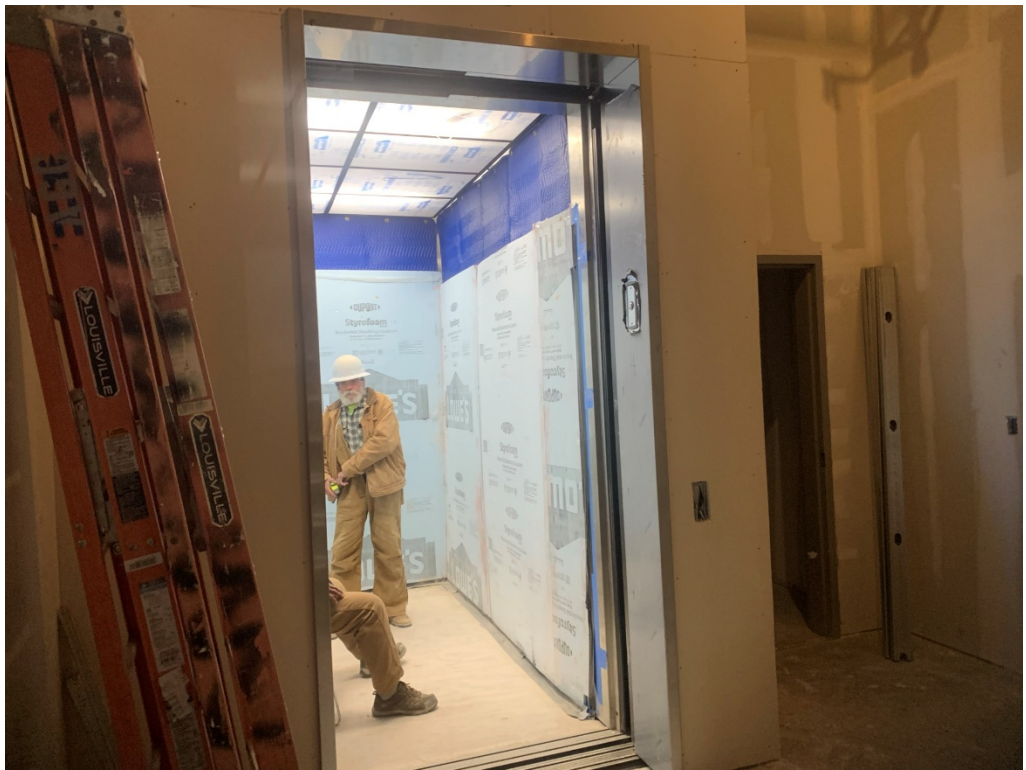
Figure 18 – Maintenance Elevator Operational and in Use

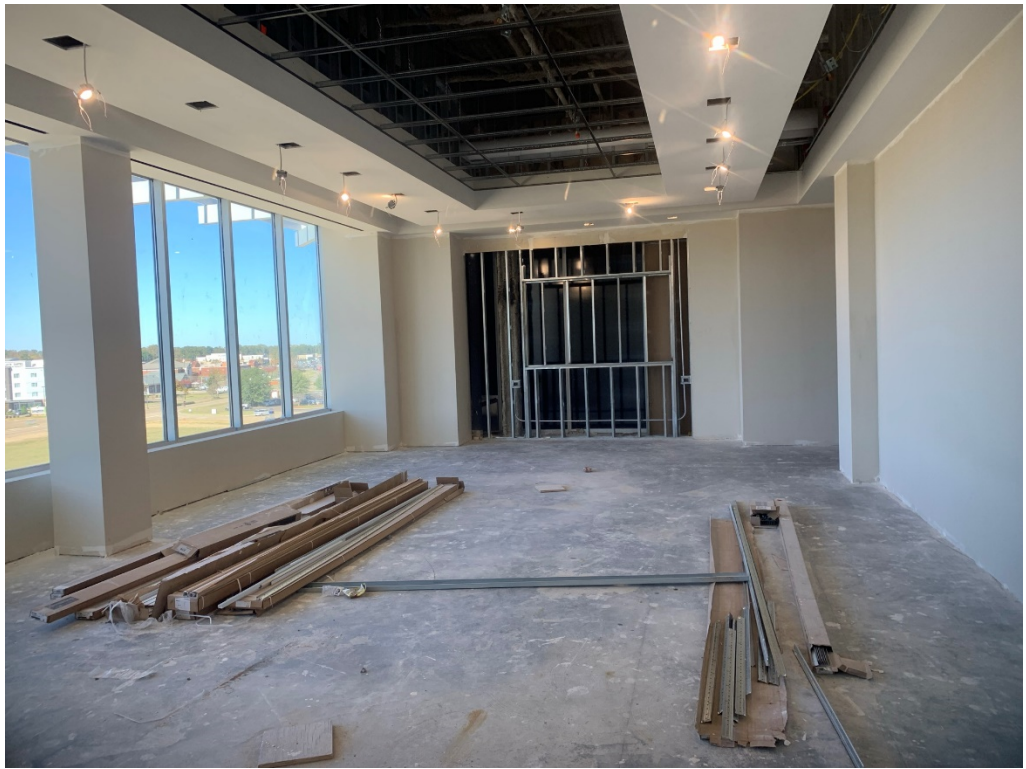
Figure 19 – Board Room Progress

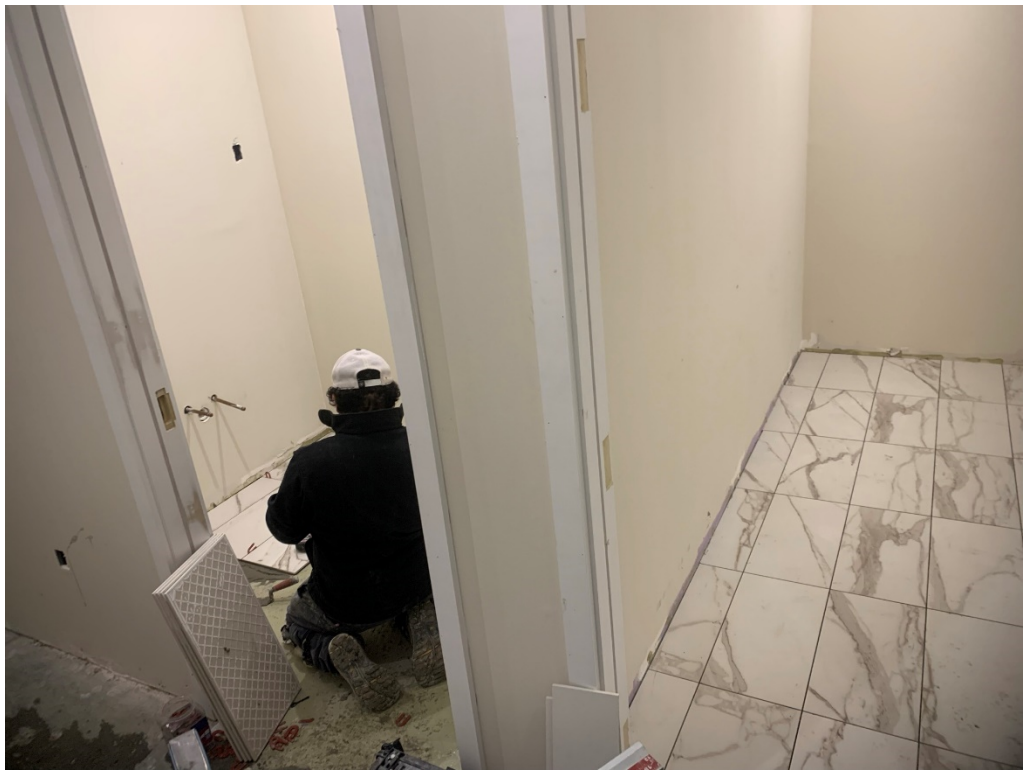
Figure 20 – Tile at fourth Floor Exec. Toilets
