Architect's Field Report

3 December 2021

15094 Community Bank Headquarters / Report Number 031

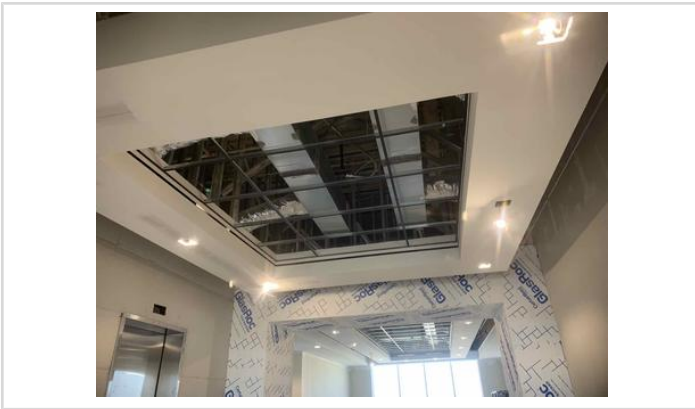
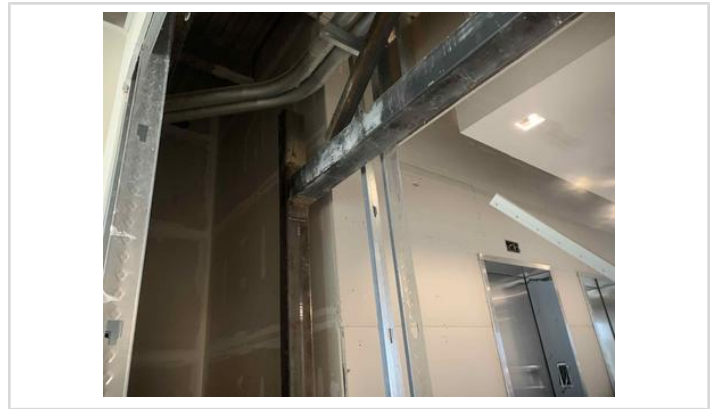
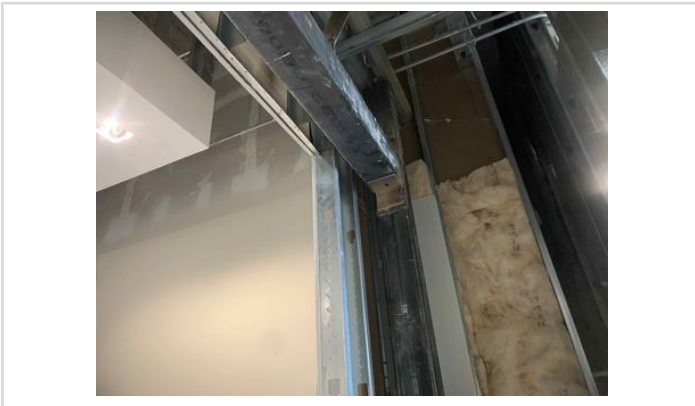
Observation Misc Issues #161: Lobby furr down heights

Description Due to the change in height of door 4001a, The furr down opposite this door in the elevator lobby should match in height; Issues concerning tile joints shall also be considered so that they line up with this new furr down height.

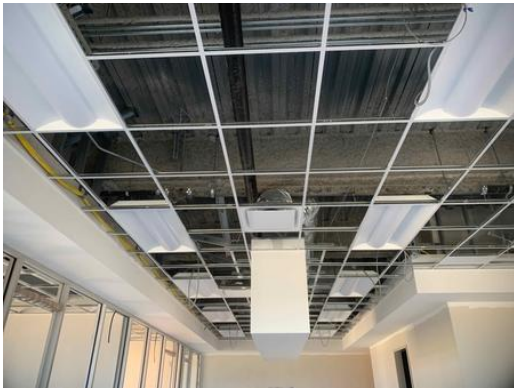
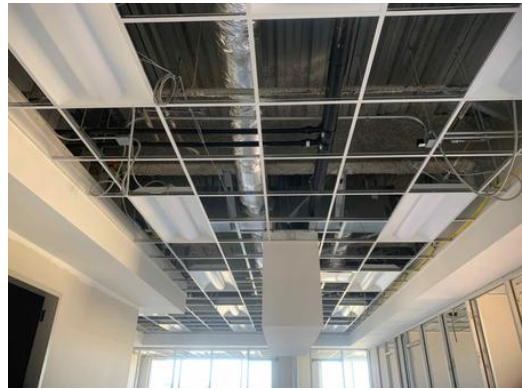
Observation Corrective Action #156: Ceiling grid not centered

Description Ceiling grid is not centered in the room; adjust to center in 3401 open office

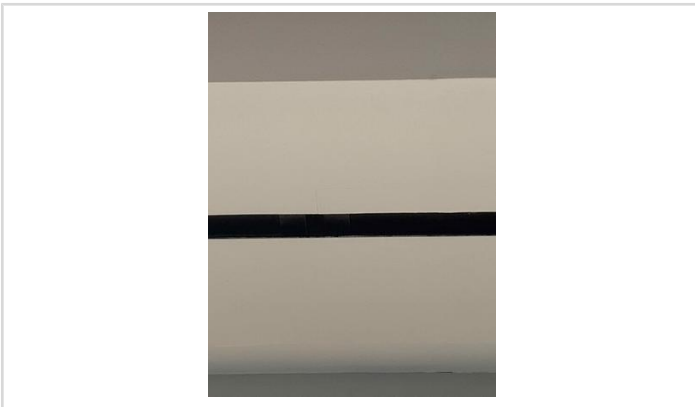
Observation Corrective Action #155: Missing tape at diffusers

Description Mud cracking at diffusers; probably missing paper tape

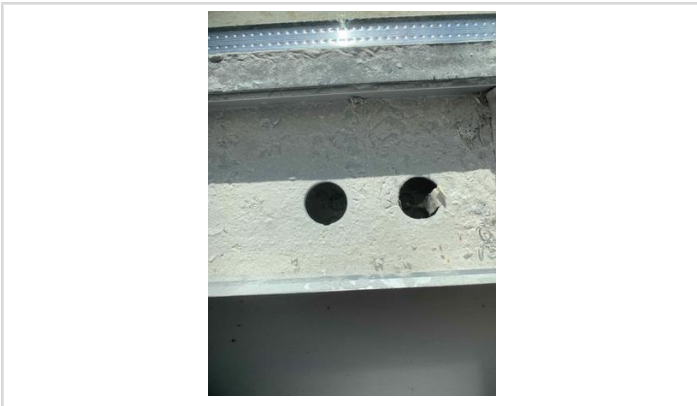
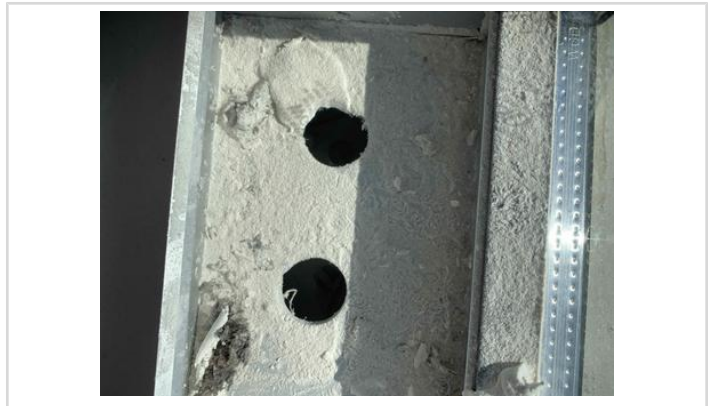
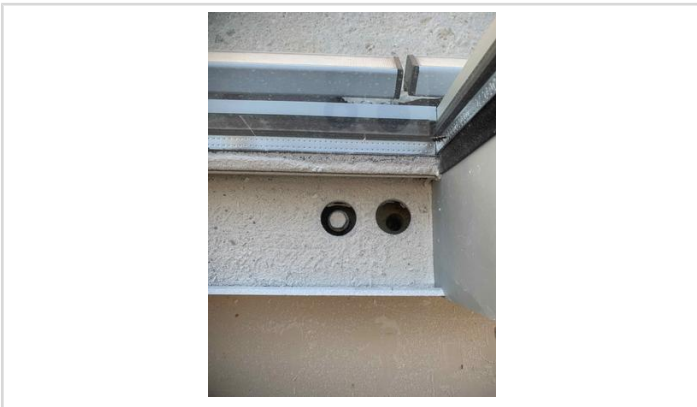
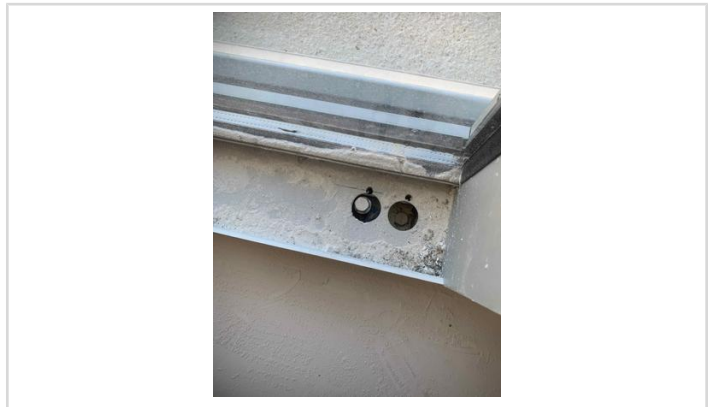
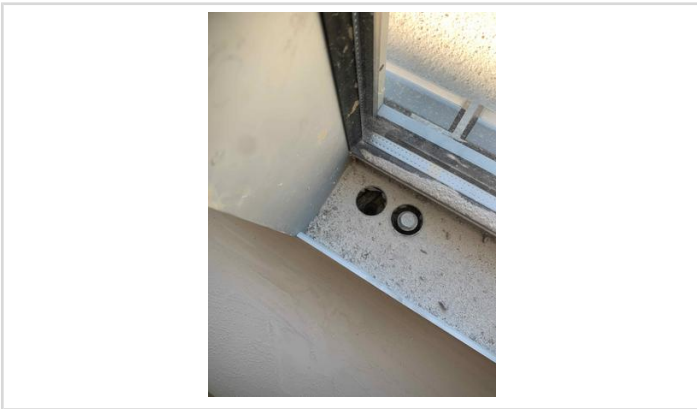
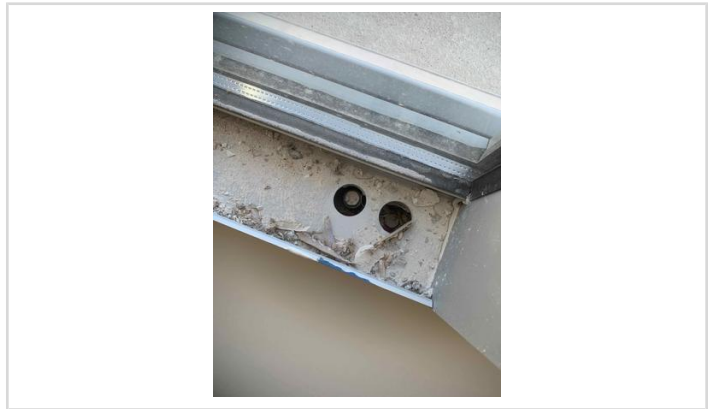
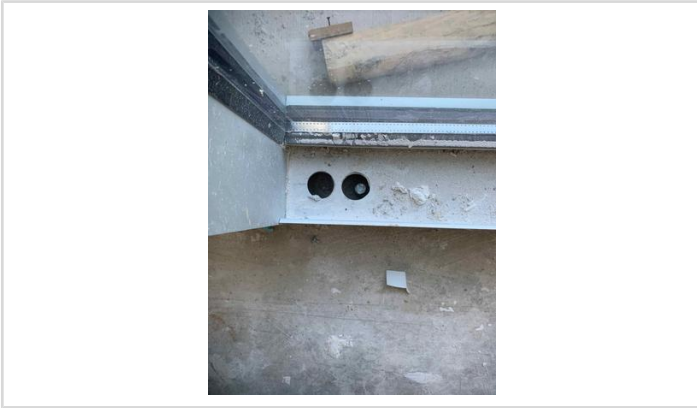
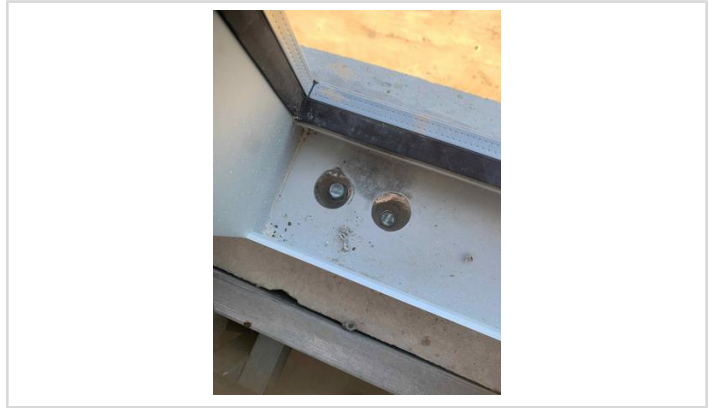
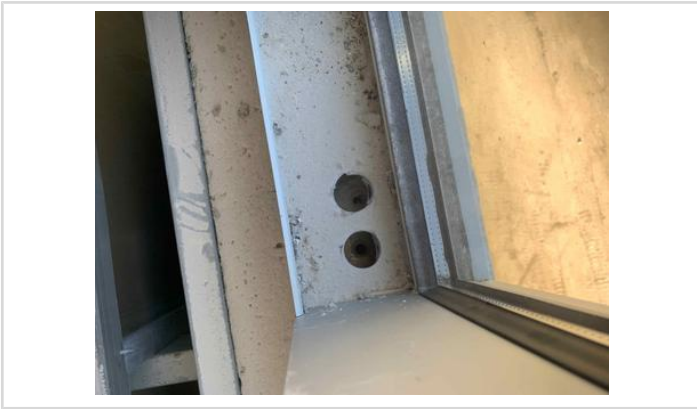
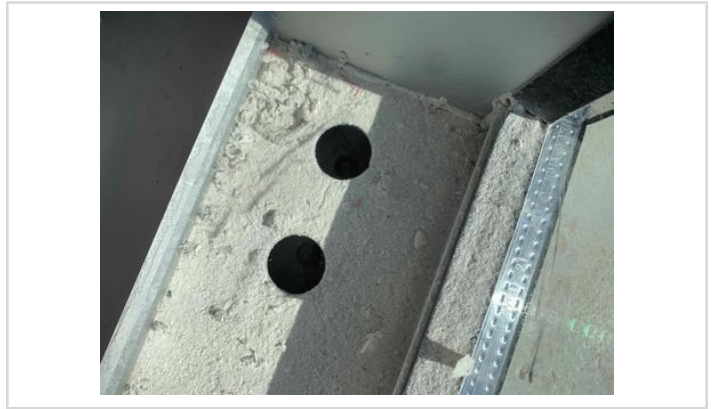
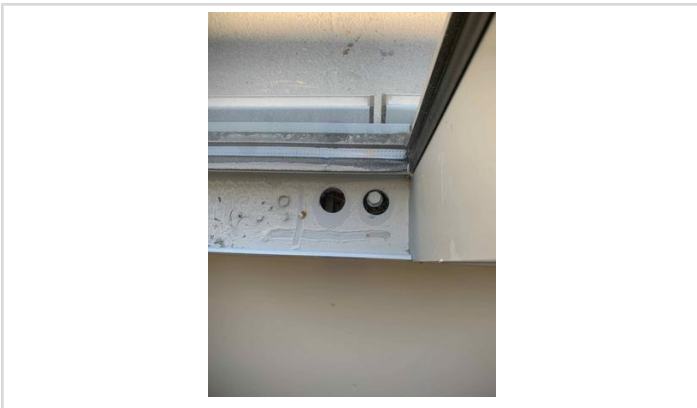
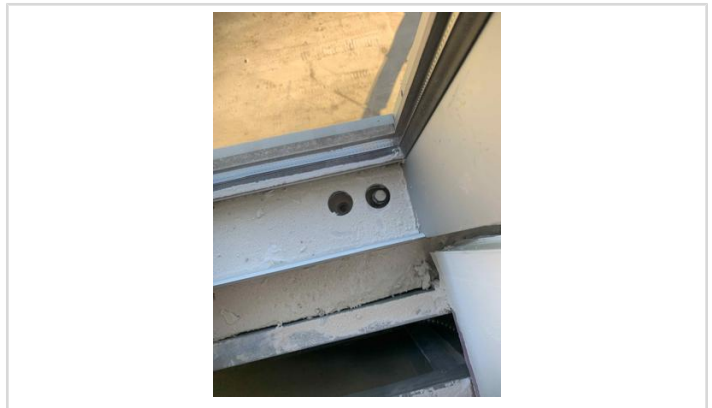
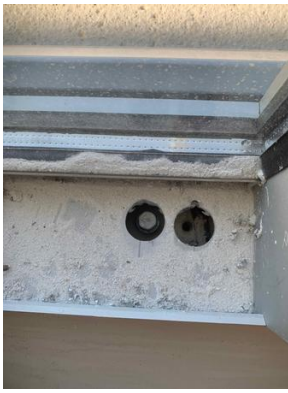
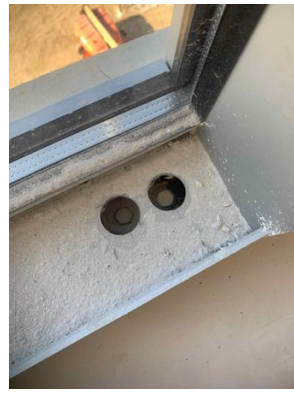
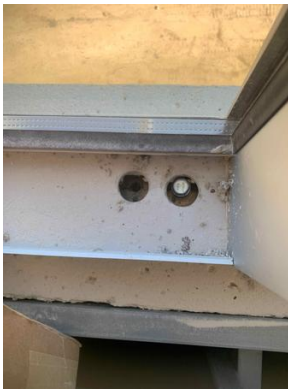
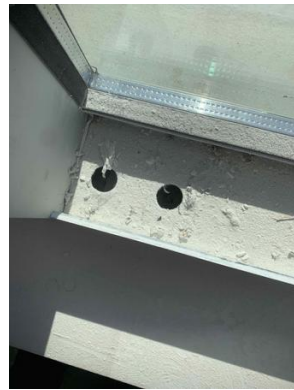
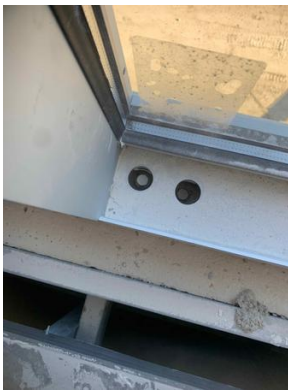
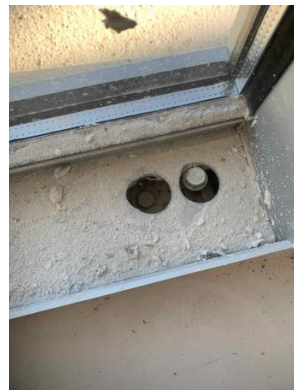
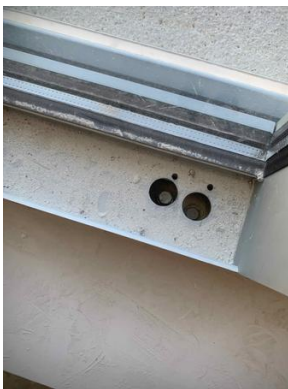
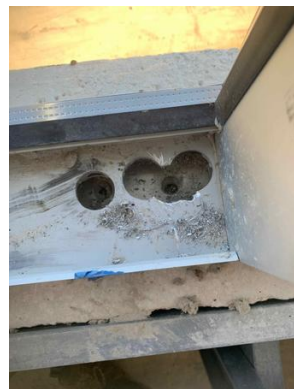
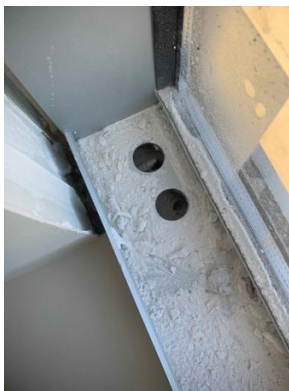
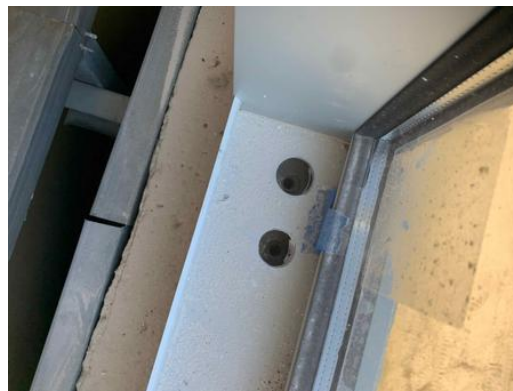
Observation Corrective Action #154: Missing or incomplete bolt install at aluminum frames

Description Missing screws or screws not fully set

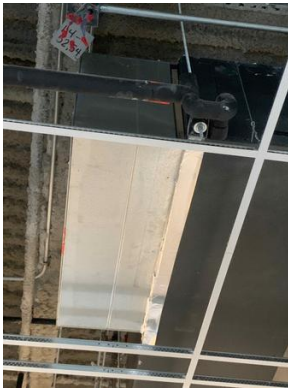
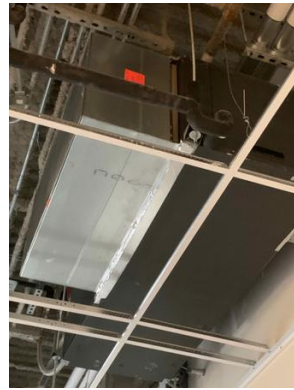
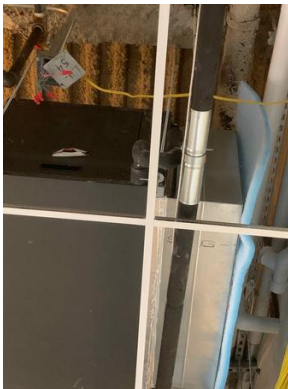
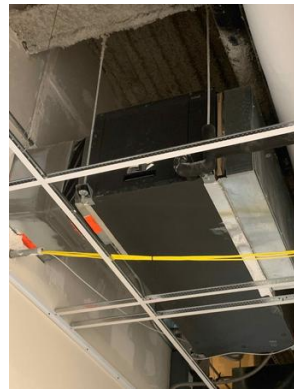
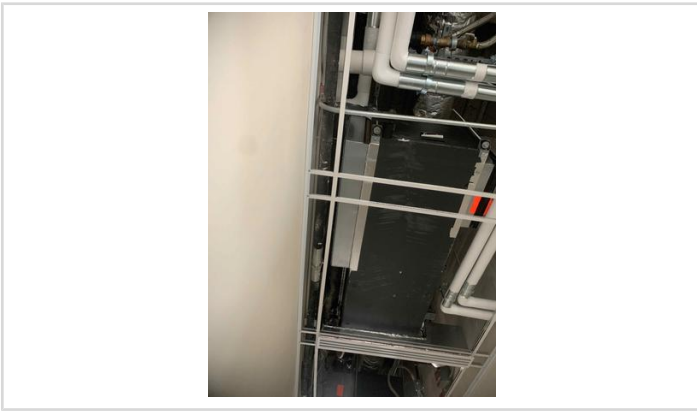
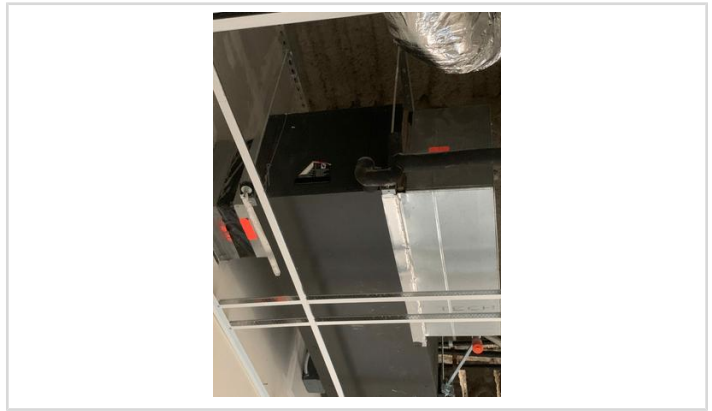
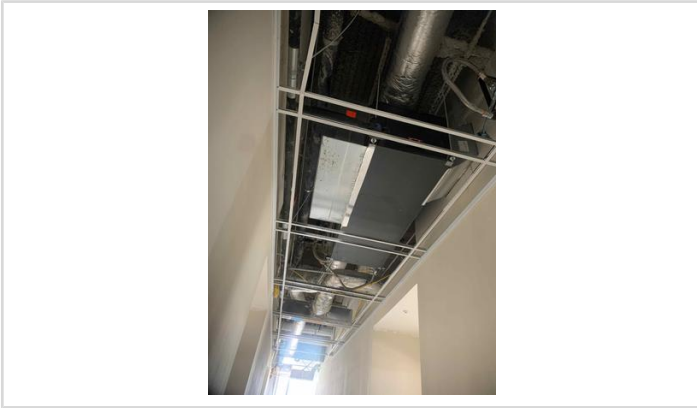
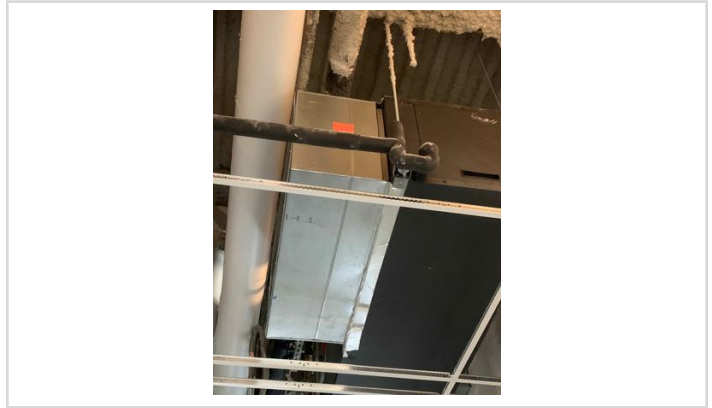
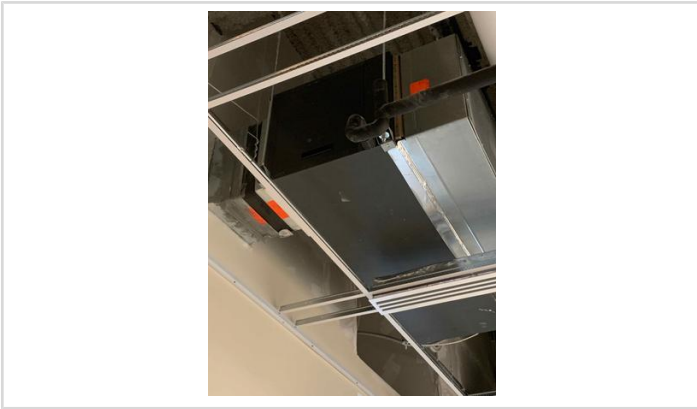
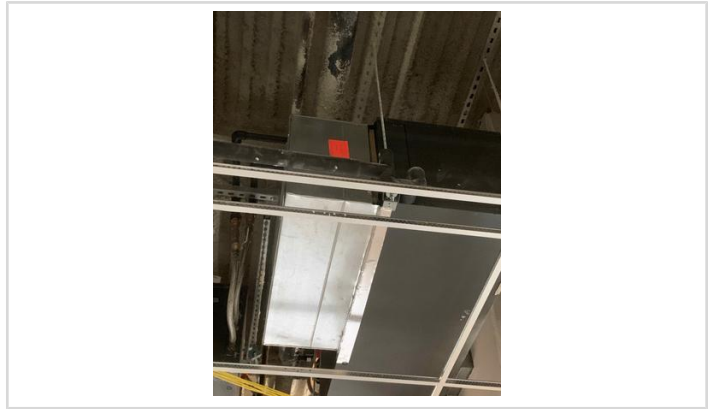
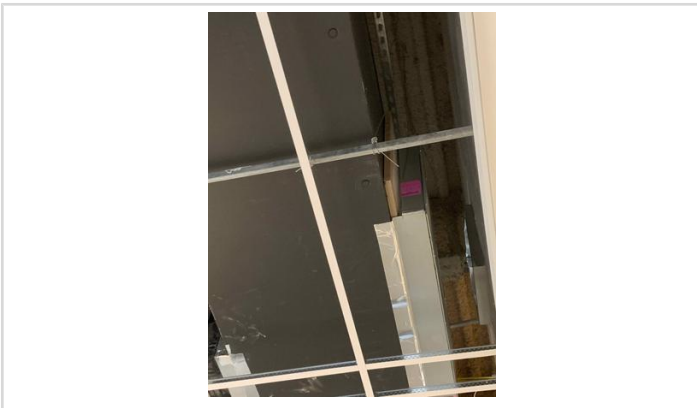
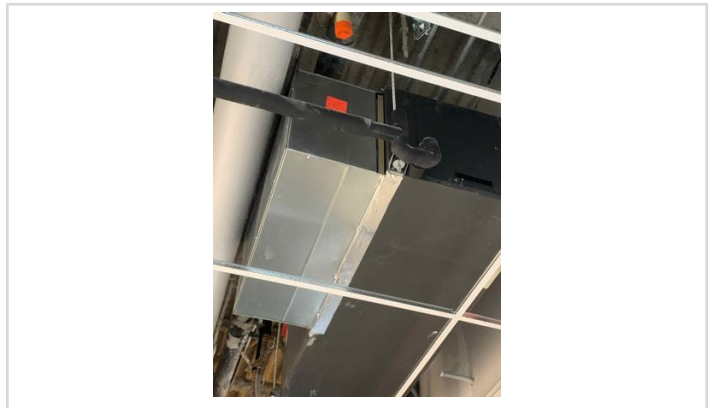
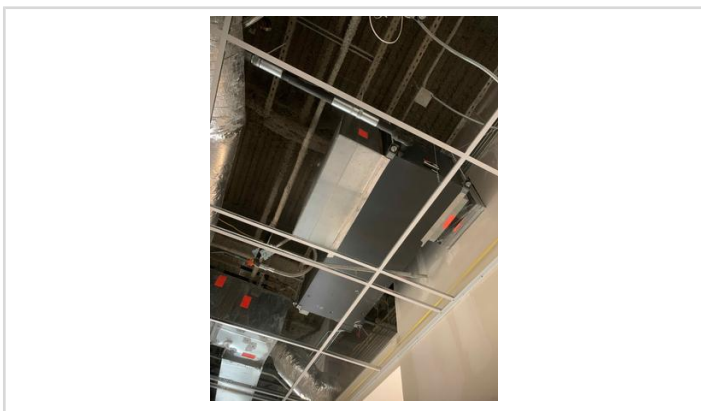
Observation Misc Issues #153: HVAC maintenance issue for filter

Origin		Status	Initiated
Created By	Paul Purser (Dale Partners Architects, P.A.)	Date Created	Dec 2, 2021
Assignee		Distribution	
Notification Date		Priority	
Location	Interior>Level 4	Trade	MECHANICAL
Due Date	Dec 9, 2021	Private	No
Contributing Condition		Contributing Behavior	
Hazard			
Linked Drawings			
Spec Section			
Description	Unable to change filter without damaging new due to drain placement		
Attachments
