Architect's Field Report

12 December 2021

15094 Community Bank Headquarters / Report Number 032

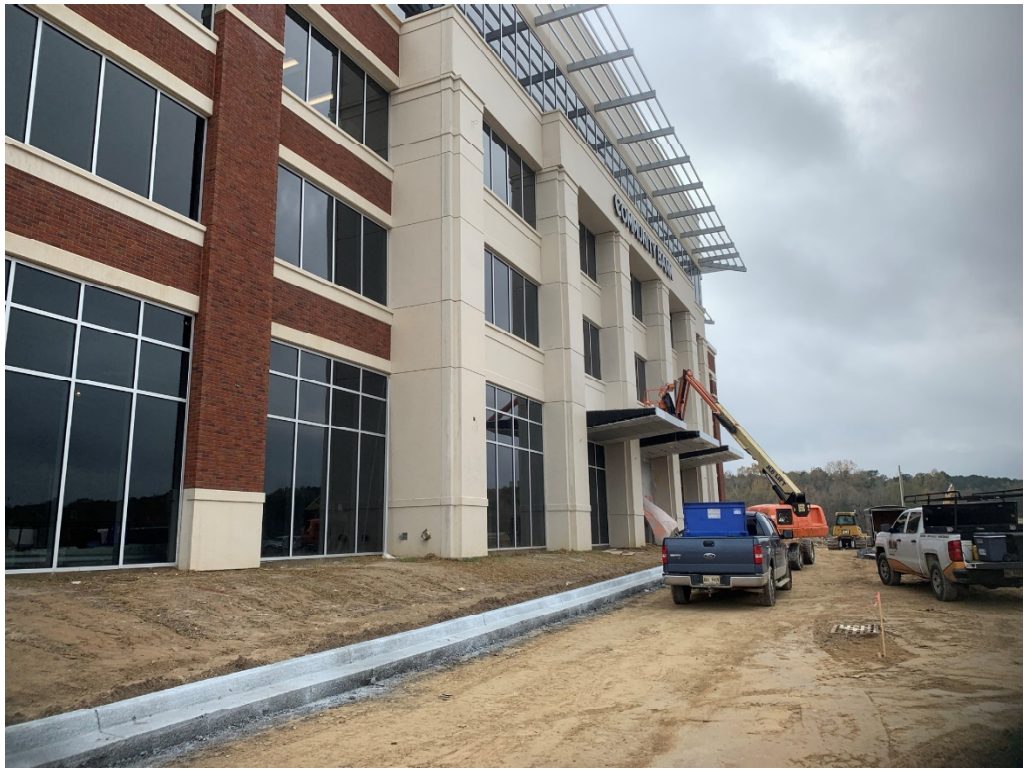
Figure 1 – West Façade; curb installed

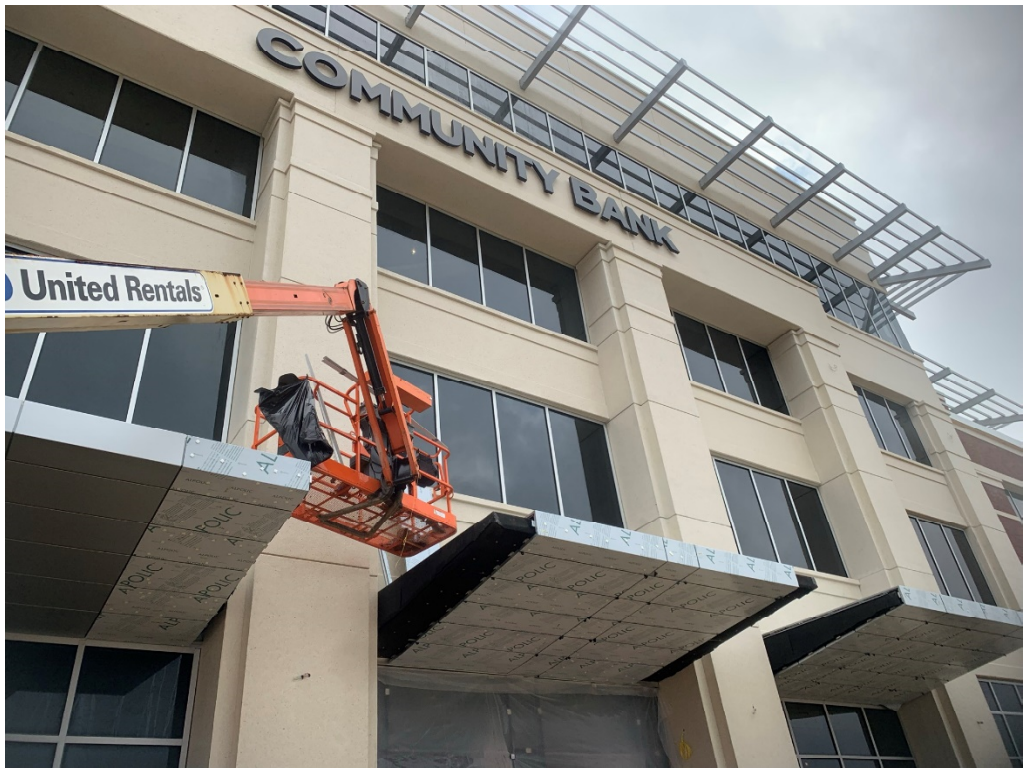
Figure 2 – Aluminum Cladding is ongoing

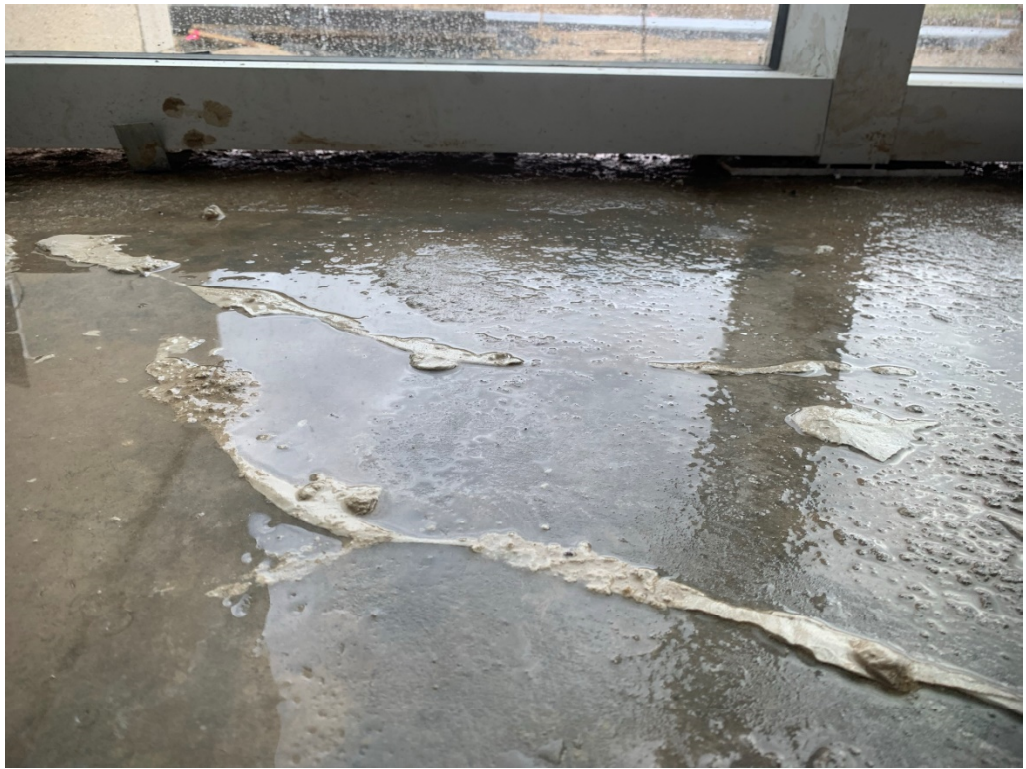
Inside, there is a lot of moisture at the first level. This will bleed to the upper floors and needs to be corrected to reduce moisture at the upper levels. The most likely culprit appears to be the sealant, still to be installed at the curtain walls.

Figure 3 – High moisture levels at the 1st floor; awaiting elastomeric sealant

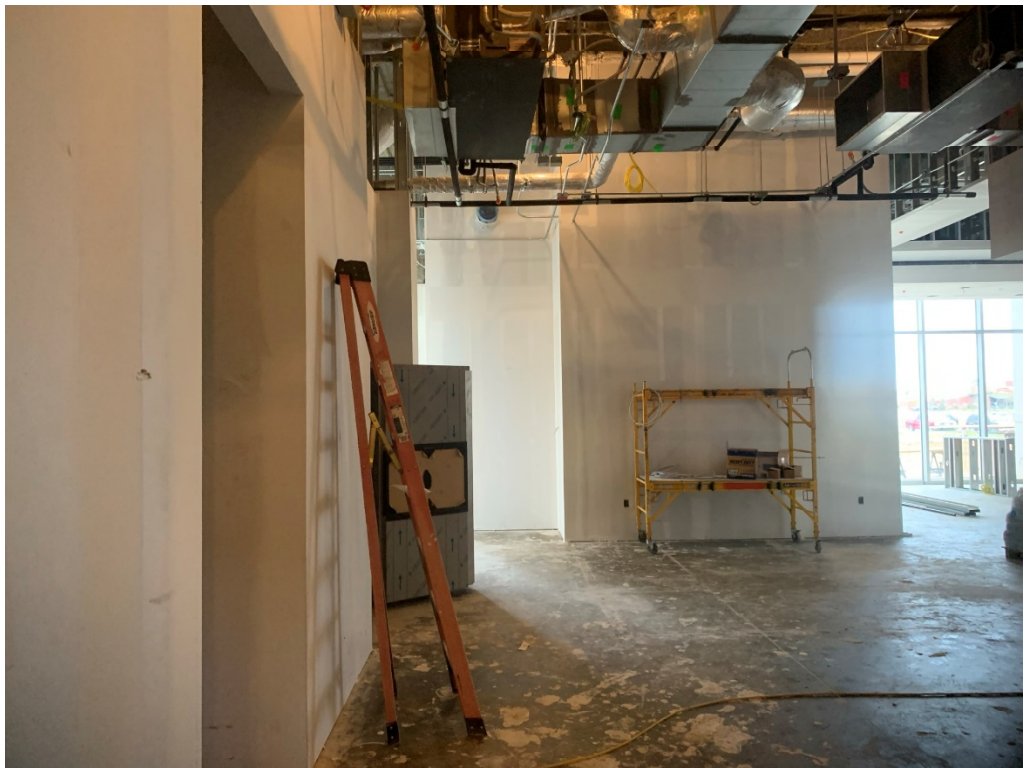
Figure 4 – Drywall is ongoing throughout

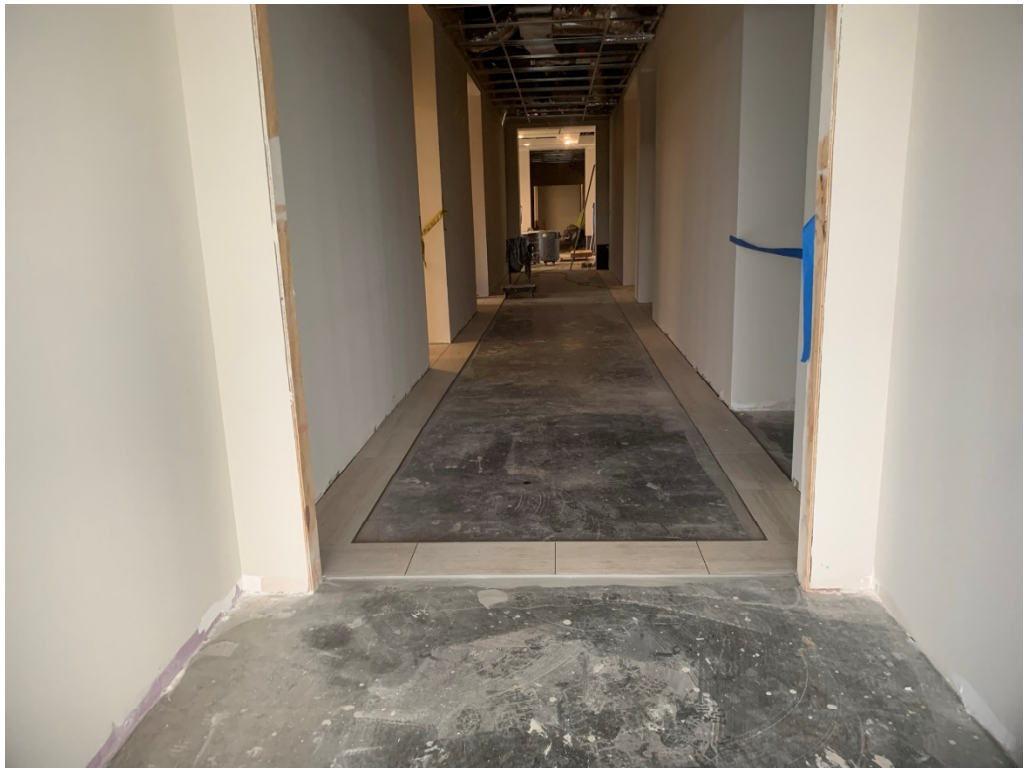
Figure 5 – Tile is ongoing throughout

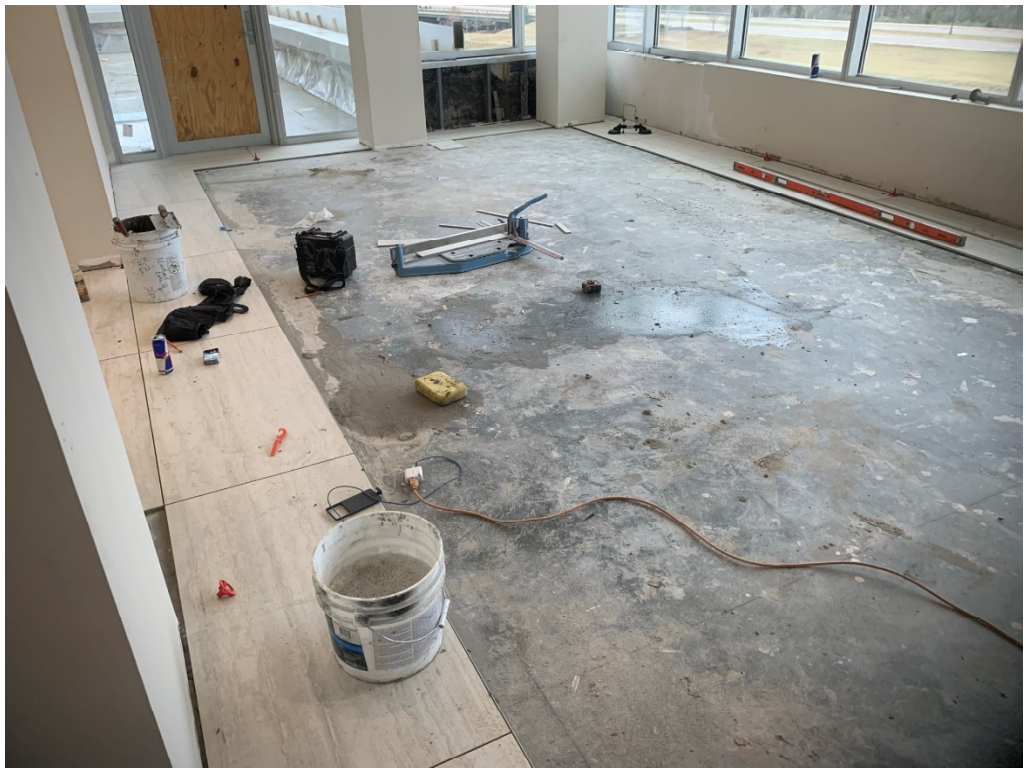
Figure 6 – Tile is ongoing throughout

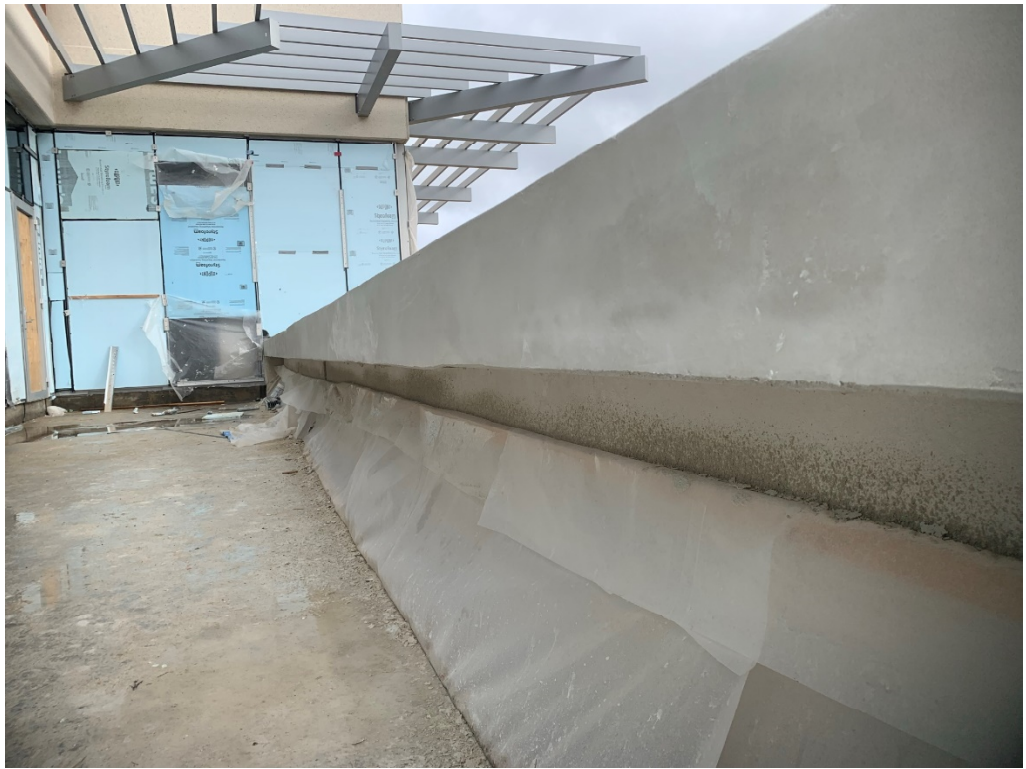
Figure 7 – Bottom edge of new concrete requires straightening at 4th floor balconies

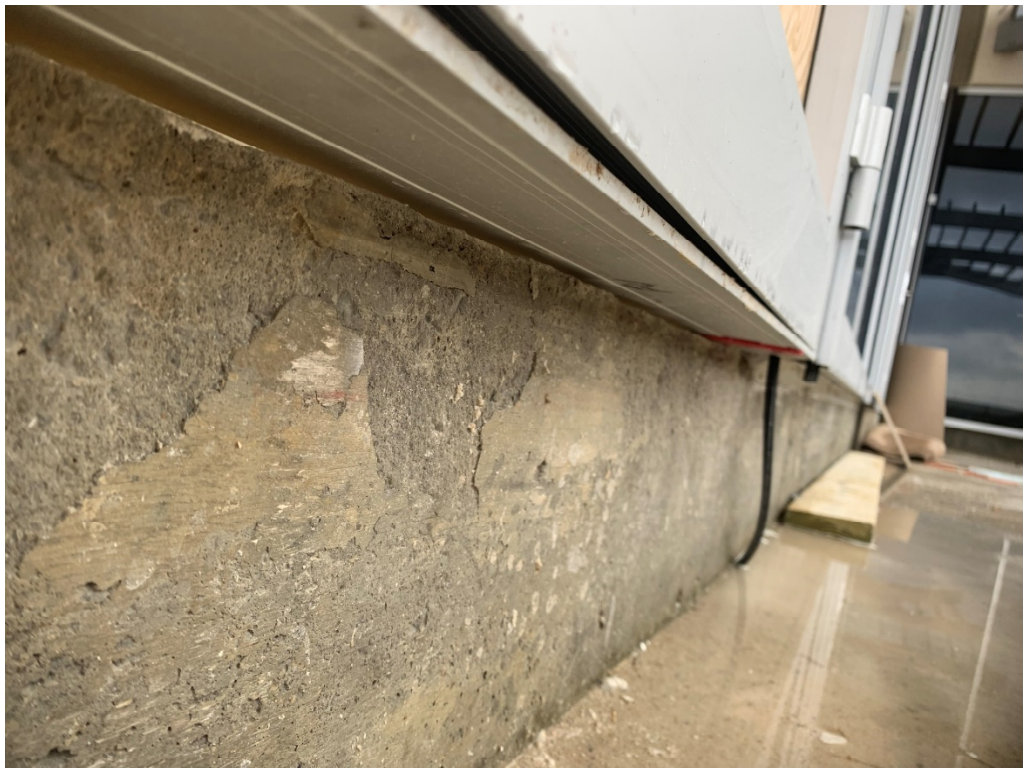
Figure 8 – No Caulking present in some locations below curtain walls assemblies at balconies on 4th

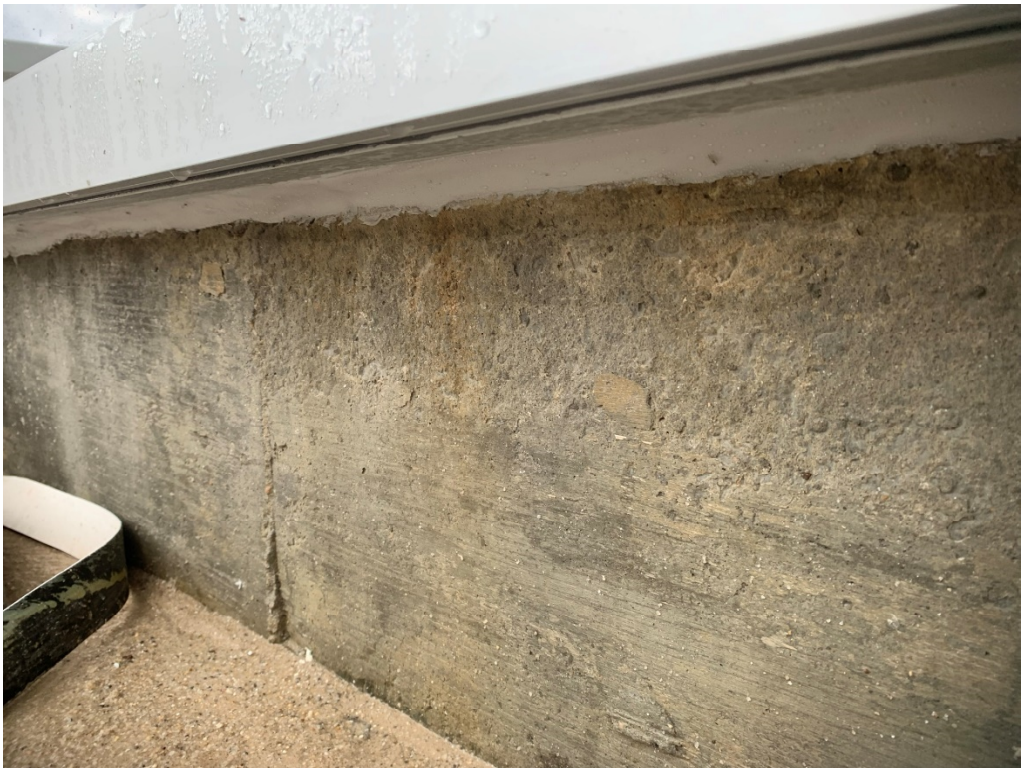
Figure 9 – Caulking below curtain walls assemblies at balconies on 4th

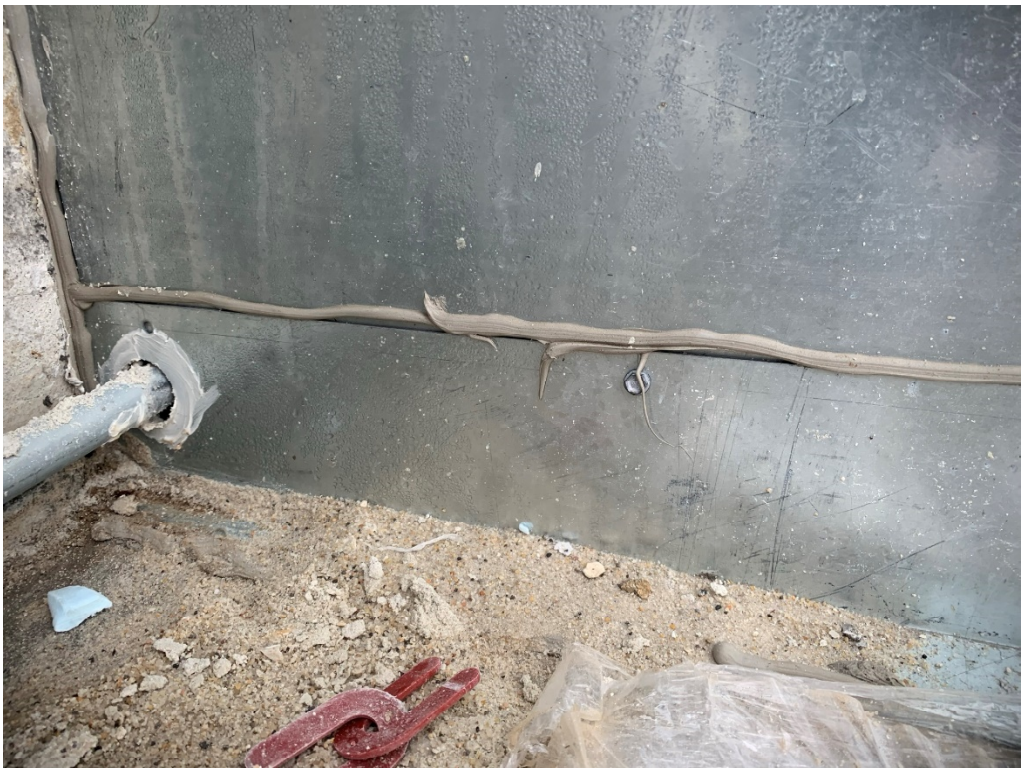
Figure 10 – Poorly caulked flashing will have water intrusion

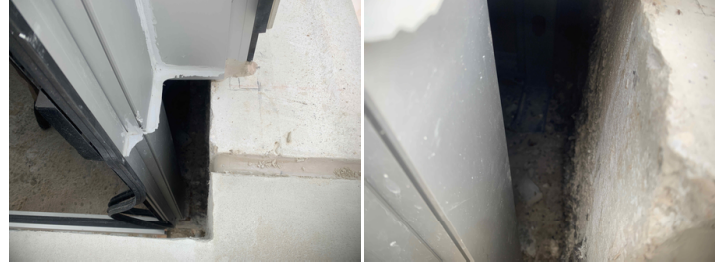
#198: Seal gaps at store front outside corners at all balconies

Type: **Work to Complete > Work to Complete**
Location: **Exterior>Building>Curtain Walls**
Trade: **Initiated**
Date Notified: **High**
Due Date: **2021-12-17**
Spec Section:
Assignee:
Description: **Each corner at building ends needs more attention for air and water Tightness**
Created By: **Paul Purser**

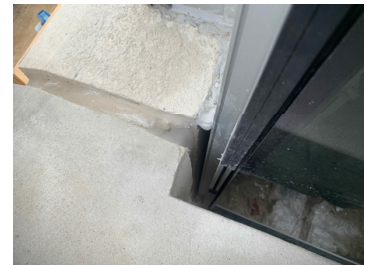
#197: Poorly sealed condition

Type: **Quality > Corrective Action**
Location: **Interior>Level 4>4113 Exec. Office**
Trade: **Initiated**
Date Notified: **Urgent**
Due Date: **2021-12-17**
Spec Section:
Assignee:
Description: **Continue mastic at vertical gap between framing and precast to prevent water intrusion ; Outside at corner**
Created By: **Paul Purser**

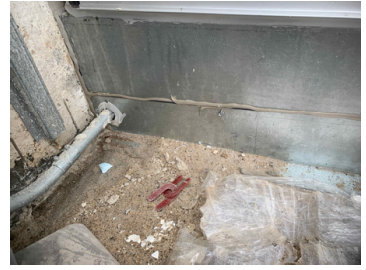
#196: Counter flashing

Assignee: Description:
This is actually outside on the balcony; flashing has been very poorly caulked And Seal is not continuous

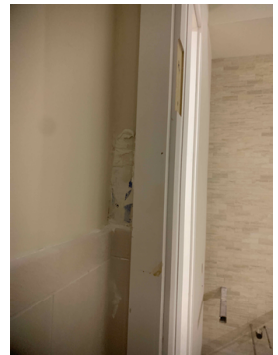
#195: Finish mud smooth at back side of all door jambs in toilets (typical)

Assignee: Description:
This issue is at most every location

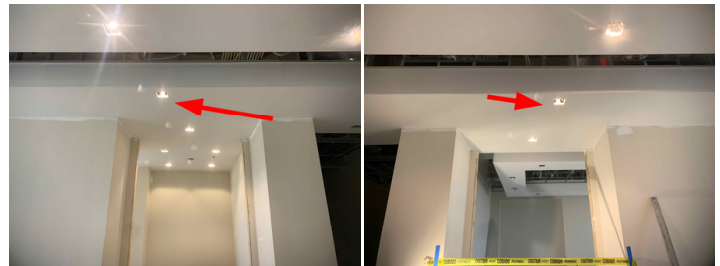
#194: Lights not on plans

Assignee: Description:
These lights do not appear to be on our floor plan

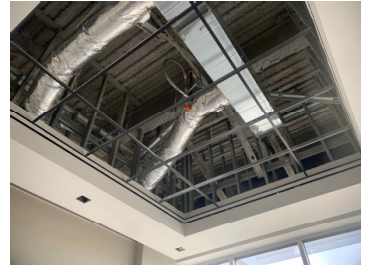
#193: Bracing for pendant fixture

Type: **Work to Complete > Work to Complete**
Location: **Interior>Level 4>4143 Small Conf.**
Trade:
Status: **Initiated**
Date Notified:
Priority:
Due Date: **2021-12-17**
Spec Section:
Assignee:
Description:
Created By: **Paul Purser**
Description: **Ensure that pendant light will be properly braced**

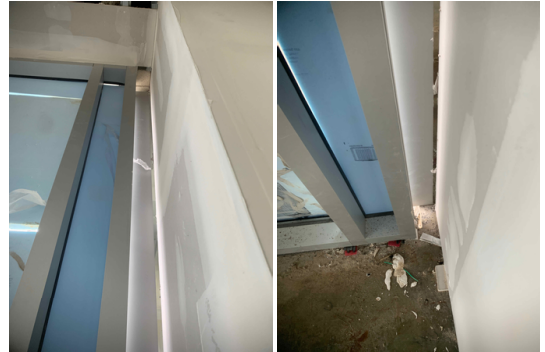
#192: Cavity will need insulation

Type: **Work to Complete > Work to Complete**
Location: **Interior>Level 4>4151 CIO Office**
Trade:
Status: **Initiated**
Date Notified:
Priority:
Due Date: **2021-12-17**
Spec Section:
Assignee:
Description:
Created By: **Paul Purser**
Description: **Will this cavity receive foam?**

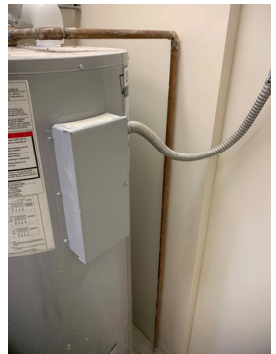
#191: Secure piping

Type: **Work to Complete > Work to Complete**
Location: **Interior>Level 4>4207 Storage**
Trade:
Status: **Initiated**
Date Notified:
Priority:
Due Date: **2021-12-17**
Spec Section:
Assignee:
Description:
Created By: **Paul**
Description: **Secure all copper piping With strapping**

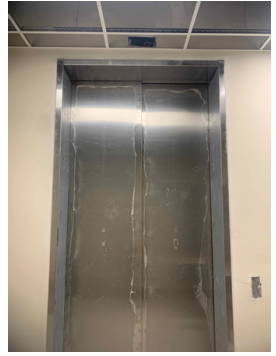
#185: Elevator indicator above ceiling

Created By: **Relocate indicator Same as Observation 184.**
Paul Purser

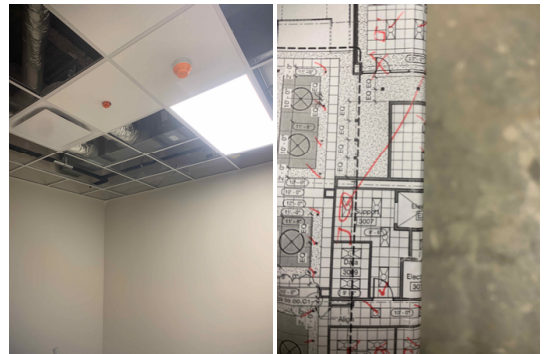
#183: Missing light

Created By: **Install light per plans**
Paul

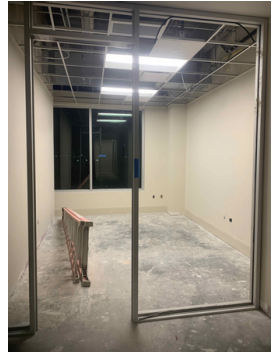
#182: Room is too large

Type: **Quality > Corrective Action**
Location: **Interior>Level 3>3402 Marketing**
Trade:
Status: **Ready For Review**
Date Notified:
Priority: **High**
Due Date: **2021-12-14**
Spec Section:
Assignee:
Description:
Created By: **Paul Purser**
This room is 2 feet wider than it should be

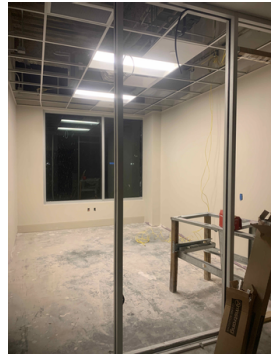
#181: This room is too small

Type: **Quality > Corrective Action**
Location: **Interior>Level 3>3404 Marketing**
Trade:
Status: **Ready For Review**
Date Notified:
Priority: **High**
Due Date: **2021-12-14**
Spec Section:
Assignee:
Description:
Created By: **Paul Purser**
This room is 2 feet shorter than it should be

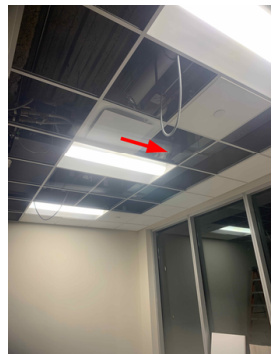
#180: Move supply register closer to the window

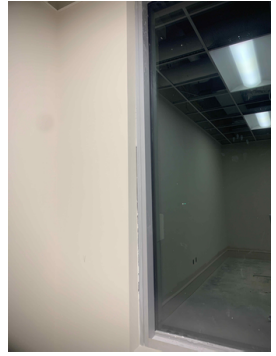
#179: Drywall is severely bowed where store front connects

Assignee: Description: **Who all needs to be Removed and reinstalled so that it is straight up against storefront jamb**

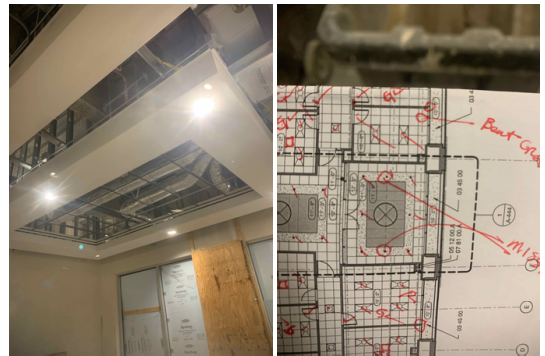
#178: Missing lights

Assignee: Description: **There are two missing lights in this furr down**

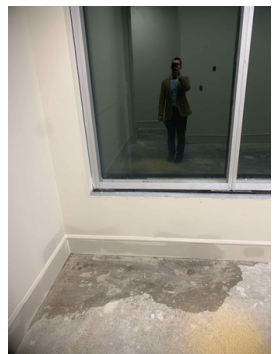
#177: Leak at façade

Created By: **Water is entering façade**
Paul Purser

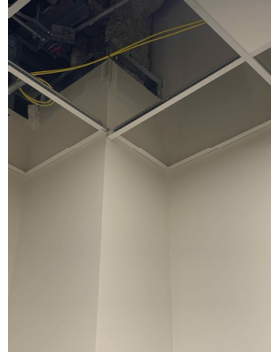
#176: Missing corner and unfinished grid

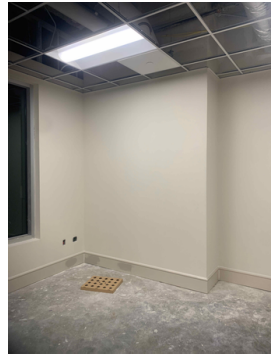
#175: Where is our nook?

Type: **Quality > Corrective Action** Location: **Interior>Level 3>3204 Credit Director**
Trade: Status: **Closed**
Date Notified: Priority:
Due Date: **2021-12-09** Spec Section:
Assignee: Description: **Plans indicate a nook here**
Created By: **Paul Purser**

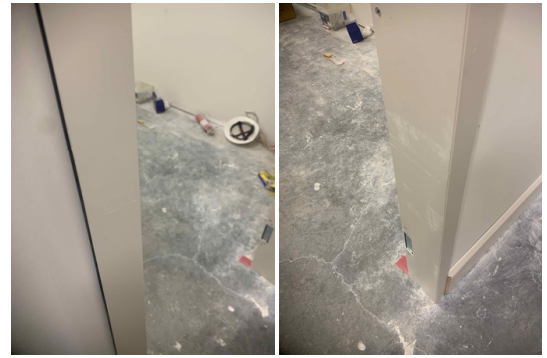
#174: Scratches on prefinished jambs

This frame will need to be replaced

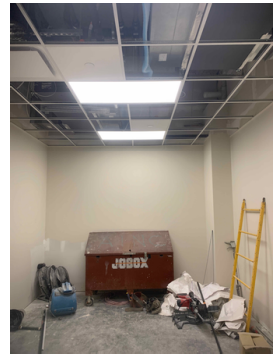
#173: Are these flat panel lights correct?

Description:
Are these the correct lights?

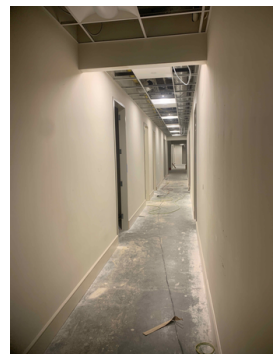
#172: Missing door?

Description:
Are we missing a door here?

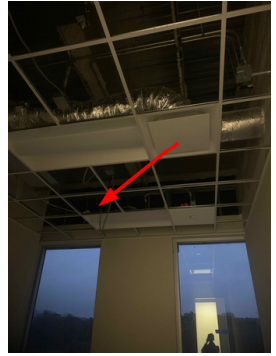
#171: Move register closer to window

Move register as indicated

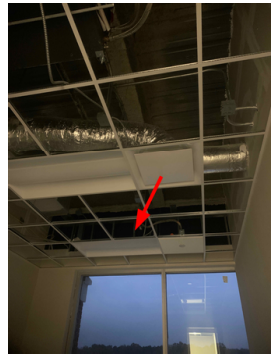
#170: Move supply register closer to window

Move register as indicated

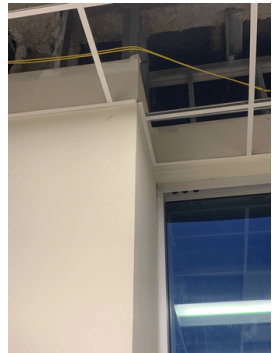
#169: Missing corner grid

Missing corner grid piece

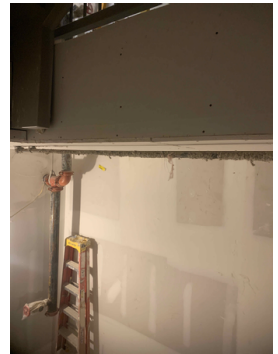
#167: Exposed pipe in south stairwell at landing between level 1 & 2

Clean and paint pipe

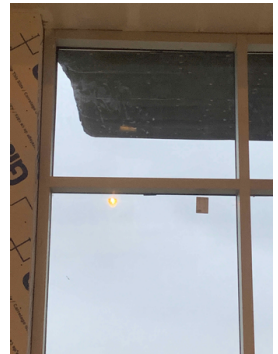
#166: Misaligned storefront

Horizontal member out of square

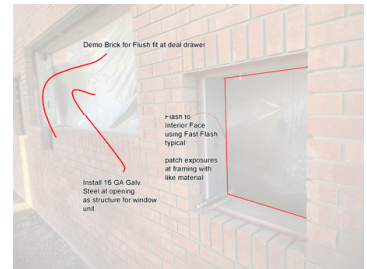
#164: Bank Teller Window Flashing

Per our on site meeting last week, details for flashing the teller window are as follows:

Fast flash will be employed to flash each opening to the interior wall plane and unit shall be sealed with mastic at that location. Flashing shall be applied at all jambs, sills, headers, and corners throughout. Openings in metal framing shall be covered with like material.

At the shelf created by the new metal stud wall below the precast panel, fast flash shall be applied to brick surface, horizontal shelf, & down face of gypsum substrate.

At the main window, galvanized steel shall be employed continuously around opening so that window unit can be brought out flush with brick face. Where this unit meets the deal drawer, the steel may be notched as needed to fit drawer. The deal drawer shall be flush with both the window unit as well as the brick face.

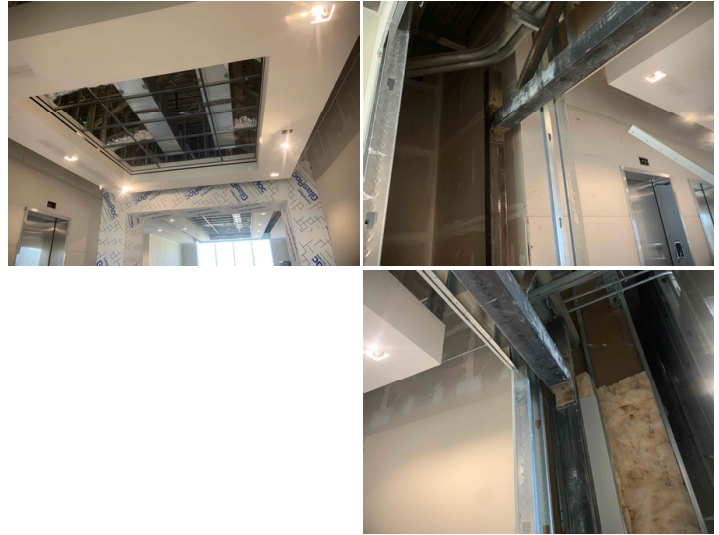
#161: Lobby furr down heights

Description:
Due to the change in height of door 4001a, The furr down opposite this door in the elevator lobby should match in height; Issues concerning tile joints shall also be considered so that they line up with this new furr down height.

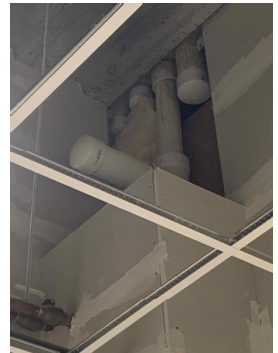
#157: PVC in plenum

Description:
Finish drywall to floor deck so that PVC is not exposed in Plenum

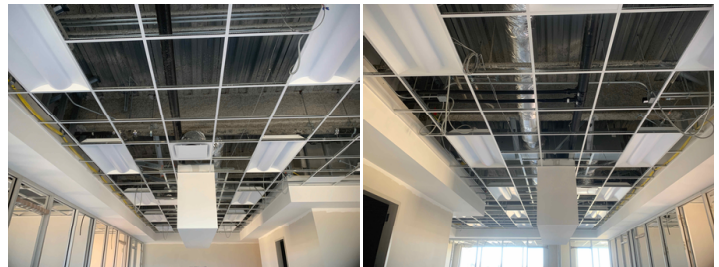
#156: Ceiling grid not centered

Ceiling grid is not centered in the room; adjust to center in 3401 open office

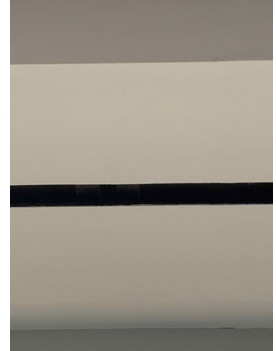
#155: Missing tape at diffusers

Description:
**Mud cracking at diffusers;
probably missing paper tape**

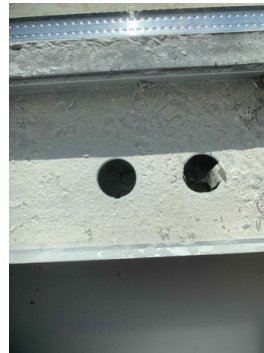
#154: Missing or incomplete bolt install at aluminum frames

Description:
Missing screws or screws not fully set

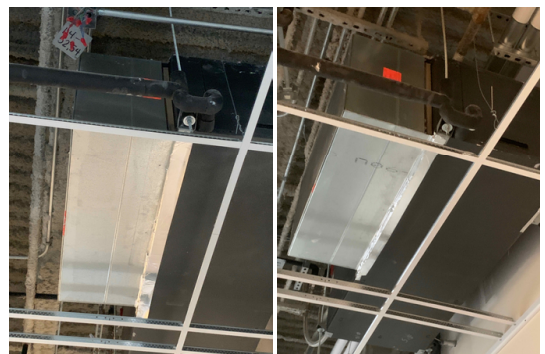
#153: HVAC maintenance issue for filter

Description:
**Unable to change filter without
damaging new due to drain
placement**
