Architect's Field Report

15094 Community Bank Headquarters / Report Number 033

Date / Time 20 January 2022 / 1:00 PM

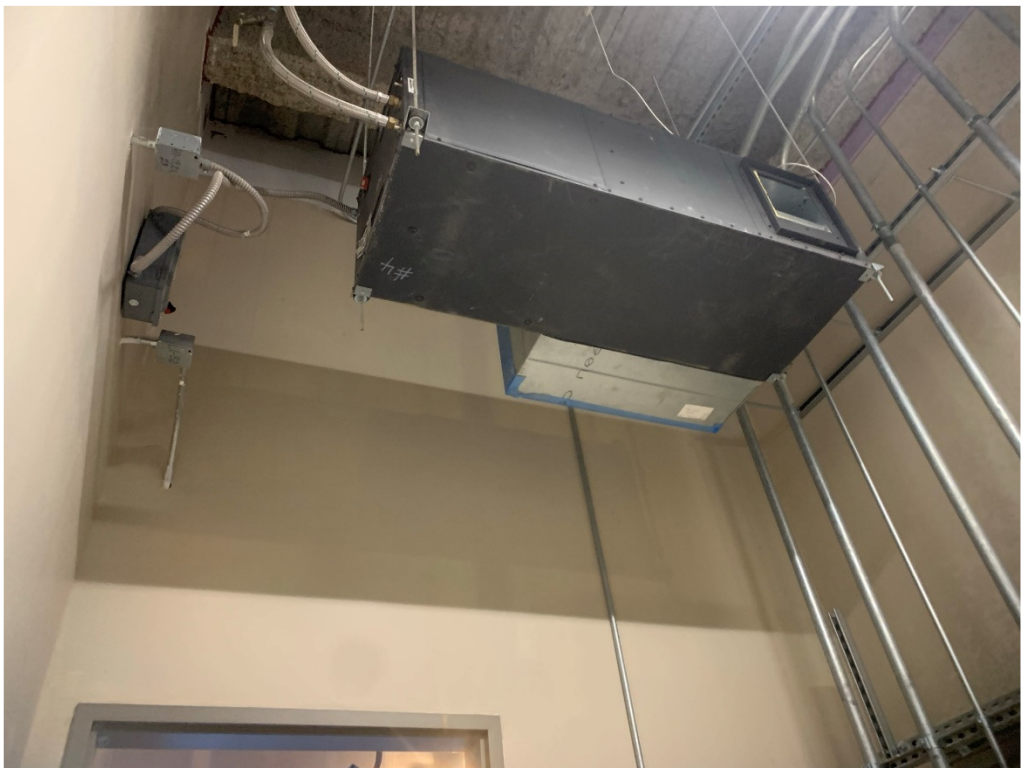
Figure 10 – Unit Missing Drainage

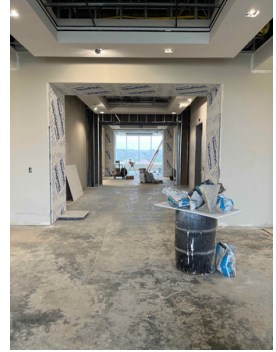
### #277: Incorrect substrate installed

Type:	Location:
<b>Quality &gt; Corrective Action</b>	<b>Interior&gt;Level 4&gt;4002 Bank Office Area</b>
Trade:	Status:
	<b>Initiated</b>
Date Notified:	Priority:
<b>2022-01-20</b>	
Due Date:	Spec Section:
<b>2022-01-27</b>	
Assignee:	Description:
<b>Ben Adams (Acoustics, Inc.)</b>	<b>This elevation gets tile per A483/4; replace drywall with glass roc</b>
Created By:	
<b>Paul Purser</b>

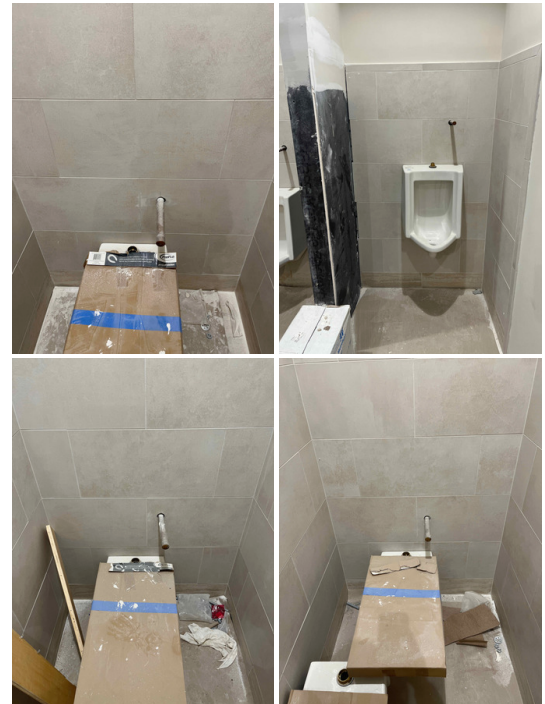
### #276: Toilets not centered

Type:	Location:
<b>Quality &gt; Corrective Action</b>	
Trade:	Status:
	<b>Initiated</b>
Date Notified:	Priority:
<b>2022-01-20</b>	
Due Date:	Spec Section:
<b>2022-01-27</b>	
Assignee:	Description:
<b>Josh Smith (Fountain Construction Co., Inc.)</b>	<b>Toilets are not centered throughout the building; center toilets</b>
Created By:	
<b>Paul Purser</b>

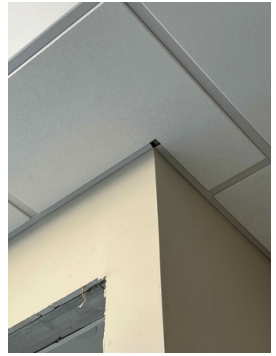
## #275: Missing corner grid

Description: **Missing corner at grid**

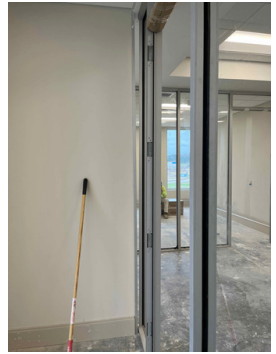
## #274: Inconsistent gap

Description: **Gap between storefront and wall is crooked and needs to be straightened**

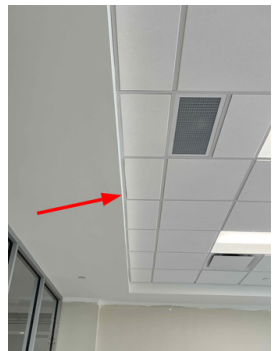
## #273: Crooked act

Created By: **Re cut crooked tile**  
**Paul Purser**

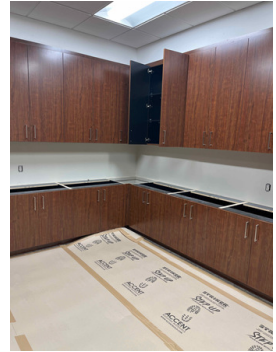
**#272: Missing cabinet bumpers/silencers**

Type: **Quality > Corrective Action** Location: **Interior>Level 3>3104 Workroom**  
Trade: Status: **Initiated**  
Date Notified: **2022-01-20** Priority:  
Due Date: **2022-01-27** Spec Section:  
Assignee: **Berry Terrell (Deas Millwork)** Description: **The open cabinet is missing bumpers on the doors**  
Created By: **Paul Purser**

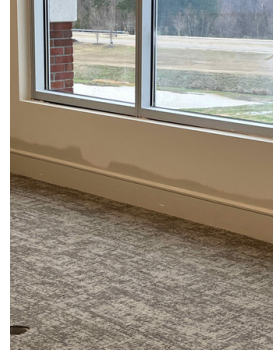
**#271: Gap at drywall and storefront**

Type: **Quality > Corrective Action** Location: **Interior>Level 3>3108 Conference**  
Trade: Status: **Initiated**  
Date Notified: **2022-01-20** Priority:  
Due Date: **2022-01-27** Spec Section:  
Assignee: **Robert Clay (Fountain Construction Co., Inc.)** Description: **Level up will for even gap at storefront**  
Created By: **Paul Purser**

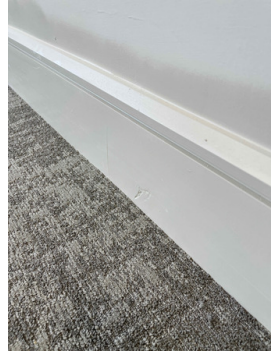
**#270: Imperfections at base**

Description:  
**Putty and repaint for smooth finish Throughout**

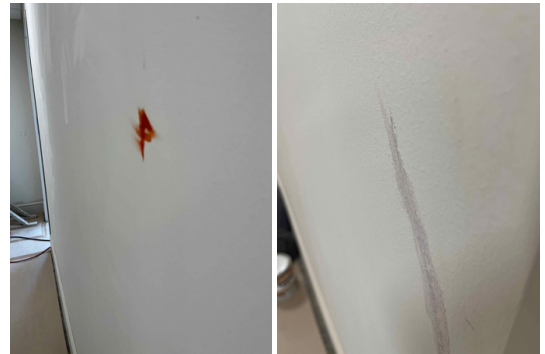
### #269: Dropped caulking in various locations

Description:  
**These will need to be sanded smooth before they are painted So that the texture of the wall is flat and smooth**

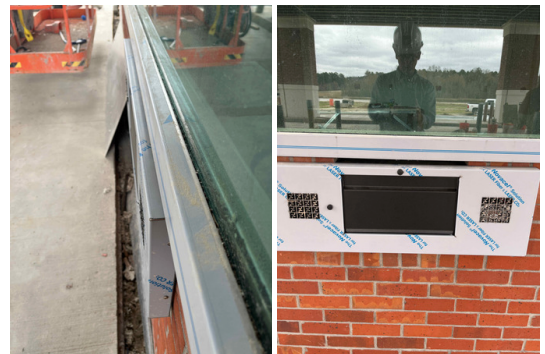
### #268: Deal drawer not aligned with window

Description:  
**Deal drawer is not in line with window; There is also a large gap between it and the window frame above it**

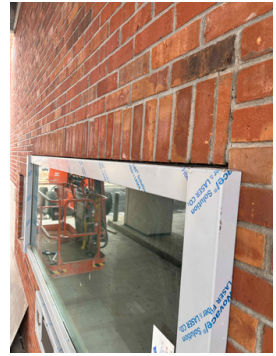
### #267: Drip edge not installed per revised drawing

Type: **Quality > Corrective Action** Location: **Exterior>Building**  
Trade: Status: **Initiated**  
Date Notified: **2022-01-20** Priority:  
Due Date: **2022-01-27** Spec Section:  
Assignee: Description:  
**Robert Clay (Fountain Construction Co., Inc.)** **Per our revised drawing there is supposed to be a drip edge at the top of this window**  
Created By:  
**Paul Purser**

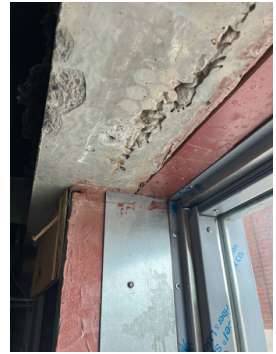
### #266: Missing steel plate and fast flash

Type: **Quality > Corrective Action** Location: **Interior>Level 1>1264 Drive-Thru Teller**  
Trade: Status: **Initiated**  
Date Notified: **2022-01-20** Priority: **High**  
Due Date: **2022-01-27** Spec Section:  
Assignee: Description:  
**Robert Clay (Fountain Construction Co., Inc.)** **We are missing the steel plate at the top of this window and also no fast flash is on the underside of the precast; There is also numerous amounts of draft coming through cracks at the top where there should be an air barrier**  
Created By:  
**Paul Purser**

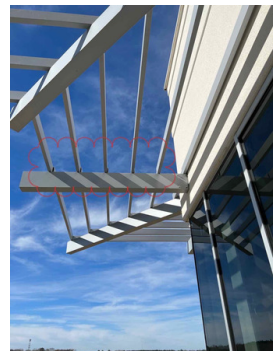
### #265: Horizontals not abutting (southwest balcony)

Description:  
**Correct alignment in tubes.**

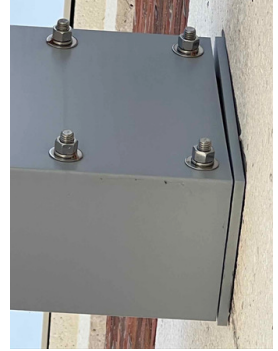
**#264: Rust penetrating through bolt holes.**

Created By: **Ryan Puckett** Investigate to determine the cause and solution for the rust on the sunshade bolts.

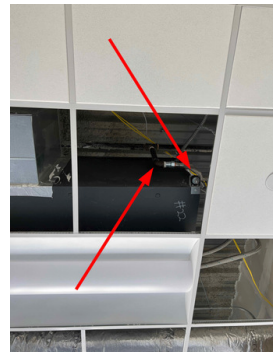
**#263: Sprinkler elbow in way of access panel on unit. Also, flex touching allthread.**

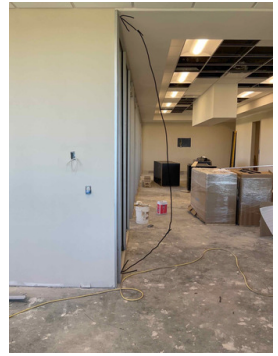
## #262: Window frame is not level

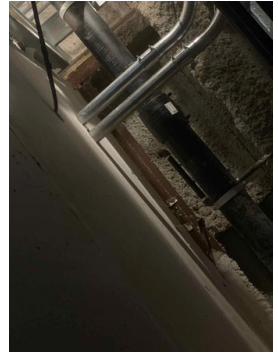
### #257: Missing fire proofing at steel beam

Assignee: **Stan Green (Fountain Construction Co., Inc.)** Description: **Inside wall cavity behind fountain near toilet rooms**

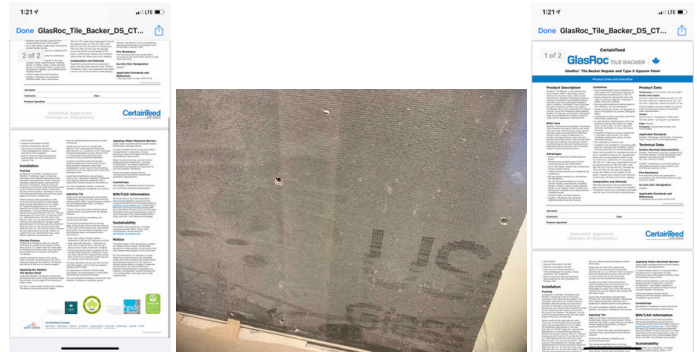
### #256: Improper fastener at tile backer

Assignee: **Ben Adams (Acoustics, Inc.)** Description: **Replace tile backer fasteners with corrosion resistant screws per manufacturer's documents.**

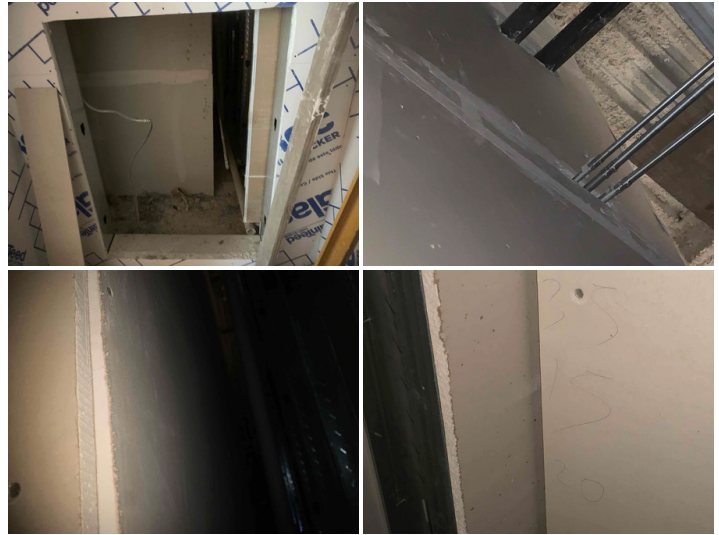
### #255: Unfinished rated wall

Description:  
**Rated wall that is not tape and pipes are not sealed**

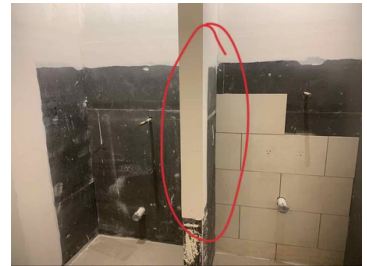
### #254: Improper substrate for tile attachment

Description:  
**remove mud so tile Can adhere**

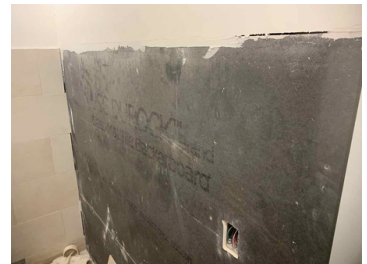
### #253: Loose tile backer

Description:  
**Backer is not screwed off the top**

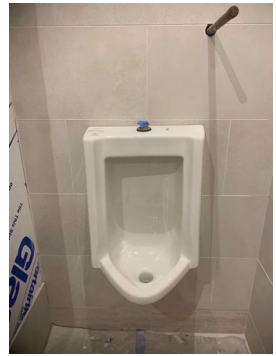
### #246: Urinal is out of level

Type: **Quality > Corrective Action** Location: **Interior>Level 3>3004 Men**  
Trade: Status: **Ready For Review**  
Date Notified: **2022-01-04** Priority: **Medium**  
Due Date: **2022-01-11** Spec Section:  
Assignee: Description:  
**Josh Smith (Fountain Construction Co., Inc.)** **Adjust urinal for level mount**  
Created By:  
**Paul Purser**

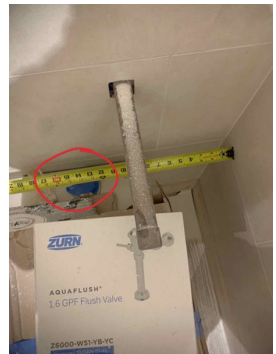
### #245: Toilets Do not meet ADA

Type: **Quality > Corrective Action** Location:  
Trade: Status: **Ready For Review**  
Date Notified: **2022-01-04** Priority: **High**  
Due Date: **2022-01-11** Spec Section:  
Assignee: Description:  
**Josh Smith (Fountain Construction Co., Inc.)** **Re-mount toilets so that they meet ADA**  
Created By:  
**Paul Purser**

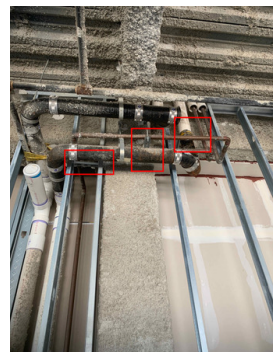
### #244: Plumbing issues

**Copper pipes should have separation from steel hangers; This connector on the right that is yellow... S. Woods, is this acceptable?**

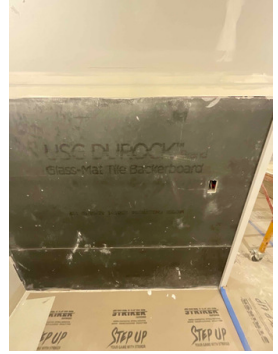
### #242: Room 1005e backer board is not screwed off

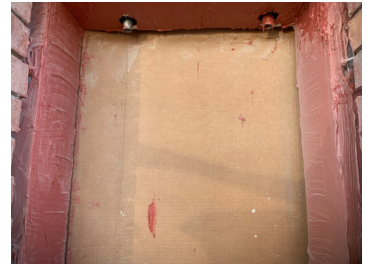
### #240: Unsealed Piping

Assignee: **Stan Green (Fountain Construction Co., Inc.)** Description: **Conduit in this opening has not been completely sealed around pipes; install metal to fill hole and cover with fast flash.**

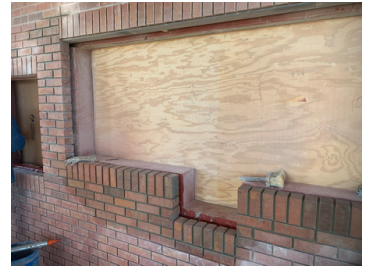
### #239: Water Proofing at Head of Opening

Assignee: Description:  
**Robert Clay (Fountain Construction Co., Inc.)** **No fast flash has been applied to the head of this opening; will this go on wet with the steel that is to be added?**

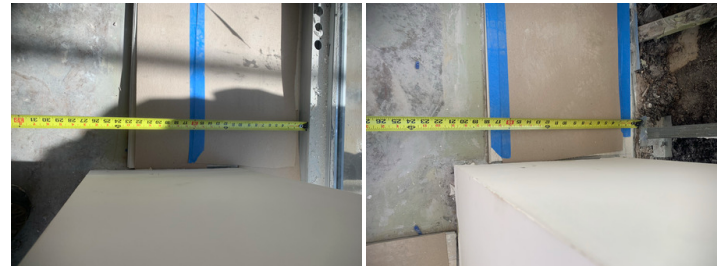
### #238: Tile Pattern @ Exec Dining

Assignee: Description:  
**Robbie Jones (Byrd & Cook)** **Tile at Exec Dining does not line up with columns as it should; see attached design change for corrective repair.**

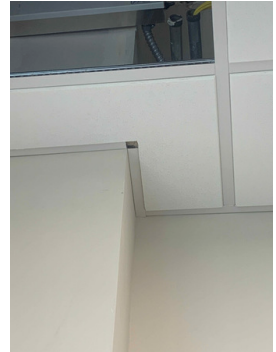
### #236: Missing corner

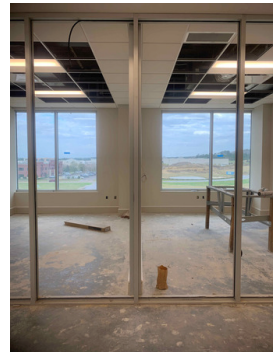
### #235: Column frame not centered on wall

Type: **Quality > Corrective Action**  
Location: **Interior>Level 3>3400 Marketing Collaborative Space**  
Trade: **Initiated**  
Status: **Initiated**  
Date Notified: **2022-01-03**  
Priority: **Medium**  
Due Date: **2022-01-04**  
Spec Section:  
Assignee: **Rex Robinson (American Glass Company, Inc.)**  
Description: **Center frame on wall end**  
Created By: **Paul Purser**

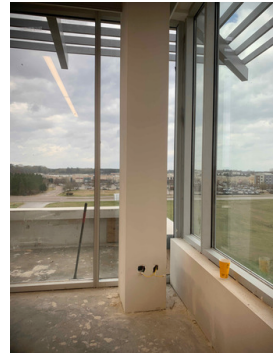
### #234: Twisted column

Description:  
**This column is twisted and needs to be made square**

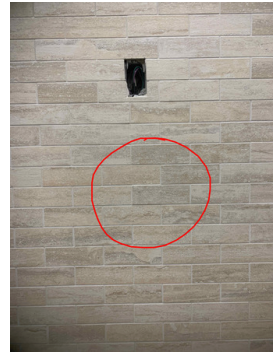
### #231: Reset non-flush tile

Description:  
**Tile is out of level with adjacent**

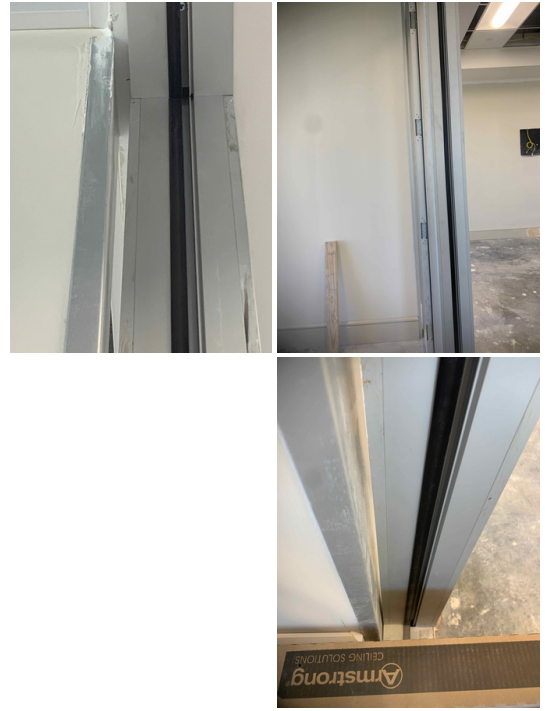
### #227: Gap between end cap and vertical frame

**Gap between endcap and frame  
is askew; Line up end cap Or  
frame so that gap is parallel  
and even from top to bottom**

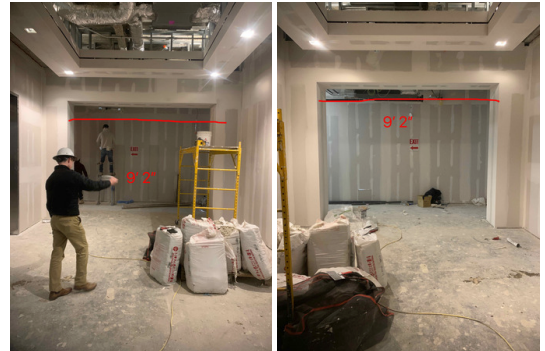
**#226: Lower portals for ceiling at hvac**

**Lowered bulk heads and  
ceiling. The 2 portals at  
Elevator Lobby 2001 need to be  
lowered to 9'-2" to  
accommodate HVAC  
installation at Hall 2003 which  
prevents the ceiling in this hall  
from being 10'-1". This ceiling,  
at hall 2003, should be lowered  
to 9'-3".**

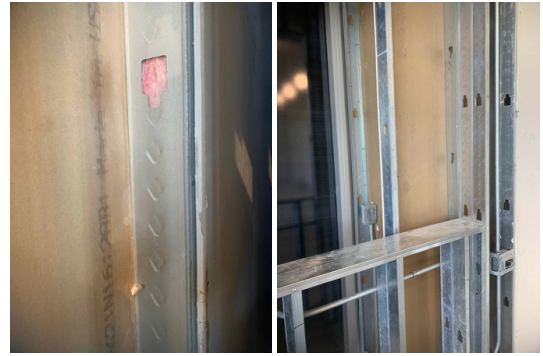
**#225: Sound proofing at office**

Assignee: Description:  
**Ben Adams (Acoustics, Inc.)**  
**Continue batt and drywall**  
**around the corner so that**  
**office is fully soundproof**

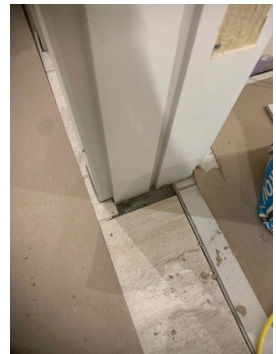
### #223: Missing tile at door jamb

Assignee: Description:  
**Robbie Jones (Byrd & Cook)**  
**At door 4122a; complete large**  
**gap with notched tile**

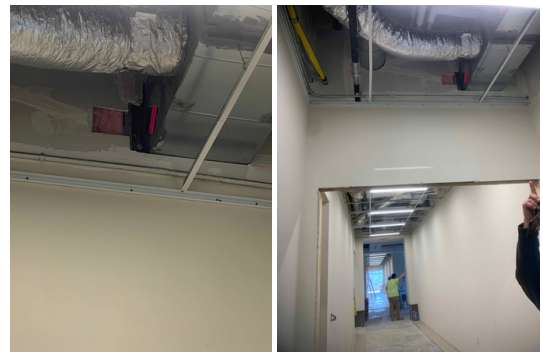
### #222: Finish Rock around duct

Assignee: Description:  
**Ben Adams (Acoustics, Inc.)**  
**Above door 4110a; complete**  
**drywall to ducting (typical)**

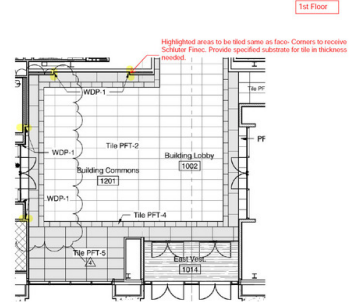
**#217: Returns to wall missing correct substrate**

Assignee:  
**Ben Adams (Acoustics, Inc.)** Description:  
**Return walls need tile substrate**

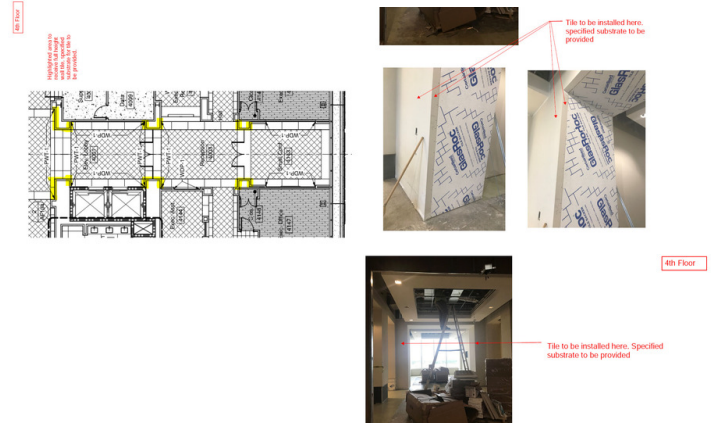
**#215: Replace Substrate for Tile Finish Surface**

Description:  
**Substrate for tile is missing; drywall has been finished in it's placed. Replace substrate for new tile finish per A-483**

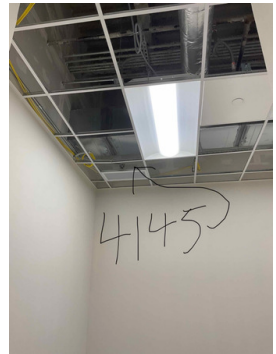
**#214: Room 4145 Ceiling grid is sagging at the joint**

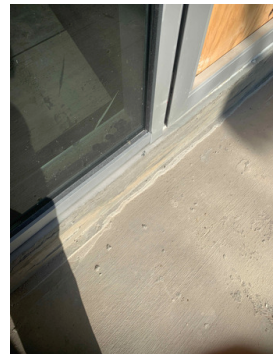
**#212: Balcony Curtain Wall with Protruding Ledge**

Description:  
**Per the latest detail concerning balcony flashing, this ledge Poses an issue and will need to be corrected:**

**This condition and any like it will need a flashing over the top of the concrete and below the curtain wall to prevent moisture infiltration into concrete. Contractor will need to dig out installed caulking and bed in a piece of flashing at least 1 inch beneath curtain wall; seal to curtain wall. This flashing shall overlap with drip edge the termination bar to be provided at TPO. This flashing shall match curtain wall finish and needs to be a MIN of 16 GA.**

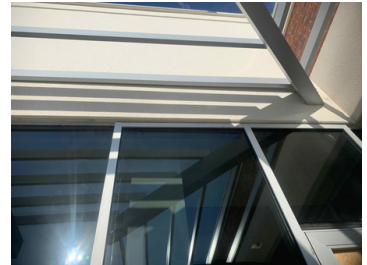
### #211: Missing drip line

Type: **Work to Complete > Misc Issues**  
Location: **Interior>Level 4>4203 Private Dining**  
Trade: **Initiated**  
Status: **Initiated**  
Date Notified: **2021-12-20**  
Priority:  
Due Date: **2021-12-21**  
Spec Section:  
Assignee: **Robert Clay (Fountain Construction Co., Inc.)**  
Description: **There is no drip line here**  
Created By: **Paul Purser**

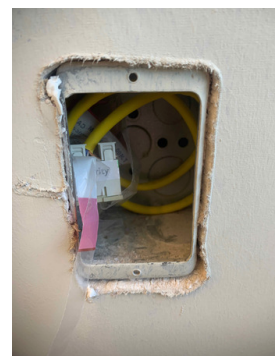
### #209: Missing elec box insulation throughout

Type: **Quality > Corrective Action**  
Location:  
Trade: **Initiated**  
Status: **Initiated**  
Date Notified: **2022-01-17**  
Priority:  
Due Date: **2021-12-21**  
Spec Section:  
Assignee: **Danny Coffey (Fountain Construction Co., Inc.)**  
Description: **I don't see any evidence of**

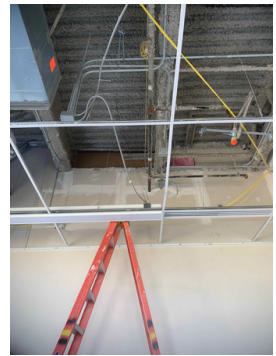
### #206: Finish drywall and insulation to roof deck

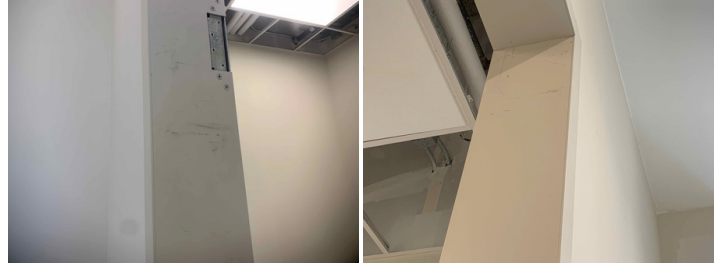
### #205: Prefinished material damaged

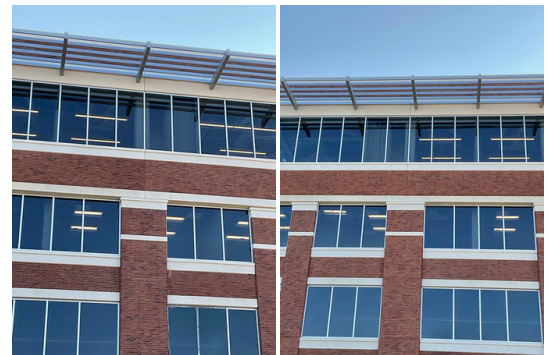
### #204: Hallway not centered

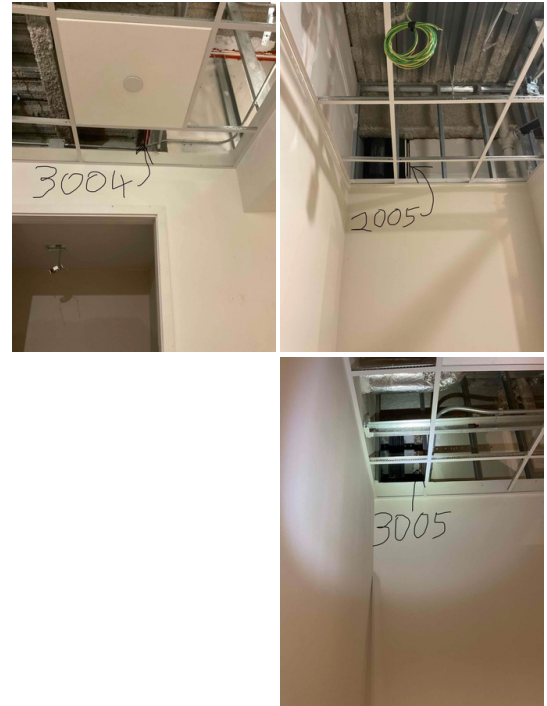
## #201: Room 3342 light is in wrong place
