## Architect's Field Report

16 February 2022

15094 Community Bank Headquarters / Report Number 034

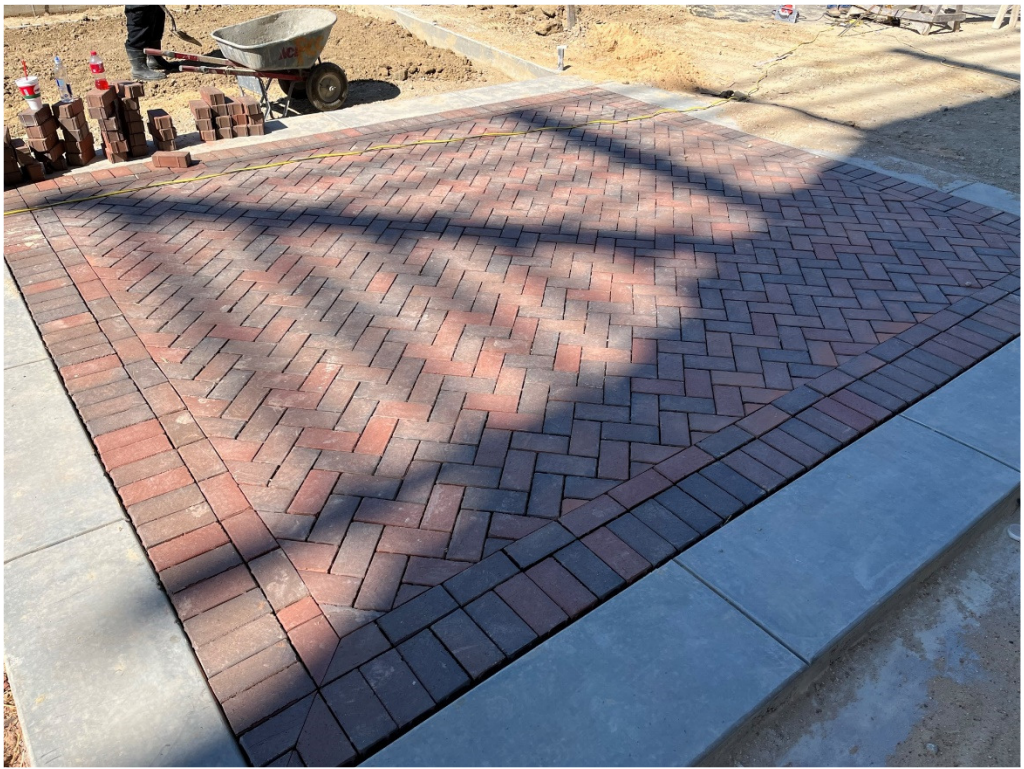
Figure 3 – Brick paver Installation looks good

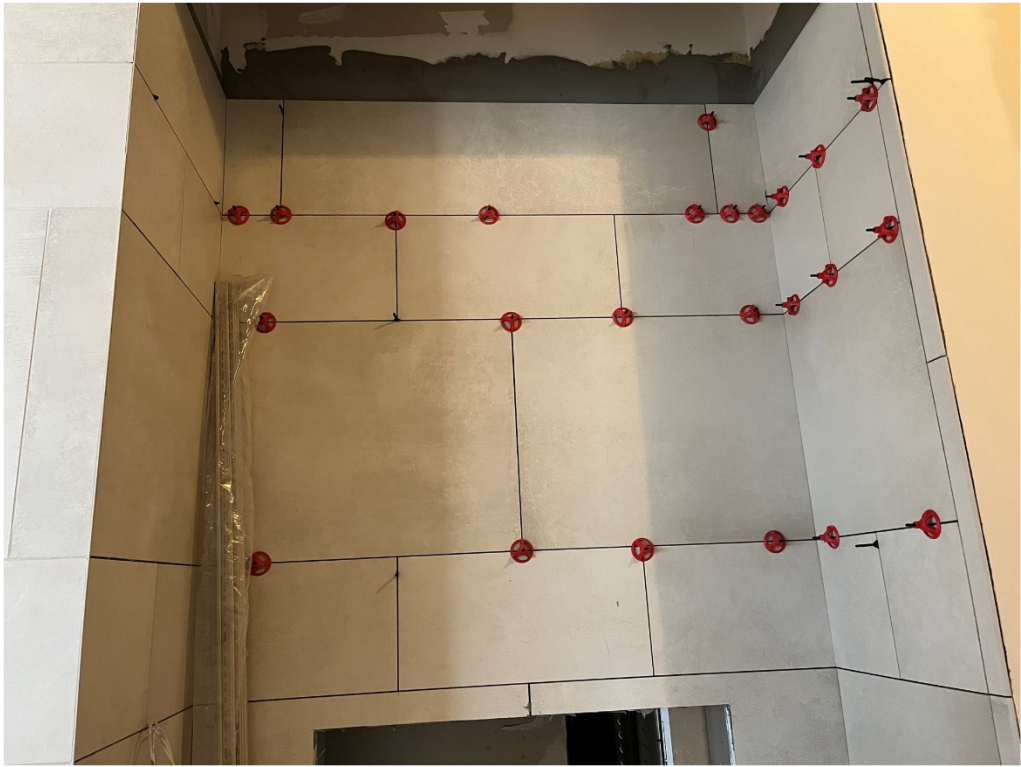
Figure 5 – Is this nook to receive tile; per an email sent on the 10<sup>th</sup> of January, I did not think so, but perhaps something has changed?

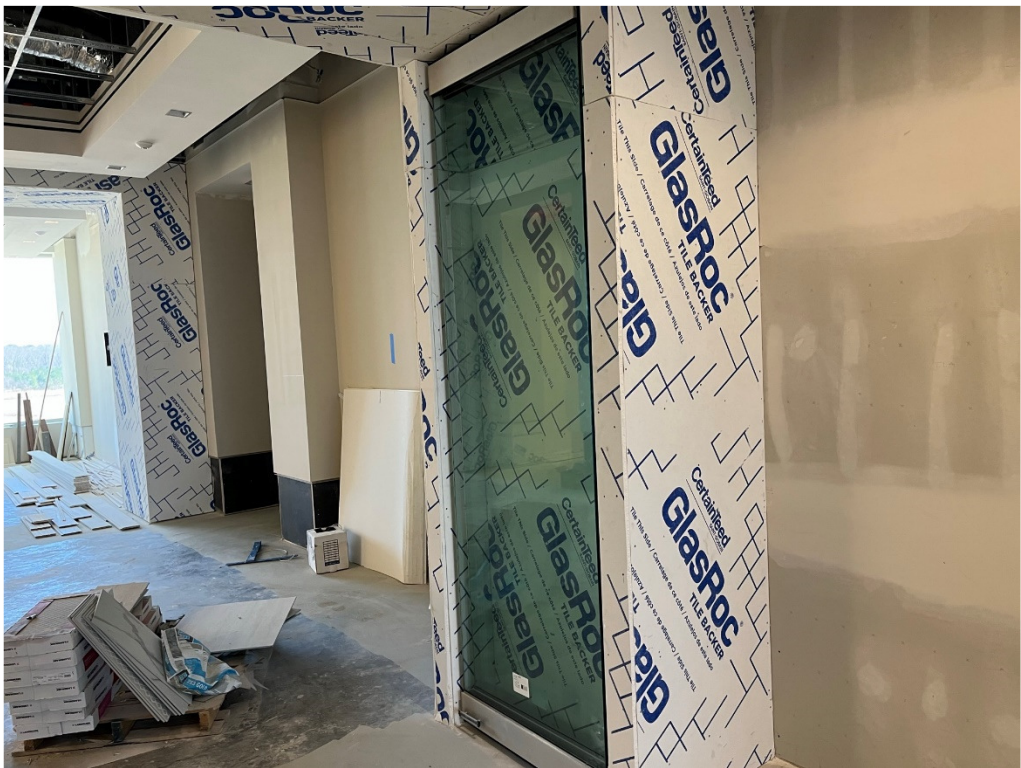
At the 4<sup>th</sup> floor elevator lobby, Mr. Puckett expressed concern about the installation of gypsum. Some of the wall panels are bowed and need adjusting for level. He also had issue with the installation of the recessed glass doors as prior to their install and the gypsum and framing around them, he discussed with the contractor making the glass panels flush with the finished tile. They are not installed as discussed per Mr. Puckett.

Figure 8 – Doors Recessed per drawings; Owner expressed to contractor prior to install that he wanted glass to be flush with finish tile; these are recessed and will not be flush

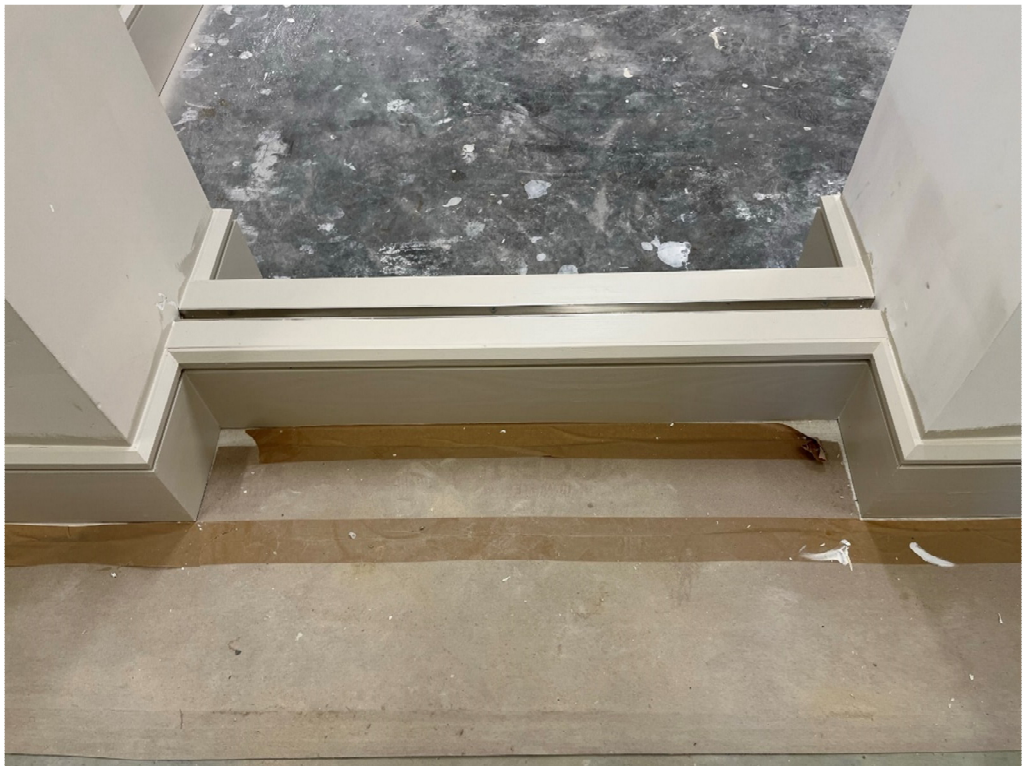
Figure 9 – Good Installation of Glass Receiver

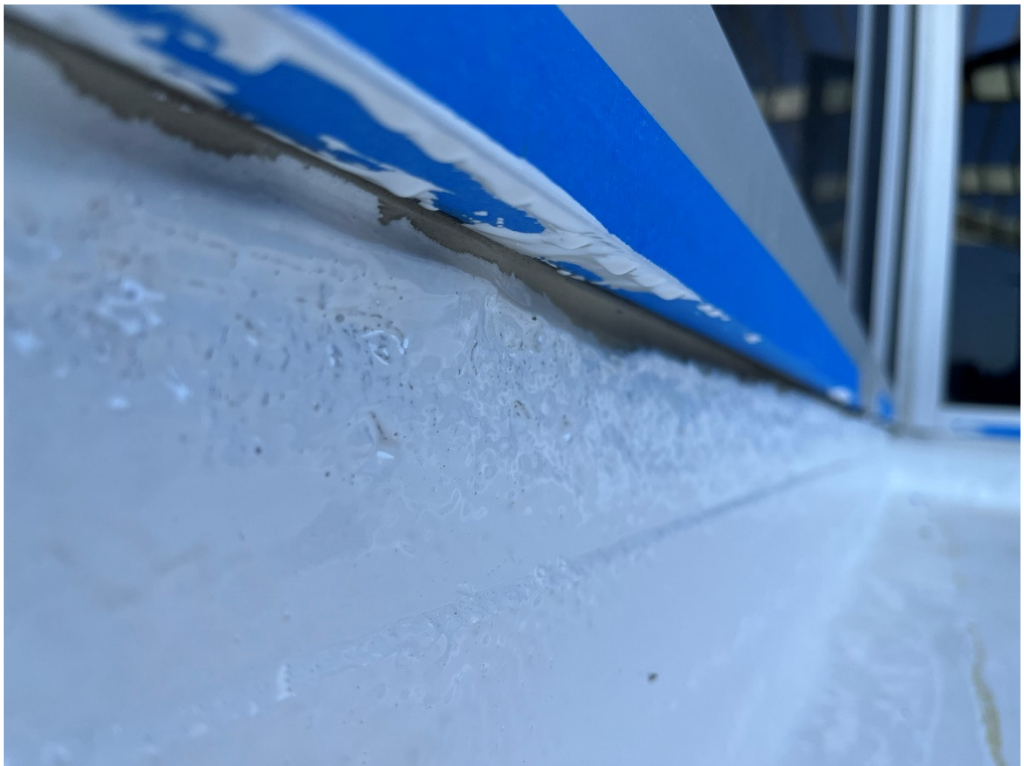
Figure 10 – Liquid Roofing Product installed to underside of AL Framing

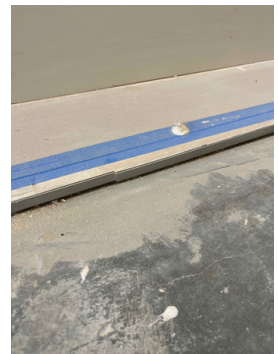
### #304: Non flush trim

Type:	Location:
<b>Quality &gt; Corrective Action</b>	<b>Interior&gt;Level 4&gt;4201 Hall</b>
Trade:	Status:
	<b>Initiated</b>
Date Notified:	Priority:
<b>2022-02-16</b>	
Due Date:	Spec Section:
<b>2022-02-22</b>	
Assignee:	Description:
<b>Robert Clay (Fountain Construction Co., Inc.)</b>	<b>Reset trim for flush connection</b>
Created By:	
<b>Paul Purser</b>

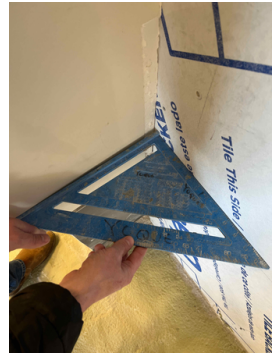
### #303: New wall out of square

Assignee: **Robert Clay (Fountain Construction Co., Inc.)** Description: **Newly built wall is out of square w wall and floor at nw end**

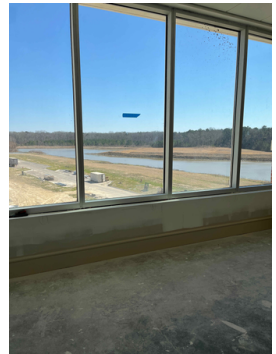
### #302: Sill drywall not even

Assignee: **Robert Clay (Fountain Construction Co., Inc.)** Description: **Make drywall at window sill flush with aluminum framing**

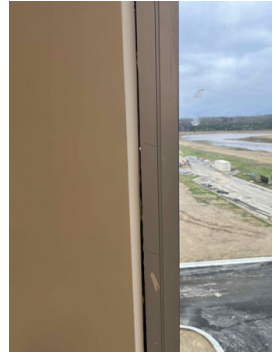
### #285: Caulking not complete at exterior store front window installation

Description:  
**Are there more windows like this?**

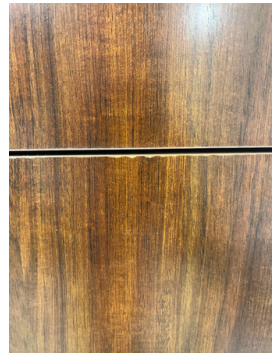
### #284: Tear out noted on Millwork Door Panels

**Door panels noted in this room that have tear out and need to be repaired or replaced**

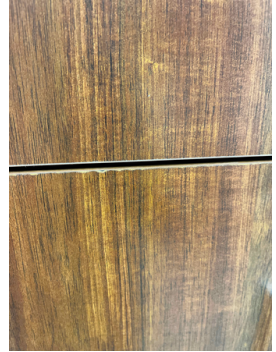
**#283: Replace door panels**

Assignee: **Berry Terrell (Deas Millwork)** Description: **Replace doors where chip out from dimensioning boards has occurred**

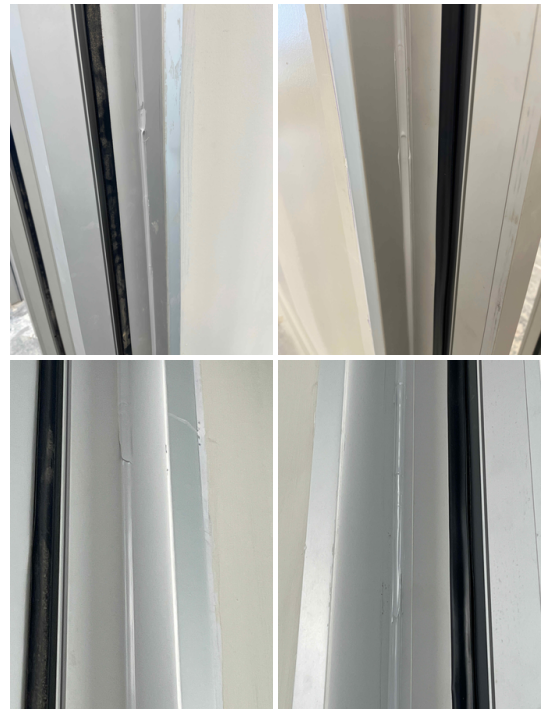
**#282: Remove and reinstall sealant at wall caps and storefront connection**

Assignee: **Rex Robinson (American Glass Company, Inc.)** Description: **Remove and reinstall sealant at wall caps and storefront connection**

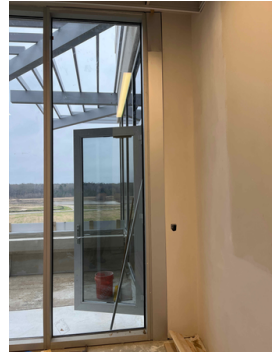
**#281: Use full length piece without joint at storefront connection**

Assignee:      Description:  
**Rex Robinson (American Glass Company, Inc.)**      **Replace jointed finish material with full length without joint**

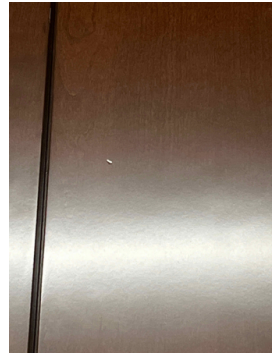
**#280: Gouge at door panel**

Assignee:      Description:  
**Berry Terrell (Deas Millwork)**      **Replace door panels**

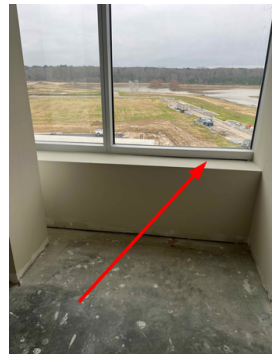
**#279: Drywall shelf is inconsistent**

Assignee:      Description:  
**Stan Green (Fountain Construction Co., Inc.)**      **Level out drywall so that distance between corner and**

top edge of window frame is  
the same throughout

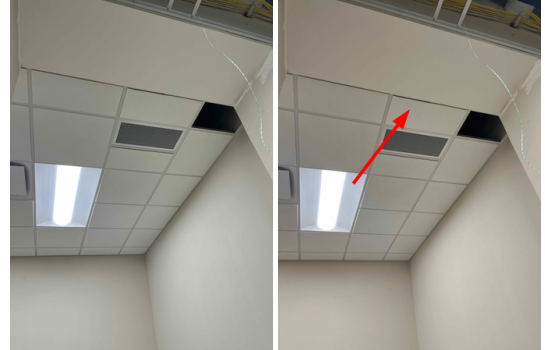
**#278: Cut edge very apparent from hallway**

Type: **Quality > Corrective Action**  
Location: **Interior>Level 4>4146 CIO Asst.**  
Trade: **Ready For Review**  
Date Notified: **2022-01-26**  
Priority: **Low**  
Due Date: **2022-02-01**  
Spec Section:  
Assignee: **Ben Adams (Acoustics, Inc.)**  
Description: **Chamfer cut edge, paint edge and turn cut towards office.**  
Created By: **Paul Purser**

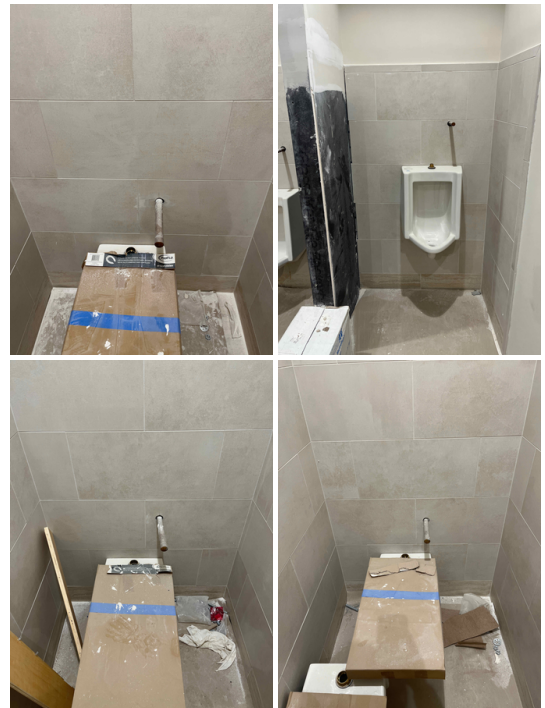
**#276: Toilets not centered**

Type: **Quality > Corrective Action**  
Location:  
Trade: **Ready For Review**  
Date Notified: **2022-01-20**  
Priority:  
Due Date: **2022-01-27**  
Spec Section:  
Assignee: **Josh Smith (Fountain Construction Co., Inc.)**  
Description: **Toilets are not centered throughout the building; center toilets**  
Created By: **Paul Purser**

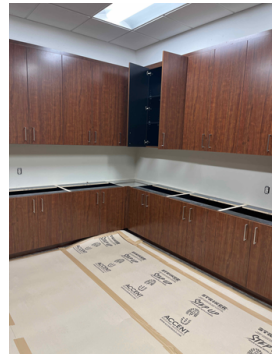
**#272: Missing cabinet bumpers/silencers**

Assignee: Description:  
**Berry Terrell (Deas Millwork)**  
**The open cabinet is missing  
bumpers on the doors**

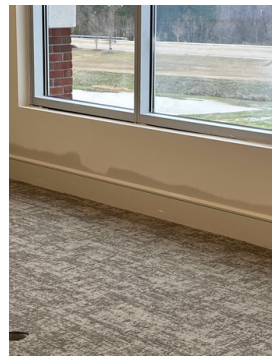
### #271: Gap at drywall and storefront

Assignee: Description:  
**Stan Green (Fountain  
Construction Co., Inc.)**  
**Level up will for even gap at  
storefront**

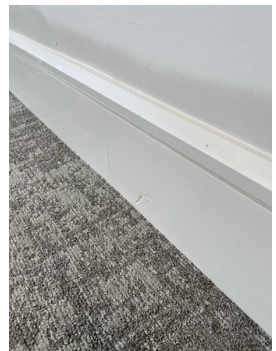
### #270: Imperfections at base

Assignee: Description:  
**Berry Terrell (Deas Millwork)**  
**Putty and repaint for smooth  
finish Throughout**

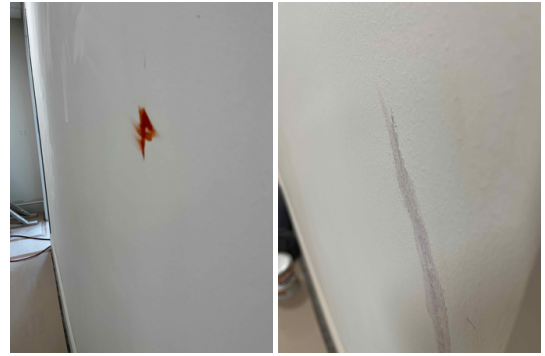
### #269: Dropped caulking in various locations

Description:  
**These will need to be sanded smooth before they are painted So that the texture of the wall is flat and smooth**

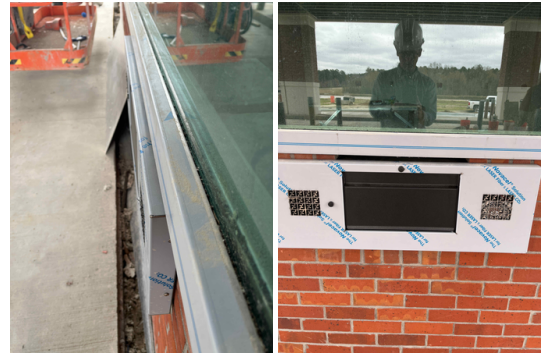
### #268: Deal drawer not aligned with window

Description:  
**Deal drawer is not in line with window; There is also a large gap between it and the window frame above it**

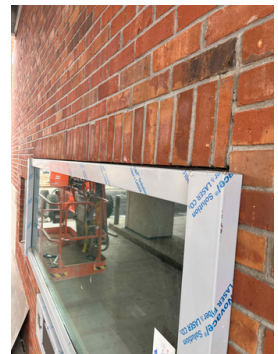
### #267: Drip edge not installed per revised drawing

Description:  
**Per our revised drawing there**

**is supposed to be a drip edge at the top of this window**

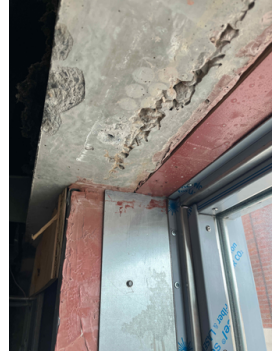
**#266: Missing steel plate and fast flash**

Description:  
**We are missing the steel plate at the top of this window and also no fast flash is on the underside of the precast; There is also numerous amounts of draft coming through cracks at the top where there should be an air barrier**
