## Architect's Field Report

15094 Community Bank Headquarters / Report Number 035

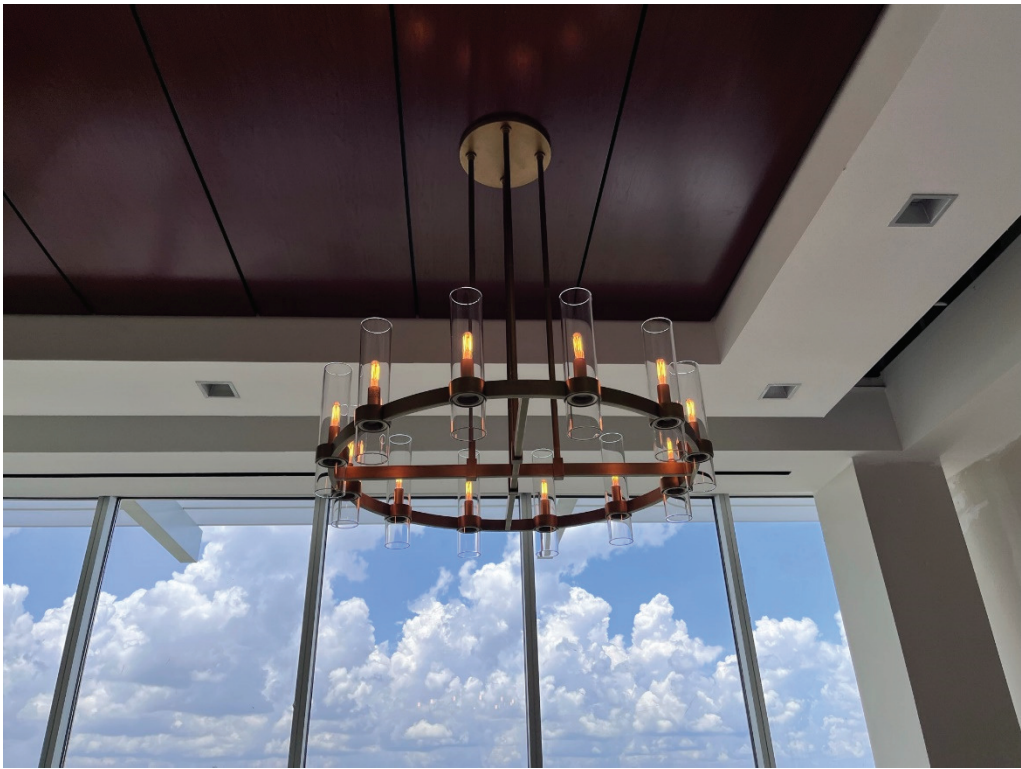
Figure 1 – Light Fixture Installation

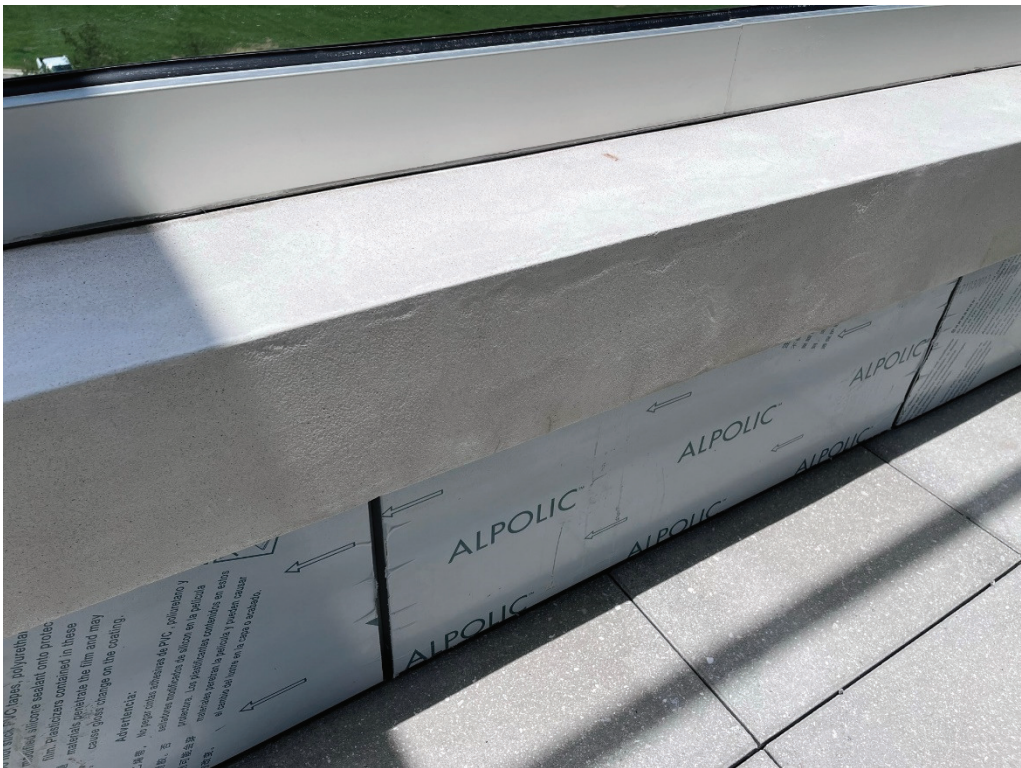
**Observations** On site, we met with the remediation crew to inspect balconies. There are still notable deformities in the work, but it is hard to see them unless it's the right time of day for the day to make them clear. The crew intends to continue remediation.

Figure 2 – Balcony Remediation

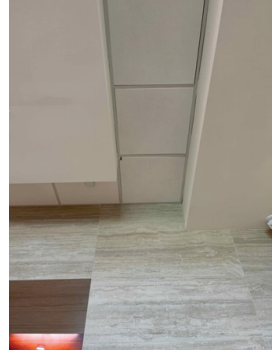
### #428: Redo tile cut

Type: **Quality > Corrective Action** Location: **Interior>Level 4>4002 Bank Office Area**

Created By: **Paul Purser** **Redo corner tile cut**

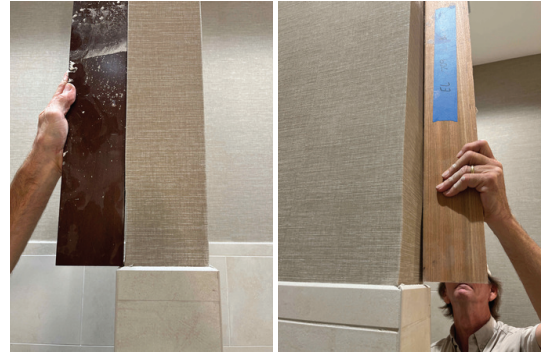
### #427: Crooked mud work

Type: **Quality > Corrective Action** Location: **Interior>Level 4>4004 Men**

Created By: **Paul Purser** **Redo mudwork straight**

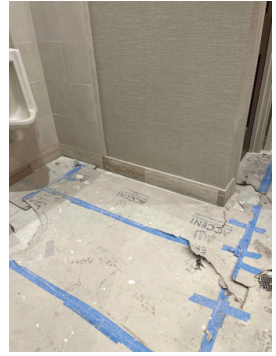
### #426: Mismatch tile

**Interior>Level 4>4004 Men**

**Change out dark colored tiles with a closer match**

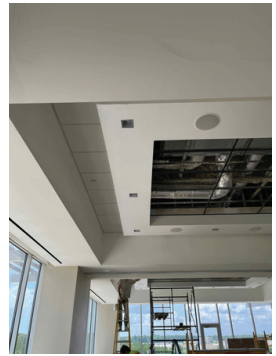
**#425: Check all lights**

**Interior>Level 4>4211 Banquet/Dining Room 2**

**Check all lights in this room; many are crooked**

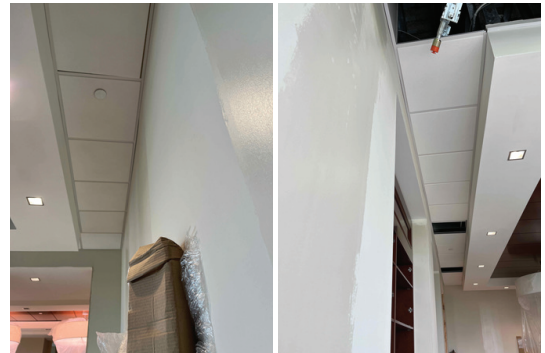
**#424: Straighten walls**

**Interior>Level 4>4202 Exec. Lounge**

**Straighten mud work at corner grid wall mold**

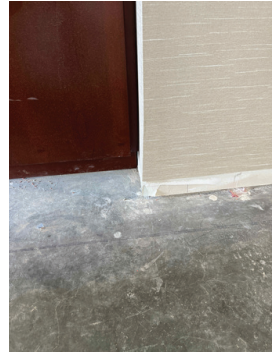
### #423: Straighten flared corner

Type: **Quality > Corrective Action** Location: **Interior>Level 4>4103 Board Room**

Assignee: **Lavon Grace (Metro Painting, Inc.)** Description: **Repair corner to straight**

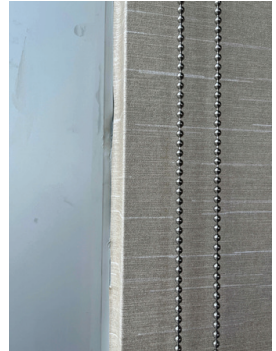
### #422: Rework caulking

Type: **Quality > Corrective Action** Location: **Interior>Level 4>4131 Exec. Office**

Assignee: **Rex Robinson (American Glass Company, Inc.)** Description: **Rework caulking**

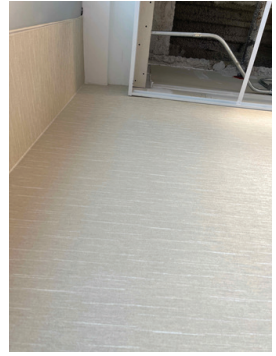
### #421: Hump in drywall

Type: **Quality > Corrective Action** Location: **Interior>Level 4>4137 Exec. Office**

**Repair drywall so it's straight**

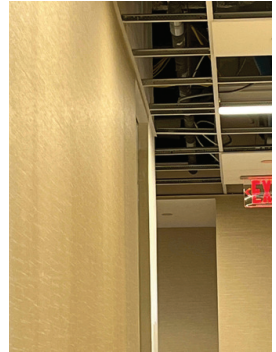
### #420: Humped drywall

**Interior>Level 4>4011 Hall**

**Straight drywall**

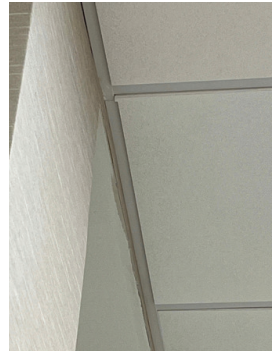
### #419: Wall mould does not align

**Interior>Level 4>4134 Exec. Asst.**

**Rework grid at Wall and Tile**

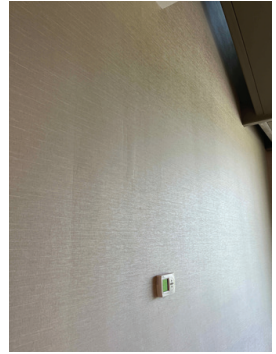
### #415: Repair wall smooth

Type: **Quality > Corrective Action** Location: **Interior>Level 3>3500 Monumental Stair**

Assignee: **Lavon Grace (Metro Painting, Inc.)** Description: **Repair wall to smooth and recover with wallpaper**

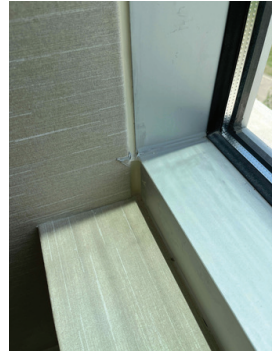
### #414: Caulking

Type: **Quality > Corrective Action** Location: **Interior>Level 4>4212 Banquet/Dining Room 3**

Assignee: **Rex Robinson (American Glass Company, Inc.)** Description: **South east corner store front windows**

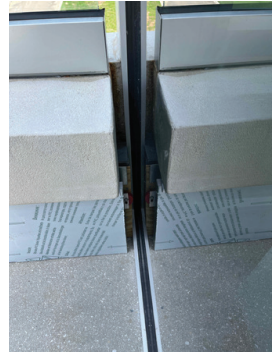
### #413: Exposed framing and sheathing

Type: **Quality > Corrective Action** Location: **Exterior>Building**

Description:  
**Northwest balcony; close in  
gap with break metal**

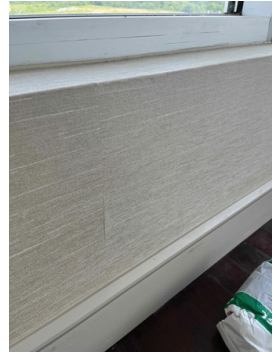
### #412: Wallpaper not fully adhered

Location:  
**Interior>Level 4>4131 Exec.  
Office**

Description:  
**Wallpaper is not fully adhered  
to surface**

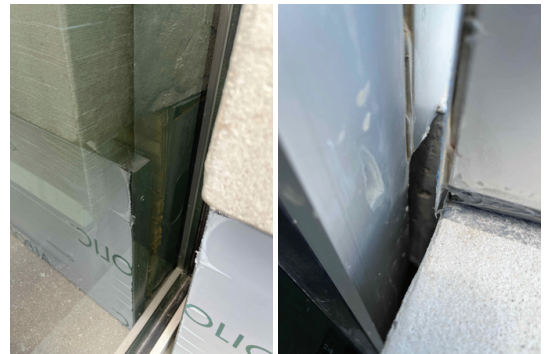
### #411: Exposed framing and opening

Location:  
**Exterior>Building**

Description:  
**Cover exposed framing and  
sheathing with break metal;  
cover opening with break metal**

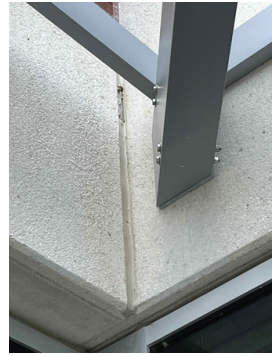
### #410: Repair caulk smooth

Type: **Quality > Corrective Action** Location: **Exterior**  
Trade: Status: **Initiated**  
Date Notified: **07/05/22** Priority:  
Due Date: **07/12/22** Spec Section:  
Assignee: Description:  
**Stan Green (Fountain Construction Co., Inc.)** **South east balcony caulking Is not smooth; re-weren't caulking for smooth look**  
Created By:  
**Paul Purser**

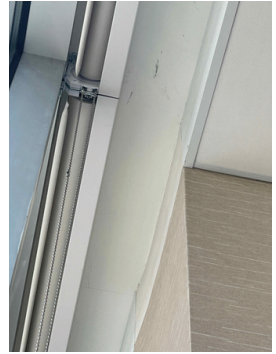
### #406: Paint needed

Type: **Quality > Corrective Action** Location: **Interior>Level 4>4151 CIO Office**  
Trade: Status: **Initiated**  
Date Notified: **07/05/22** Priority:  
Due Date: **07/05/22** Spec Section:  
Assignee: Description:  
**Lavon Grace (Metro Painting, Inc.)** **Touch up paint at ceiling and paint at upper column wall**  
Created By:  
**Paul Purser**

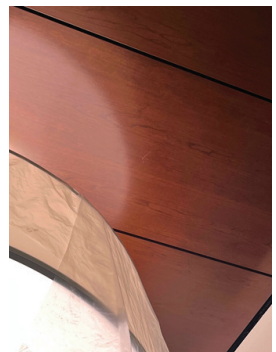
### #405: Damaged wood panel

Type: **Quality > Corrective Action** Location: **Interior>Level 4>4002 Bank Office Area**  
Trade: Status: **Initiated**  
Date Notified: **07/05/22** Priority:  
Due Date: **07/05/22** Spec Section:  
Assignee: Description:

**Damaged ceiling panel;  
replace panel**
