Architect's Field Report

15094 Community Bank Headquarters / Report Number 036

Date / Time 14 July 2022 / 1:15 PM

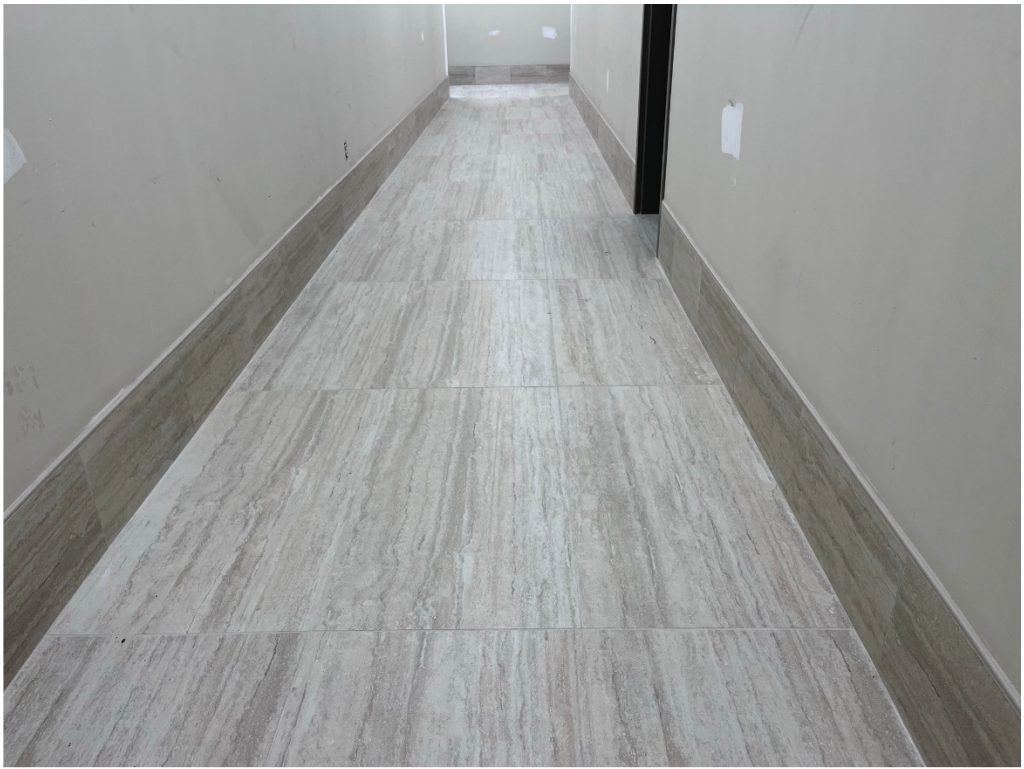
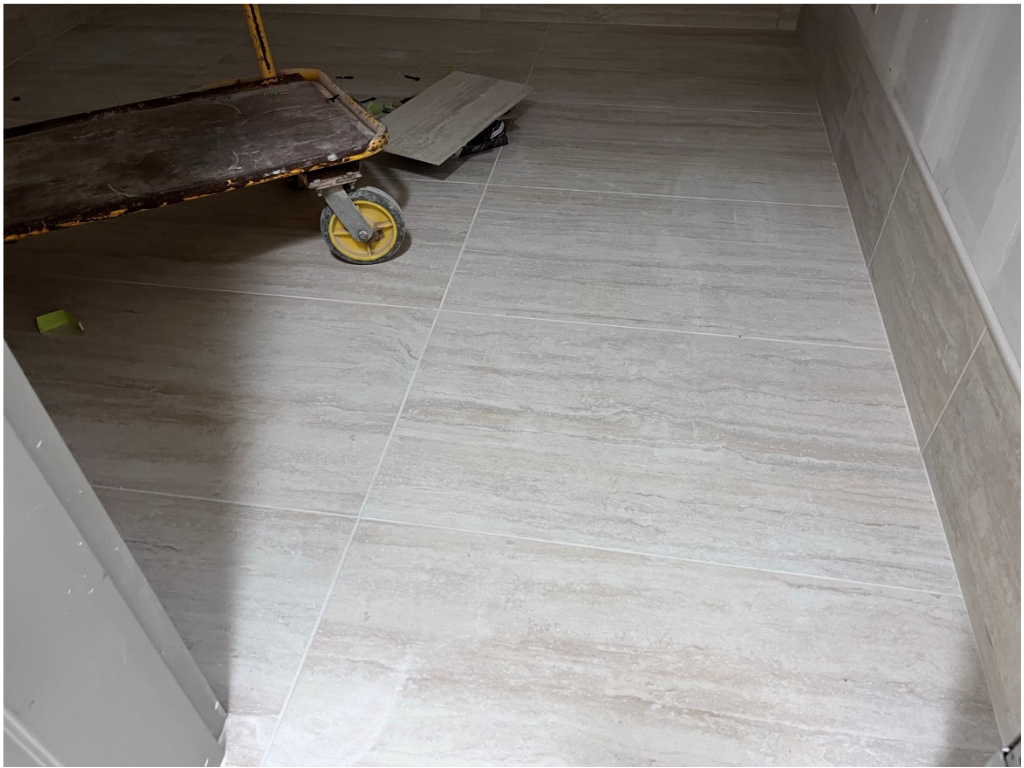
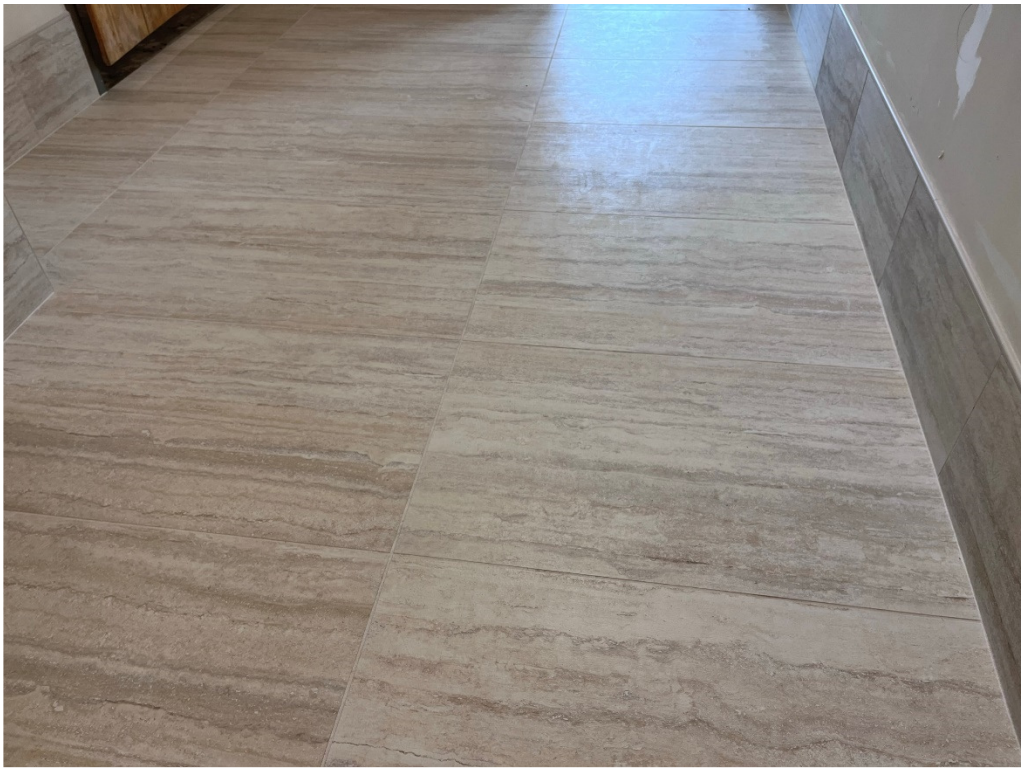
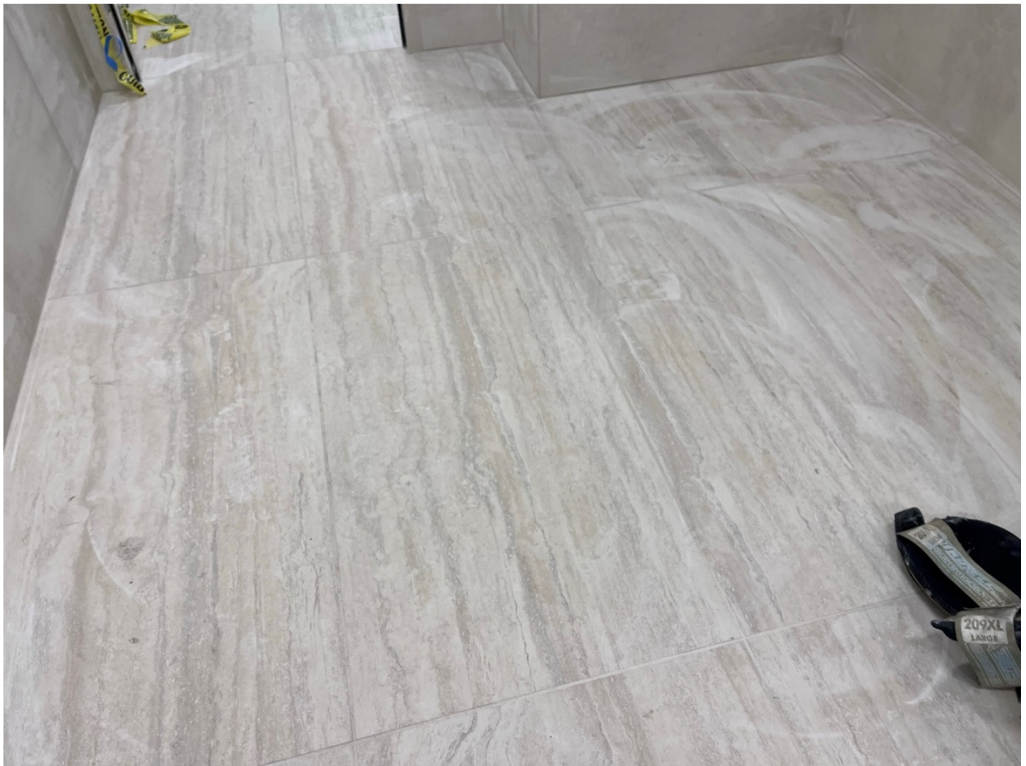
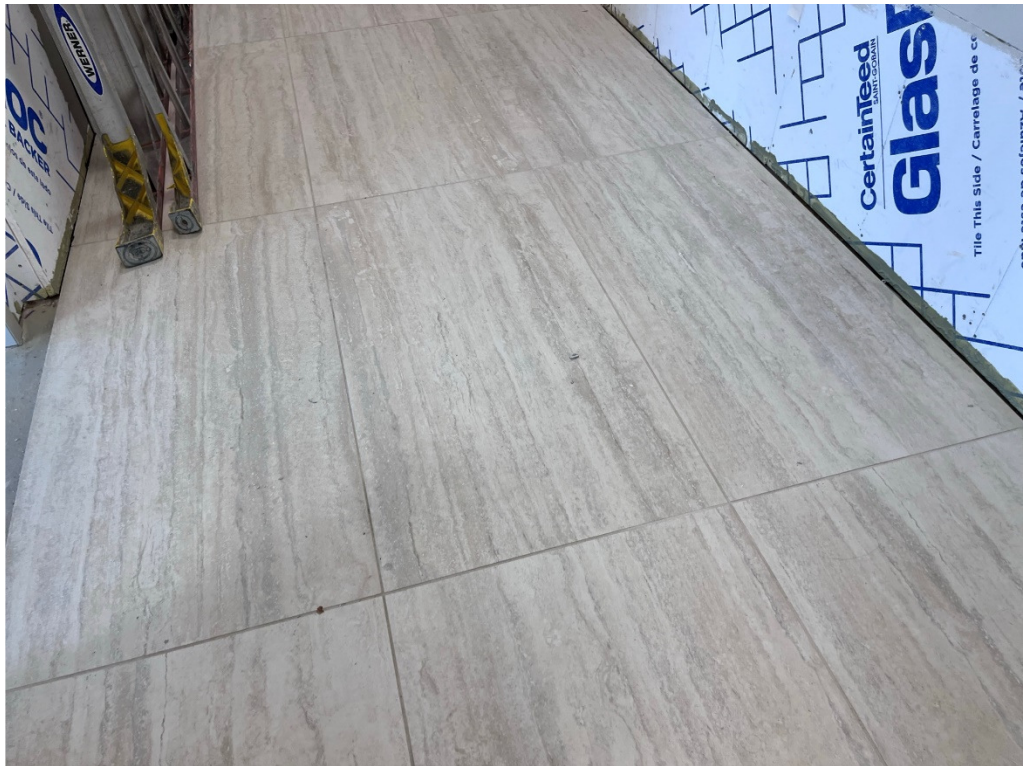
Figure 1 – Grout Installed

Figure 2 – Grout Installed

Figure 3 – Grout Installed

Figure 4 – Grout Installed

Figure 5 – Grout Installed

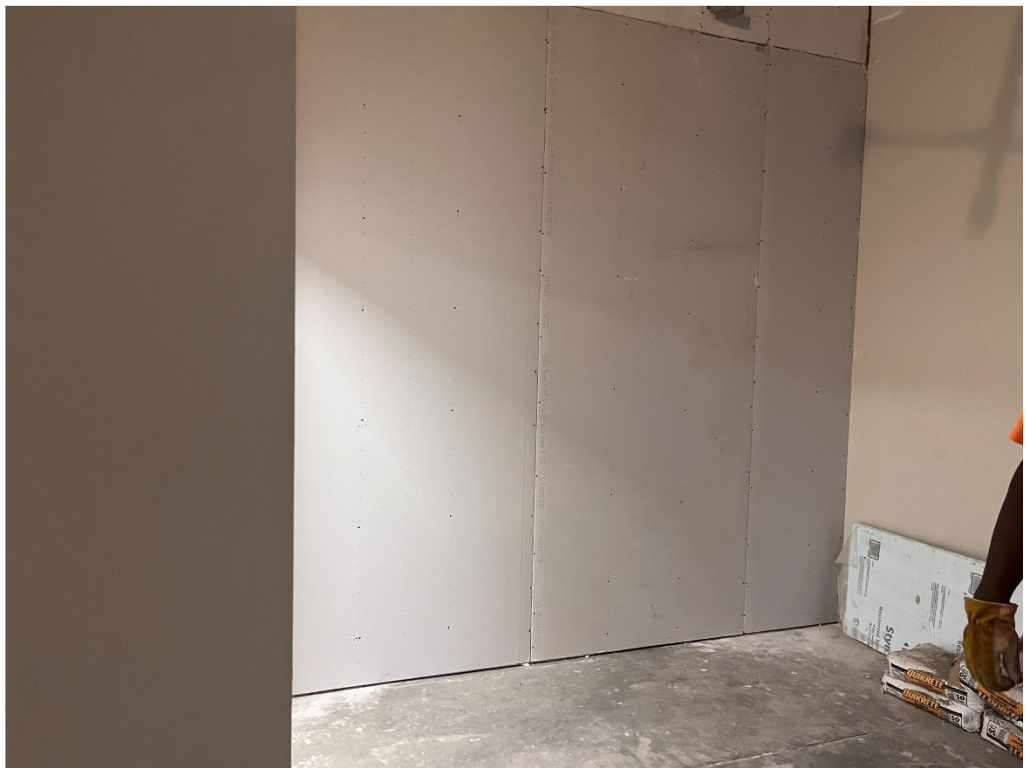
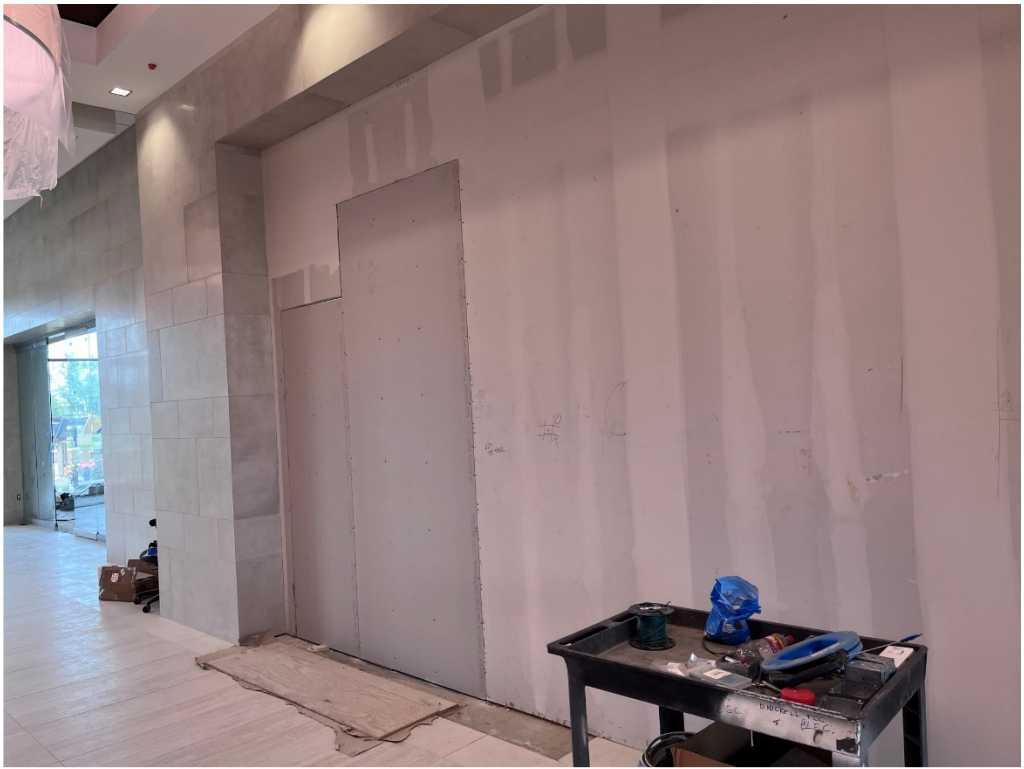
Figure 6 – Filled but still requires finishing

Figure 7 – Filled but still requires finishing

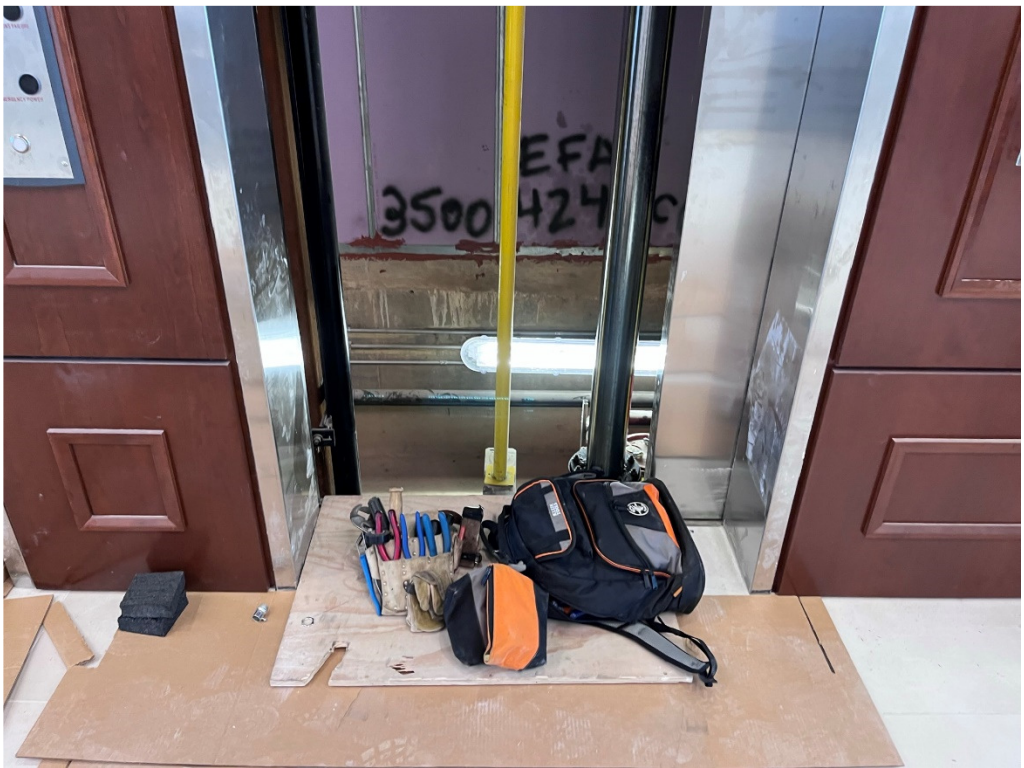
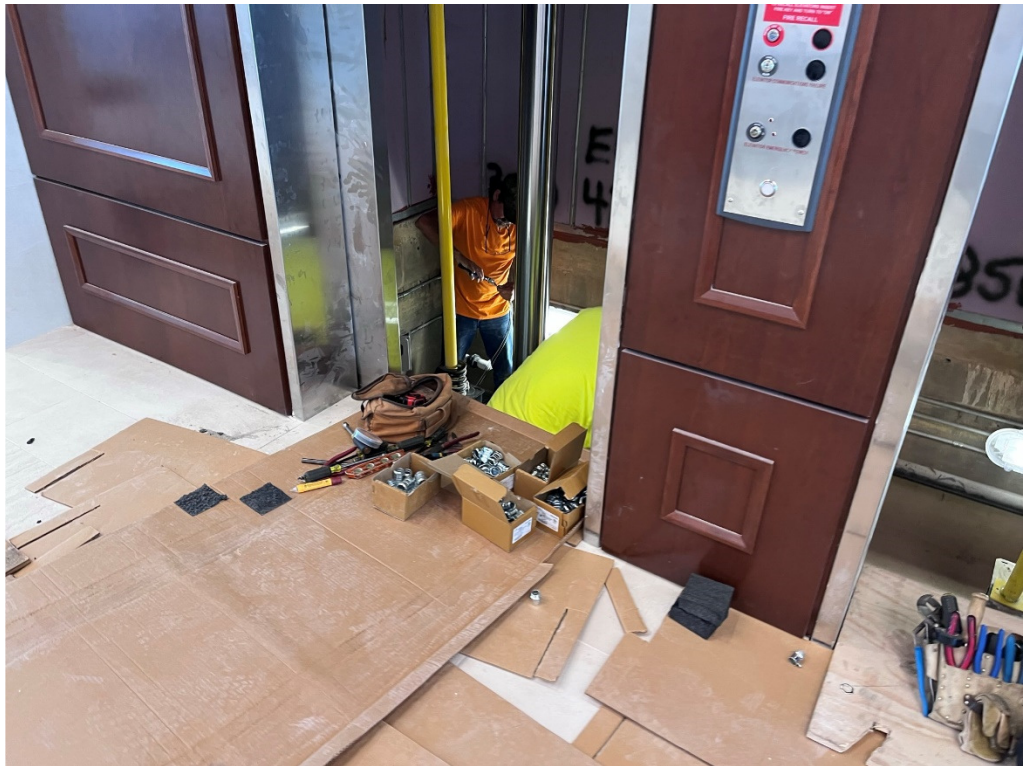
Figure 8 – Elevator work is ongoing

Figure 9 – Elevator work is ongoing

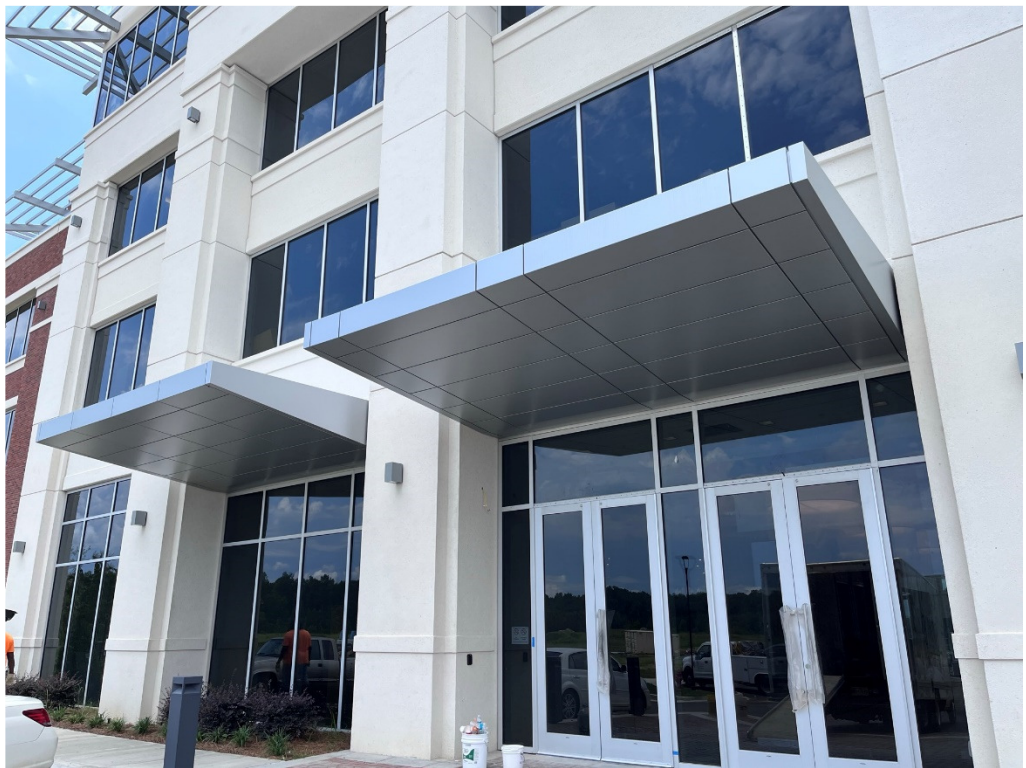
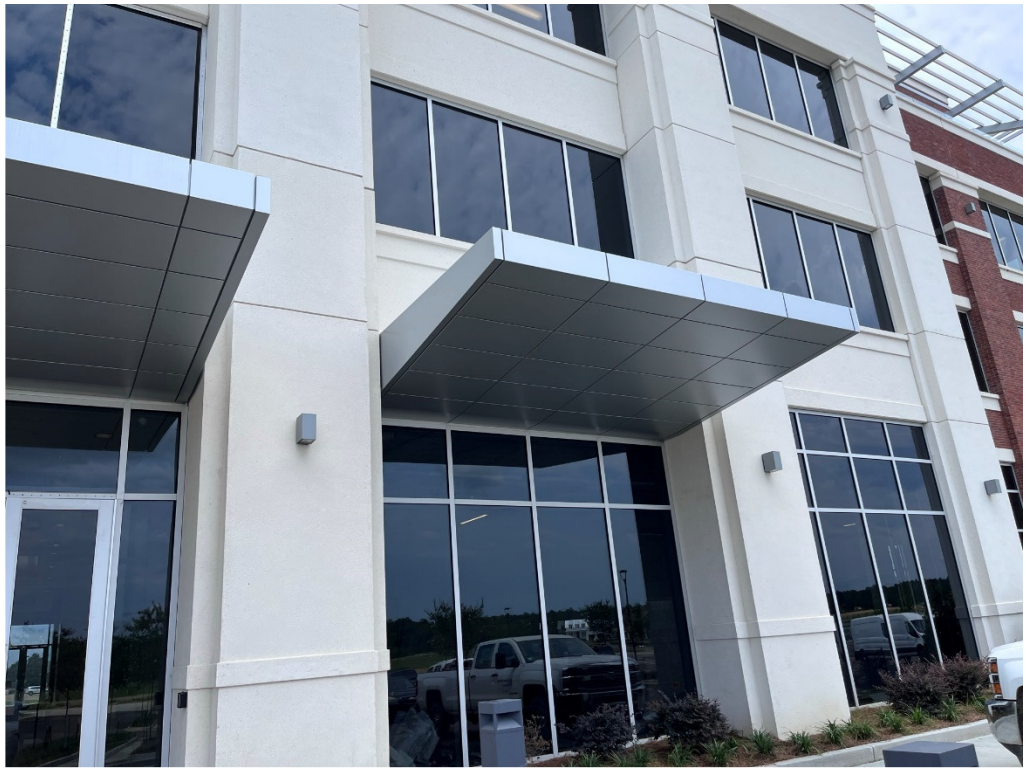
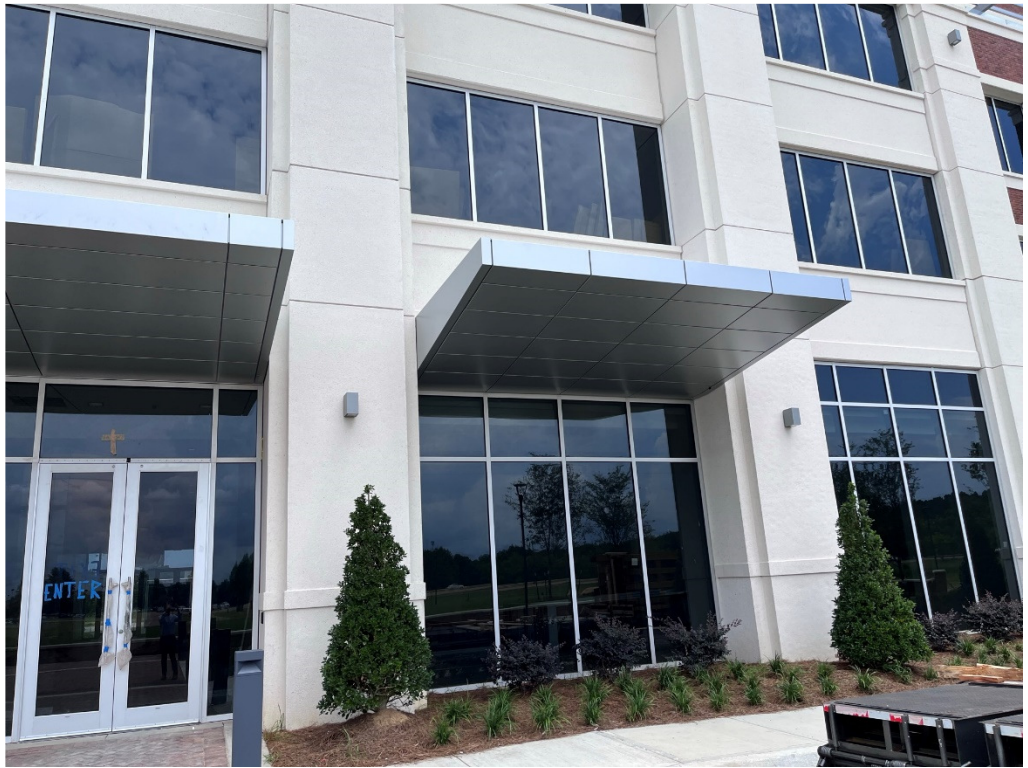
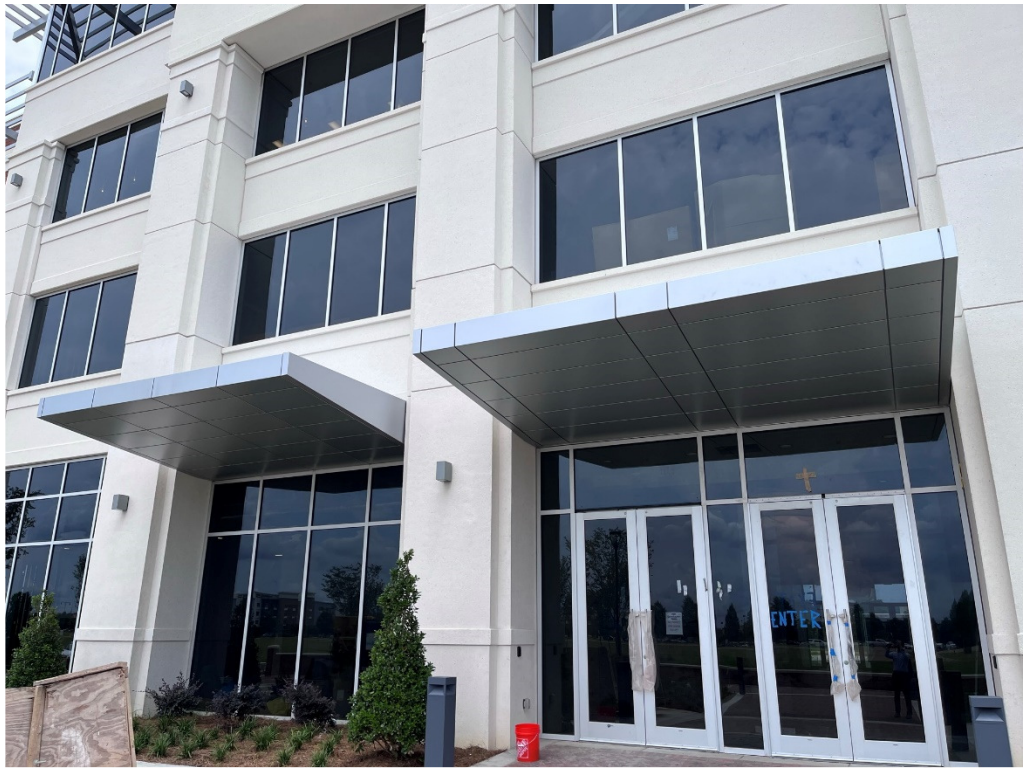
Figure 10 – Canopies are complete

Figure 11 – Canopies are complete

Figure 12 – Canopies are complete

Figure 13 – Canopies are complete

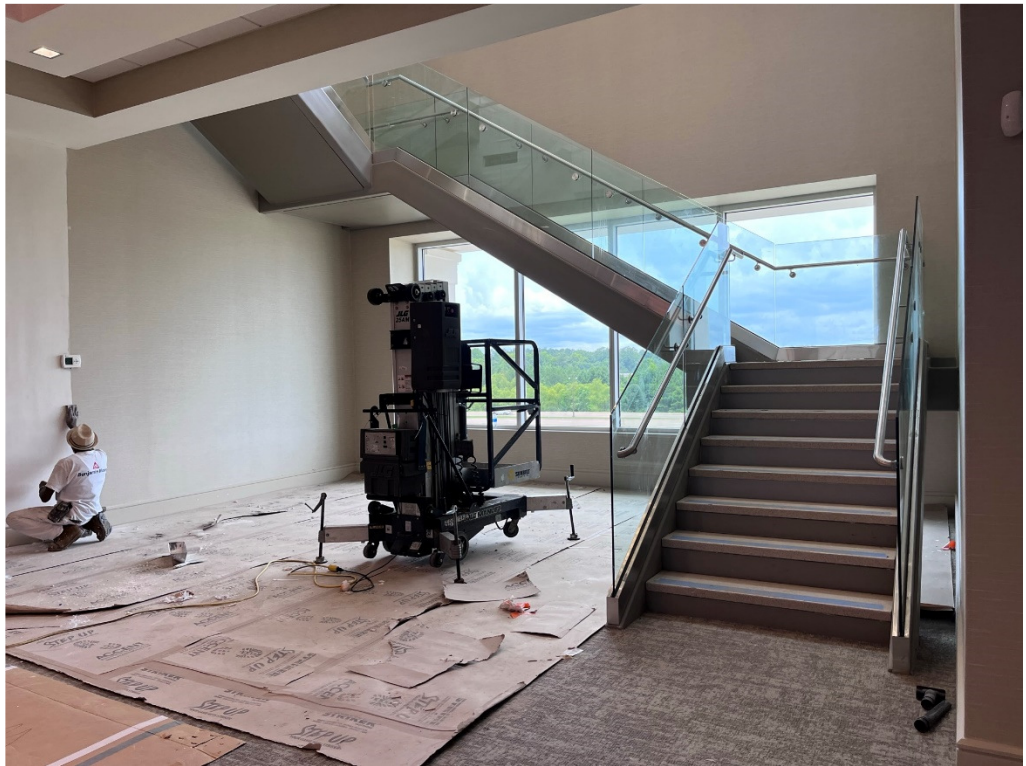
Figure 14 – Scaffolding is removed

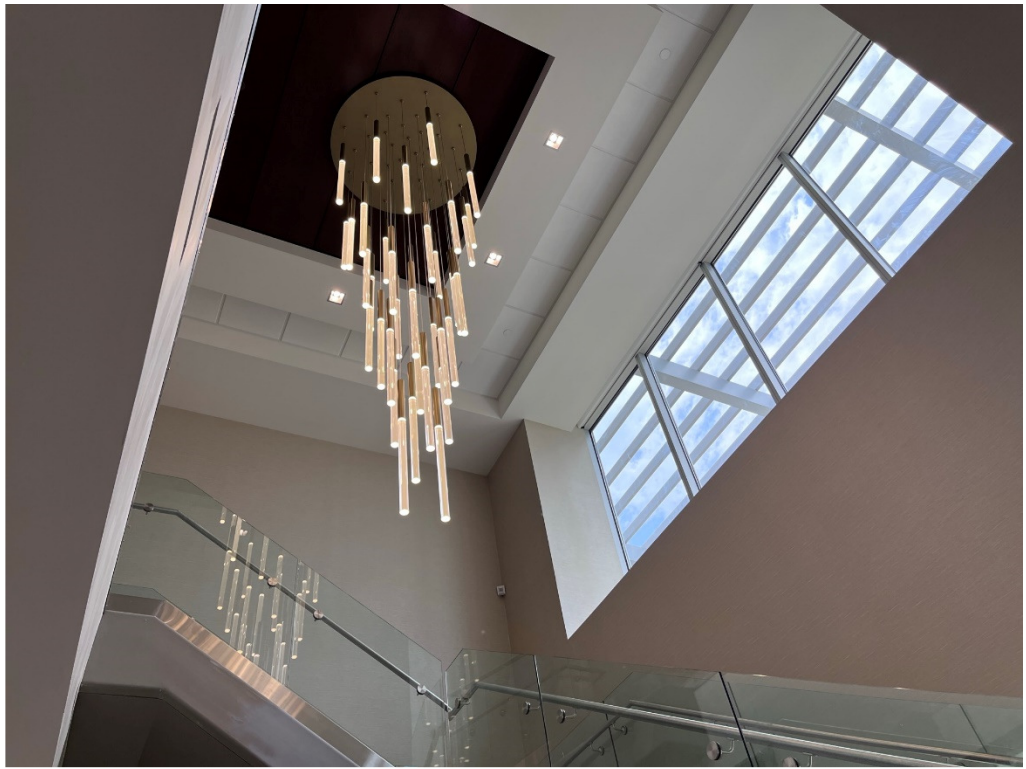
Figure 15 – Light Fixture Installed

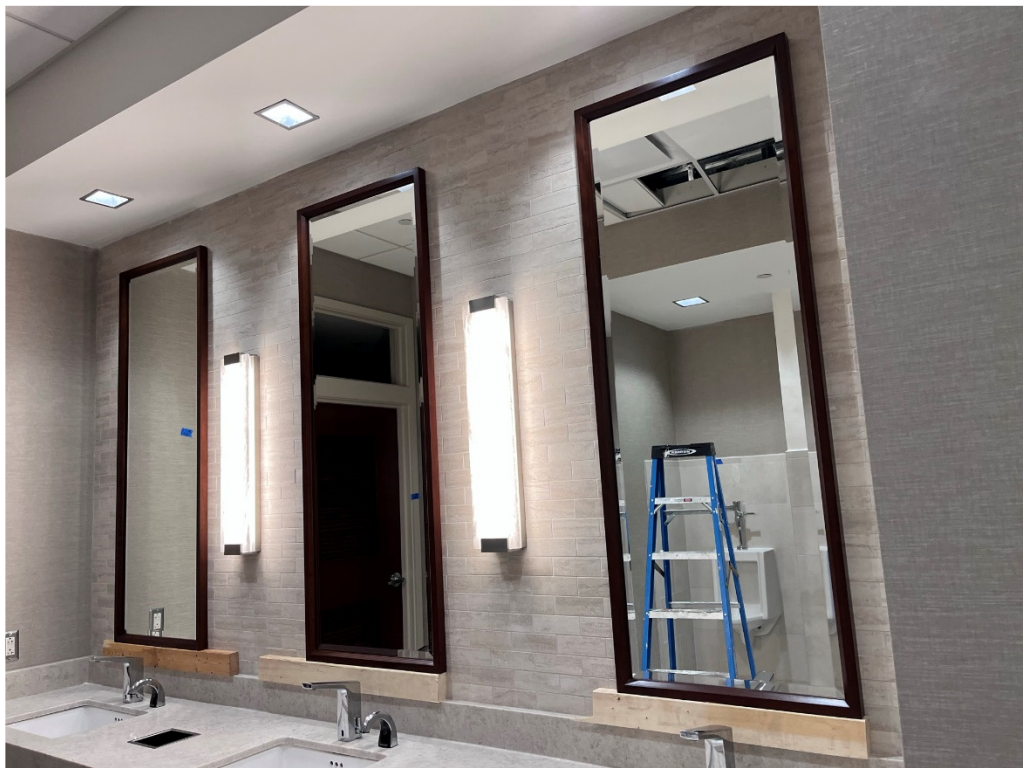
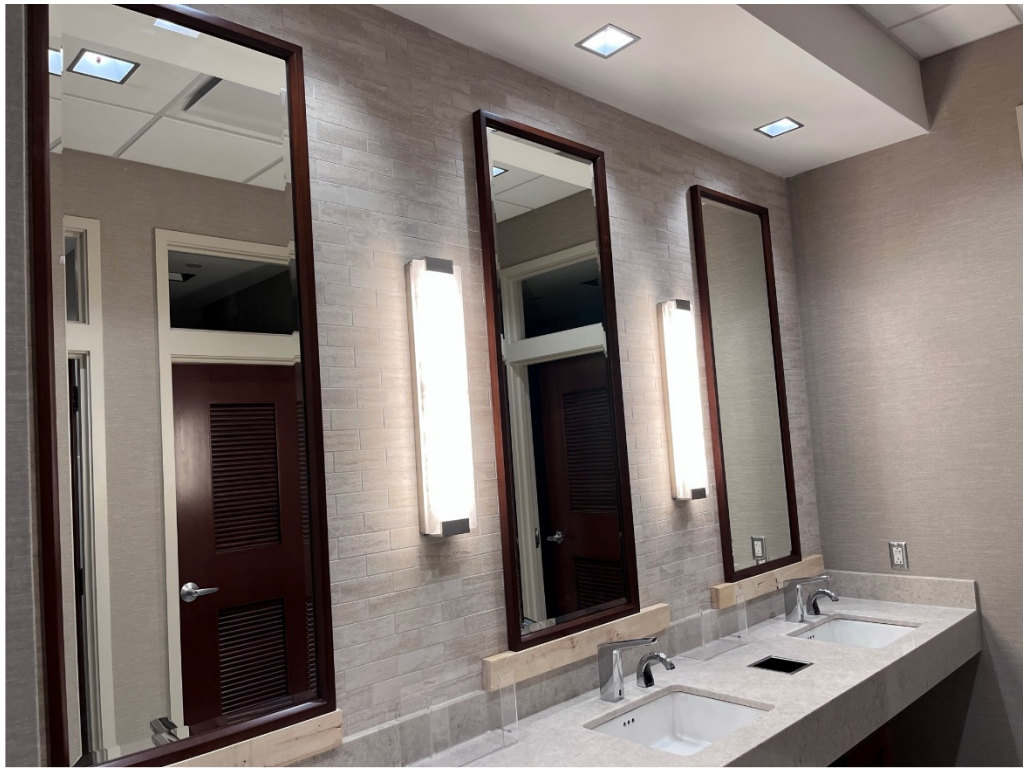
Figure 16 – Mirrors installed with temporary supports

Figure 17 – Mirrors installed with temporary supports

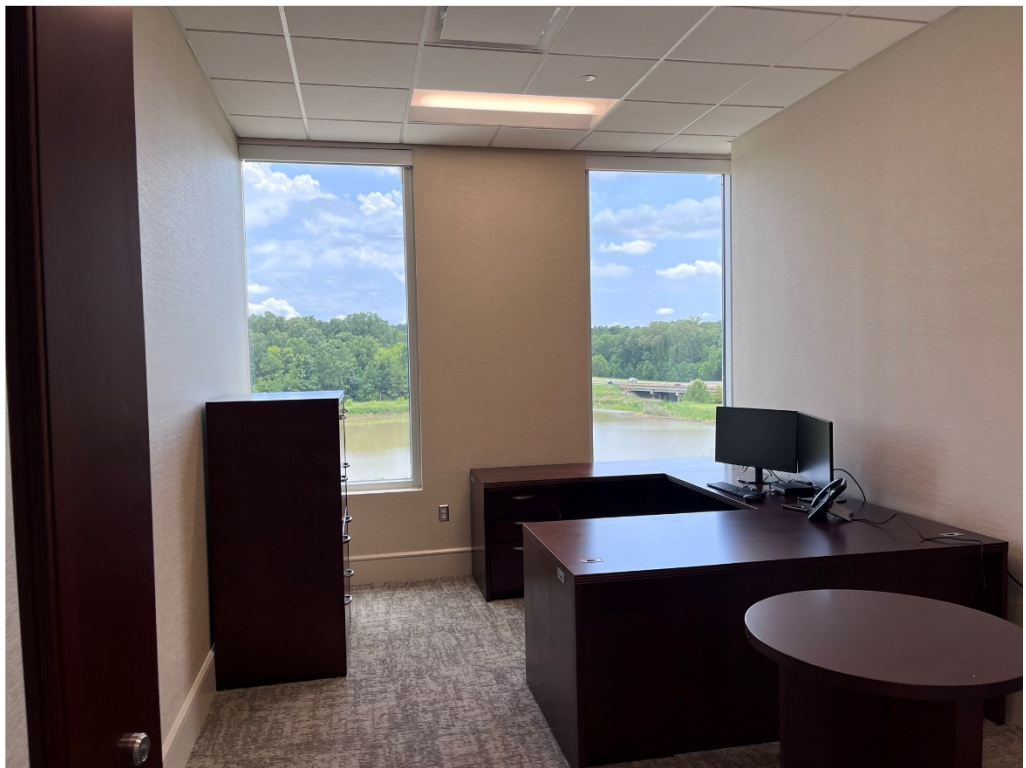
Figure 18 – Blinds installed typical

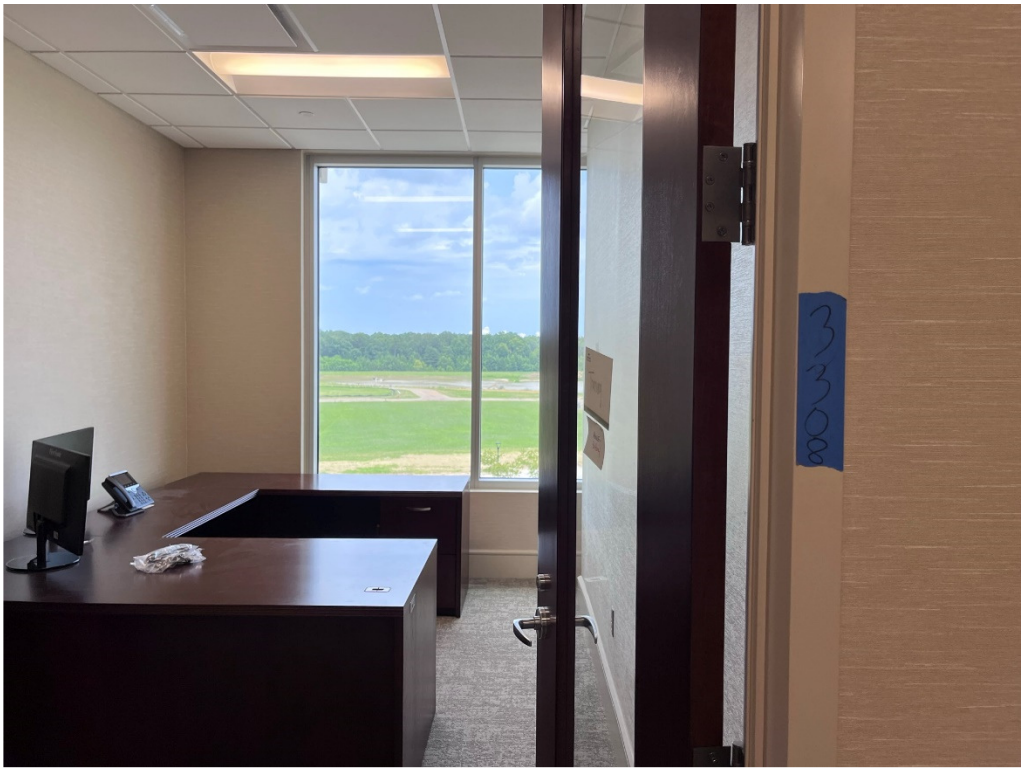
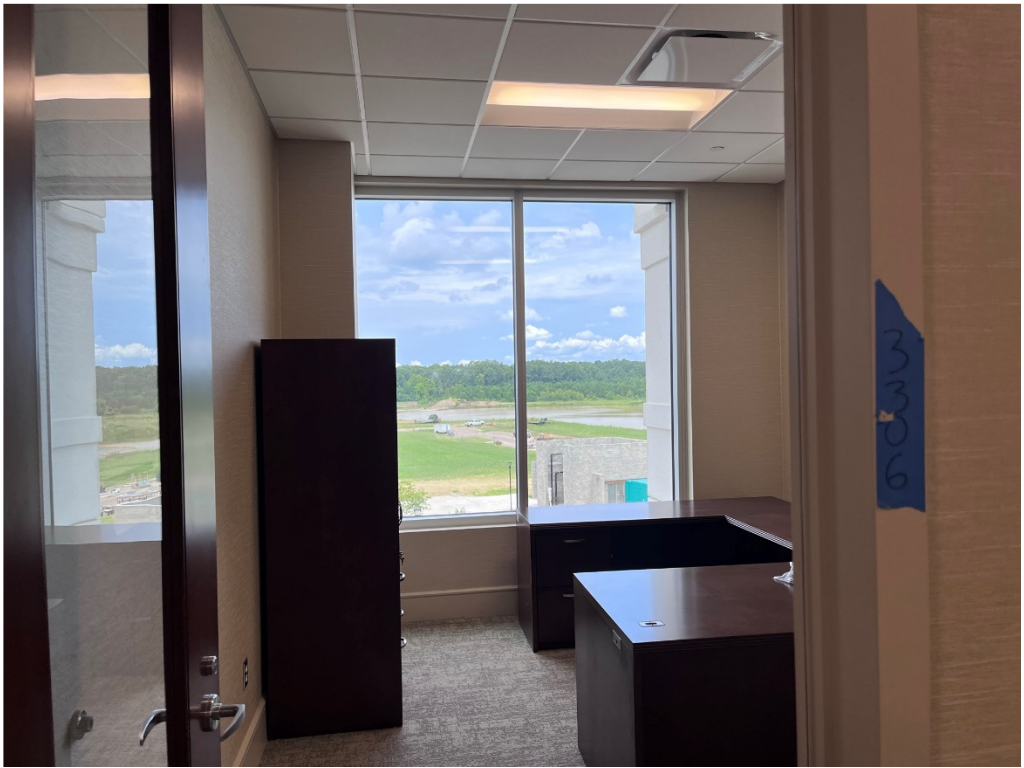
Figure 19 – Room where blinds are missing

Figure 20 – Room where blinds are missing

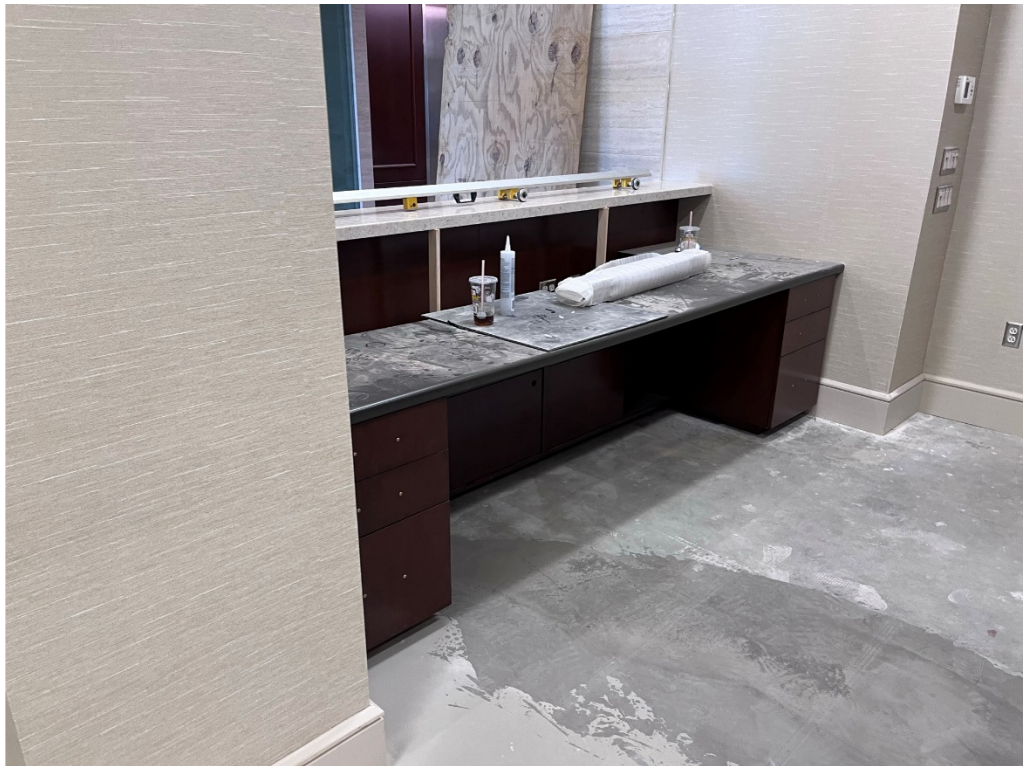
Figure 21 – Stone work is ongoing

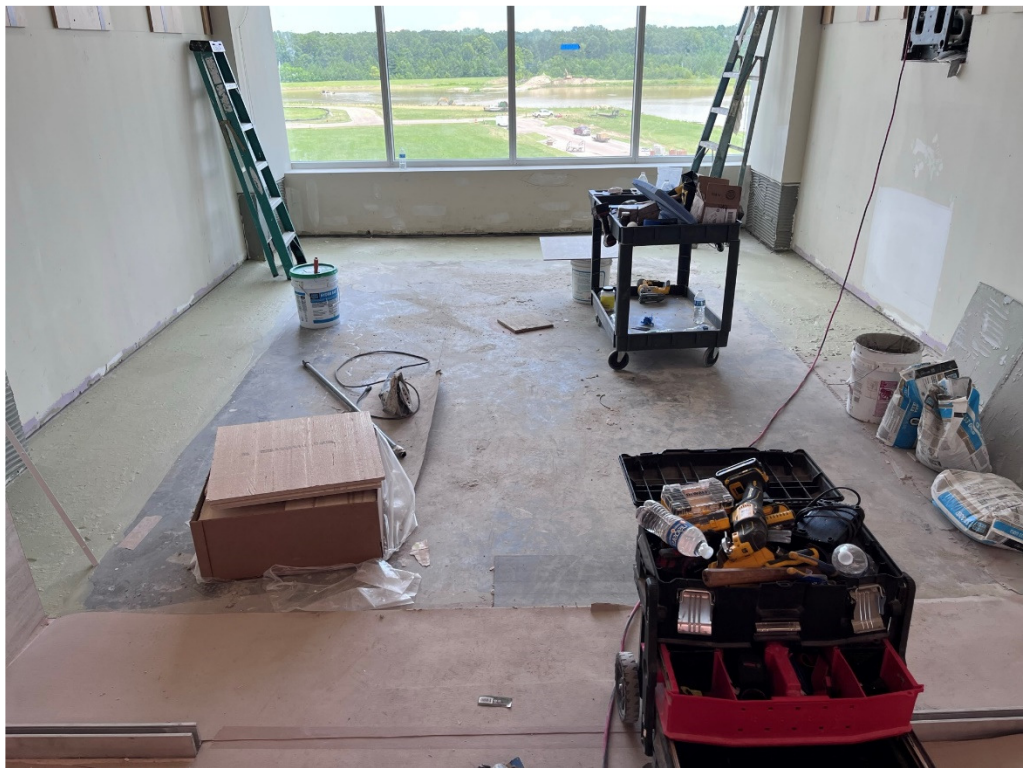
Figure 30 – Tile work has not begun
