Architect's Field Report

21 July 2022

15094 Community Bank Headquarters / Report Number 037

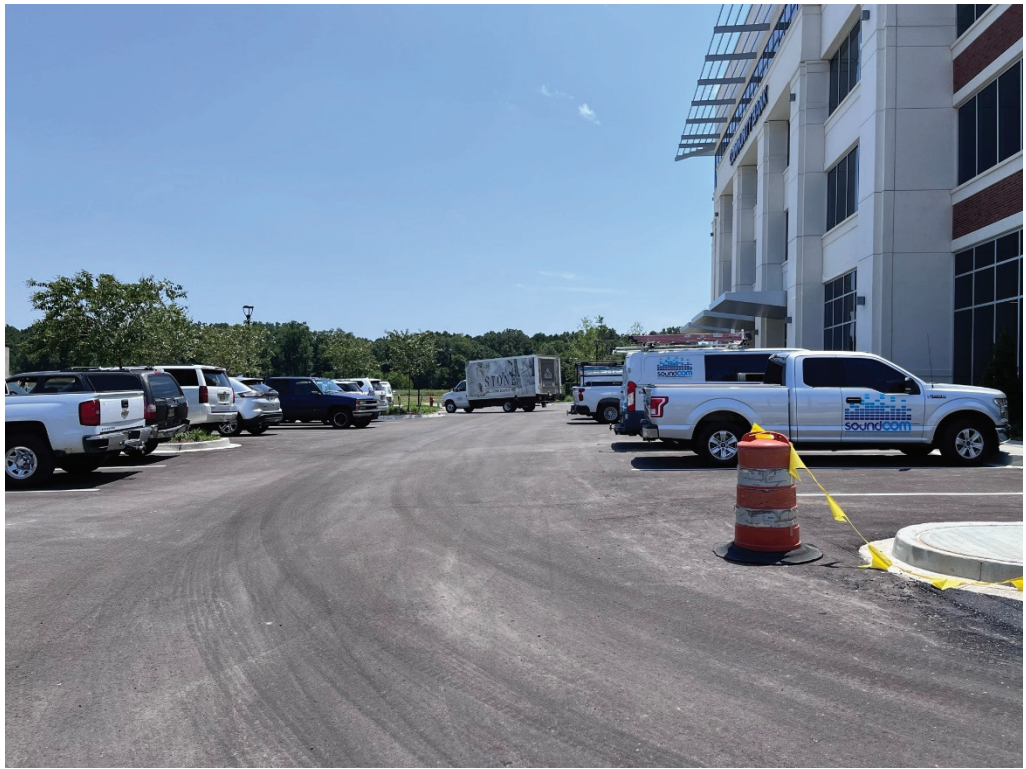
Figure 1 – Many workers on site today

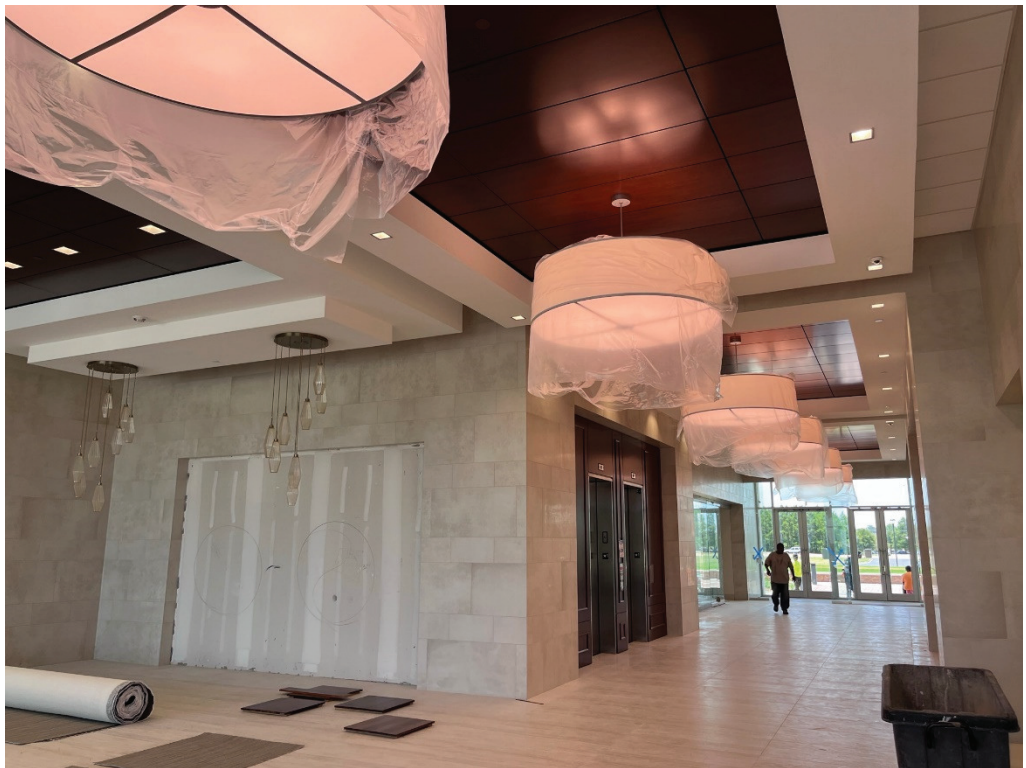
Figure 2 – Lights installed at first floor lobby

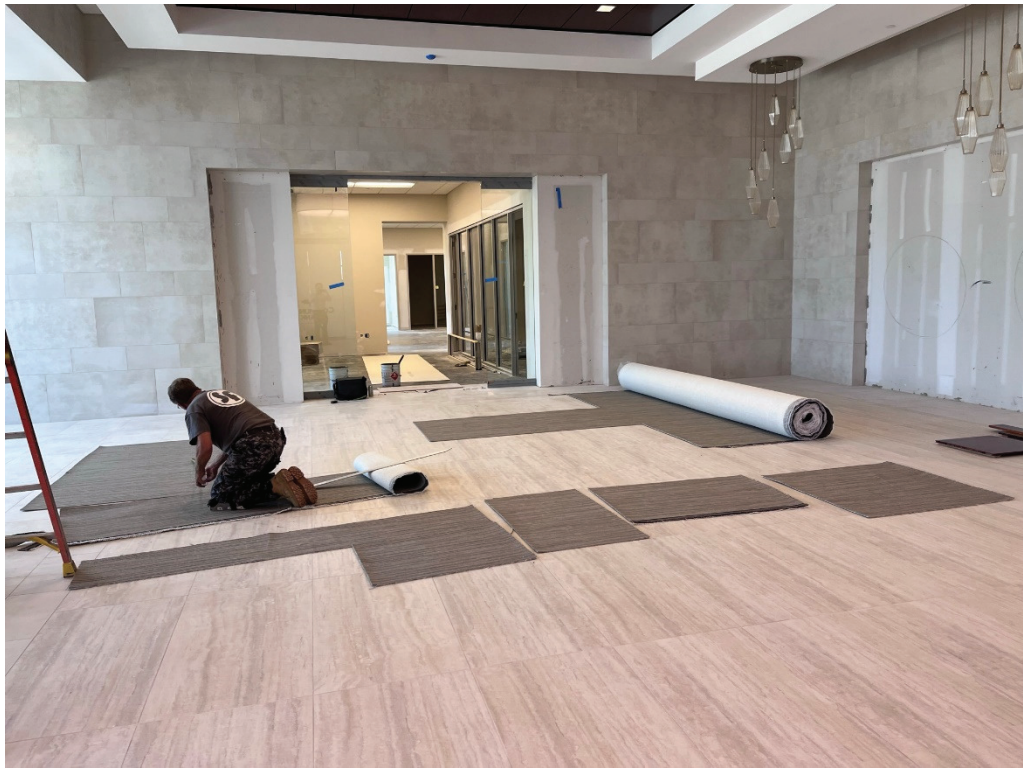
Figure 3 – Carpet for Stairwell installations

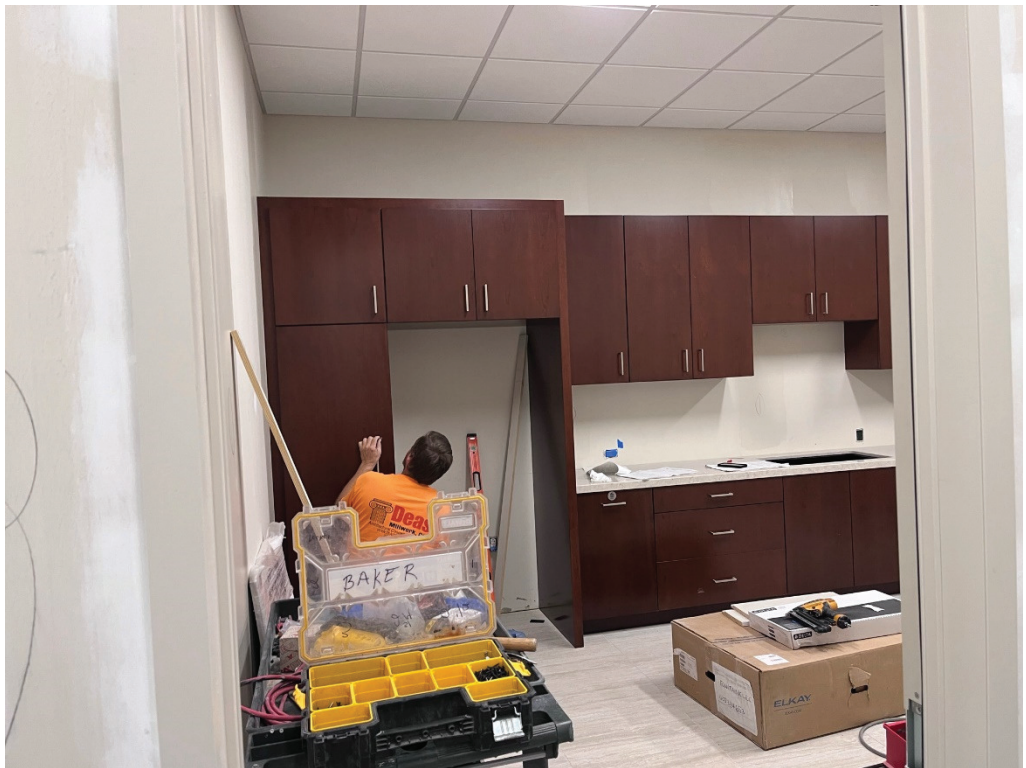
Figure 4 – Millwork Installation at 1st Floor

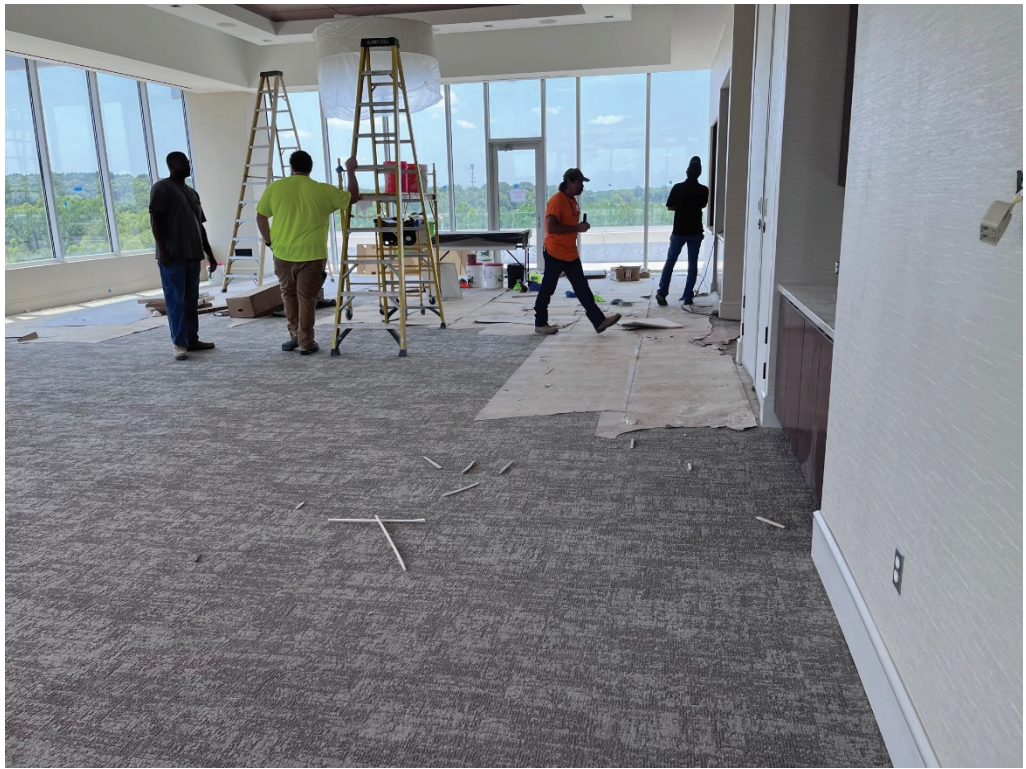
Figure 5 – Electrical ongoing

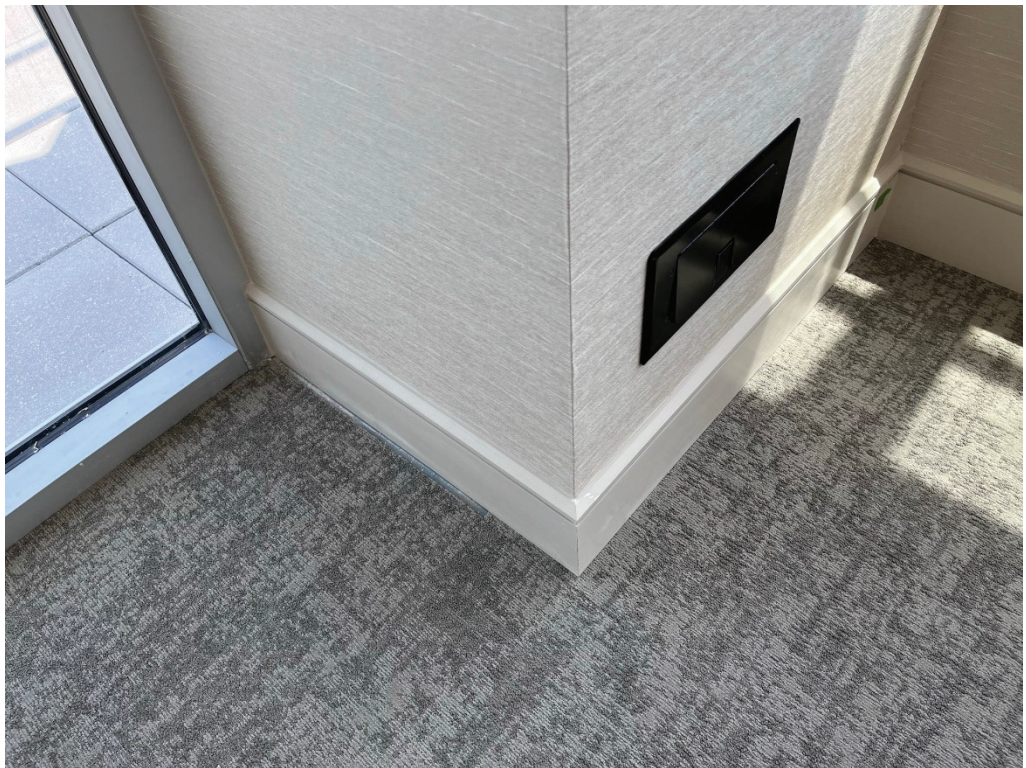
Figure 6 – Some Carpet needed in gap SE corner

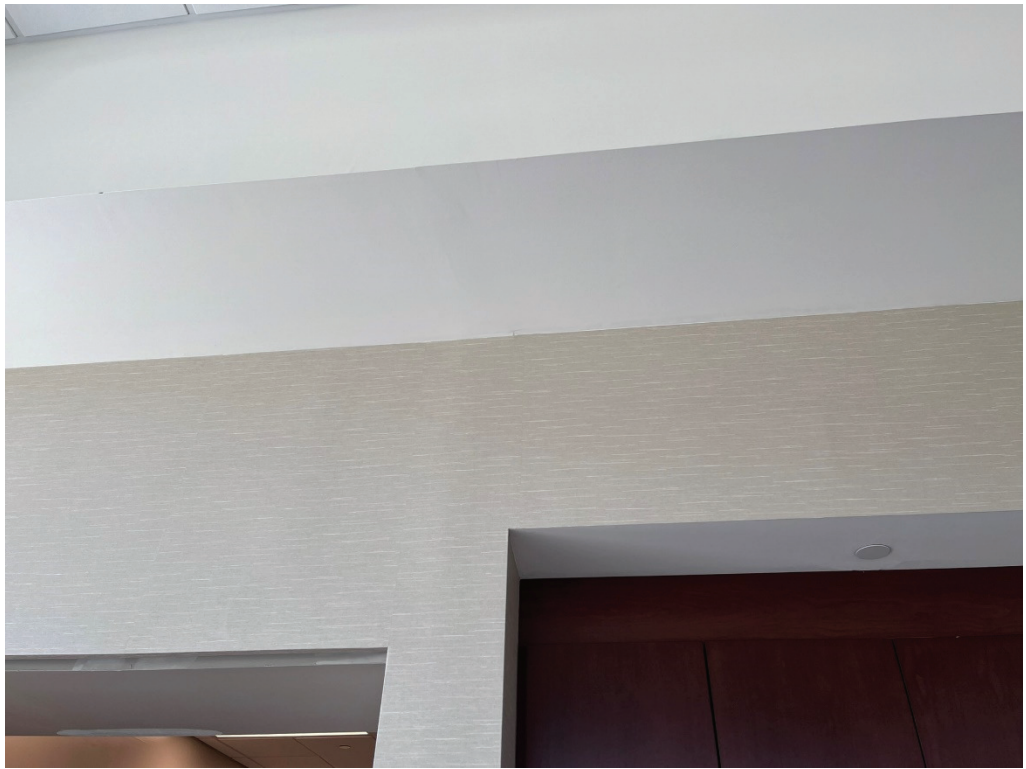
Figure 7 – Bulges Apparent in places near kitchen pass-thru

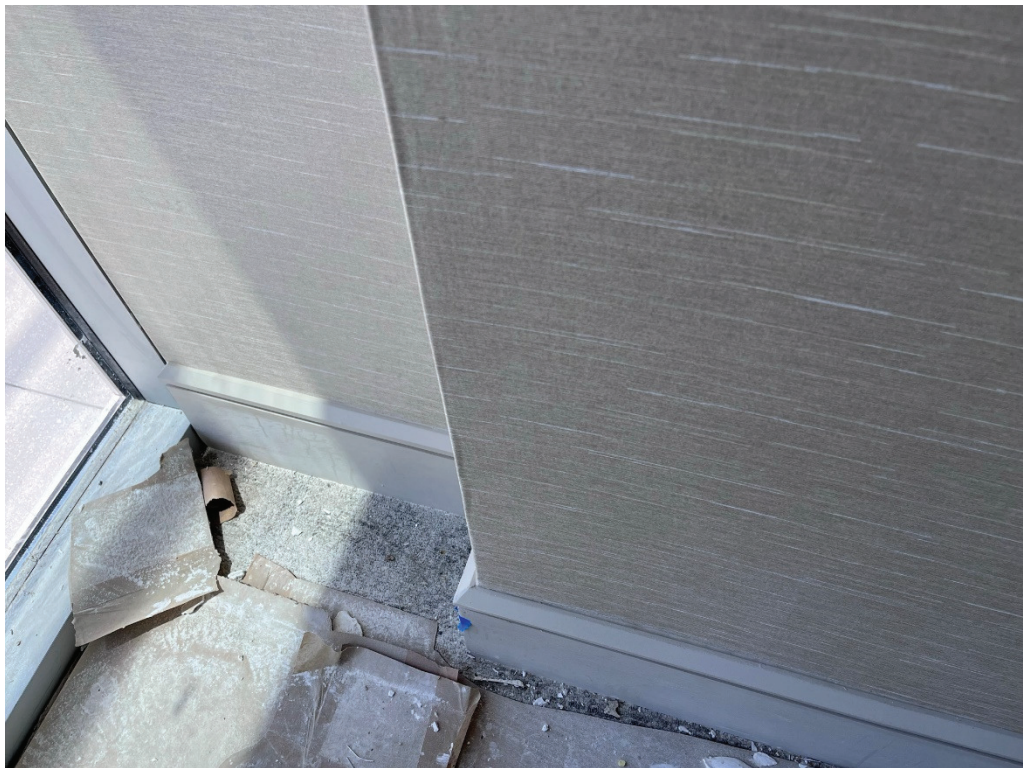
Figure 8 – Pour Corners in Large Meeting 4th Floor

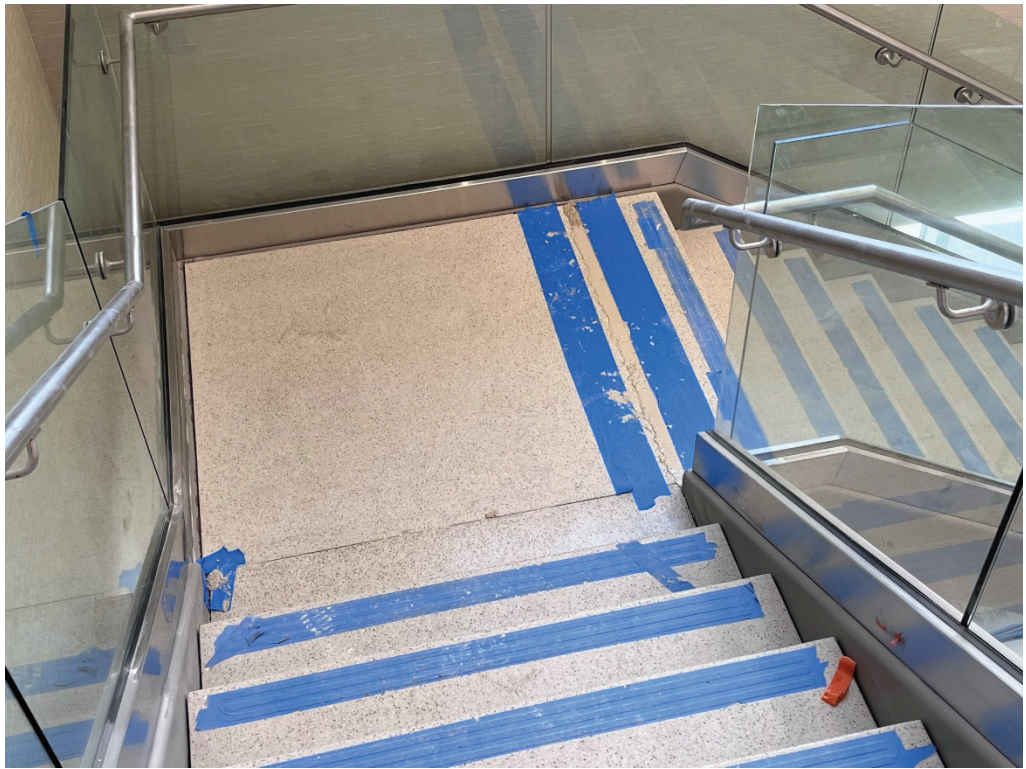
Figure 9 – Landing Gap Filled; finish work ongoing

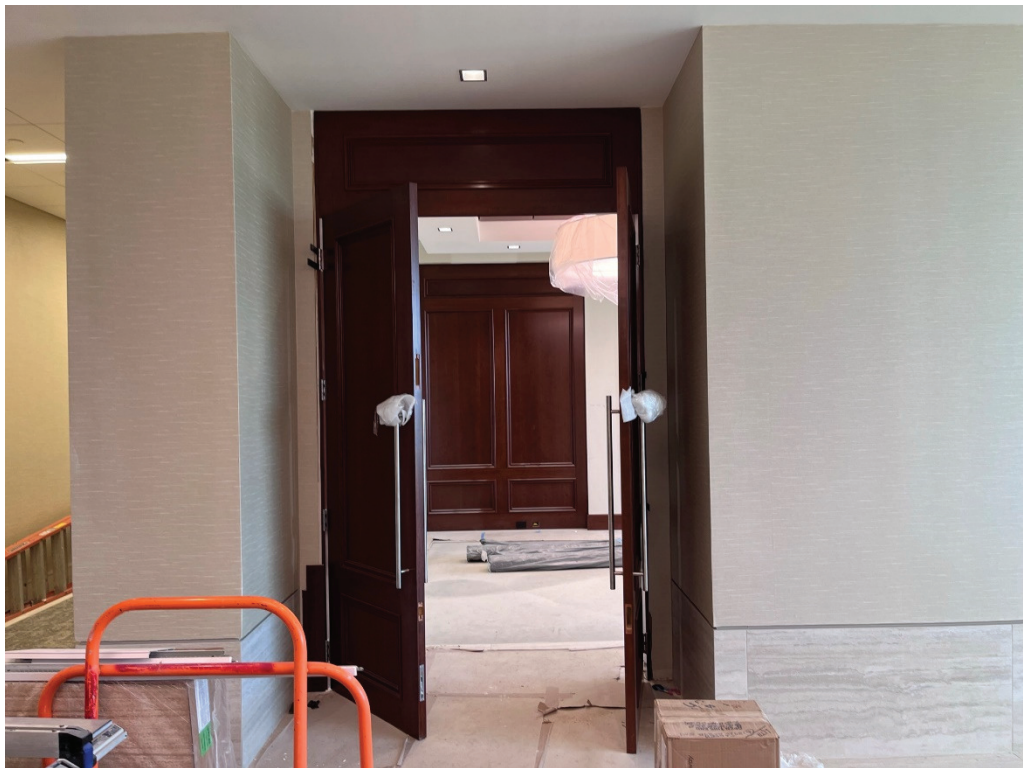
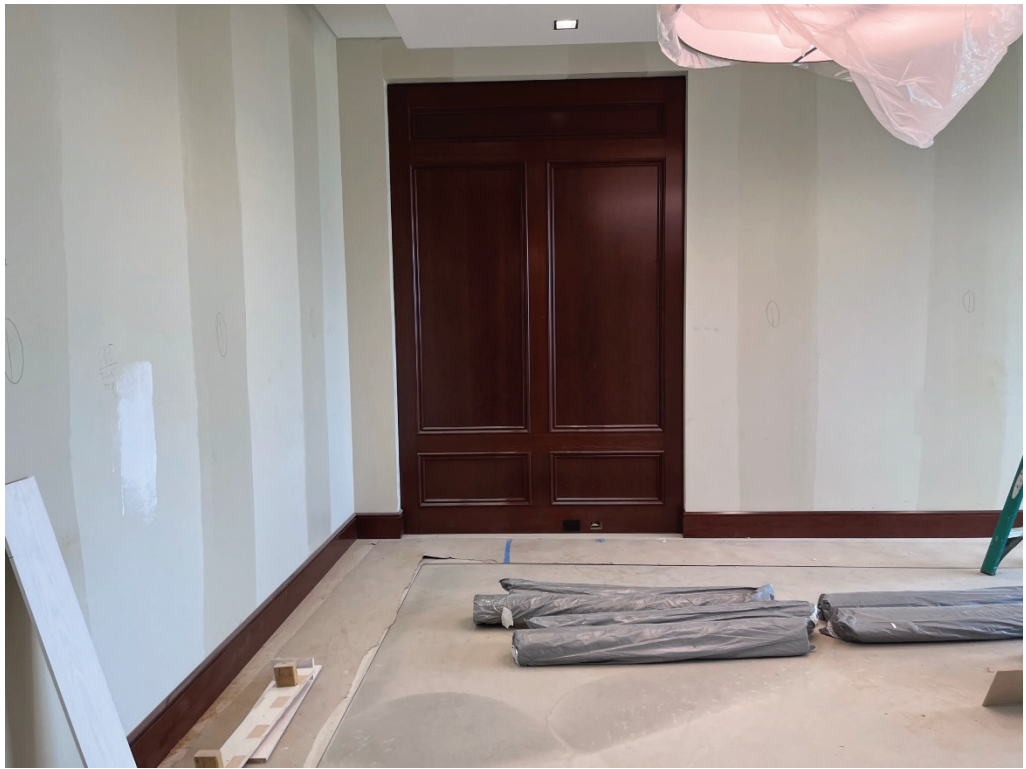
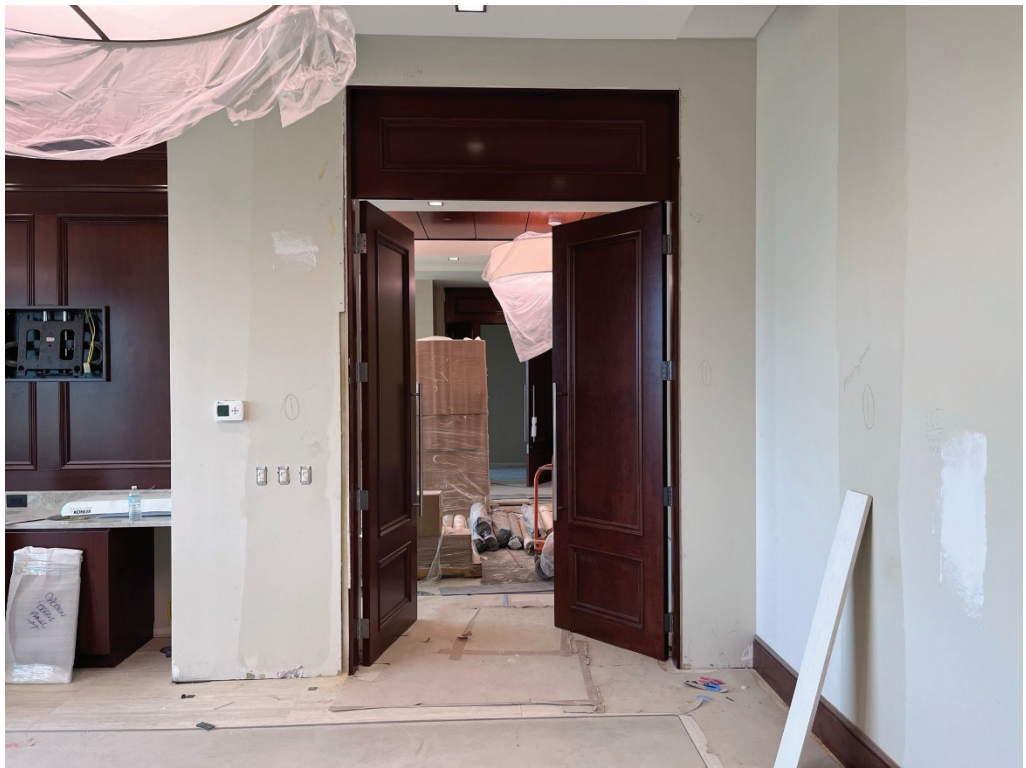
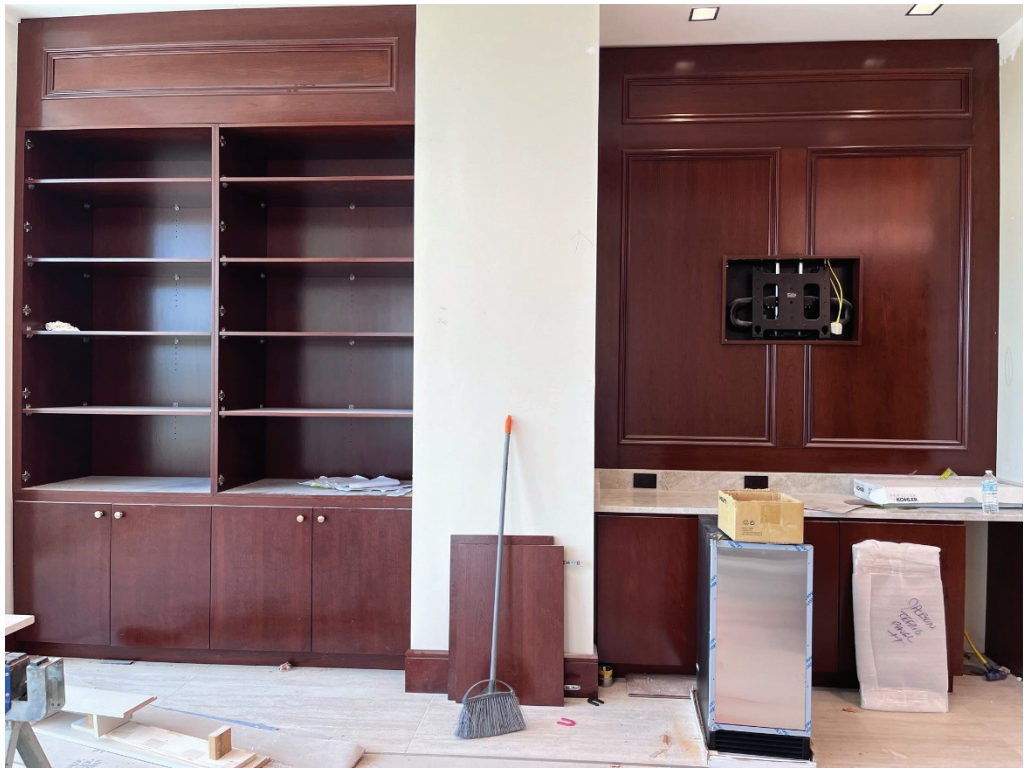
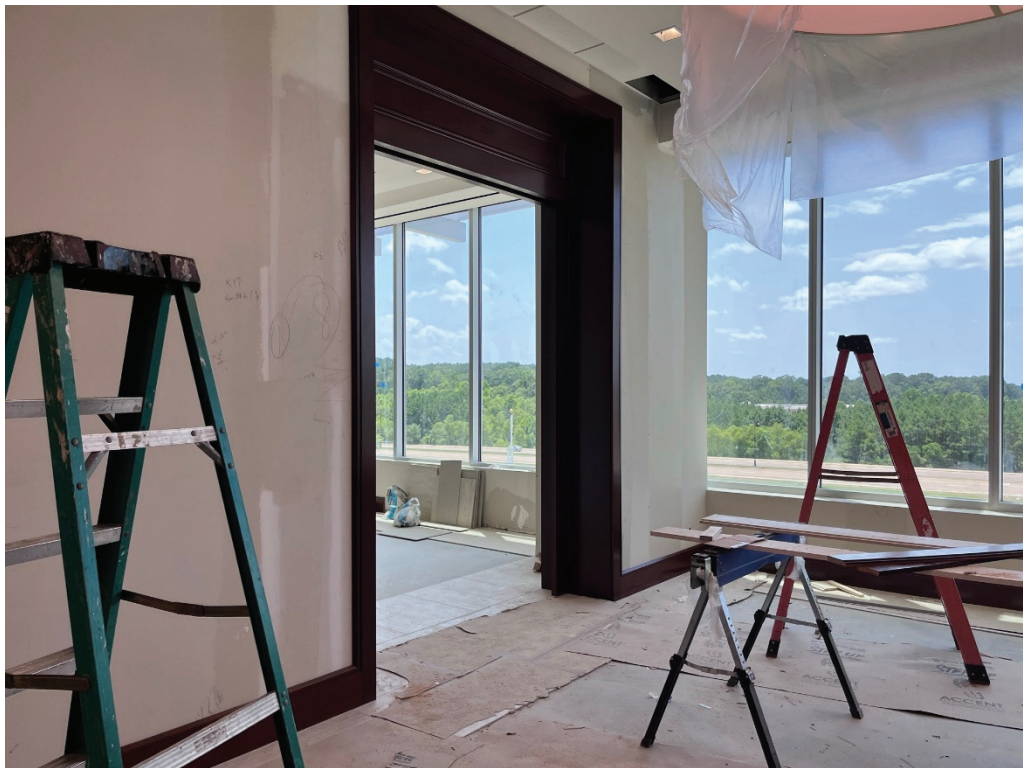
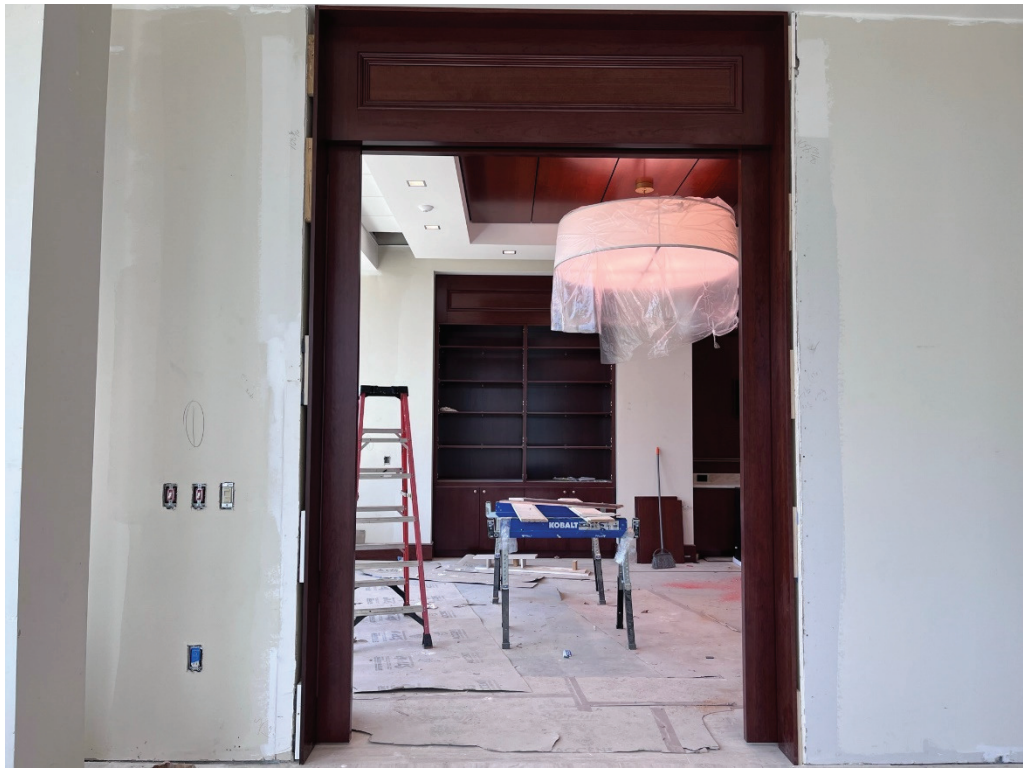
Figure 10 – Private Dining and Lounge Millwork

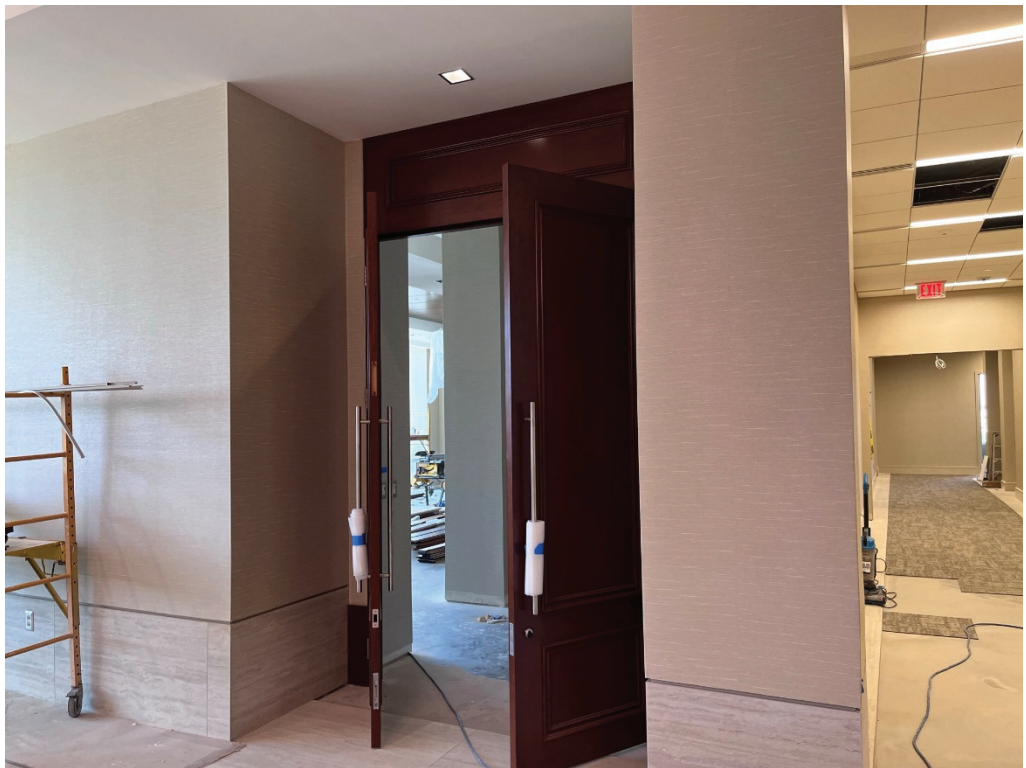
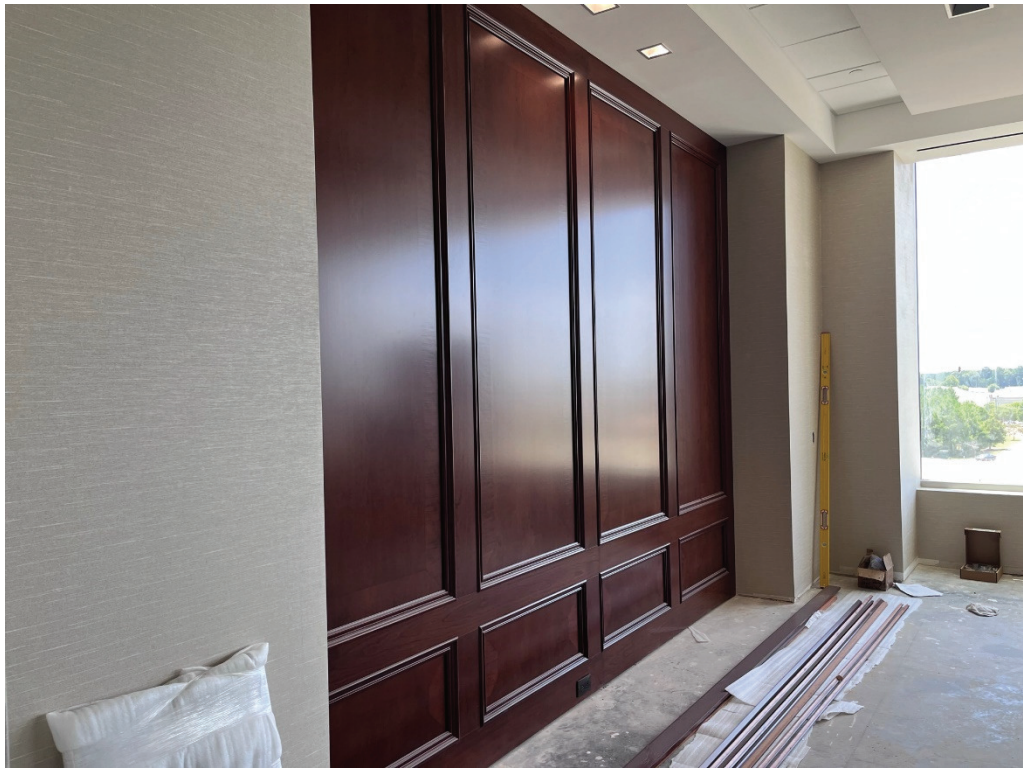
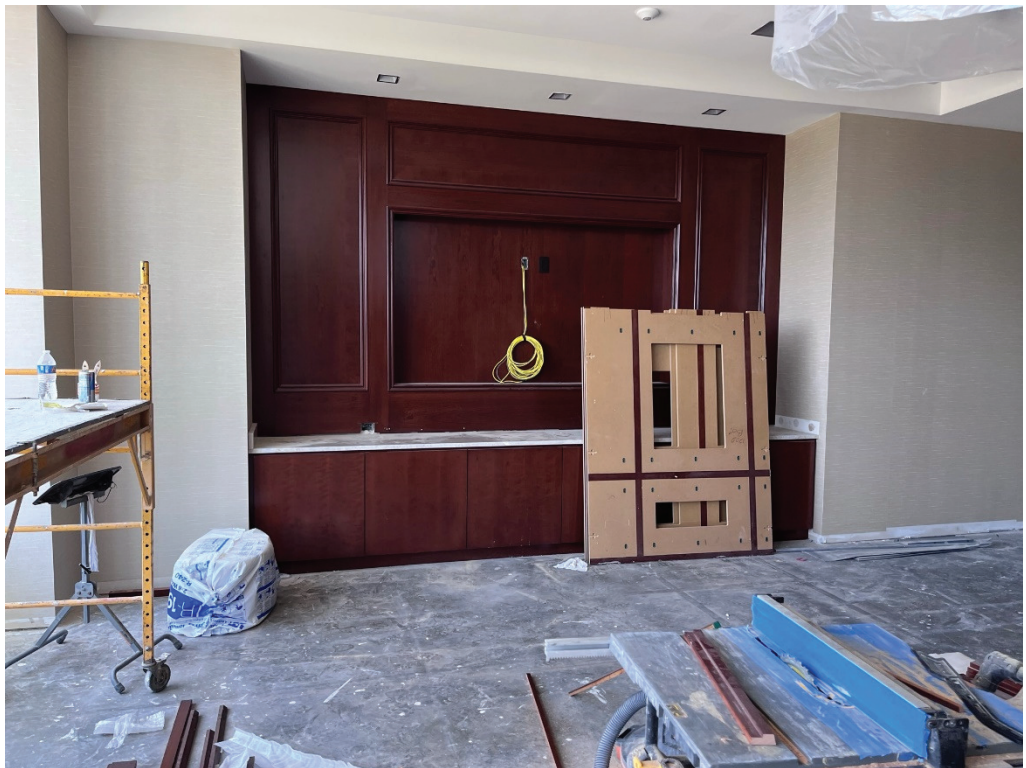
Figure 16 – Board Room Millwork

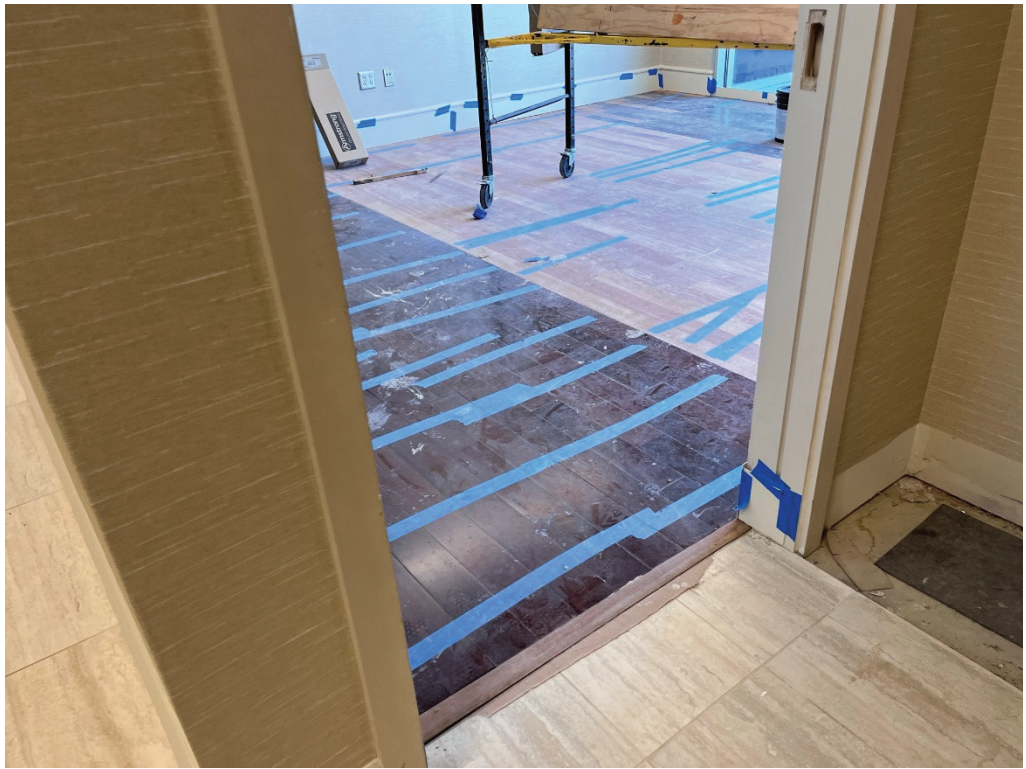
Figure 19 – Some Rooms still to be sanded

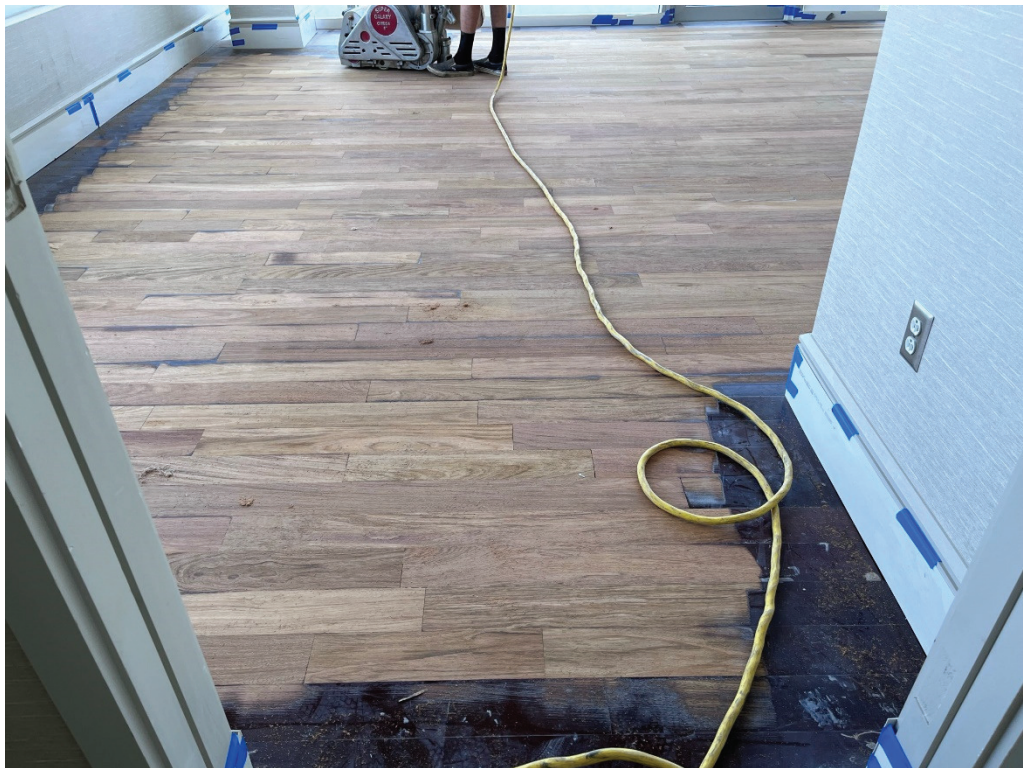
Figure 20 – Sanding Ongoing

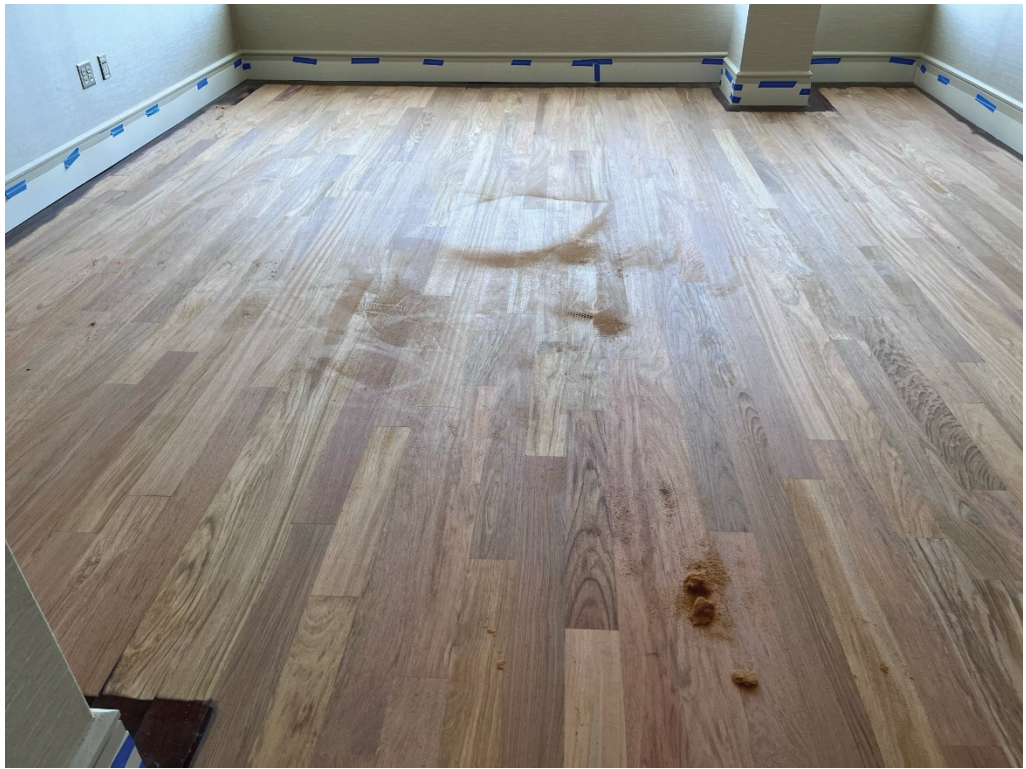
Figure 21 – Approx. 60% of sanding complete

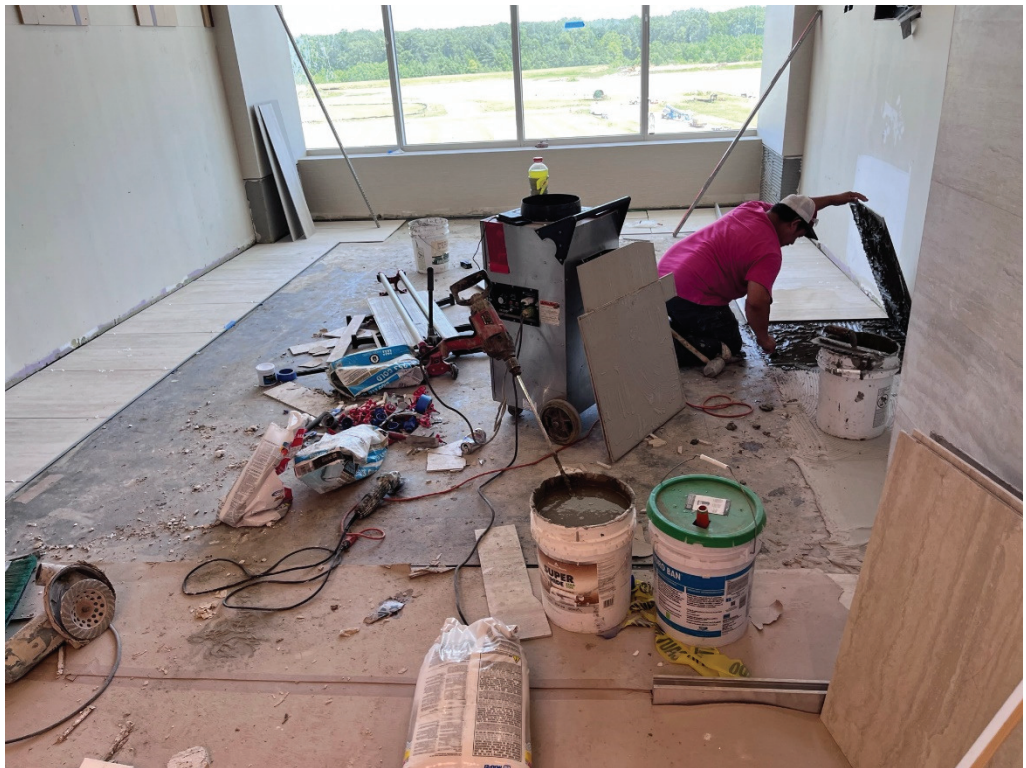
Figure 22 – 4th Floor Conference Tile Progress

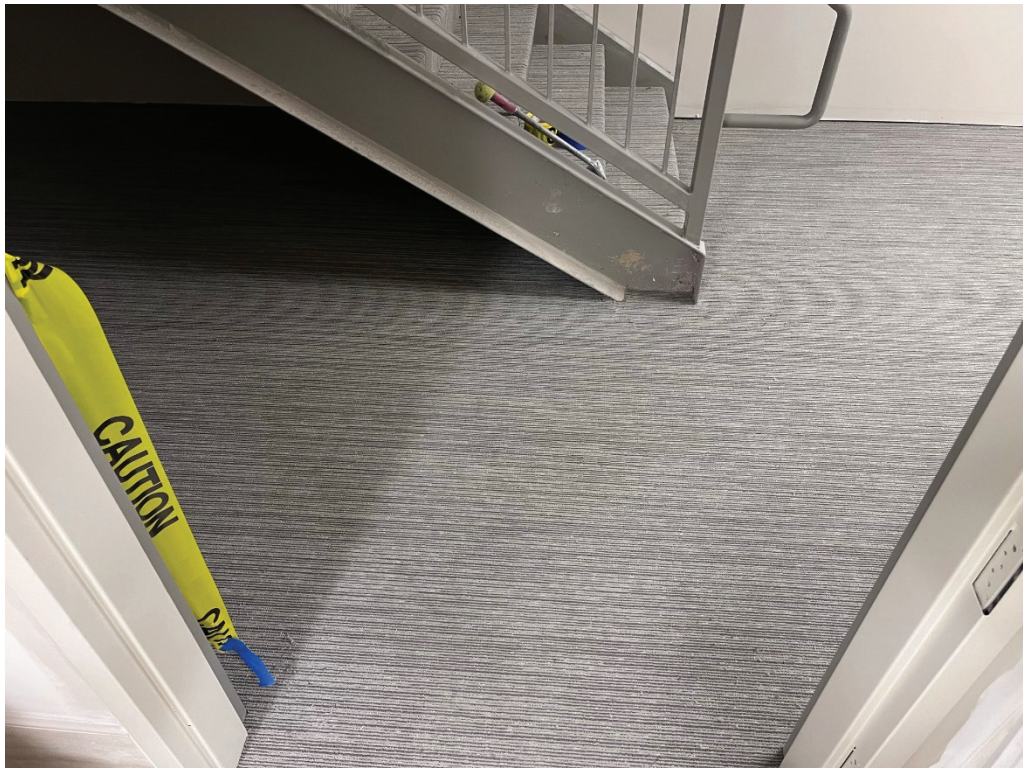
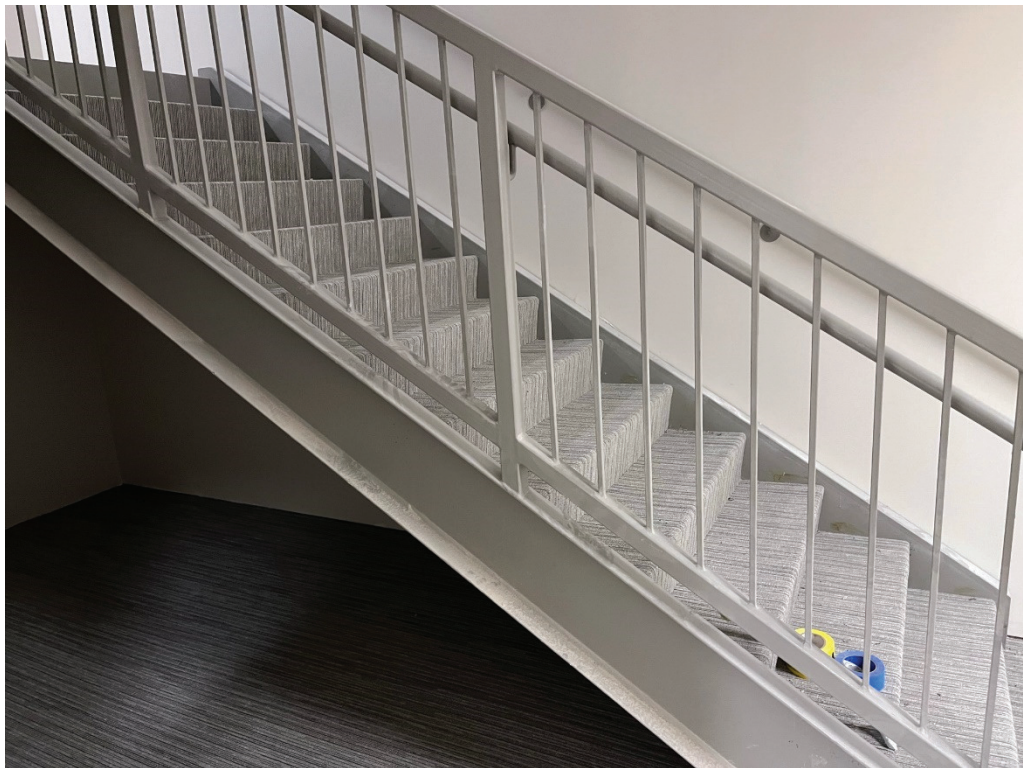
Figure 23 – Carpet Installed at Stairwell
