## Architect's Field Report

28 July 2022

15094 Community Bank Headquarters / Report Number 038

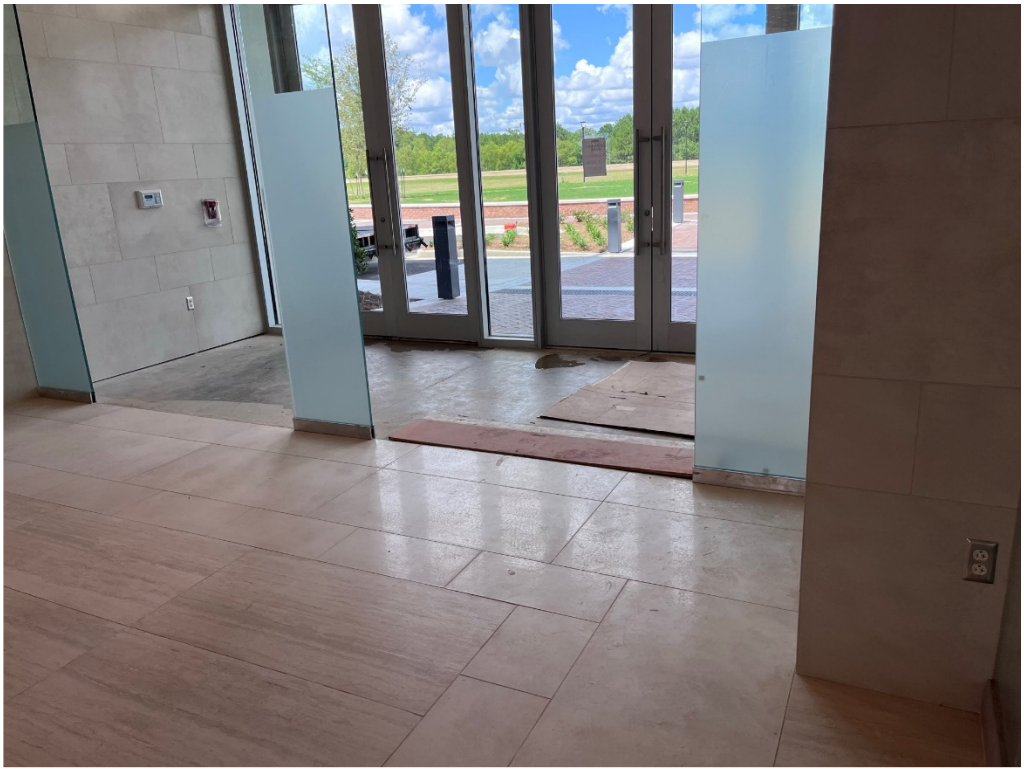
First floor lobby has been cleaned and appears in good order as far as the floor is concerned. Walk off mats have not been installed yet, however. Drywall to receive wood and temporarily to be painted ceiling white are still awaiting finishing. Entries are still awaiting glass

Figure 1 – 1<sup>st</sup> Floor Entry Progressp

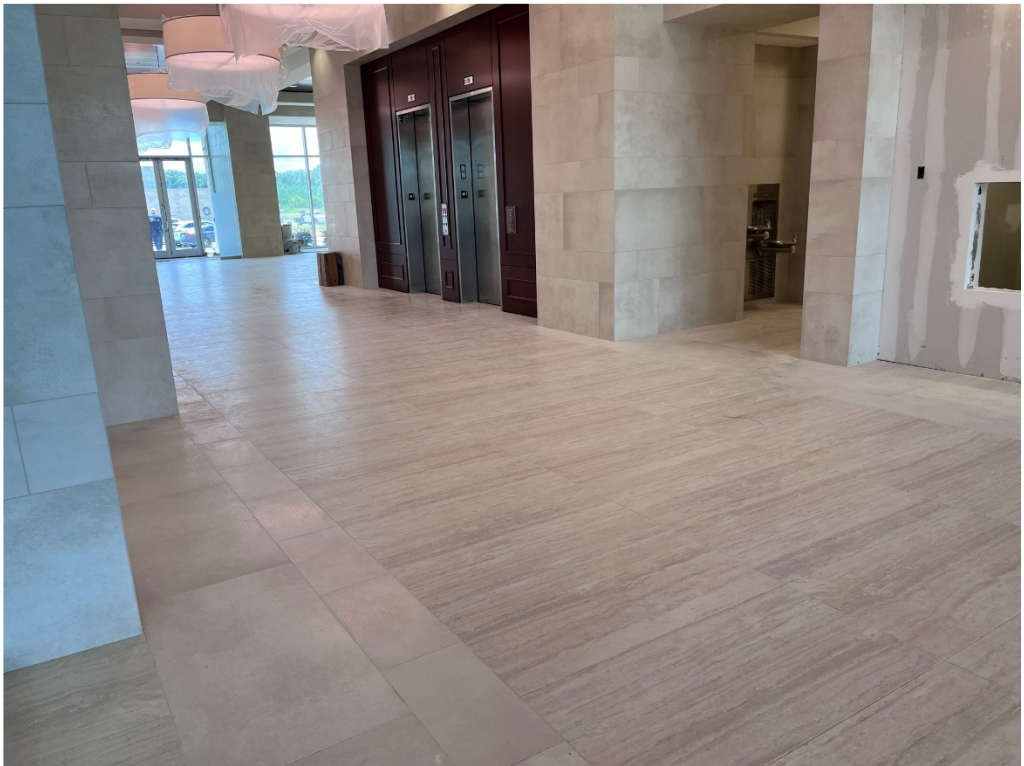
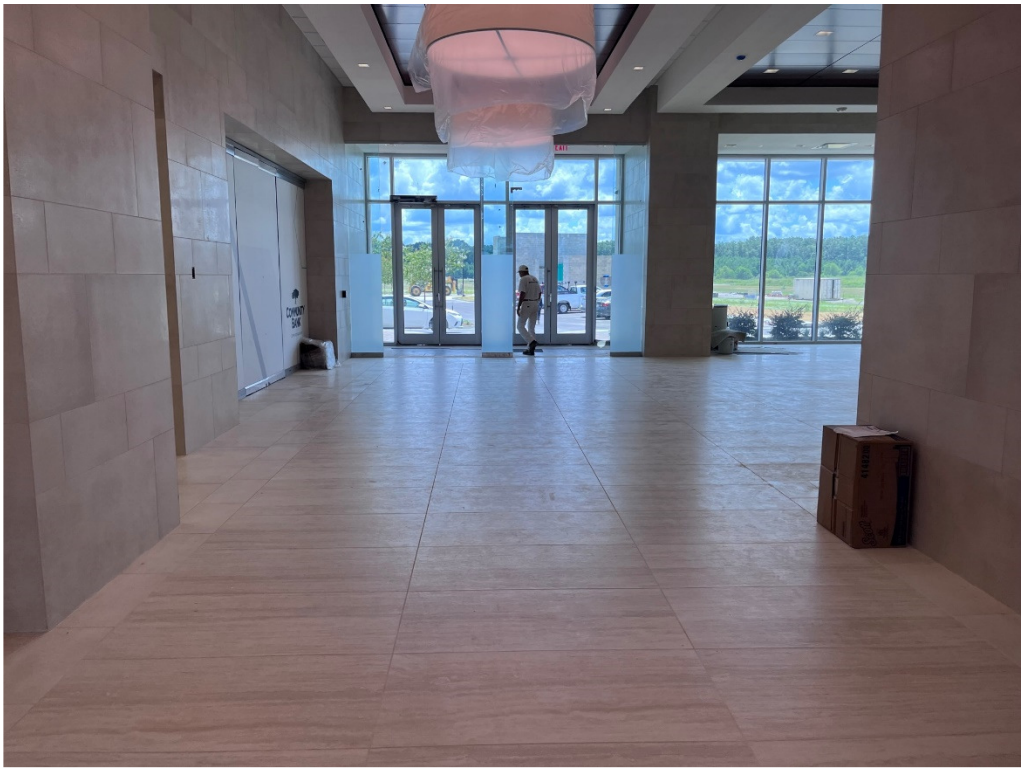
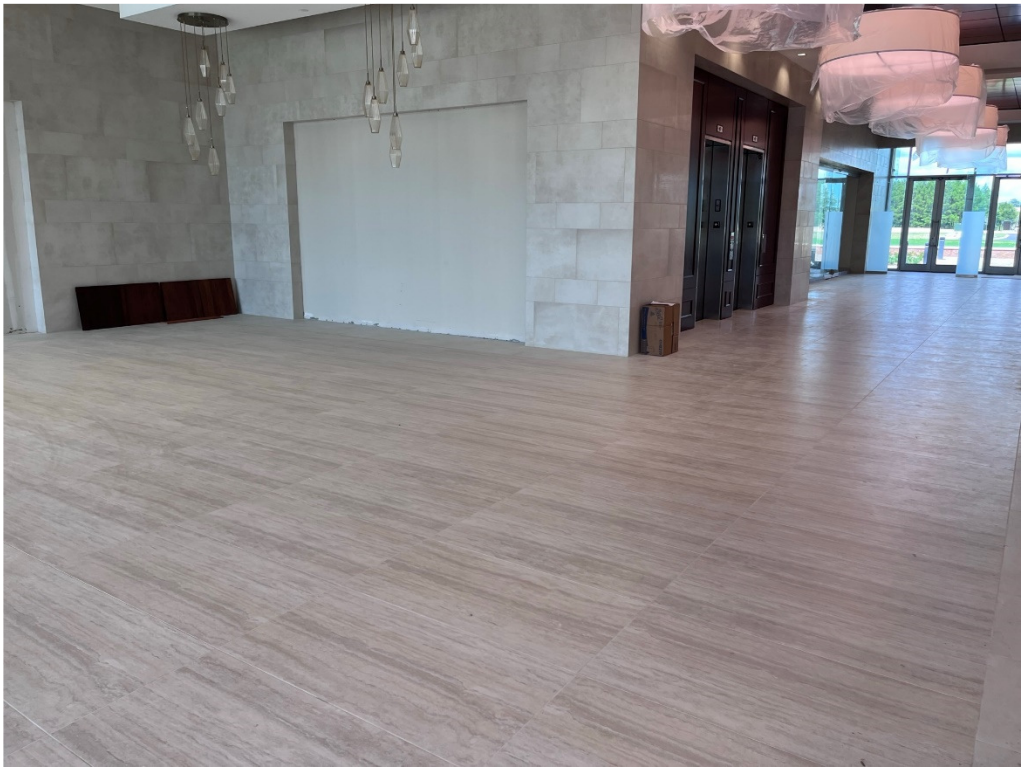
Figure 2 – 1<sup>st</sup> Floor Clean Lobby

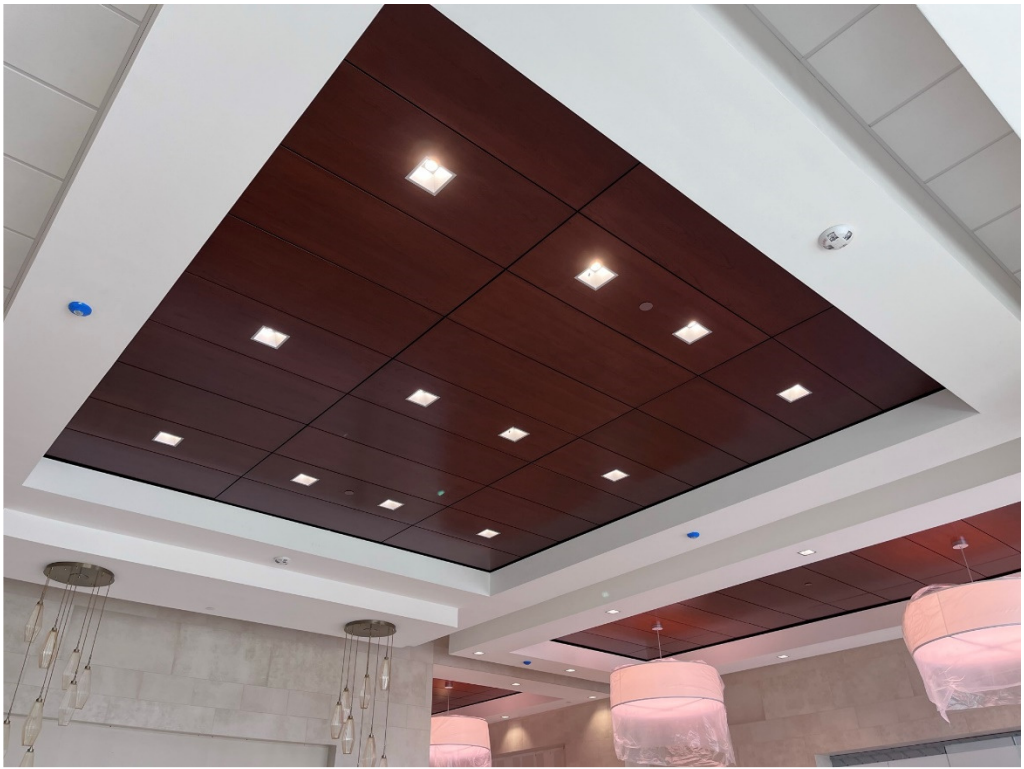
Figure 5 – 1<sup>st</sup> Floor Lobby Ceilings

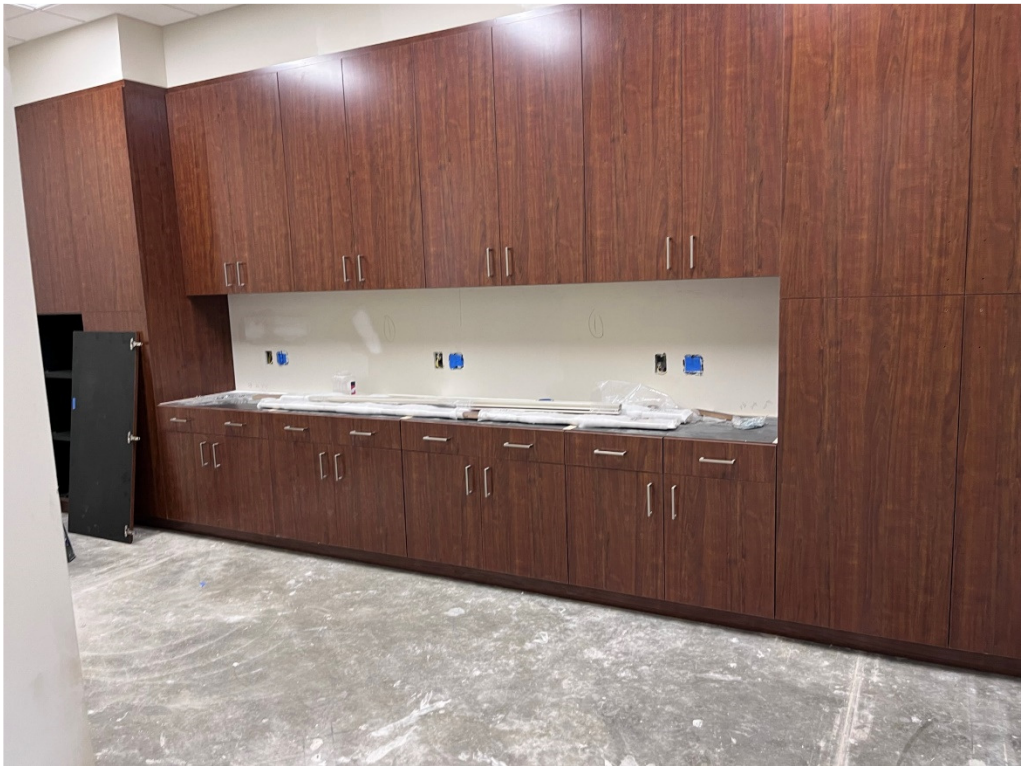
Figure 6 – 1<sup>st</sup> Floor Workroom Progress

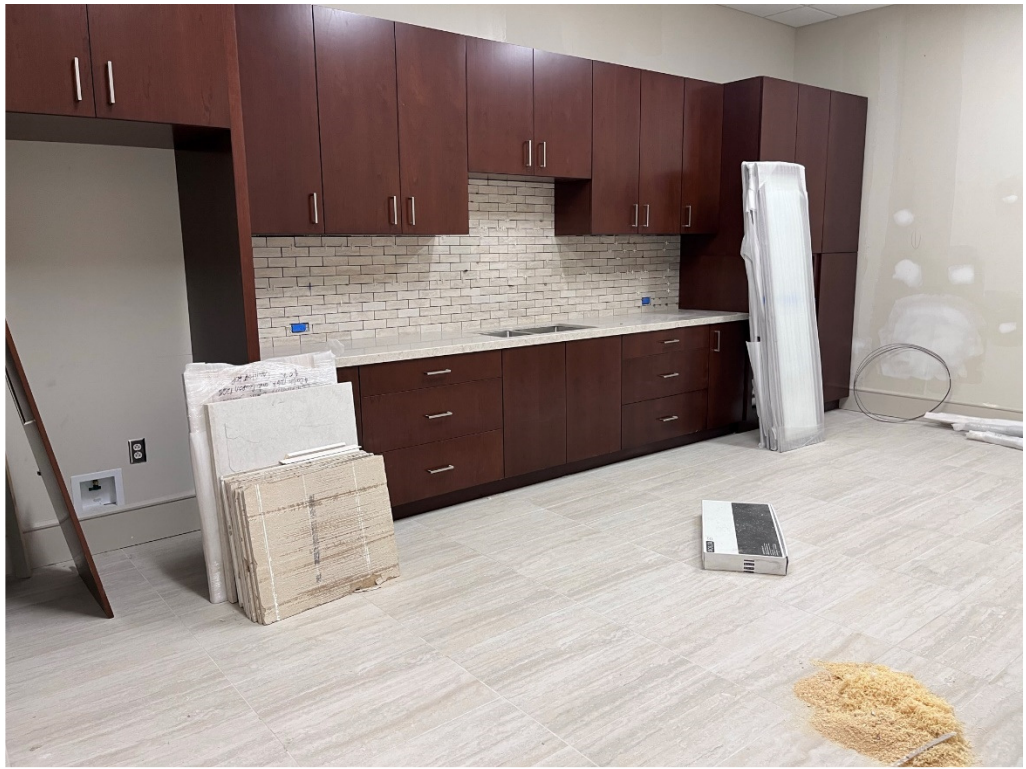
Figure 7 – 1<sup>st</sup> Floor Break Progress

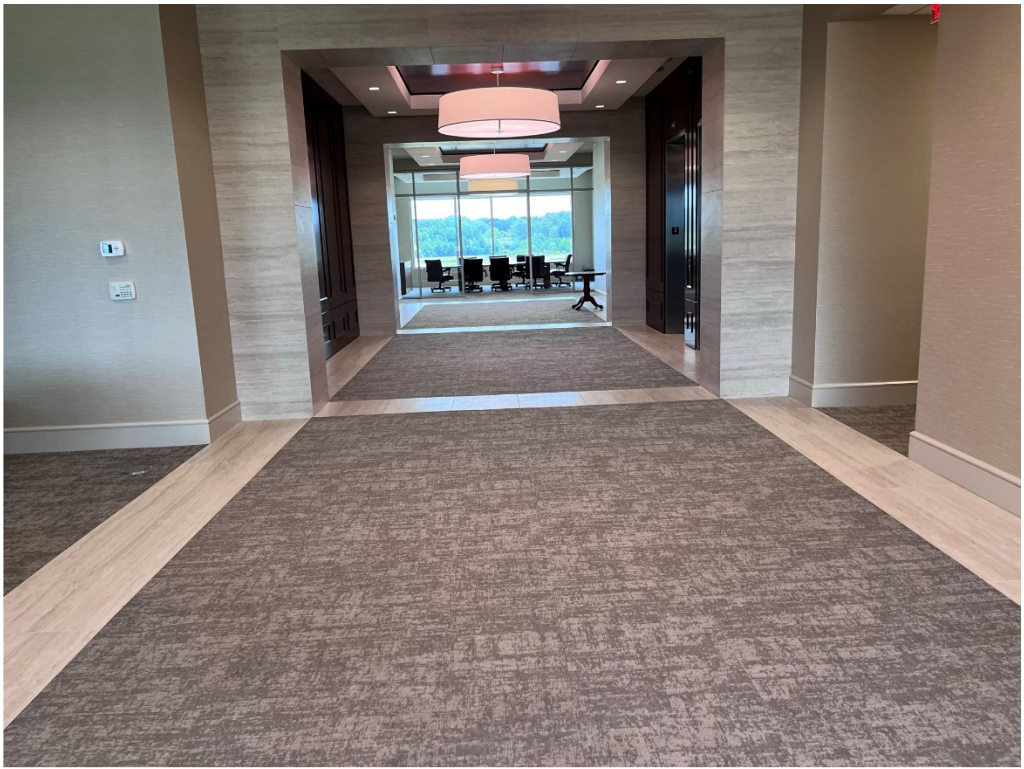
Figure 9 – 3<sup>rd</sup> Floor lobby

The third floor is clean and I was able to mark off 4 punch list items. There are 18 items still open on the punch list for the 3<sup>rd</sup> floor.

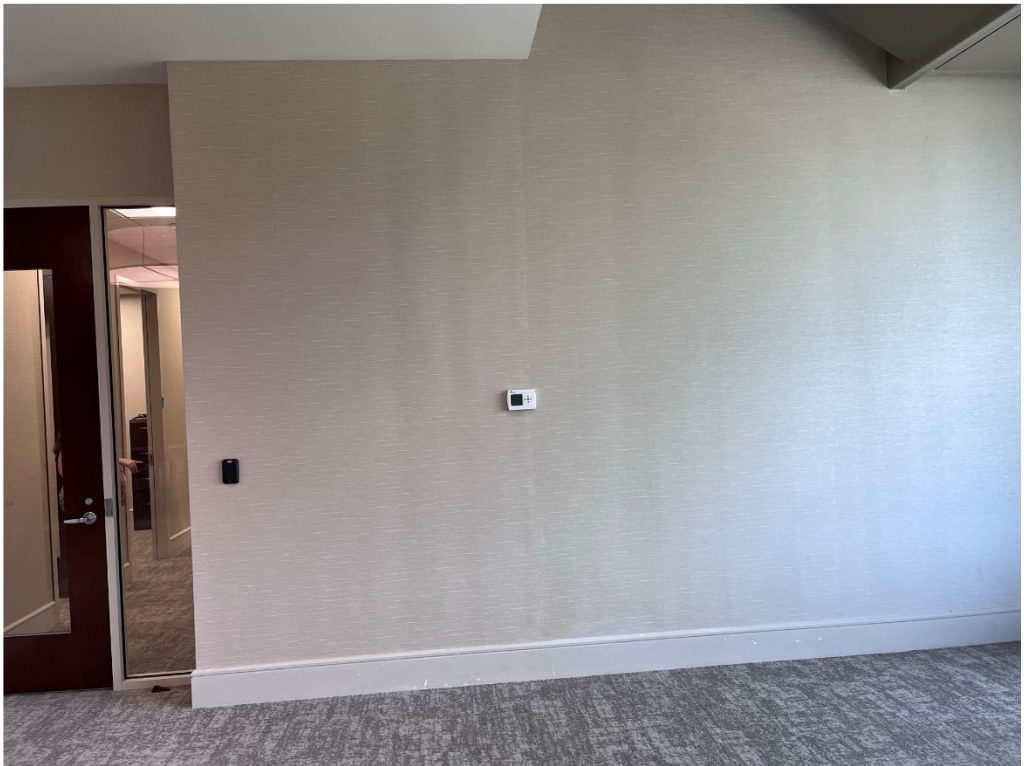
Figure 10 – Repair at 3<sup>rd</sup> floor wall still has visible deformities

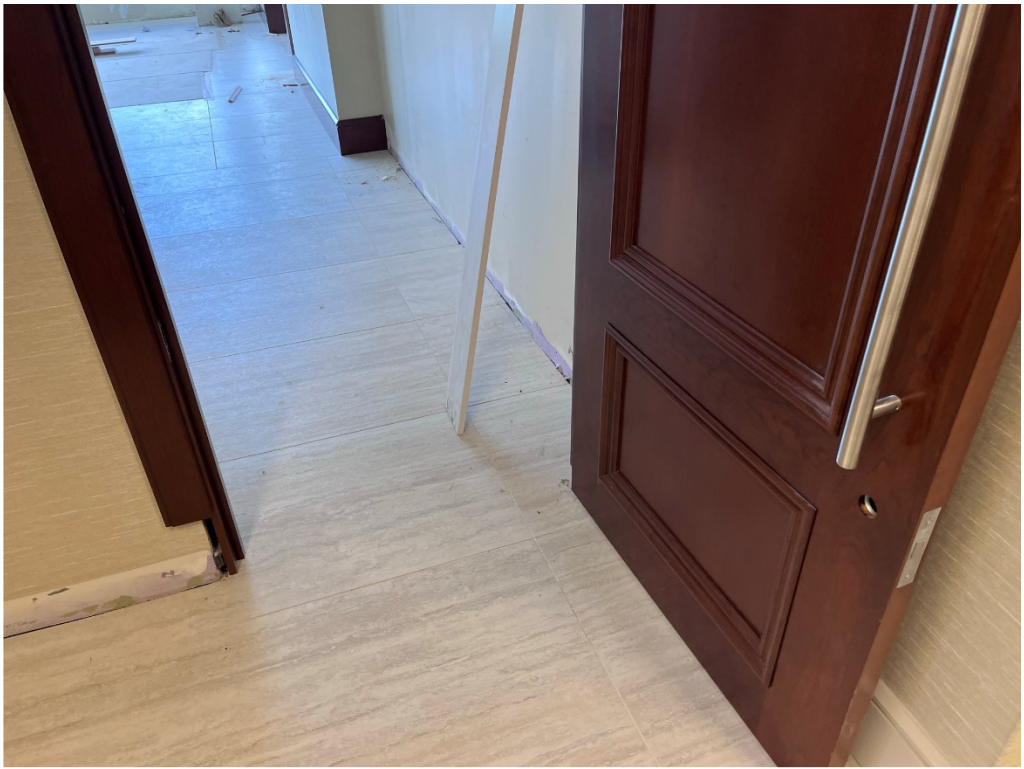
At the fourth floor, all wood floors have been stained and have received urethane. Ceilings in executive office appear complete. Flooring work is ongoing at the lobby. Millwork is ongoing as well. Also, wall covering installation. Carpet has been laid in the board room.

Figure 11 – Millwork is Ongoing

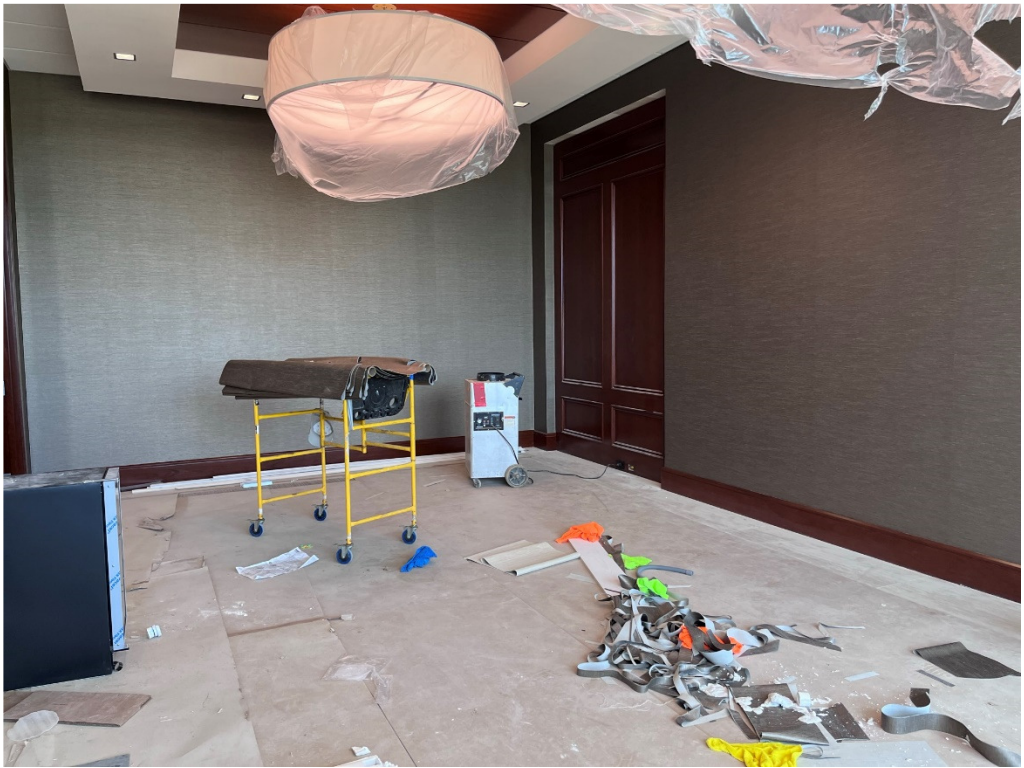
Figure 12 – Wall Covering progress

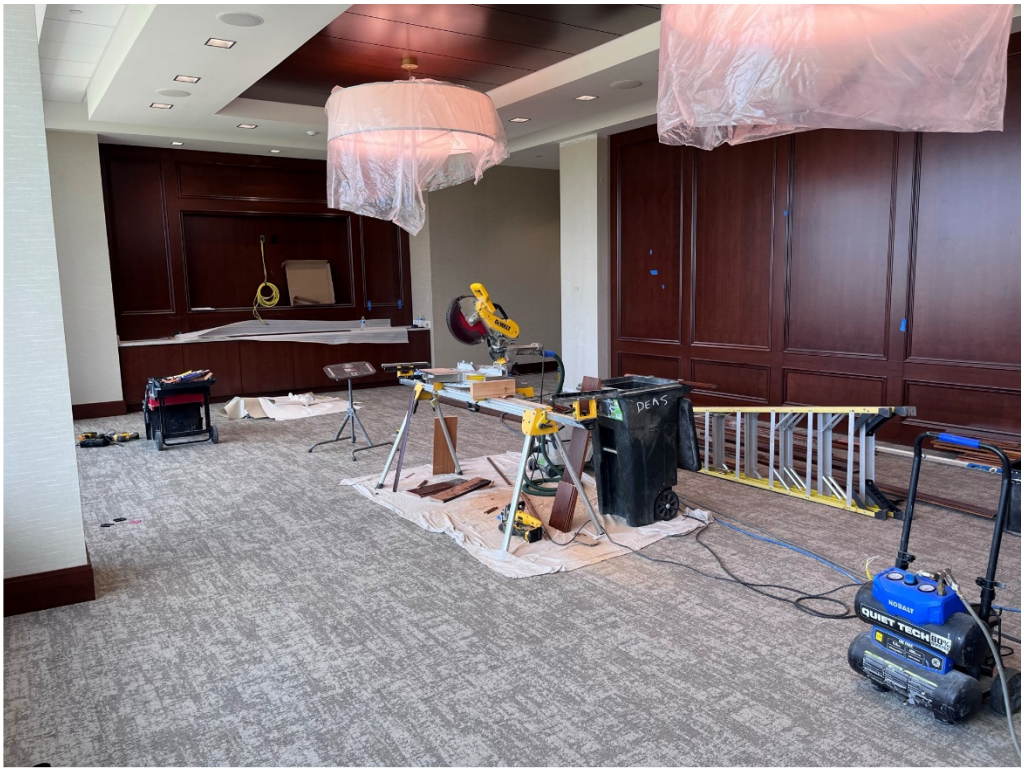
Figure 13 – Board Room Progress

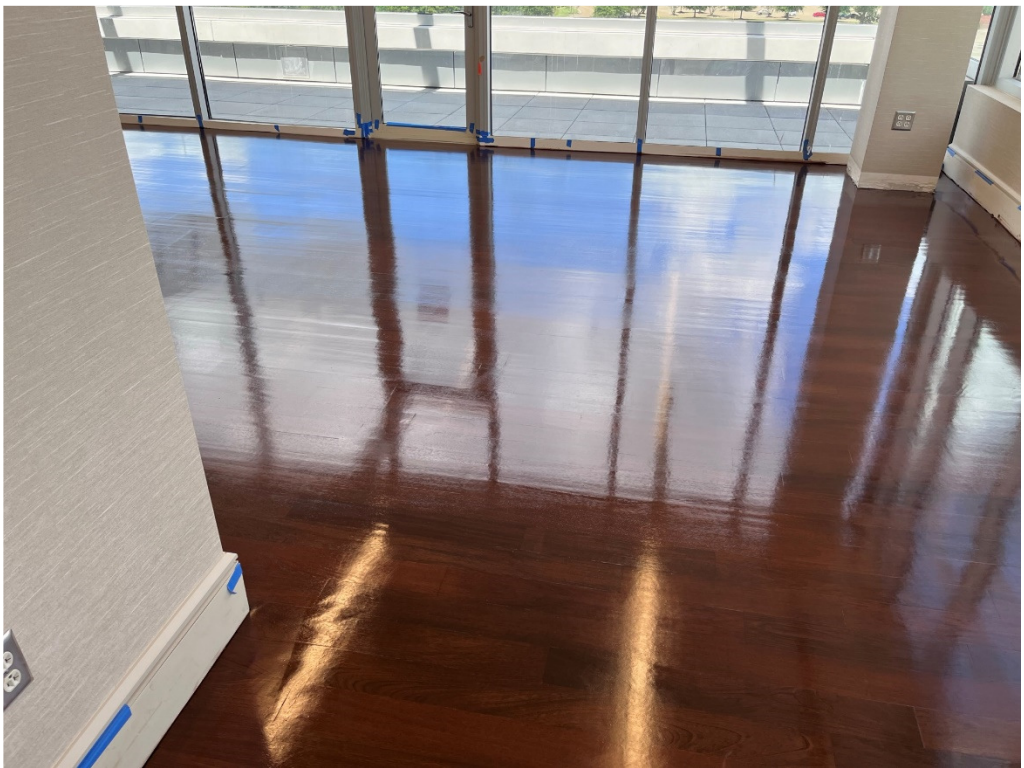
Figure 14 – Wood Floor, Drying

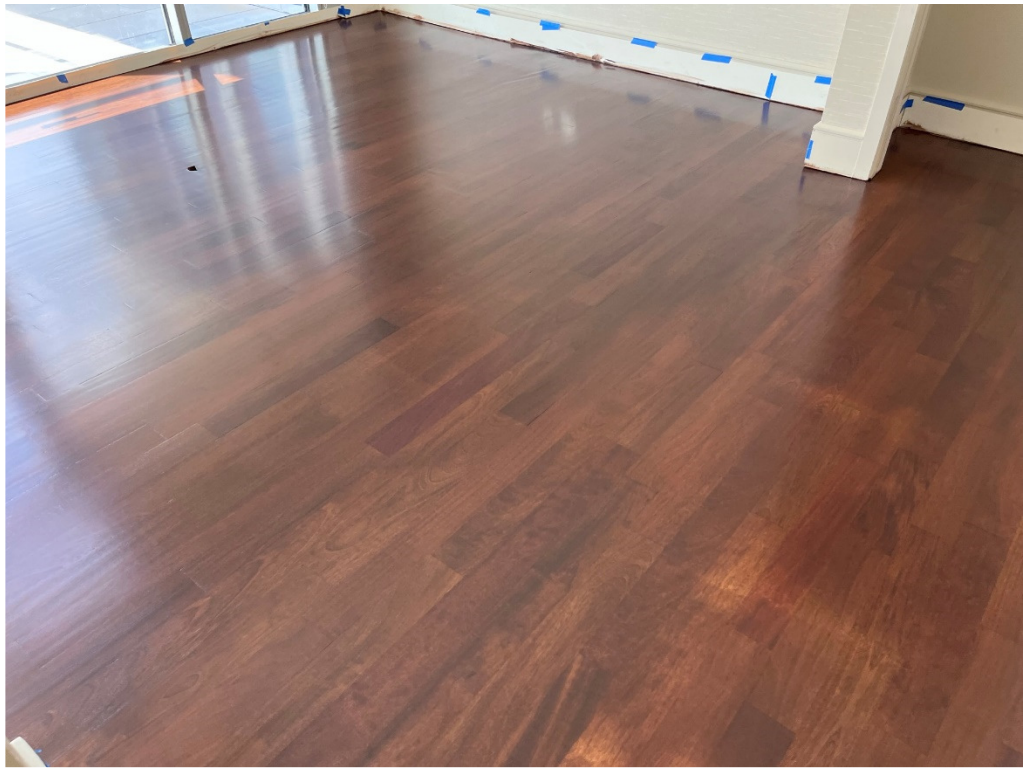
Figure 15 – Finished Wood Floor

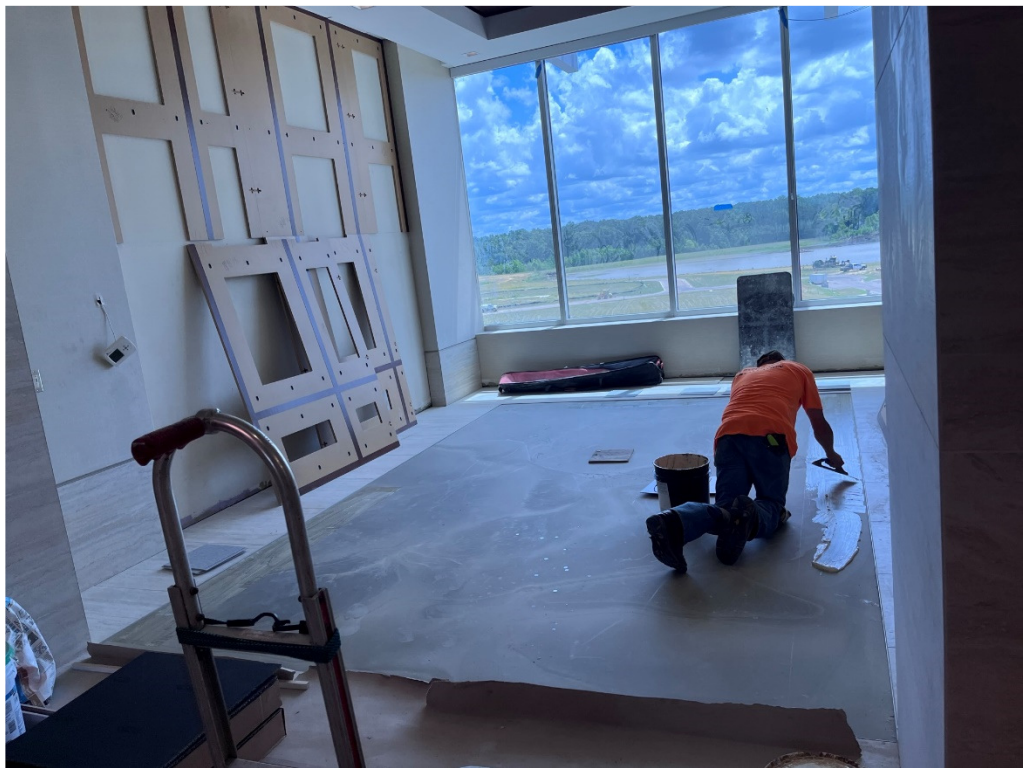
Figure 16 – Small Conference Progress

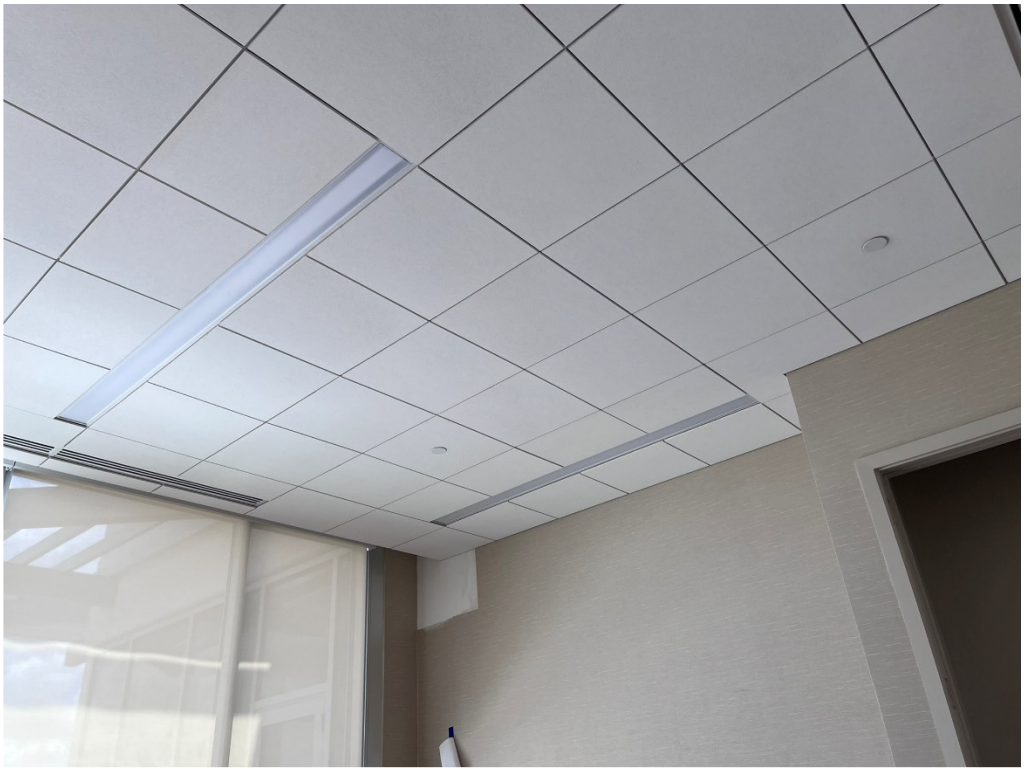
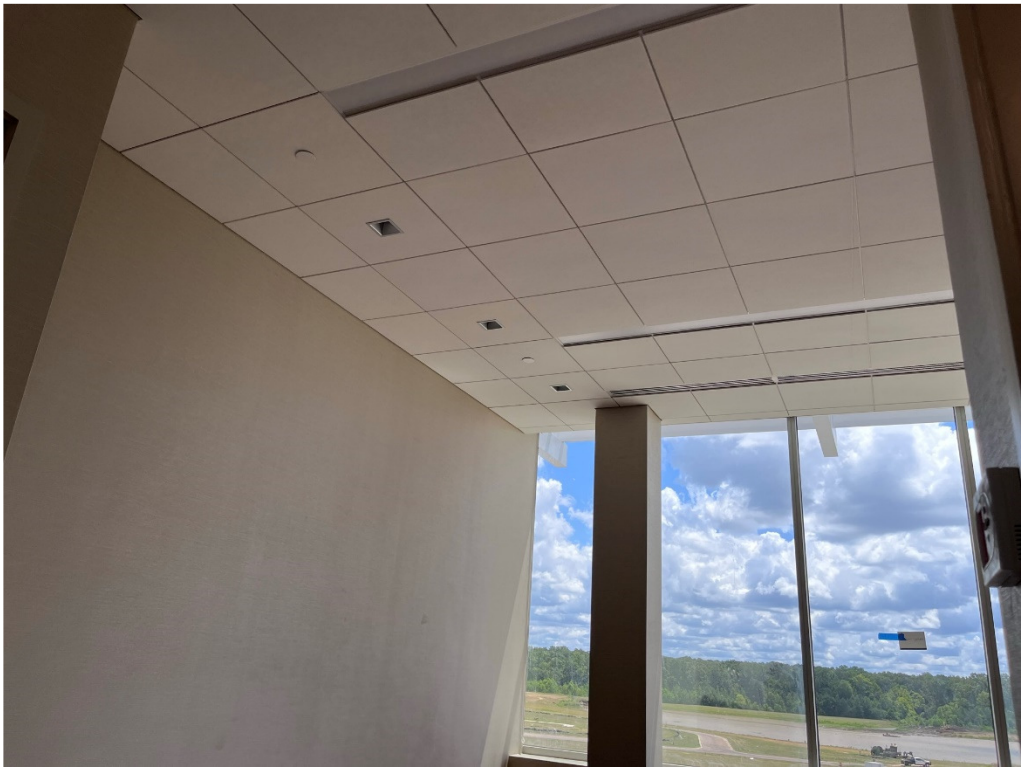
Figure 17 – Executive Office Ceilings
