Architect's Field Report

30 August 2022

15094 Community Bank Headquarters / Report Number 039

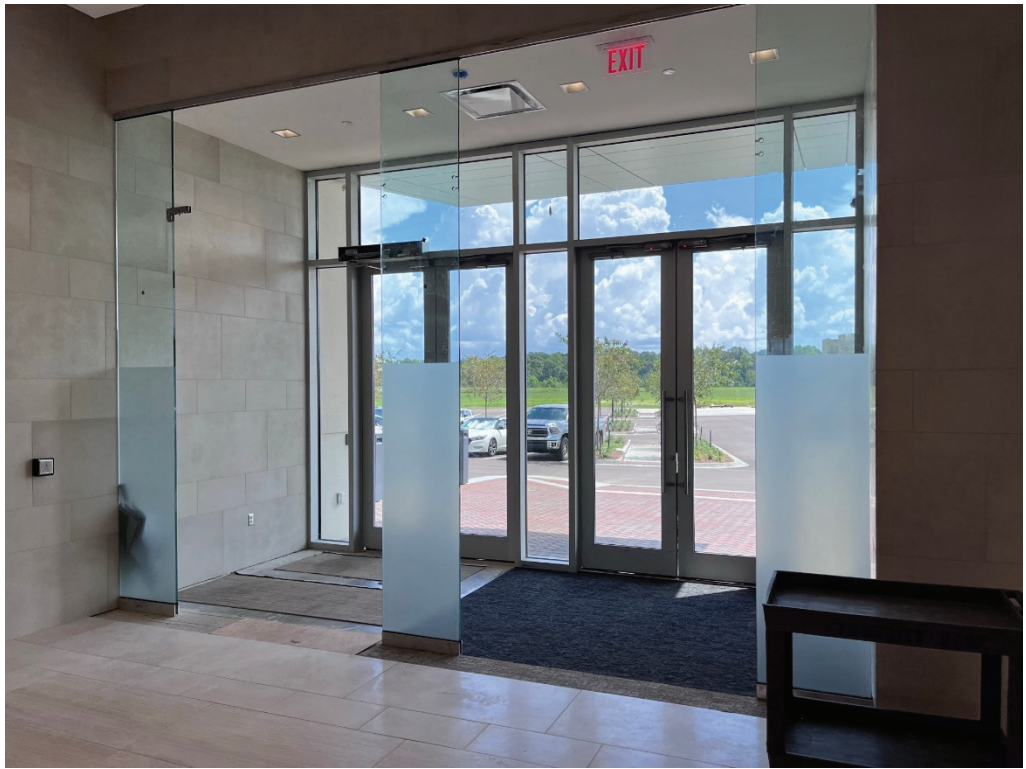
Figure 1 – 1st Floor Entry Progress

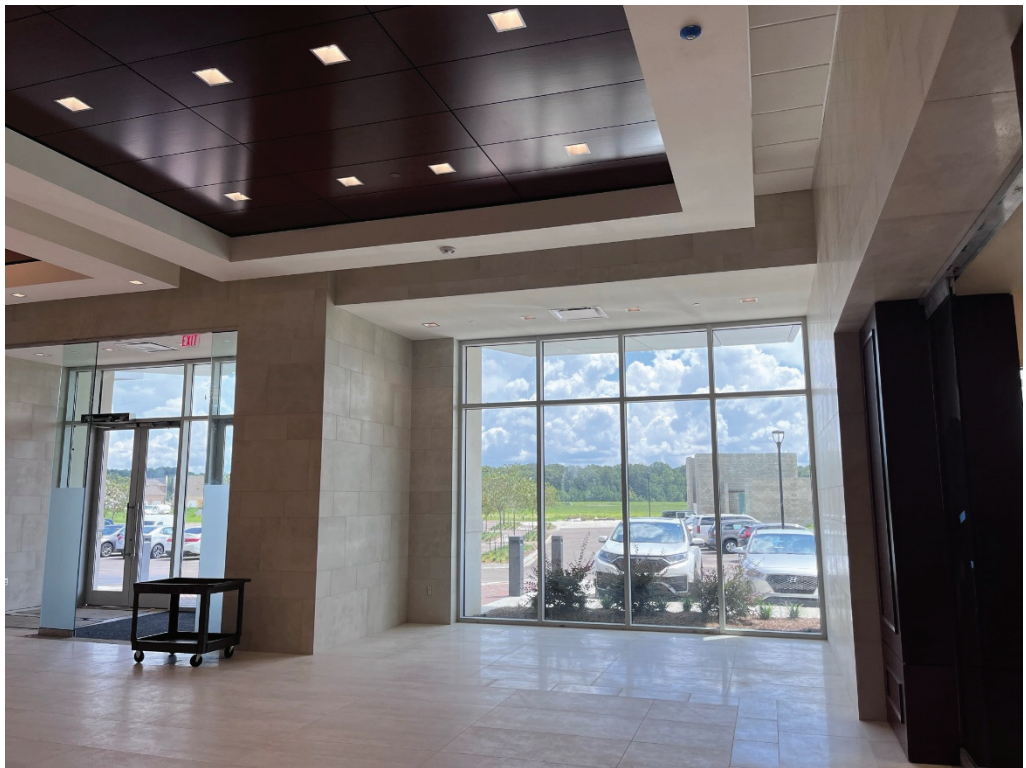
Figure 2 – 1st East Lobby

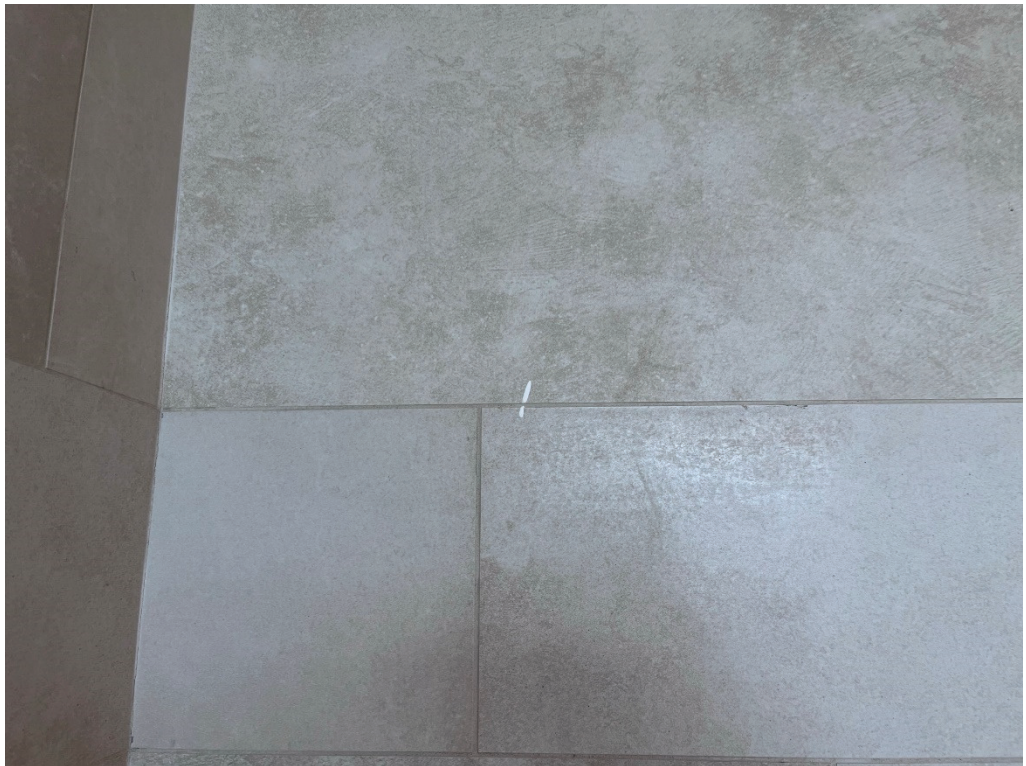
Figure 3 – Paint Noted on Tile Wall in East Lobby

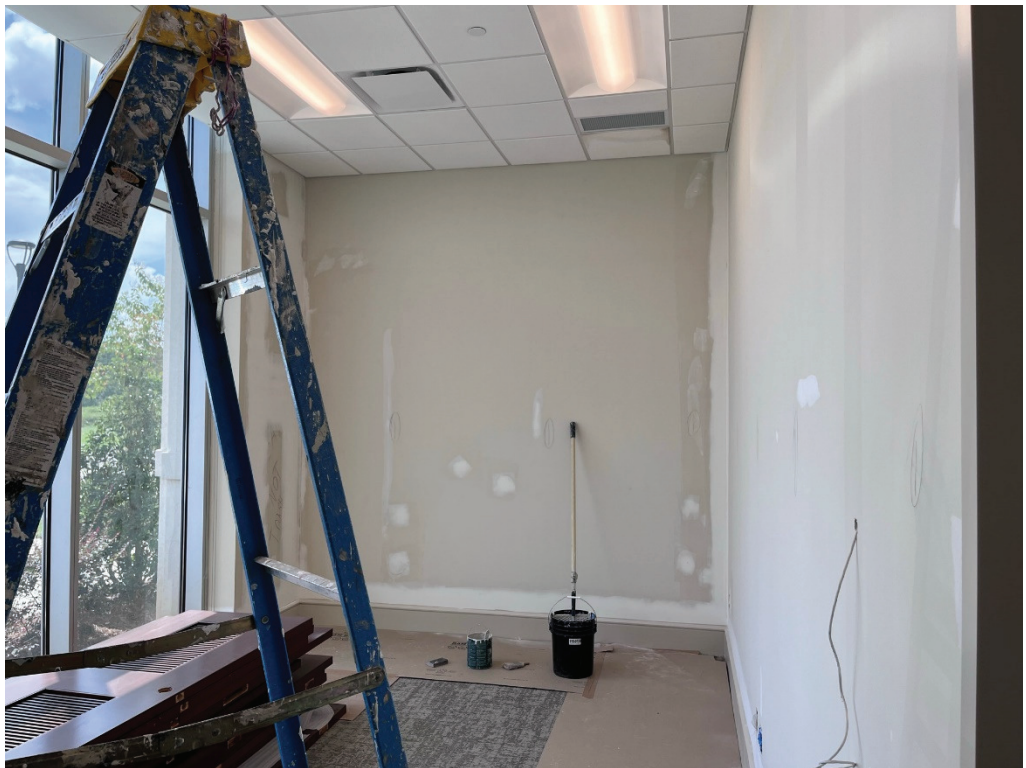
Figure 4 – 1st Floor East Offices prepared for Wall Coverings

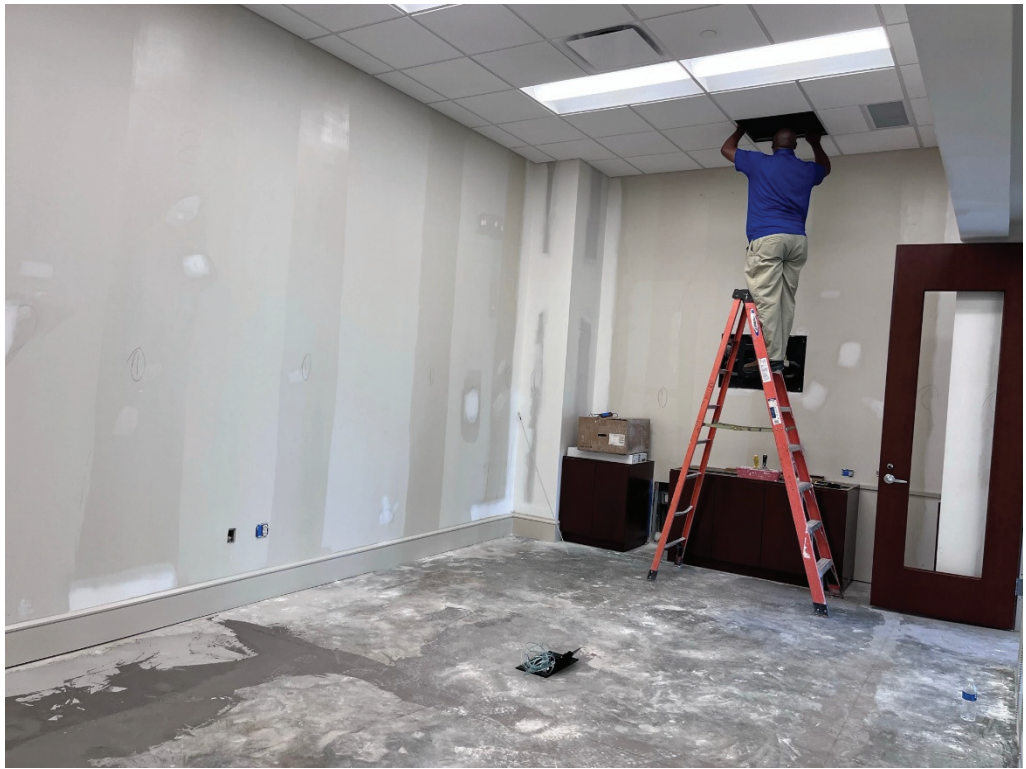
Figure 5 – Network Installer On Site in Conference 1st Floor

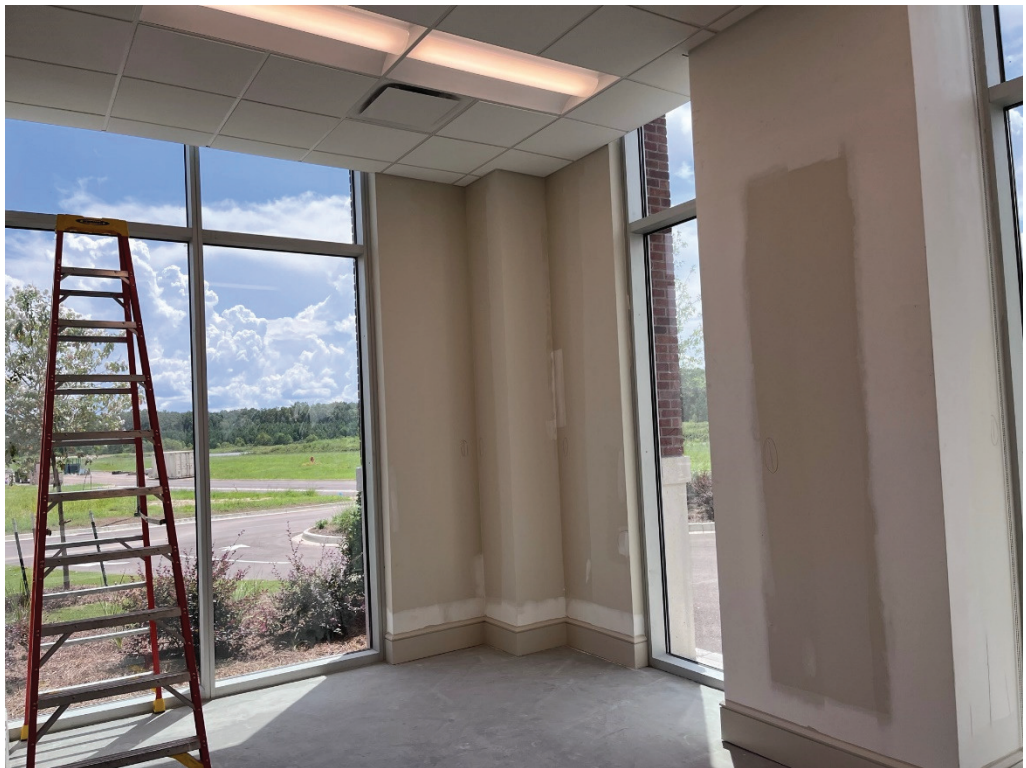
Figure 6 – 1st Floor East Offices

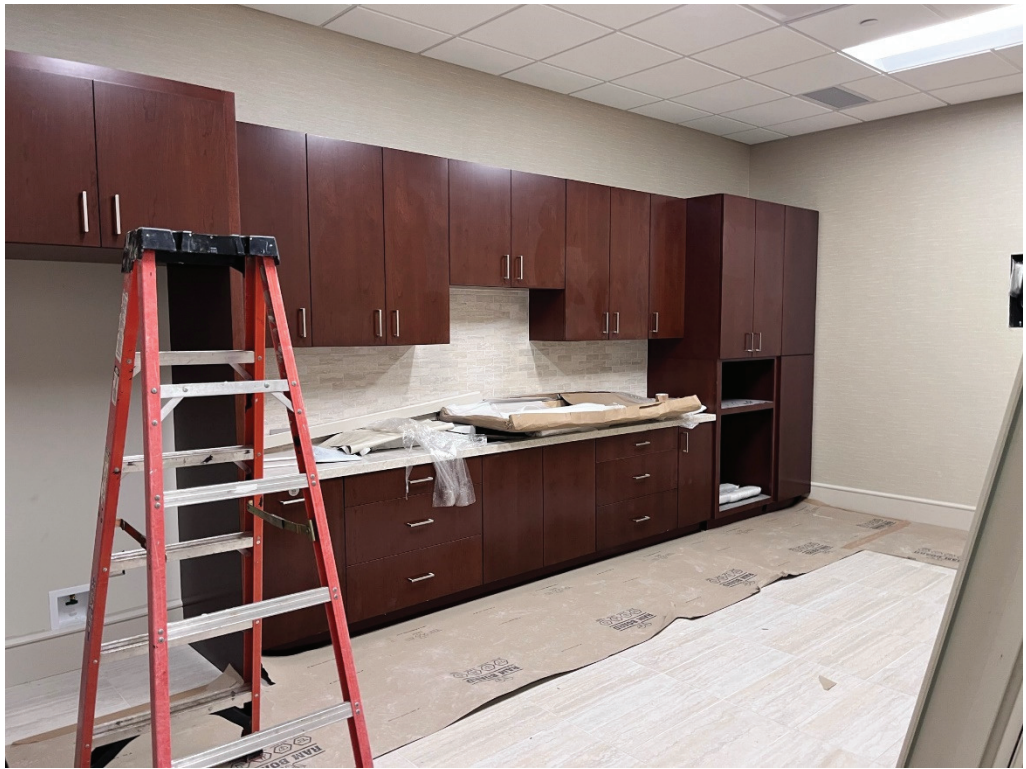
Figure 7 – 1st Floor Break Progress

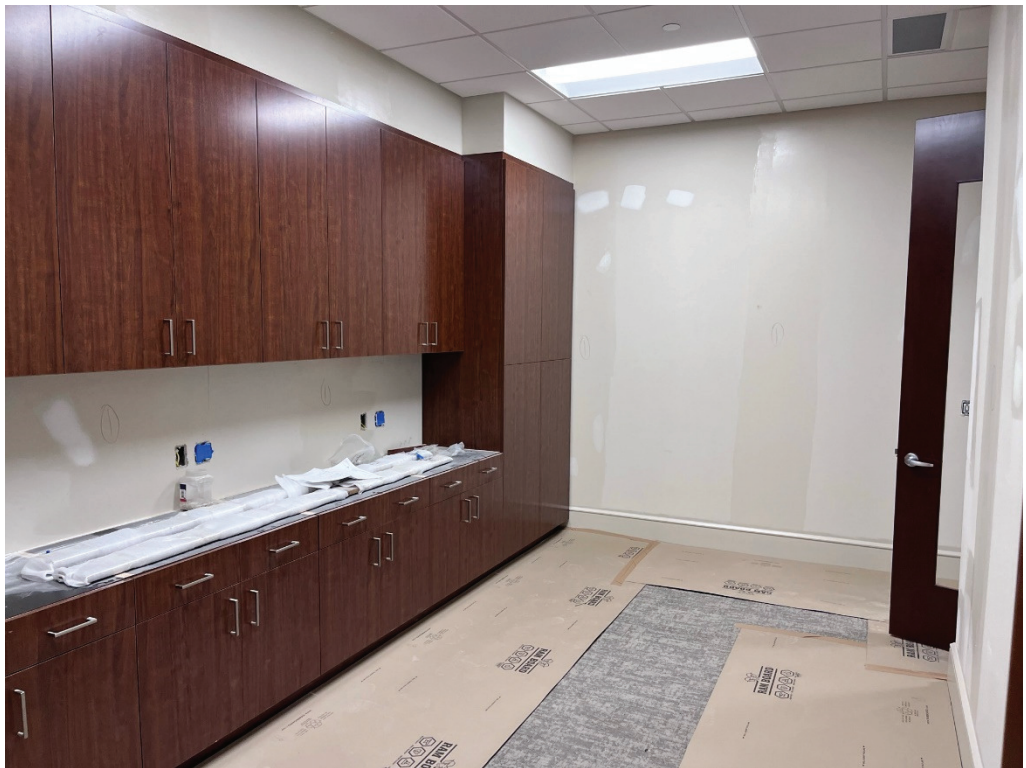
Figure 8 – Carpet Installed in Many Rooms at 1st

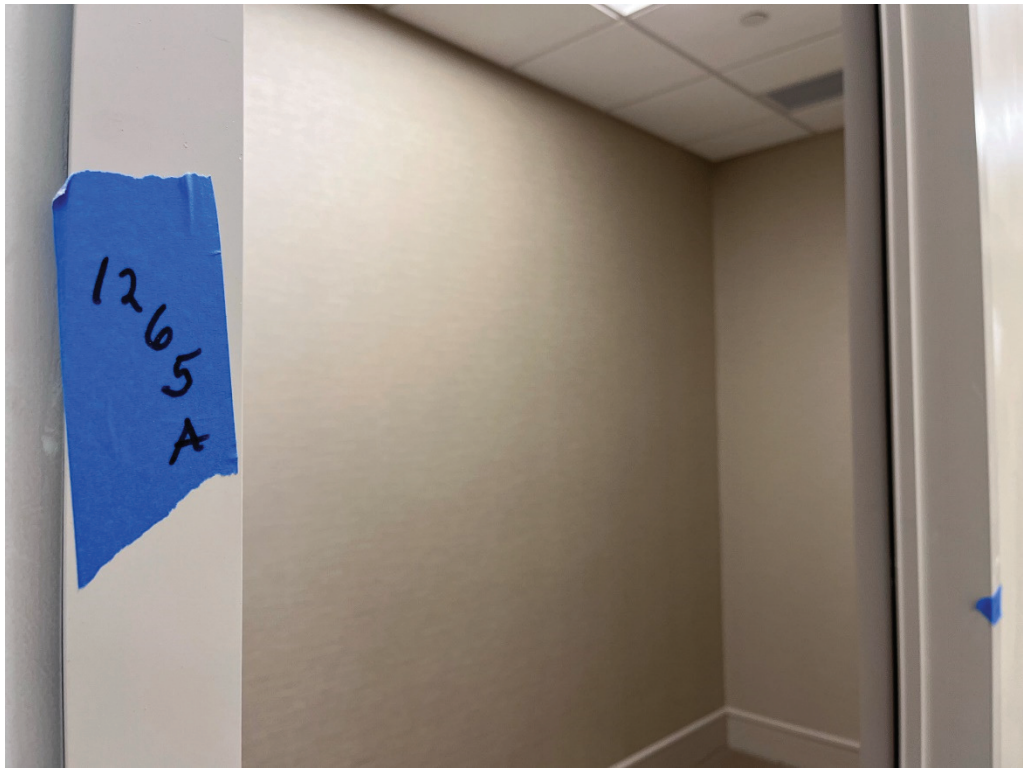
Figure 9 – 1st Floor Wall Coverings are Ongoing

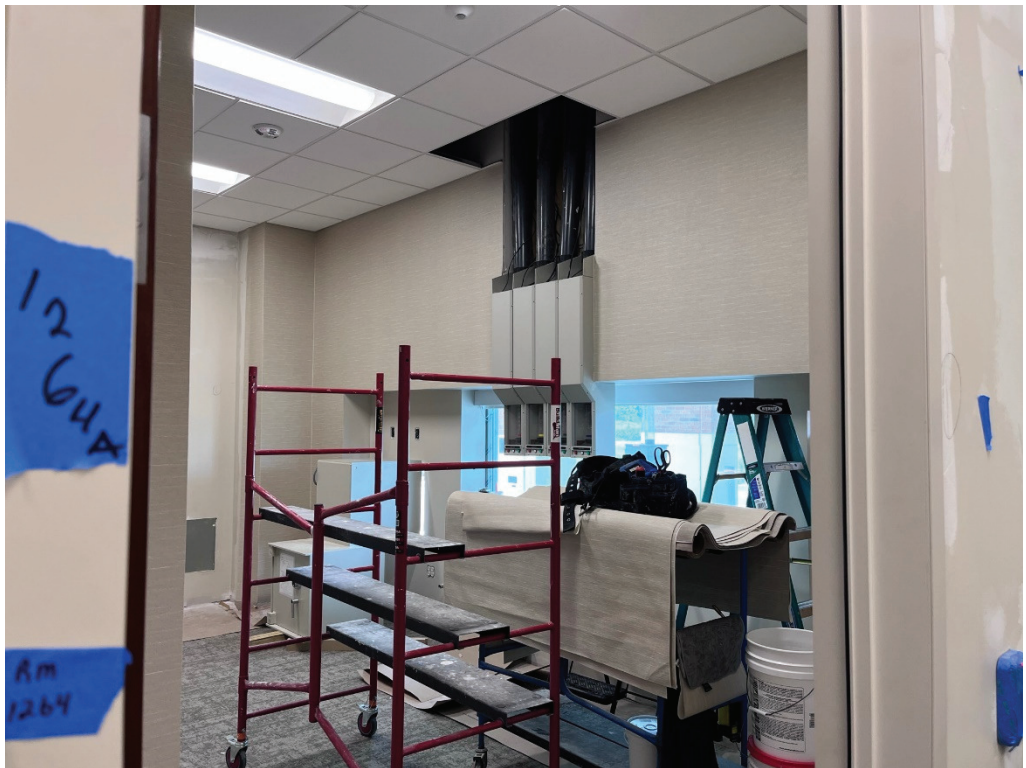
Figure 10 – Equipment Installers were at work in bank telling drive thru

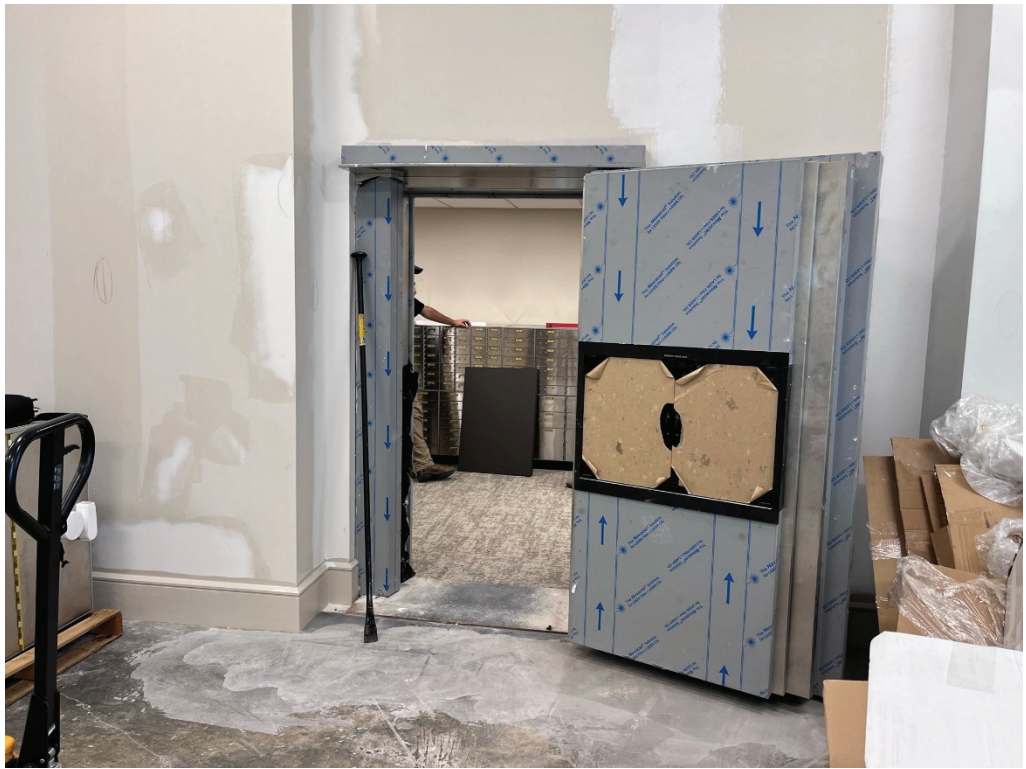
Figure 11 – Workers were present at Vault

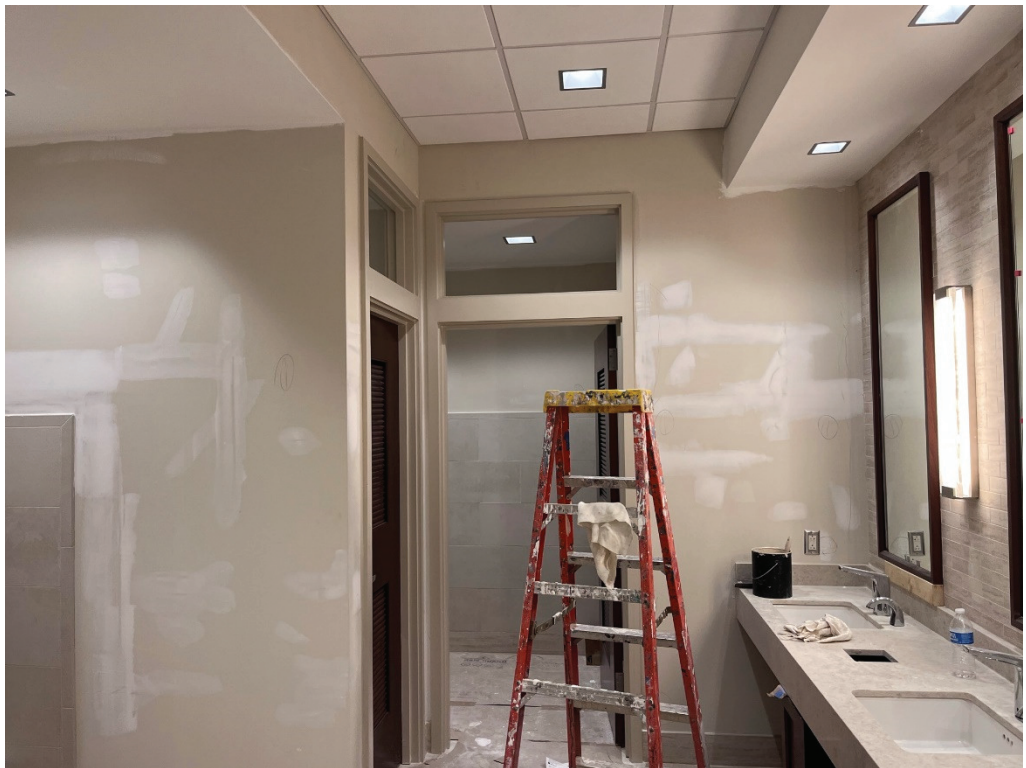
Figure 12 – Progress in First Floor Toilet Rooms

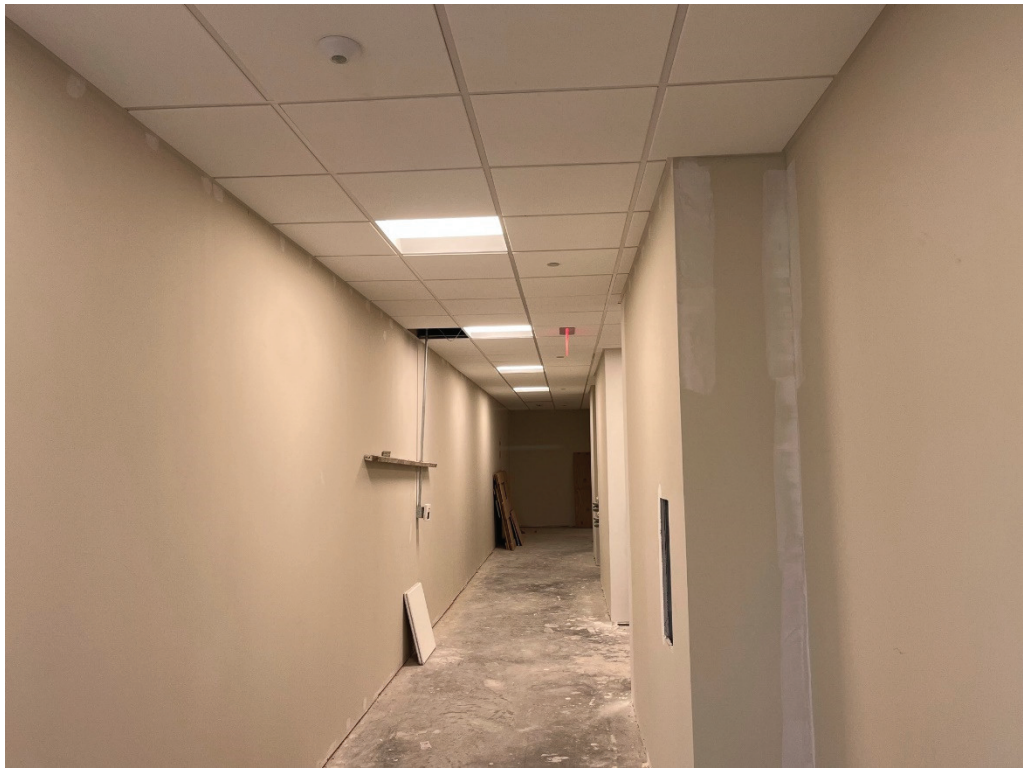
Figure 13 – 2nd Floor Shared Space Ceilings Installed

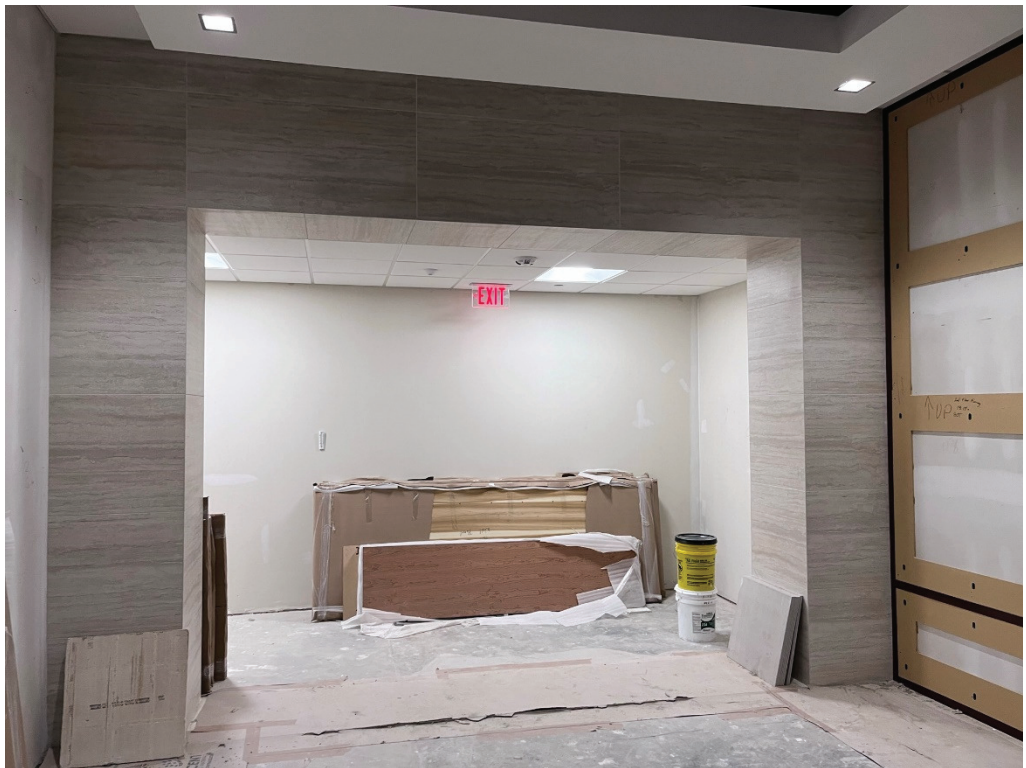
Figure 14 – 2nd Floor Shared Space Ceilings Installed

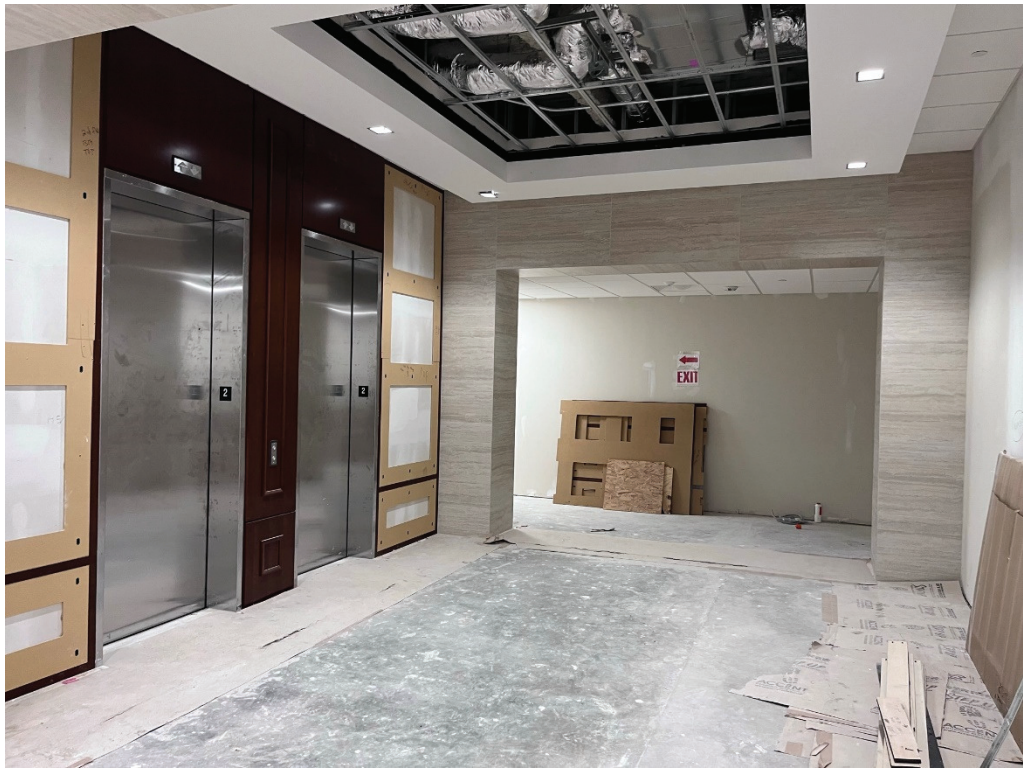
Figure 15 – 2nd Floor Shared Space Ceilings Installed

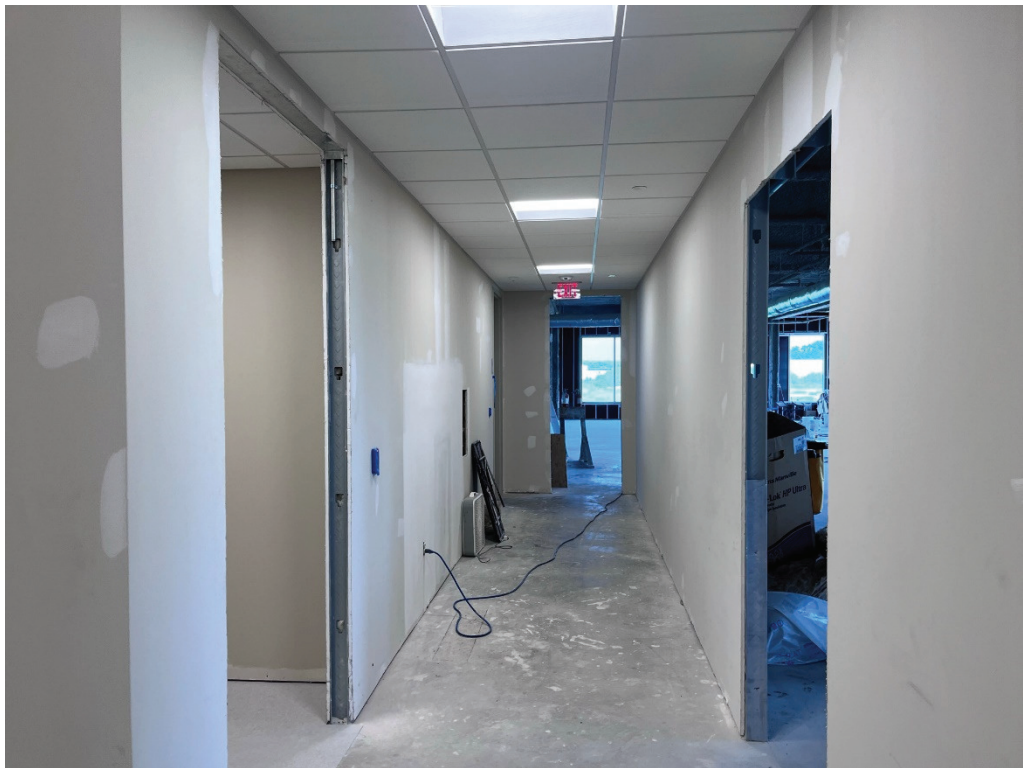
Figure 16 – 2nd Floor Shared Space Ceilings Installed

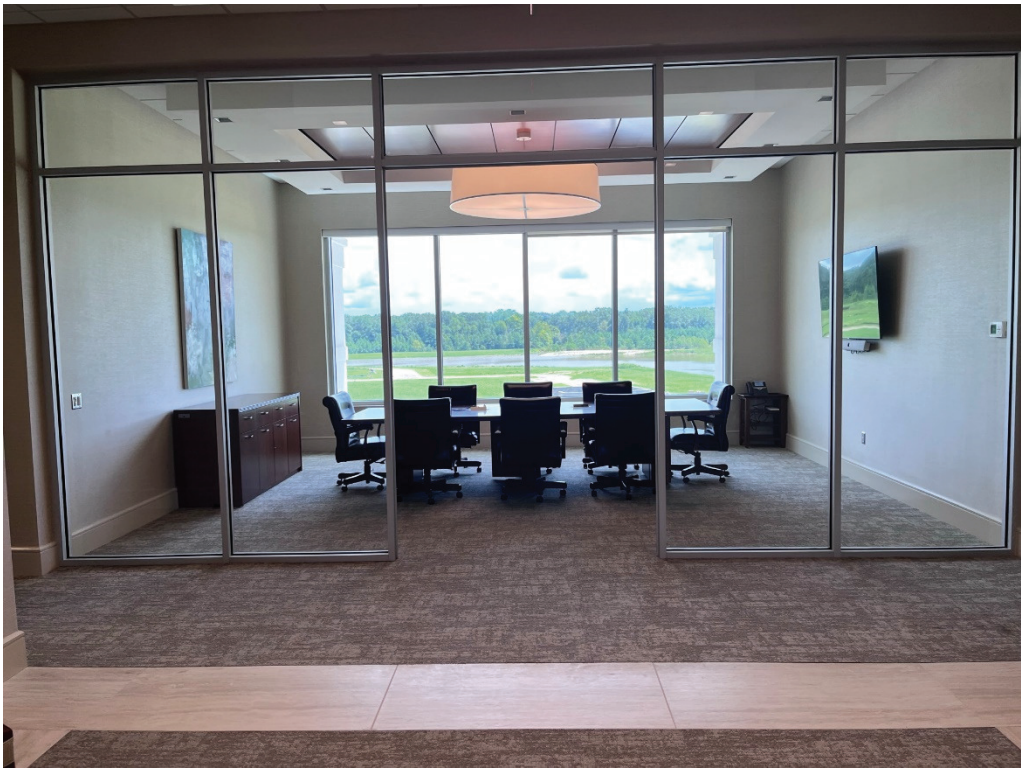
Figure 17 – 3rd Floor Conference Awaiting Doors

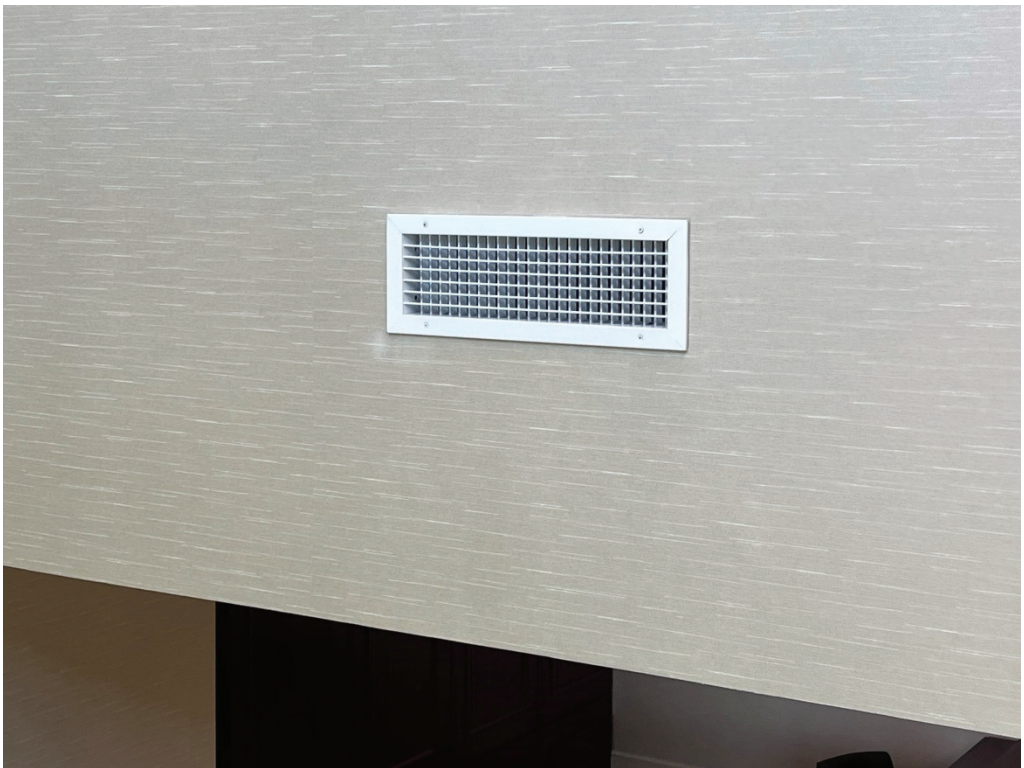
Figure 18 – Some Clean up still needed at vent between 3rd and 4th

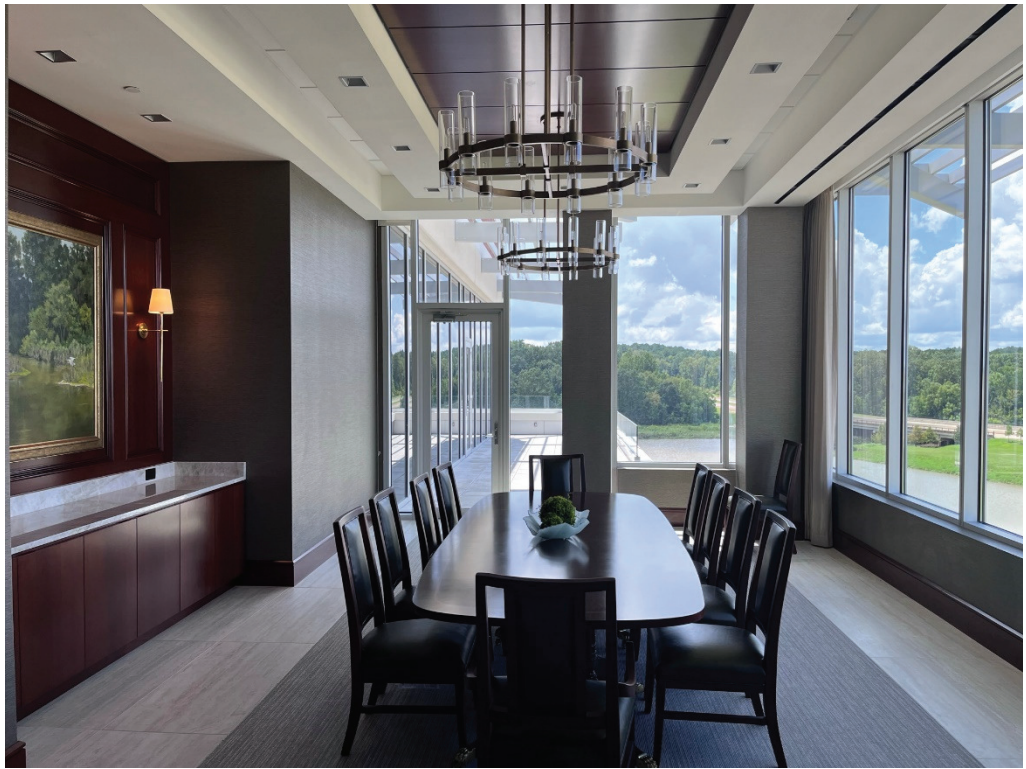
Figure 19 – 4th Floor Dining with Furniture (still a lot of work needed at ceiling)

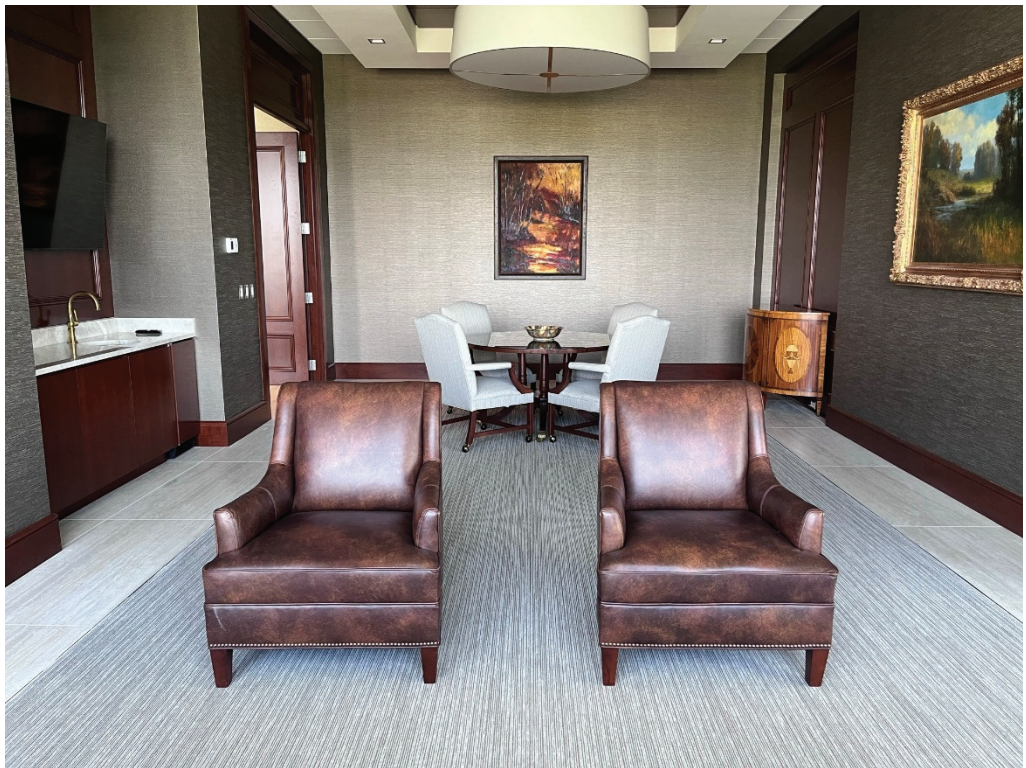
Figure 20 – 4th Floor Exec Space w Furniture

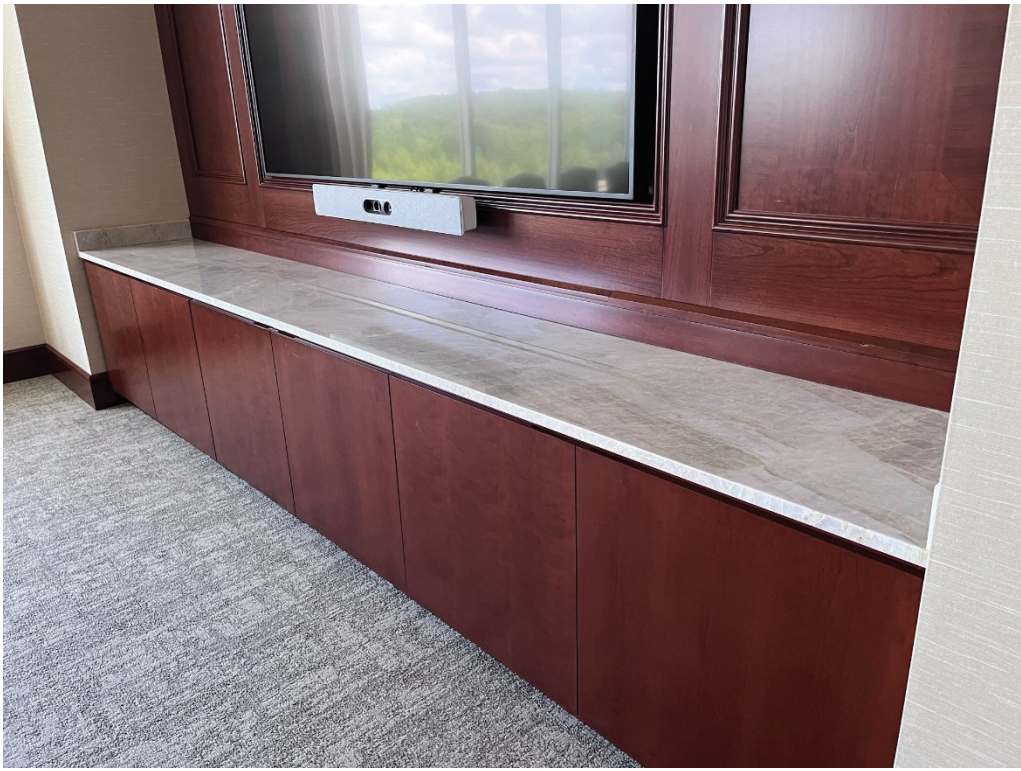
Figure 21 – Temp Backsplash Installed

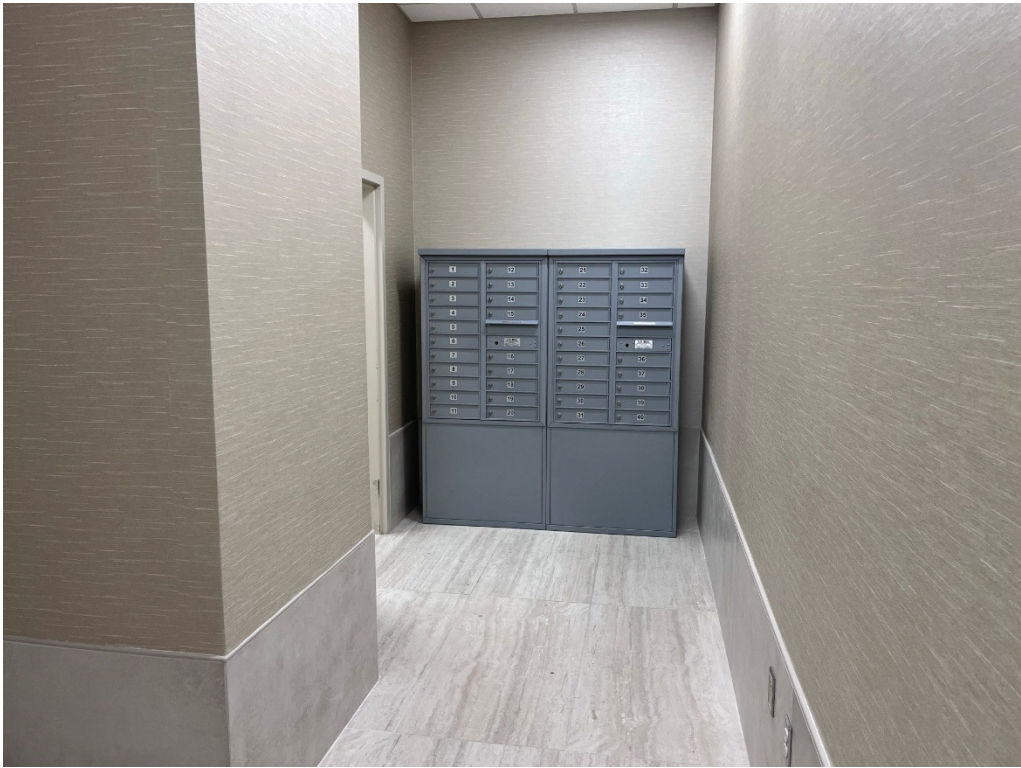
Figure 22 – 1st Floor PO Boxes
