Architect's Field Report

02 October 2019

18043-BW Beechwood Elementary / Report Number 002

Work in Progress Parking Lot Compaction & Sewer Line Rework / Ceiling Grid Demo

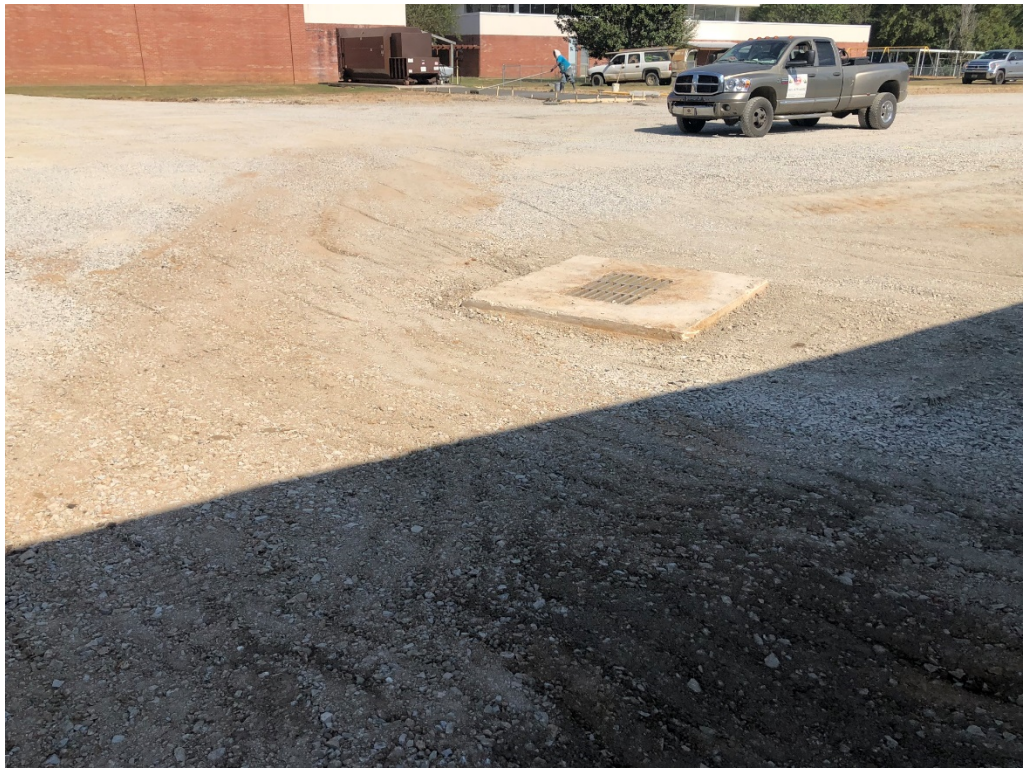
I immediately met Jason Stewart, Luke Walker, Jason McCoy, and Scott Mallette (Caydens) concerning sewer pipe damage and repair. We discussed the existing pipe is thin walled PVC and less than 18 inches below top of substrate; We spoke with Brad Griffin, (Mendrop Eng.) over the phone he recommended to repair with SCH 40 PVC until either pipe is outside of paved parking or is 18 inches below substrate.

Figure 5 – West Side of Parking (area that sewer was Damaged and Replaced)

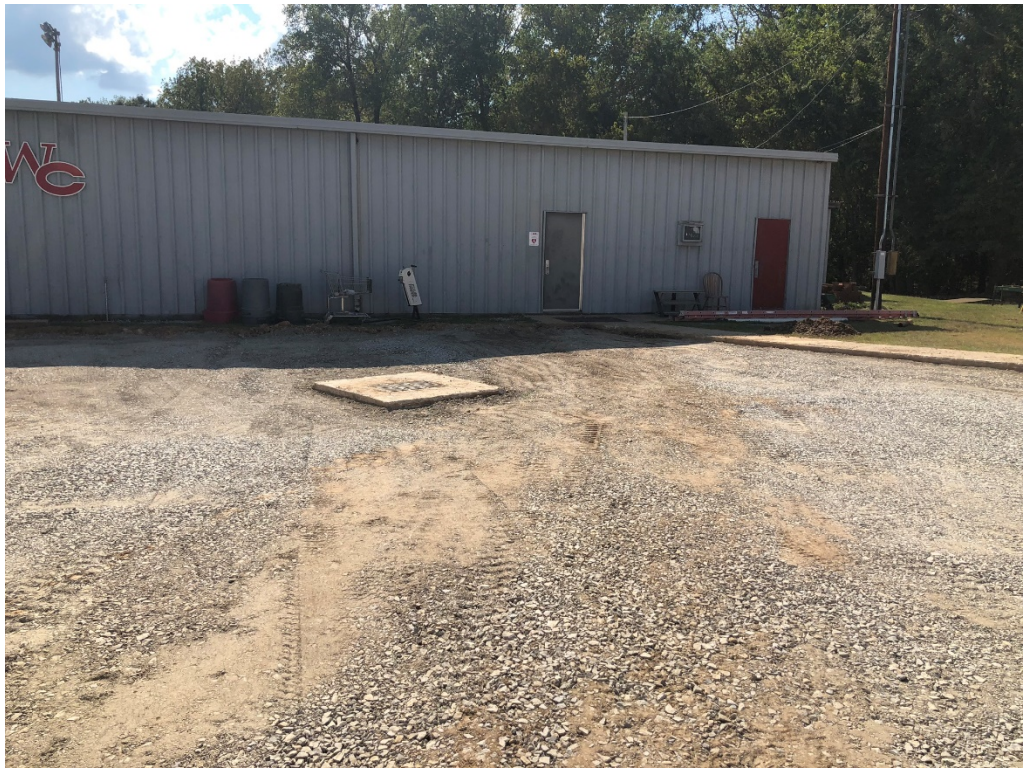
Figure 7 – Area that Sewer was Damaged and Replaced

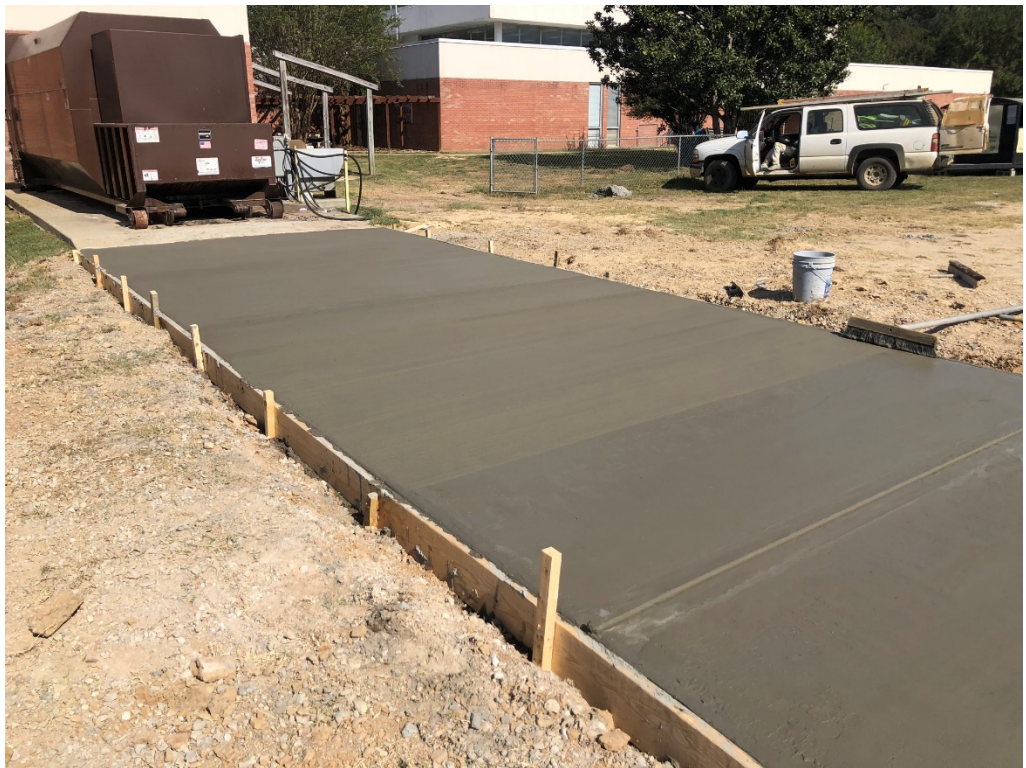
Substrate compaction was being performed in parking area; concrete finishers were completing work on the dumpster slab.

Figure 8 – Dumpster Pad Installed with Control Joints

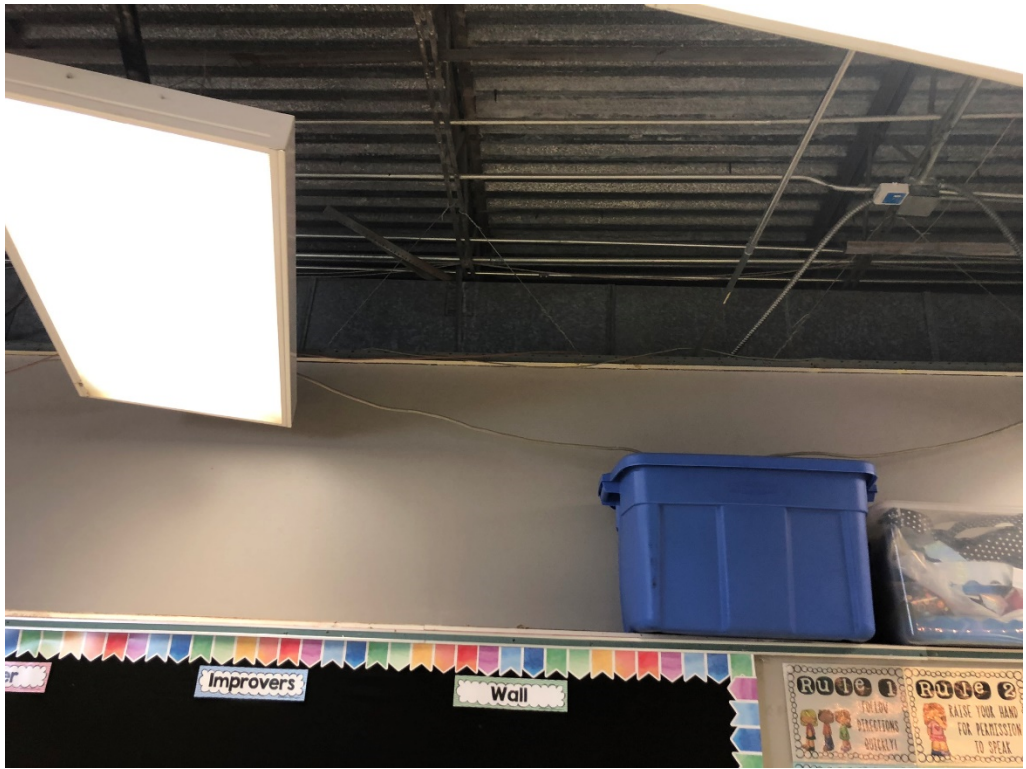
Figure 11 – Some Walls Prevent Sound Transference

Items to Verify Future demo in Class Spaces to be performed in every other room for reduced opportunity of sound transference.

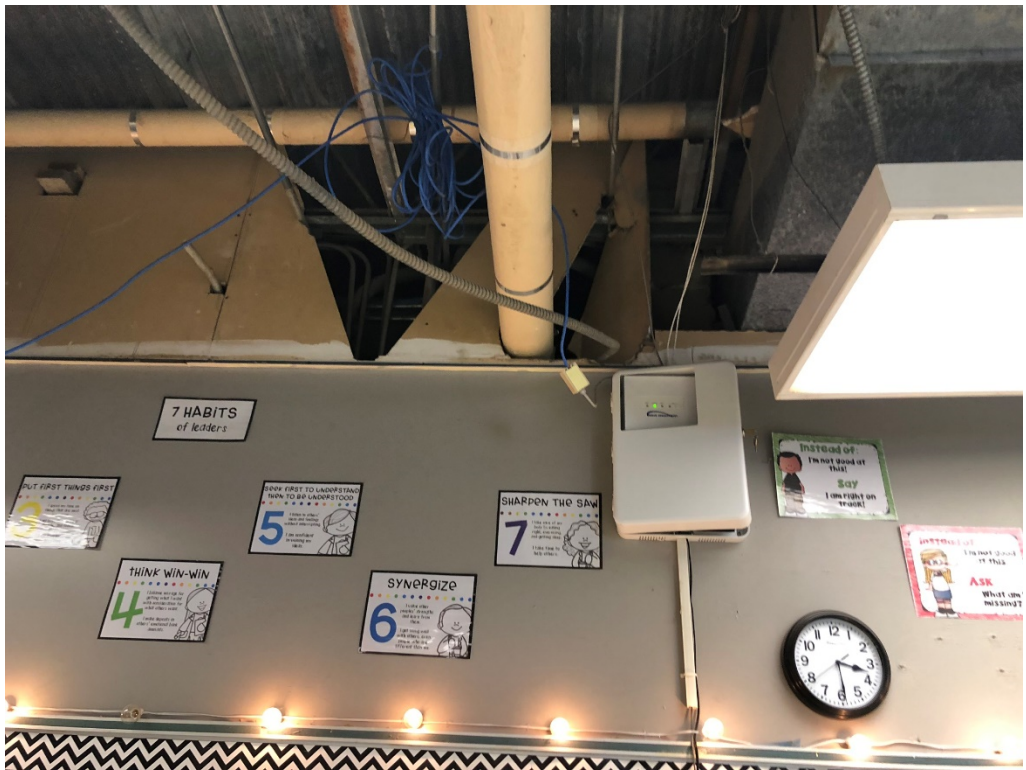
Figure 12 – Some Do NOT Prevent Sound Transference

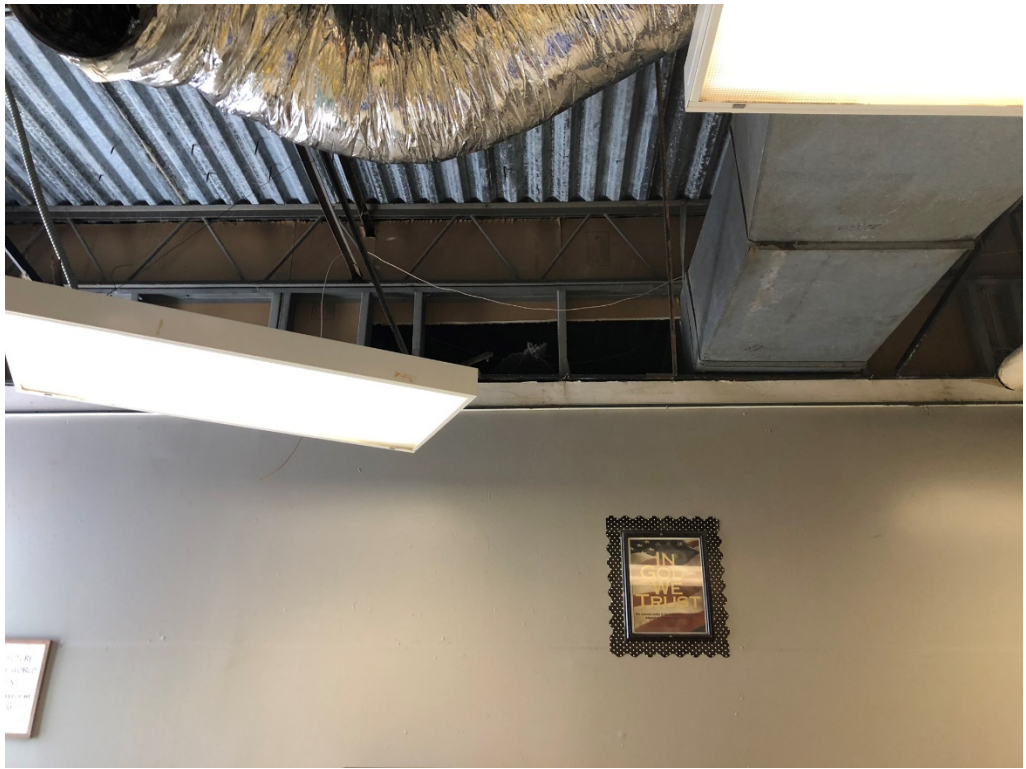
Figure 13 – Example of Opening in Upper Walls

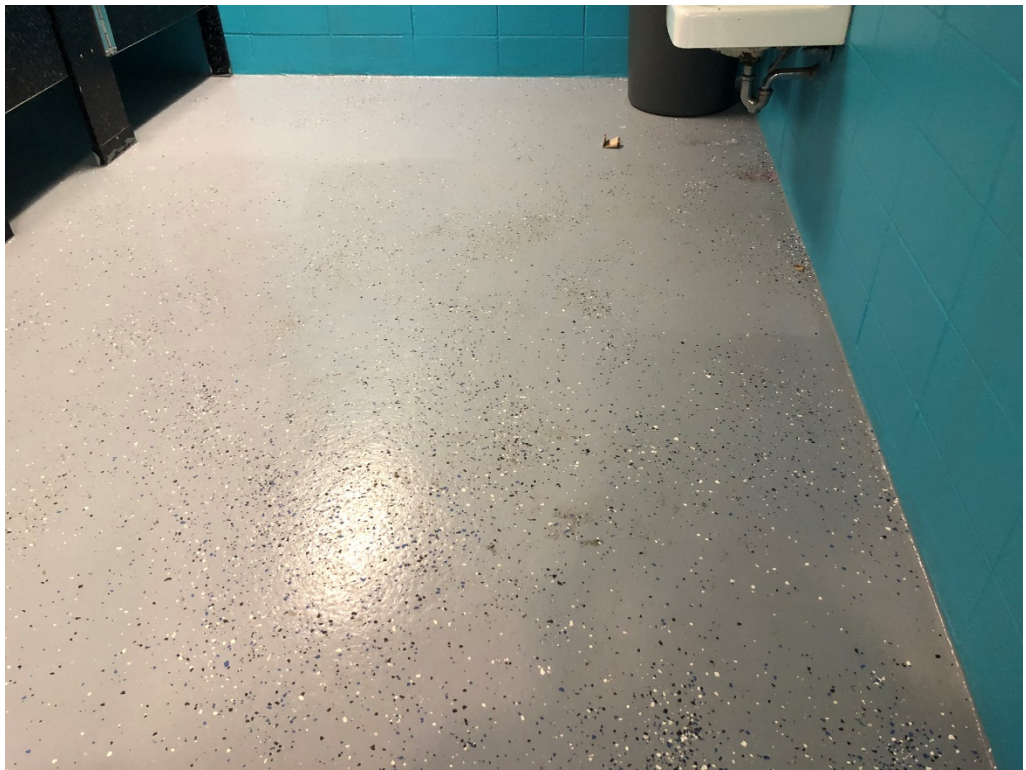
I noted that bathrooms have previously been painted prior to construction.

Figure 14 – Previously Painted Bathroom

Action Required Confirm Acceptability of Bathrooms' Floor Paint with client.

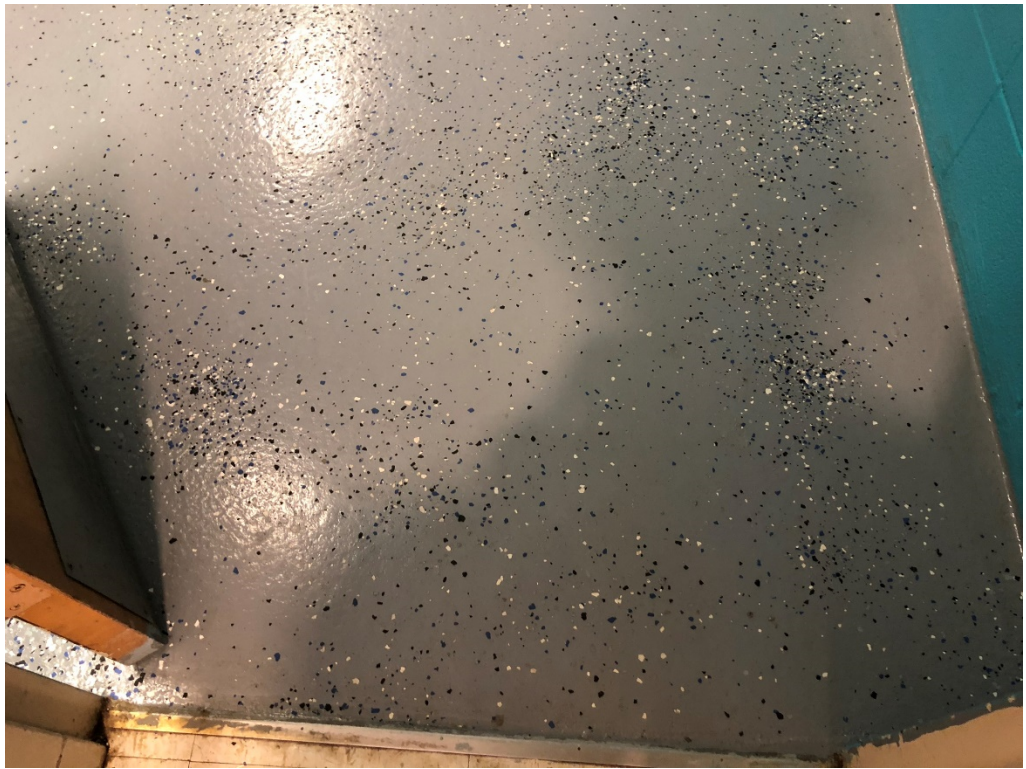
Figure 15 – Previously Painted Bathroom

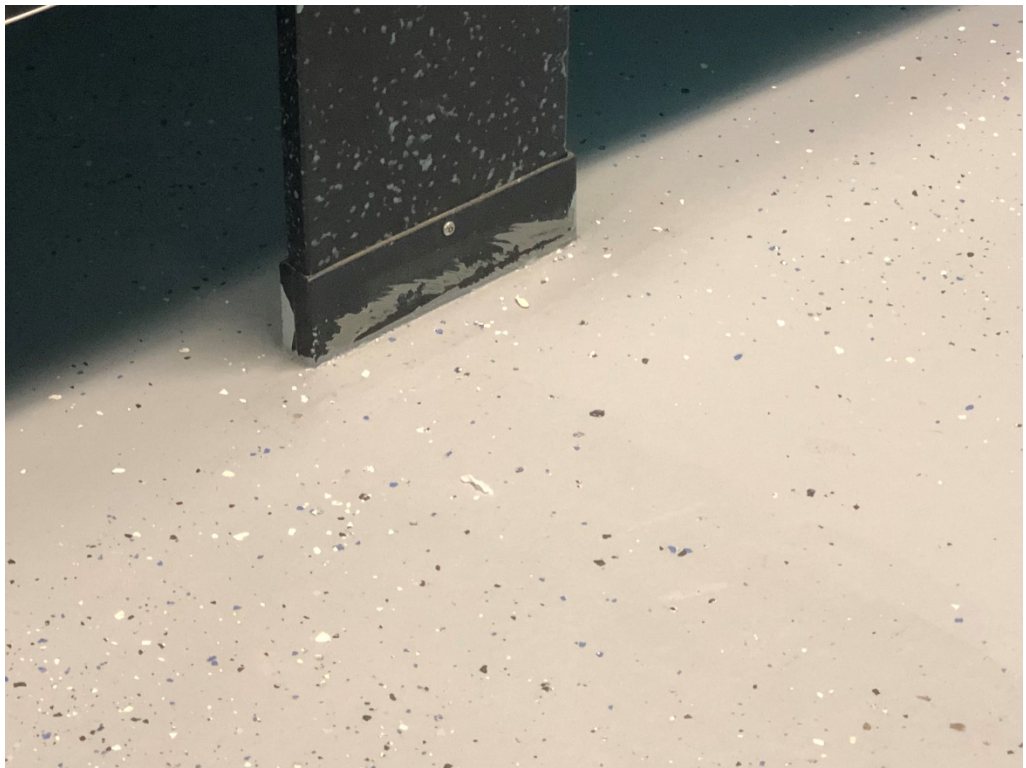
Figure 16 – Paint Noted on Toilet Partitions (Typical)

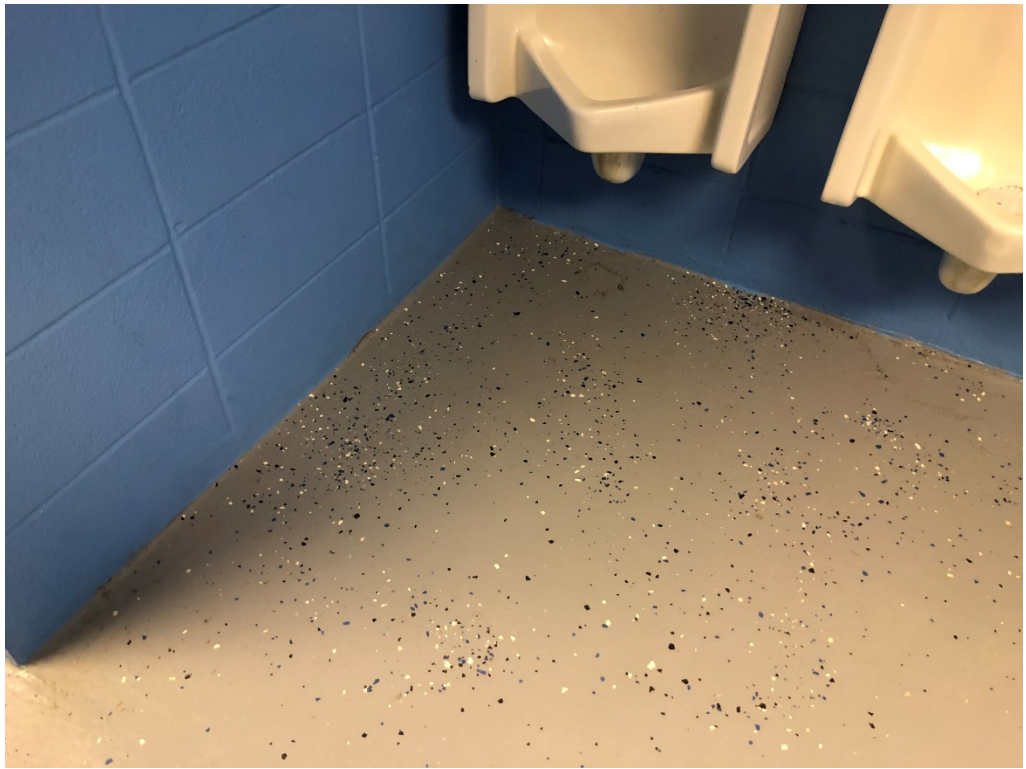
Figure 17 – Previously Painted Bathroom

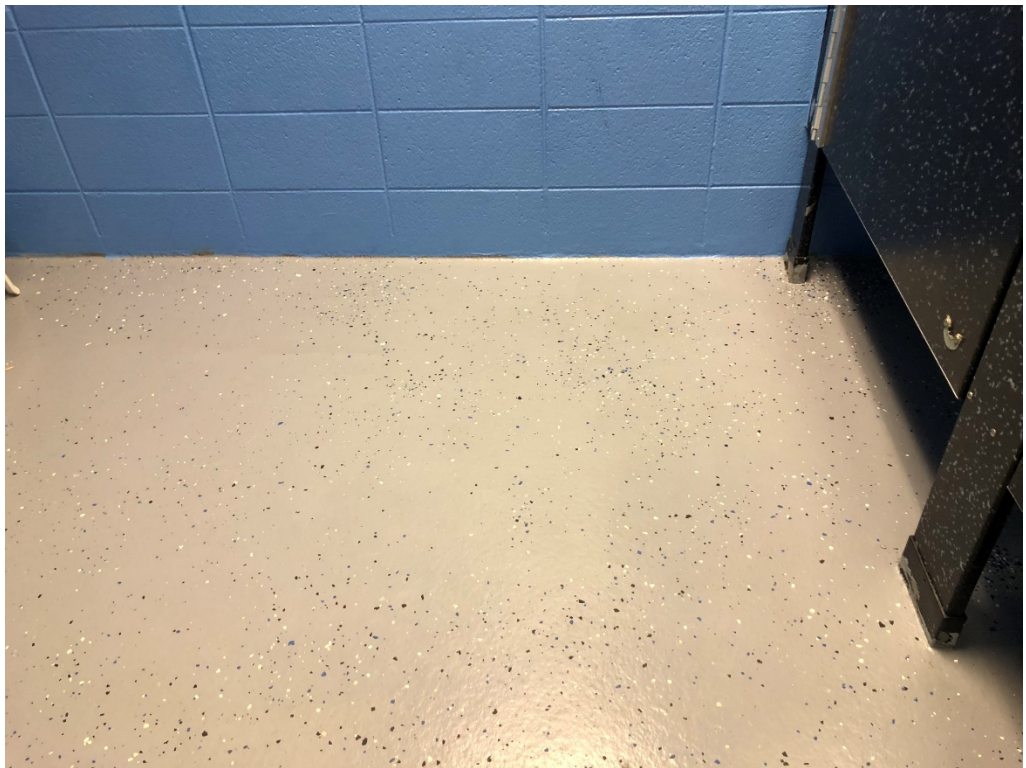
Figure 18 – Previously Painted Bathroom

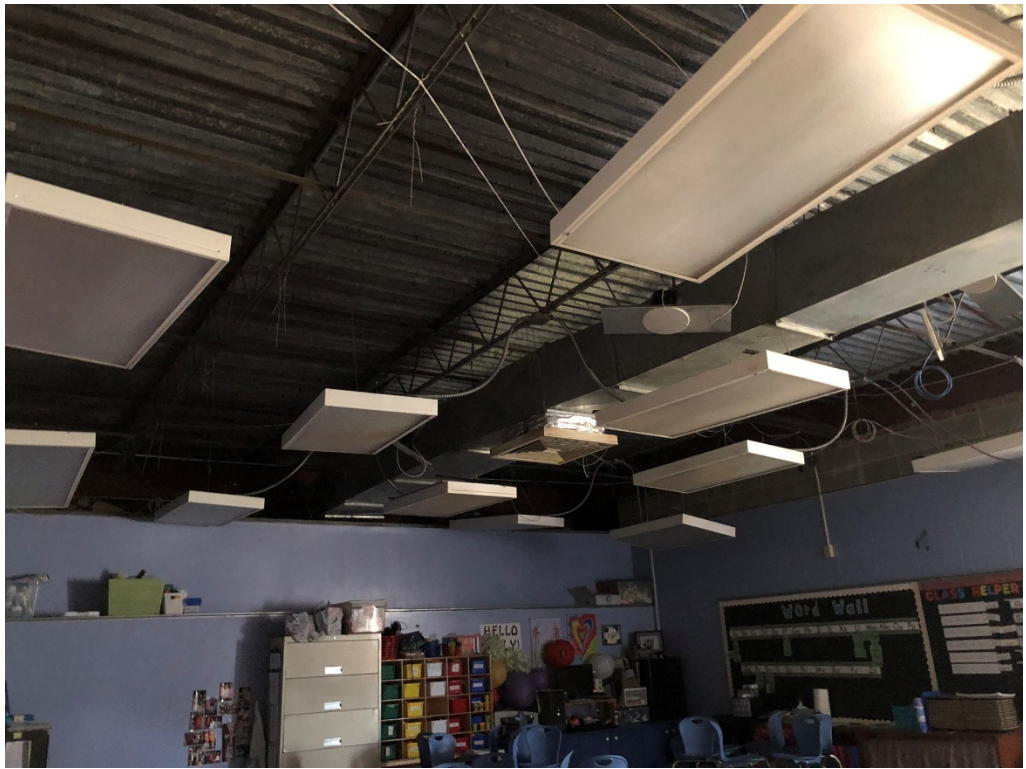
Interior ceiling demolition continued in building 1. Ceiling tile has been removed as well as grid in 35% of classrooms.

Figure 19 – Classroom Ceiling Demo

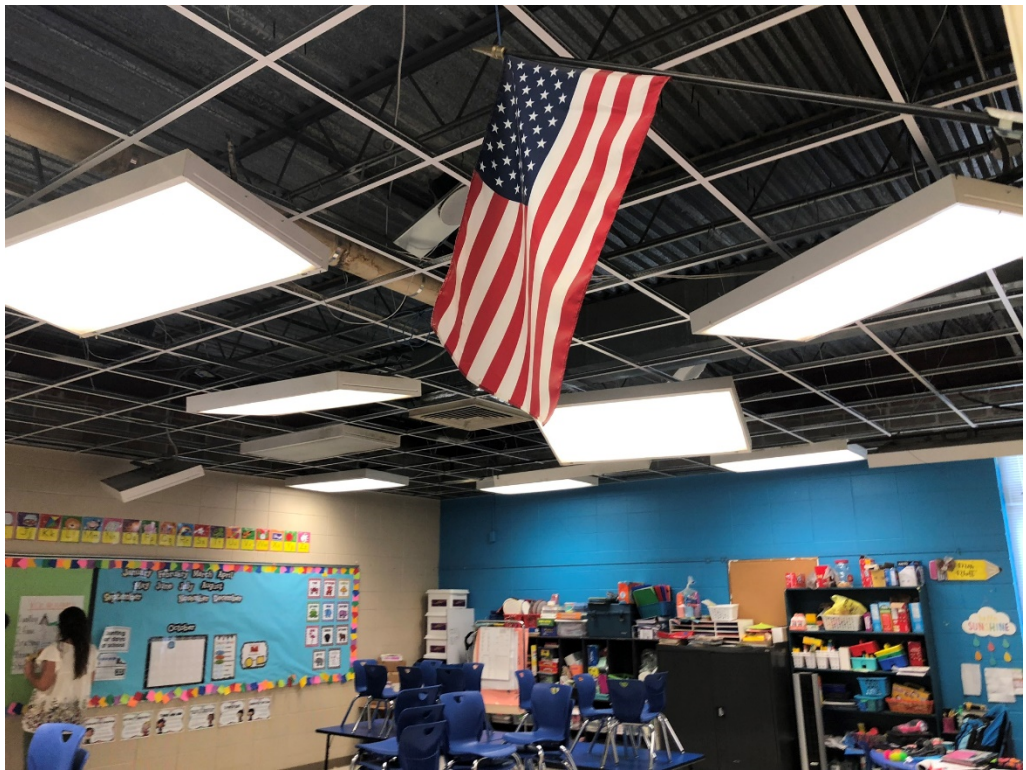
Figure 20 – Classrooms with Removed Tile

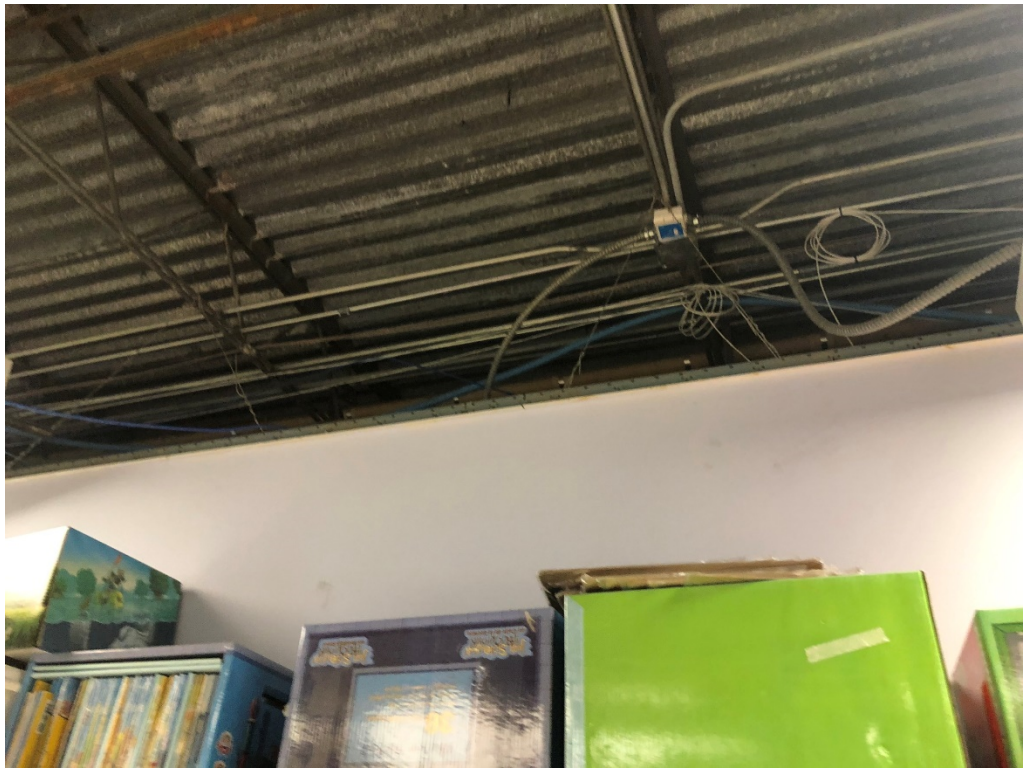
Figure 21 – Example of Typical Short Wall Opening to Furr Down in Main Space

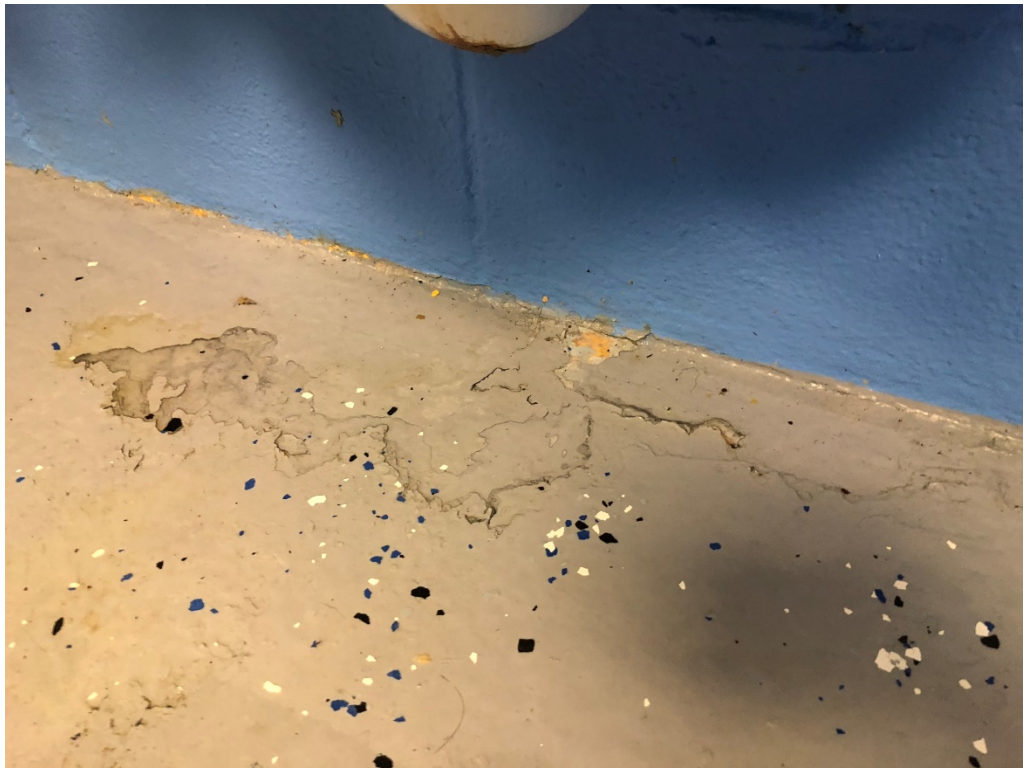
Figure 23 – Failed Paint from Previous Work (NOT Typical)

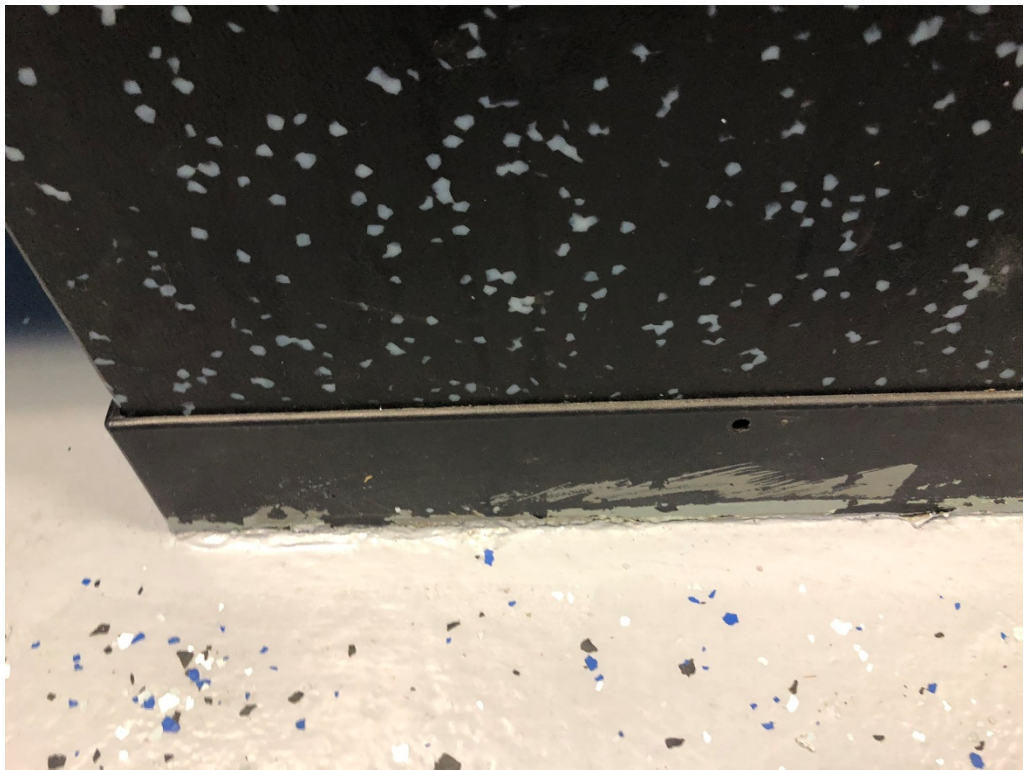
Figure 24 – Paint on Partitions

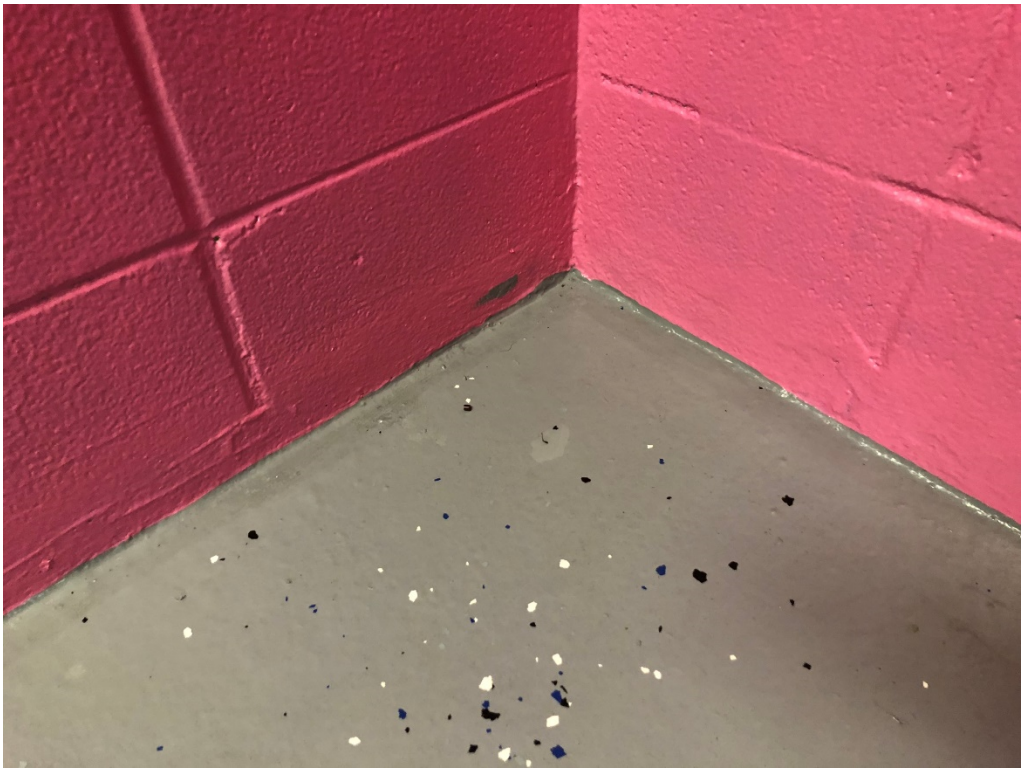
Figure 25 – Paint on Wall (Typical)

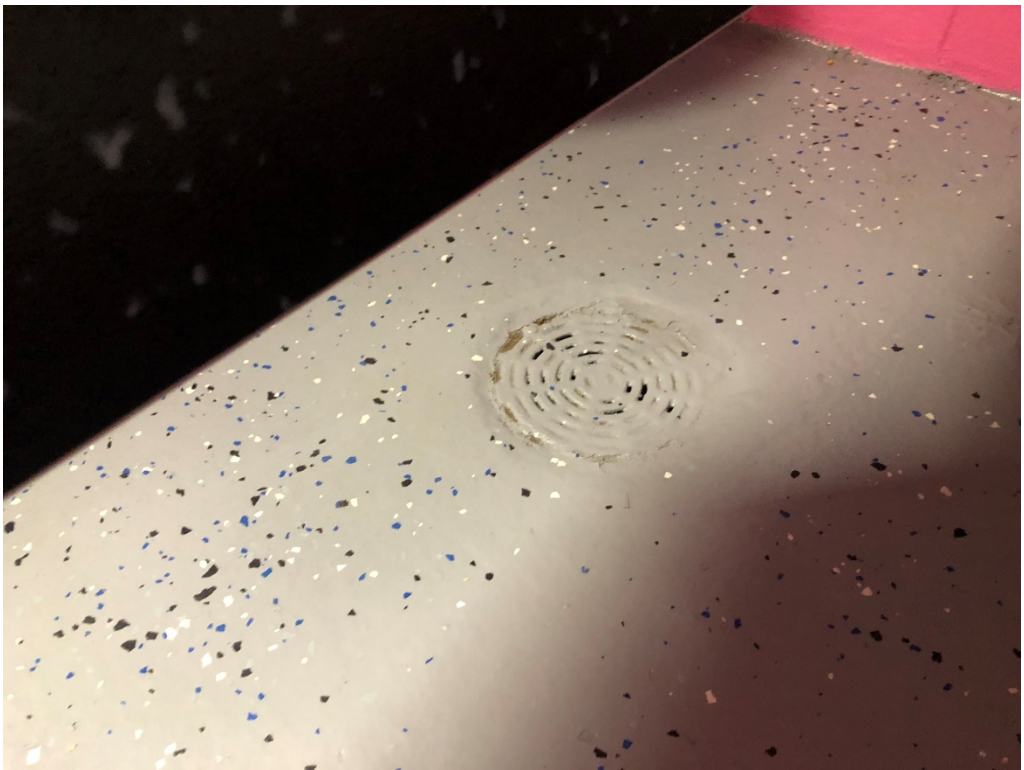
Figure 26 – Floor Drains More than 50% Blocked By Previous Work (Typical)

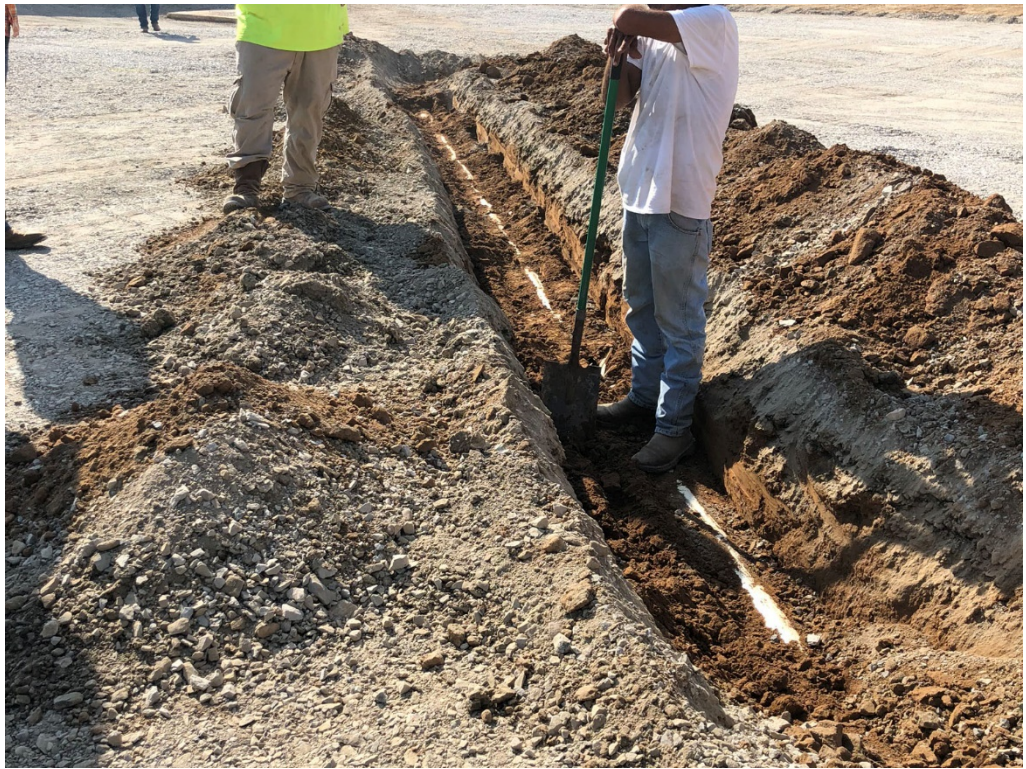
Figure 27 – Excavation of Thin Wall Pipe

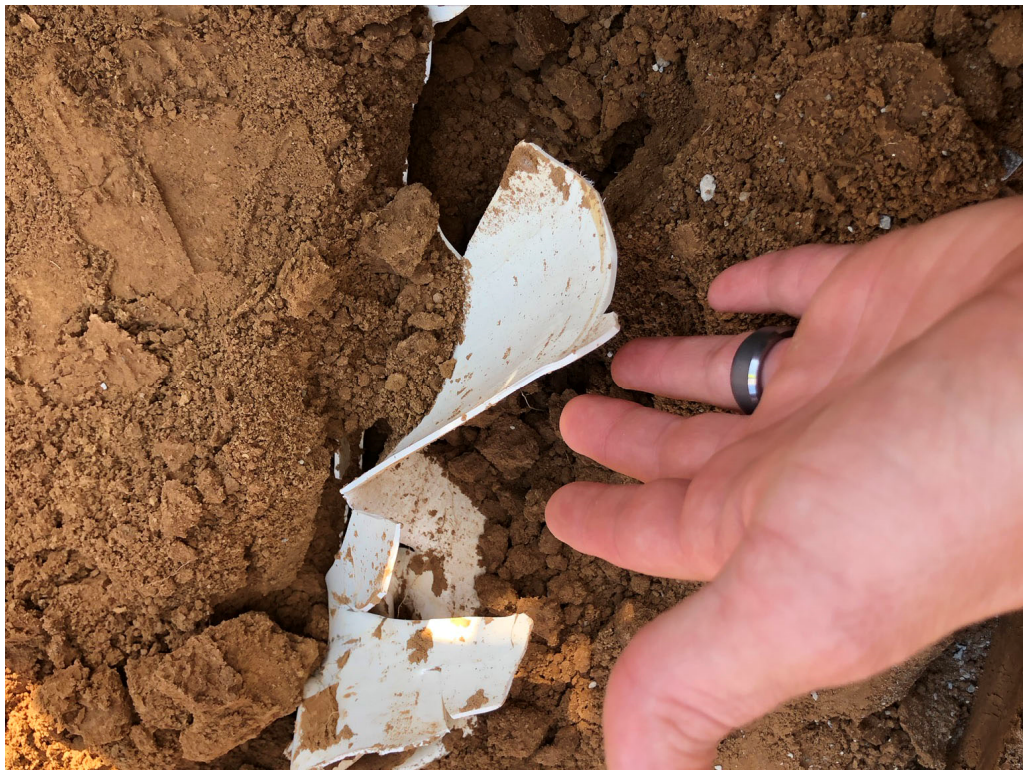
Figure 28 – Thin Wall Pipe (Hand for Size Reference)

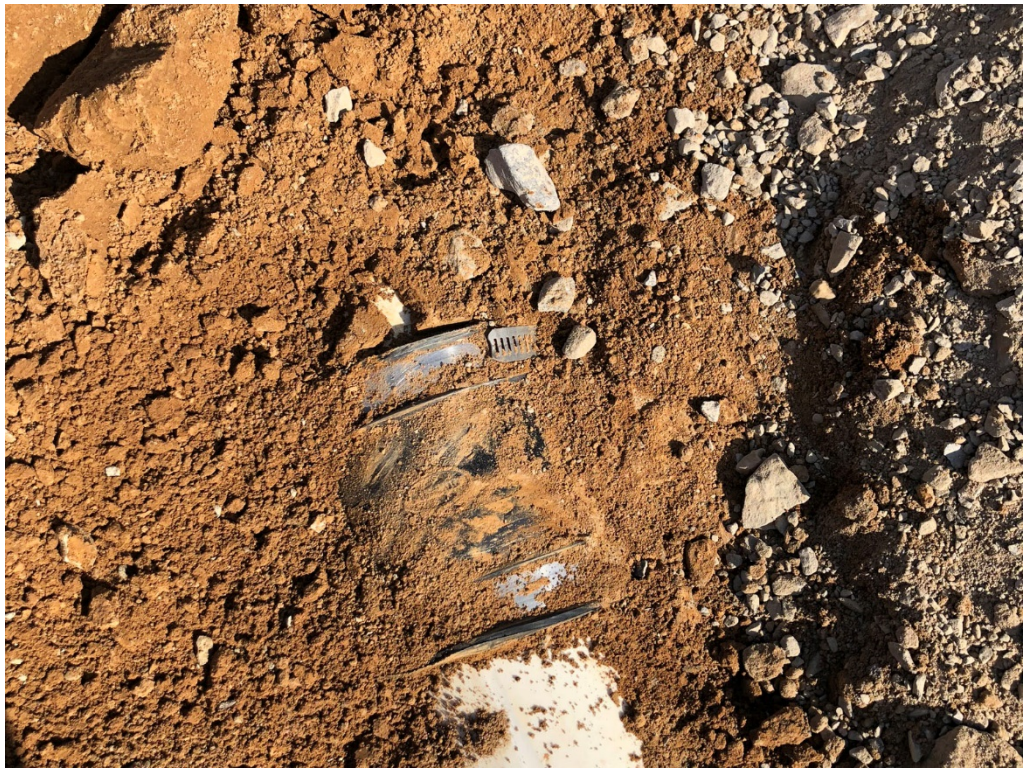
Figure 29 – Example of Repair between Thin Wall Pipe to SHC 40 PVC
