Architect's Field Report

09 October 2019

18043-BW Beechwood Elementary / Report Number 002

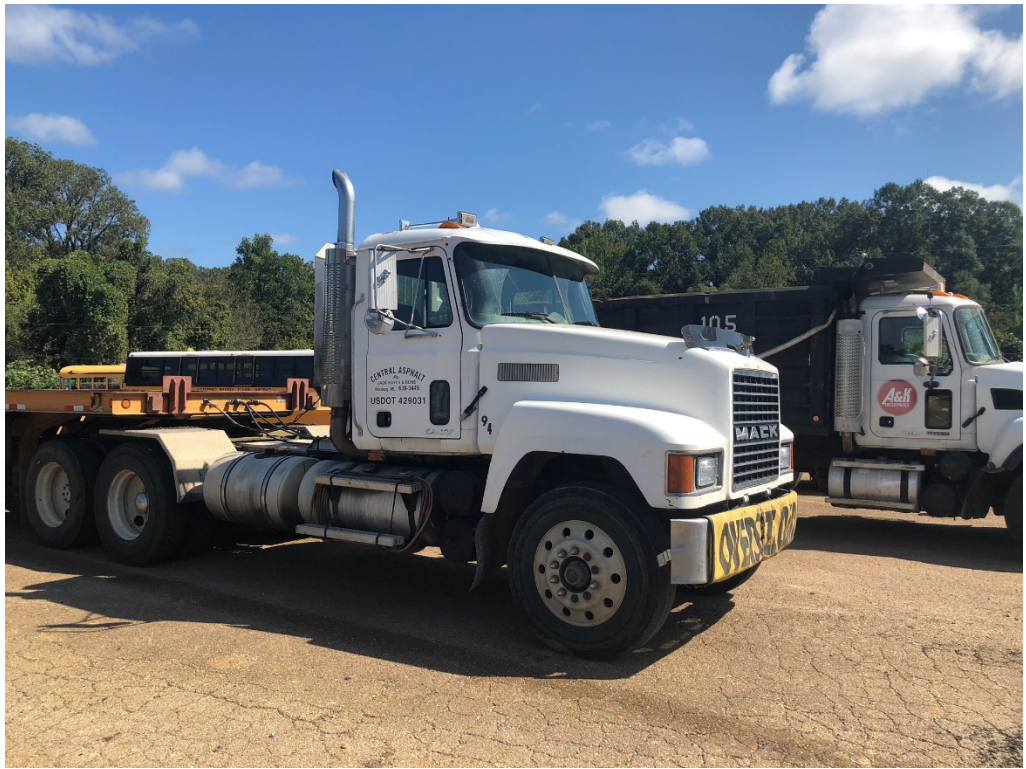
Figure 1 – Parking Area Used for Staging

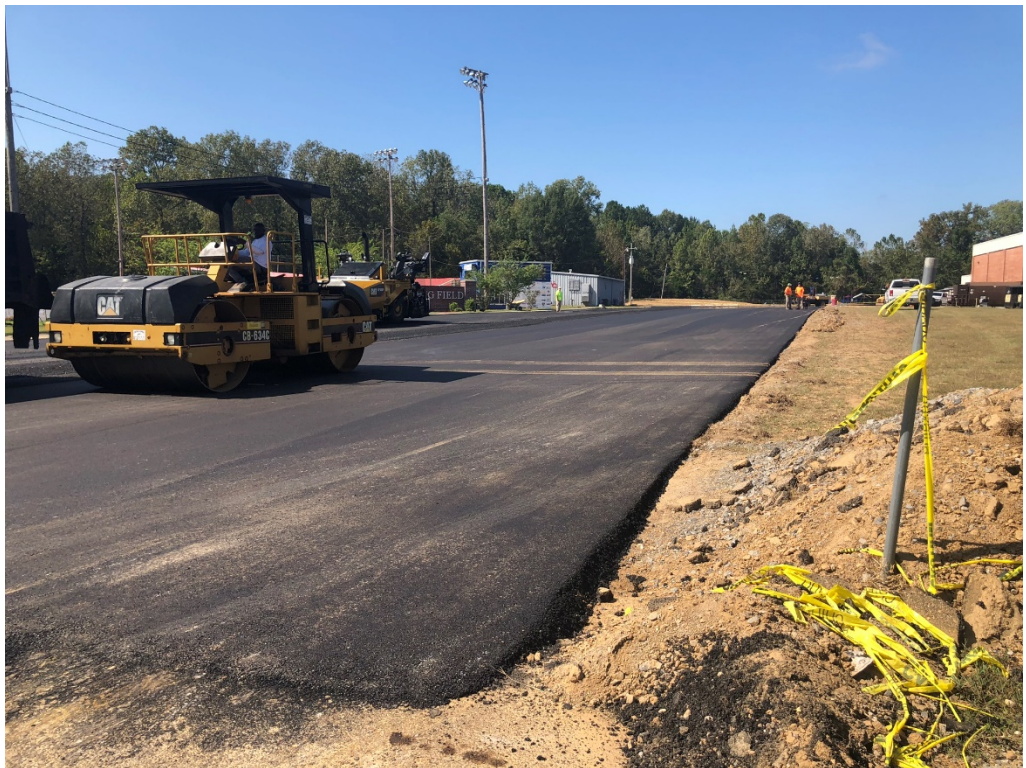
Figure 2 – East Corner Looking West

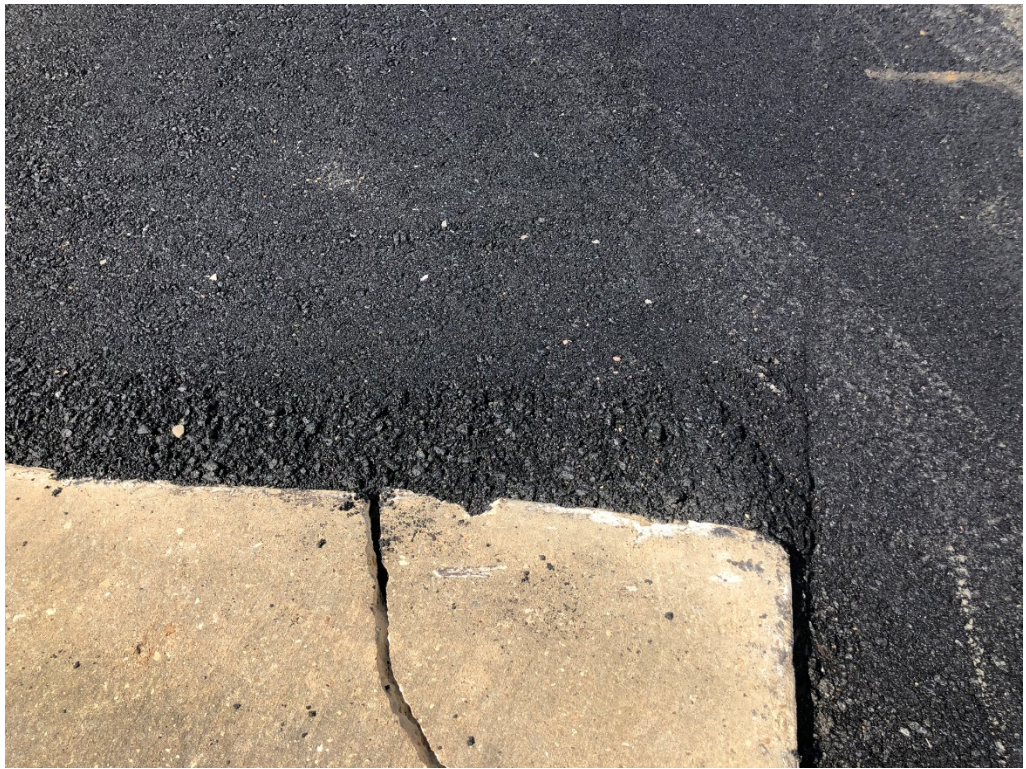
Figure 3 – Unfinished Paving at South Corner and Existing Sidewalk

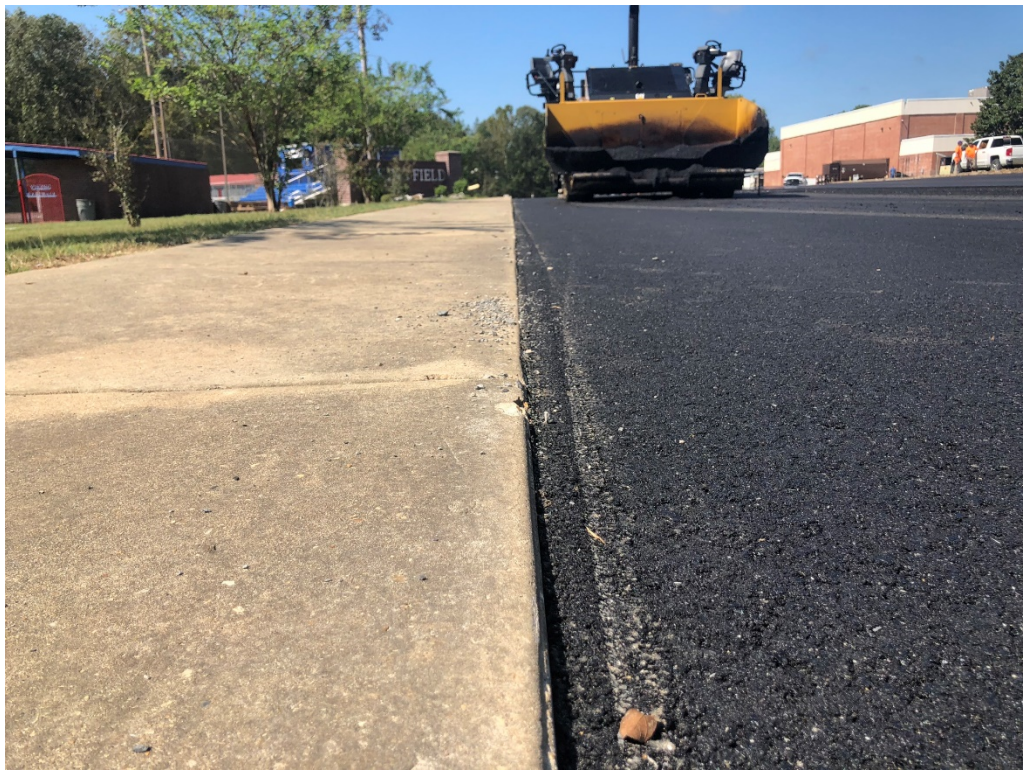
Figure 4 – Base Asphalt Paving Layer

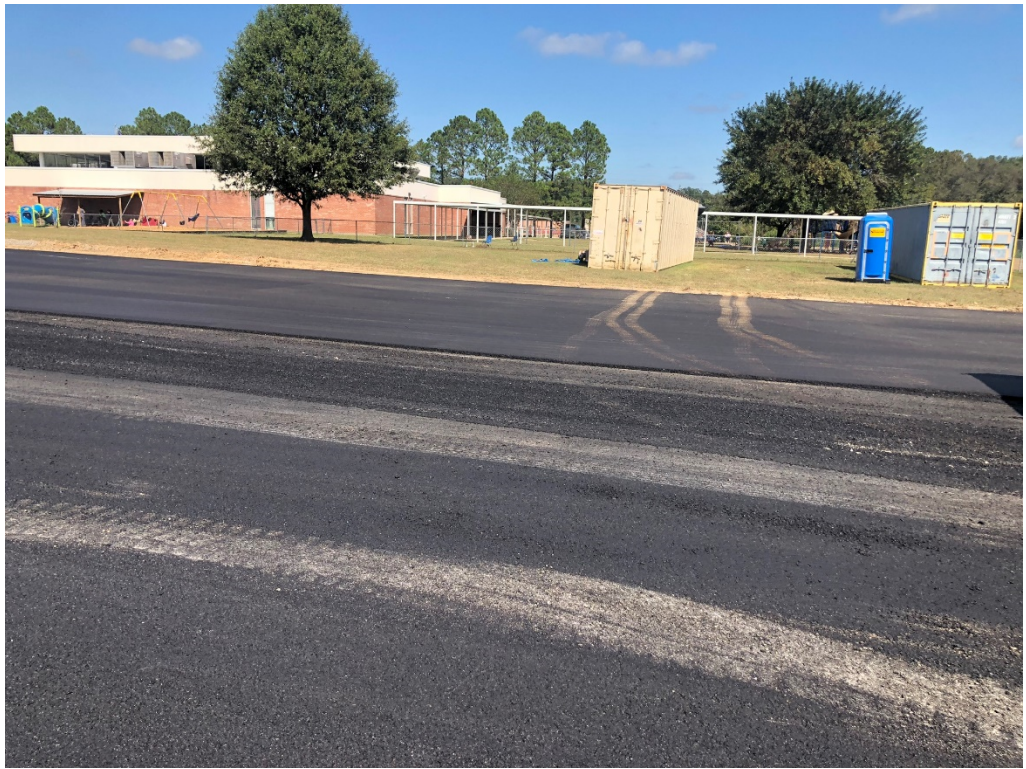
Observations Arriving, I noted paving work in progress. Central Asphalt was installing top layer of asphalt.

Figure 5 – Top Layer and Base Layer Asphalt

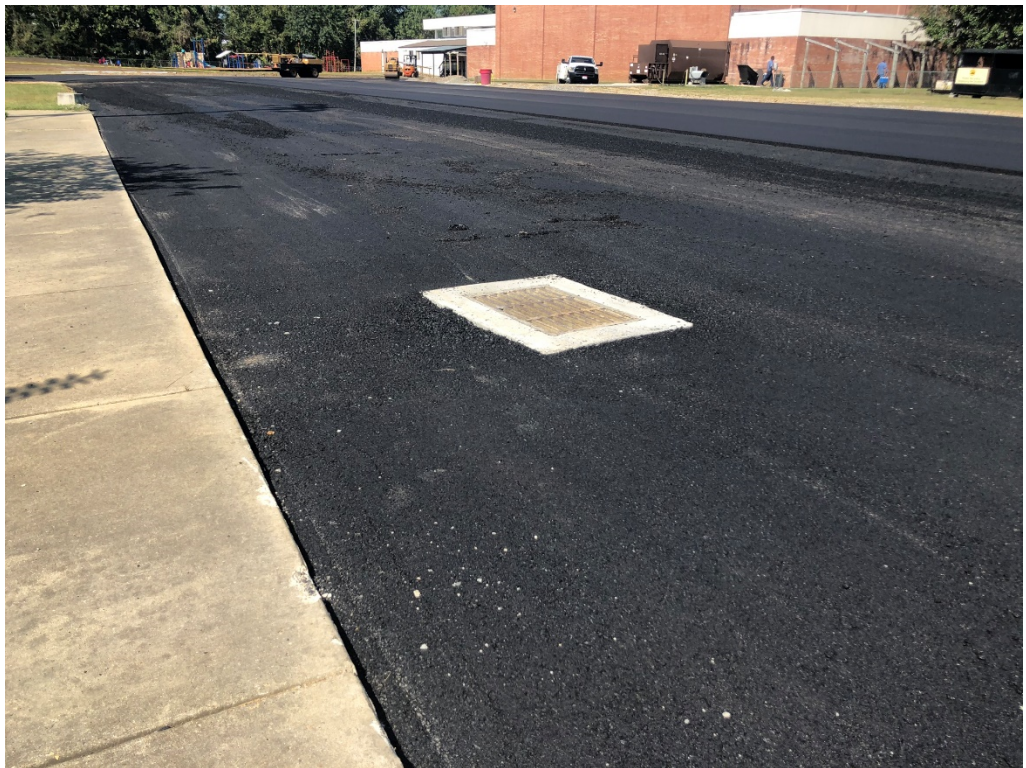
Figure 6 – Base Layer Even with Concrete Drain

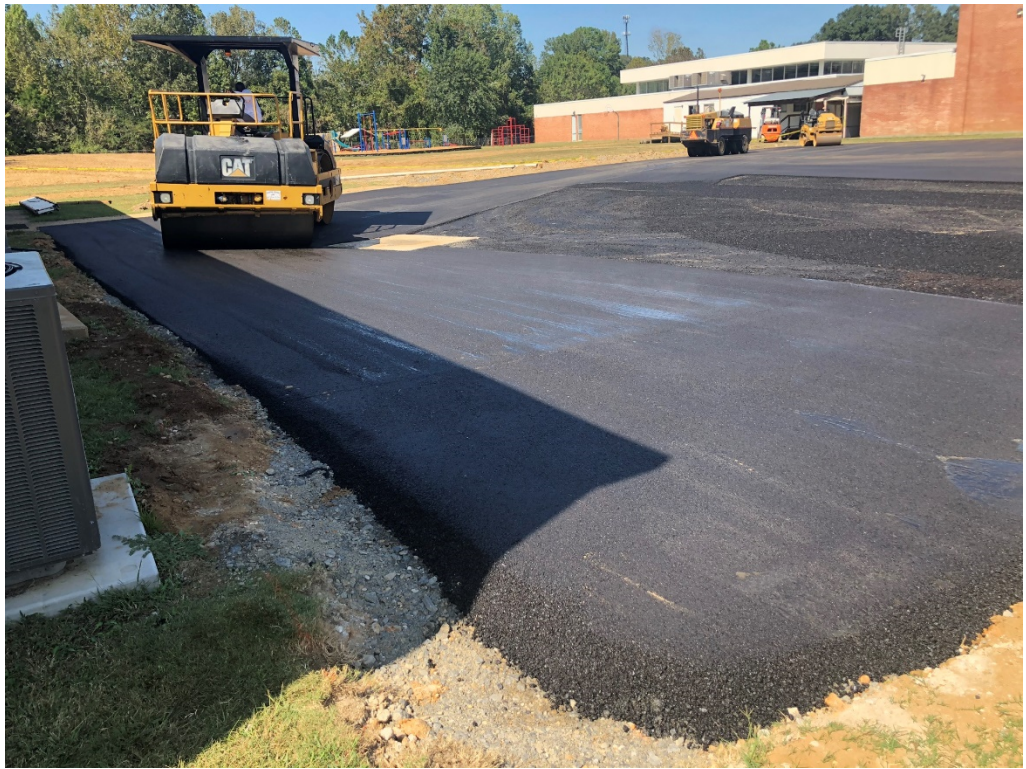
Figure 7 – Top Layer at West Corner

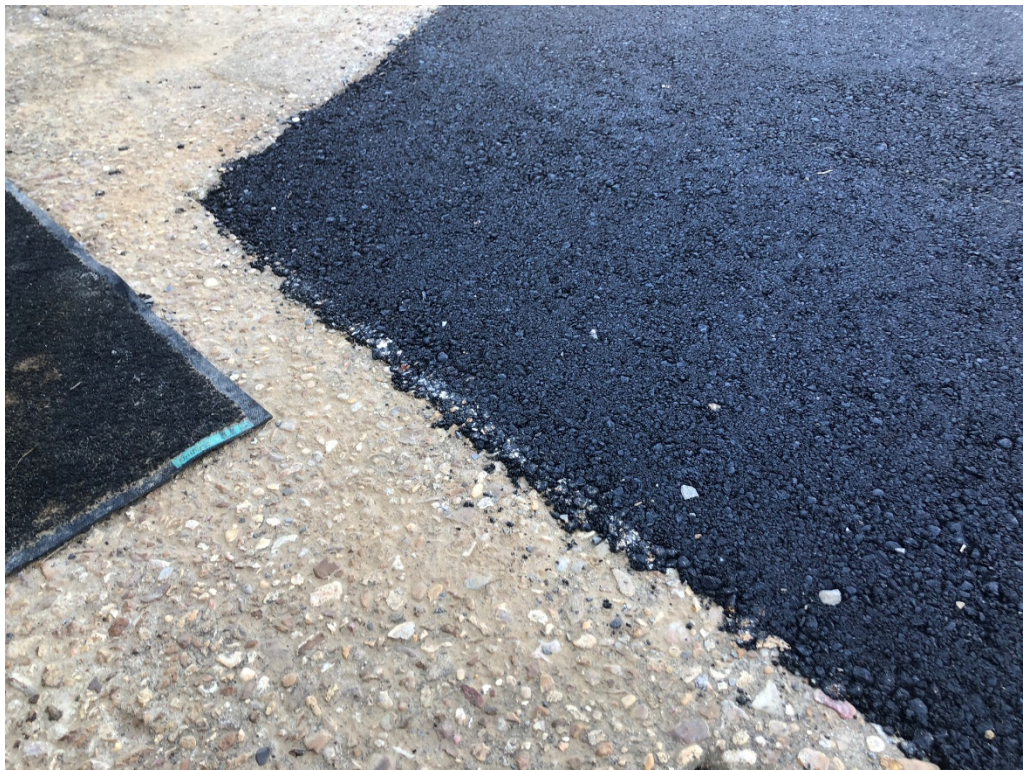
Figure 8 – Top Layer Even with Sidewalk

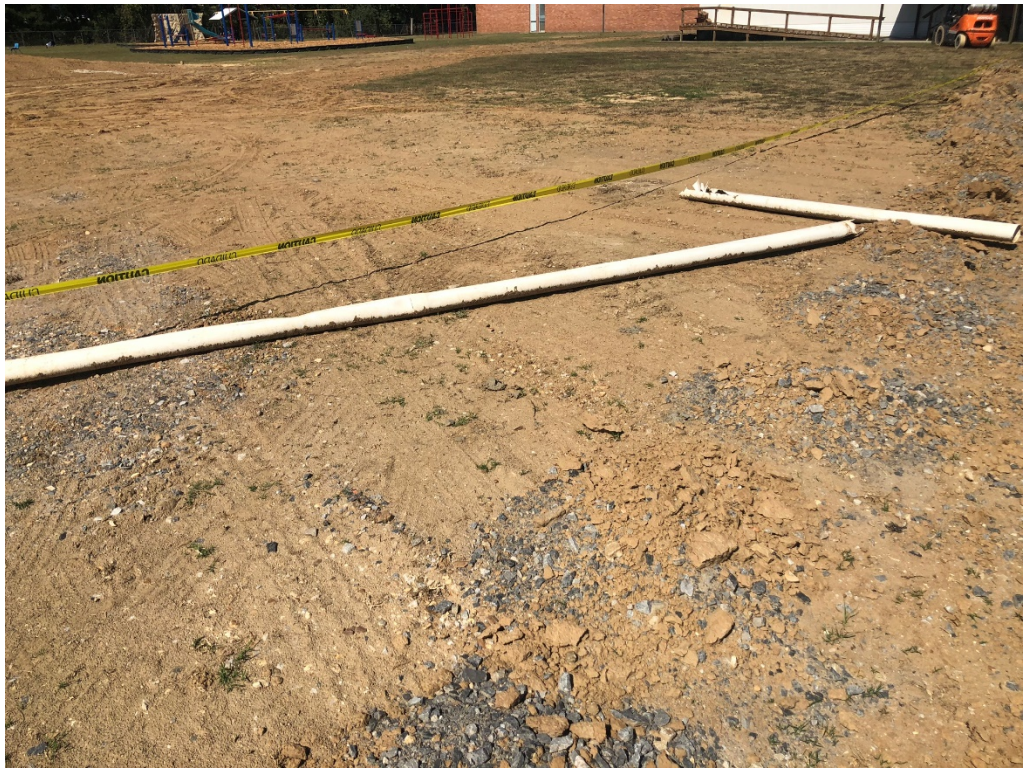
Figure 9 – Undisposed Excavated Drain Pipe

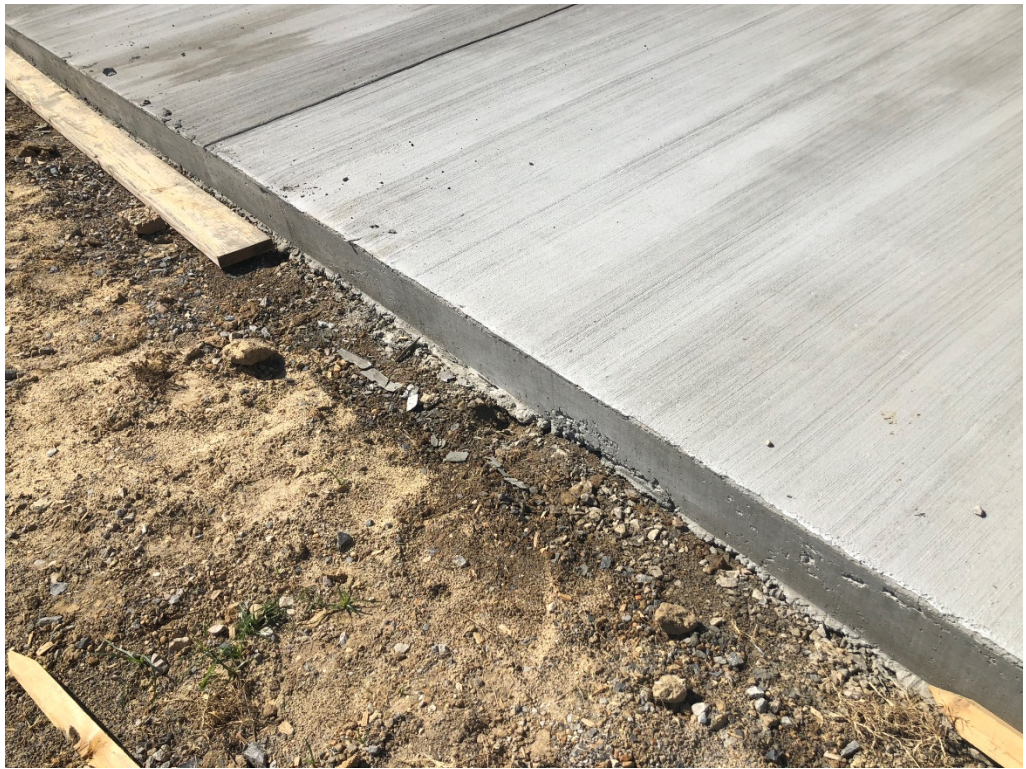
Figure 11 – Undisposed Formwork at Dumpster Slab

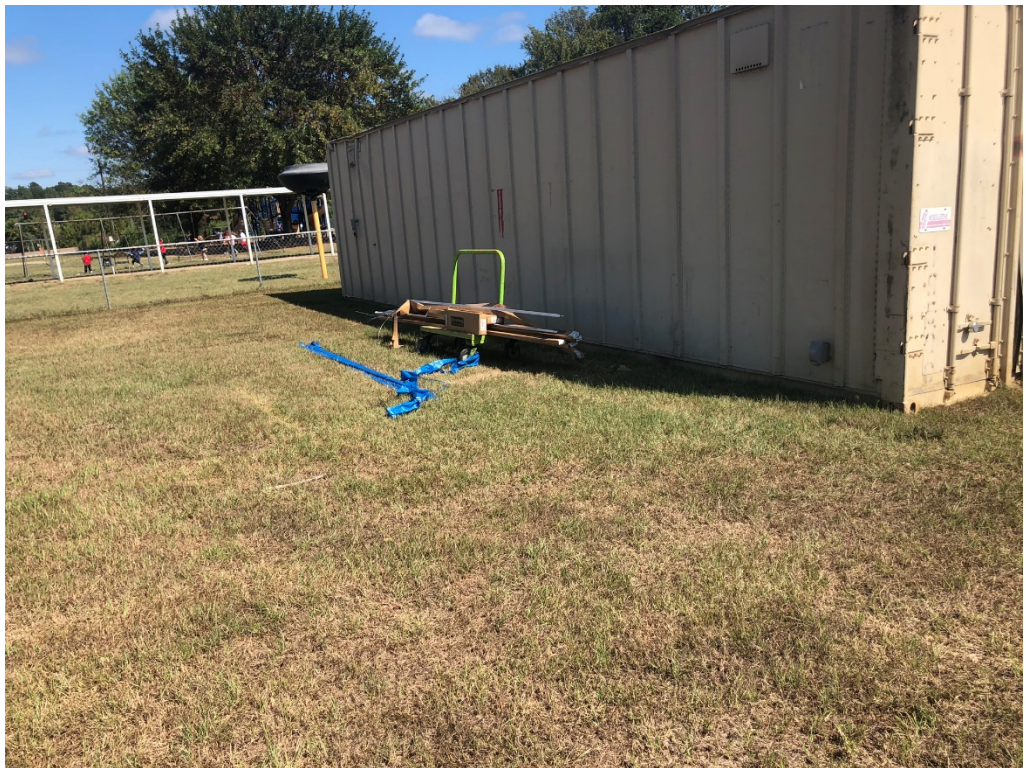
Figure 12 – Ceiling Material

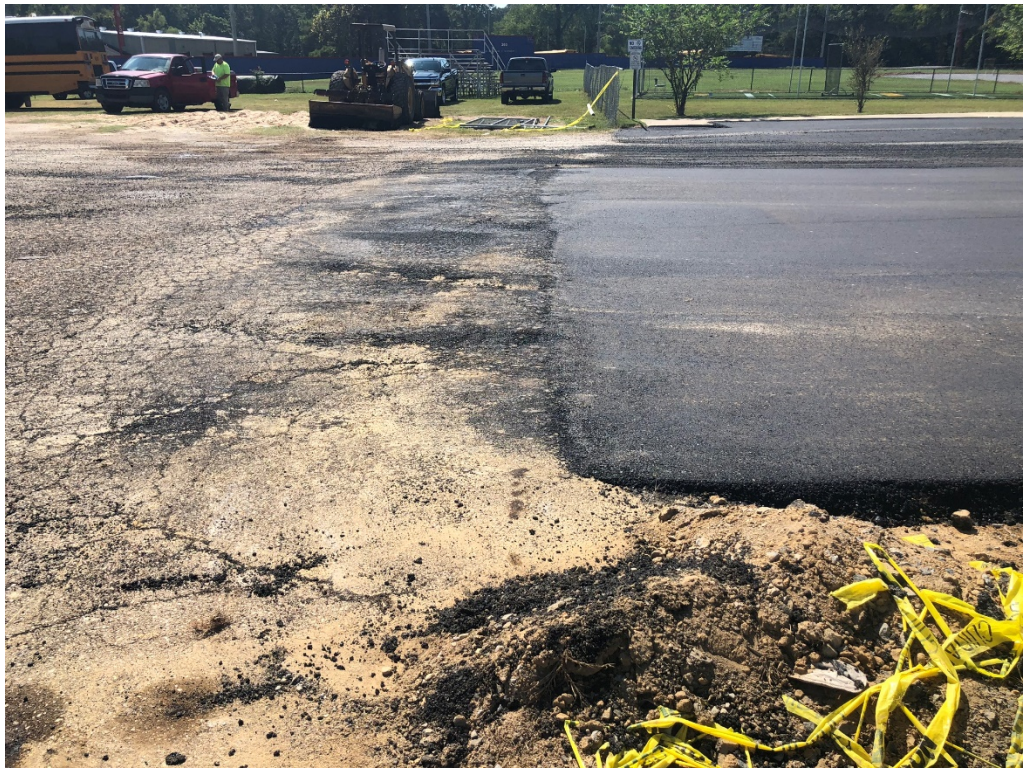
Figure 13 – New Paving Even with Existing Paving

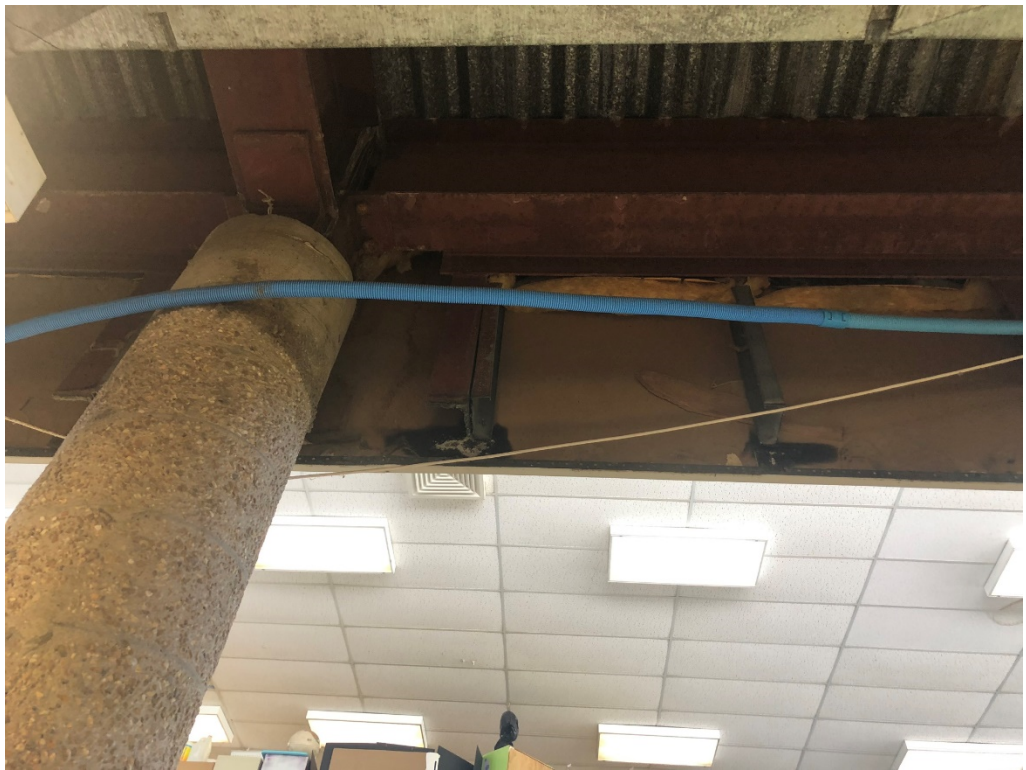
Figure 22 – Existing Furr Down Structure (Typical)

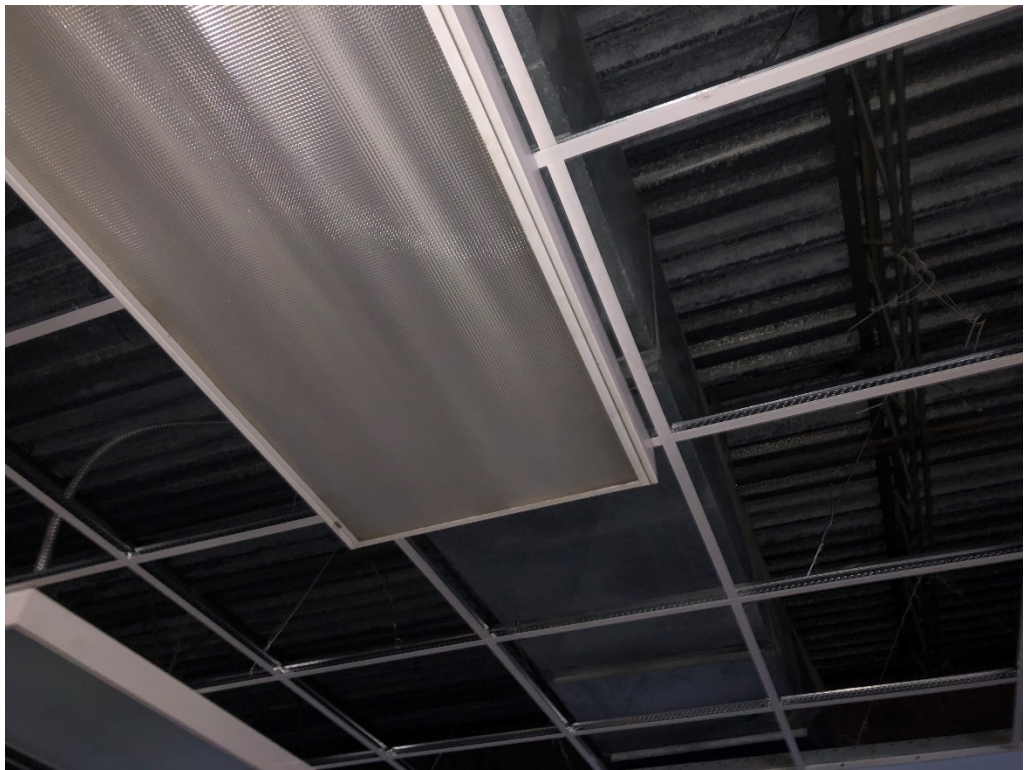
Figure 30 – Misaligned light with Framework

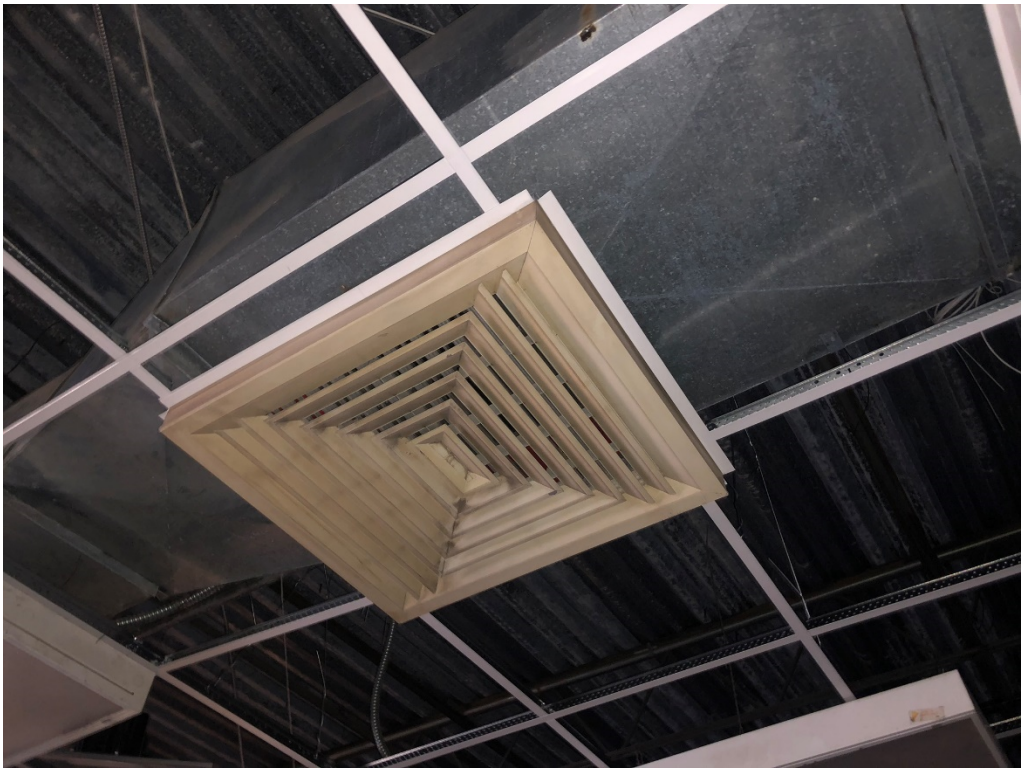
I reviewed interior ceiling work at Building 1; demo has continued and grid work has been installed however no ceiling tiles have been installed.

Figure 31 – Unfinished Grid Corners
