## Architect's Field Report

16 October 2019

18043-BW Beechwood Elementary / Report Number 004

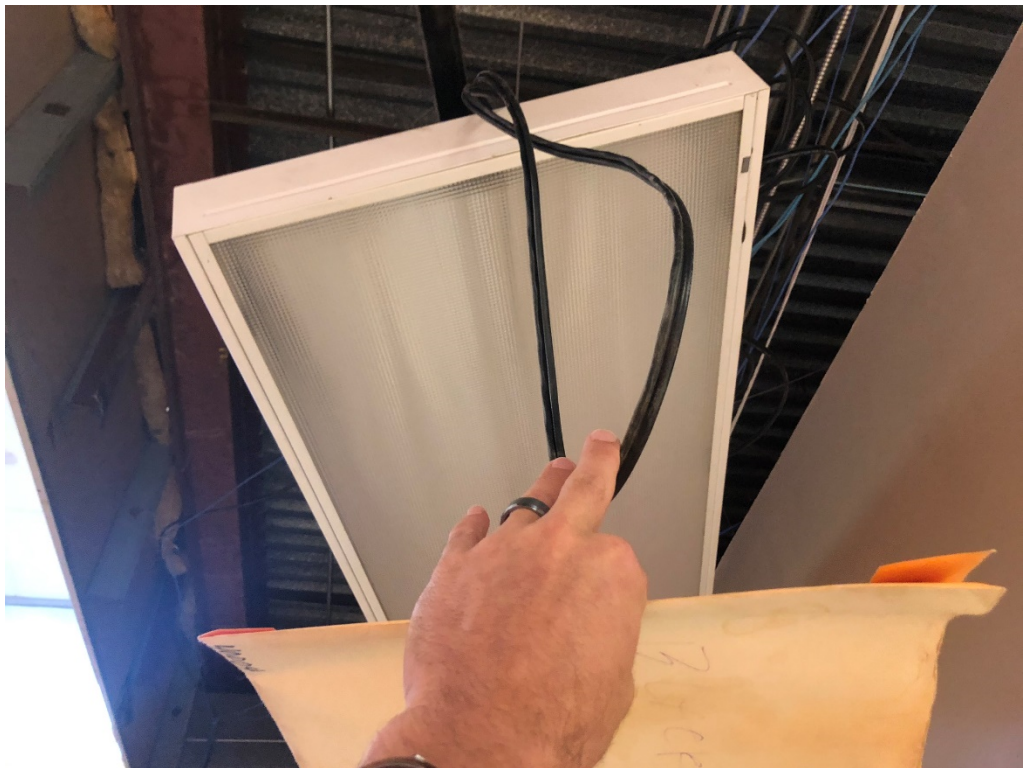
Figure 4 – Hanging Wire

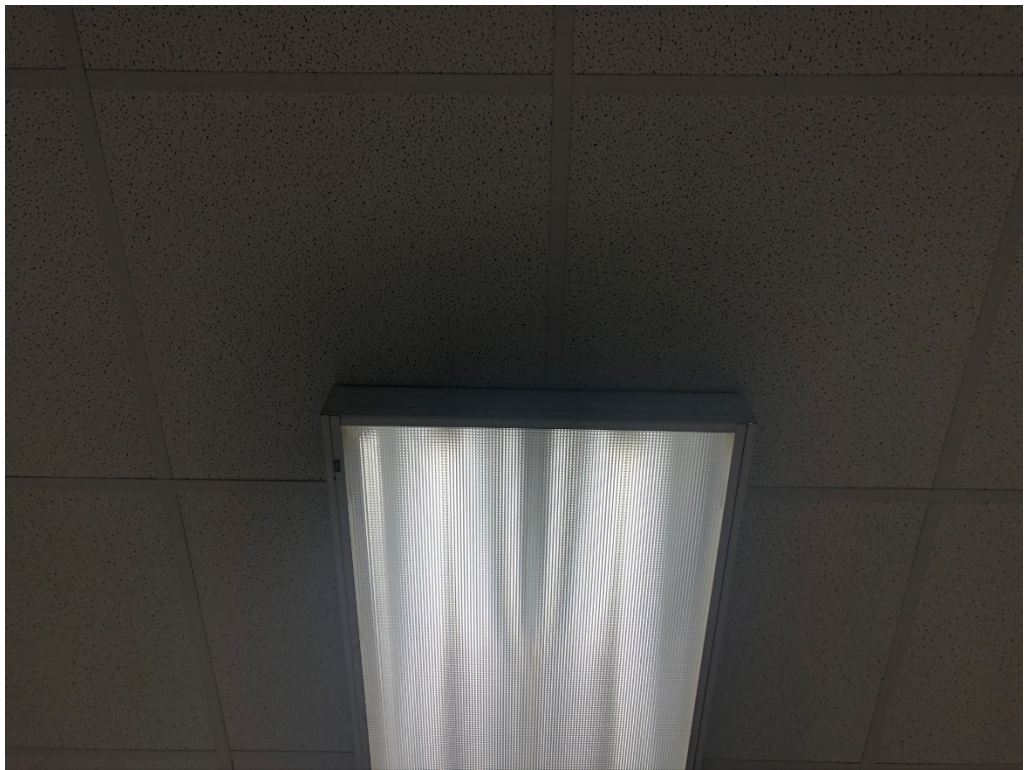
Figure 6 – Off Center Lighting

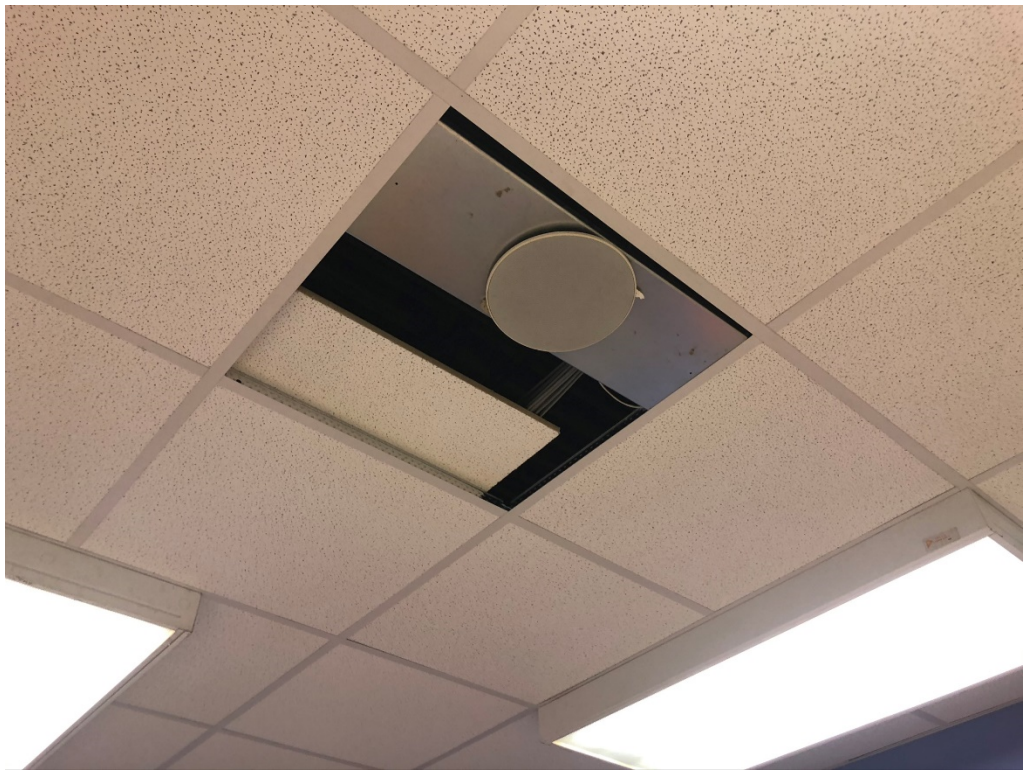
Where 2x2 Ceilings have been reinstalled, audio tiles have not been refitted around audio equipment.

Figure 8 – Unfinished Audio Installation

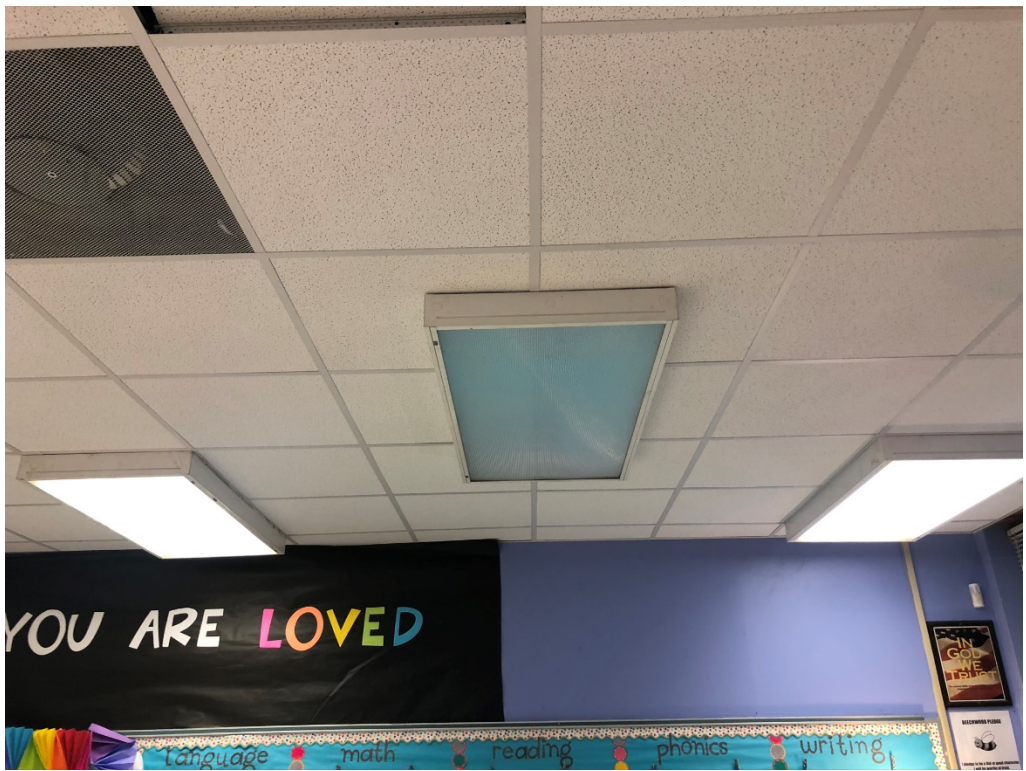
Figure 9 – Off-Center Lighting

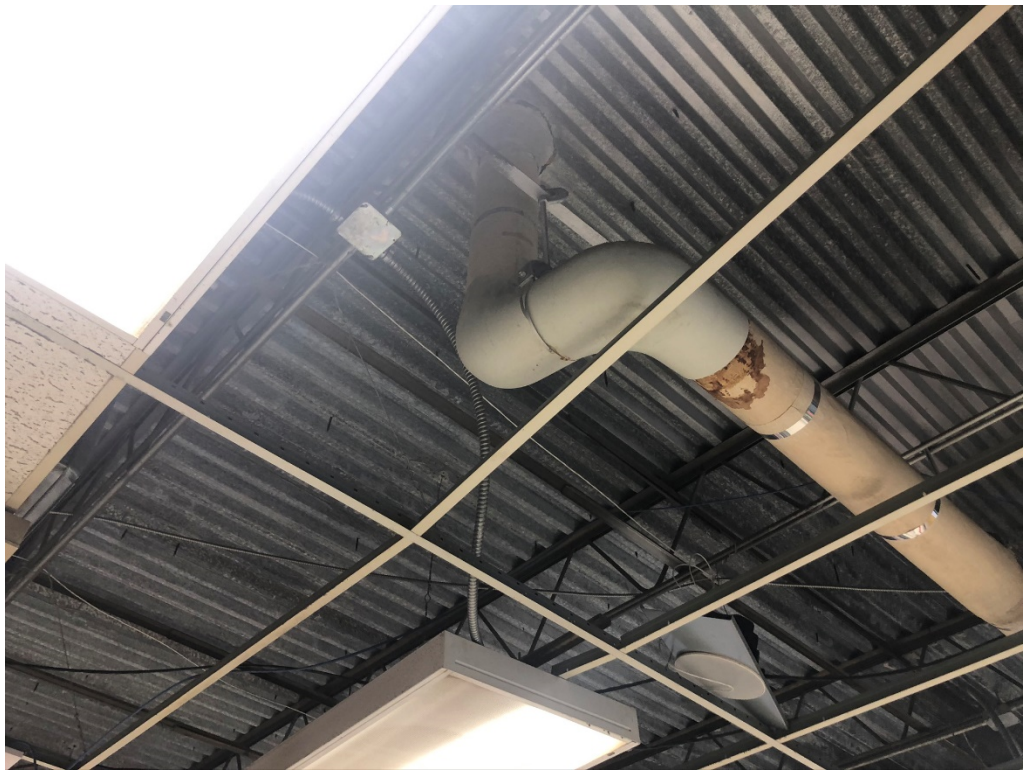
At the most Southern Corner room, there is a leak but the 2x2 ceiling has not been reinstalled.

Figure 10 – Leak in South Corner Classroom

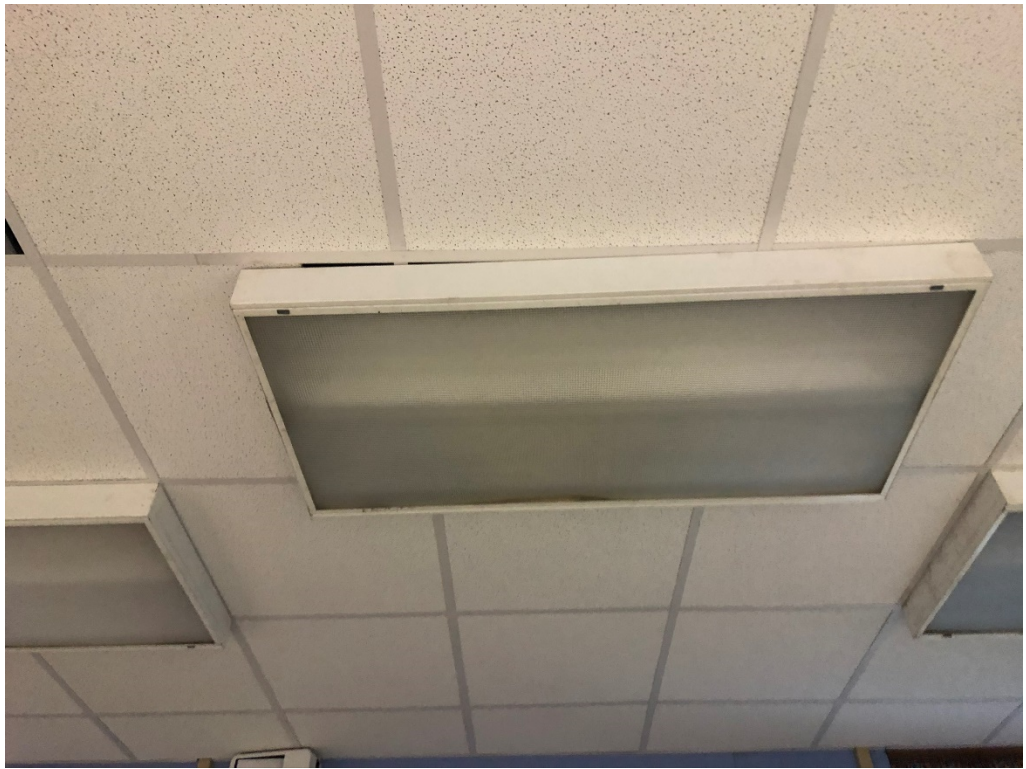
Figure 11 – Angled Lighting (Needs Adjustment)

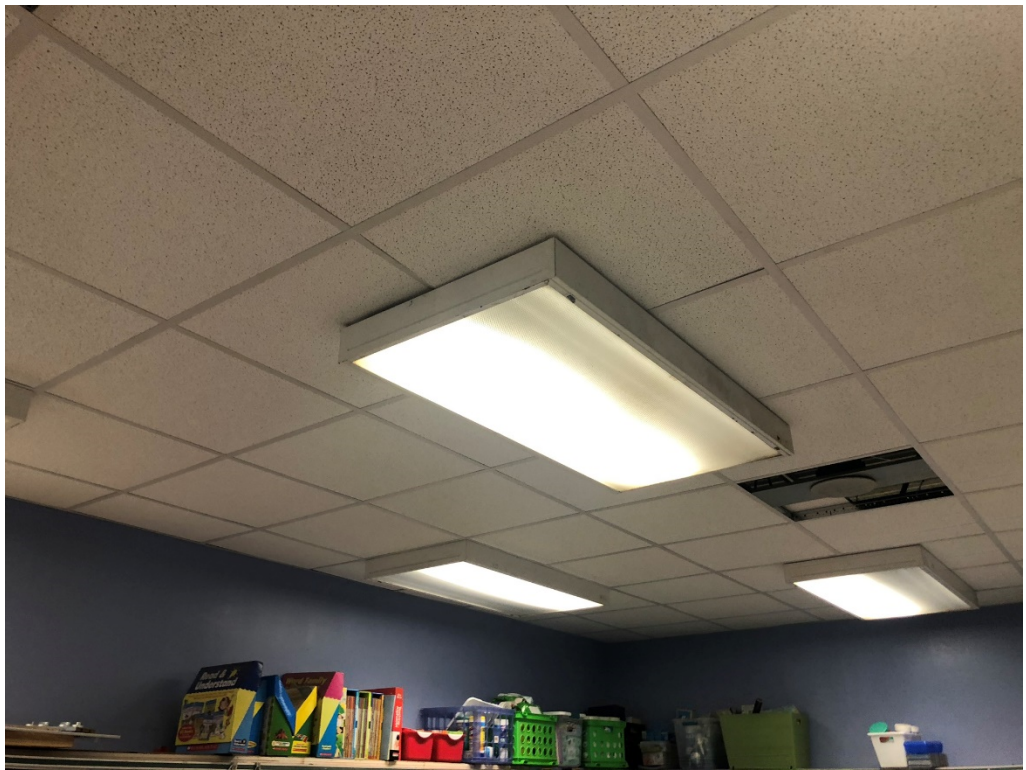
Figure 12 – Note Gap Between Light and Tiles is more on Left than Right

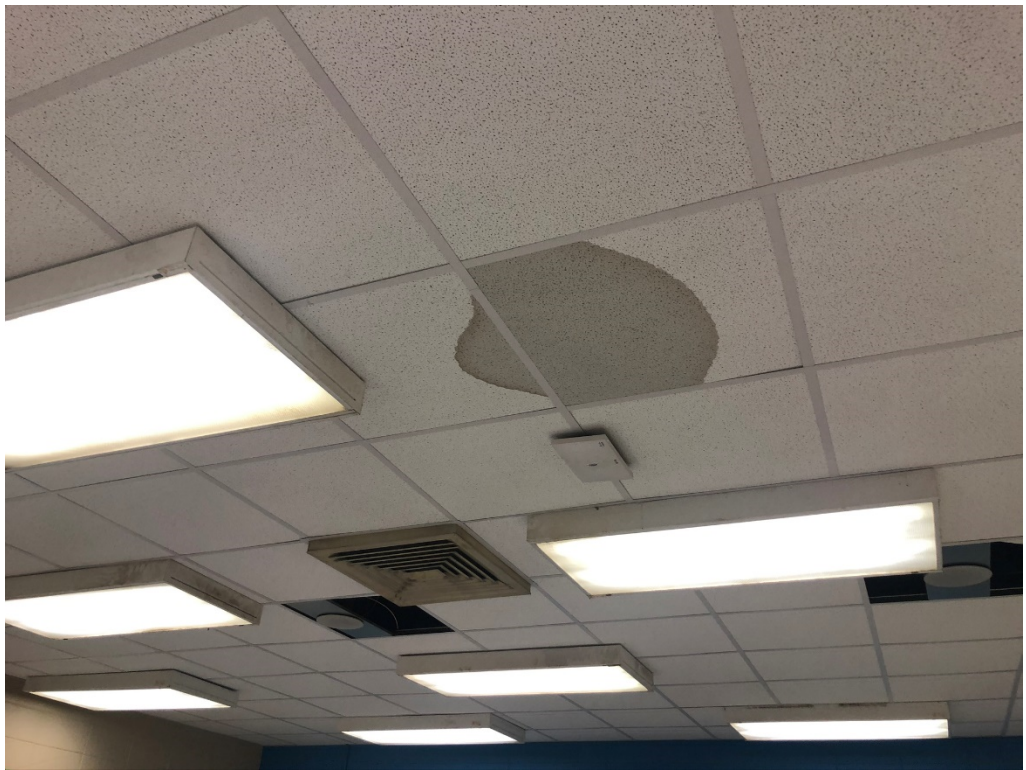
At the most Eastern Corner room, there is also a leak but the 2x2 tile has been reinstalled and is now damaged.

Figure 14 – Leak at East Corner Classroom

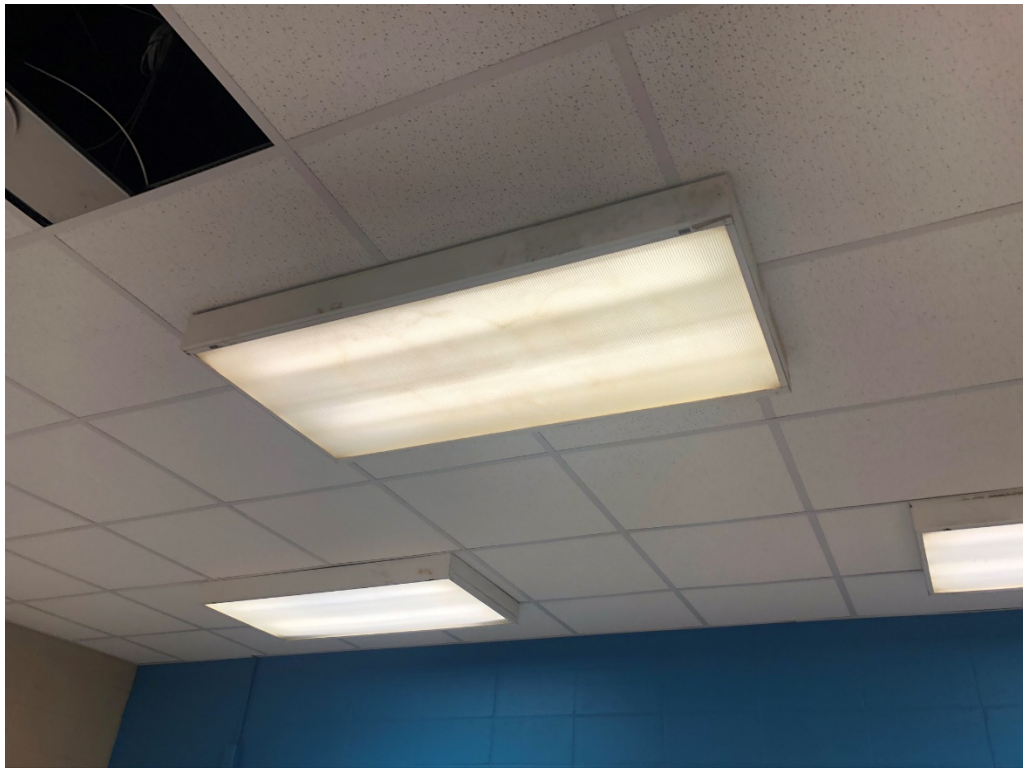
Figure 15 – Lighting Off alignment by 3- inches

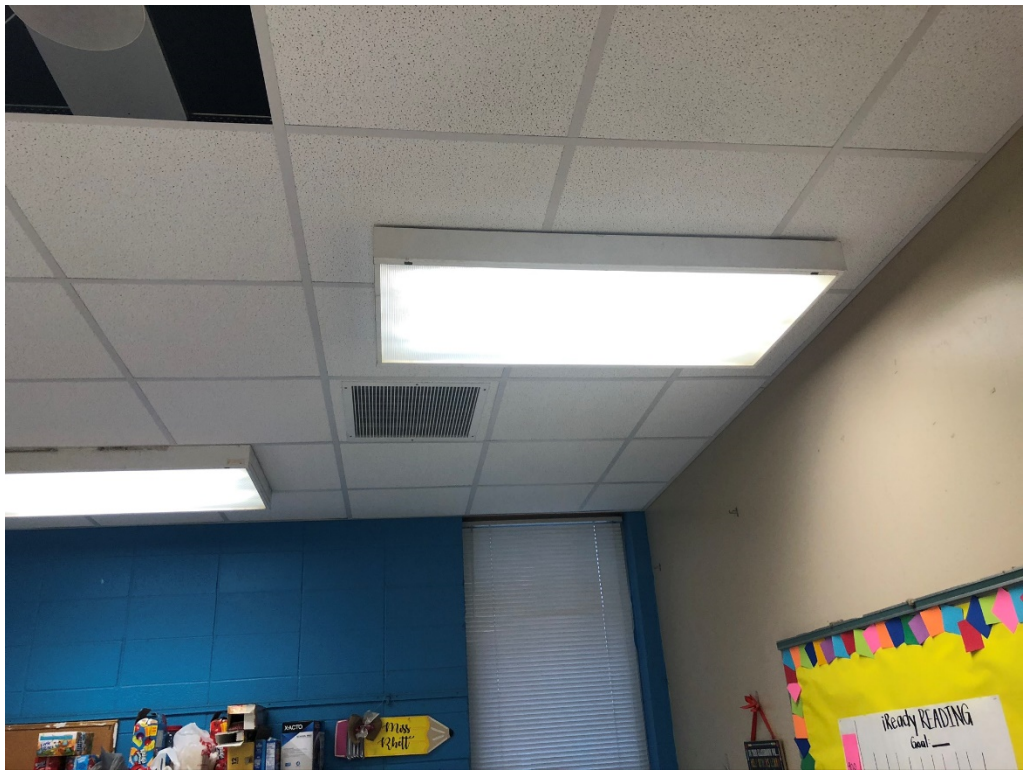
Figure 16 – Offset Lighting

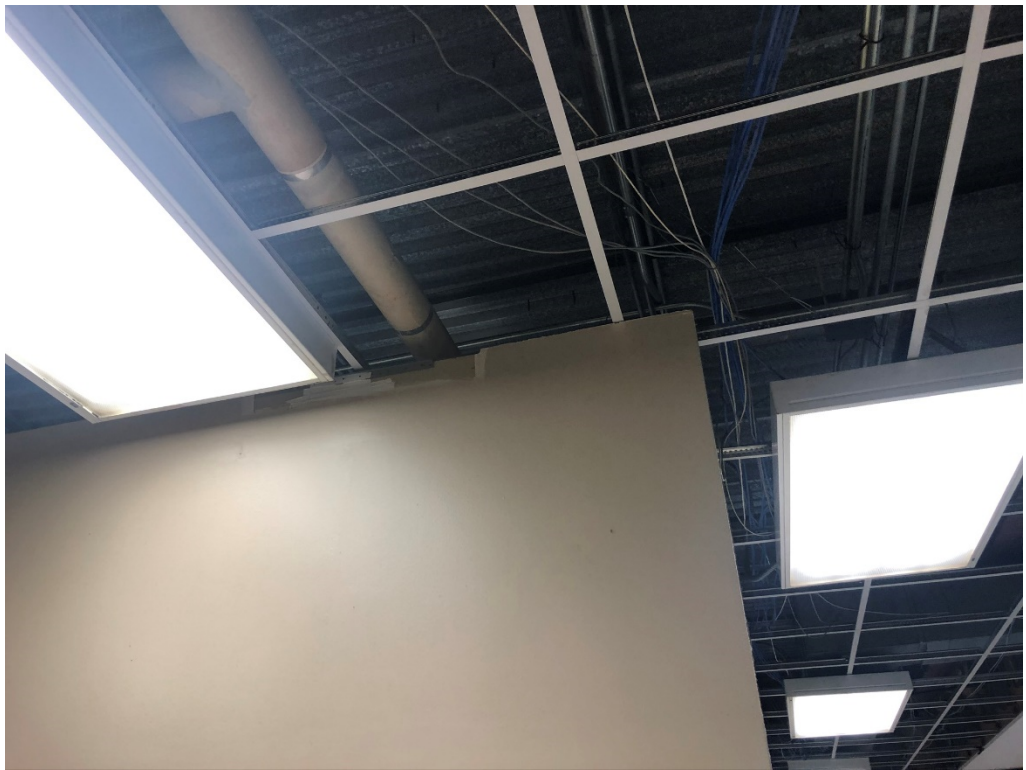
Figure 18 – Grid Installation Missing Corner
