Architect's Field Report

25 October 2019

18043-BW Beechwood Elementary / Report Number 006

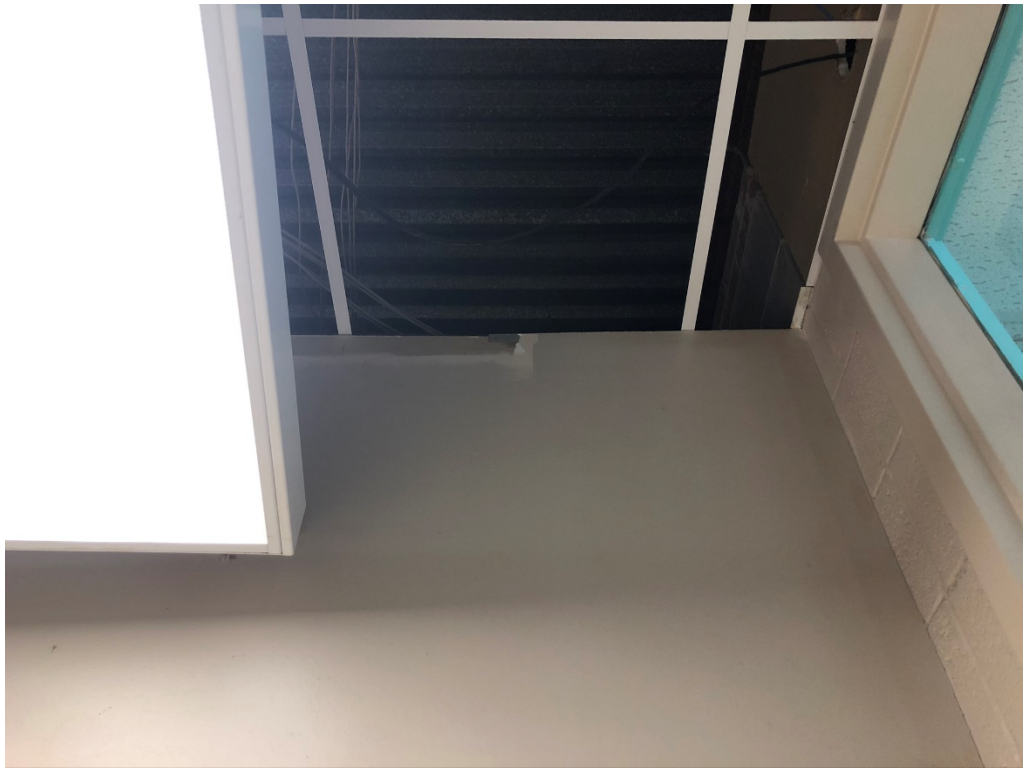
Figure 1 – Damage at Upper Drywall & No Corner In Place

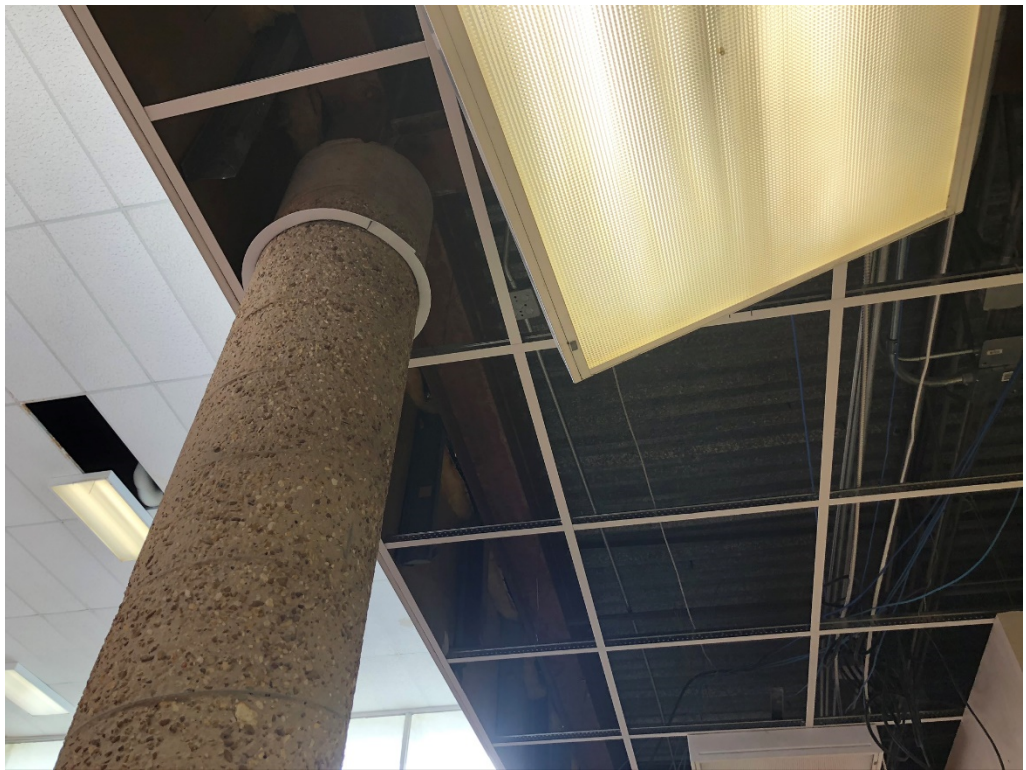
Figure 2 – Example of Curved Grid Corner

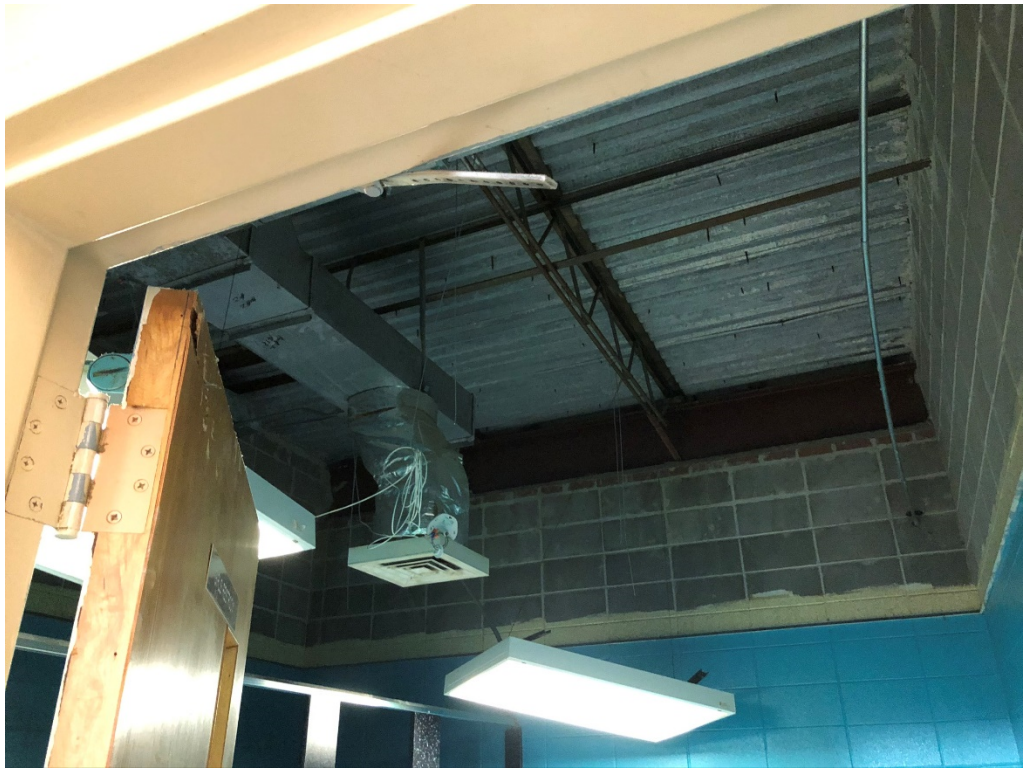
Figure 3 – Demo at Bathrooms

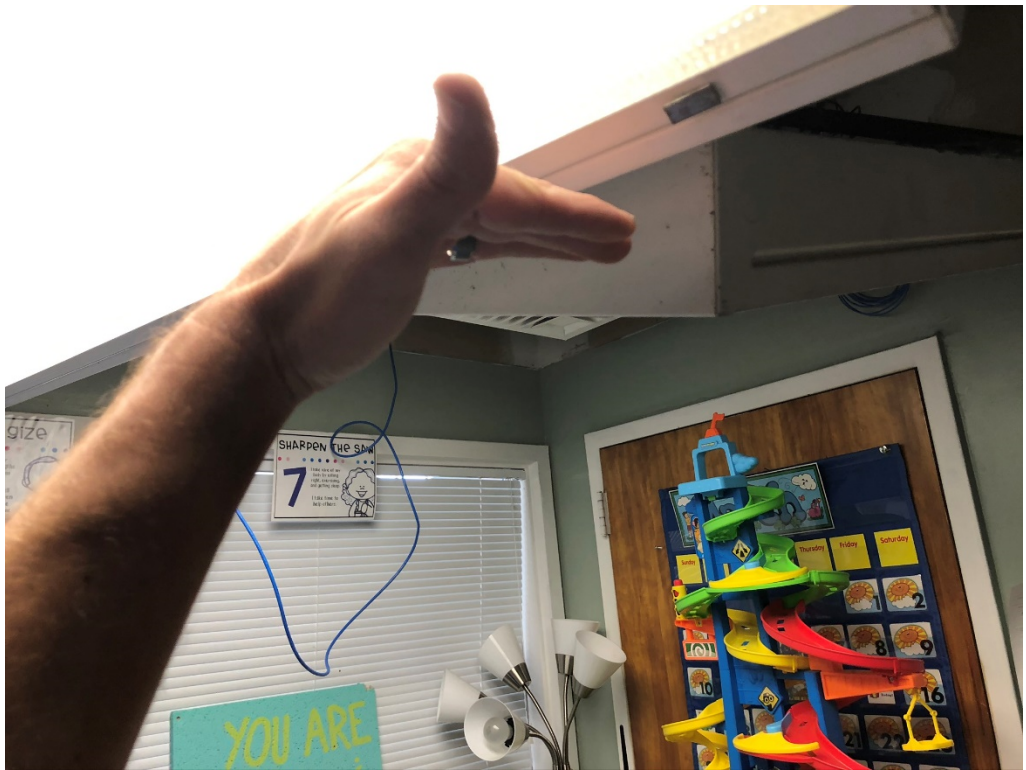
Figure 4 – Low Hung Light

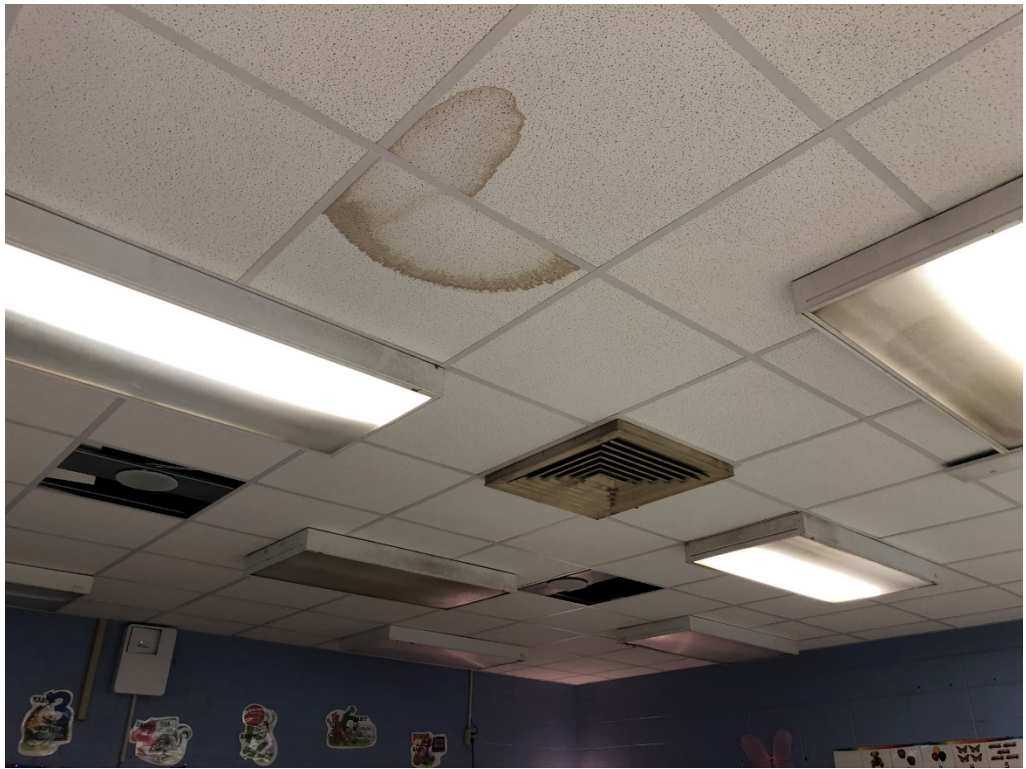
I noted progress in the building number 1. Tiles in the southern most classroom have been installed and damaged due to previously noted roof leak.

Figure 5 – Water Damaged Tile at Room 111

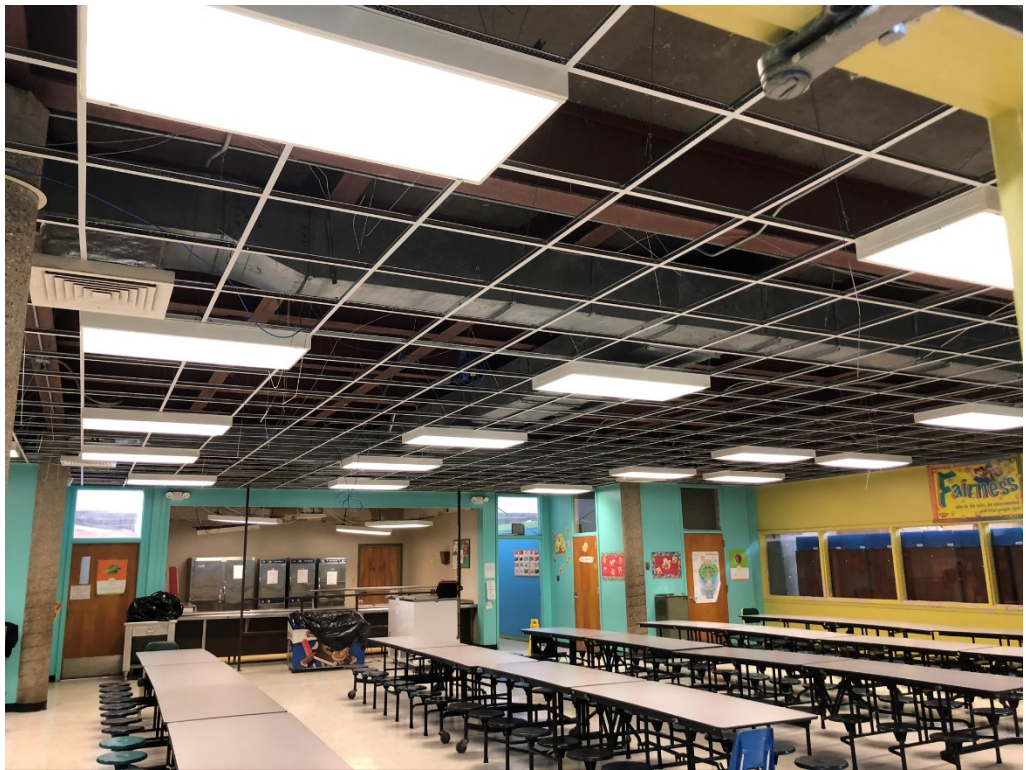
Figure 6 – Demo and Put Back at Dining 117

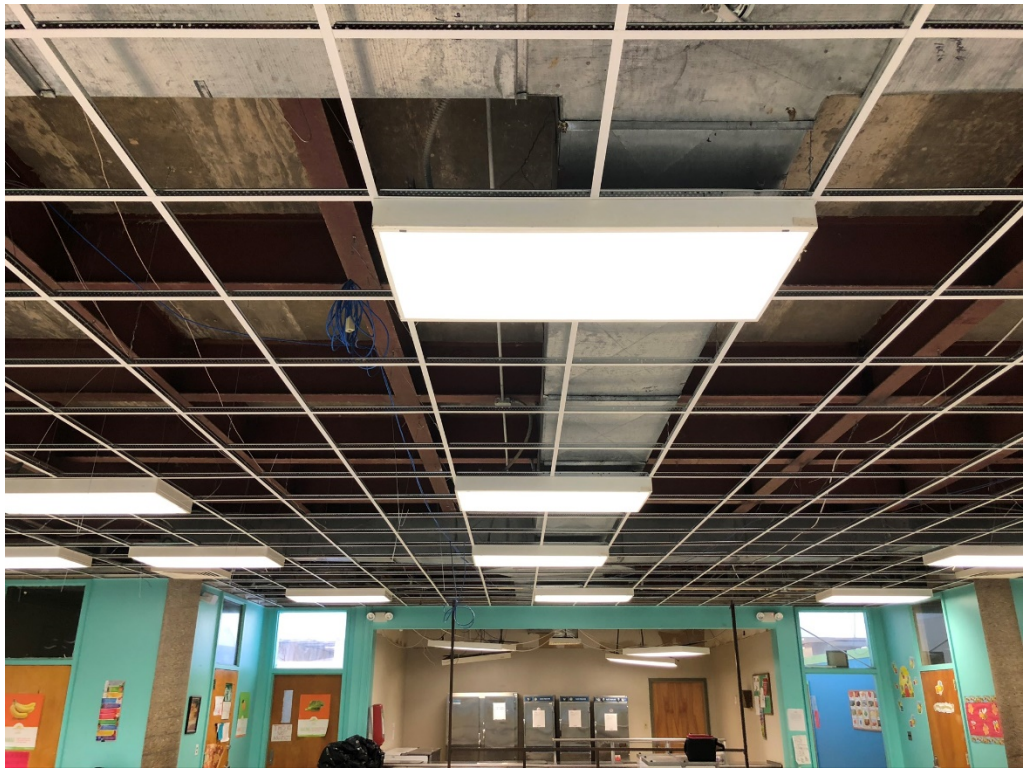
Figure 7 – Properly Aligned Lighting

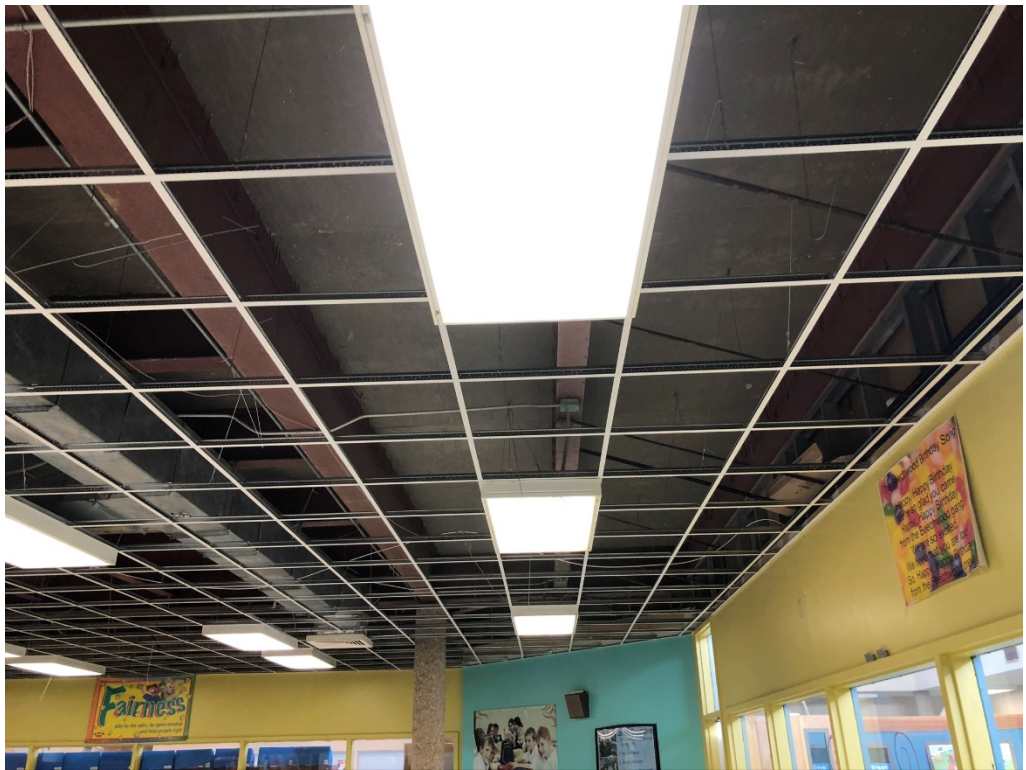
Figure 8 – Properly Aligned Lighting

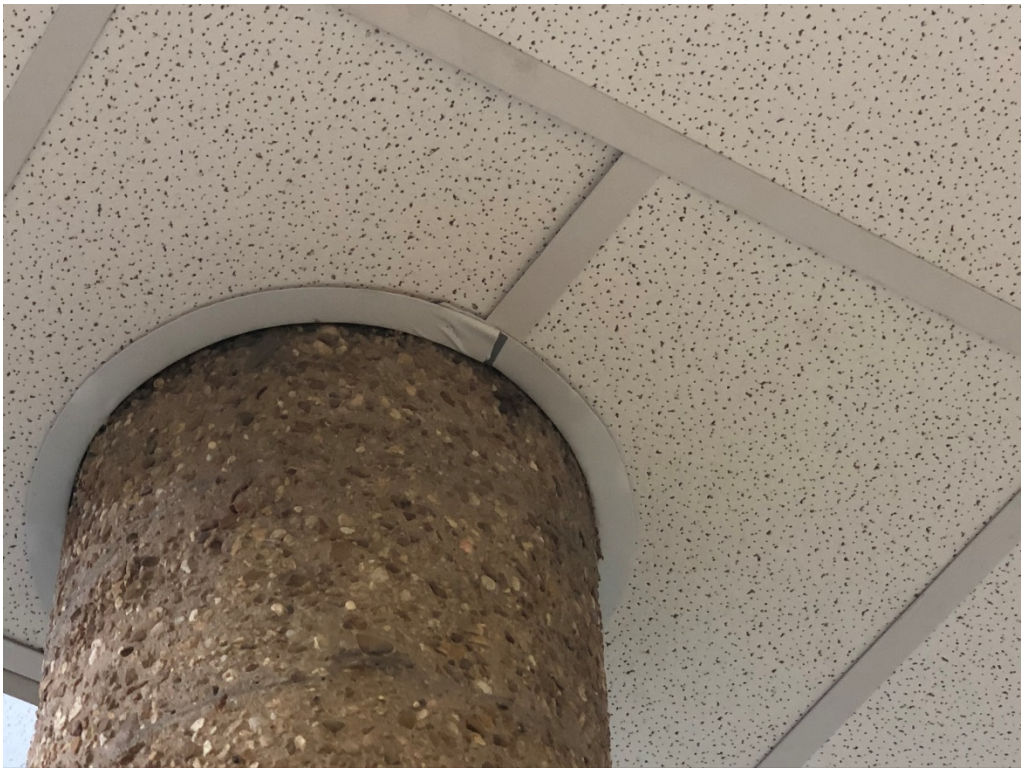
Figure 9 – Damage at Newly Installed Curved Corner Near Work Room 109A

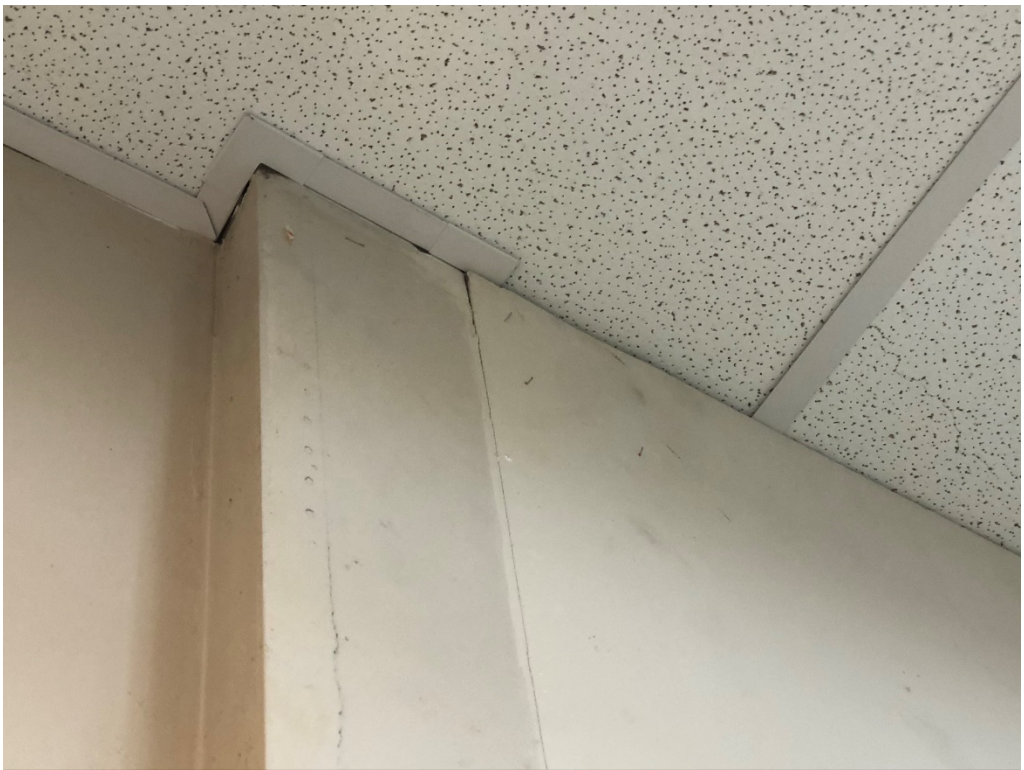
Figure 10 – Corner not Continuous Corridor 127

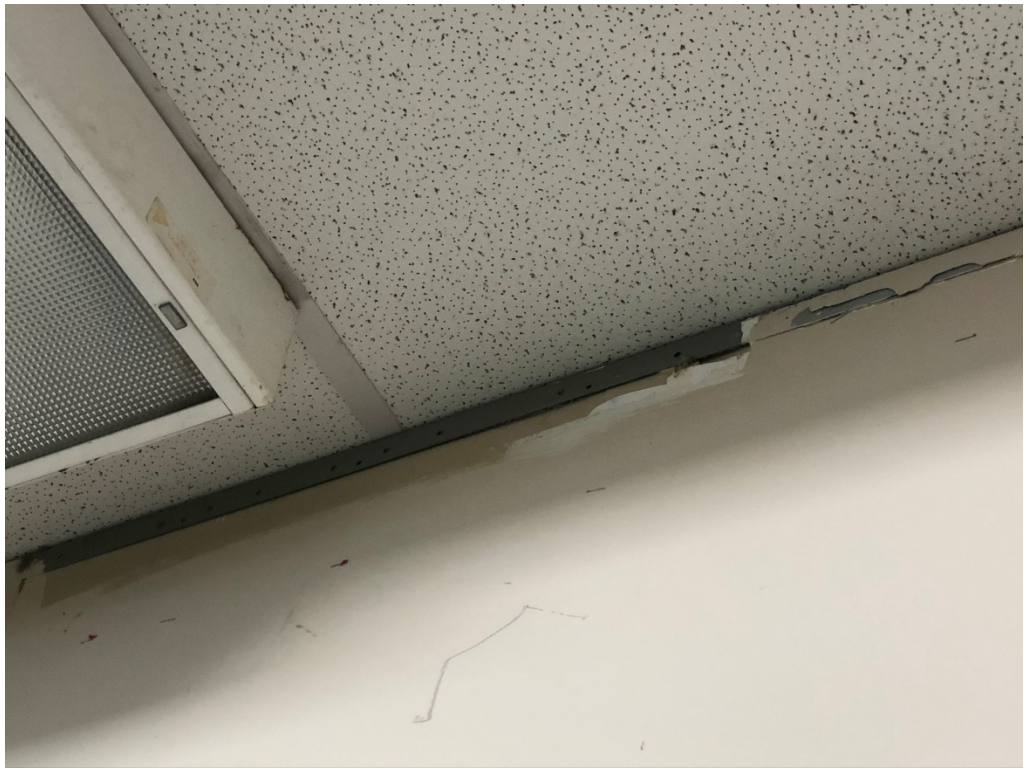
Figure 11 – Drywall Damage at Upper Wall Corridor 127

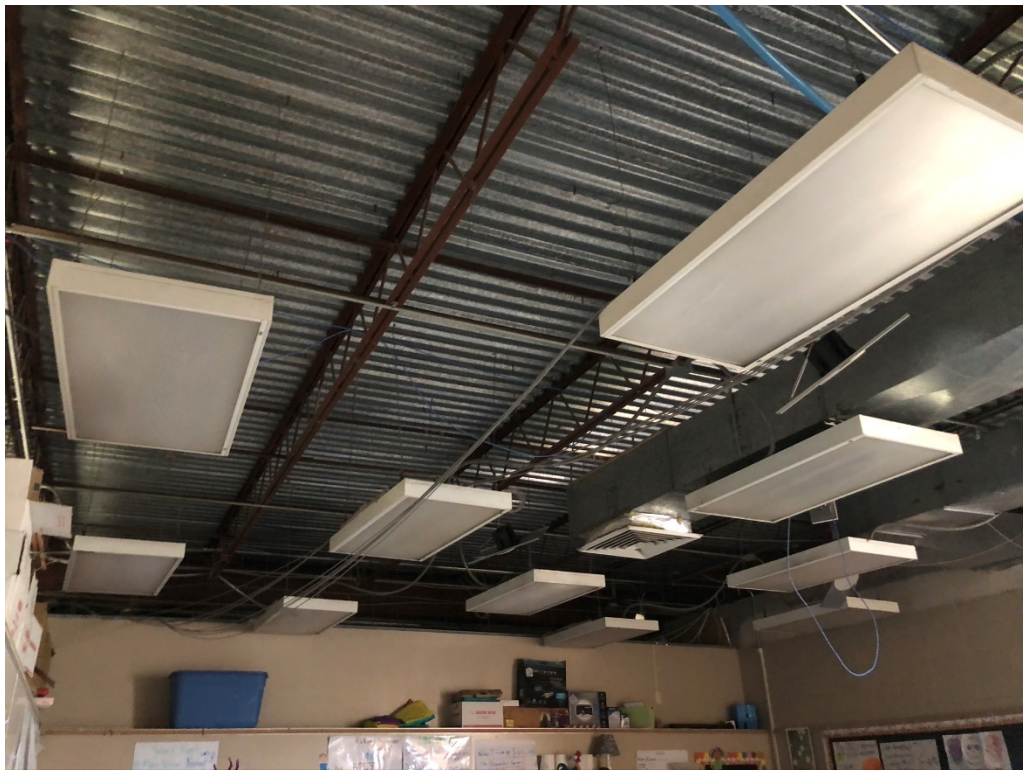
Demolition in building has followed every other room demo recommendation for 2 rooms so far (314 & 312).

Figure 12 – Demo in Building 3 Room 314

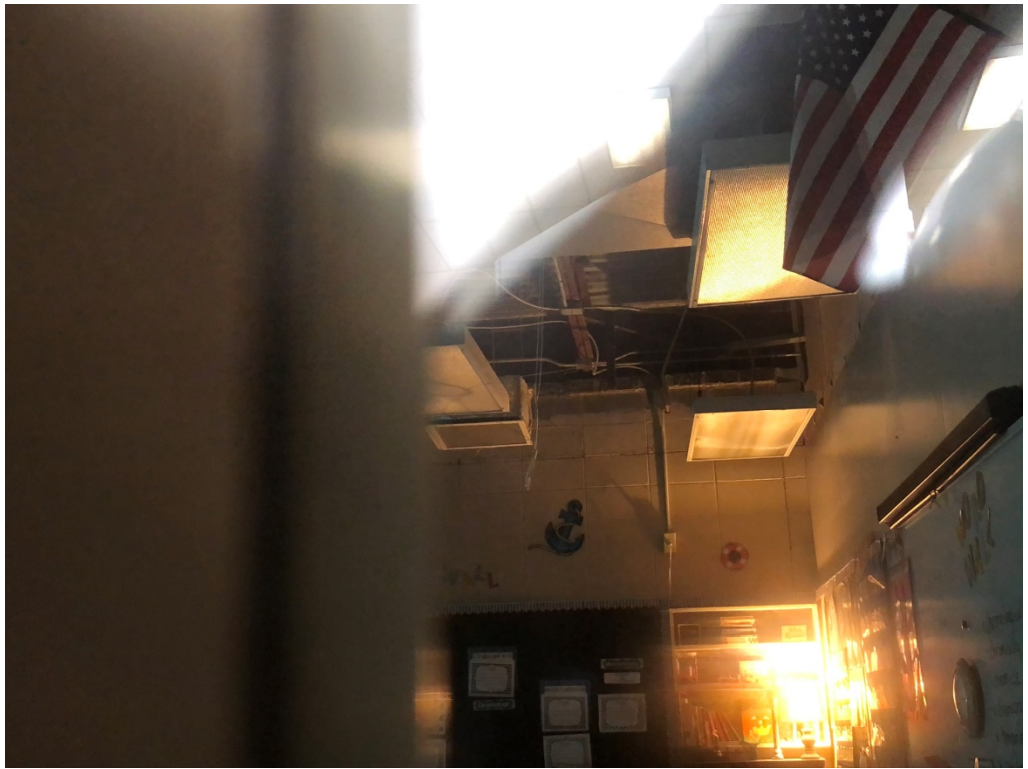
Figure 13 – Demo in Building 3 Room 312
