Architect's Field Report

15 November 2019

18043-BW Beechwood Elementary / Report Number 009

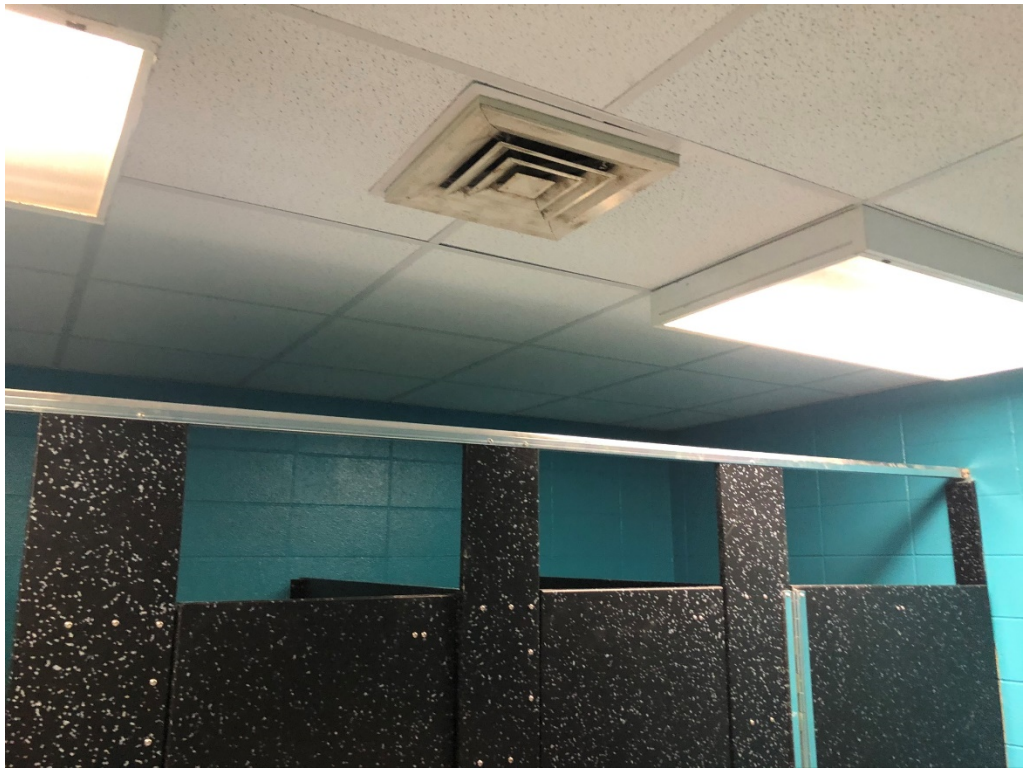
Building 1 Bathrooms have ceiling tile installed.

Figure 1 – Building 1 Bathrooms Completed

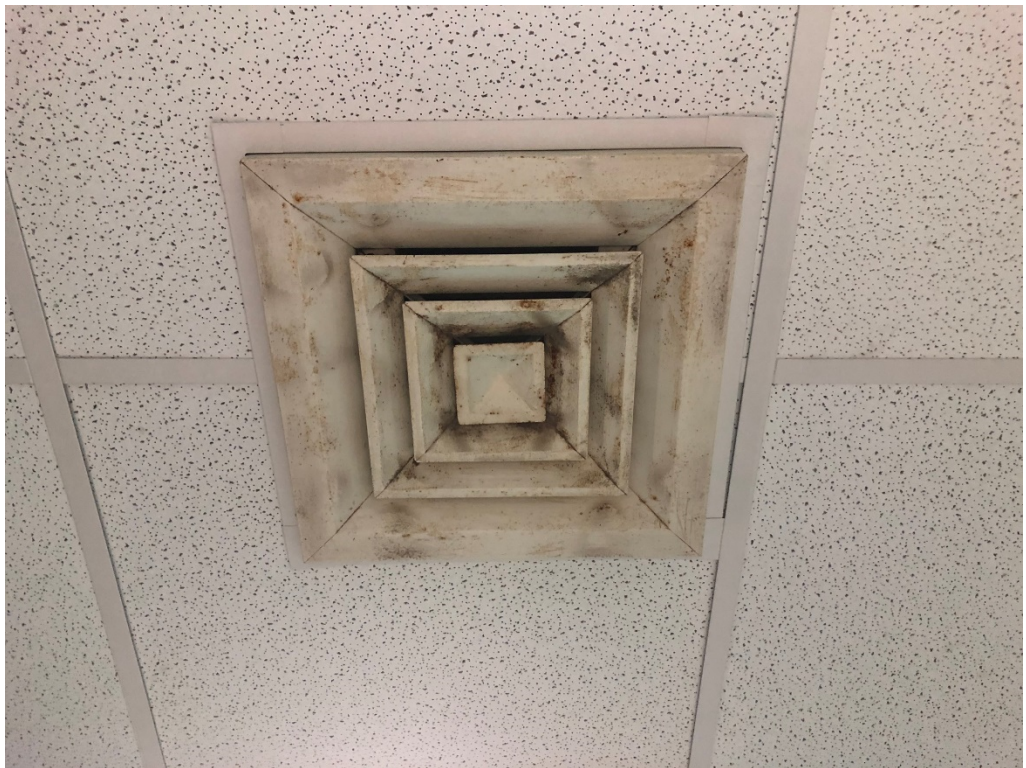
Figure 2 – Confirm Timeline on Clean and Repaint of vents

Items to Verify Confirm Timeline for Clean and Paint of Vents. (Figure 2)
Confirm Timeline for Reinstallation of Sensor. (Figure 5)
Confirm Timeline for Reinstallation of Speaker. (Figure 7)
Confirm Acceptability of Discolored Ceiling Tiles. (Figure 11)

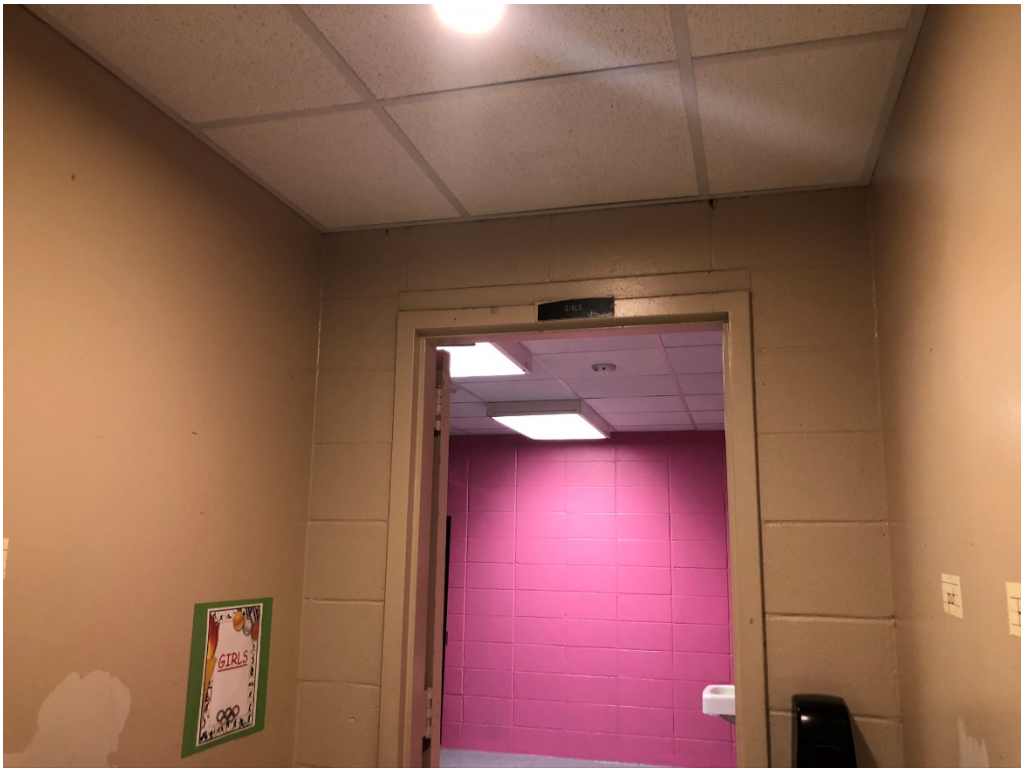
Figure 3 – Building 1 Bathroom

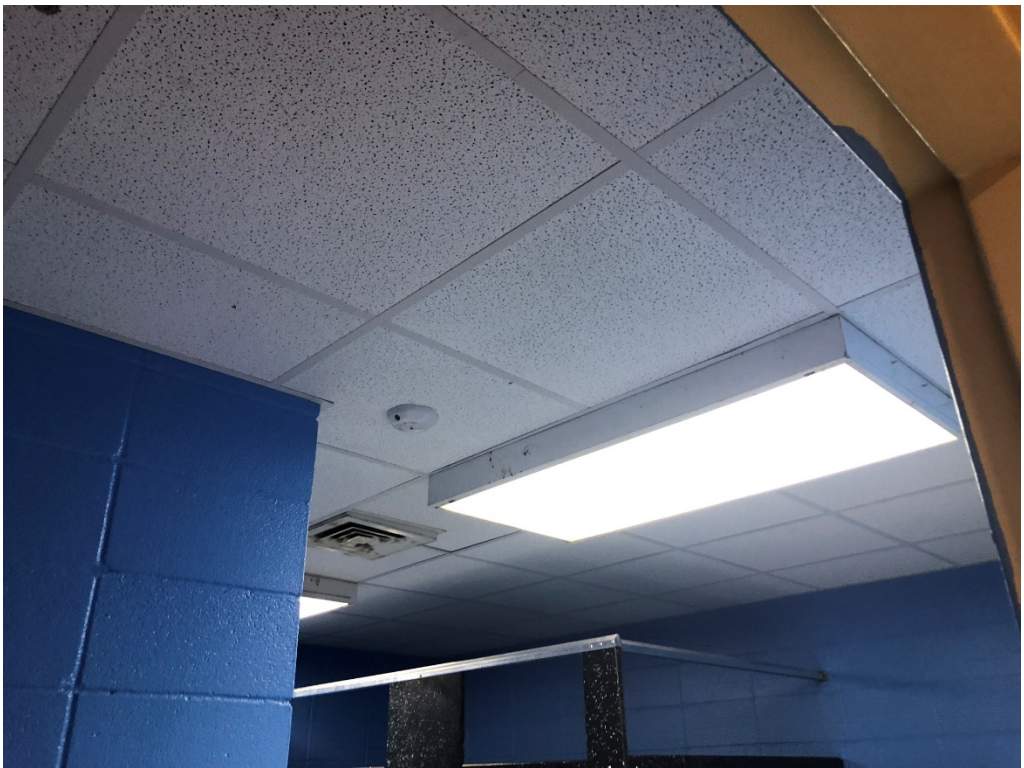
Figure 4 – Building 1 Bathroom

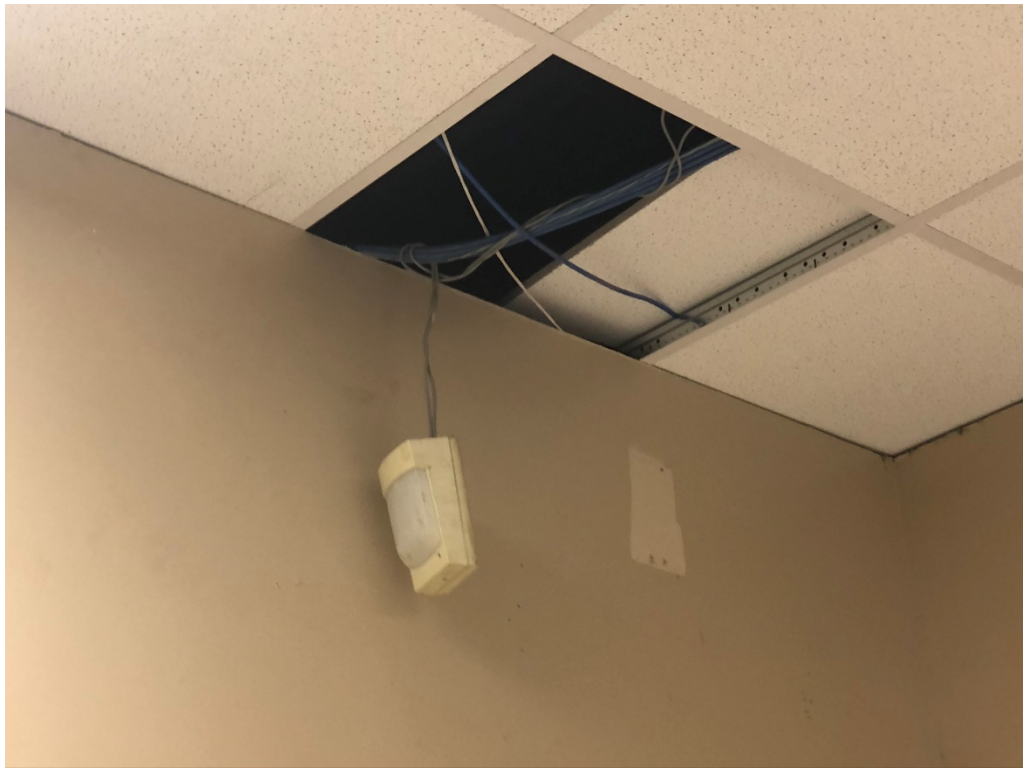
Figure 5 – Confirm what is issue with this not installed in Building 1 Corridor North Corner

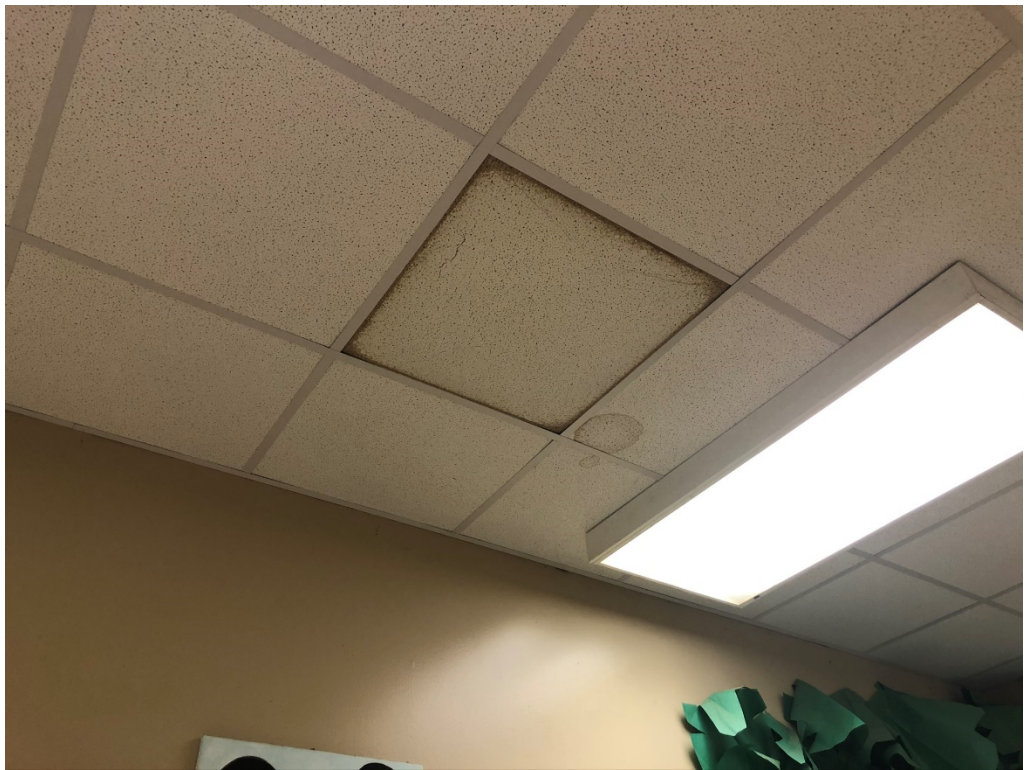
Figure 6 – Building 1 North Entry Water Damage

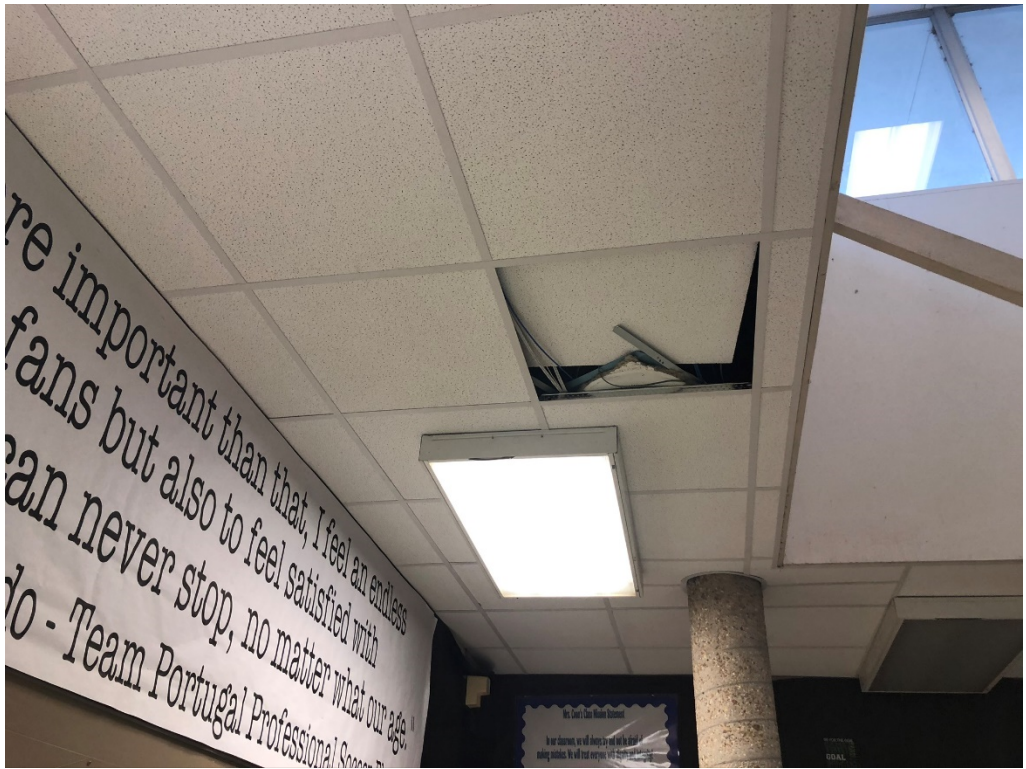
Figure 7 – Confirm when existing speaker shall be installed to tile

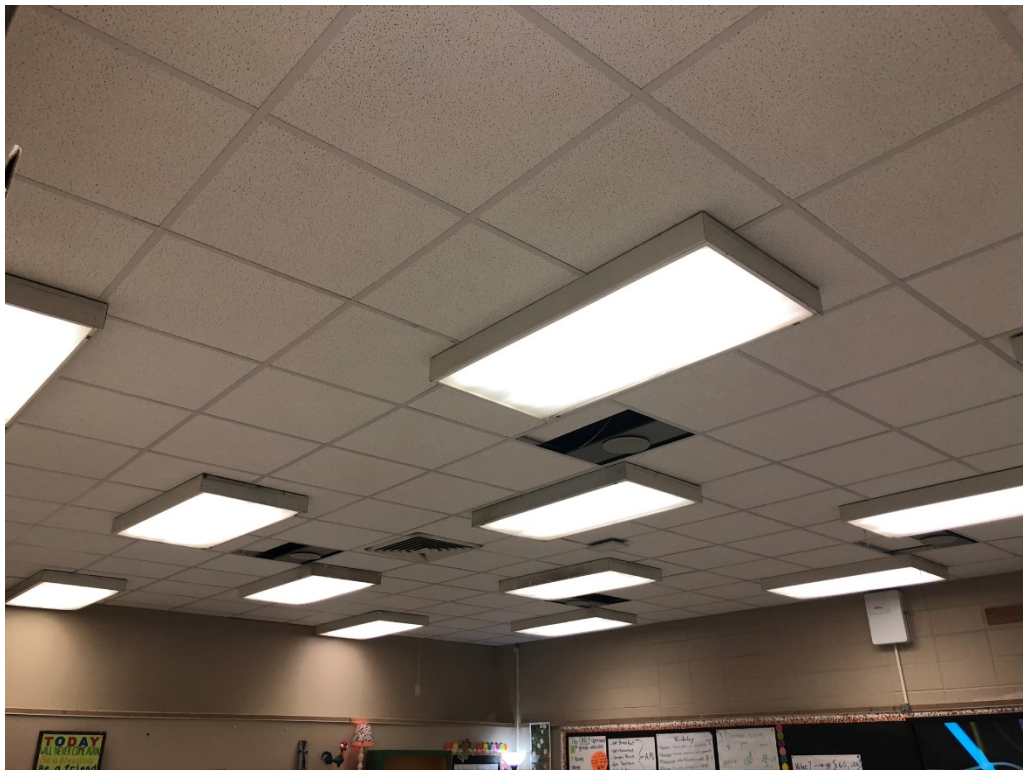
Figure 8 – Building 3 Reinstallation (Typical)

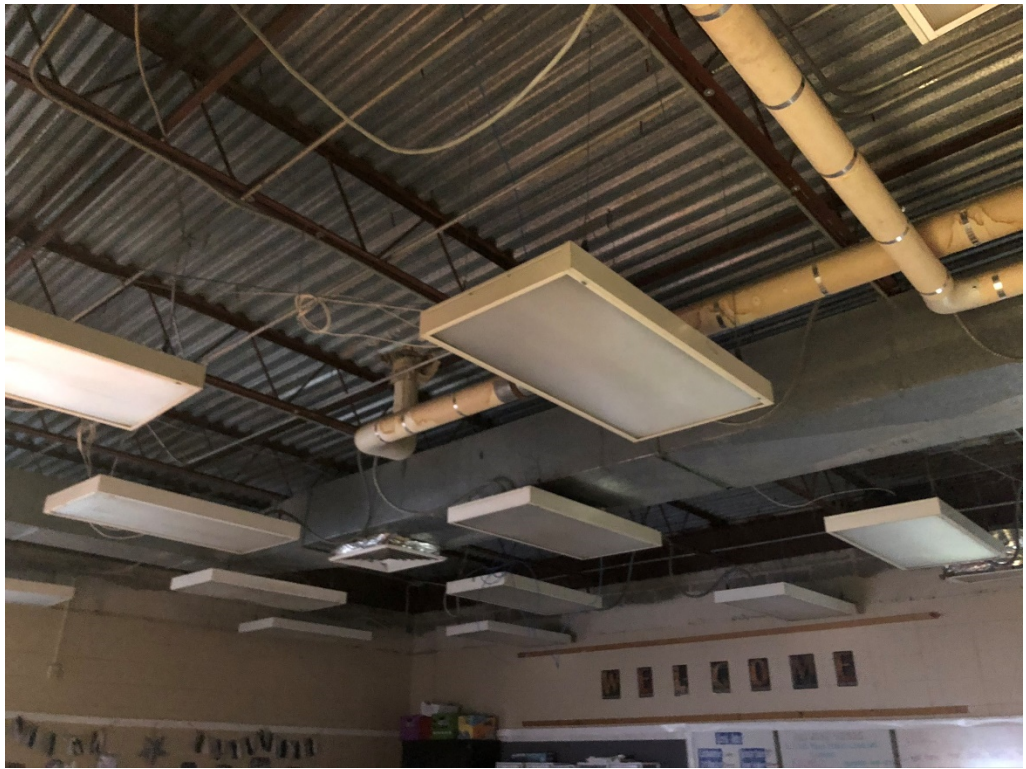
Figure 9 – Building 3 Demolition (Typical)

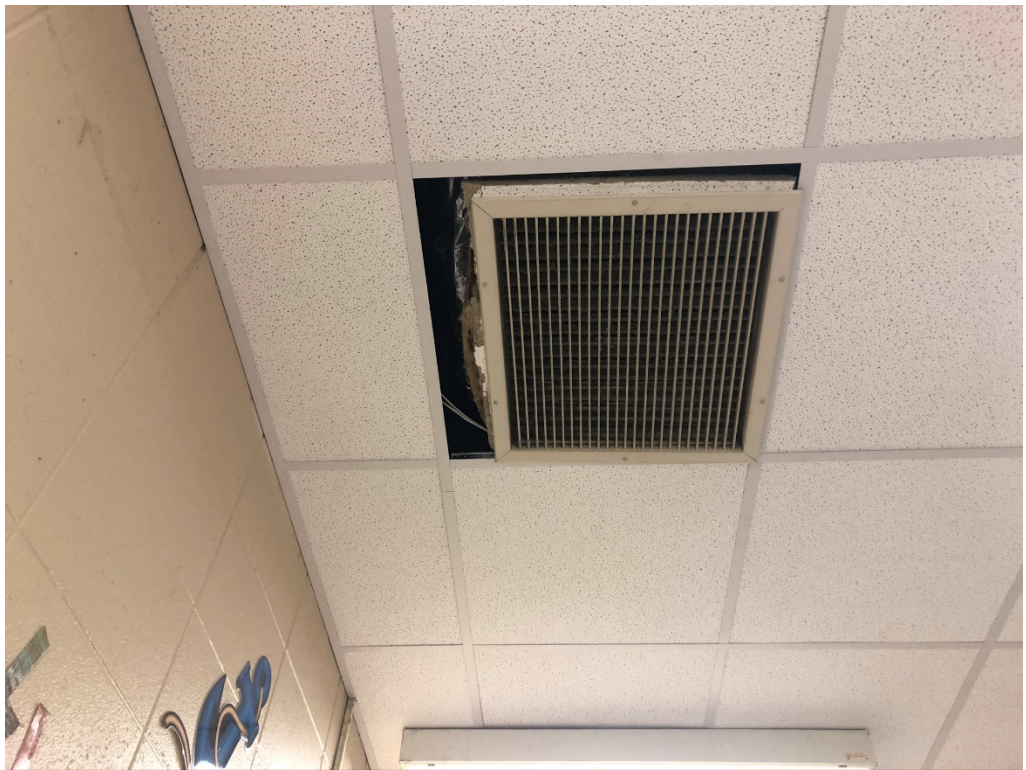
Figure 10 – Vent Awaiting New Tile Surround

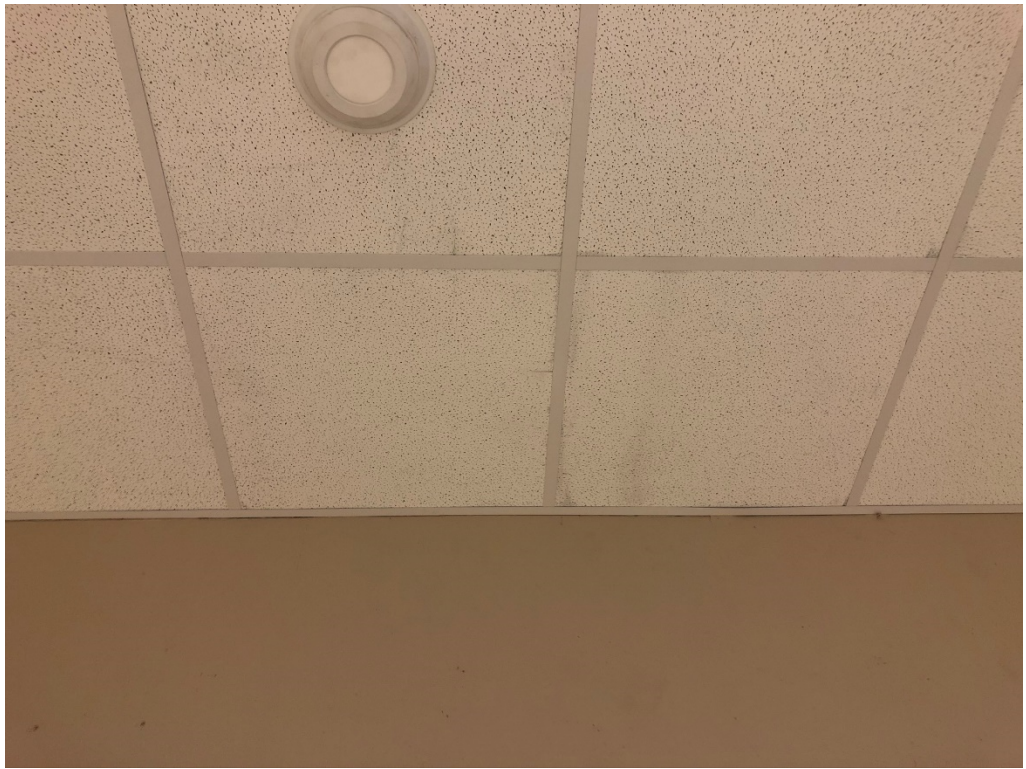
Figure 11 – Confirm Acceptability of discolored Ceiling Tile in Use SW Side Corridor Bldg 3

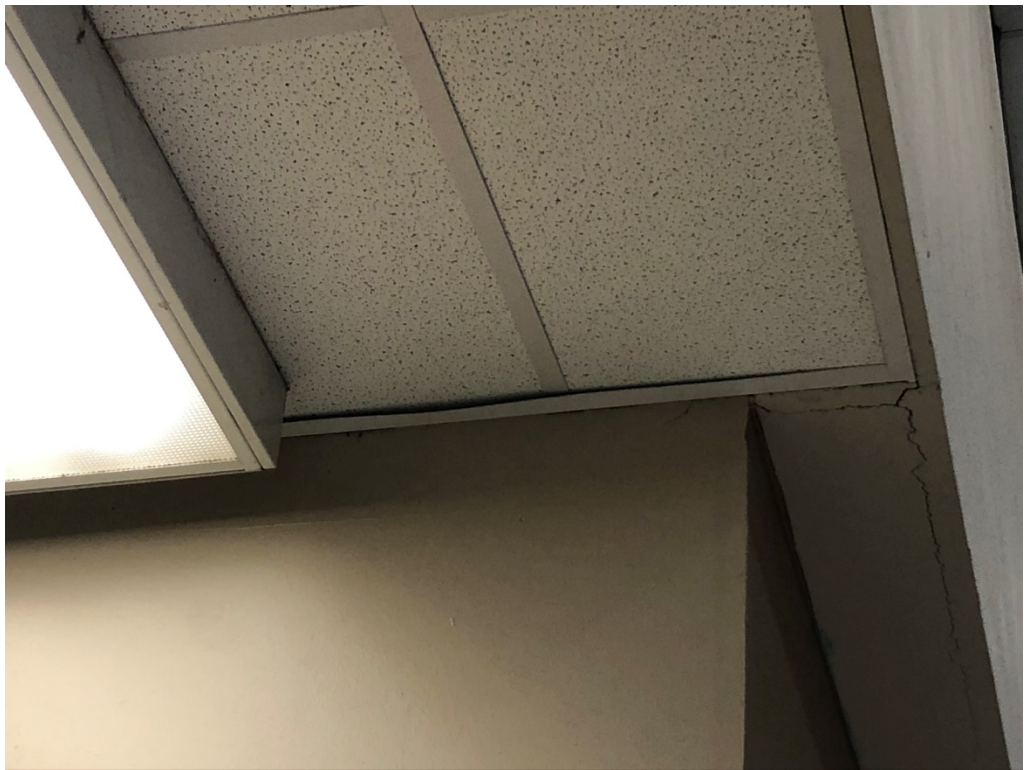
Figure 12 – Deformed Corner NW Side Corridor Building 3

Action Required Repair/Replace Deformed Corner. (Figure 12)
