## Architect's Field Report

20 November 2019

18043-BW Beechwood Elementary / Report Number 010

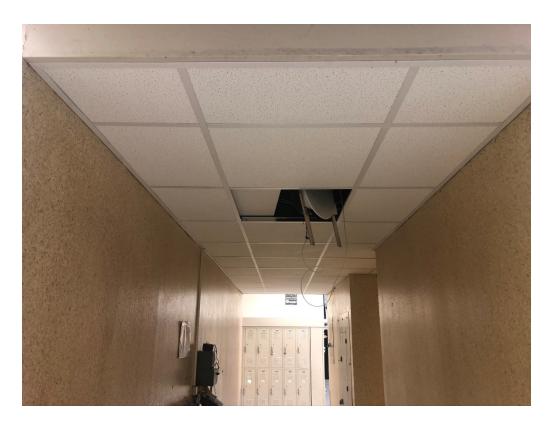
Figure 1 – Building 3 Hall

continues at an appropriate rate. Some item on reinstallation have not been completed (see figure 1, 2, 4, & 5).

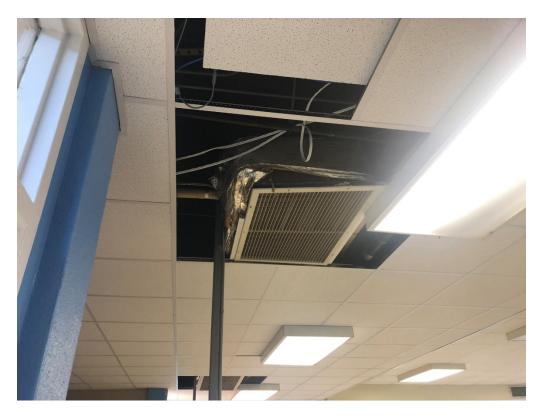
Figure 2 – Building 3 Cafeteria Unfinished Registers

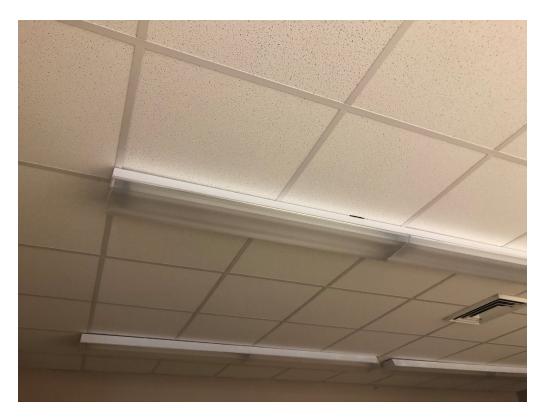
Figure 3 – Building 3 Cafeteria Notch Showing @ Light

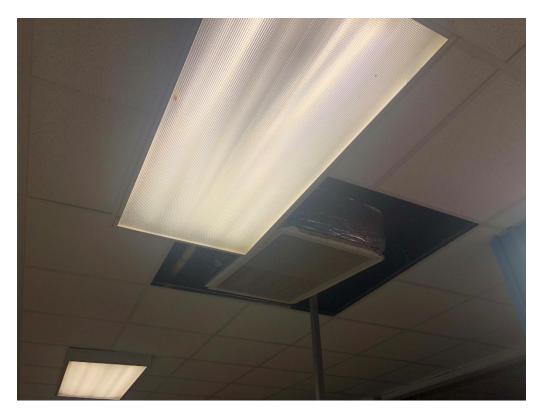
Figure 4 – Building 3 Cafeteria Unfinished Registers

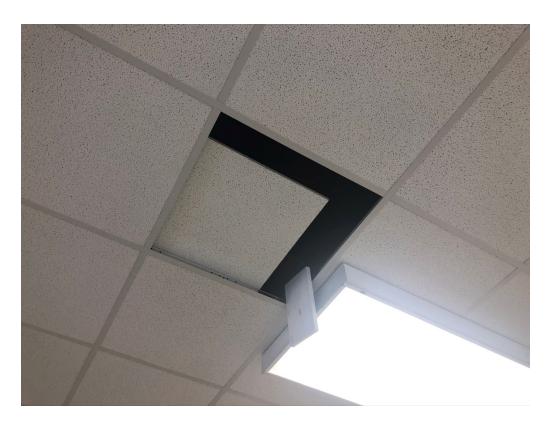
Figure 5 – Building 3 Cisco Router (What's the plan here?)

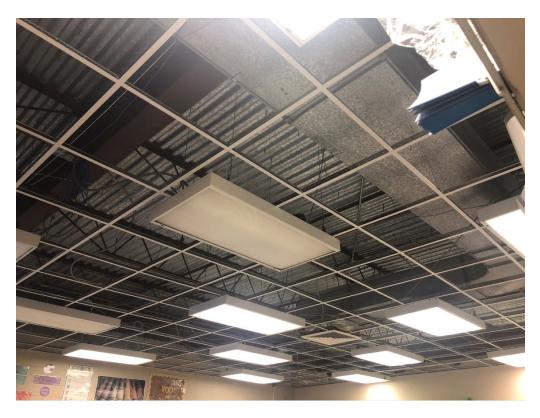
Figure 6 – Typical Grid Put Back Building 3

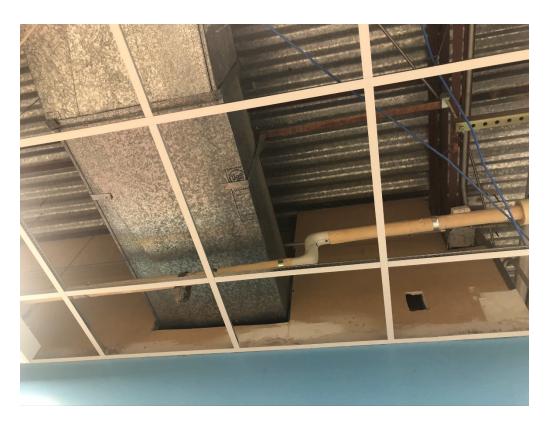
I also spoke with Ms. Donna Smith in Room 302 who mentioned that a 12" piece of rebar had fallen on her computer equipment. She says that no damage was made. On inspection of where it possibly could have fell from, I noted a pipe hanger that appears to have been installed

originally, but has since been disconnected (see figure 7).

Figure 7 – Pipe Hanger Not In use

Confirm Pipe Hanger was not in Use Prior to Demo and does not require

reinstallation (Figure 7).

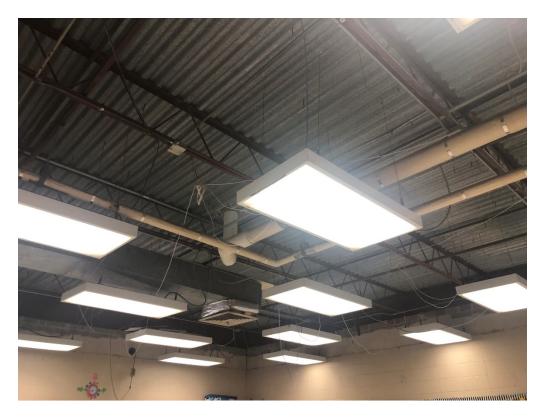
Figure 8 – Typical Demo in Building 3

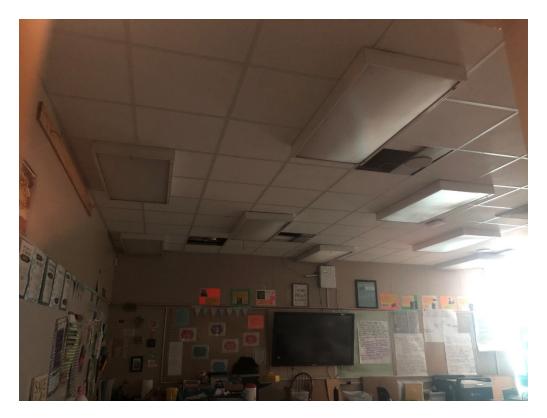
Figure 9 – Typical Finished Ceiling in Building 3
