Architect's Field Report

13 December 2019

18043-BW Beechwood Elementary / Report Number 013

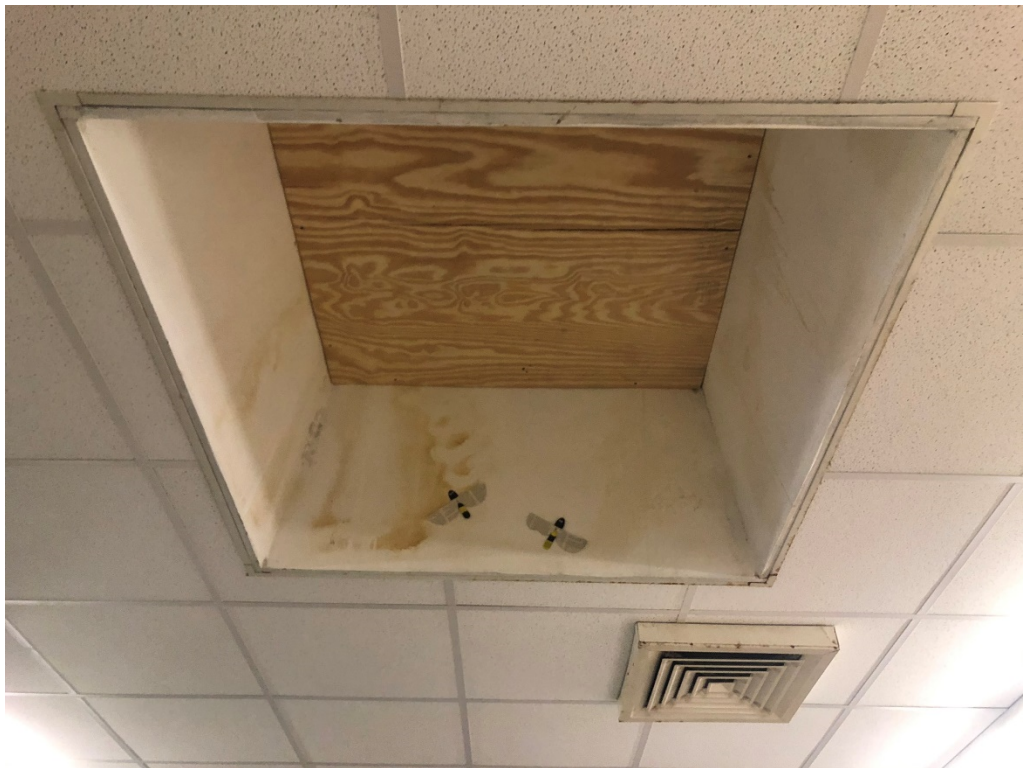
Building 2 Art class room has been installed, also. There is some corner grid in this room around the skylight that has not been replaced and looks unsightly.

Figure 2 – Building 2 Art Class (rust on old grid)

Items to Verify Plan for corner grid in Art Class (building 2)

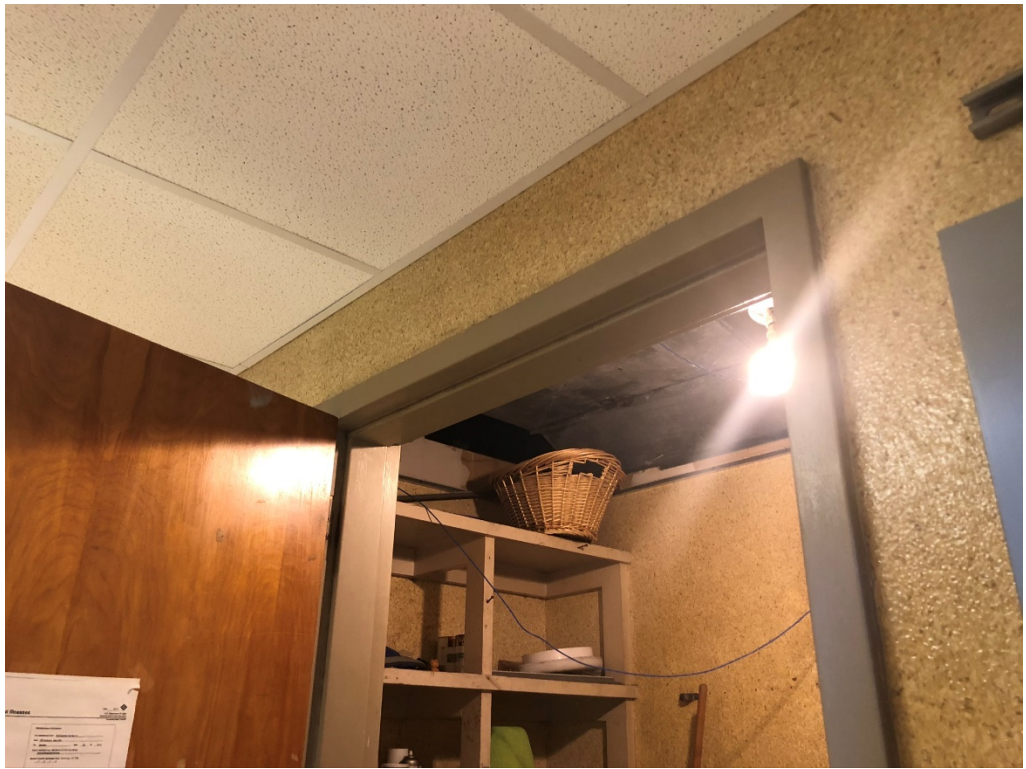
Figure 3 – Janitor Room @ 100D in building 1 (no ACT)

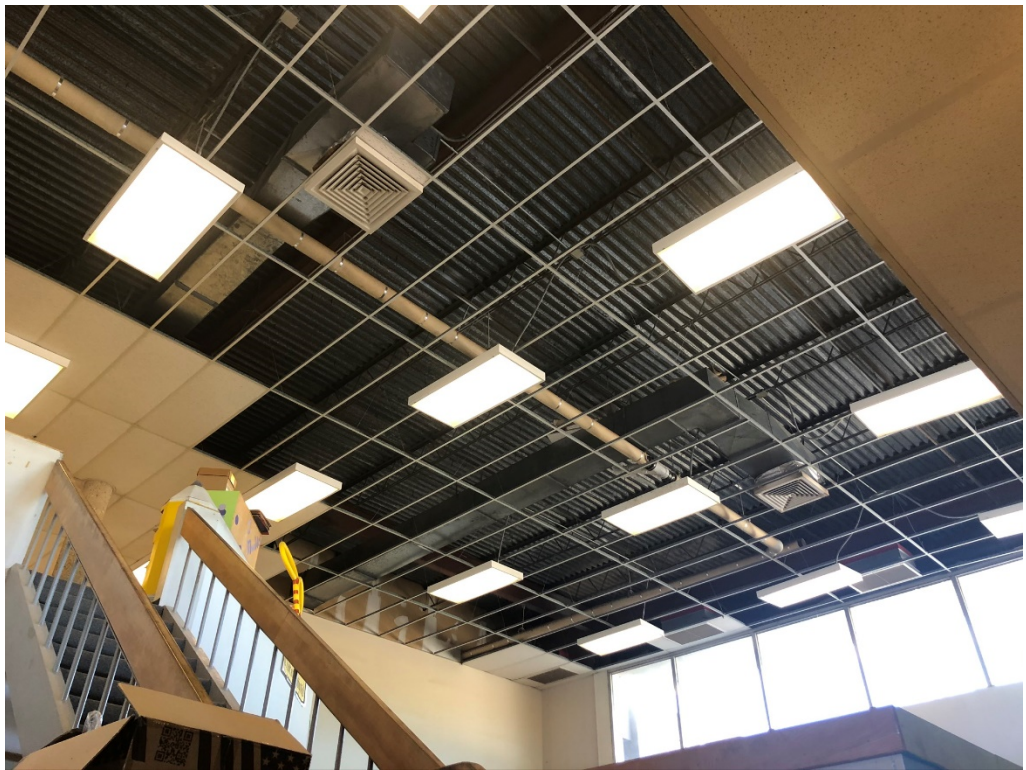
Observations Arriving on site, I walked building 1 first to check on work. High ceilings have tiles removed.

Figure 4 – Building 1 Tile Removed

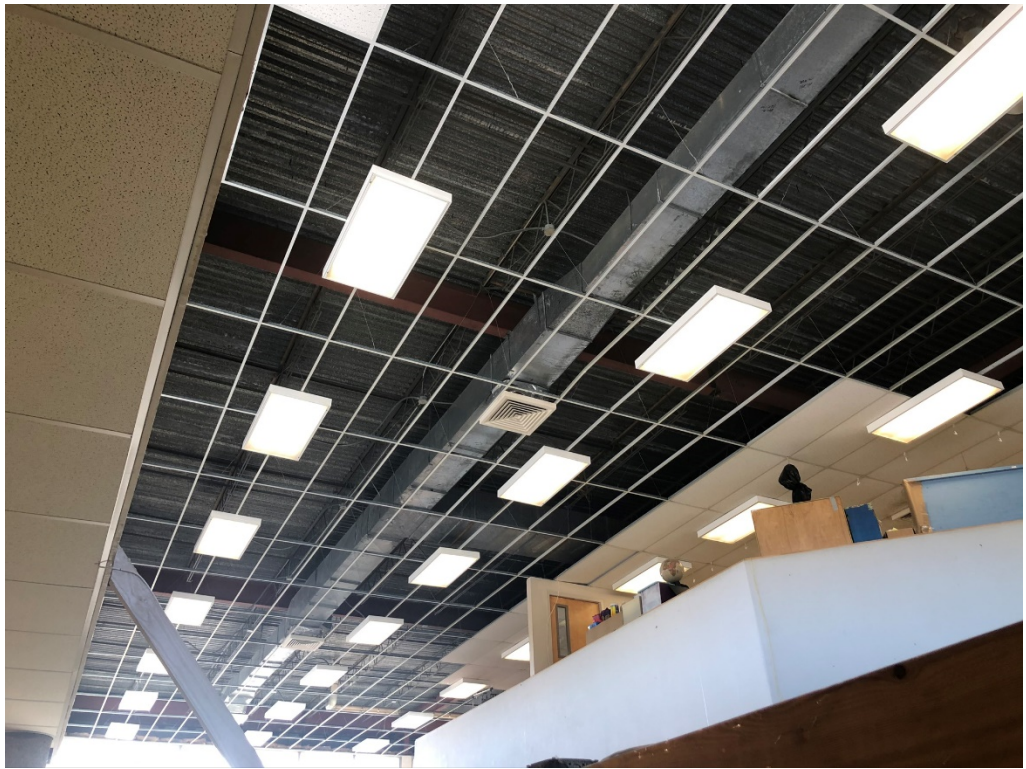
Figure 5 – Building 1 Tile Removed

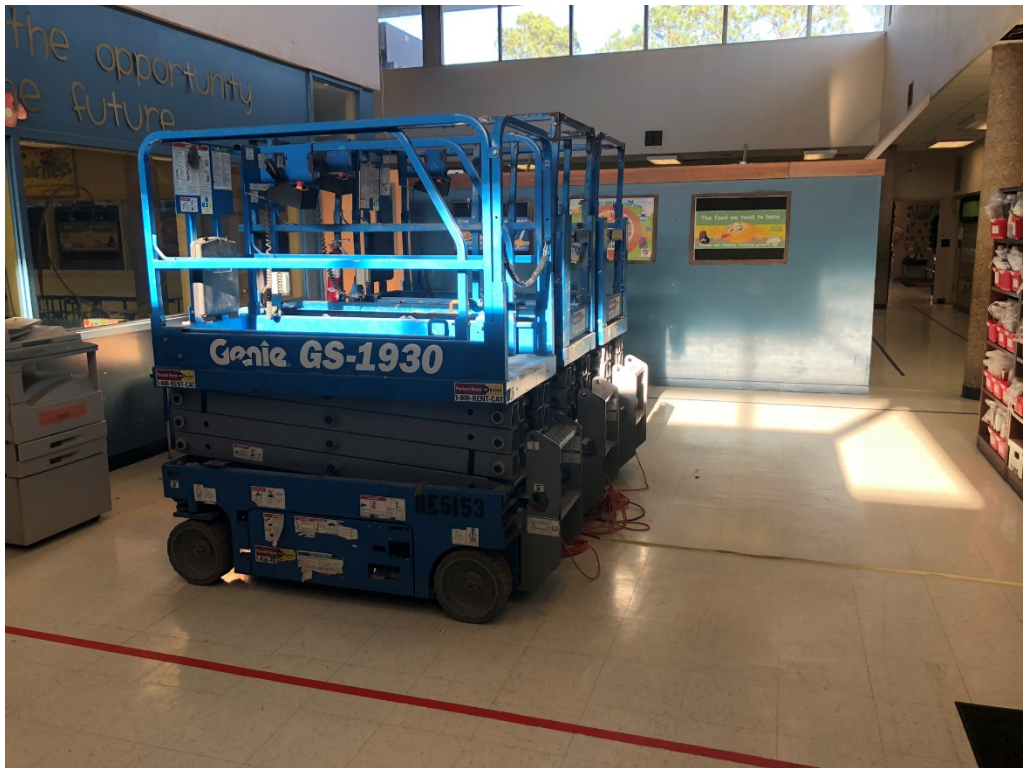
Figure 6 – Lifts stored on Site

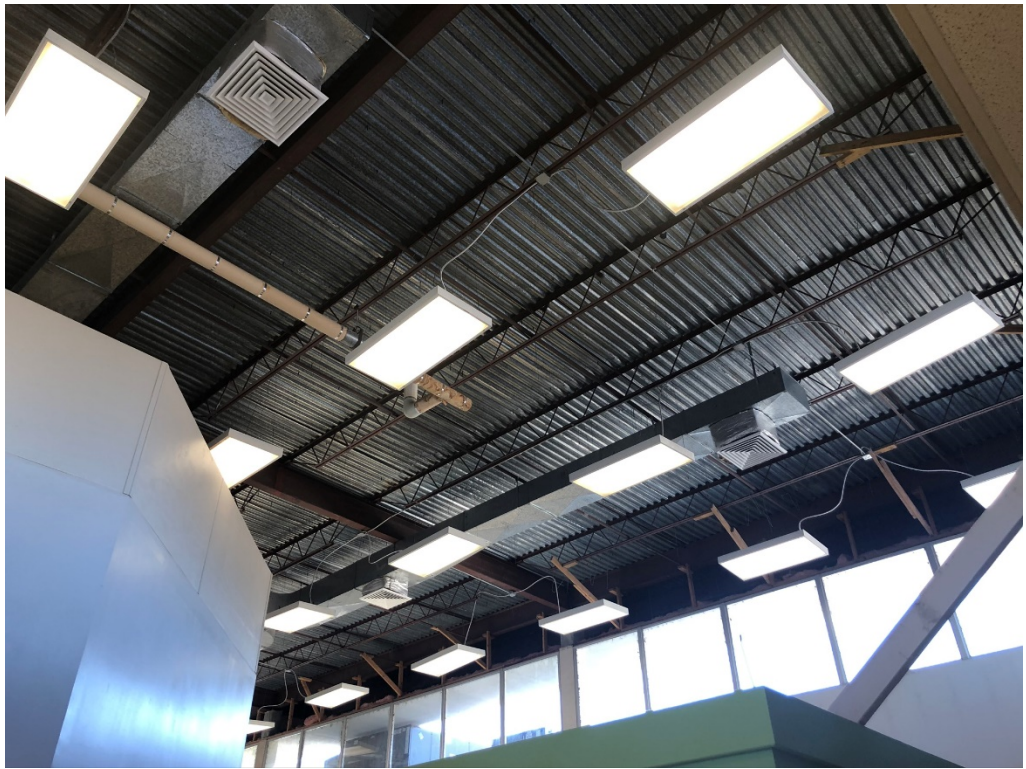
In building 3, high ceiling grid has been removed.

Figure 7 – Building 3 (grid removed)

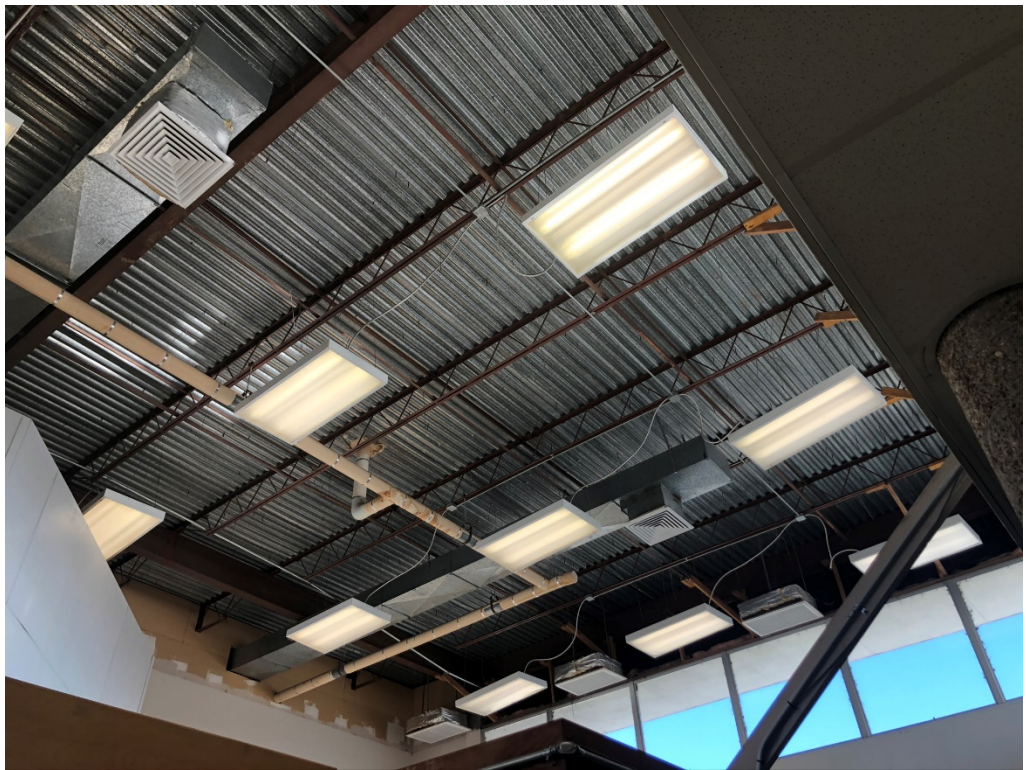
Figure 8 – Building 3 (grid removed)

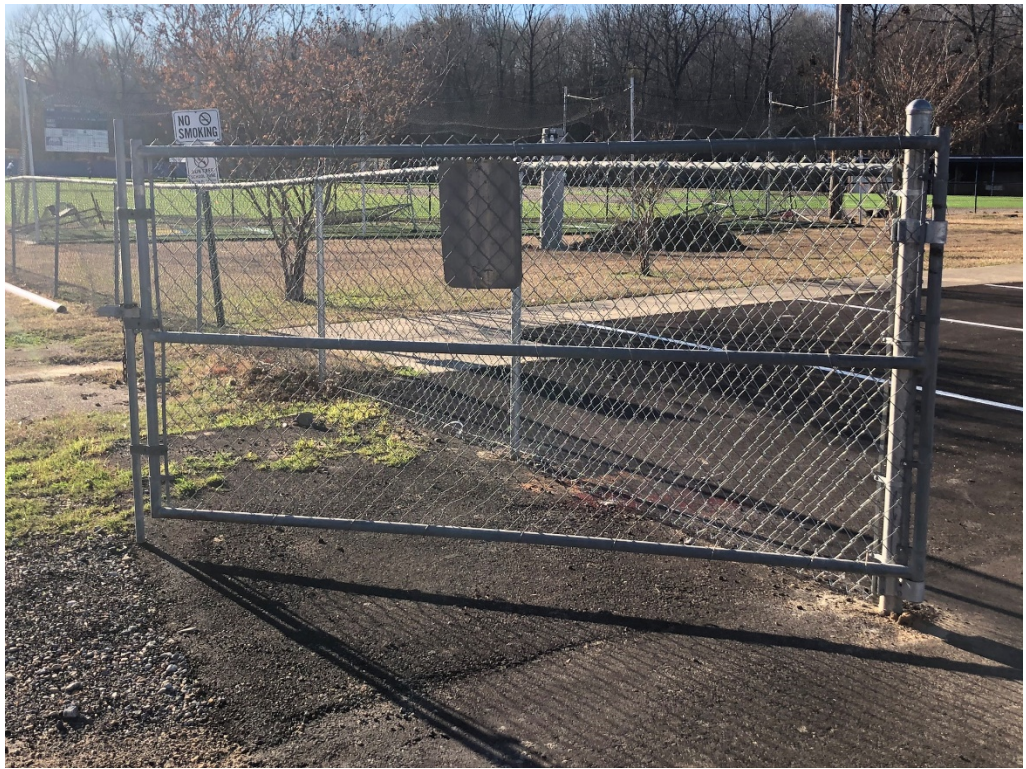
Figure 9 – Double Gate Re-Installed

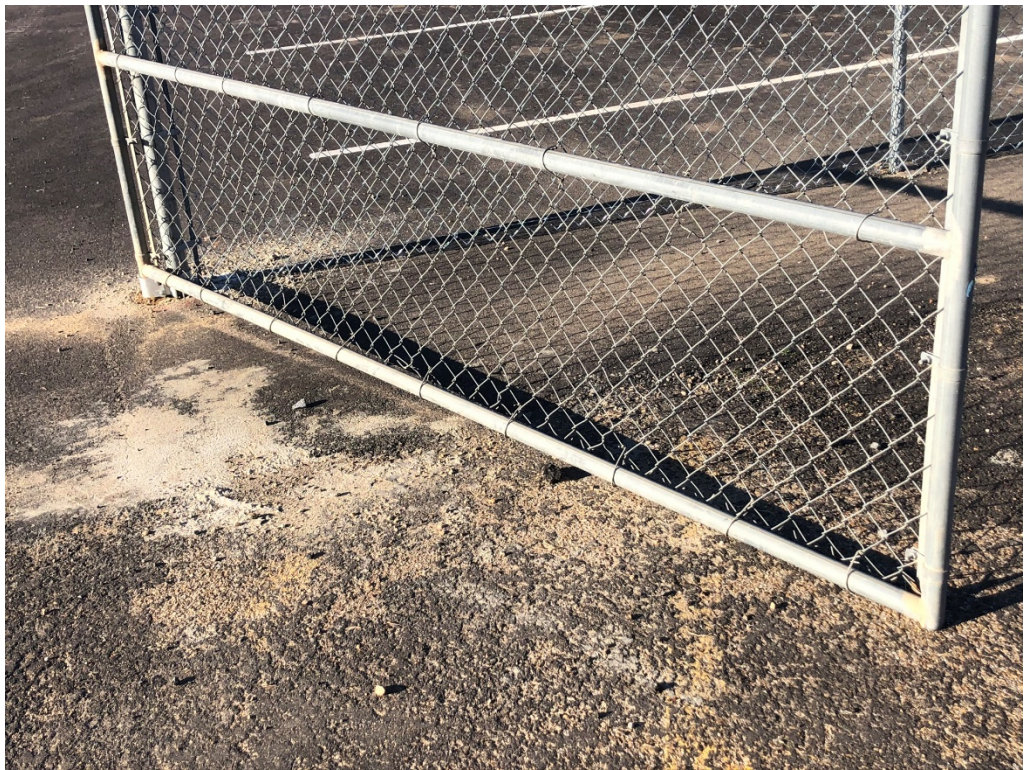
Figure 10 – Double Gate Re-Installed
