Architect's Field Report

07 January 2020

18043-BW Beechwood Elementary / Report Number 016

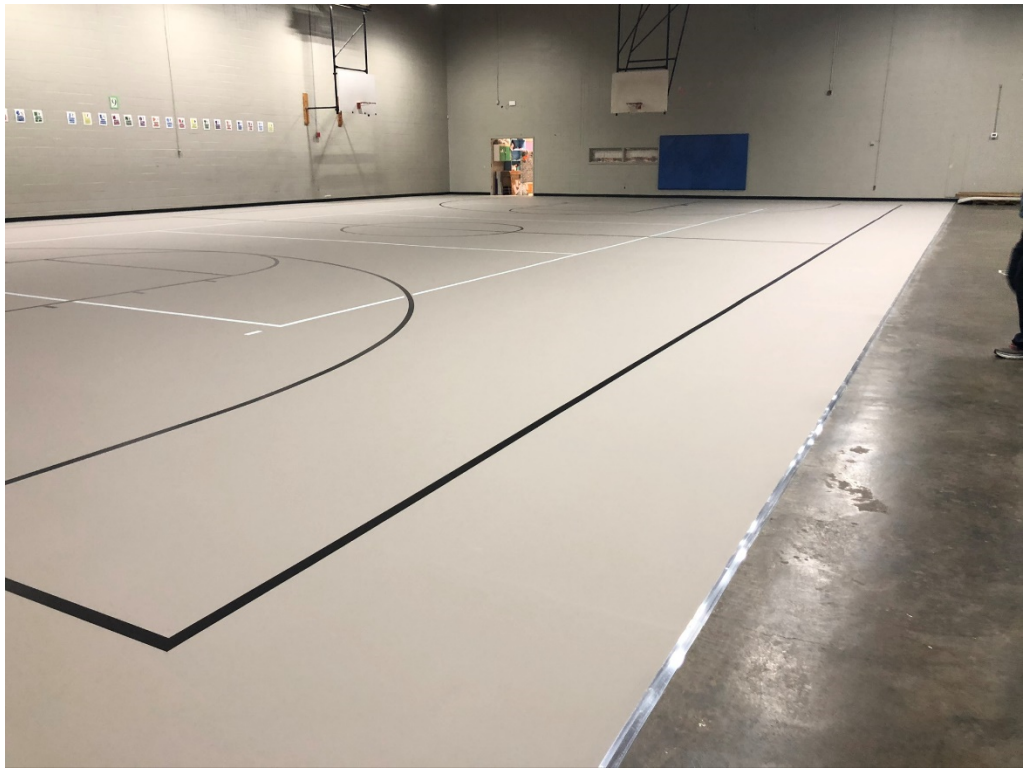
Observations I arrived prior to our AOC monthly meeting to perform a site walk. I noted gym floor work is complete and in the final curing process.

Figure 1 – Gym Floor

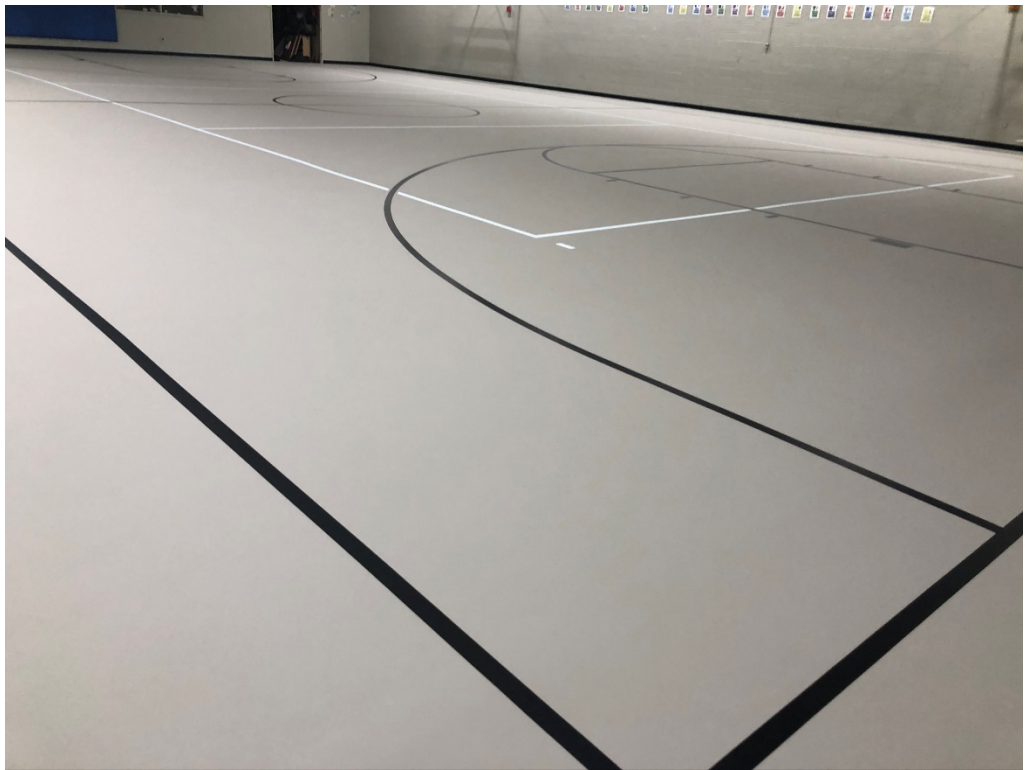
Figure 2 – Gym Floor

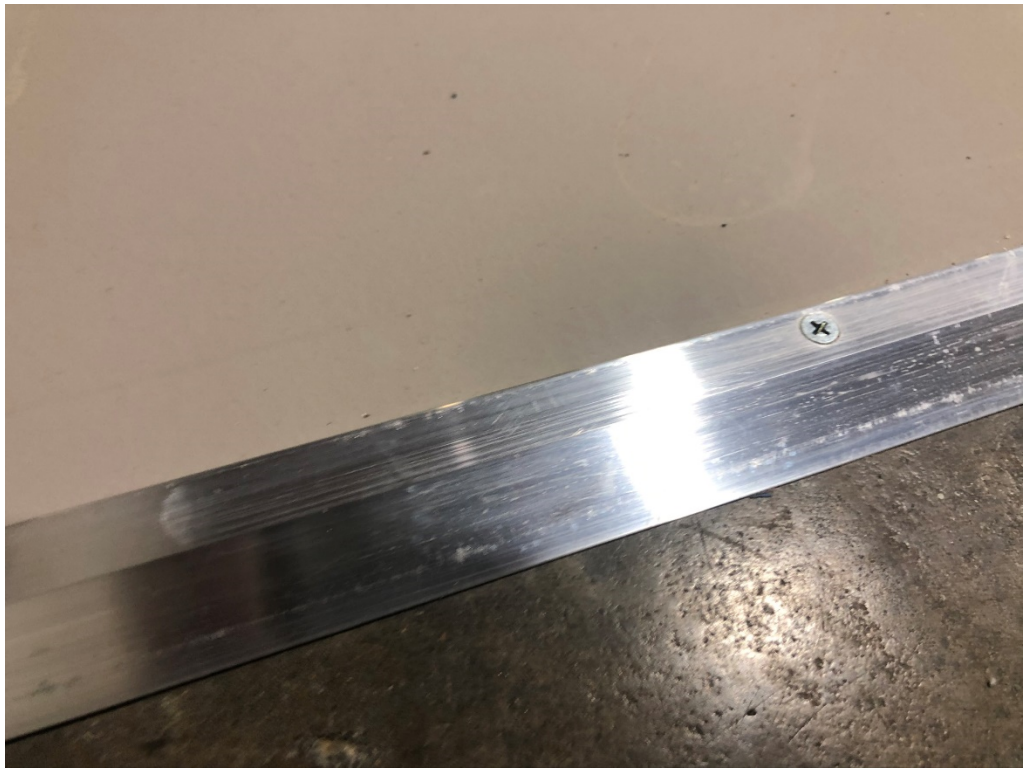
Figure 3 – Gym Floor Aluminum Threshold

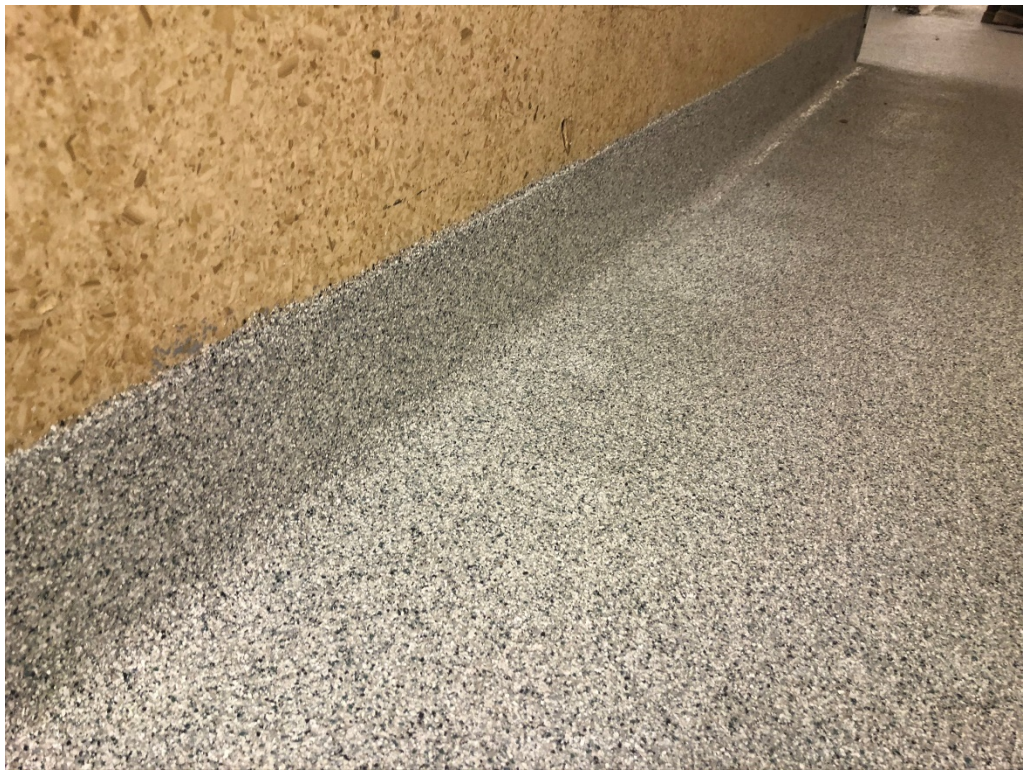
I spoke with Luke Walker about floor finishes in vestibule spaces. He noted that there is still touch up to be performed and clean up as well. Trash held off from installing FRP in these spaces due to this.

Figure 4 – Vestibule Floor Finishes

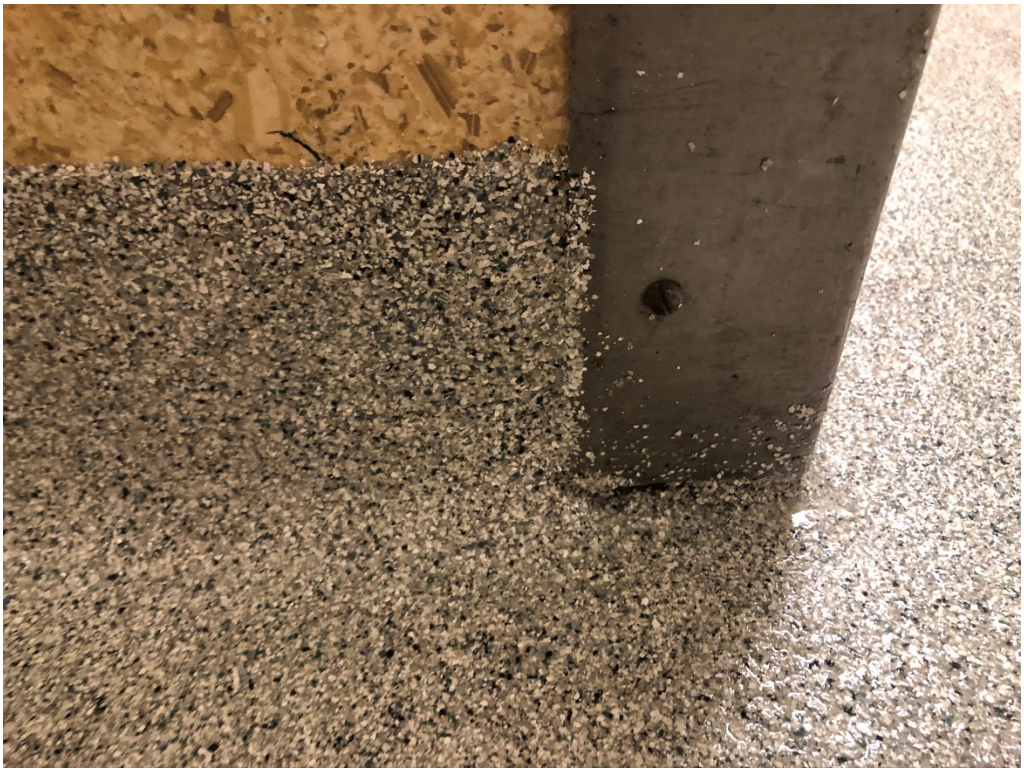
Figure 5 – Clean Required @ vertical Wall Components (typical)

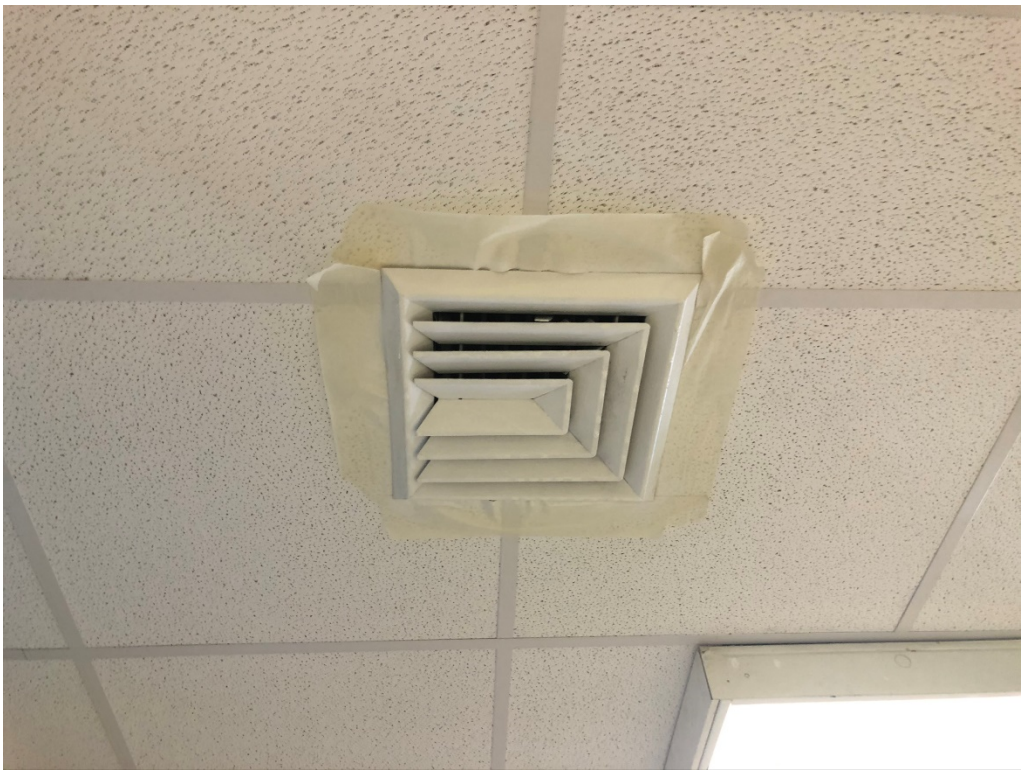
Luke indicated that painting of vents was ongoing and that this week, new doors will be installed in Building 2 corridor this week.

Figure 6 – Vents in the Process of RePainting

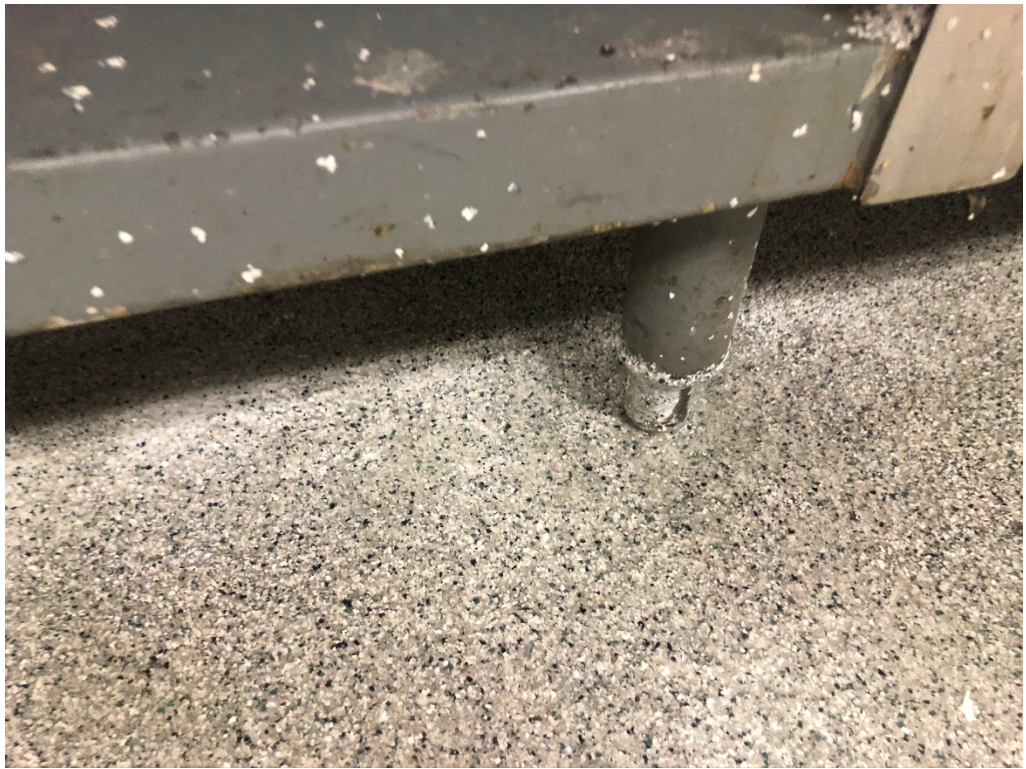
Figure 7 – Clean up Required @ Kitchen Equipment

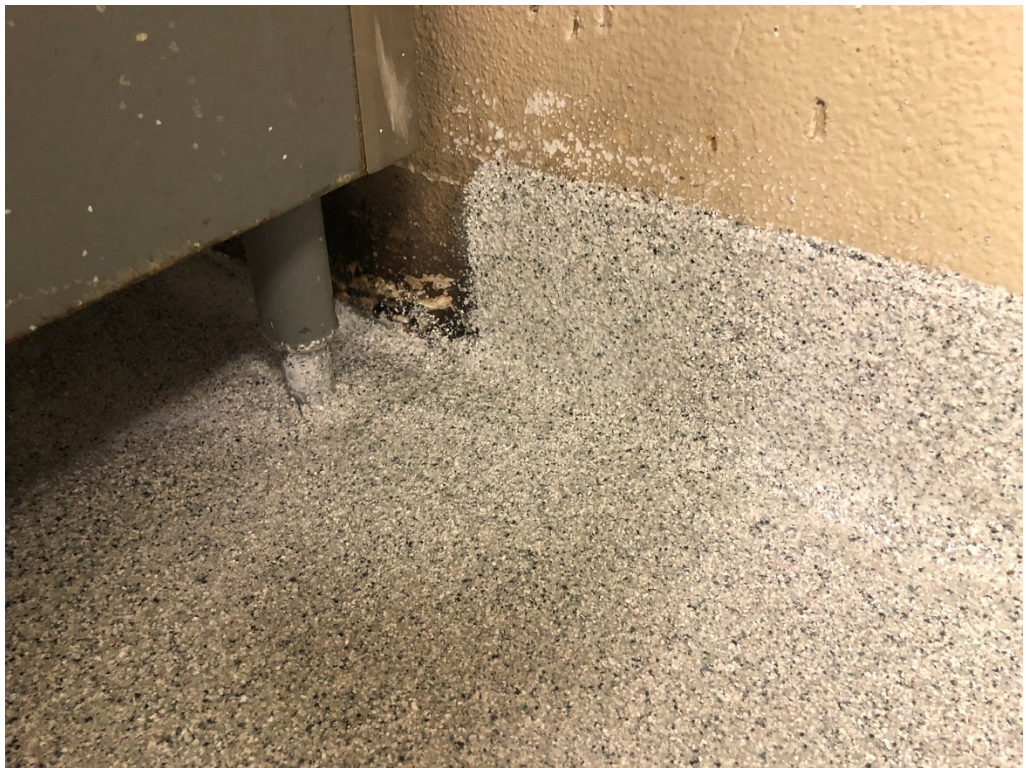
Figure 8 – Unfinished due to Inability to Move Kitchen Equipment

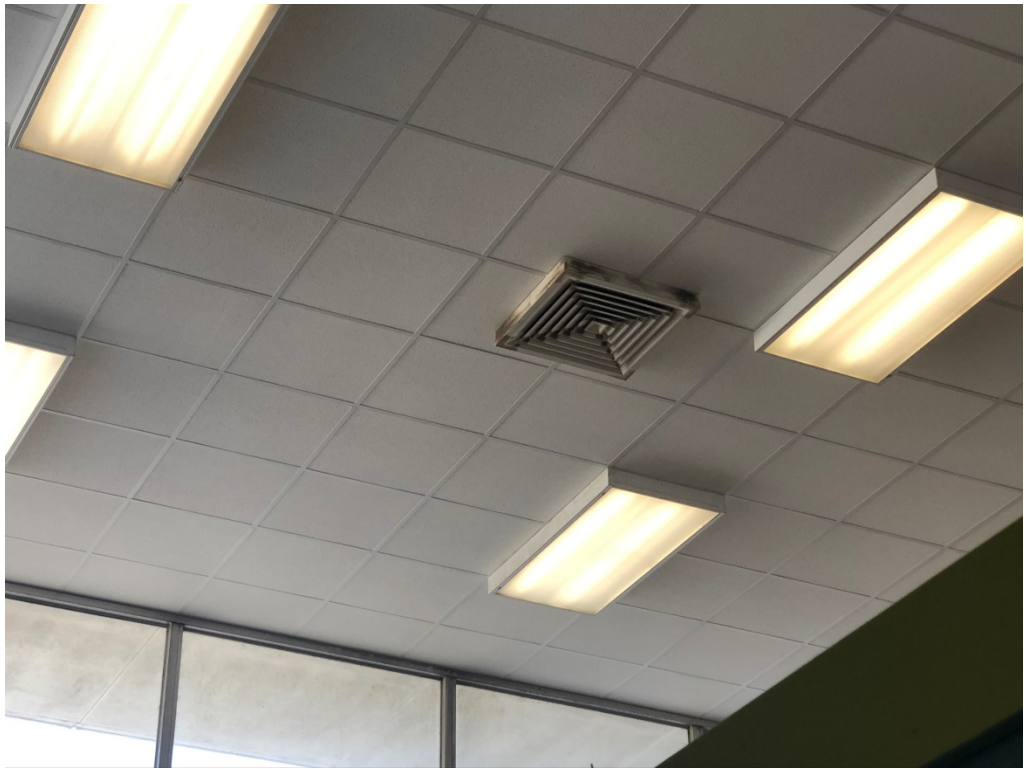
Figure 9 – Vents still to be Painted

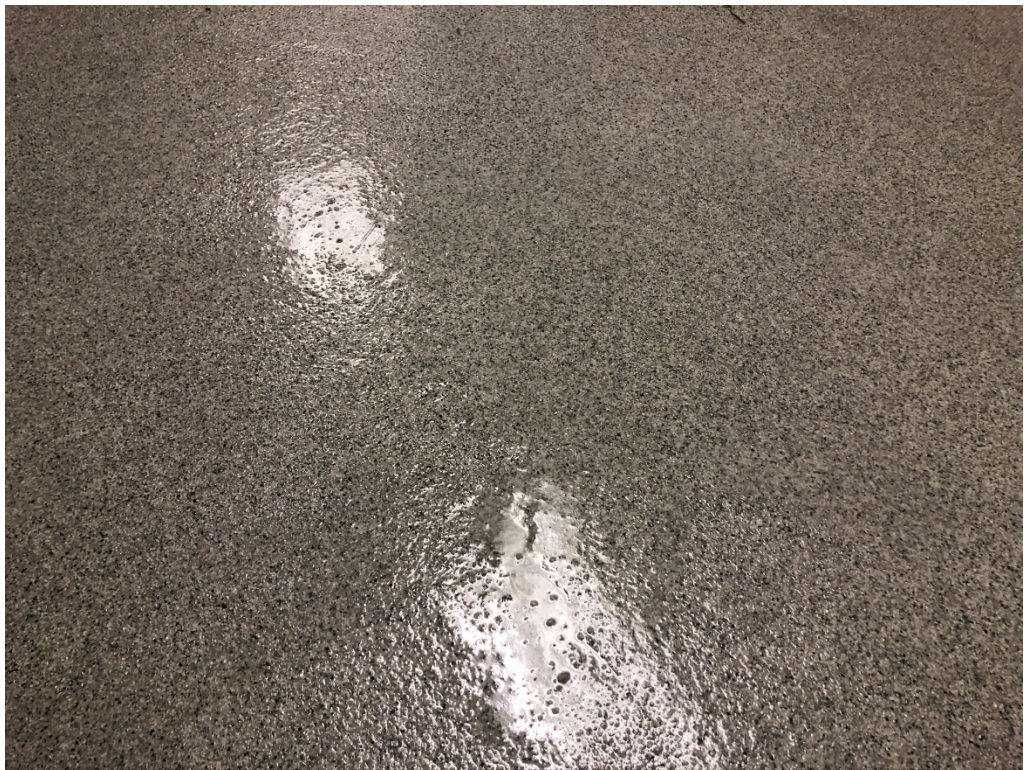
Figure 10 – Field Gloss Uneven (contractor indicated that they would add 2nd coat to correct)

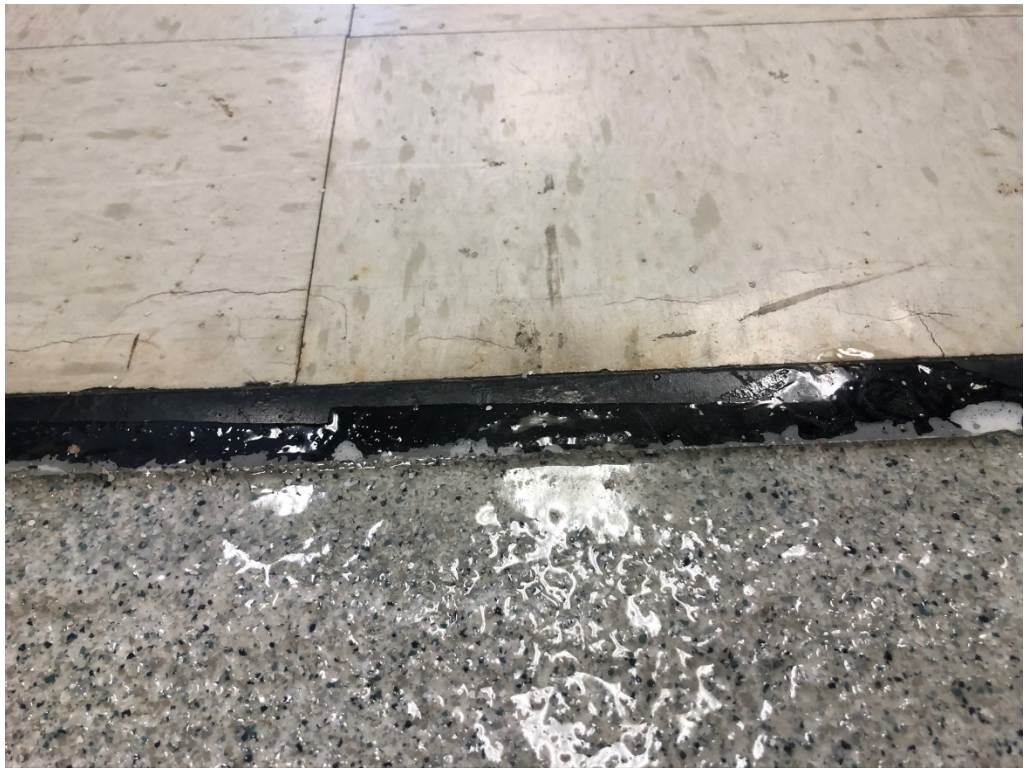
Figure 11 – Cleaning of Threshold Necessary

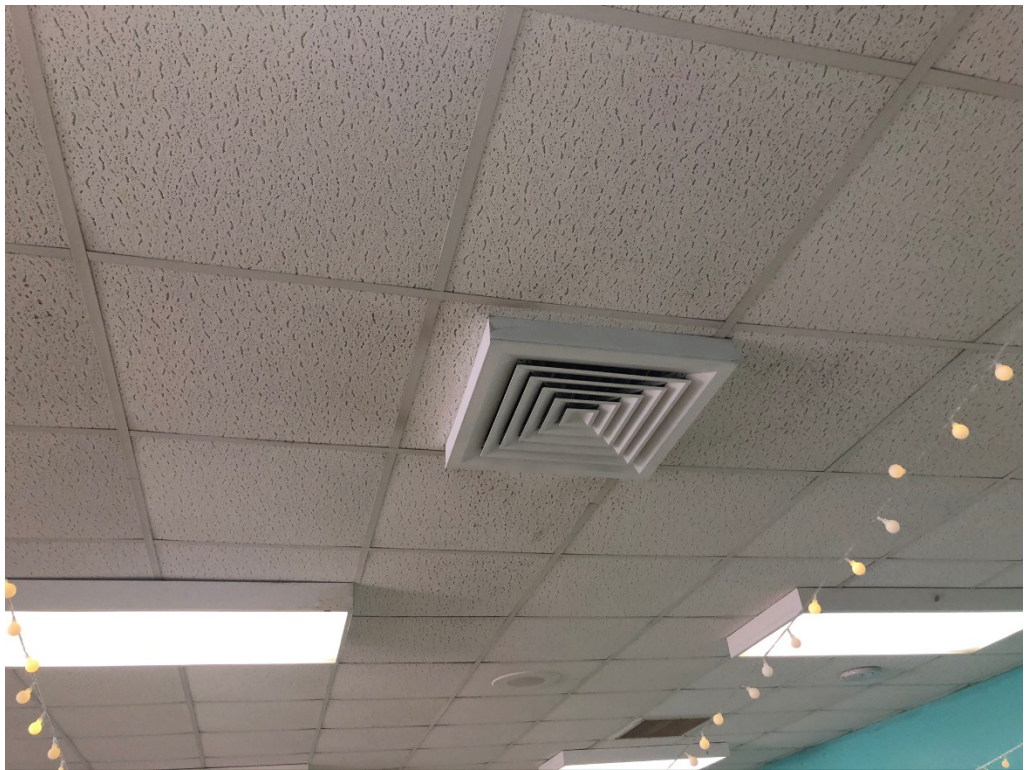
Figure 12 – Some Touch up Required at Paint for this Vent in Lobby A

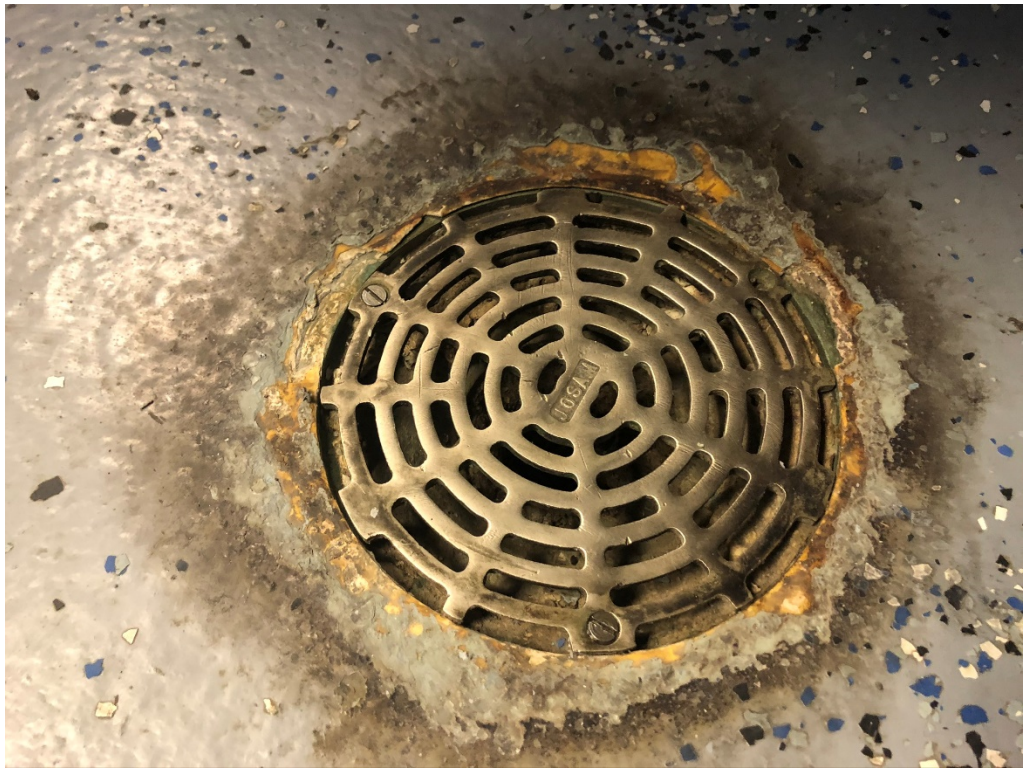
Figure 13 – Drain Grates Installed

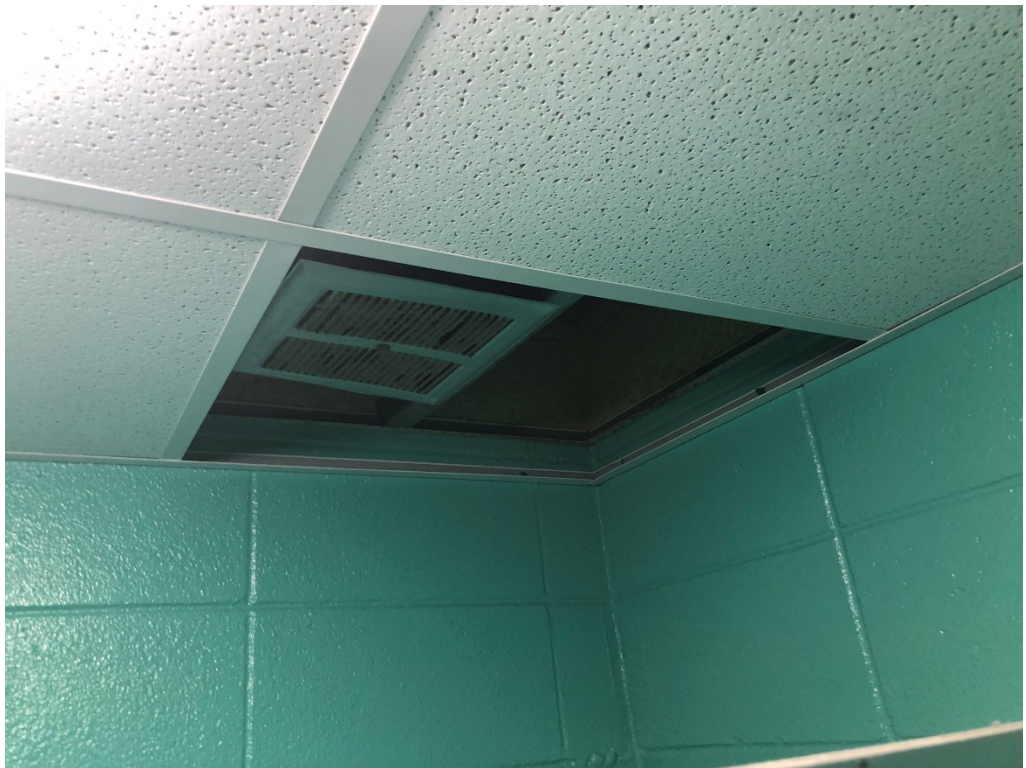
Figure 14 – Ceiling Tile and Vent Unfinished (RM T07)
