Architect's Field Report

201 Park Court, Suite B	16 January 2020	
Ridgeland, MS 39157 P 601.790.9432	18043-BW Beechwood Elementary / Report Number 017	
F 888.281.0547	Contract	Thrash Construction
One Jackson Place, Suite 250	Date / Time	15 January 2020 / 5:15 PM
188 East Capitol Street	Weather / Temp	Drizzle / 70 ° F
Jackson, MS 39201-2100	Est % Complete	58%
P 601.352.5411	Sched Conformance	+/- 00 days
F 601.352.5362	Work in Progress	None
161 Lameuse Street, Suite 201	Present at Site	School Staff Paul Purser, DBA
Biloxi, MS 39530	Observations	Arriving, I walked building 1 to 3 in succession. I noted some work
P 228.374.1409		performed in vestibules in preparation for FRP install.
F 228.374.1414		The Gym floor was in use.
		Vestibule Resinous Flooring Cleanup Issues still need attention.
	Items to Verify	None
	Action Required	None
	Report By:

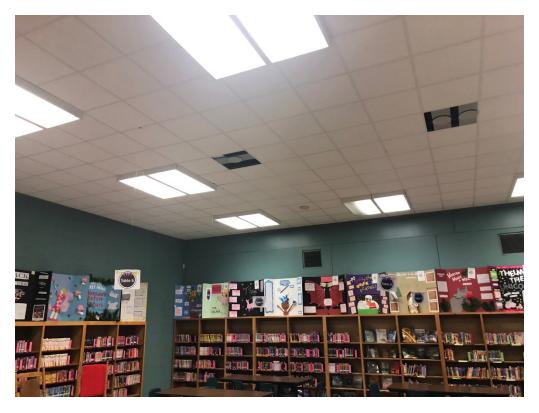
Figure 1 – Library Ceiling Installed

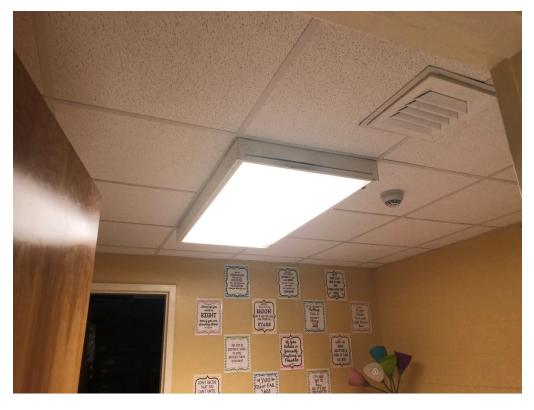
Figure 2 – Library Auxiliary Room

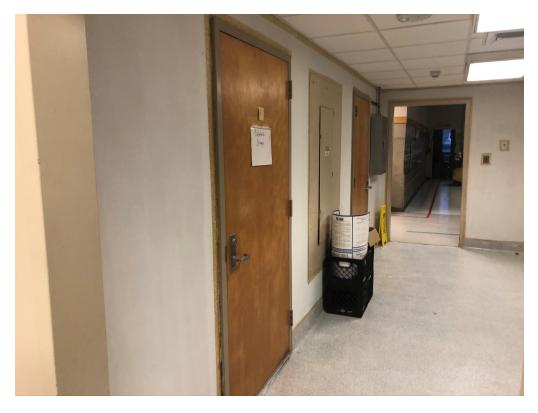
Figure 3 – Primed Panels to Received FRP @ Building 1 Vestibule

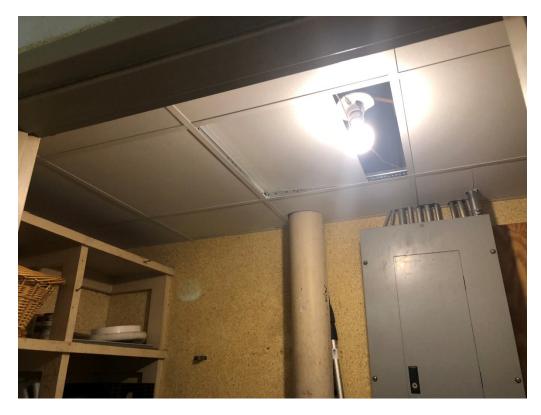
Figure 4 – Building 1 Janitor's Closet Ceiling

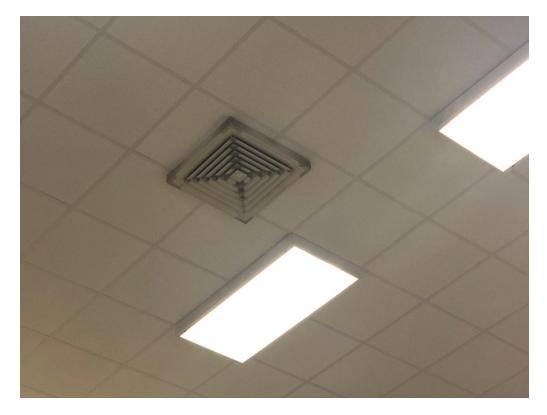
Figure 5 – High Ceiling Vents in Building 1

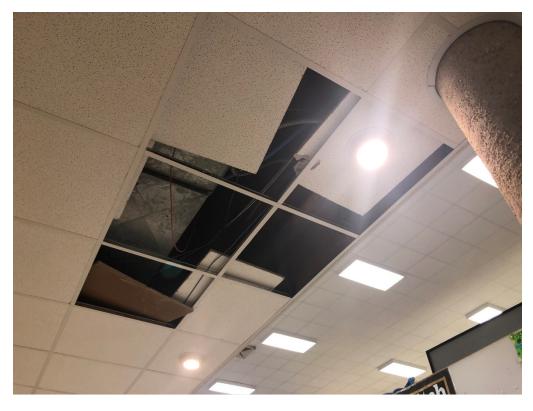
Figure 6 – Corridor in Building 1

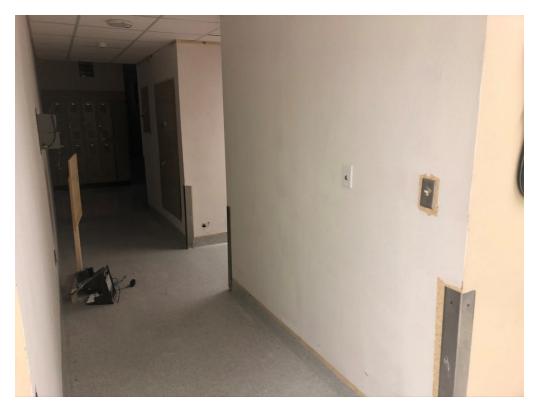
Figure 7 – Primed Panels to Received FRP @ Building 3 Vestibule

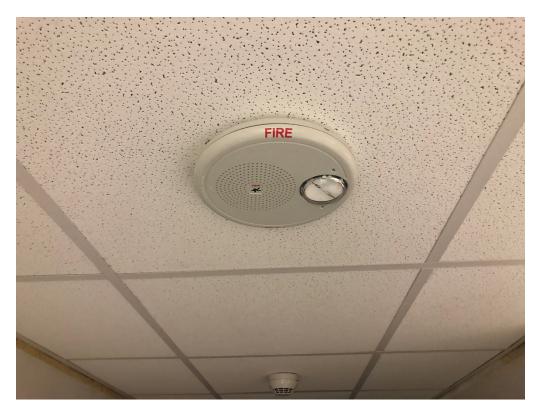
Figure 8 – Fire Alarm Installed in Vestibule Building 3

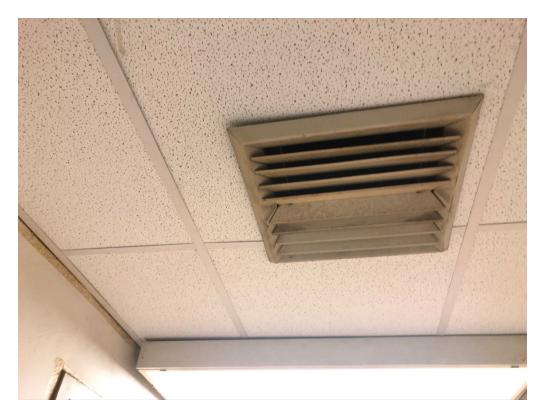
Figure 9 – Some Vents still to Paint
