## Architect's Field Report

04 February 2020

18043-BW Beechwood Elementary / Report Number 020

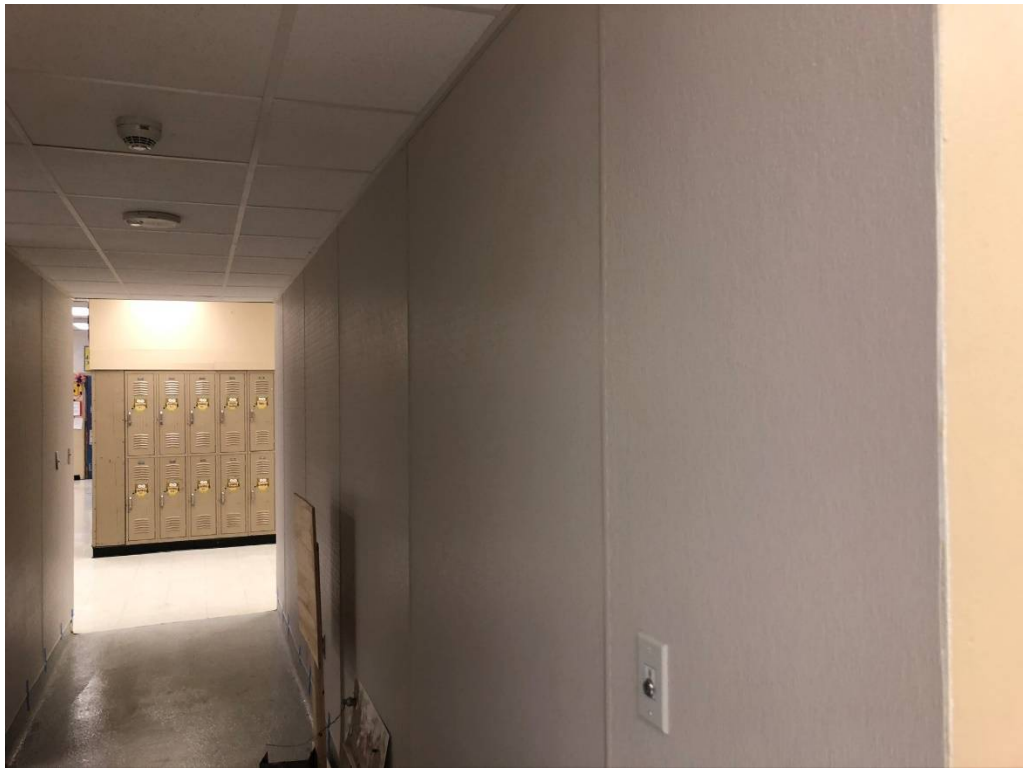
Frp in vestibules has been installed (minus corner guards). Toilet Partitions are complete and in good order.

Figure 1 – FRP installed at Vestibules

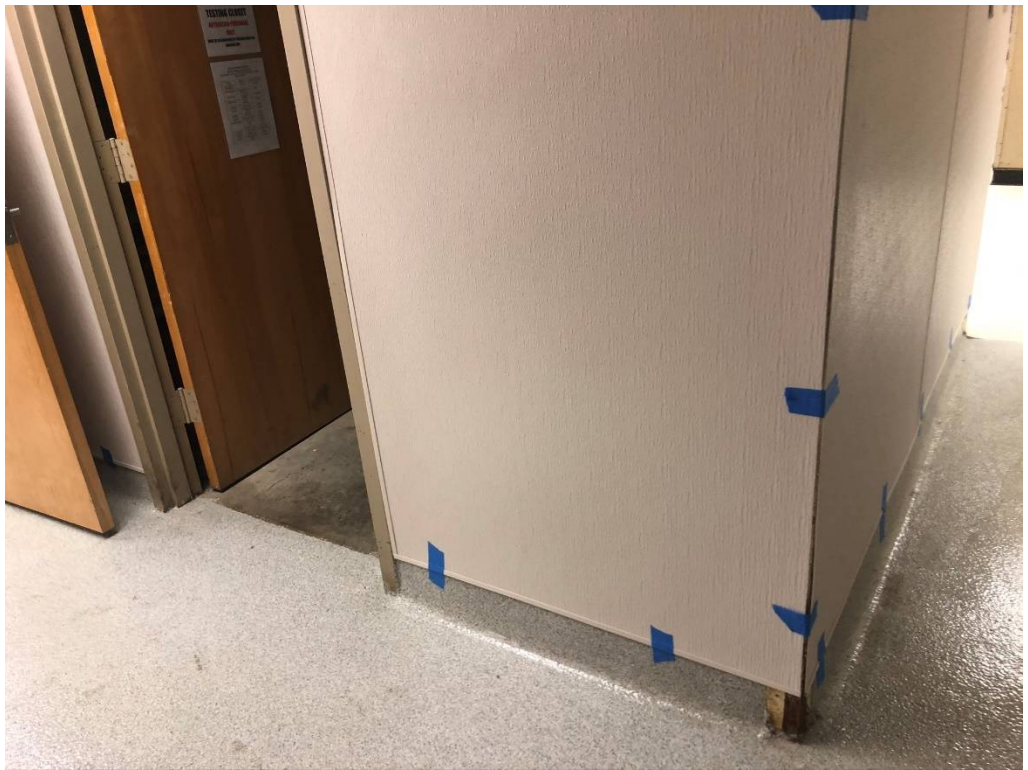
Figure 2 – FRP Corner

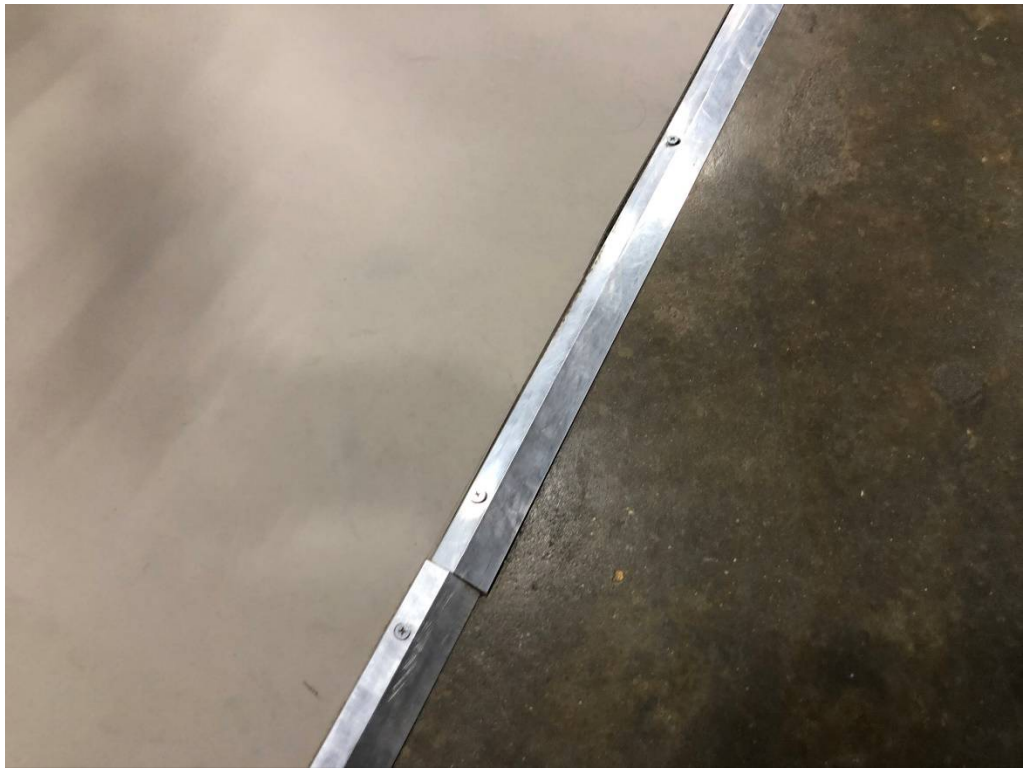
Figure 3 – Damage at Aluminum Threshold in Gym

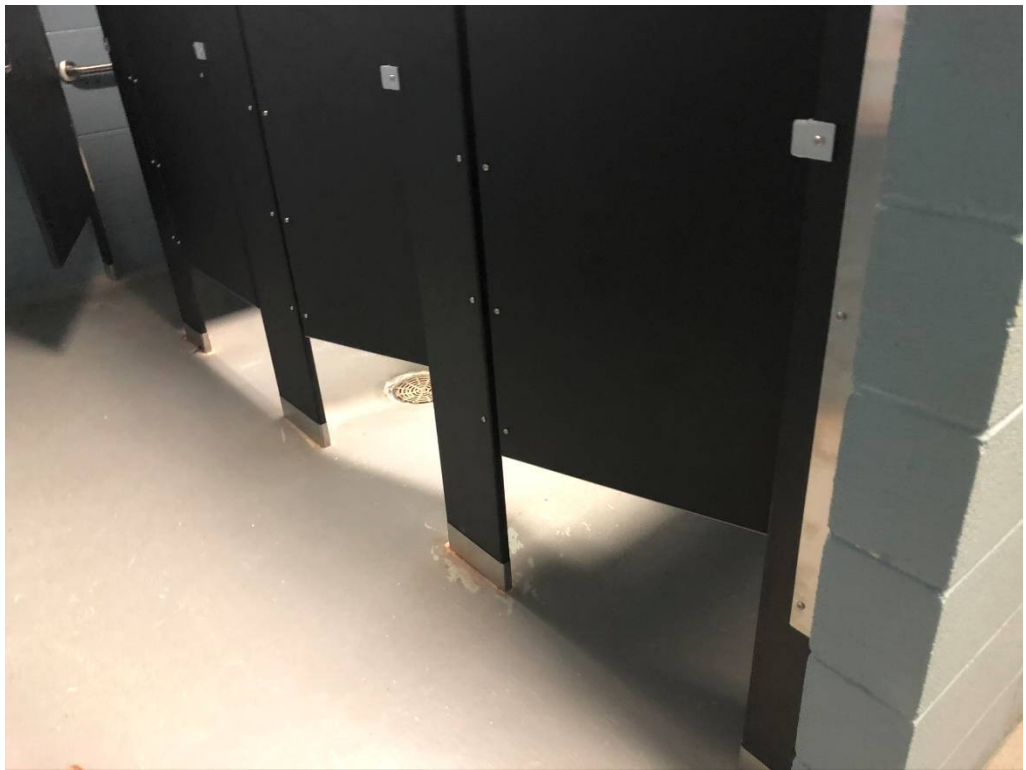
Figure 4 – New toilet Partitions (typical)

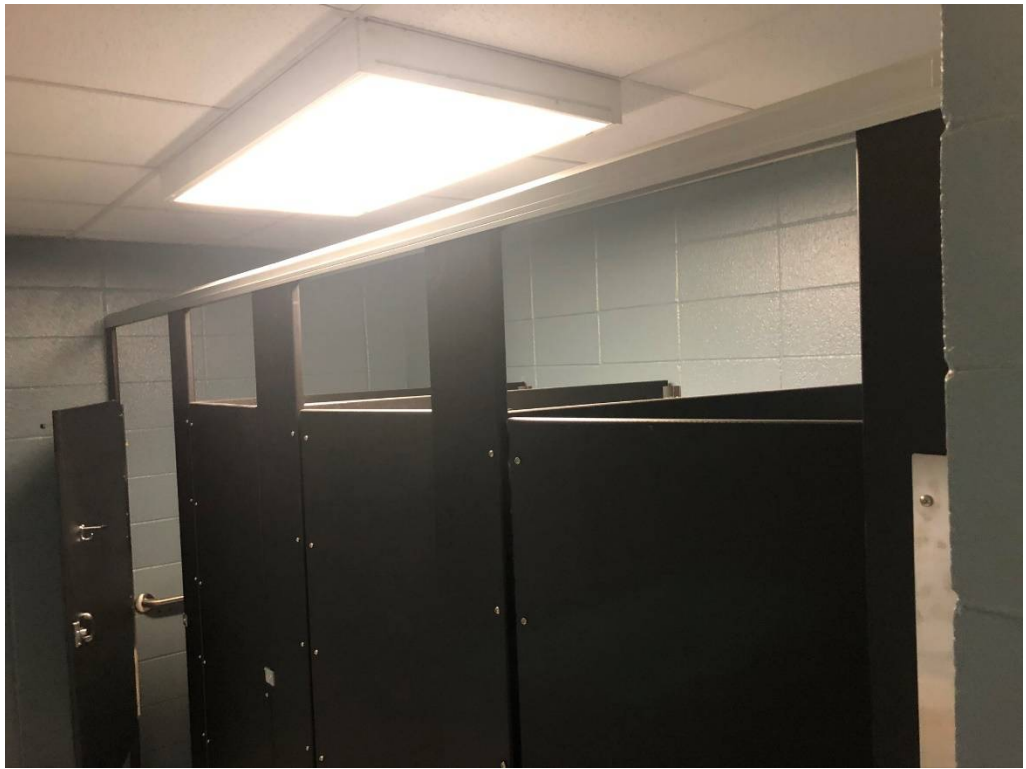
Figure 5 – New toilet Partitions (typical)

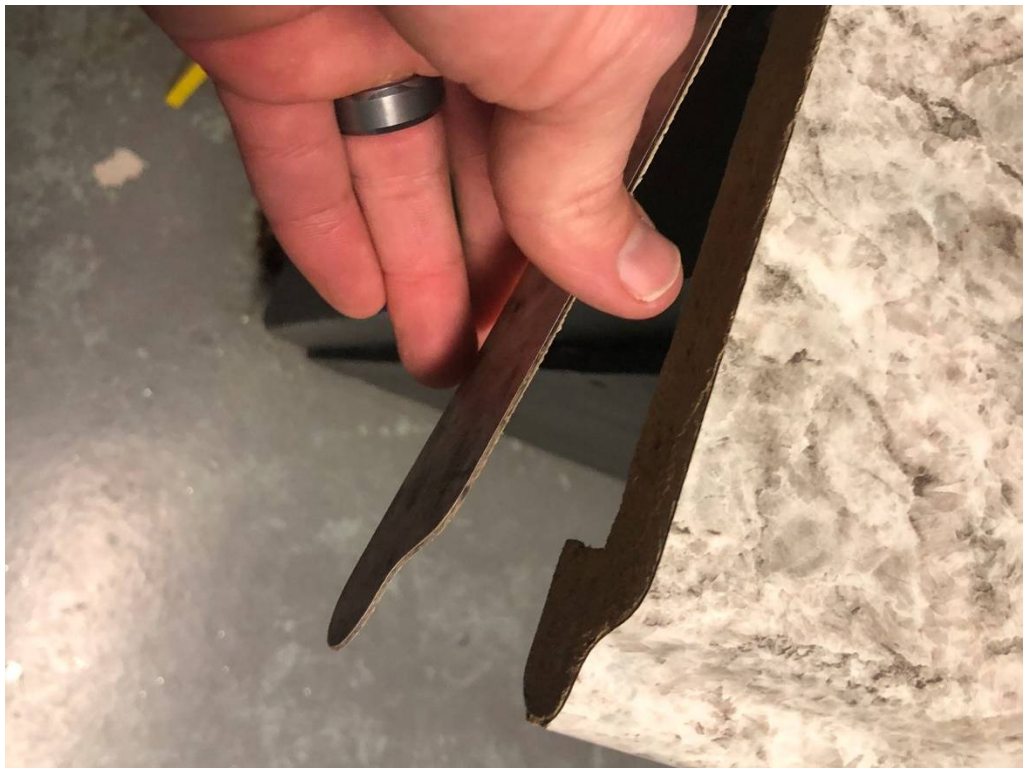
Figure 6 – Damage to New Laminate Counter

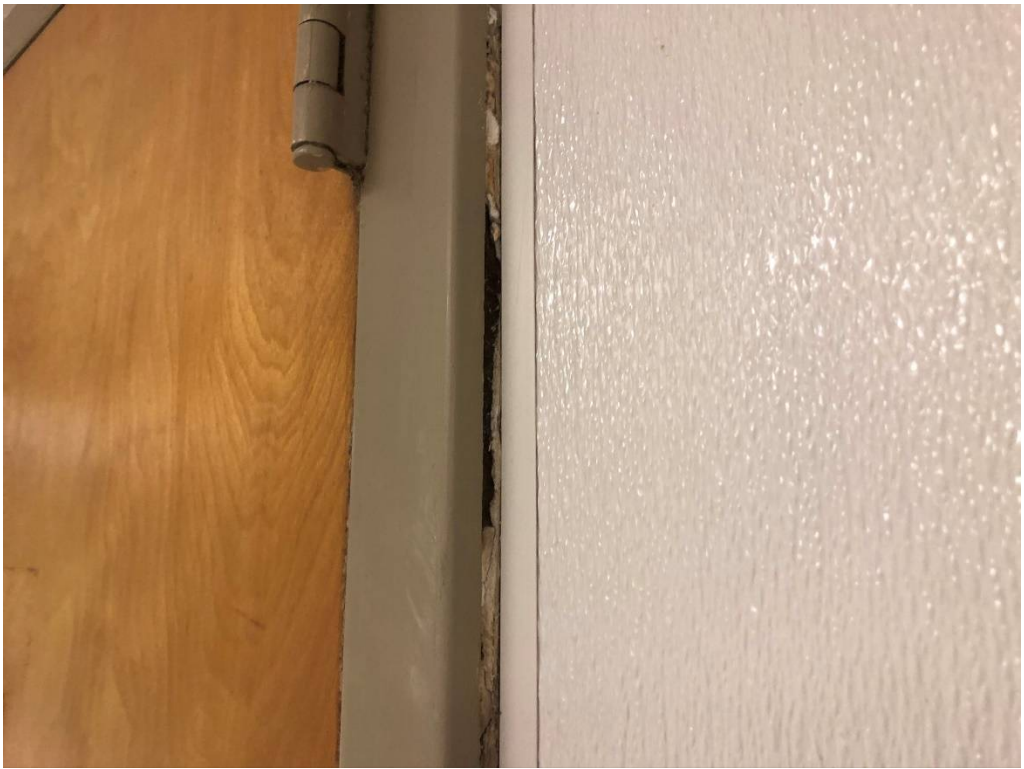
Figure 7 – Exposure at Door Jamb in Building 1 Vestibule

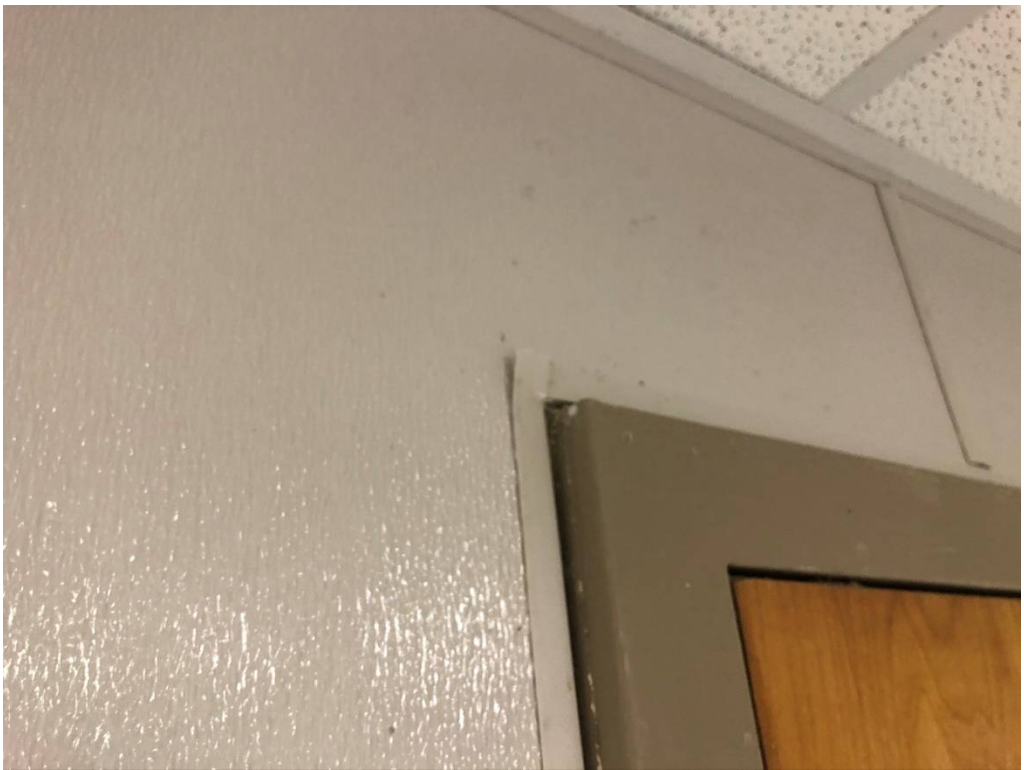
Figure 8 –Upper Corner FRP Kicked Up
