## Architect's Field Report

12 February 2020

18043-BW Beechwood Elementary / Report Number 021

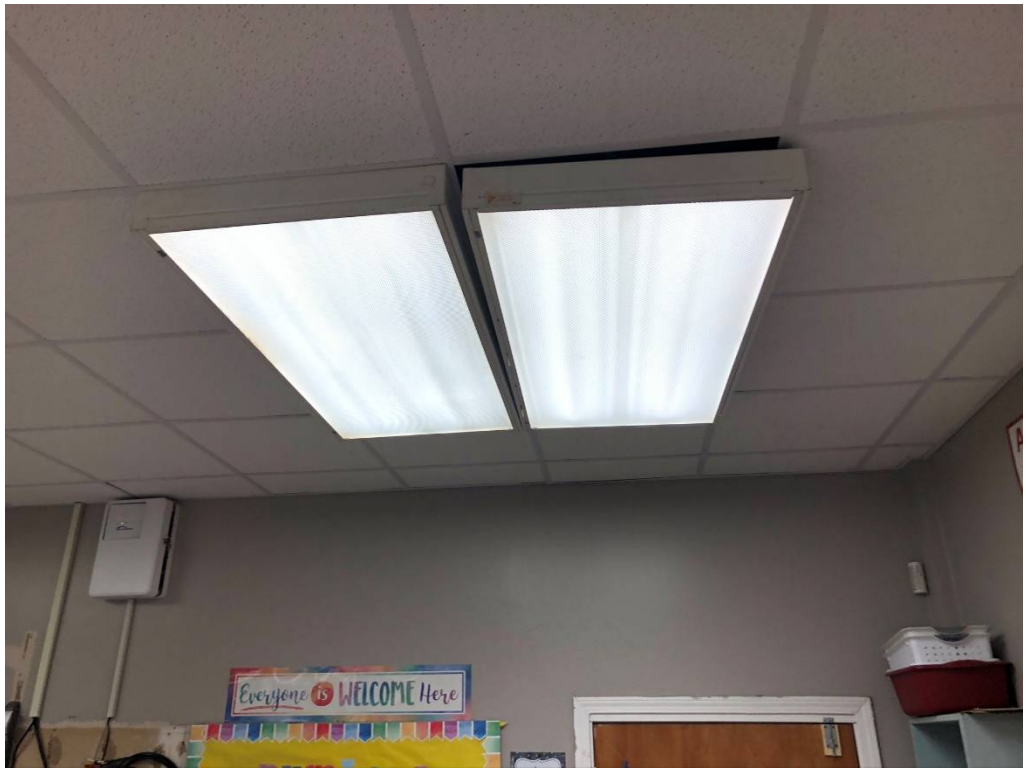
Figure 1 – Light Needs Adjusting in 210A

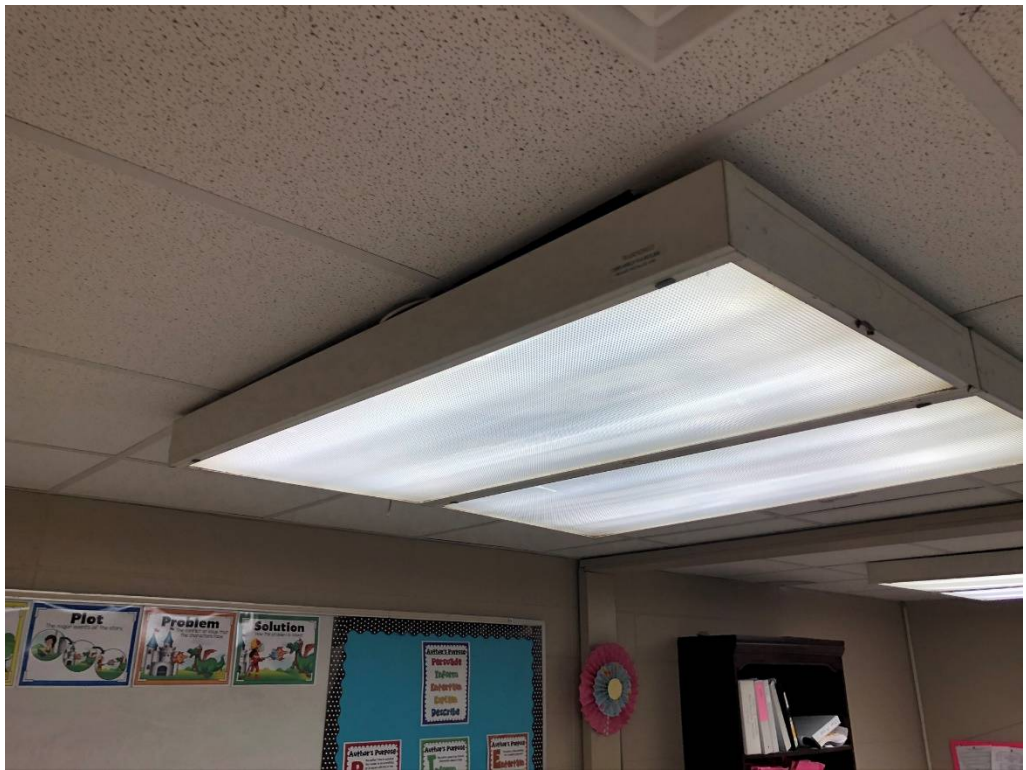
Figure 2 – Light Needs Adjusting in 304
