Architect's Field Report

19 February 2020

18043-BW Beechwood Elementary / Report Number 022

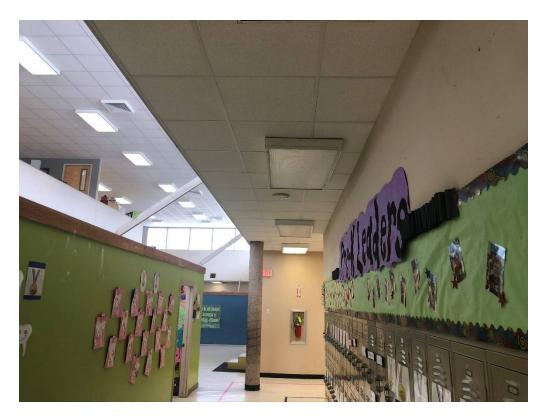
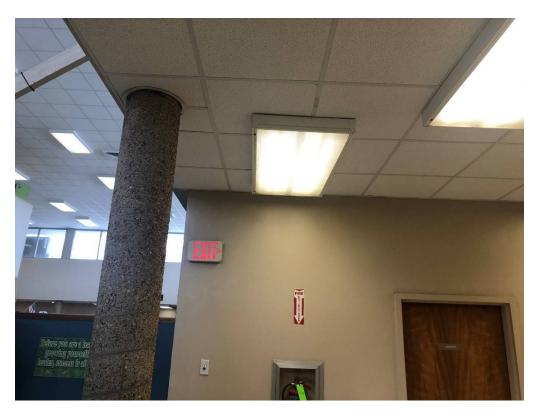
marked last week. Some lights are crooked this week that were not

before in Corridor Space.

Figure 1 – Crooked Lights in Corridor Near Room RM 110

Figure 2 – Crooked Lights in Corridor Near Room RM 110

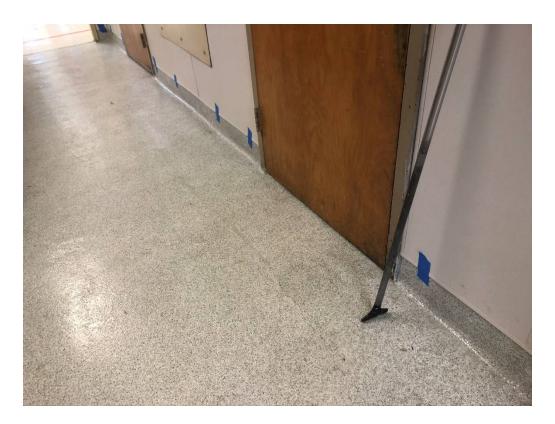
Figure 3 – Tape on FRP from install
